**ANNUAL REPORT
JULY 2013 THROUGH JUNE 2014
CALLE DEL BARCO
LANDSLIDE ASSESSMENT DISTRICT
MALIBU, CALIFORNIA**

Prepared for:
CITY OF MALIBU

April 2015
Fugro Project No. 04.62140605

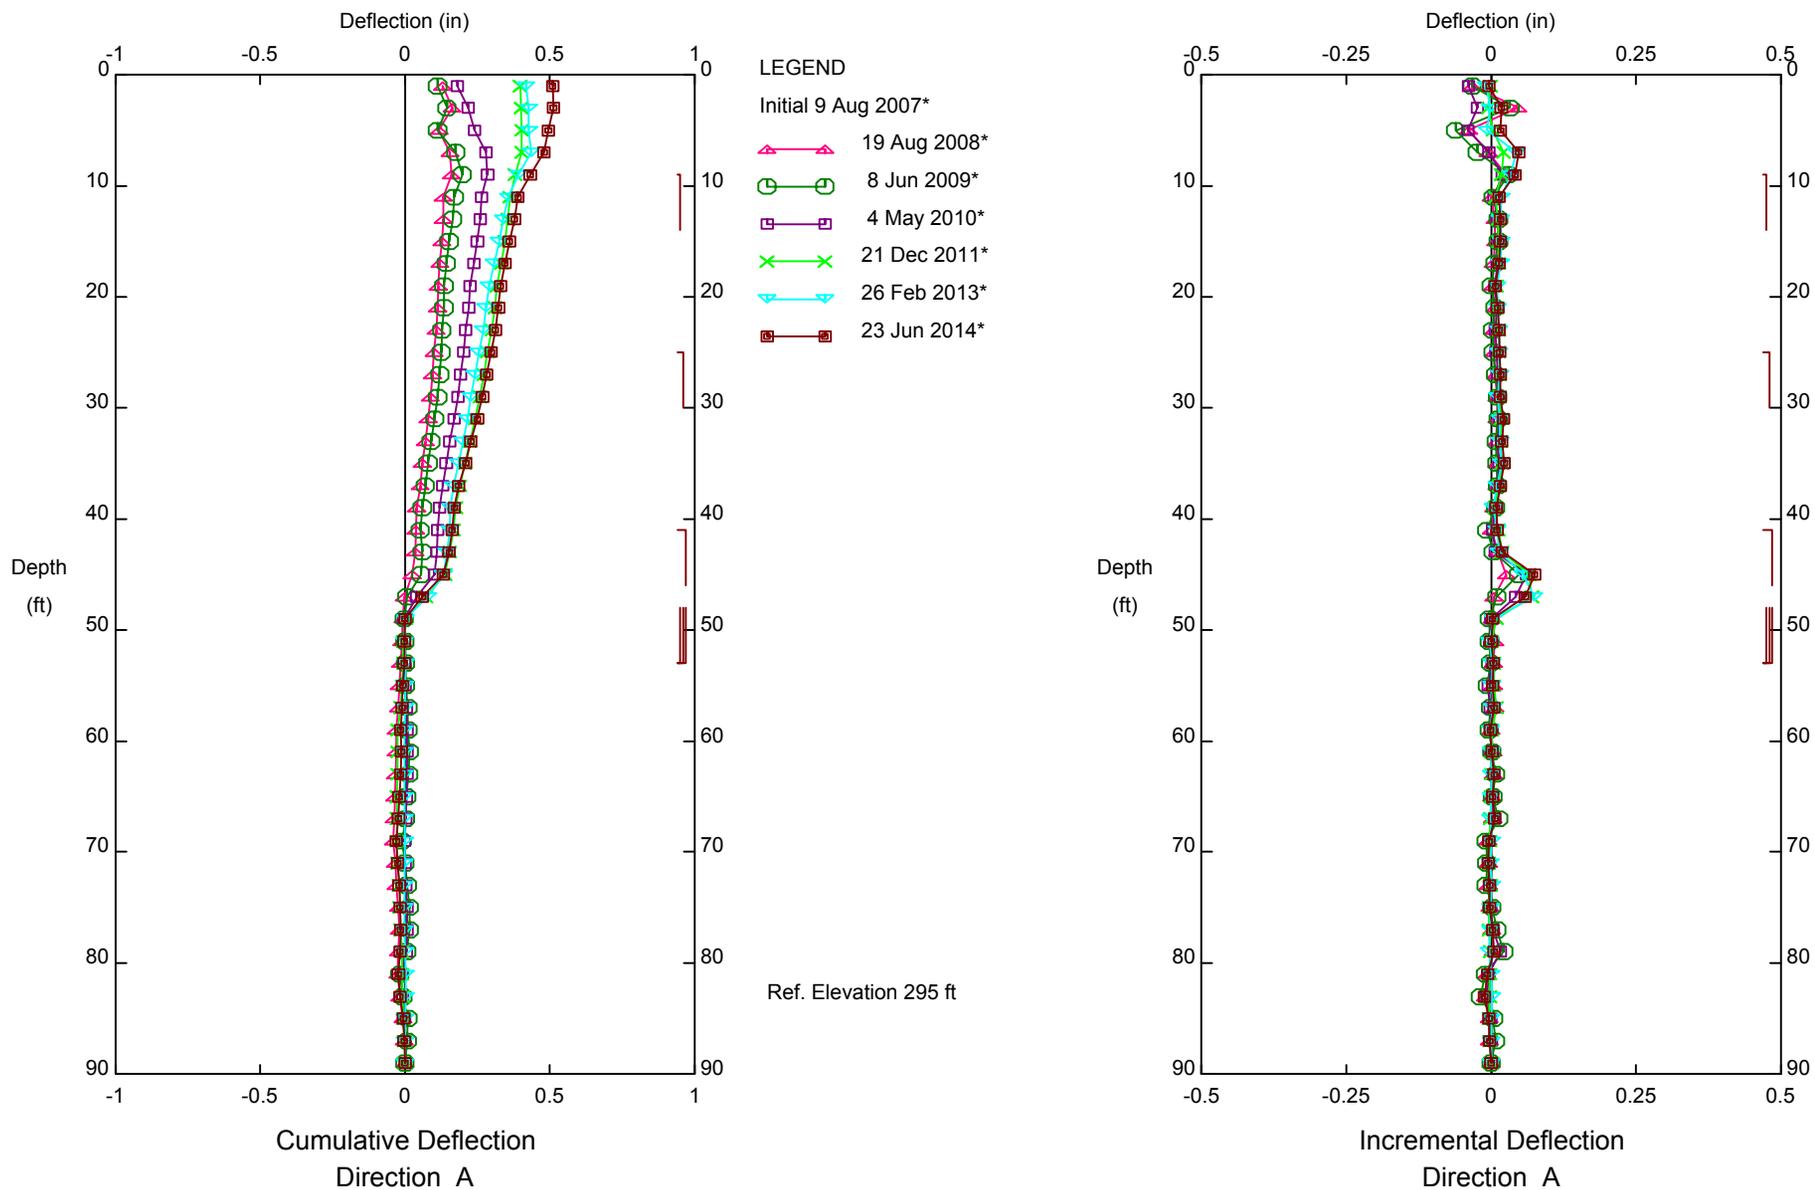
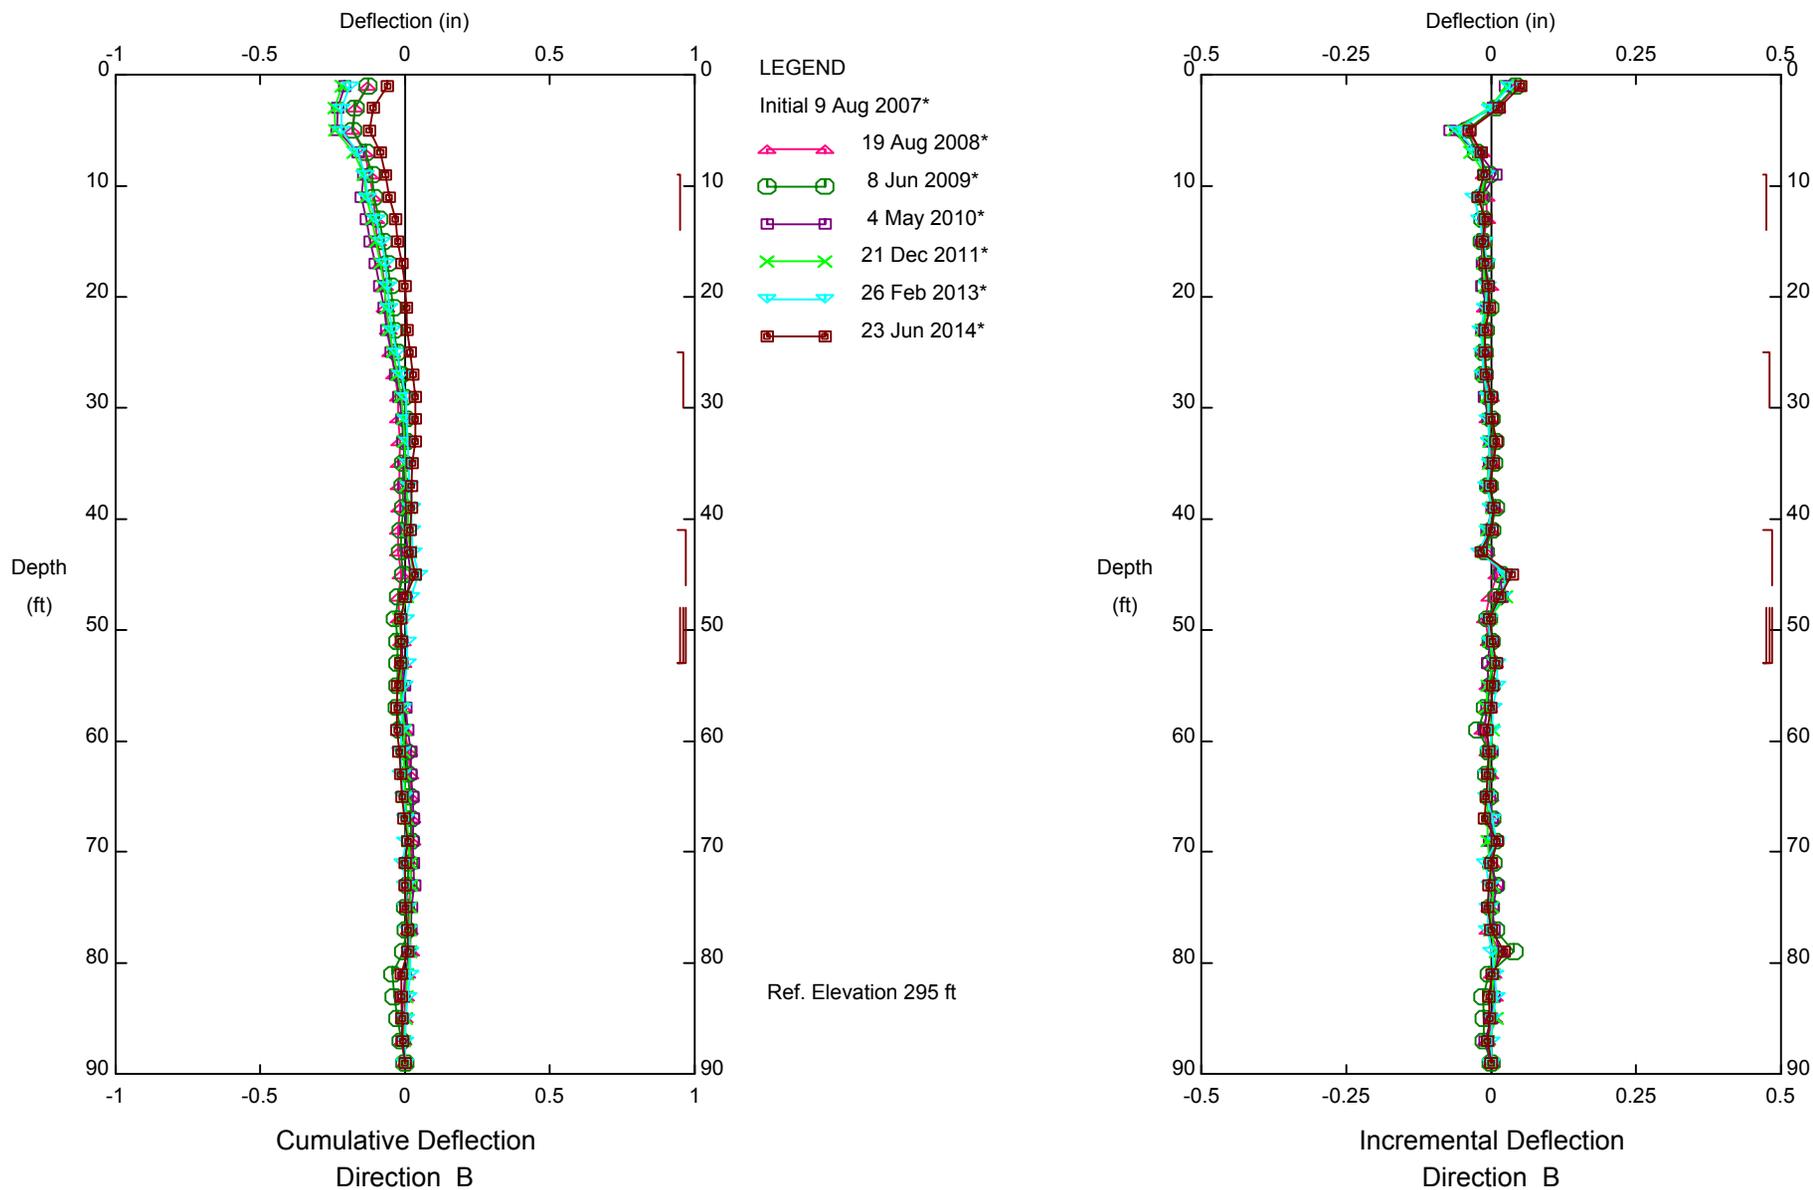
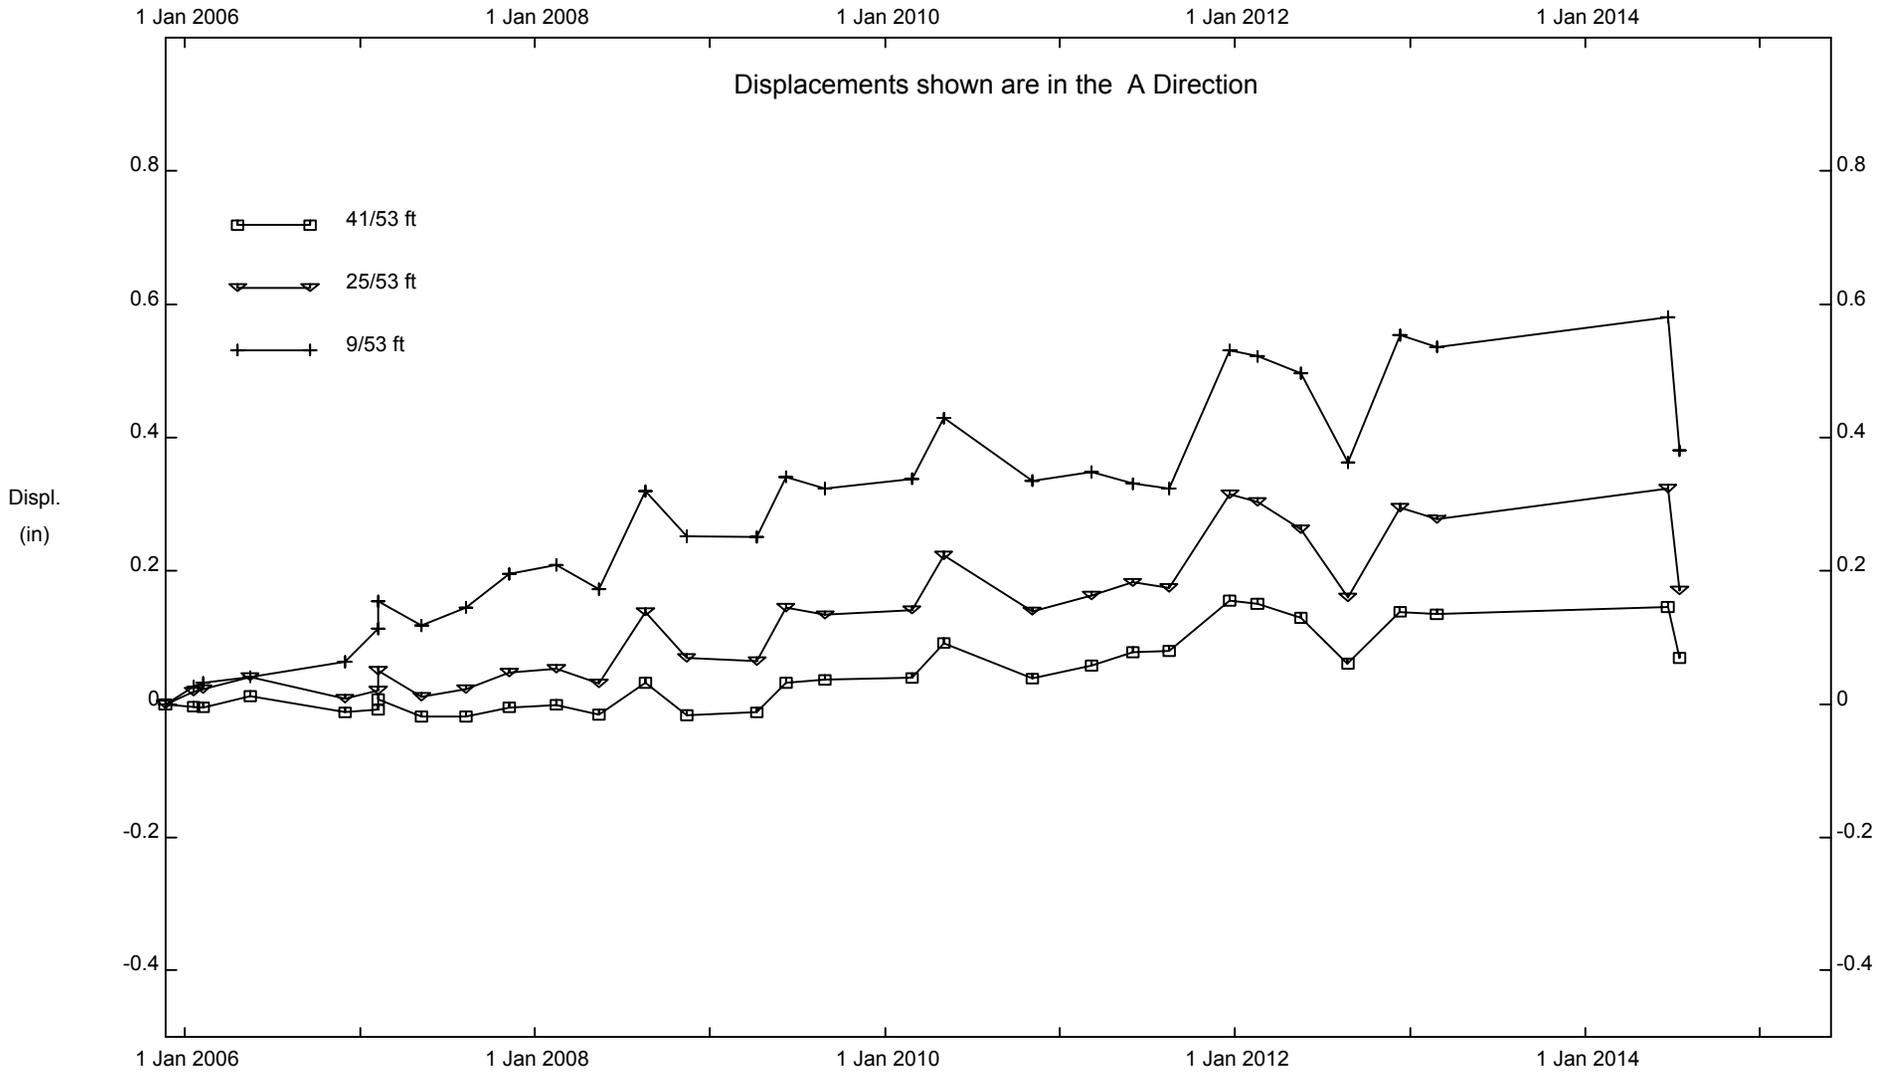
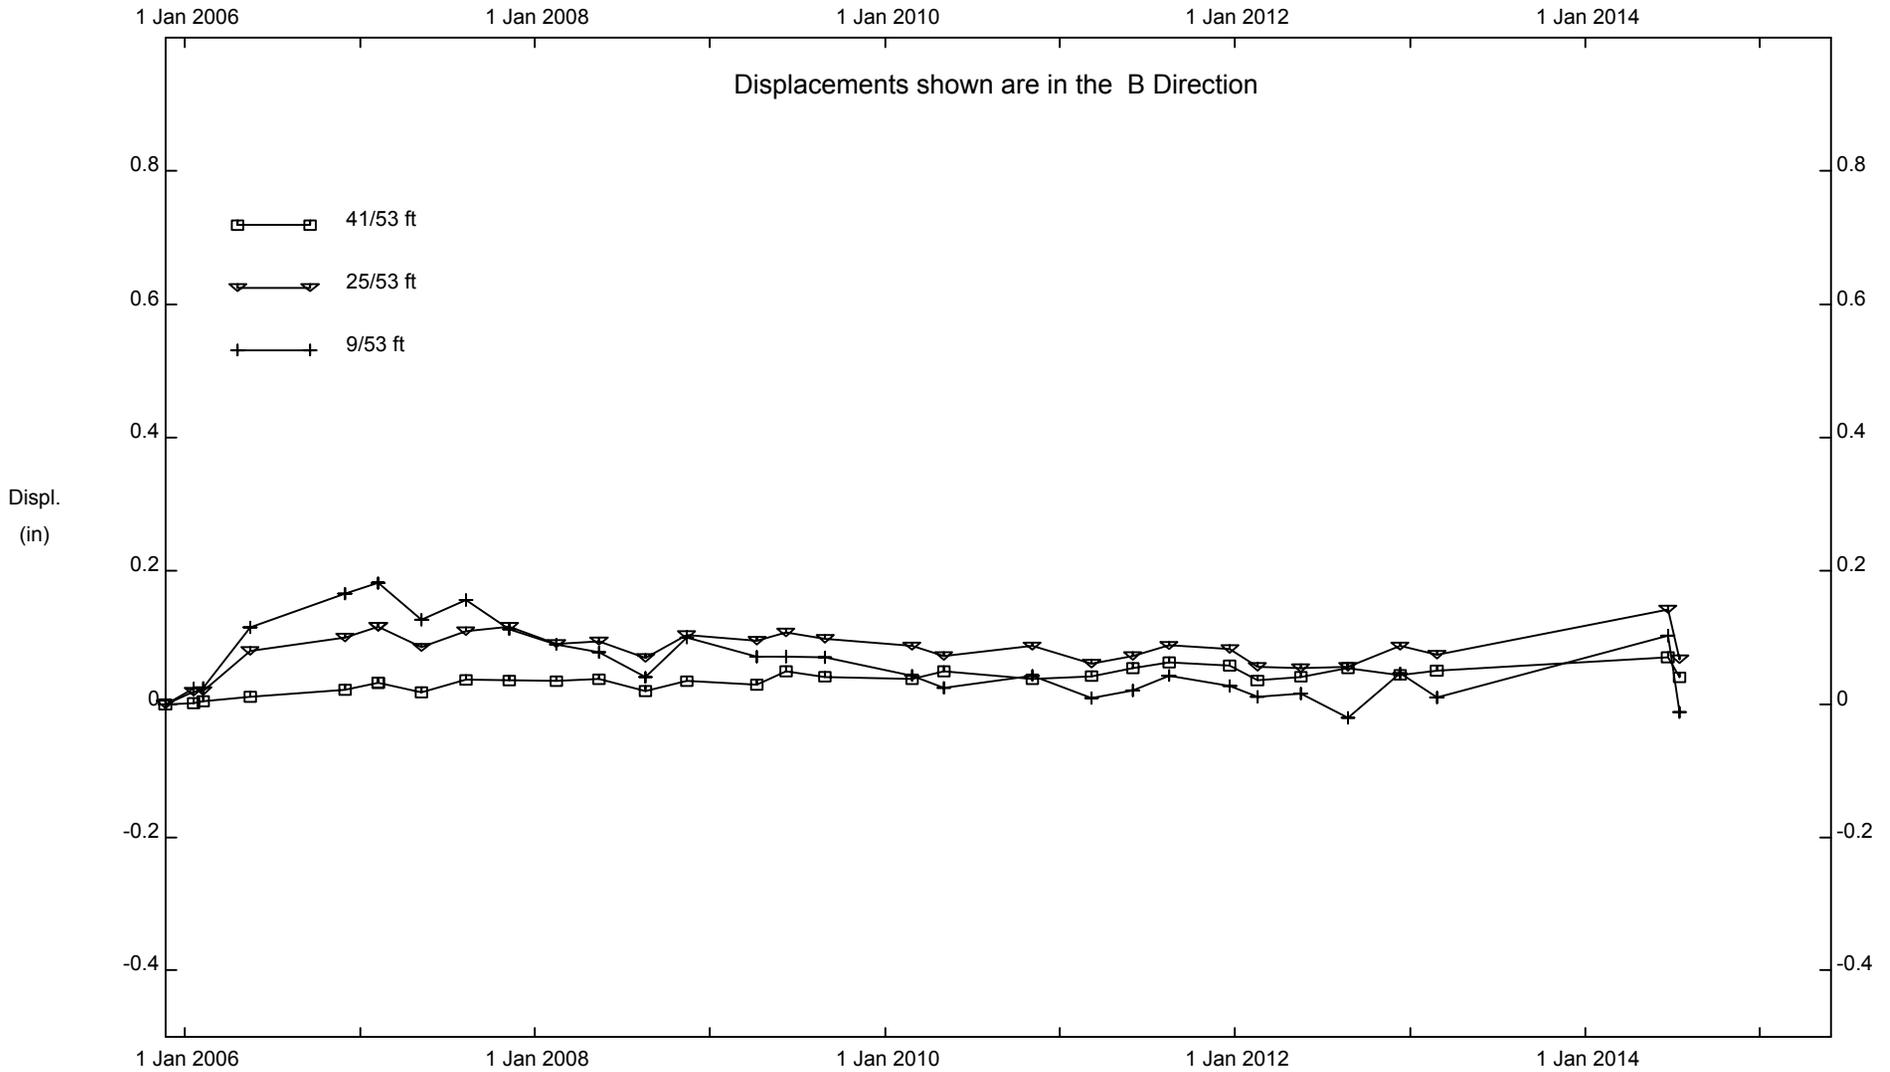
Inclinometer SI-16 exhibits a pattern of movement measured at the ground surface at an average rate of up about 0.08 inches/year since 2005, resulting in approximately 0.5 inches of cumulative displacement at the ground surface since the 2004-05 monitoring period. Movement of the inclinometer appears to be both translational at specific depths between 0 to 10 feet and between 40 and 85 feet and rotational about a hinge point at about 50 feet below the ground surface. This is similar to the movement observed in inclinometer SI-9 located in close proximity to SI-16.

Although the movement observed in inclinometers SI-9 and SI-16 has not produced observed distress in pavements or other development of which Fugro is aware, the movement is nevertheless quantifiable and can be defined by a clear trend.
