**ANNUAL REPORT
JULY 2013 THROUGH JUNE 2014
MALIBU ROAD LANDSLIDE ASSESSMENT DISTRICT
MALIBU, CALIFORNIA**

Prepared for:
CITY OF MALIBU

April 2015
Fugro Project No. 04.62140604

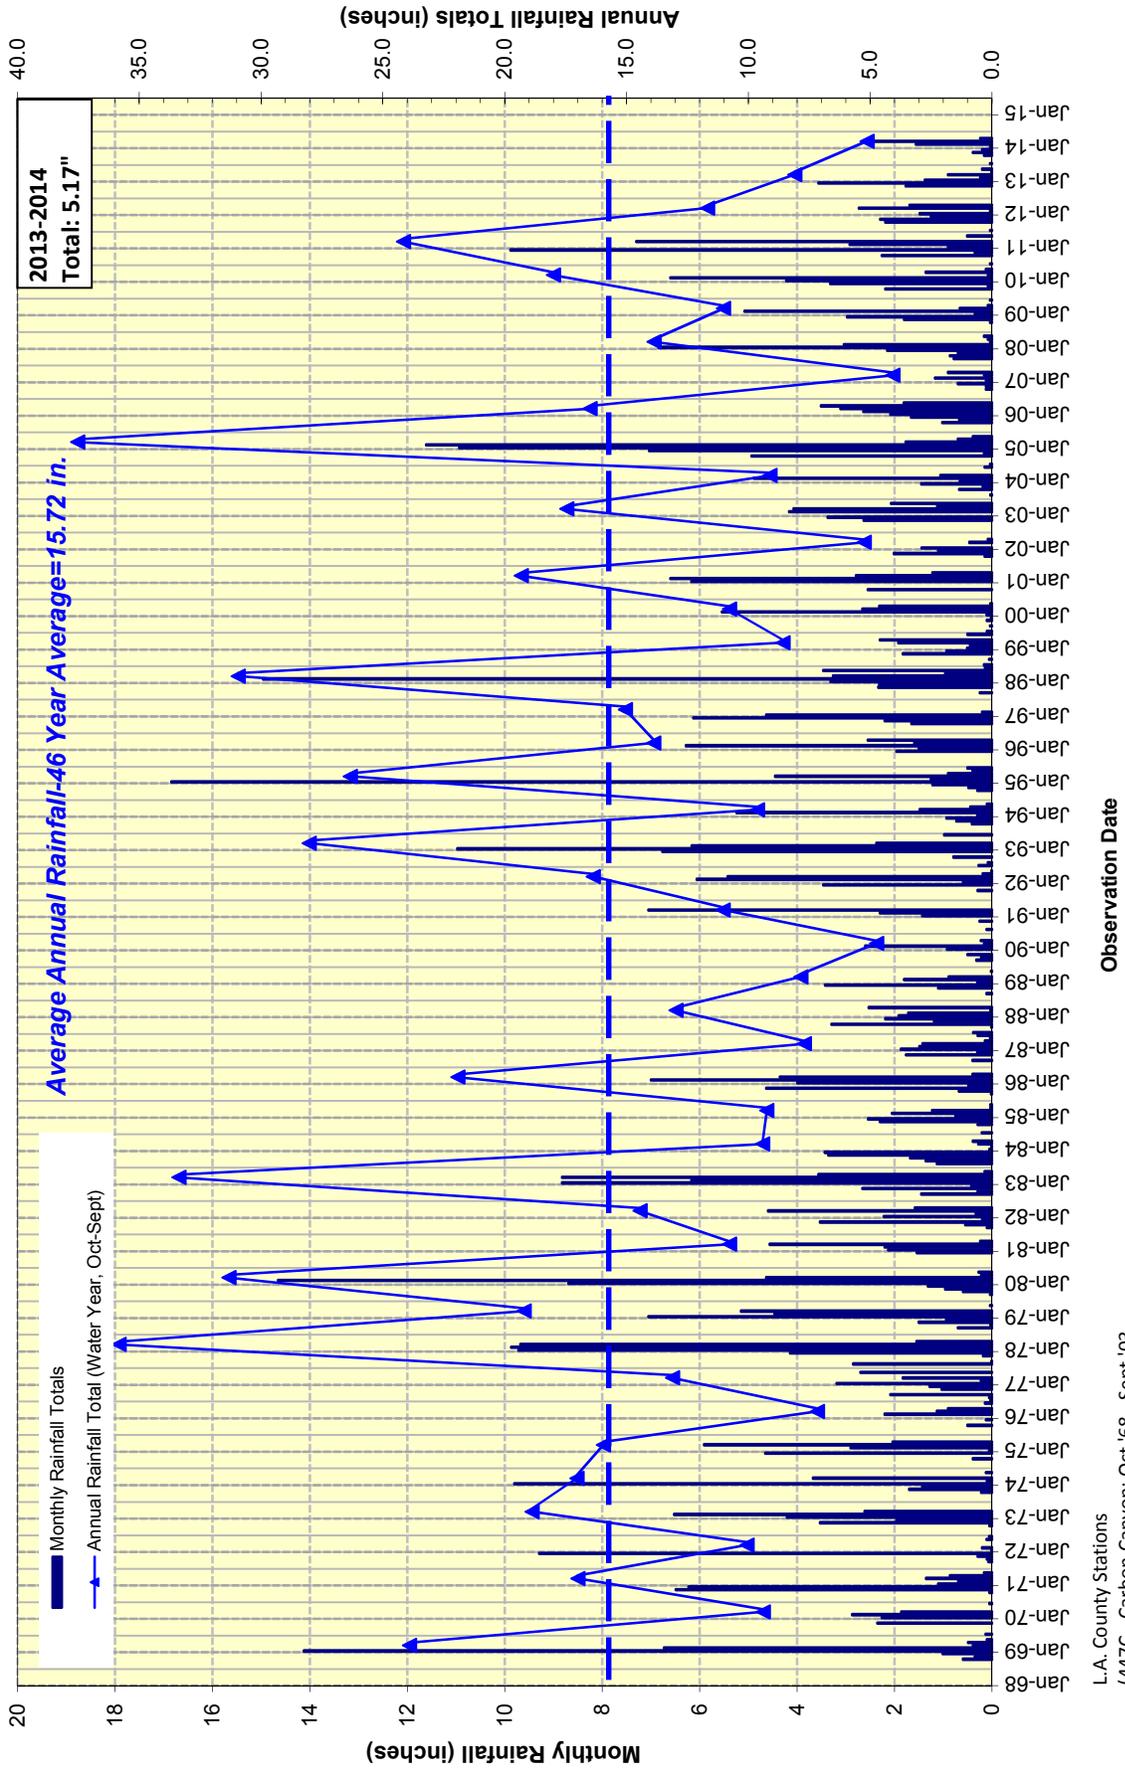
RAINFALL GRAPH
 Malibu Road Landslide Assessment District
 Malibu, California

Rainfall totals were tabulated based on recorded values from the Los Angeles County Rainfall Station 1239 - located at Big Rock Mesa. A graph of historical monthly rainfall and average annual rainfall is shown on Plate 3 - Rainfall Graph.

Rainfall data indicate that approximately 5.17 inches of precipitation fell during the monitoring period from July 2013 through June 2014. The average annual rainfall from 1968 to 2013 in the Malibu area for the monitoring period July through June is approximately 16.0 inches.

Rainfall data are usually analyzed in terms of the annual "rain season" that covers the time period from October 1 through September 30. Rainfall for October 1, 2013, through June 30, 2014, was approximately 5.13 inches. This is approximately 32 percent of the average annual rainfall of 16.0 inches for the rain seasons of 1968 through 2013.

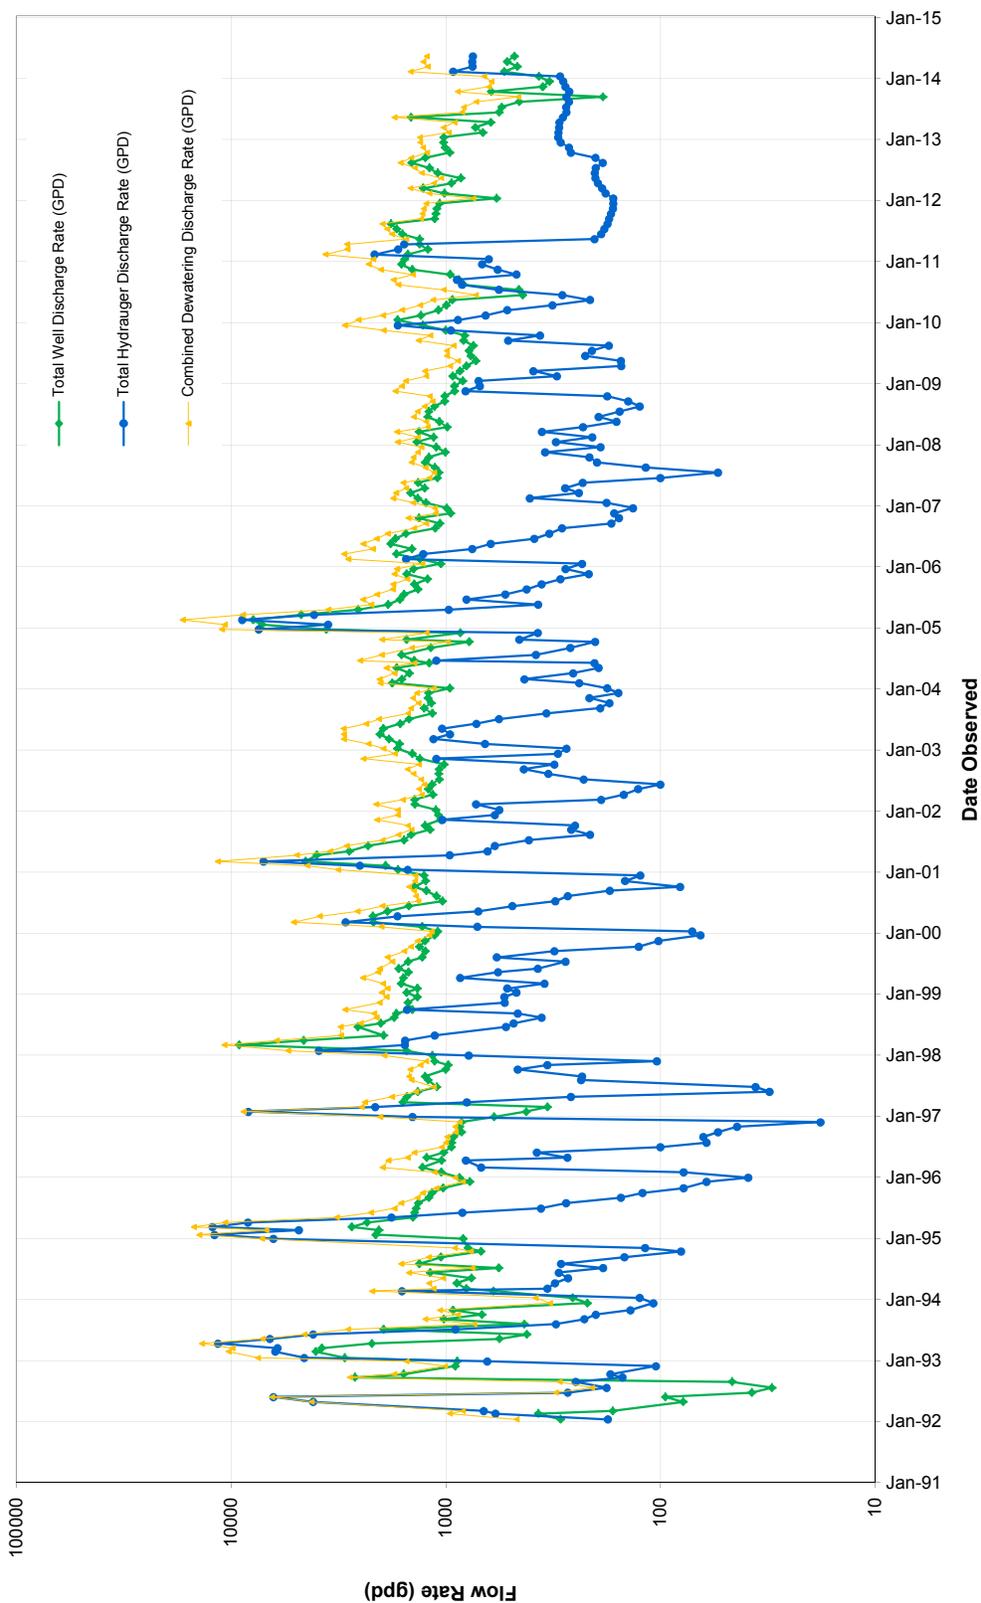
TOTAL DISCHARGE - WELLS AND HYDRAUGERS
Malibu Road Landslide Assessment District
Malibu, California

A graph of the production rate for all dewatering wells is presented on Plate 4. Graphs showing production rates of individual wells are provided in Appendix B. Production data for the dewatering wells indicates the following:

- The average total well production rate for this monitoring period was approximately 452 gallons per day (gpd). That represents a decrease of about 56.5 percent from the previous monitoring period of 1,038 gpd.

A graph of the production rate for all hydraugers is presented on Plate 4. Graphs of individual production rates for all hydraugers are included in Appendix B. Data for the hydraugers indicates the following:

- The average production rate for all hydraugers over the monitoring period is approximately 449 gpd. This represents an increase of approximately 75 percent from the average production rate of 256 gpd for the previous monitoring period.

A combined graph of the total dewatering rate for all dewatering wells and hydraugers is presented on Plate 4. Total dewatering production data for the hydraugers and wells indicates the following:

- The average total dewatering rate during the monitoring period was approximately 901 gpd. This represents a 30 percent decrease in the average rate relative to the 1,294 gpd average recorded during the previous monitoring period.

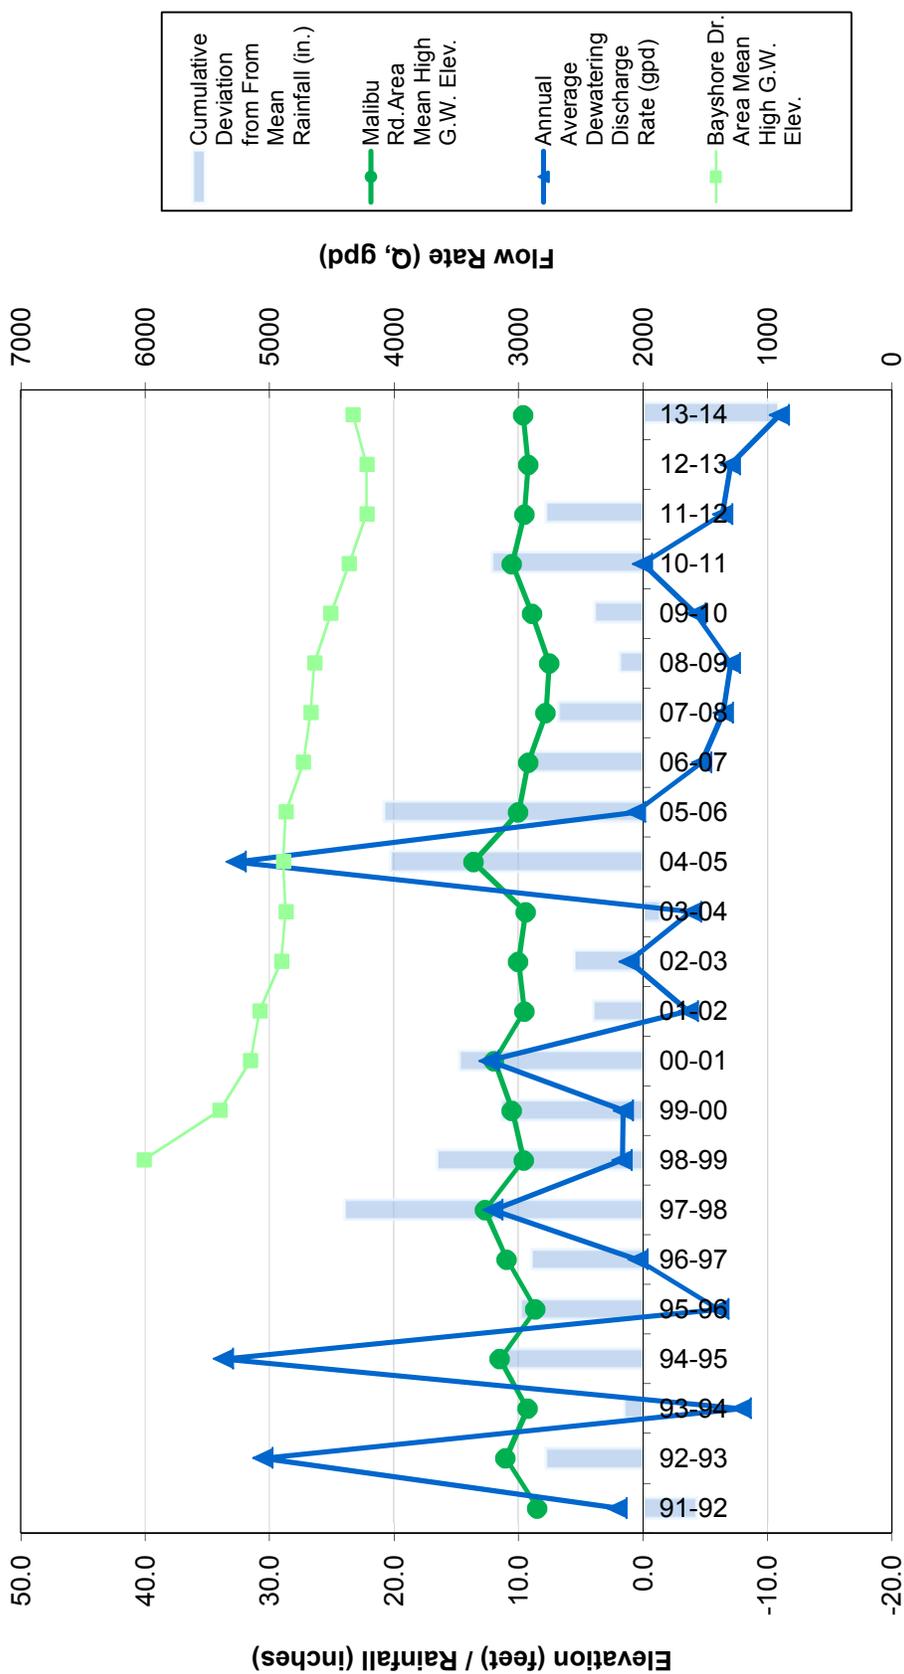
GROUNDWATER LEVELS, DEWATERING AND RAINFALL

A summary graph of mean high groundwater elevations for Malibu Road is presented on Plate 5 - Groundwater Levels, Dewatering, and Rainfall. Plate 5 also shows the average dewatering output (gpd) and the cumulative deviation from the mean annual rainfall. The mean annual rainfall used for the chart was computed using all of the data from 1988 through the present. This graph illustrates that since 2010-2011, annual rainfall has been generally decreasing. During the same period, the average dewatering output has been decreasing.

Groundwater levels rose significantly immediately following the record rainfall in the winter of 2004 to 2005 (37.6 inches). Since about mid-2005, groundwater levels in the eastern

and western portions of the district under Malibu Road have been slowly rising, while levels in the central portion of the district under Malibu Road have remained the same. Groundwater levels under Bayshore Drive have generally decreased since mid -2005. Groundwater levels under Malibu Road and Bayshore Drive the past two reporting years (2012-13 and 2013-14) have remained essentially the same, the result of below-average rainfall years (8.06 and 5.17 inches, respectively). Groundwater levels at SI-5 have decreased significantly following the installation of the replacement dewatering well, W-14, in October 2008.

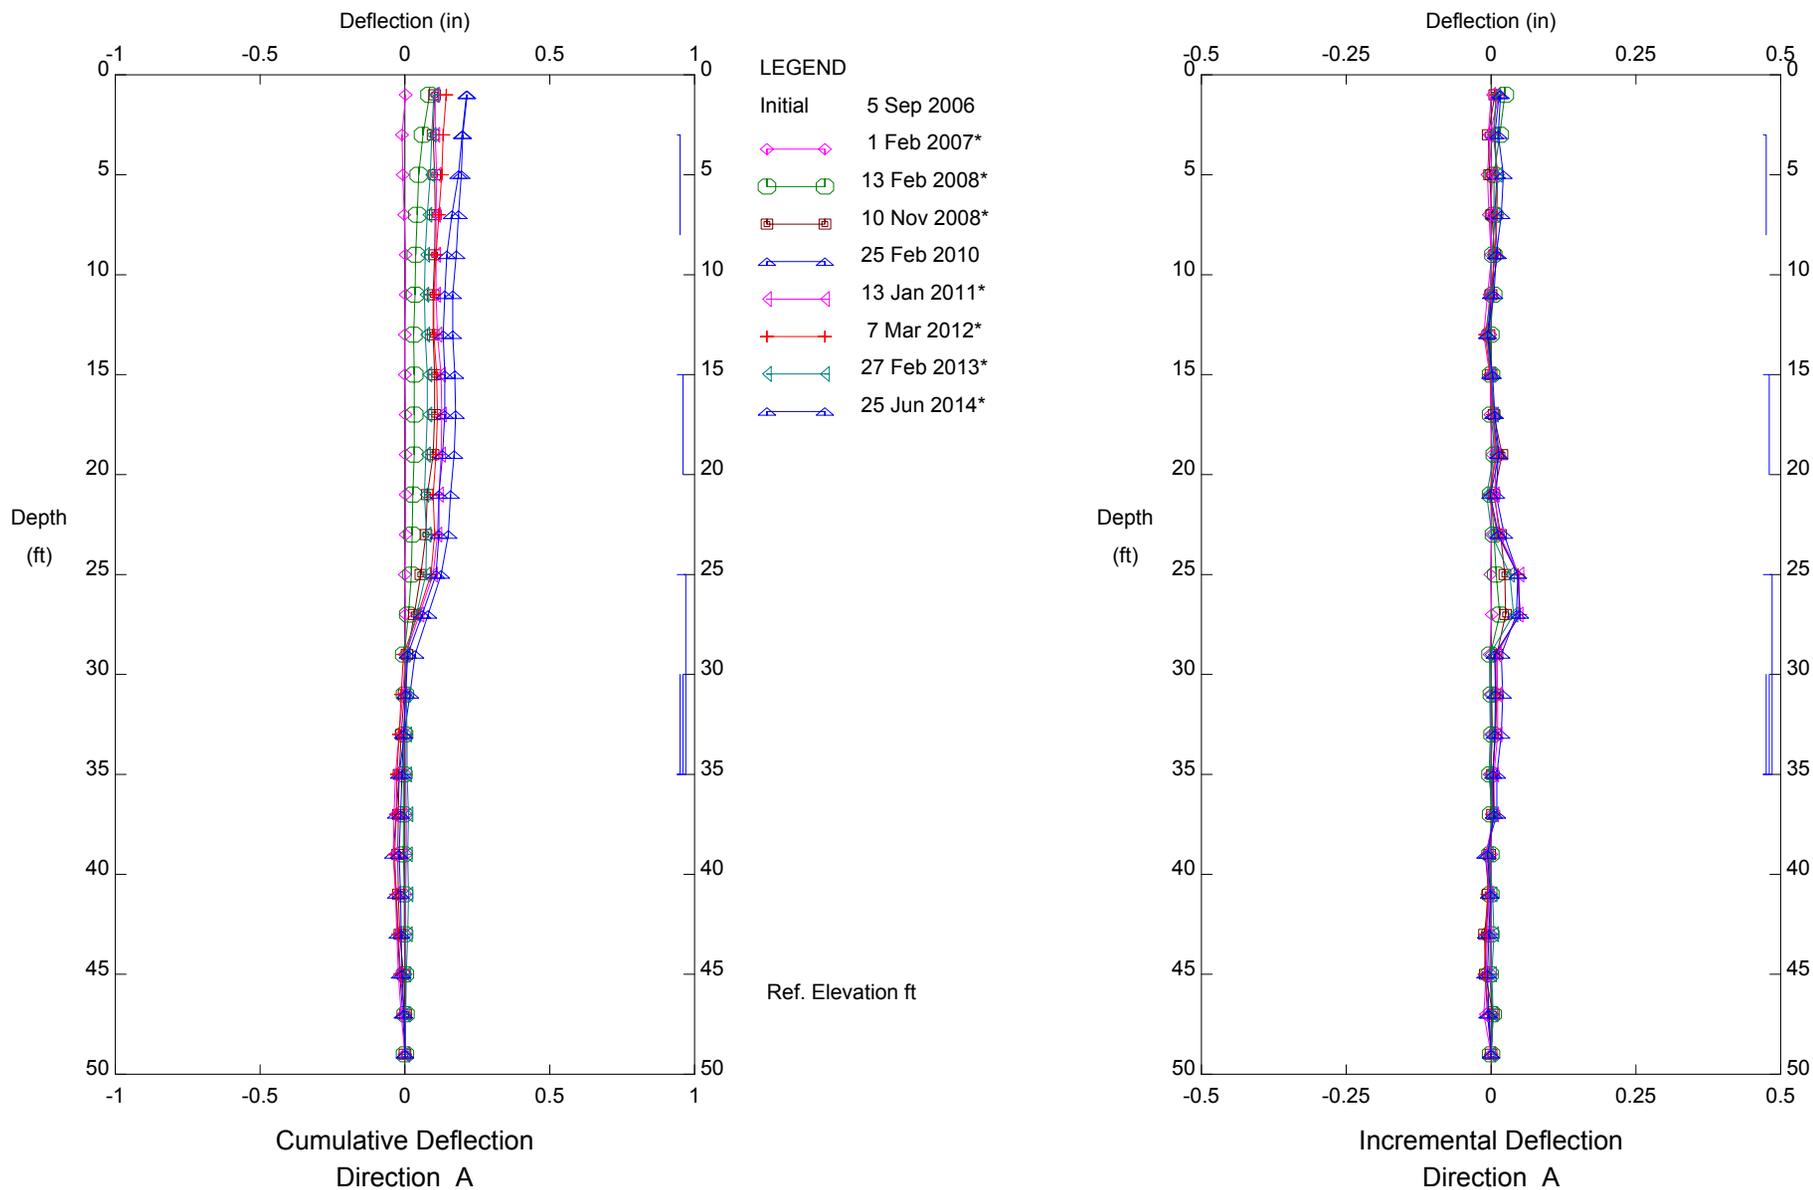
PLATE C-2a

Interpretation of inclinometer data along Malibu Road shows no clearly defined interpreted movement during the 2013-2014 monitoring year, except for SI-1A, which shows slow, steady movement at about 27 feet. Displacements appear to be less than 0.1 inch per year.

- Readings from SI-1A showed slow steady movement of less than 0.1 inch per year at a depth of 27 feet.
- Readings for the four remaining slope inclinometers show no clearly defined interpreted movement during the 2013 to 2014 monitoring year.

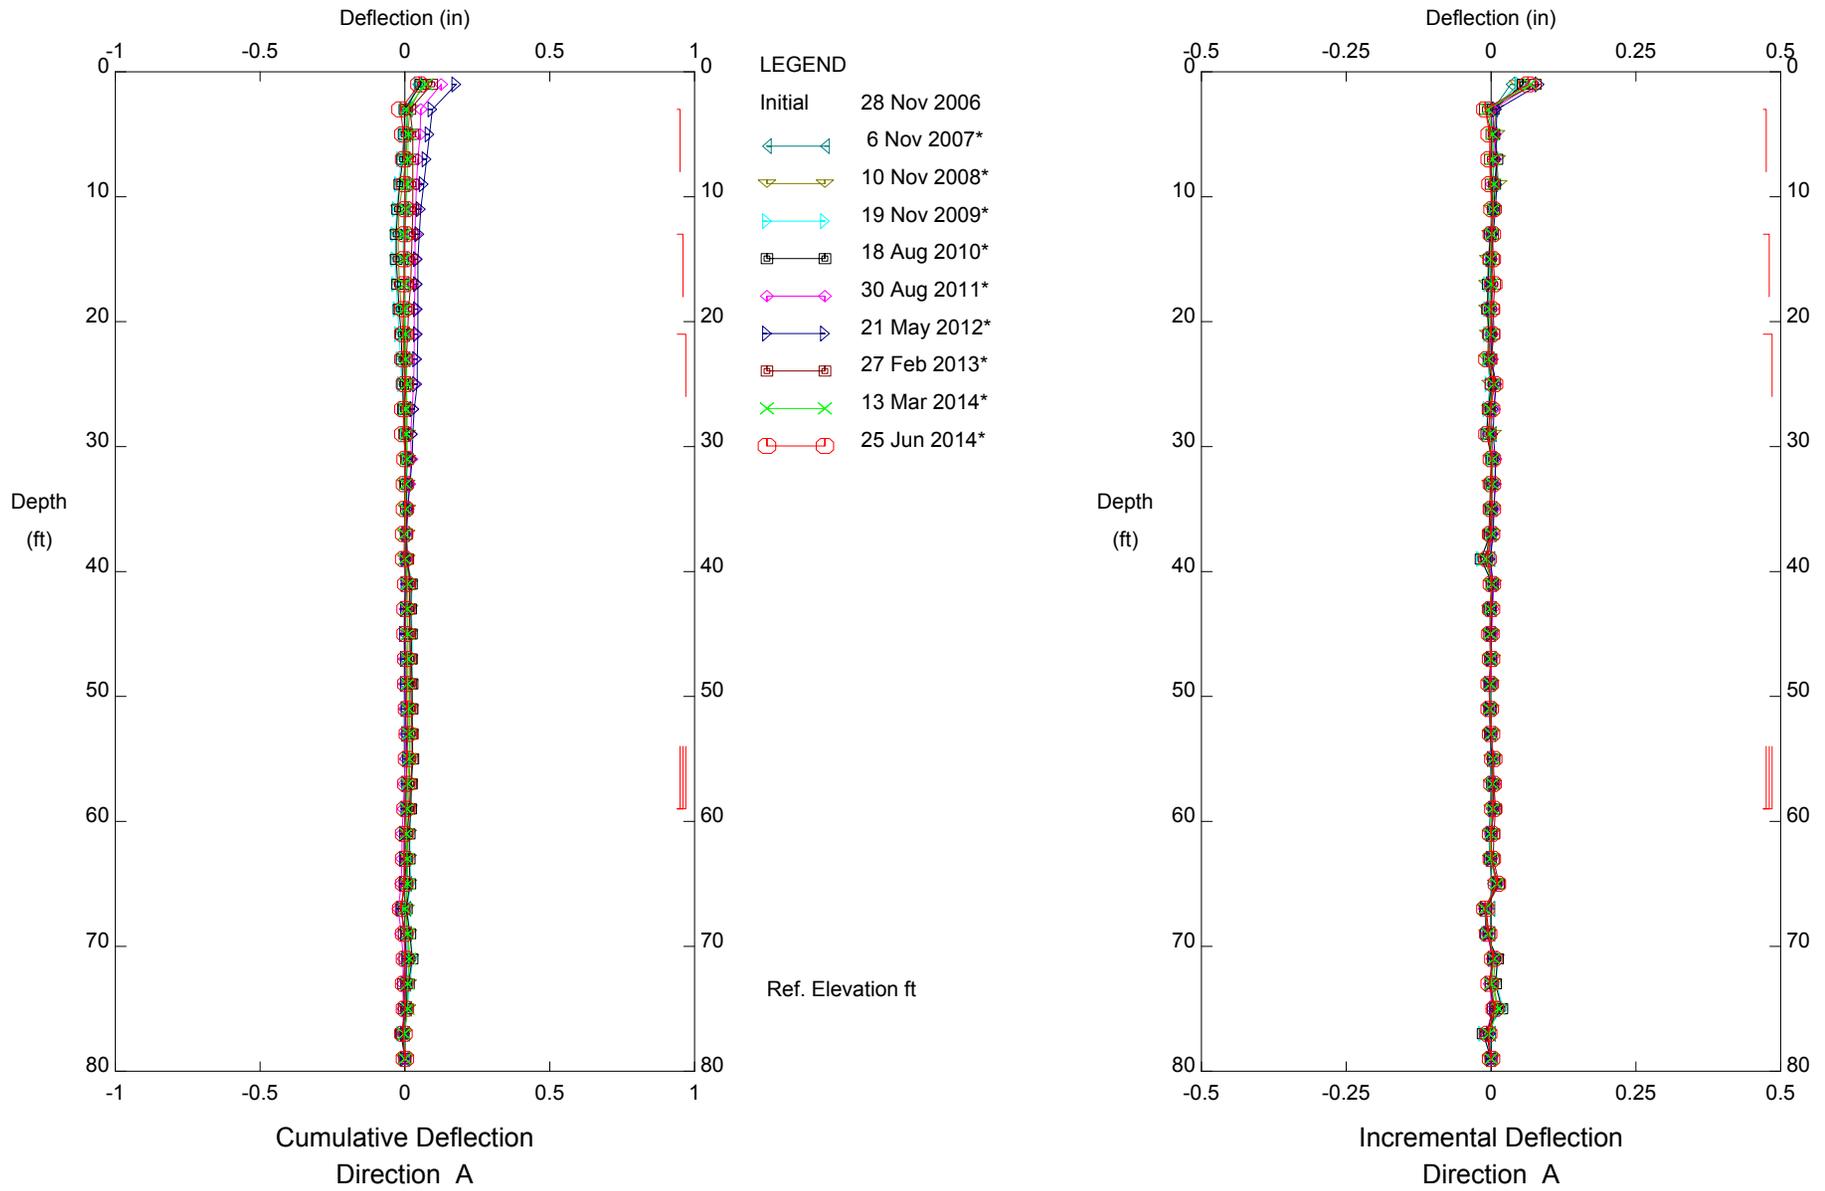
PLATE C-5a

Inclinometers SI-5 and SI-6 are located on Bayshore Drive, upslope and outside the defined limit of the most recent 1998 movement. No clearly defined interpreted movement was observed during this monitoring year in SI-5 or SI-6.
