**ANNUAL REPORT
JULY 2014 THROUGH JUNE 2015
MALIBU ROAD LANDSLIDE ASSESSMENT DISTRICT
MALIBU, CALIFORNIA**

Prepared for:
CITY OF MALIBU

November 2015
Fugro Project No. 04.62140604

Subject: Annual Report, July 2014 through June 2015, Malibu Road Landslide Assessment District

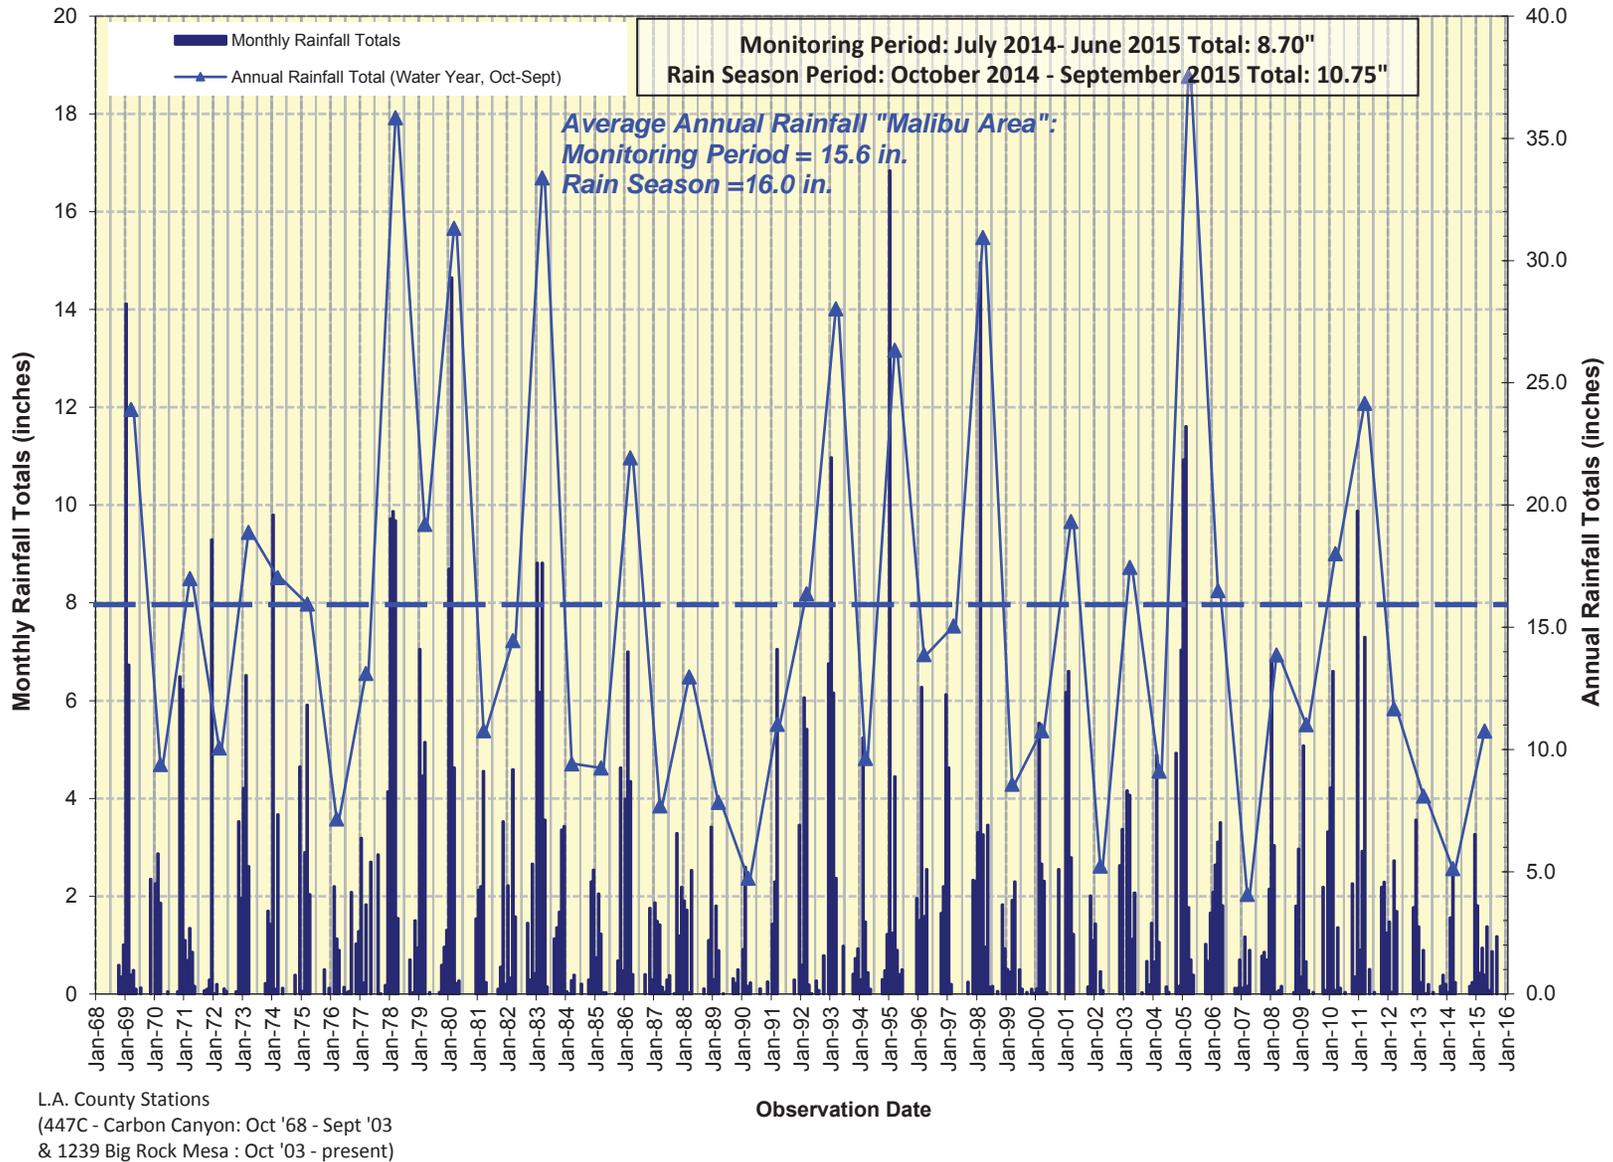
RAINFALL GRAPH
 Malibu Road Landslide Assessment District
 Malibu, California

Rainfall data indicate that approximately 8.70 inches of precipitation fell during the monitoring period from July 1, 2014 through June 30, 2015. The average annual rainfall from 1968 to 2015 in the "Malibu Area" for the monitoring period is approximately 15.6 inches.

Rainfall data are usually analyzed in terms of the annual "rain season" that covers the time period from October 1 through September 30. Rainfall for October 1, 2014, through September 30, 2015, was approximately 10.75 inches. This is approximately 33 percent of the average annual rainfall of 16.0 inches for the "rain seasons" between 1968 and 2015.

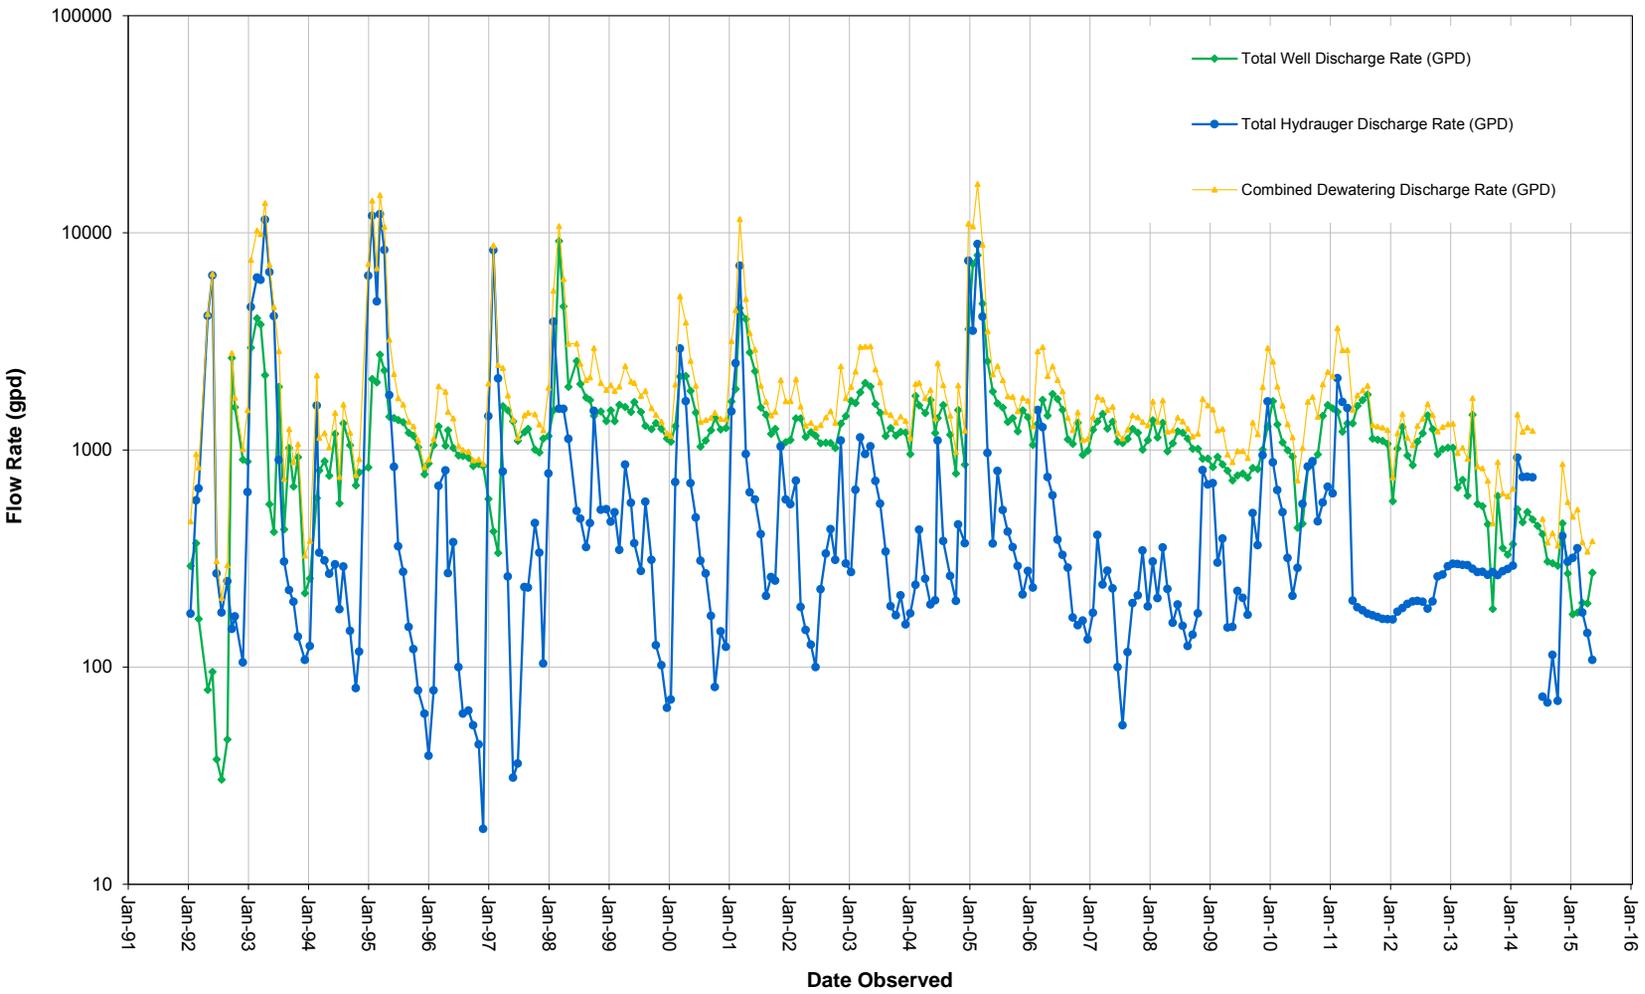
TOTAL DISCHARGE - WELLS AND HYDRAUGERS
Malibu Road Landslide Assessment District
Malibu, California

- The average total well production rate for this monitoring period was approximately 292 gallons per day (gpd). That represents a decrease of about 35 percent from the previous monitoring period production rate of 452 gpd.

- The average production rate for all hydraugers over the monitoring period is approximately 194 gpd. This represents a decrease of approximately 57 percent from the average production rate of 449 gpd for the previous monitoring period.

- The average total dewatering rate during the monitoring period was approximately 486 gpd. This represents a 46 percent decrease in the average rate relative to the 901 gpd average recorded during the previous monitoring period.

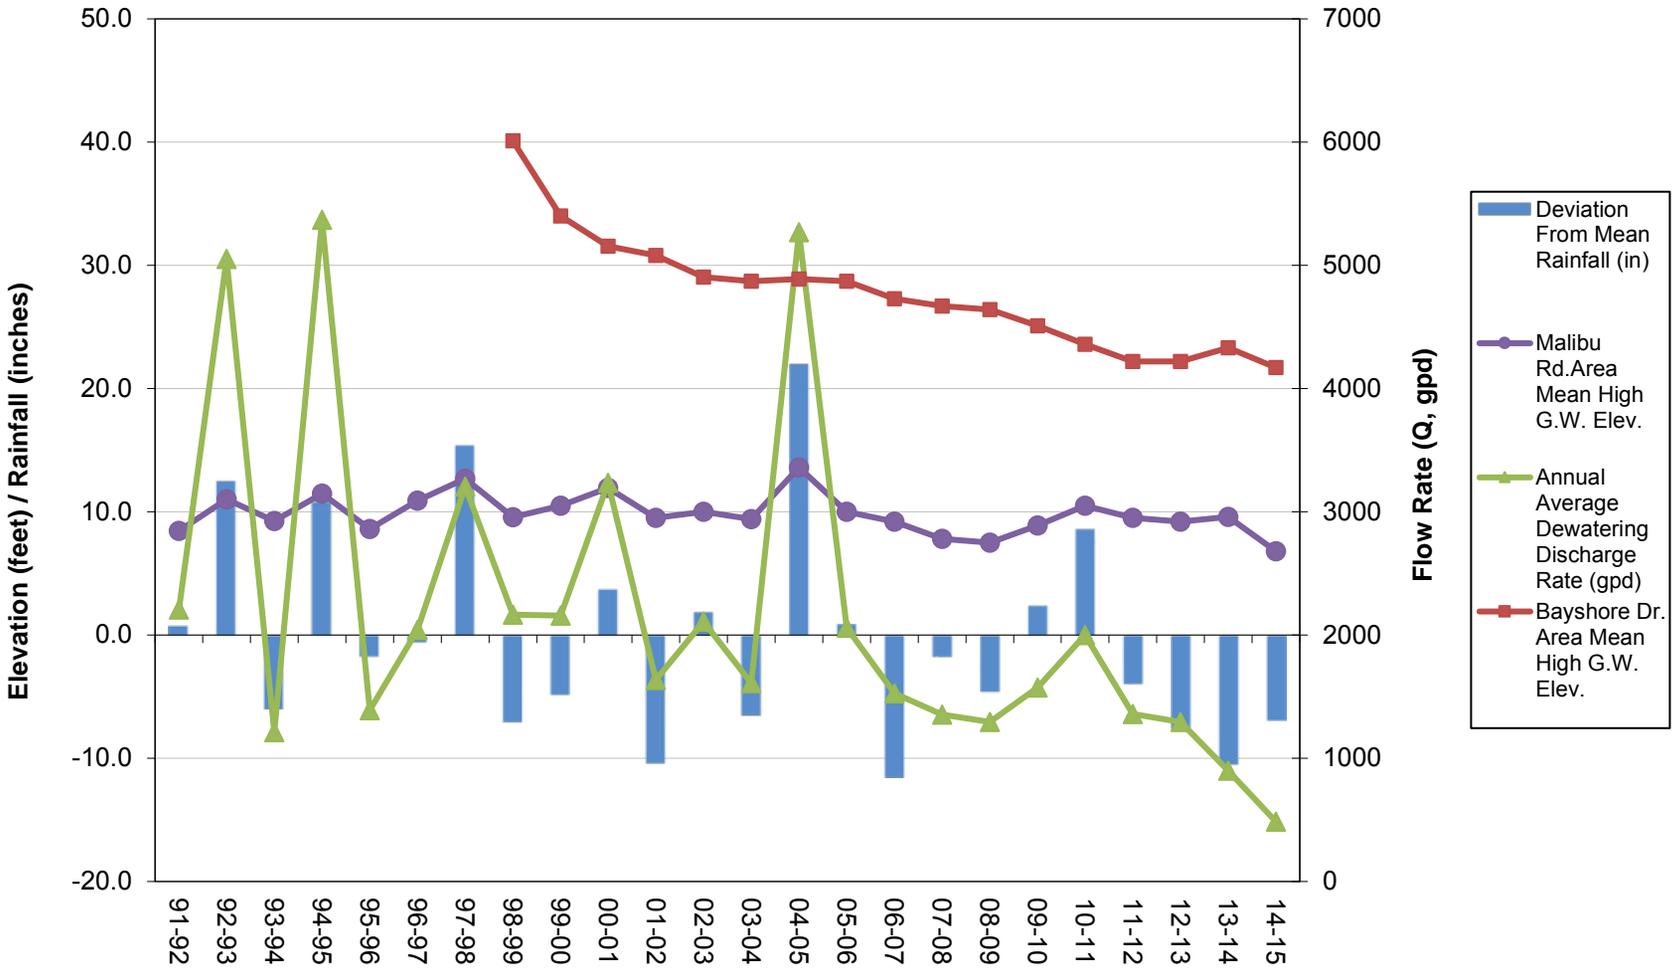
GROUNDWATER LEVELS, DEWATERING AND RAINFALL

A summary graph of mean high groundwater elevations for Malibu Road is presented on Plate 5 - Groundwater Levels, Dewatering, and Rainfall. Plate 5 also shows the average dewatering output (gpd) and the deviation from the mean annual rainfall. The mean annual rainfall used for the chart was computed using all of the data from 1988 through the present. This graph illustrates that, since 2010-2011, annual rainfall has been generally decreasing. During the same period, the average dewatering output has been decreasing.

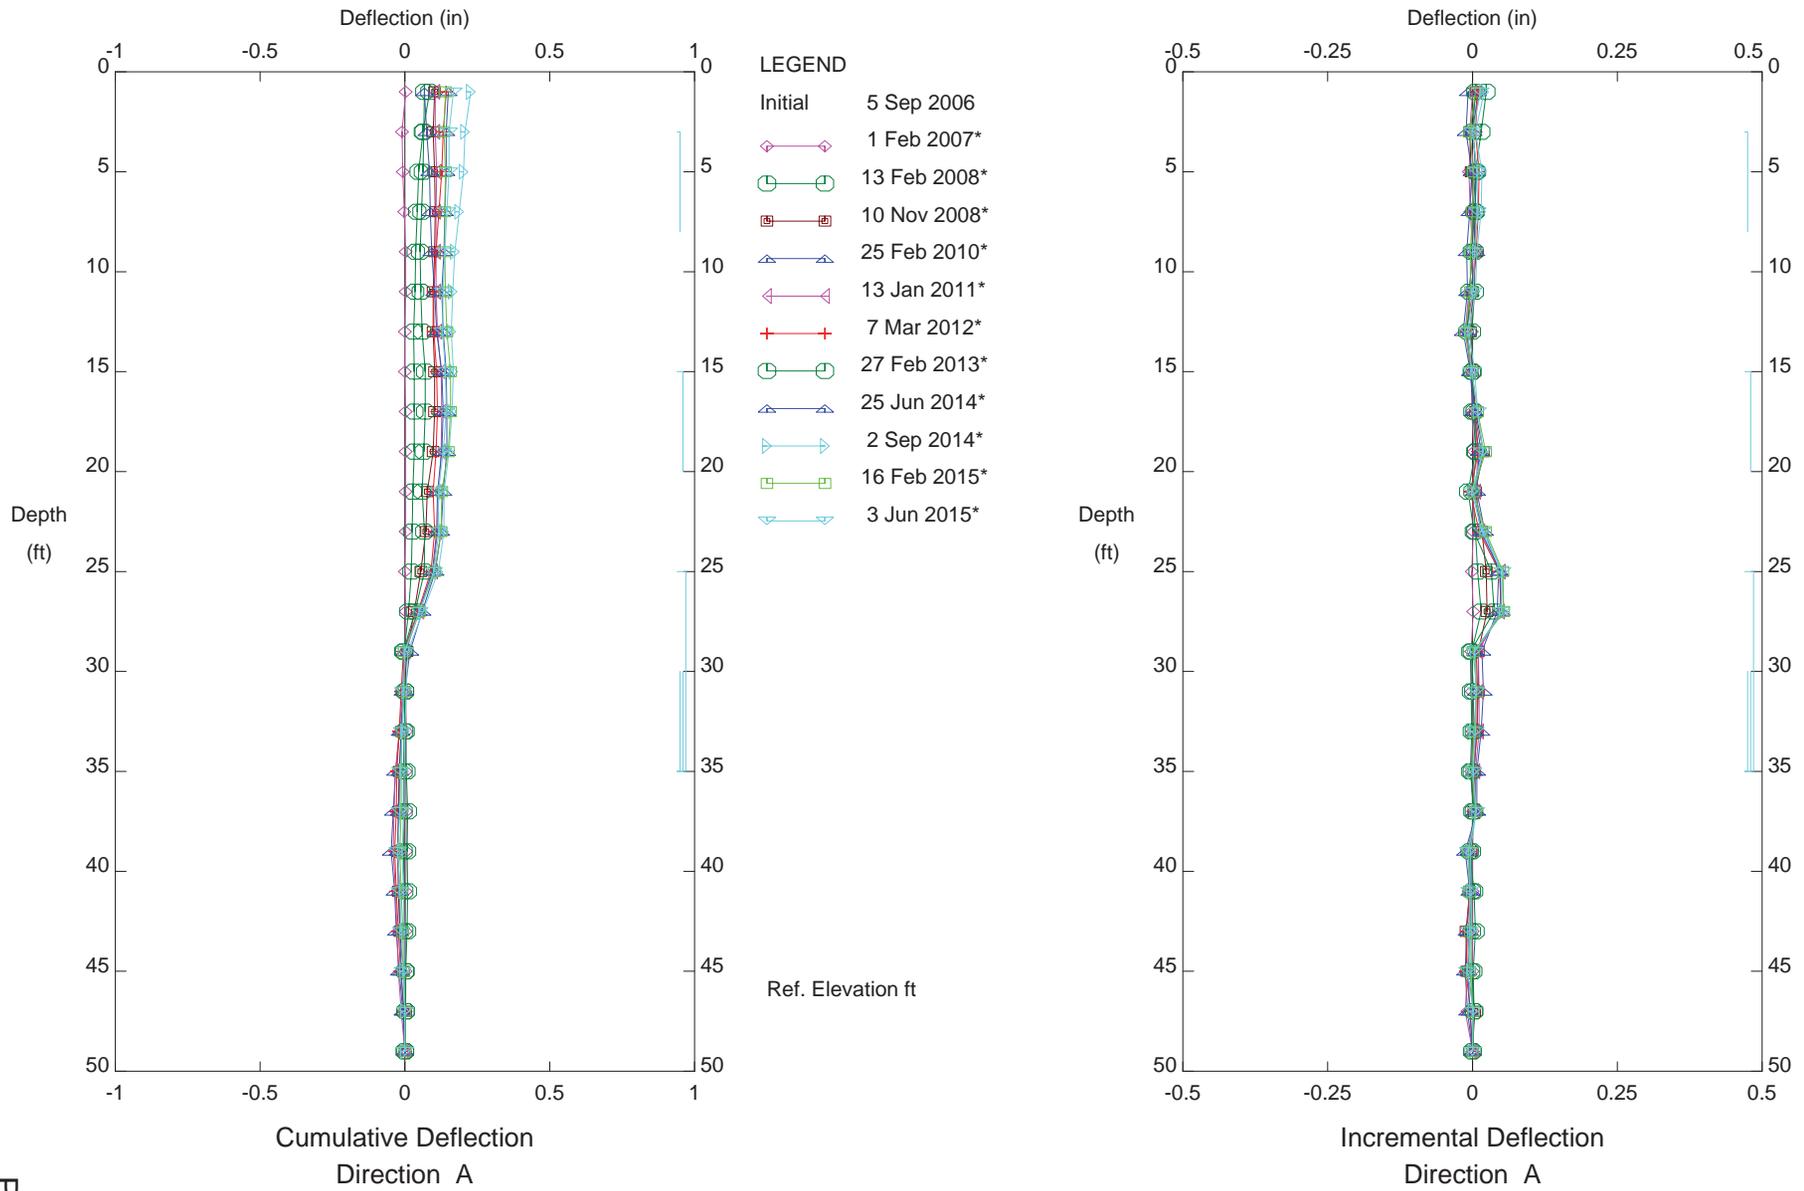
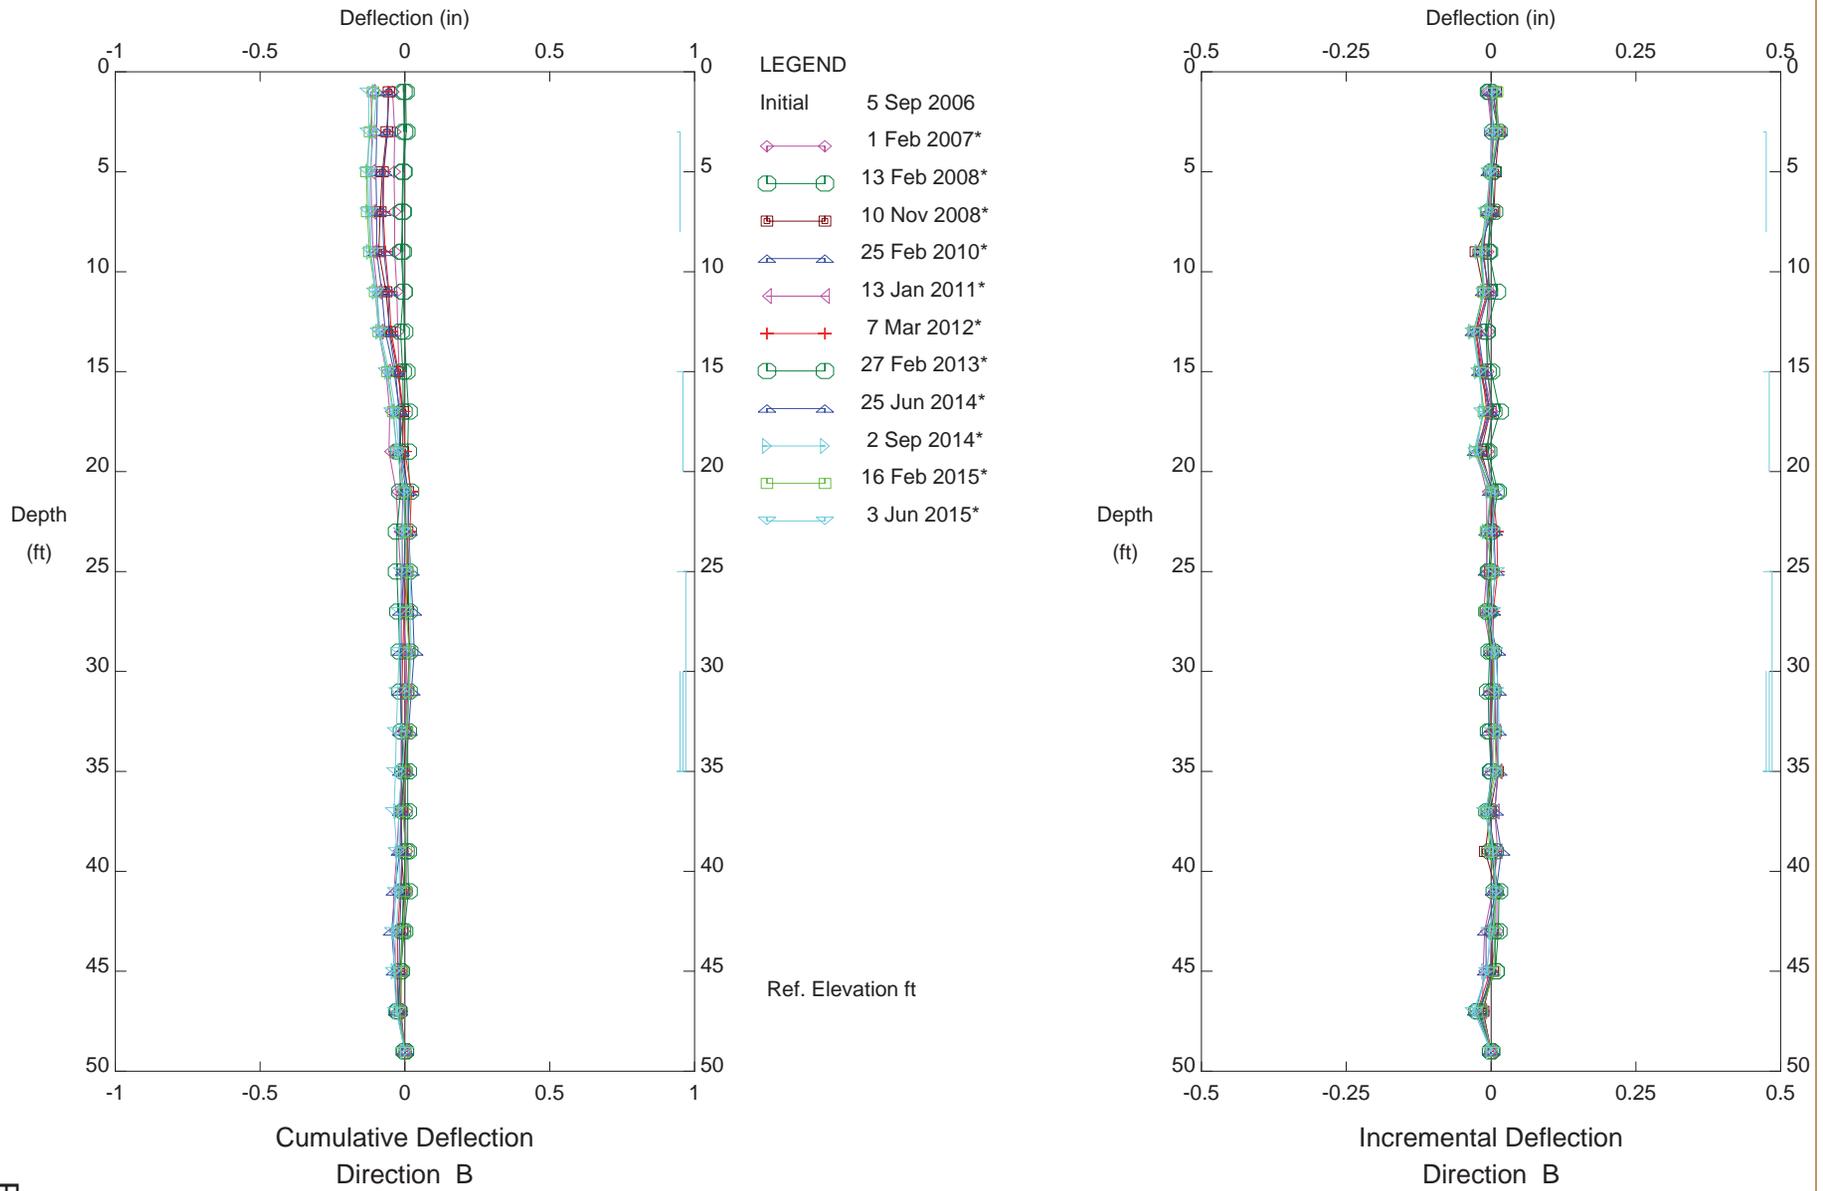
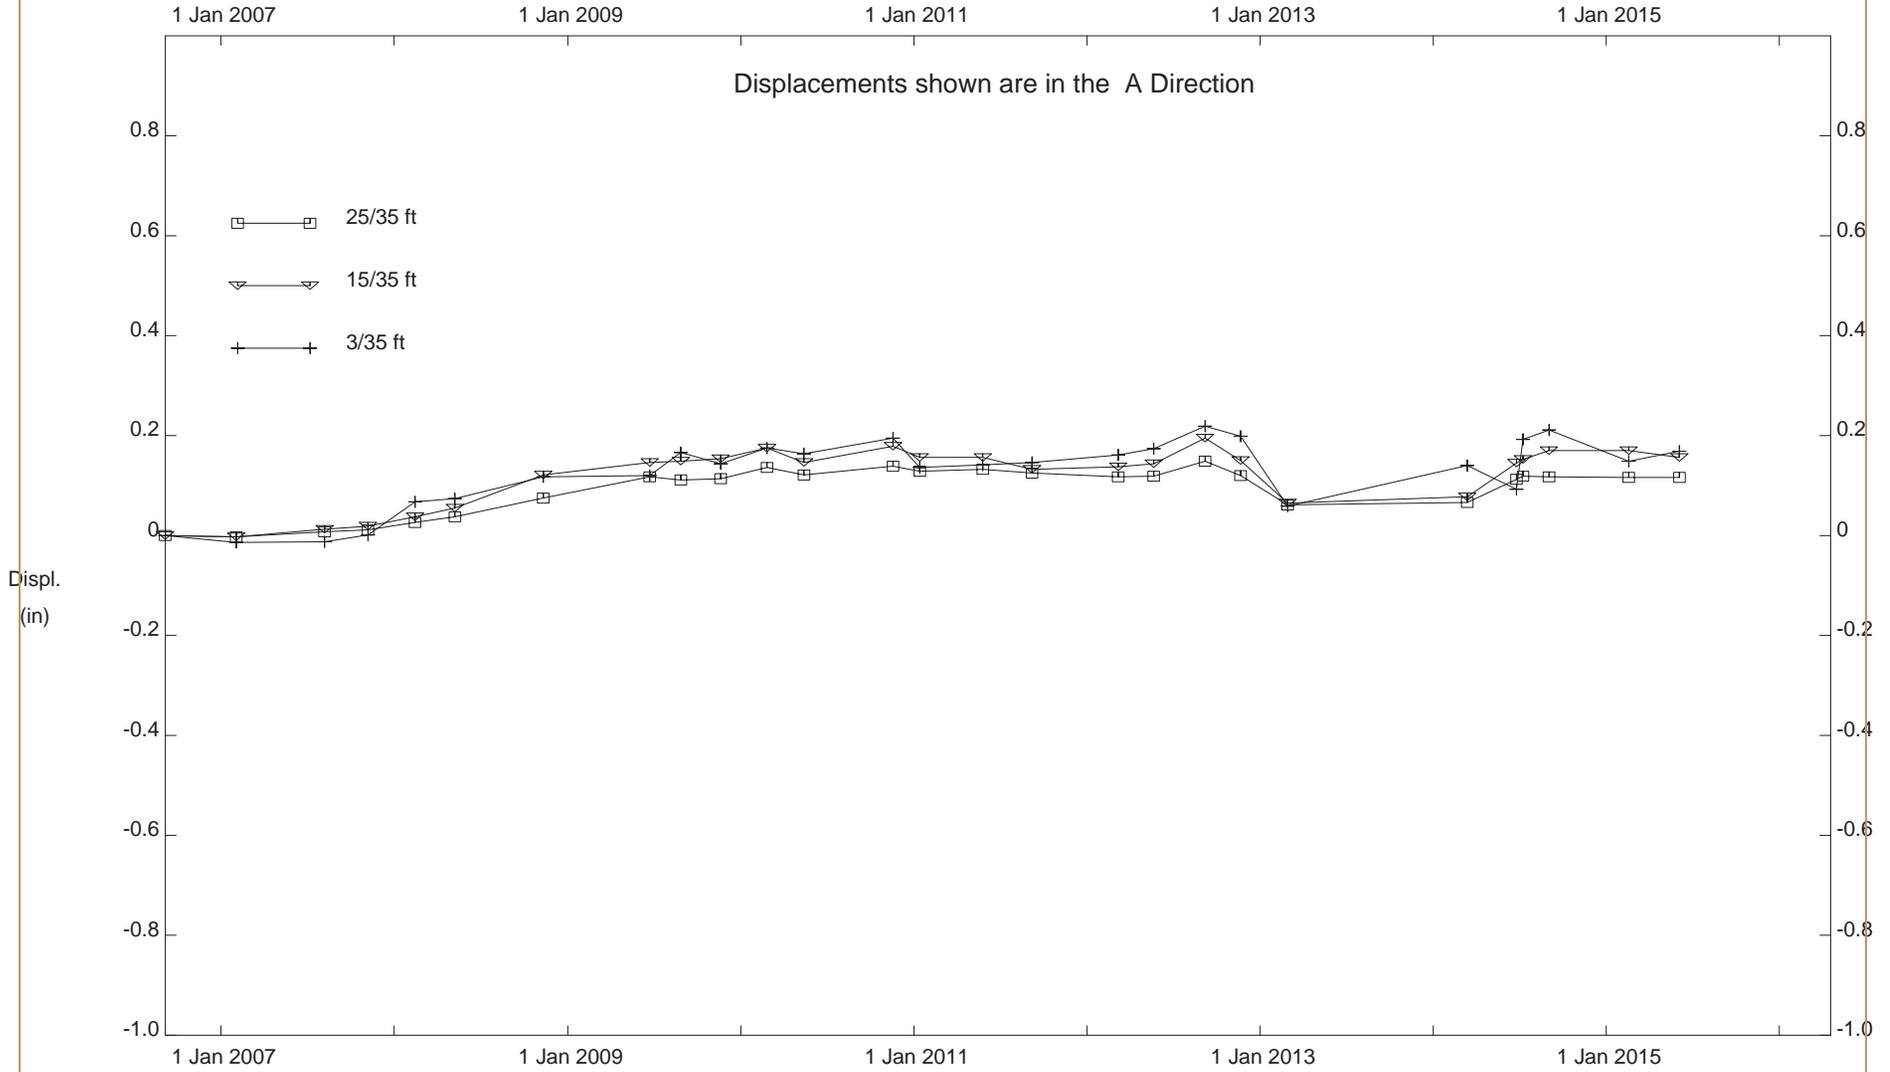
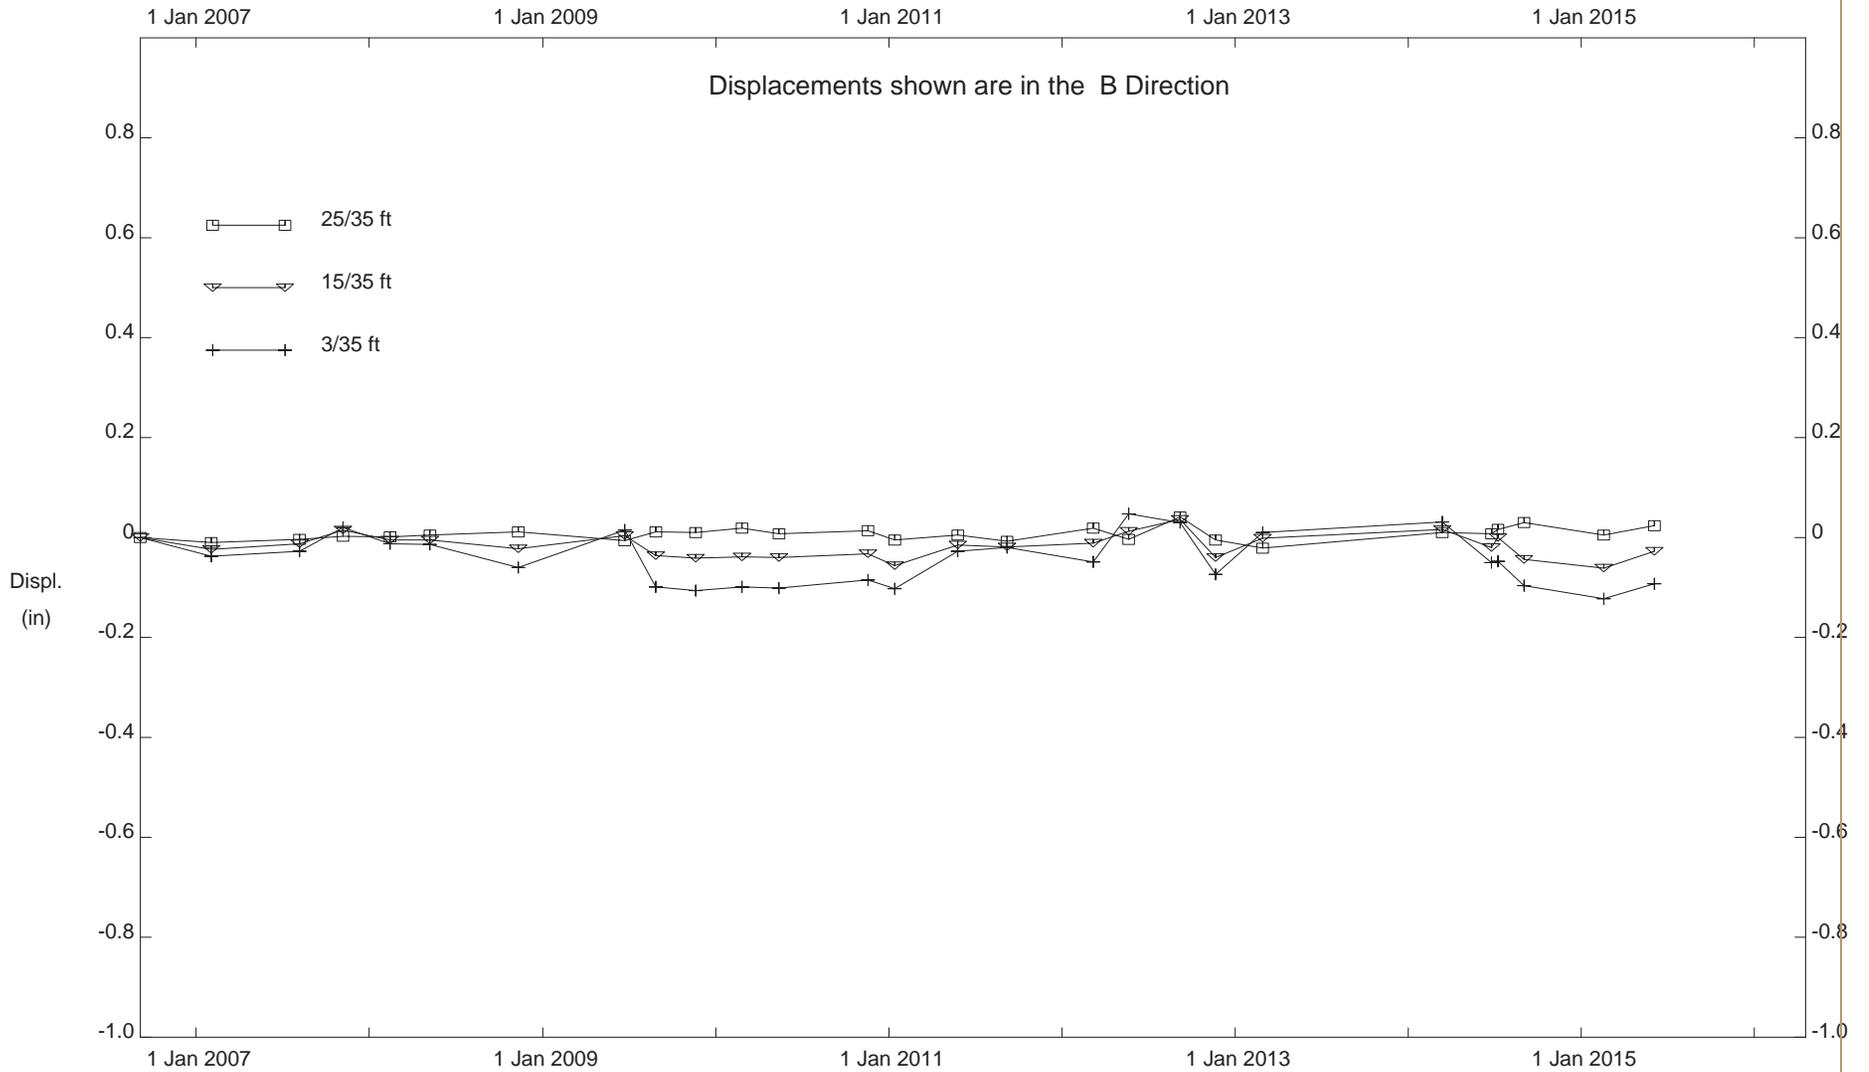
Assessment District 98-3, Inclinometer SI-1A
 City of Malibu

Interpretation of inclinometer data along Malibu Road shows no clearly defined interpreted movement during the 2014-2015 monitoring year, except for SI-1A, which shows slow, steady movement at about 27 feet. Displacements appear to be less than 0.1 inch per year.

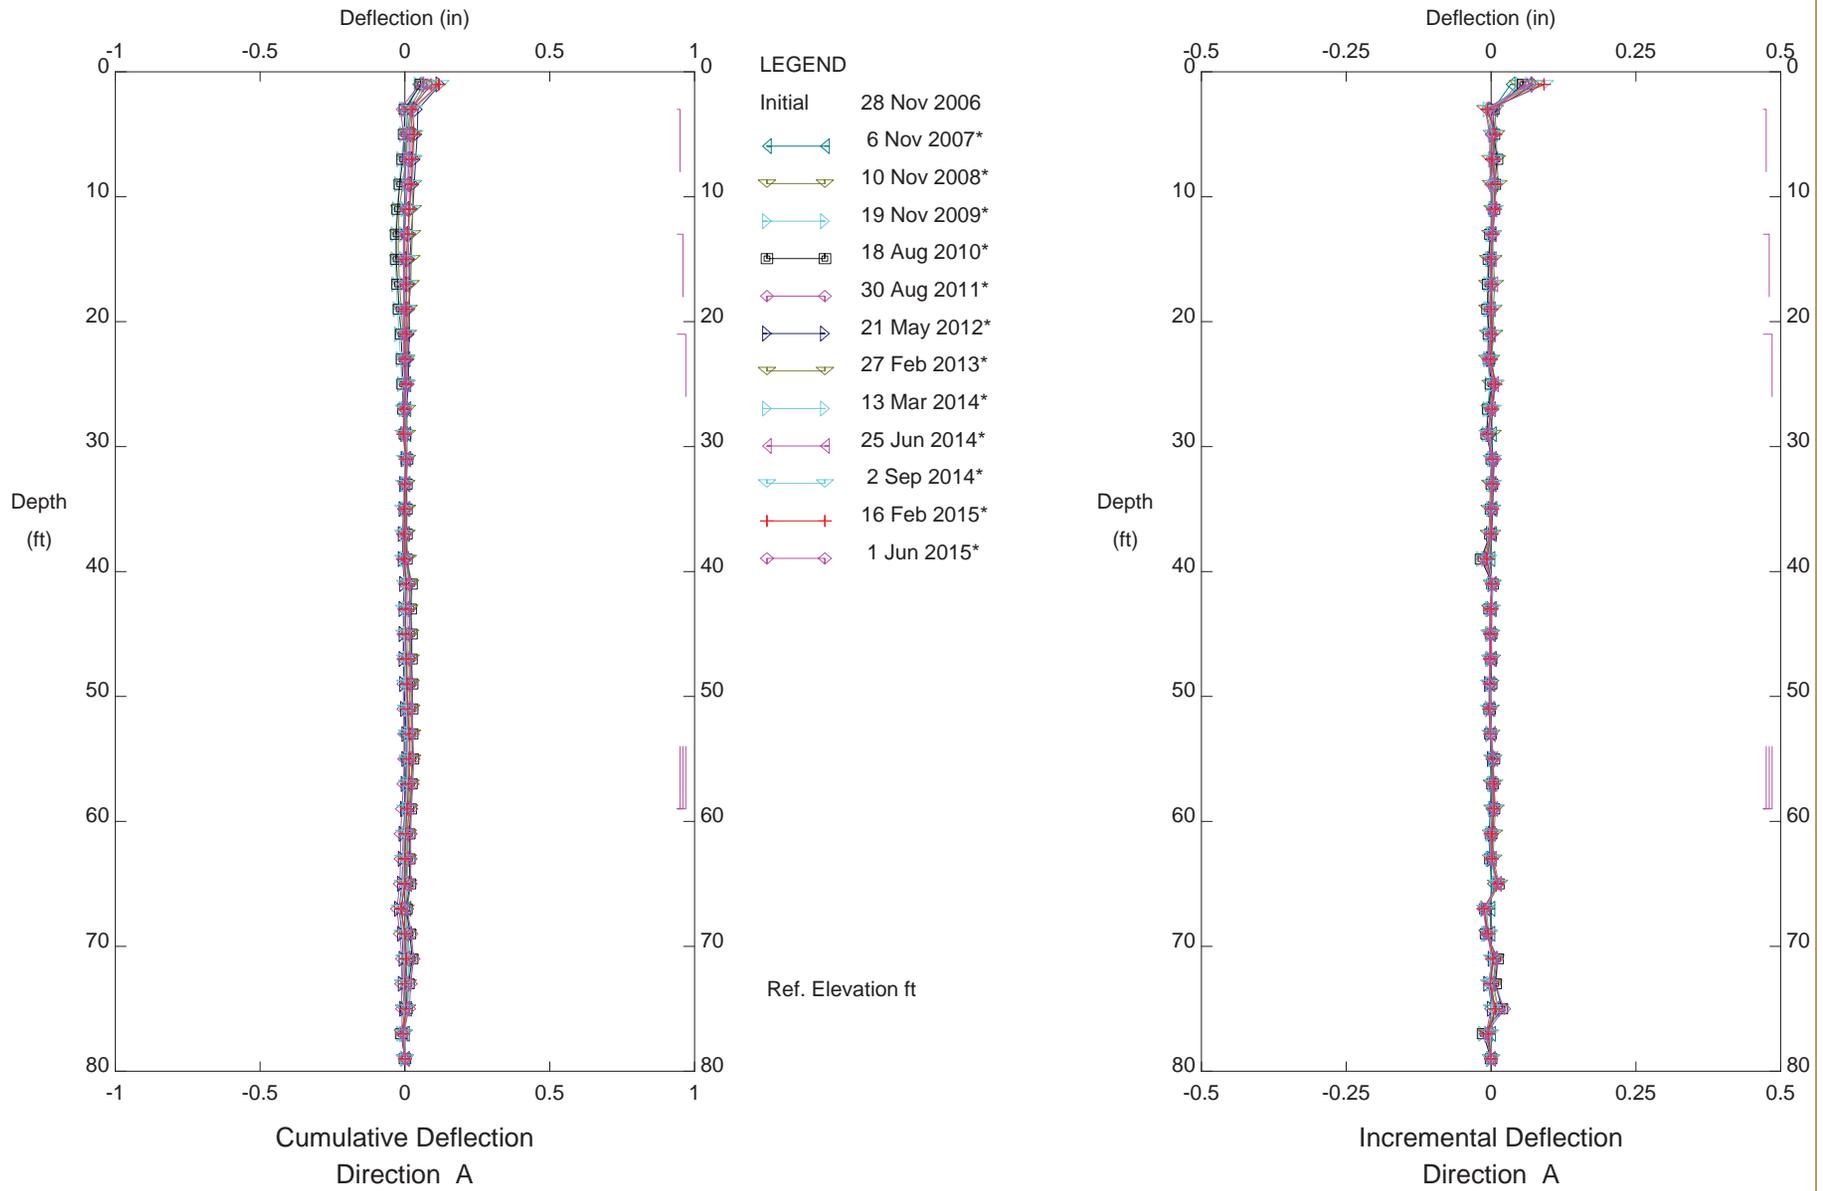
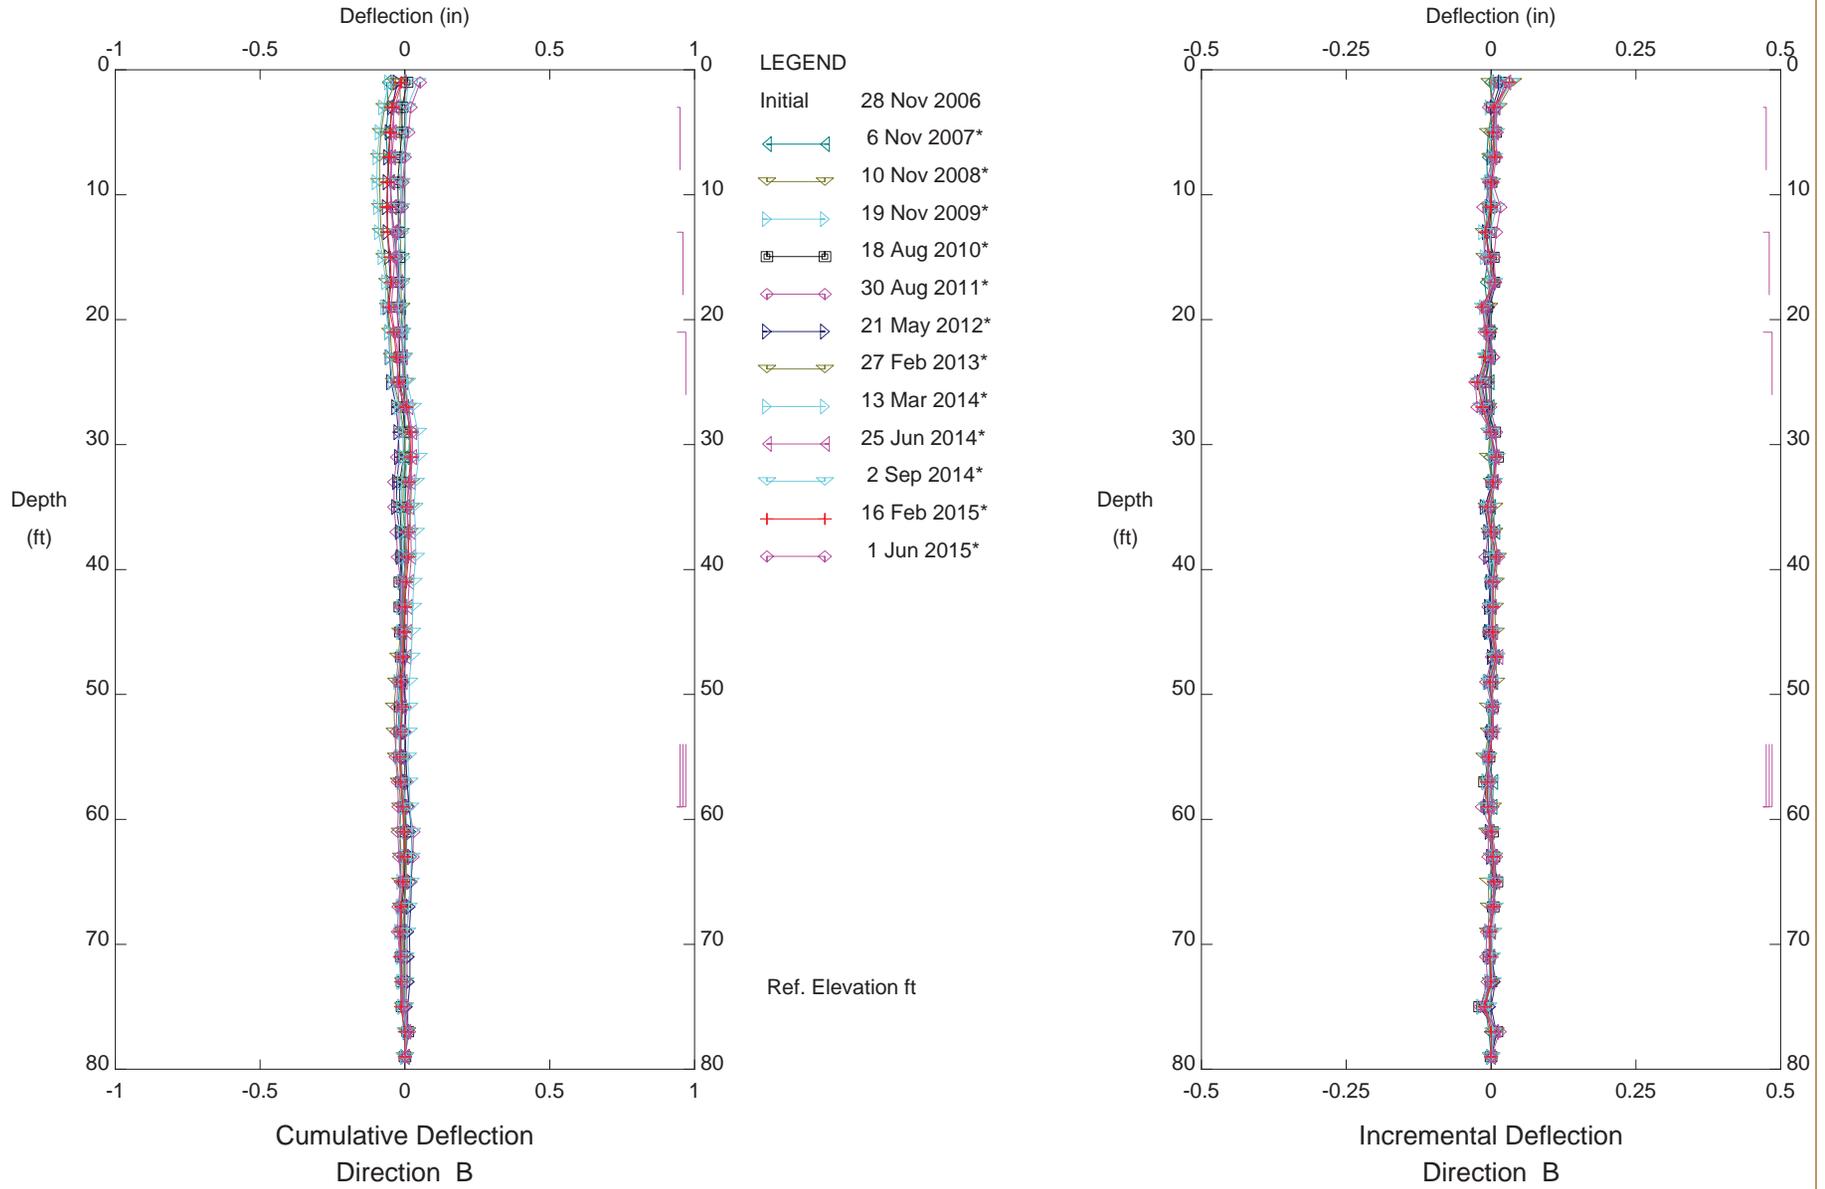
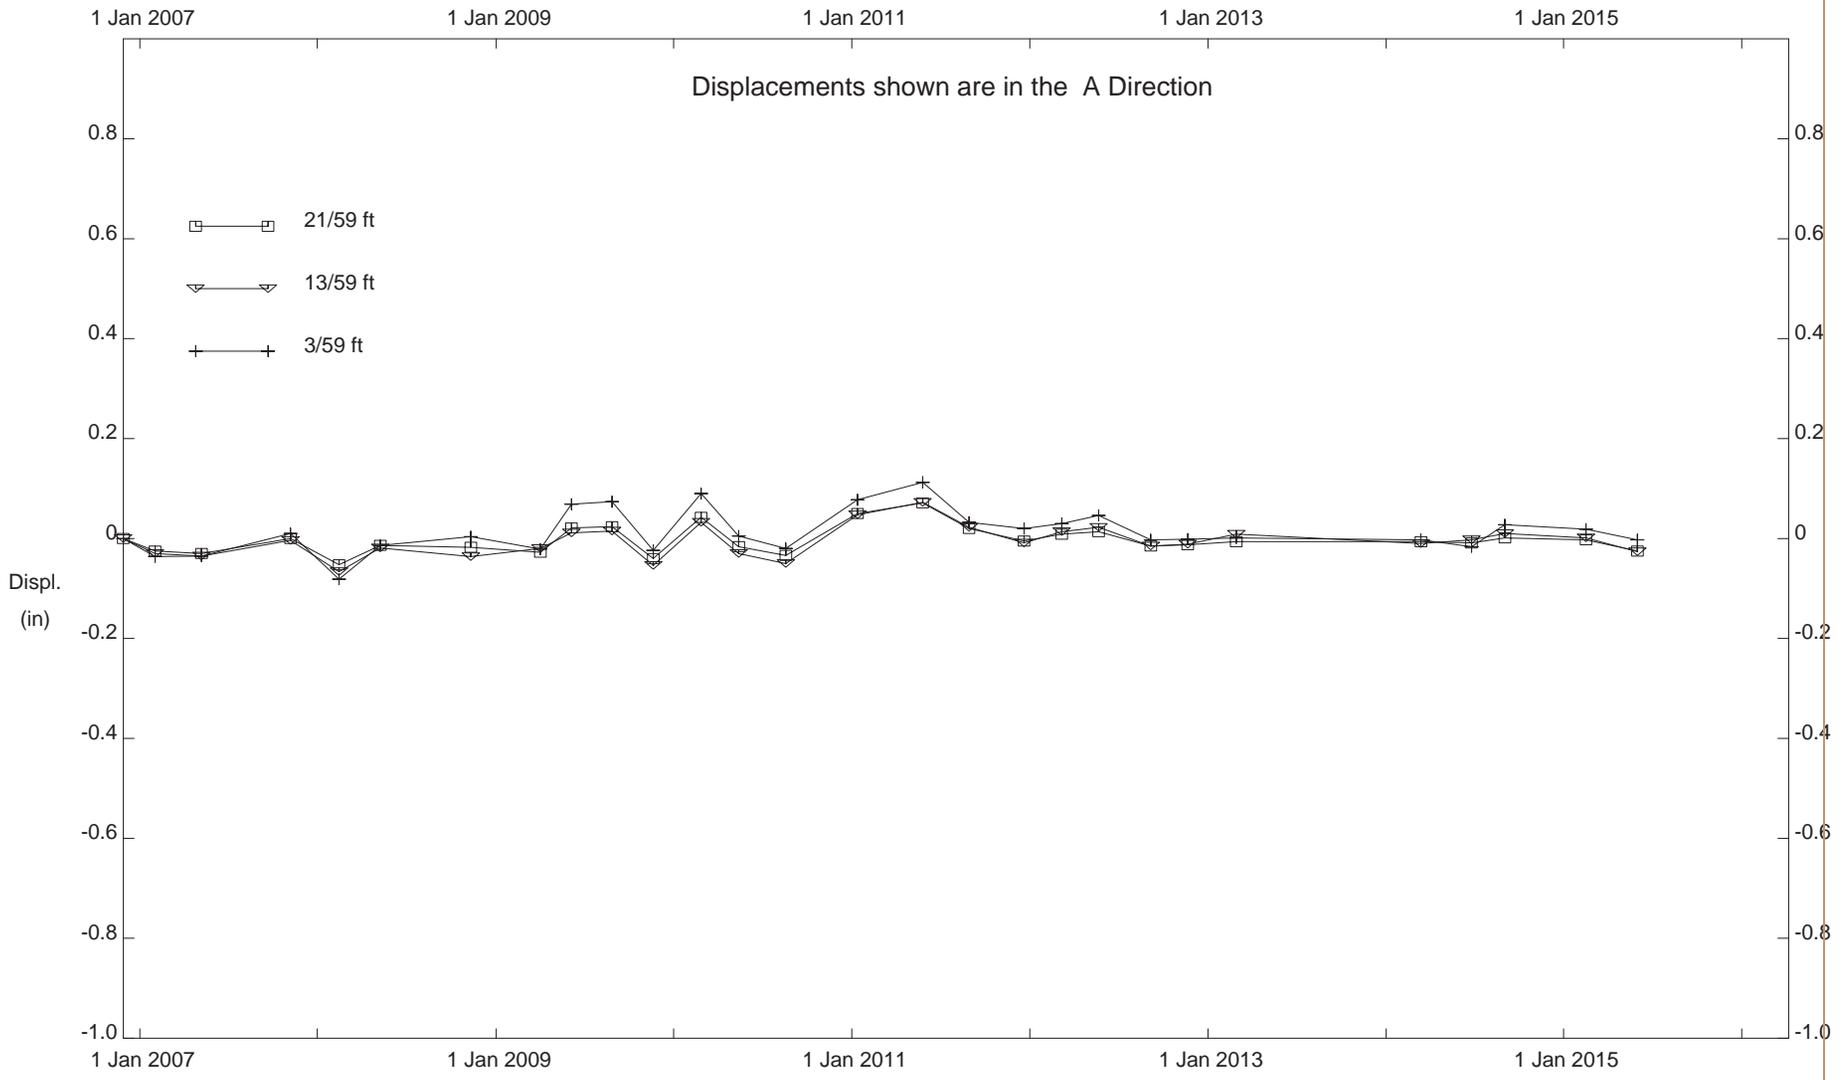
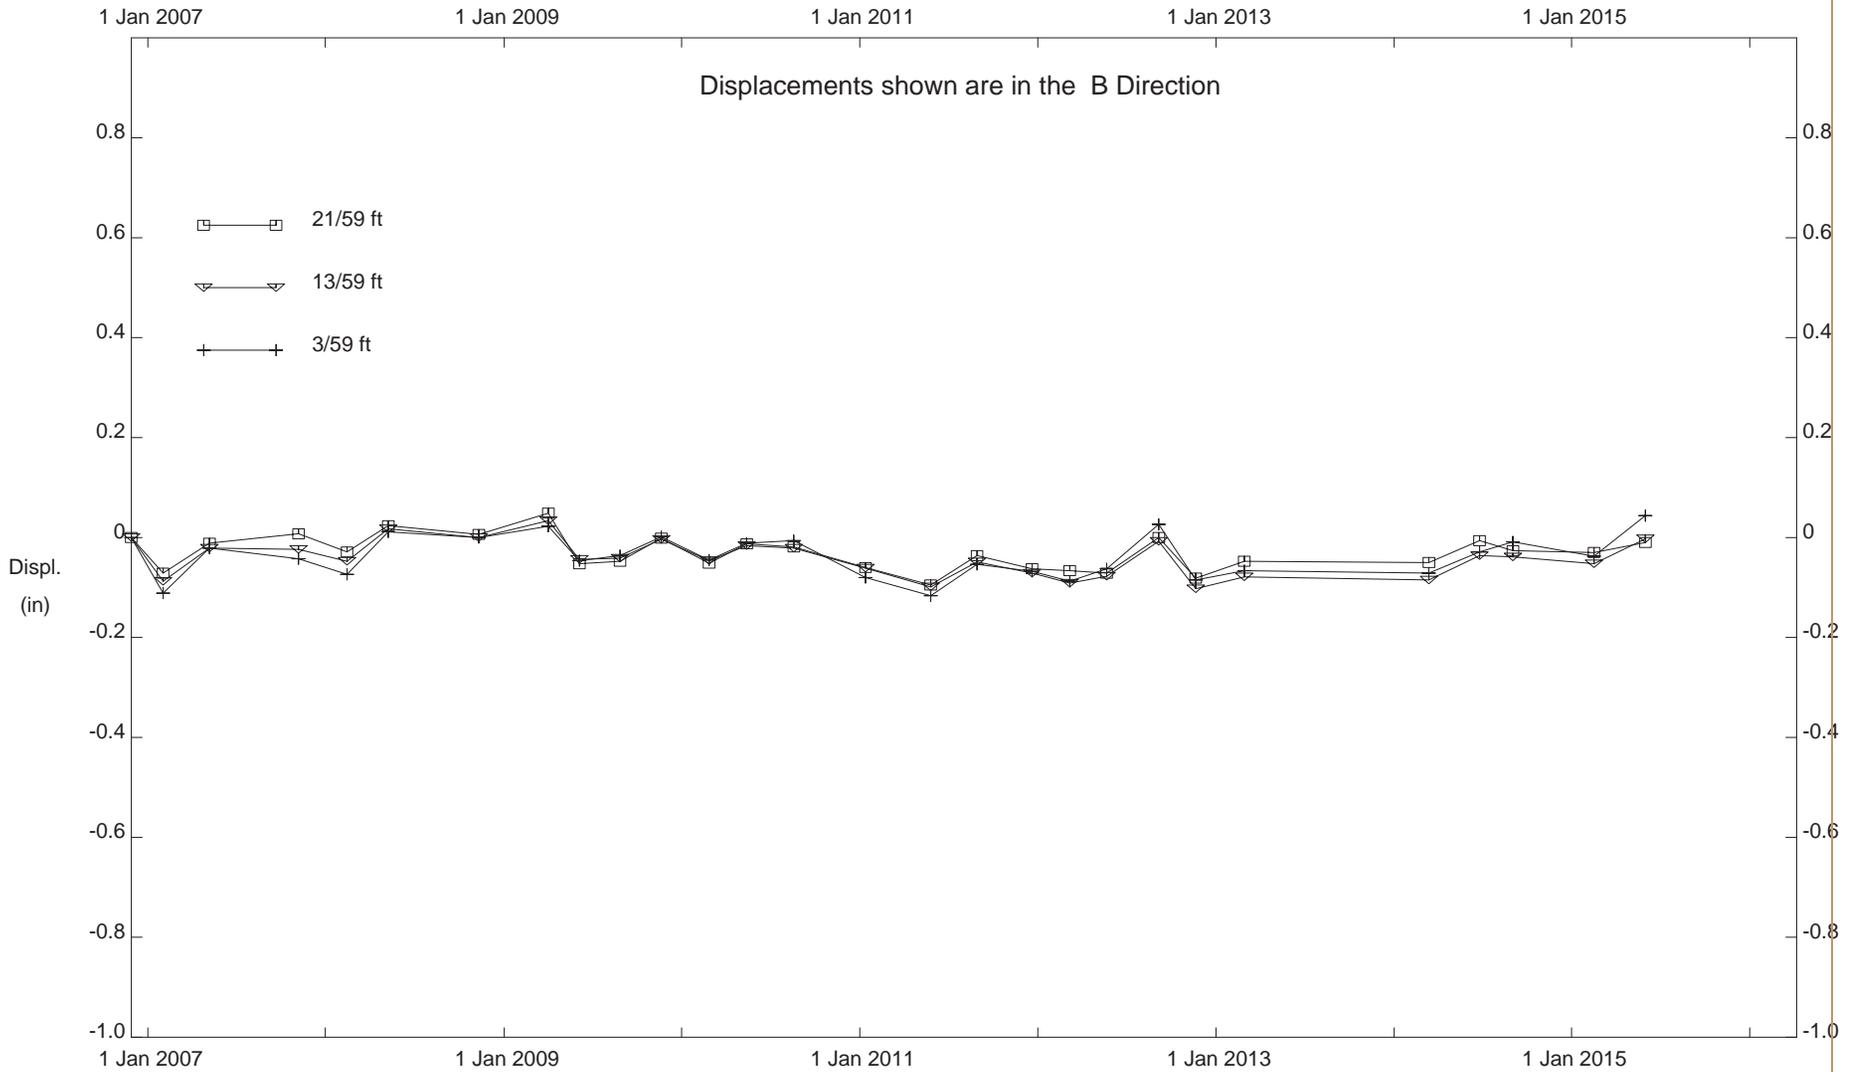
Assessment District 98-3, Inclinometer SI-5
 City of Malibu

Inclinometers SI-5 and SI-6 are located on Bayshore Drive, upslope and outside the defined limit of the most recent 1998 movement. No significant movement was observed during this monitoring year in SI-5 or SI-6.
