**ANNUAL REPORT
JULY 2014 THROUGH JUNE 2015
MALIBU ROAD LANDSLIDE ASSESSMENT DISTRICT
MALIBU, CALIFORNIA**

Prepared for:
CITY OF MALIBU

November 2015
Fugro Project No. 04.62140604

Subject: Annual Report, July 2014 through June 2015, Malibu Road Landslide Assessment District

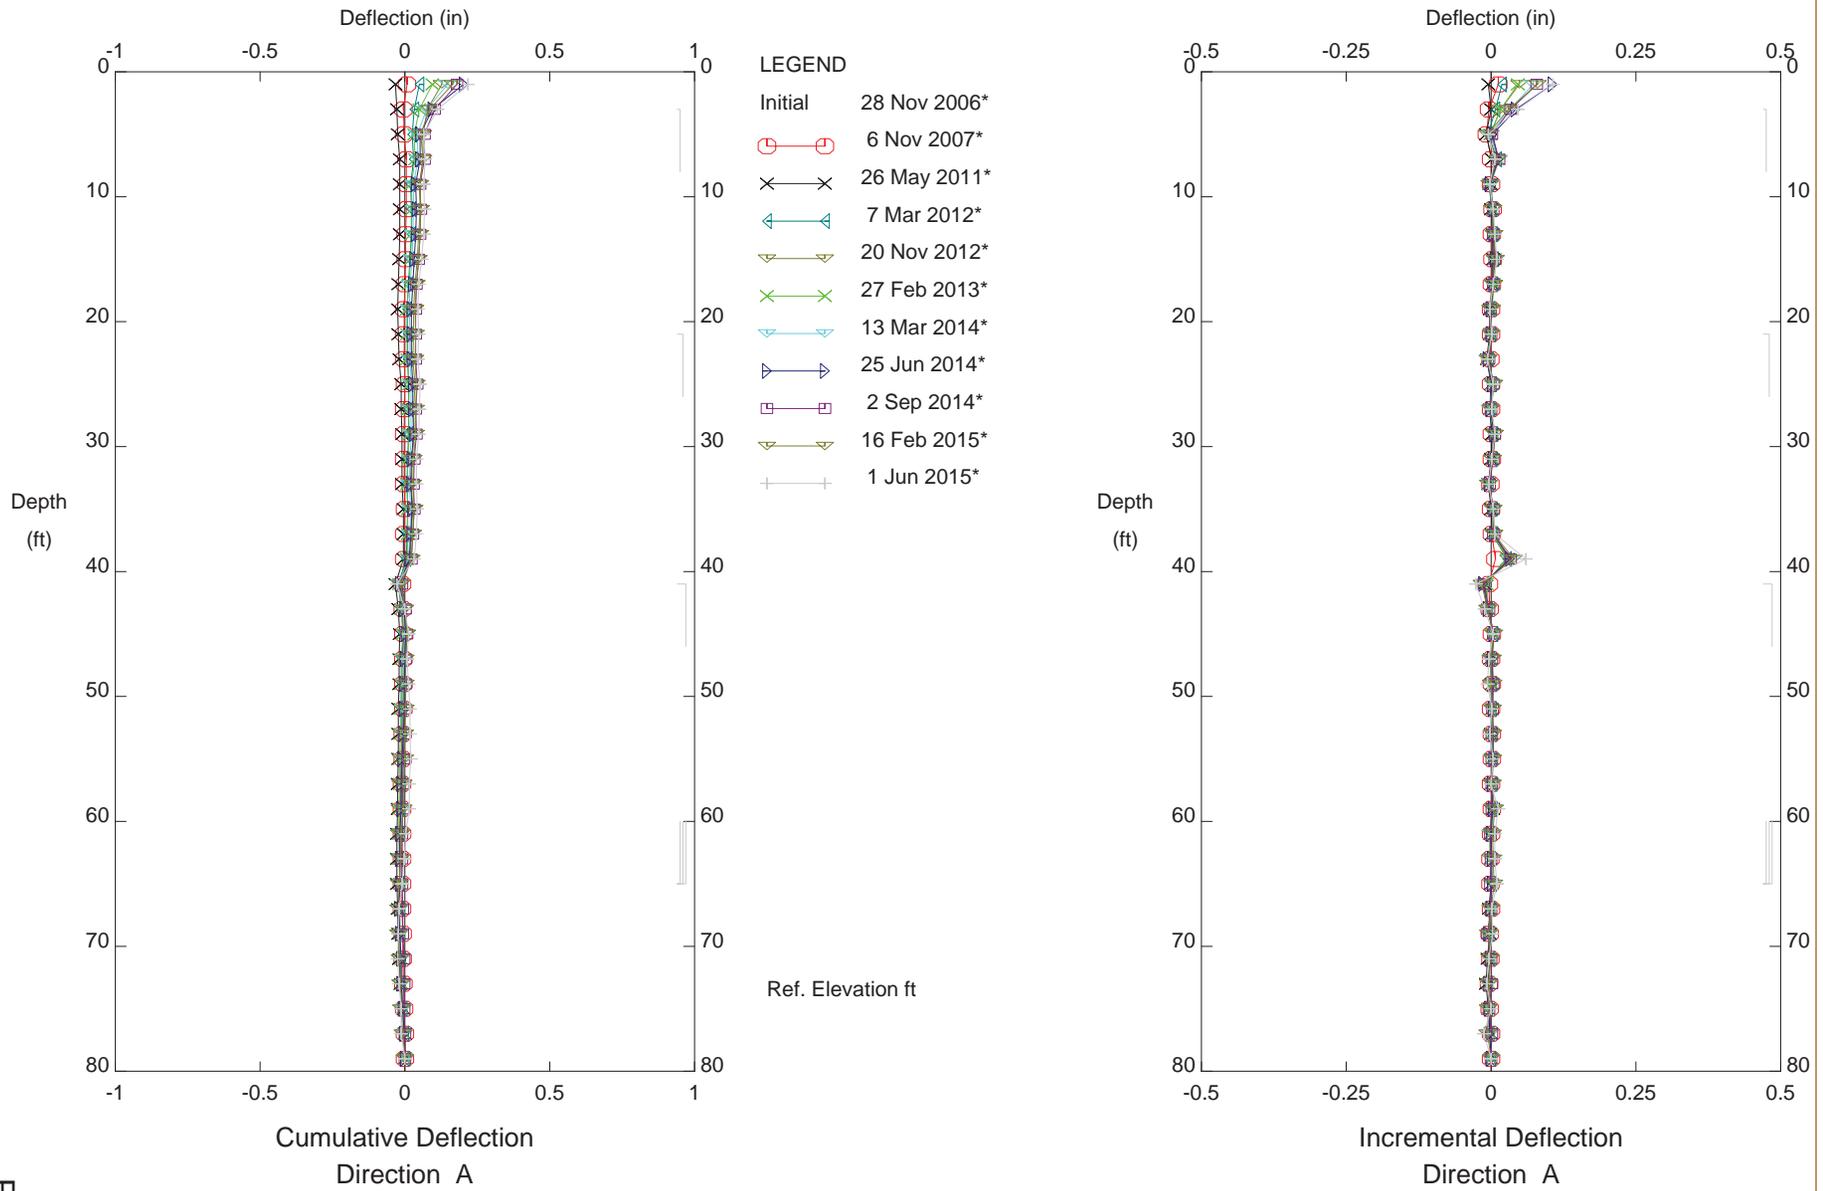
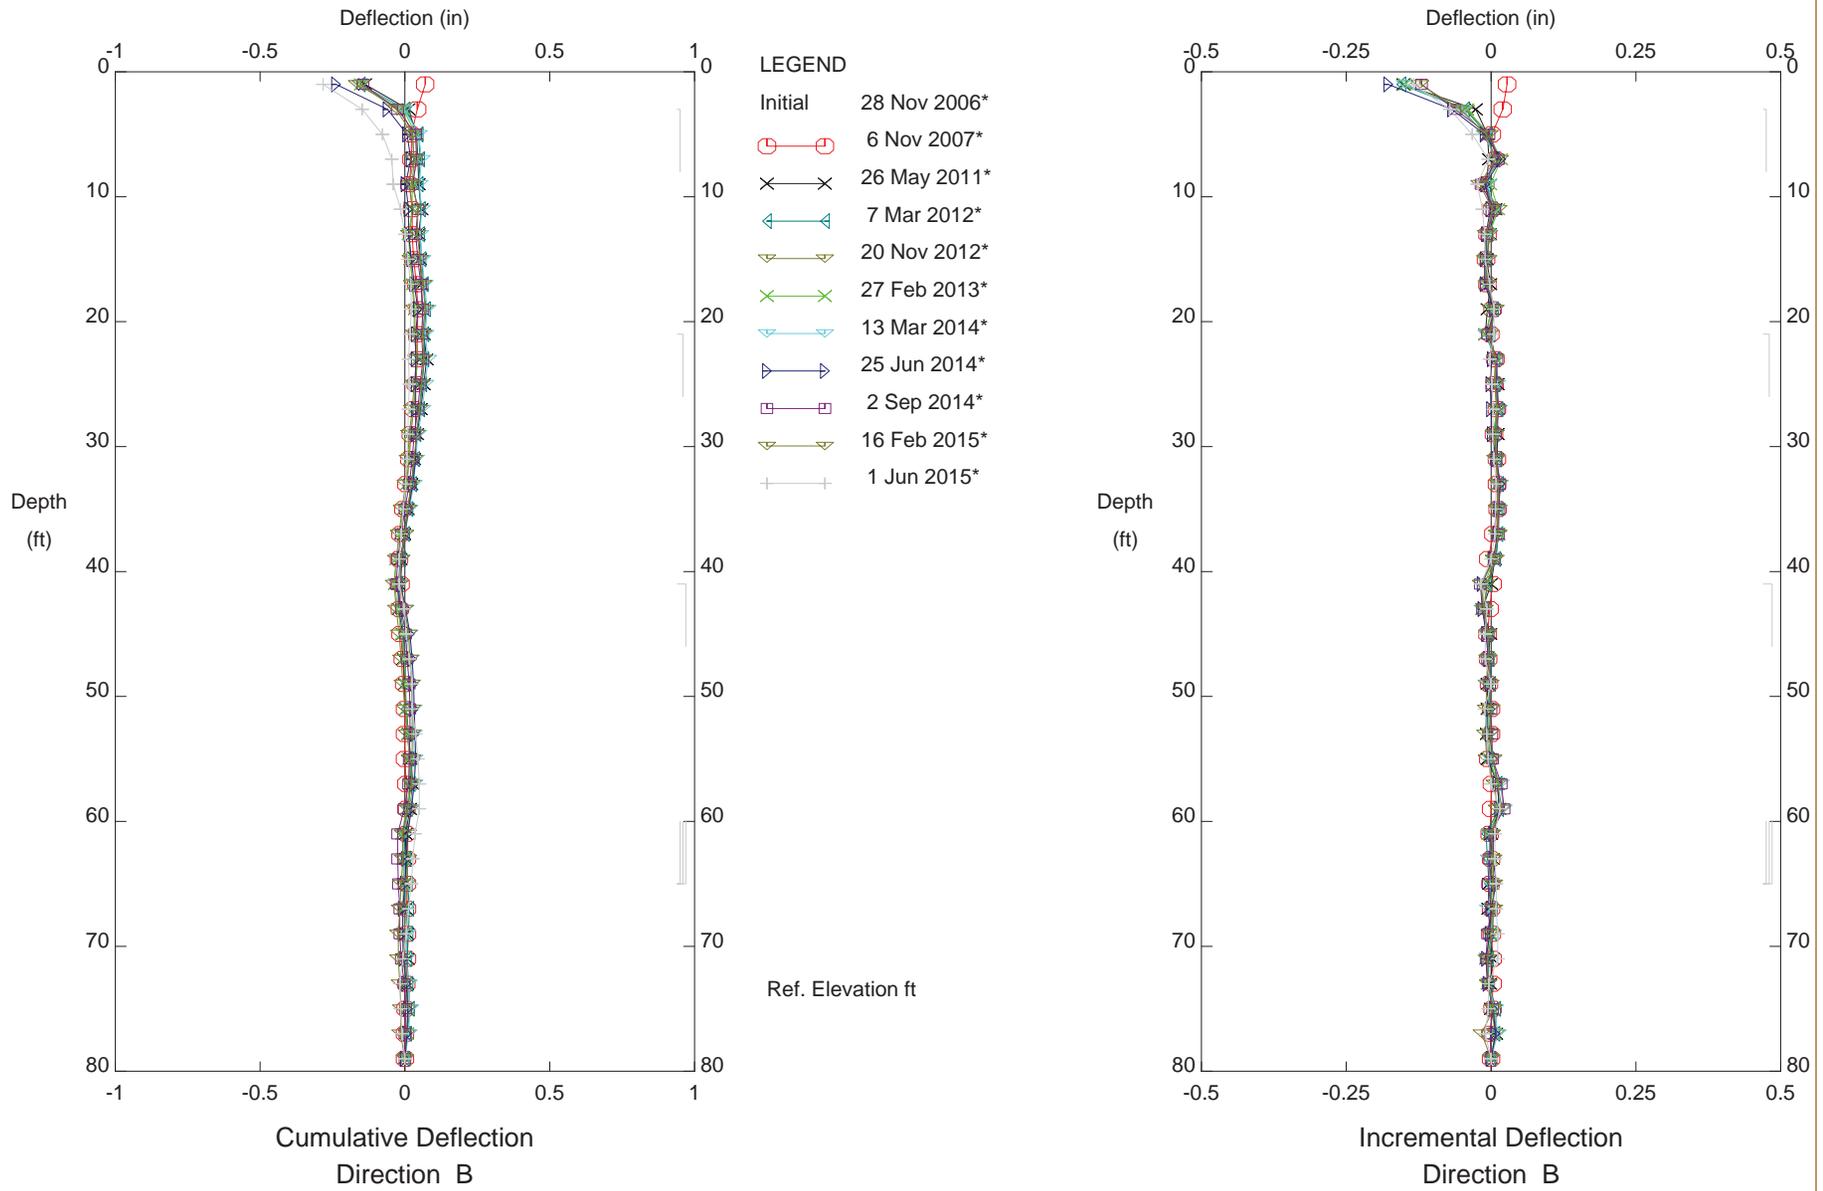
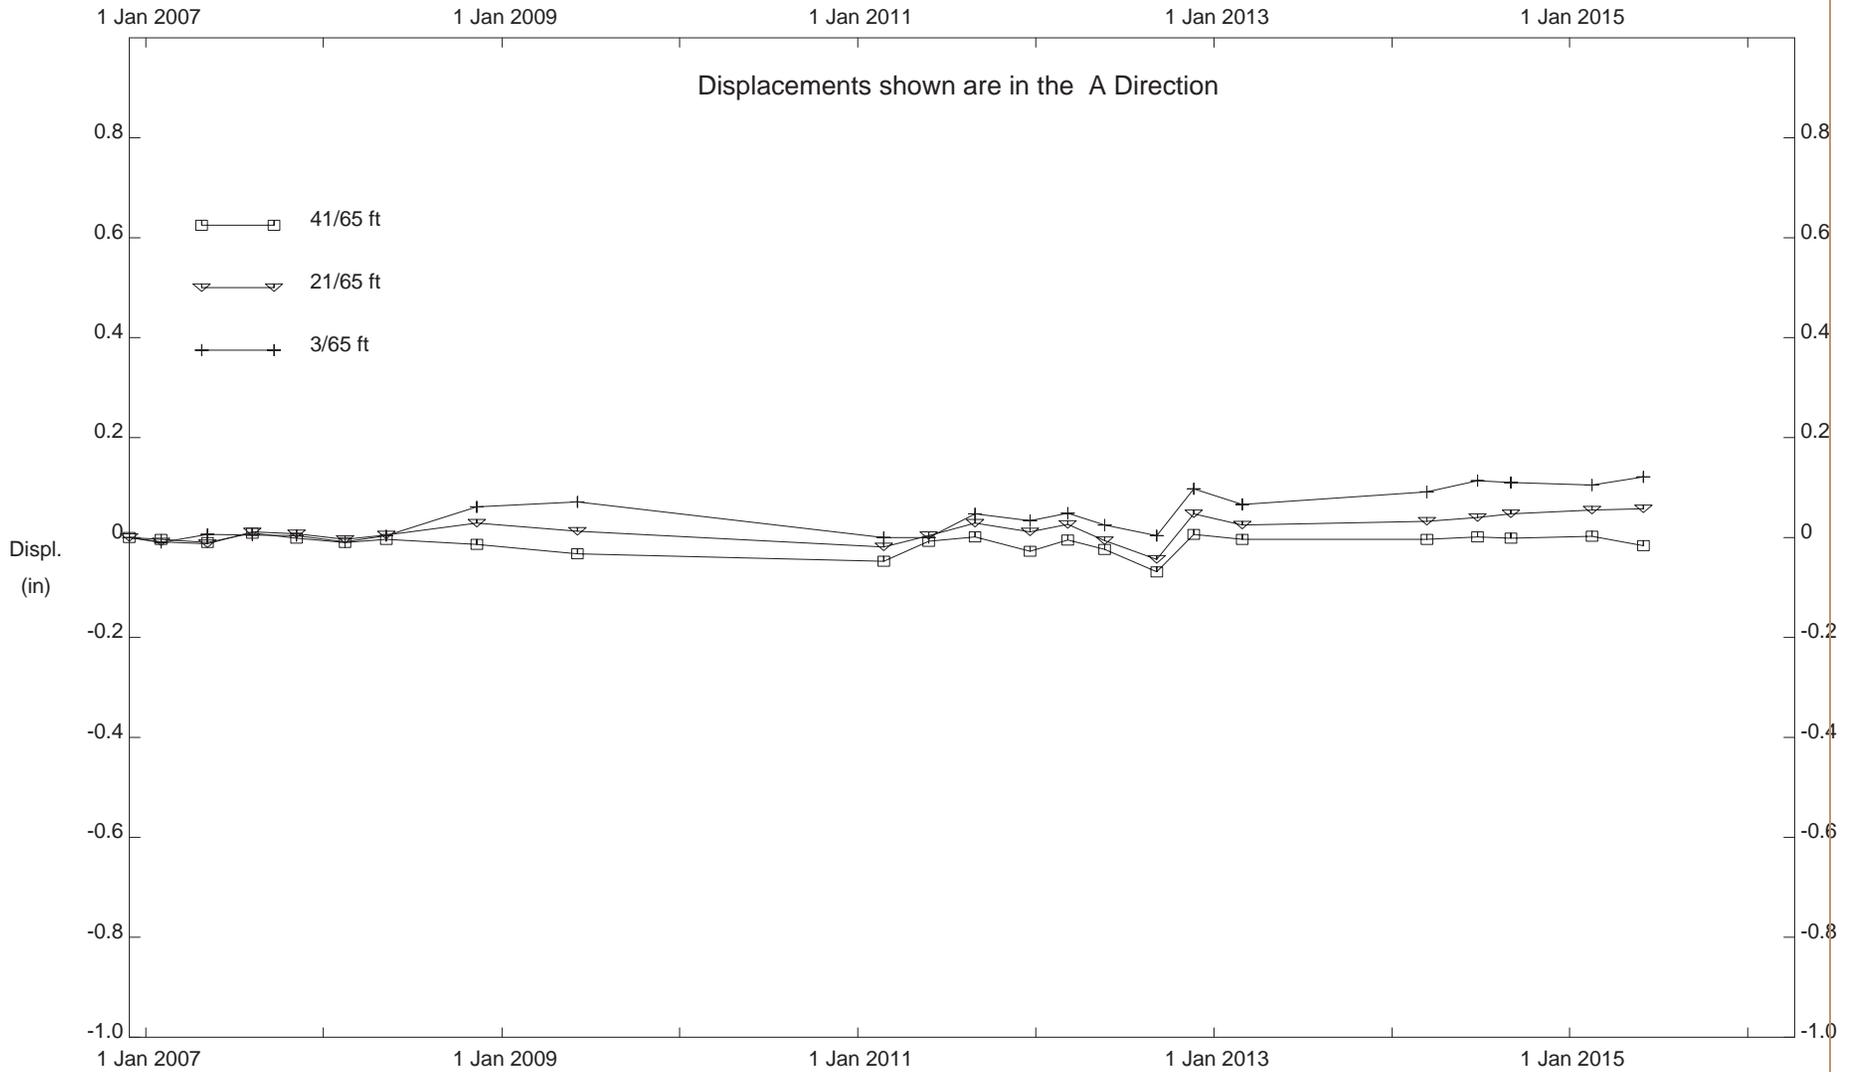
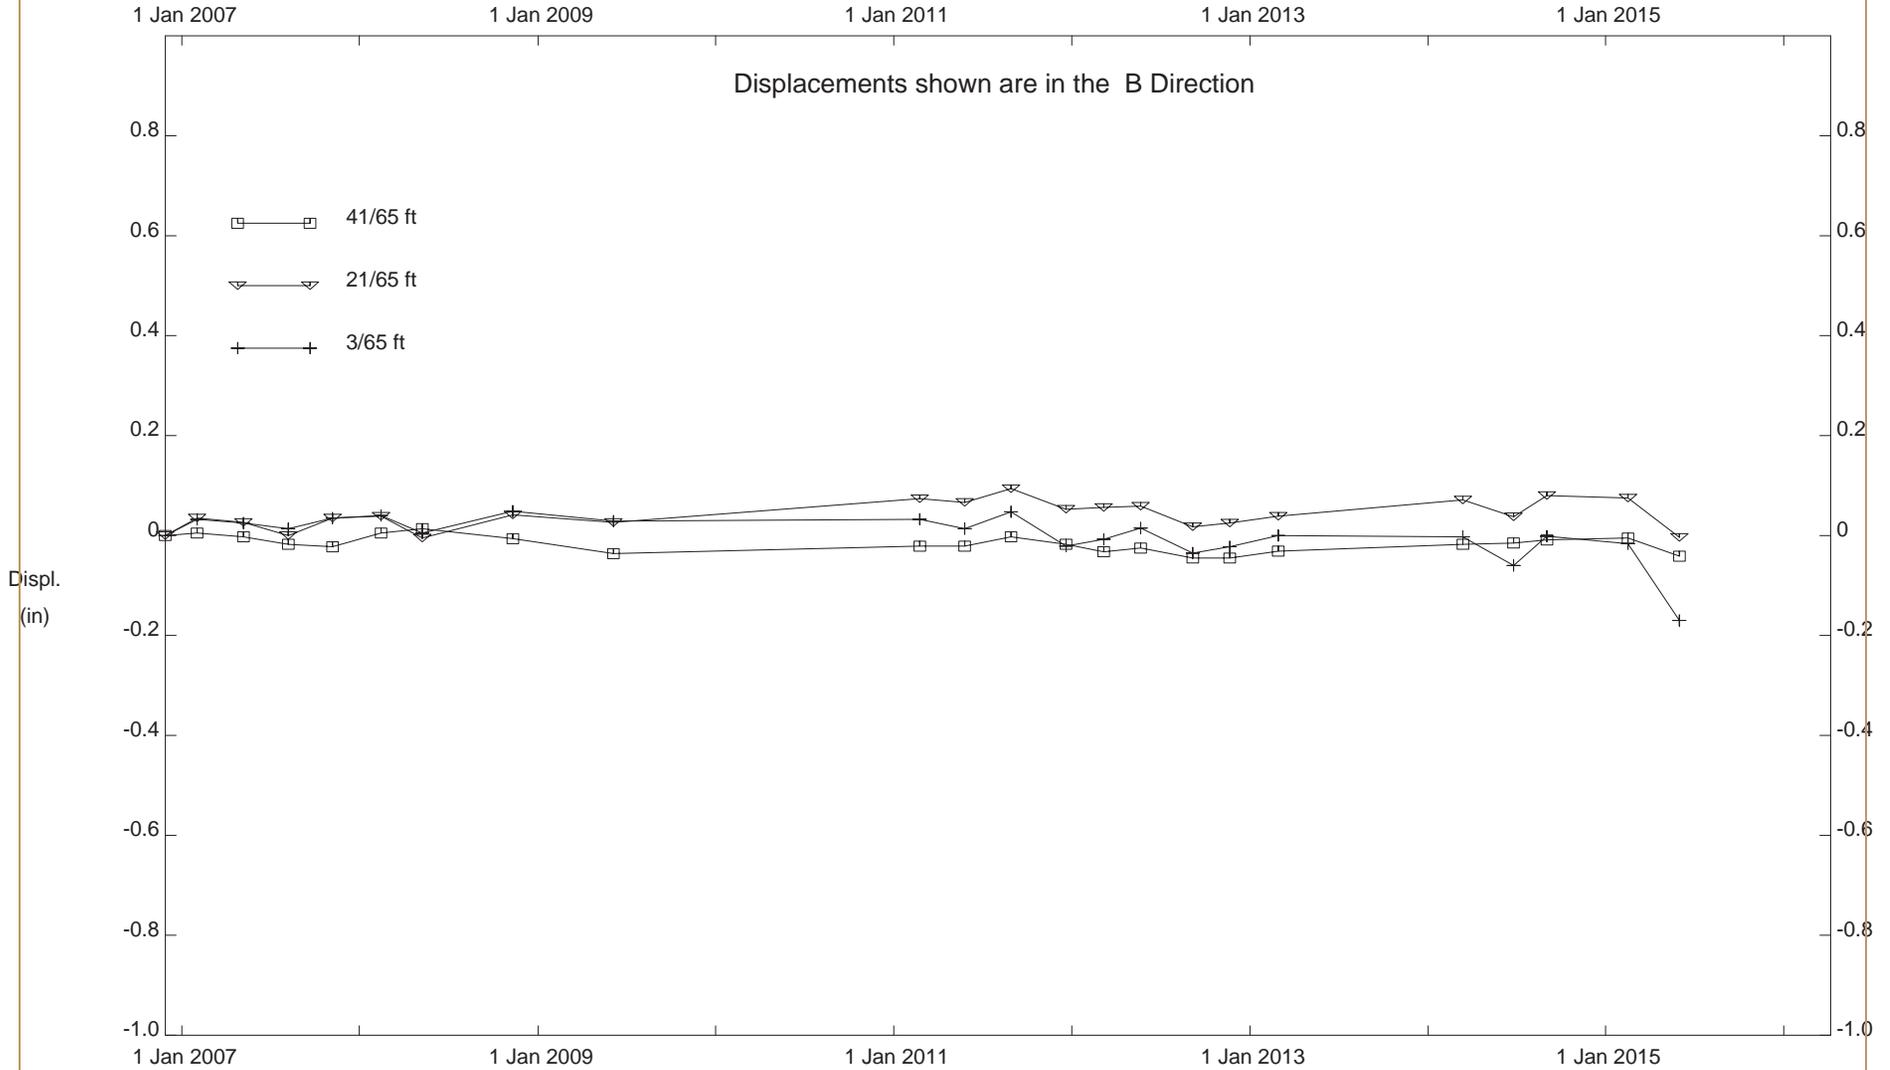
Assessment District 98-3, Inclinometer SI-6
 City of Malibu

Inclinometers SI-5 and SI-6 are located on Bayshore Drive, upslope and outside the defined limit of the most recent 1998 movement. No significant movement was observed during this monitoring year in SI-5 or SI-6.
