Corridorwide Safety Assessment Report

Pacific Coast Highway Safety Study

Malibu, California

May 2013

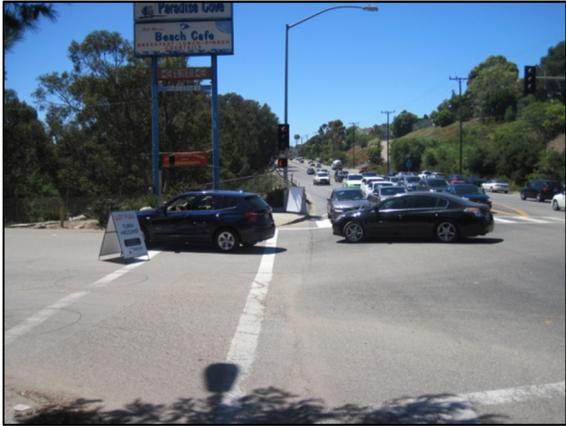
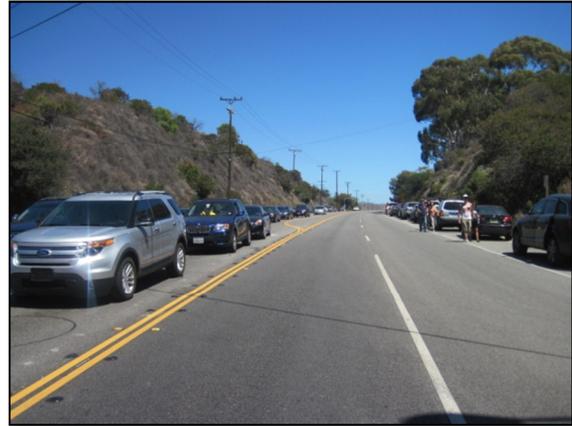
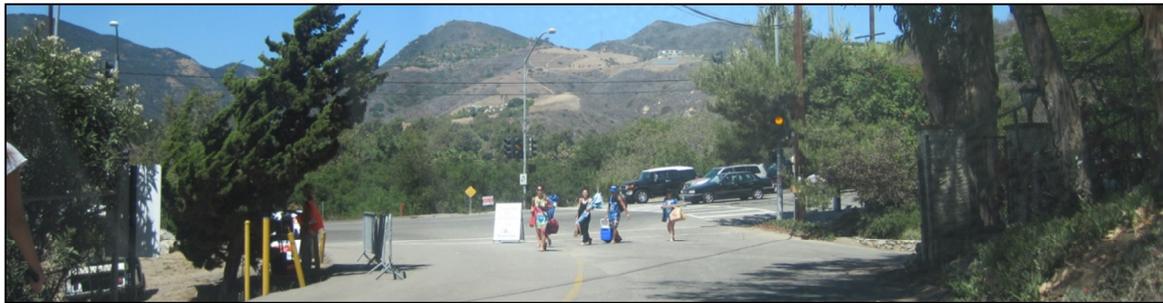
PARADISE COVE INTERSECTION

- **Parking maneuvers** along PCH contribute to congestion approaching and leaving the intersection. One of the ten accidents in the past three years was a rear end accident with a parking vehicle.
- **High crosswalk volume** contributes to congestion approaching the intersection.
- Westbound vehicles are observed to perform **u-turns** in the intersection. A 'Lot Full' sign is only visible once a vehicle is at the entrance.
- **Turning queues** into the parking lot exceed engineering estimates based on volume. Downstream operations (i.e., parking lot entrance) appear to be impacting intersection operations.
- Public feedback has expressed that this is a potential source for **DUI** accidents. One DUI accident occurred at this location in 2012, but the driver's origin is unknown at this time.

- **Admissions** collected near intersection causing pedestrians to spill over into the street.
- Pedestrians walk in the **curb lane** after parking along PCH.
- Pedestrians cross Paradise Cove Road through the **vehicle path** of travel. This negatively impacts upstream vehicular operations of the intersection and presents a pedestrian safety problem.

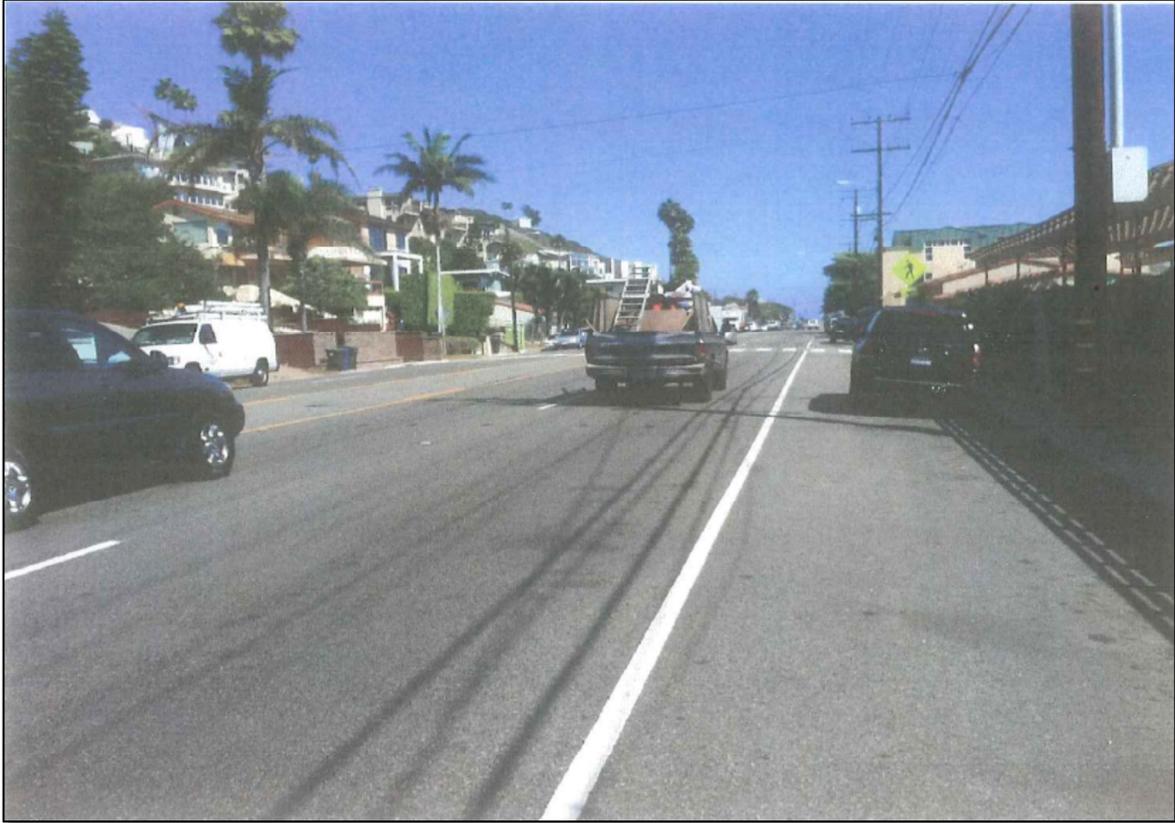
LA COSTA BEACH CLUB CROSSWALK

- **Traffic volume** along this portion of PCH exceed typical volume for a four lane divided roadway.
- **Traffic speed** is higher than the 45 mph speed limit, but most vehicles are observed to travel less than 50 mph. However, a small percentage (0.16%) of vehicles observed on a consecutive Thursday, Friday, and Saturday exceeded 60 mph. Of the ten vehicles observed exceeding 70 mph, nine occurred on Saturday.

- Motorists have become accustomed to **visual landmarks** alerting them to the presence of a crosswalk. Those common physical conditions are absent here.

- Inadequate advance **warning** of crosswalk is provided to motorists. Signs indicating the presence of a crosswalk are located approximately 20 feet north and south of the crosswalk. Similarly, "Ped Xing" warnings are painted on the roadway approximately 300 feet north and south of the crosswalk.
