**ANNUAL REPORT
JULY 2015 THROUGH JUNE 2016
CALLE DEL BARCO
LANDSLIDE ASSESSMENT DISTRICT
MALIBU, CALIFORNIA**

Prepared for:
CITY OF MALIBU

October 2016
Fugro Project No. 04.62160605

Subject: Annual Report, July 2015 through June 2016, Calle del Barco Landslide Assessment District, Malibu, California

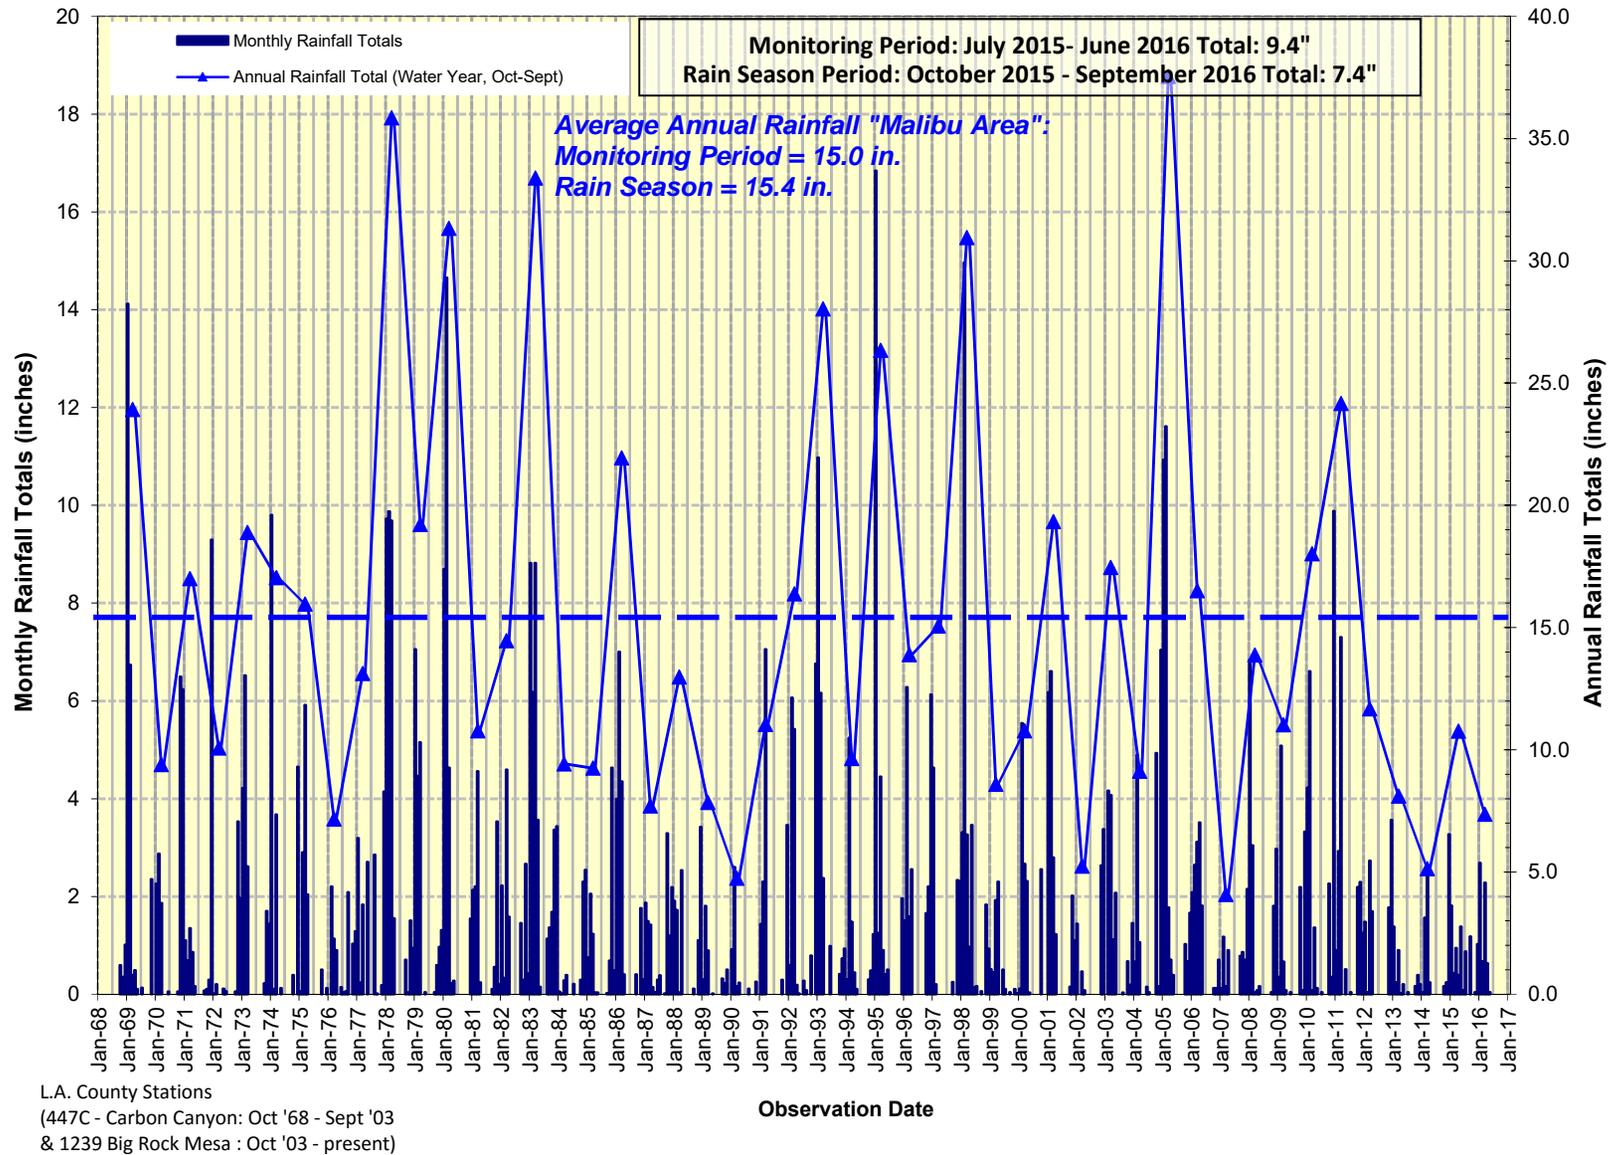
RAINFALL GRAPH

A graph of historical monthly rainfall and average annual rainfall from October 1968 through September 30, 2016 is shown on Plate 3 - Rainfall Graph. Monthly rainfall totals from 1968 through 2004 were obtained from County of Los Angeles Department of Public Works (LADPW) Carbon Canyon Rain Station 447C and monthly rainfall totals from 2004 to the present were obtained from LADPW Big Rock Mesa Rain Gauge 1239.

Rainfall data indicate that approximately 9.4 inches of precipitation fell during the monitoring period from July 1, 2015 through June 30, 2016. The average annual rainfall from 1968 to 2016 in the "Malibu Area" for the same months is approximately 15.0 inches.

However, rainfall data are usually analyzed in terms of the annual "rain season" that covers the time period between October 1 through September 30. Rainfall for October 1, 2015 through September 30, 2016 was approximately 7.4 inches. That is approximately 48 percent of the average annual rainfall of 15.4 inches for the "rain seasons" between 1968 and 2016.

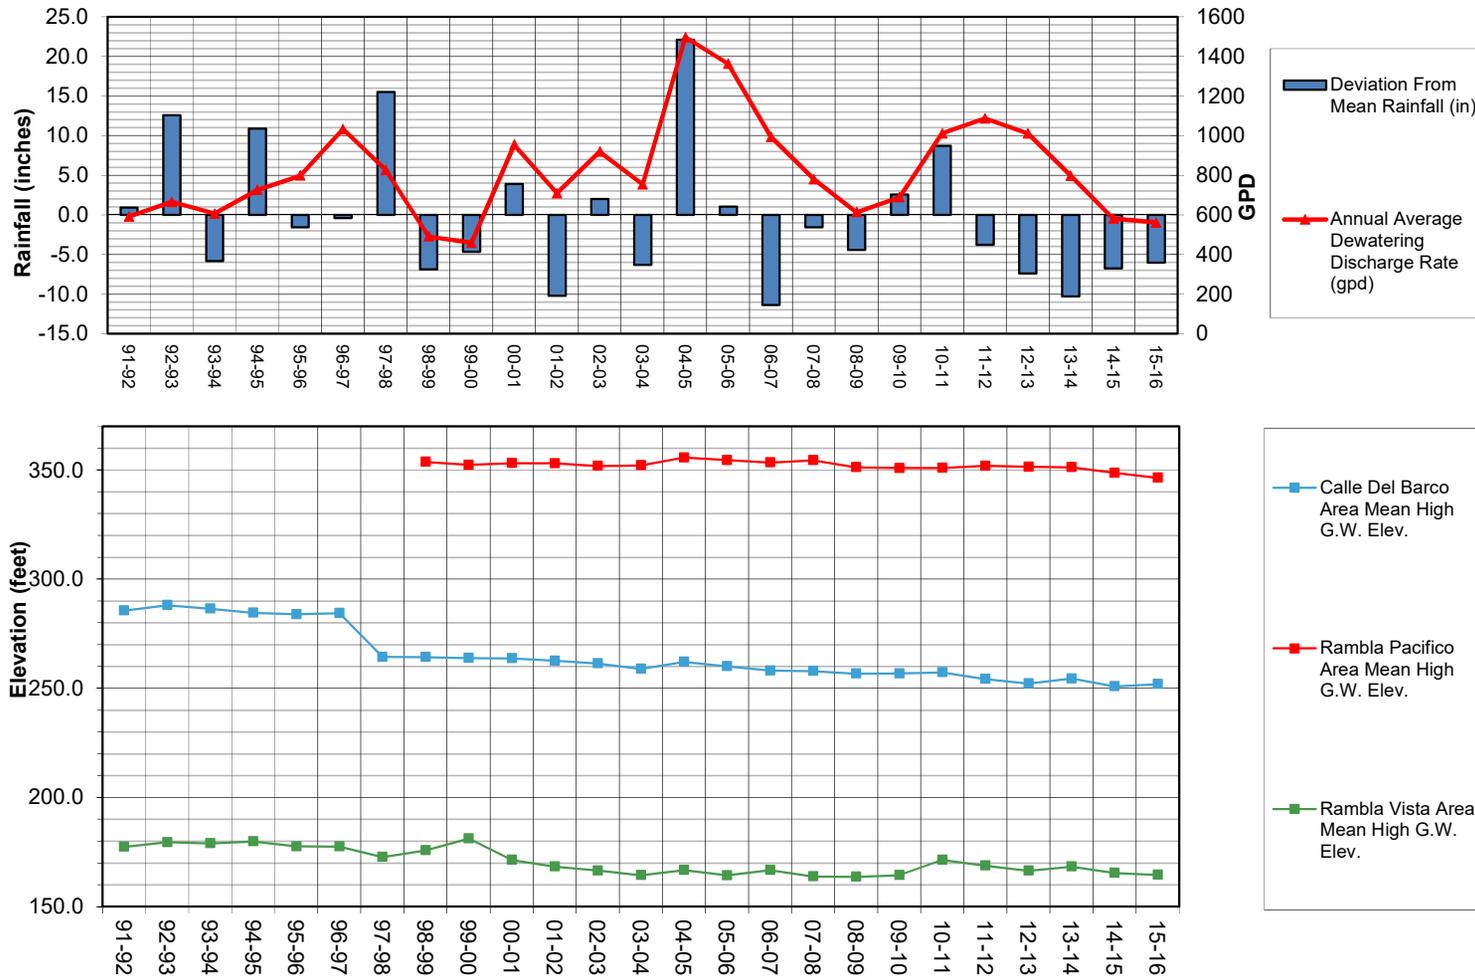
GROUNDWATER LEVELS, DEWATERING AND RAINFALL
 Calle del Barco Landslide Assessment District
 Malibu, California

Plate 5 – Groundwater Levels, Dewatering, and Rainfall shows the yearly magnitude of deviation of each years' rainfall relative to the mean annual rainfall. The graphic also shows the average annual dewatering output (gallons per day, gpd). The data illustrates that the average annual dewatering output has been decreasing with continued below average rainfall.

Summary. Groundwater levels in individual piezometers were generally lower relative to the previous year. The annual average groundwater elevations were lower than the prior year averages in the Rambla Vista and Rambla Pacifico areas and unchanged in the Calle del Barco Area. The peak groundwater elevations were lower than the prior year's peak in the Rambla Vista and Rambla Pacifico Areas and slightly higher in the Calle del Barco Area. Table 1 presents the average and highest annual groundwater levels by area. The shallow pneumatic piezometers located above the water table reflect unsaturated conditions, which indicates that there has not been sufficient recharge to maintain significant shallow perched water.

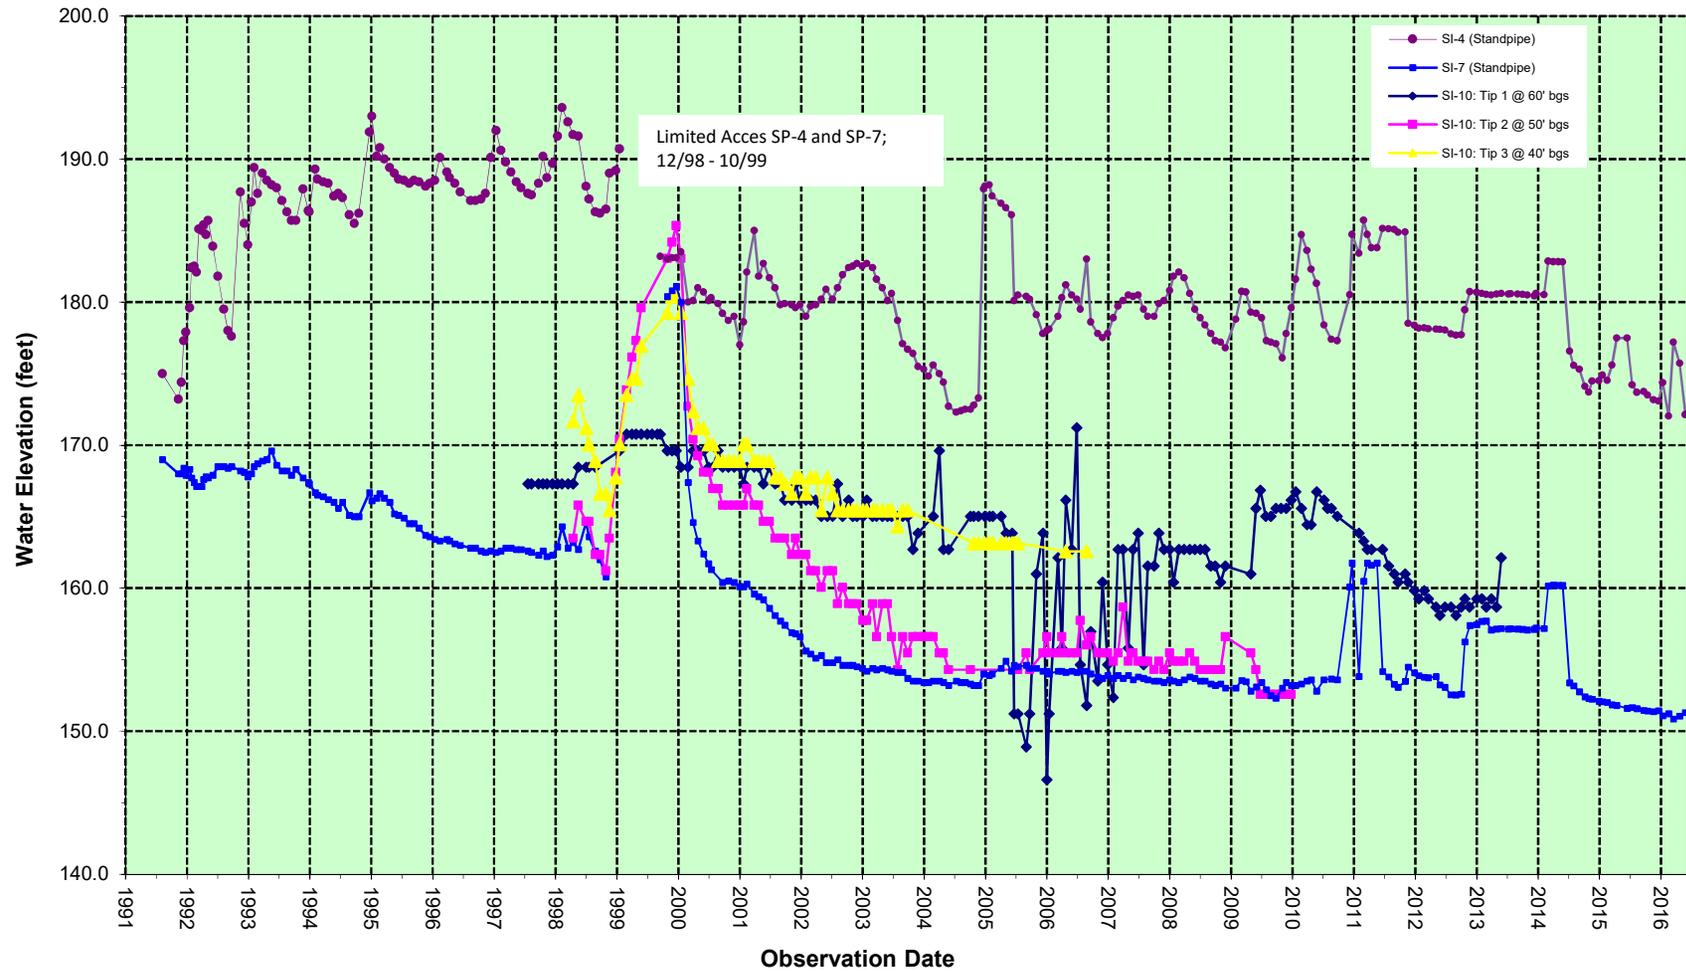
GROUNDWATER HYDROGRAPH
Rambla Vista
Calle del Barco Landslide Assessment District
Malibu, California

Rambla Vista. Groundwater elevation data for the Rambla Vista Area are presented in Plate A-3. Groundwater levels for this area are monitored using standpipes SI-7 and SI-4 and the pneumatic piezometers attached to Inclinator SI-10. In general, groundwater elevations in the Rambla Vista Area continued to decline during the 2015-2016 monitoring period. The calculated area average declined one foot when compared to the area average for the 2014-2015 monitoring period and is about 5.5 feet lower than the mean water level elevation for this area for the period of record (1991-2016).

Groundwater levels measured in standpipe SI-4 rose briefly in February and April 2016, as a result of rainfall events during those months before then declining to their lowest recorded elevations since 2004 (in March and June 2016). Groundwater elevations in SI-7 have continued to decline and recorded all-time lows for the period of record on April 5, 2016, before slightly rising. Pore pressure readings in pneumatic piezometer SI-10 Tip 3 and Tip 4 measured 0 PSI. Pneumatic piezometer SI-10 Tip 3 has read 0 PSI since September 2006 and Tip 4 has read 0 PSI since installation. It is believed that Tip 3 and Tip 4 are functioning, but are reading zero due to the groundwater elevation being lower than the piezometer tip elevation. SI-10 Tips 1 and 2 are clogged and non-functional and were last readable in June 2013 and February 2010, respectively.

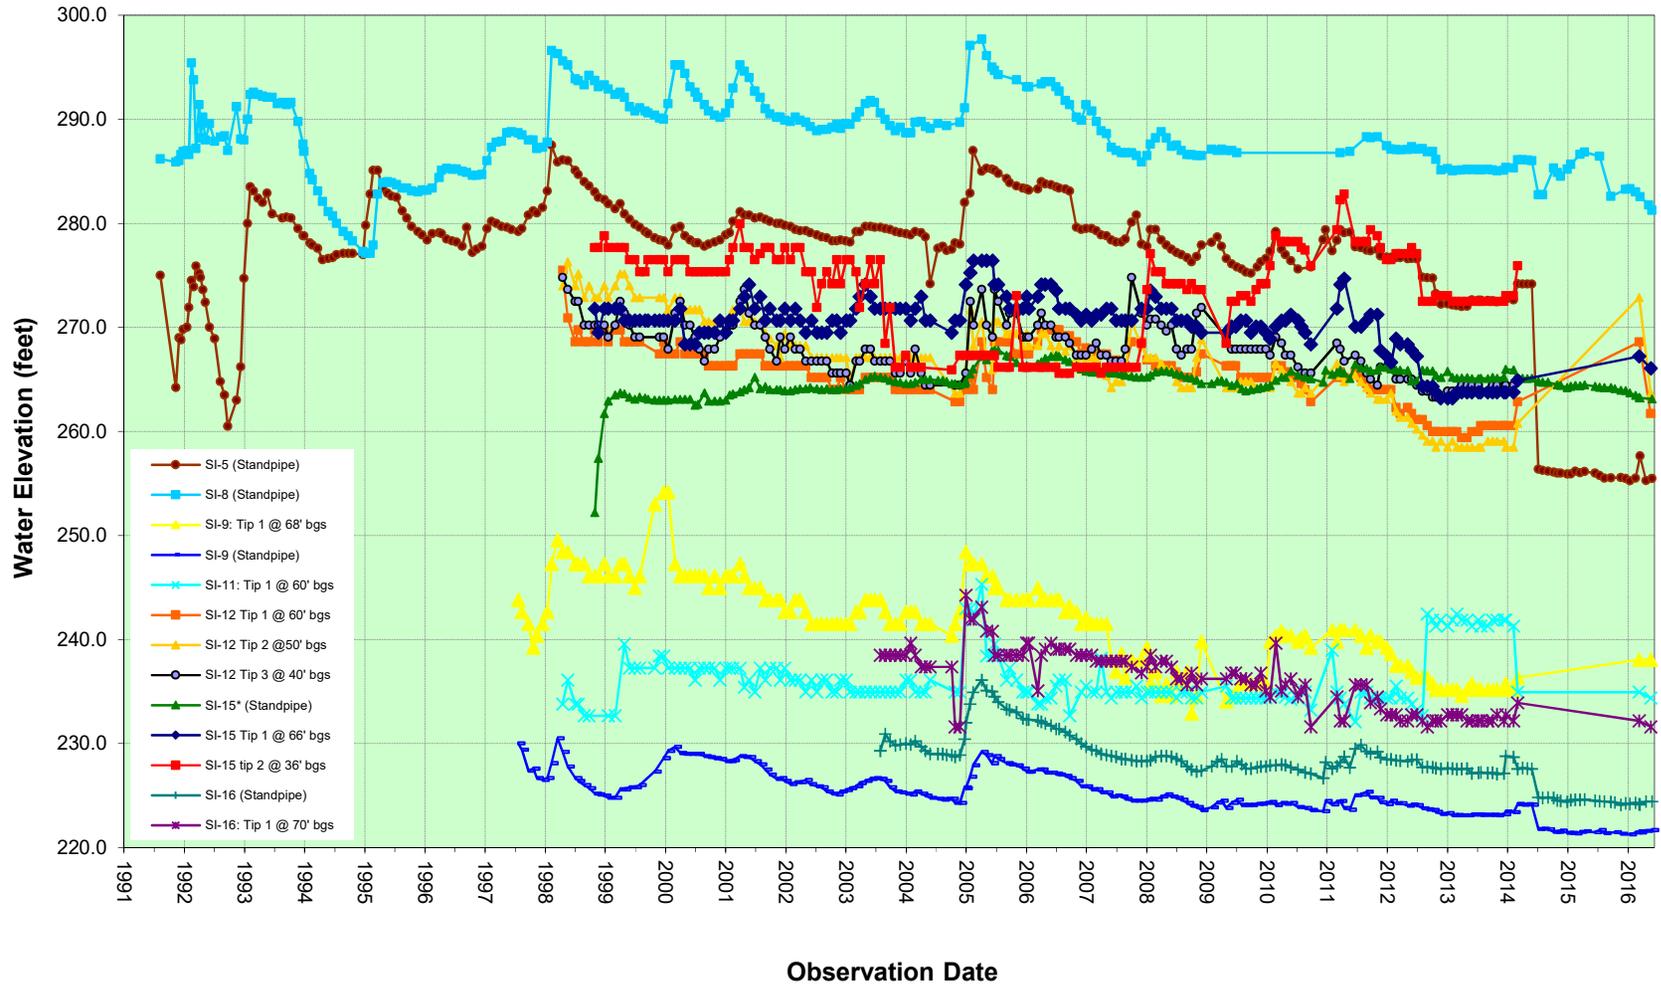
GROUNDWATER HYDROGRAPH
Calle del Barco
Calle del Barco Landslide Assessment District
Malibu, California

Calle Del Barco. Groundwater data for the Calle del Barco Area are presented on Plate A-4. Groundwater levels for this area are monitored using standpipe piezometers SI-5, SI-8, SI-9, SI-15, and SI-16 and pneumatic piezometers attached to inclinometers SI-9, SI-11, SI-12, SI-15, and SI-16. In general, groundwater elevations in the Calle del Barco Area for the 2015-2016 monitoring period remained unchanged from the 2014-2015 monitoring period with no difference between the respective calculated area averages. The Calle del Barco area remains approximately 12.5 feet below the mean water level elevation for this area over the period of record.

Water levels in all of the individual standpipe piezometers trended lower or remained unchanged throughout the monitoring year except for some temporary rises following the rainfall events of January and March 2016.

The pneumatic piezometers within the Calle del Barco Area were monitored in March 2016 and June 2016. Data are not reported for the pneumatic piezometers between March 2014 and March 2016. Pneumatic piezometer readings from March 2016 were measured shortly after significant rainfall events and with the exception of SI-16 Tip-1, which declined, all of them reflected water level rises when compared to the March 2014 readings. During the subsequent round of pneumatic piezometer readings taken in June 2016, all water levels had begun to decline. Pneumatic piezometers SI-9 Tip 2, SI-12 Tip 4, and SI-16 Tip 2 have measured 0 PSI since 1998 and none of their data are presented on Plate A-4. Pneumatic piezometers SI-15 Tip 2 and SI-12 Tip 3 are no longer functioning and no new data are presented.

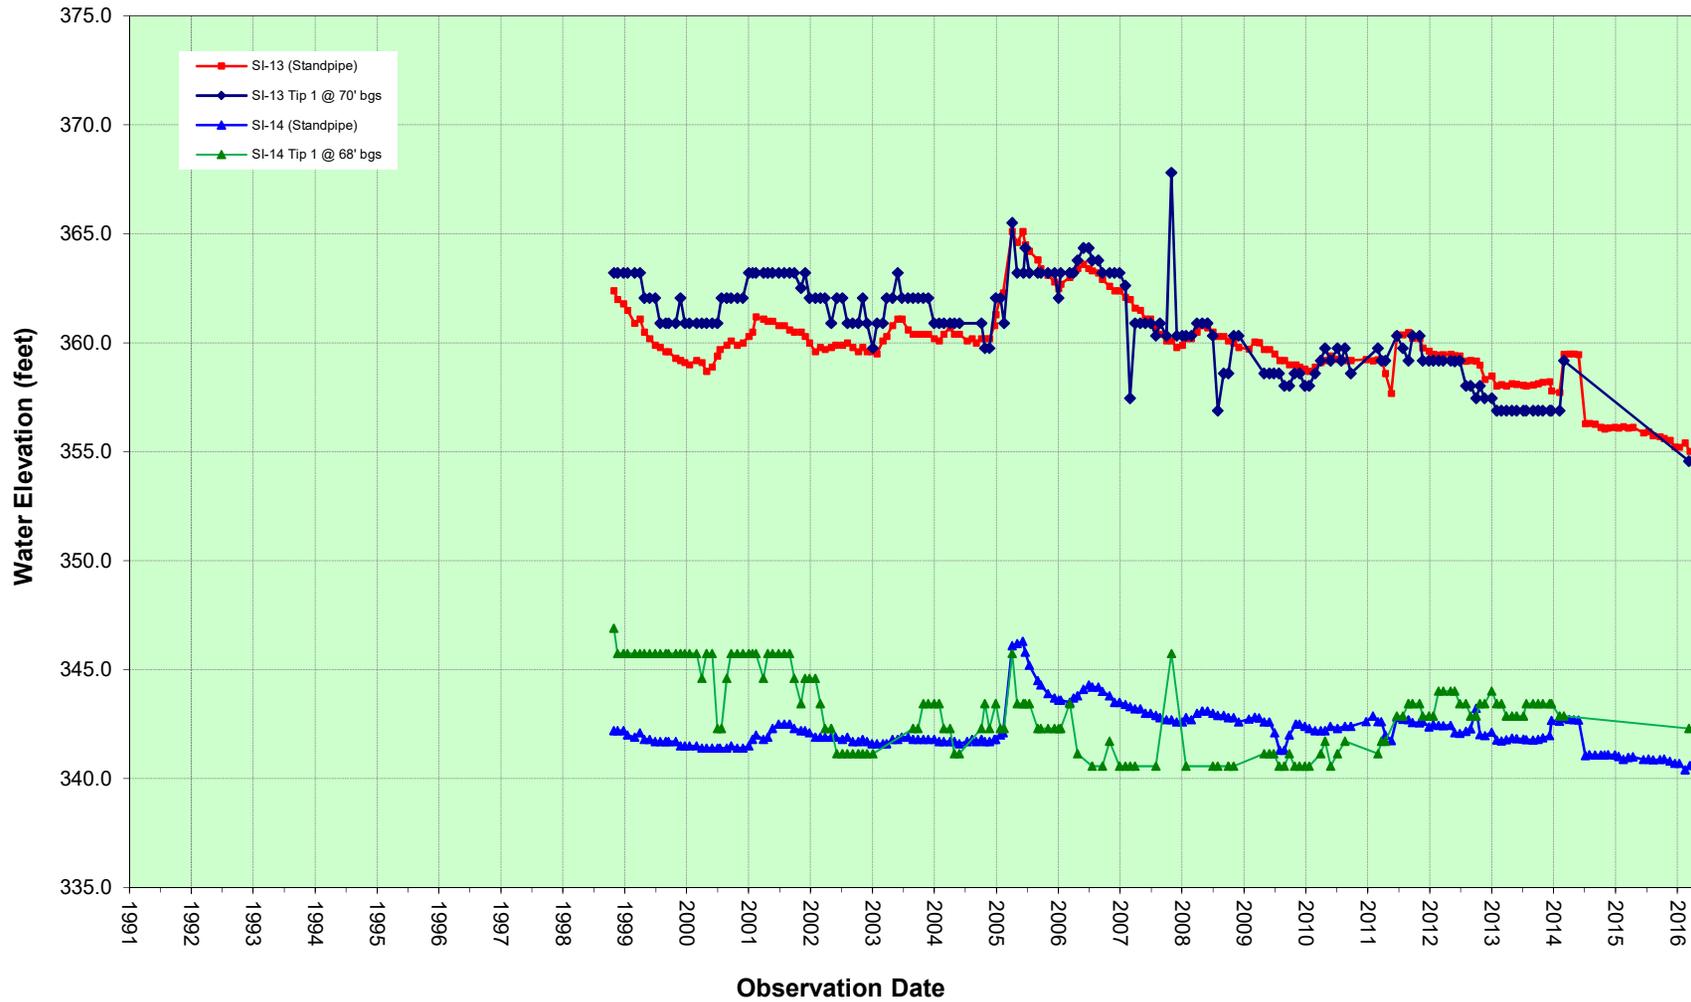
GROUNDWATER HYDROGRAPH
Rambla Pacifico
Calle del Barco Landslide Assessment District
Malibu, California

Rambla Pacifico. Groundwater data for the Rambla Pacifico Area are presented on Plate A-5. Groundwater levels for this area are monitored using standpipe piezometers SI-13 and SI-14 along with two pneumatic piezometers installed within each of those standpipes. In general, groundwater elevations in the Rambla Pacifico Area for the 2015-2016 monitoring period continued to decline. The calculated area average declined by 2.4 feet when compared to the 2014-2015 monitoring period and is 4.9 feet below the mean water level elevation for the area for the period of record.

Water levels in the individual standpipe piezometers continued to decline throughout the monitoring period and are at all-time lows for the period of record. Pneumatic Piezometers SI-13 Tip 1 and SI-14 Tip 1 continue to decline with trends that approximately correlate with their respective standpipe water levels. The shallow pneumatic piezometers (Tip 2) in both standpipes have been dry since installation and no data are reported. Dewatering well W-K, located within the Rambla Pacifico Area near SI-13 has a reported bottom elevation of 370 feet and has been completely dry since December 2015.

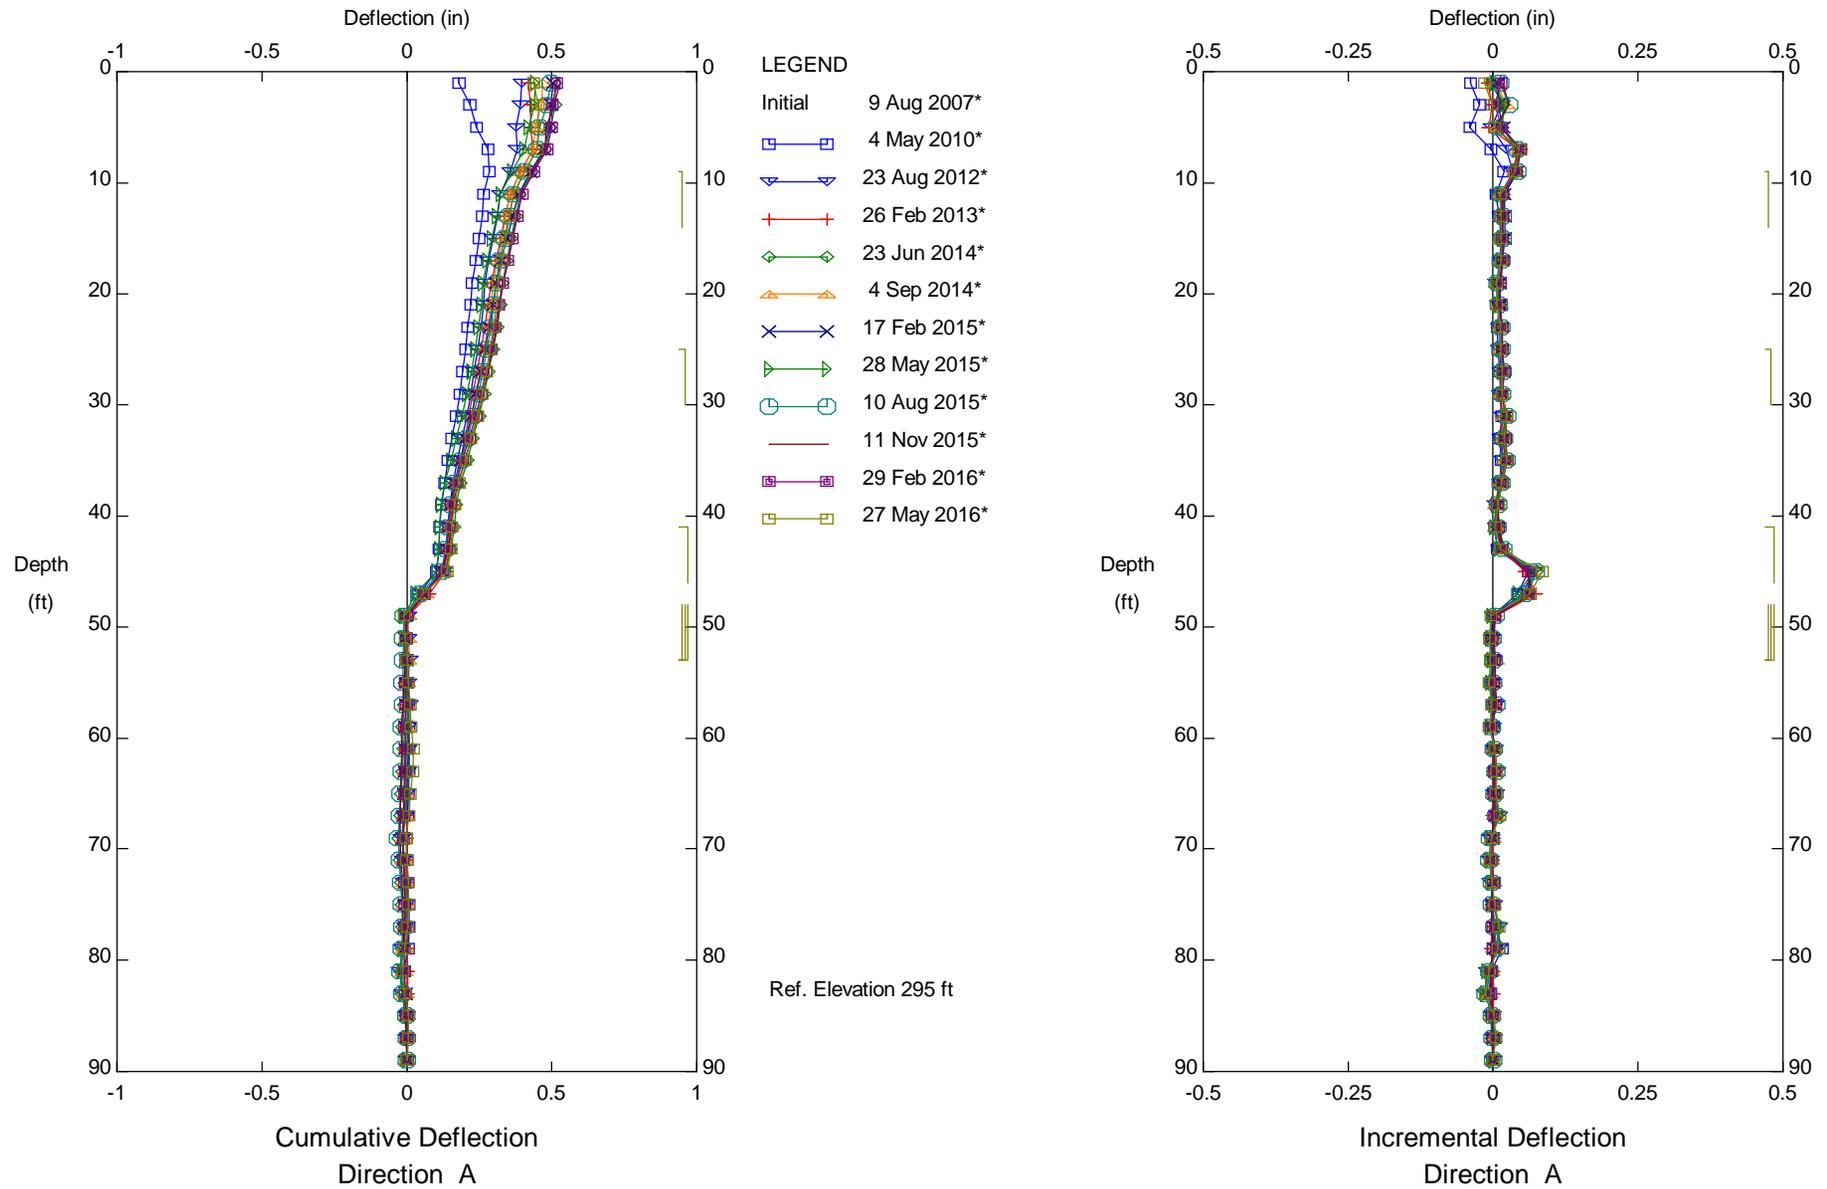
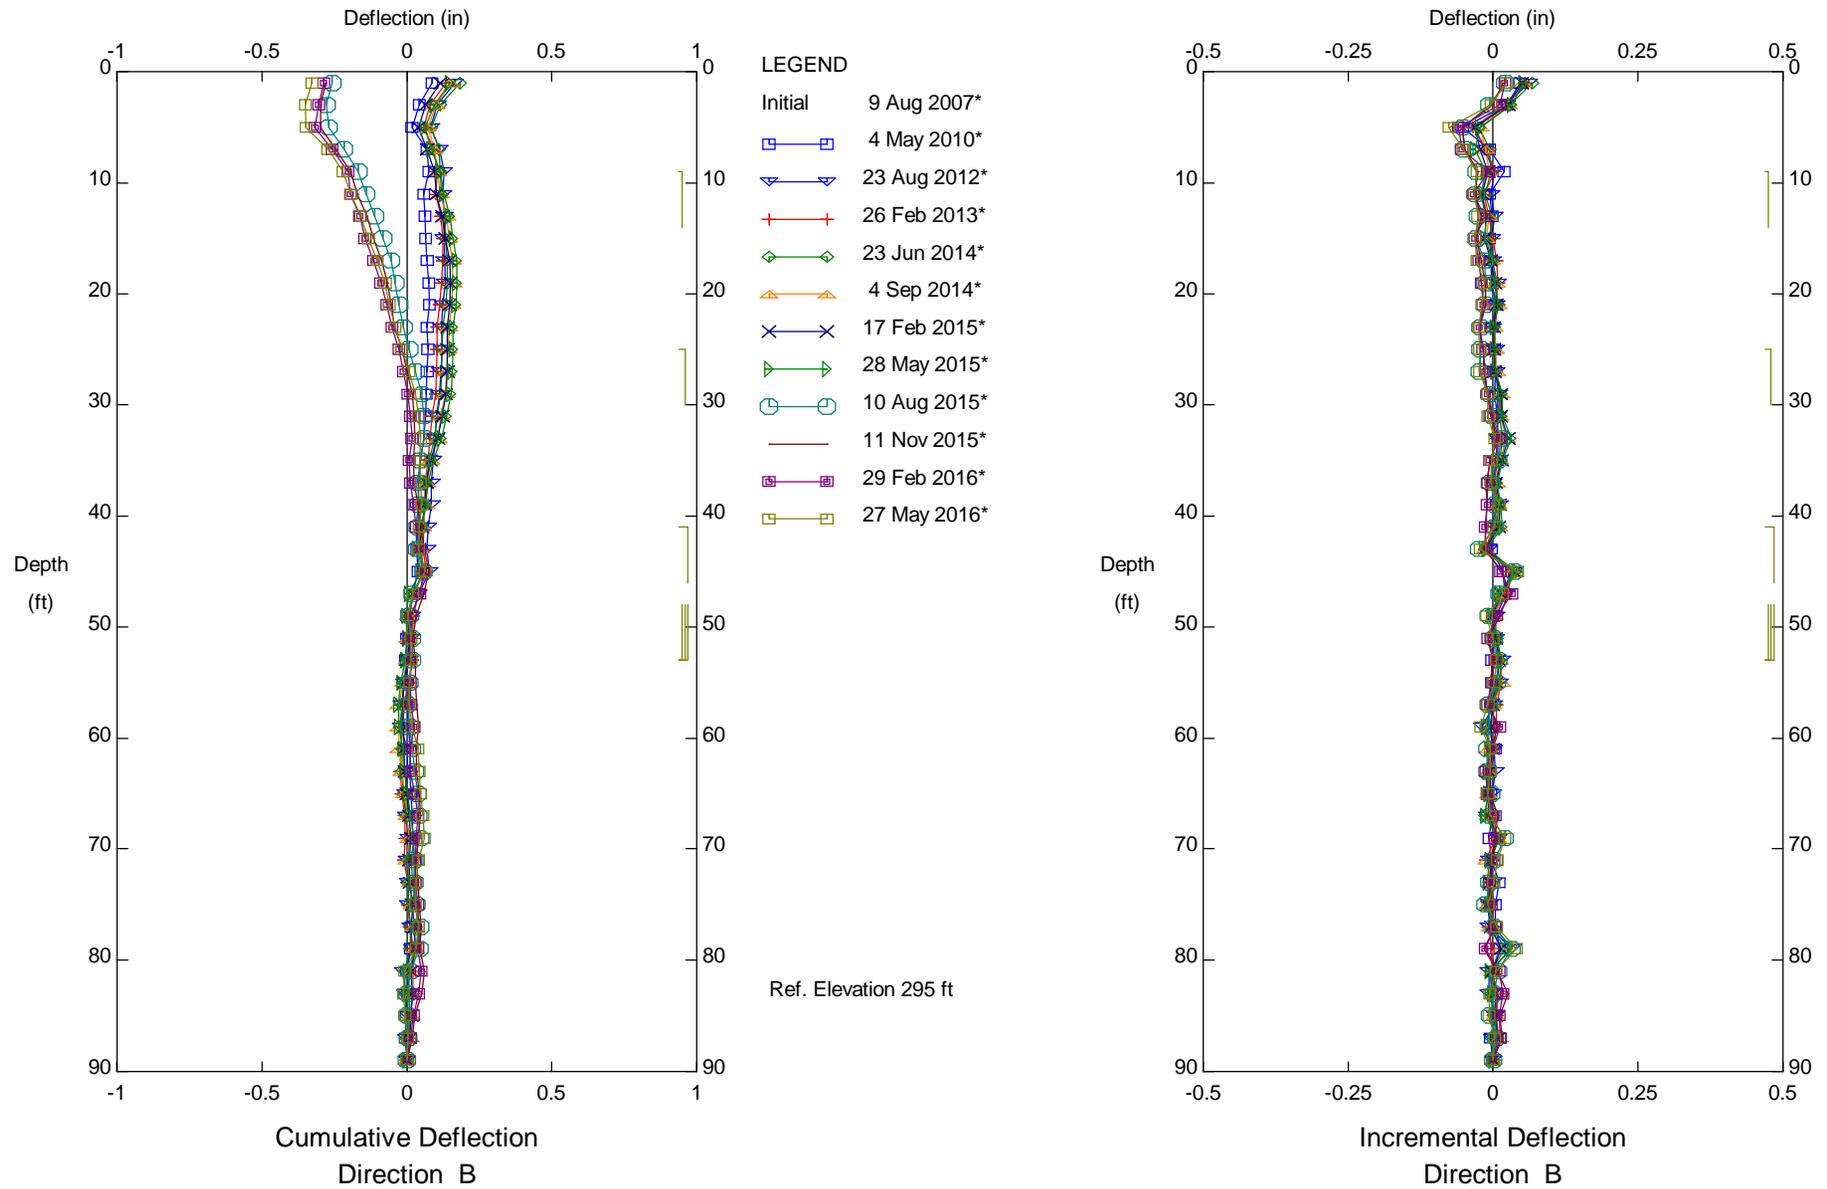
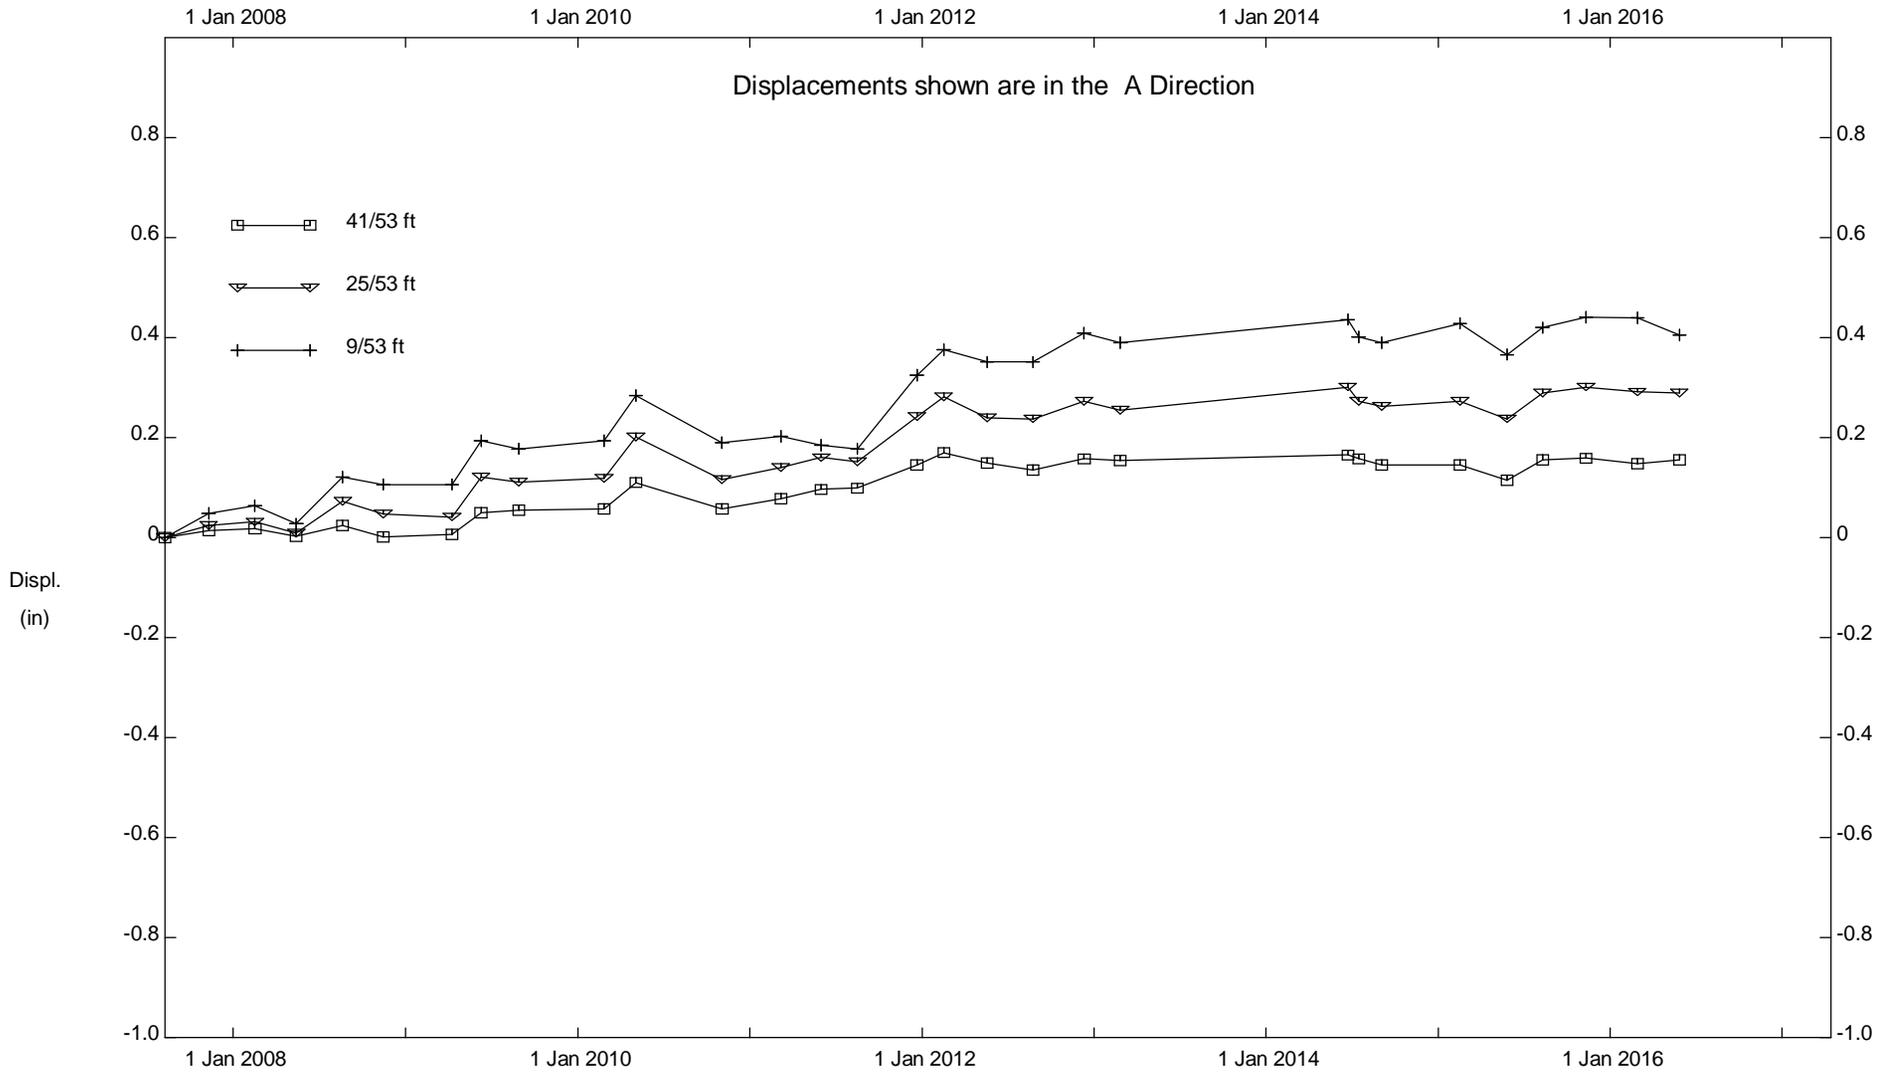
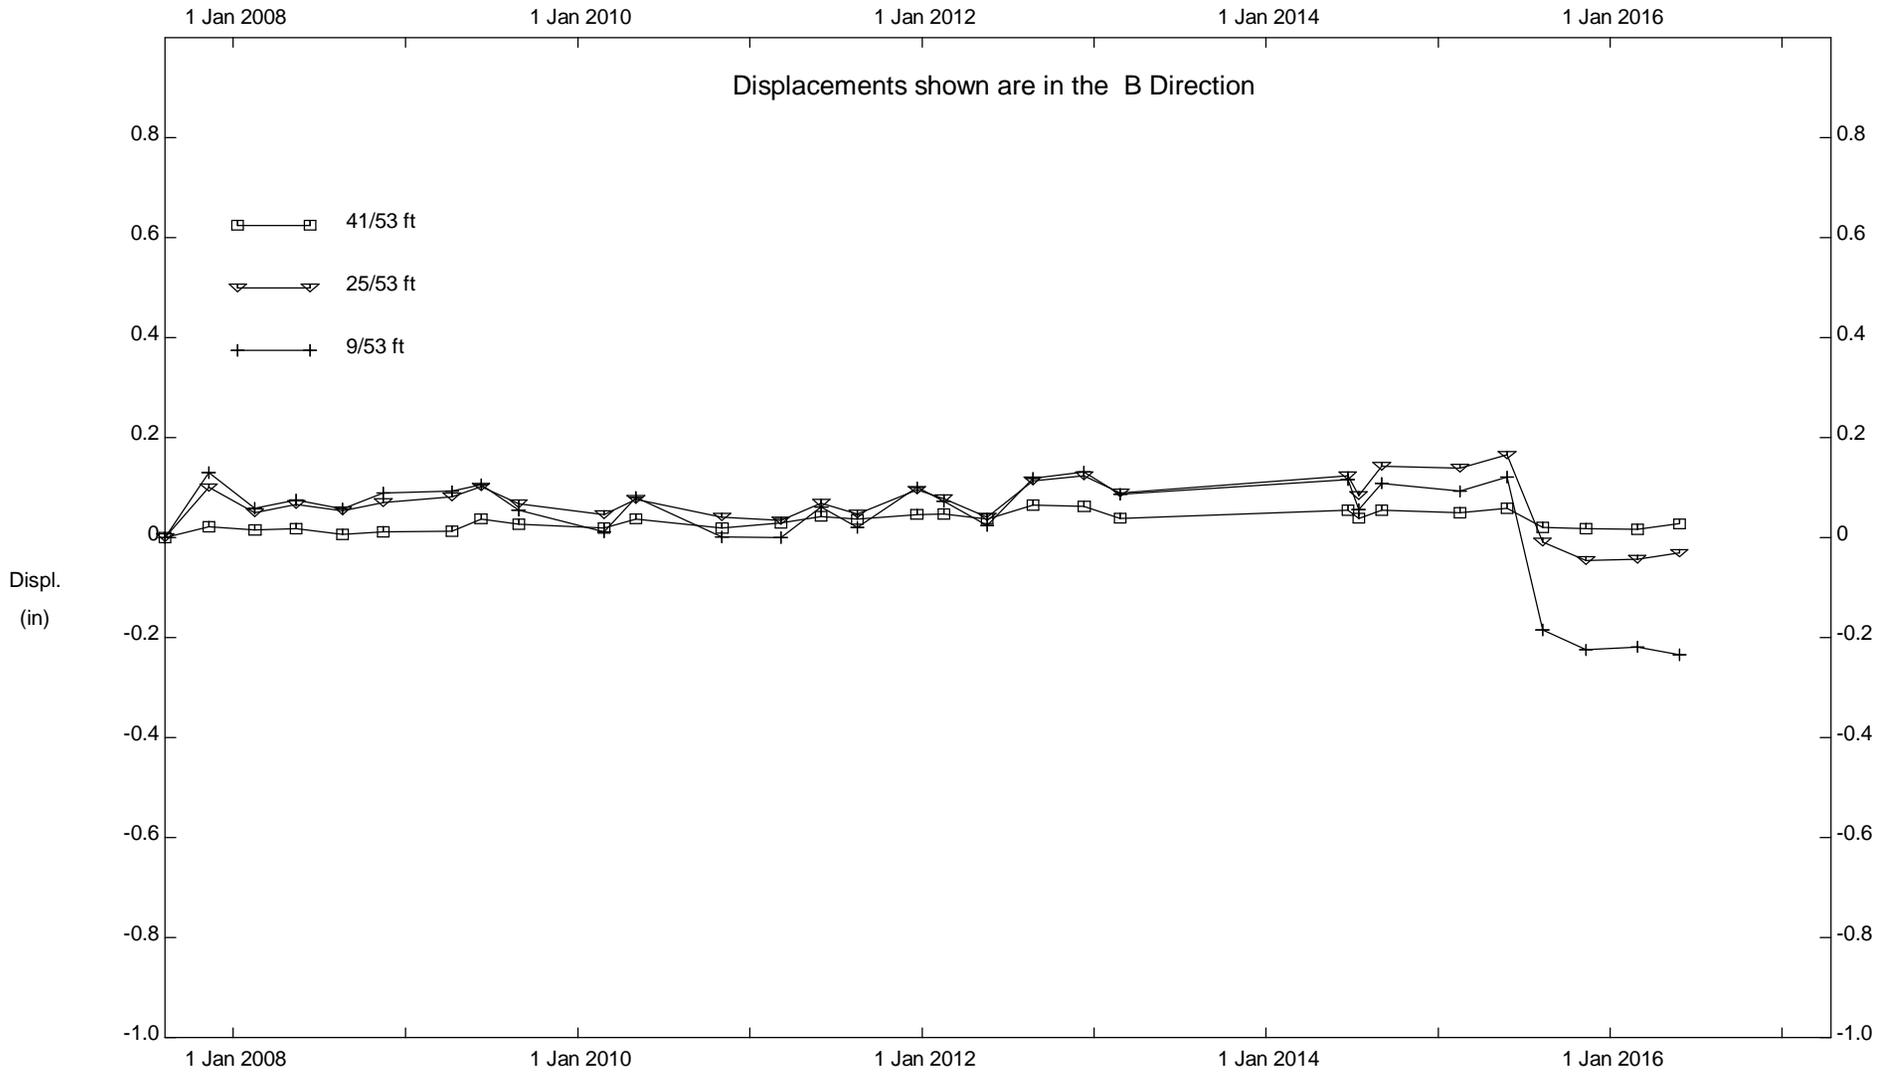
Assessment District 98-2, Inclinometer SI-16
 City of Malibu

Historically, inclinometer SI-16 has exhibited a pattern of movement measured at the ground surface at an average rate of up about 0.08 inches/year since 2005, resulting in approximately 0.5 inches of cumulative displacement at the ground surface since the 2004-2005 monitoring period. Movement of that inclinometer appears to be both translational at specific depths between 0 to 10 feet and between 40 and 50 feet and rotational about a hinge point at about 50 feet below the ground surface. That pattern of movement is similar to the movement observed in inclinometer SI-9 located in close proximity to SI-16. However, no detectable movement occurred at SI-16 over the 2015-2016 monitoring period.

Although the movement observed in inclinometers SI-9 and SI-16 has not produced new, observed distress in pavements or other development of which Fugro is aware, the movement is nevertheless quantifiable and can be defined by a clear trend.
