**ANNUAL REPORT  
JULY 2015 THROUGH JUNE 2016  
MALIBU ROAD LANDSLIDE ASSESSMENT DISTRICT  
MALIBU, CALIFORNIA**

Prepared for:  
CITY OF MALIBU

November 2016  
Fugro Project No. 04.62160604

Subject: Annual Report, July 2015 through June 2016, Malibu Road Landslide Assessment District

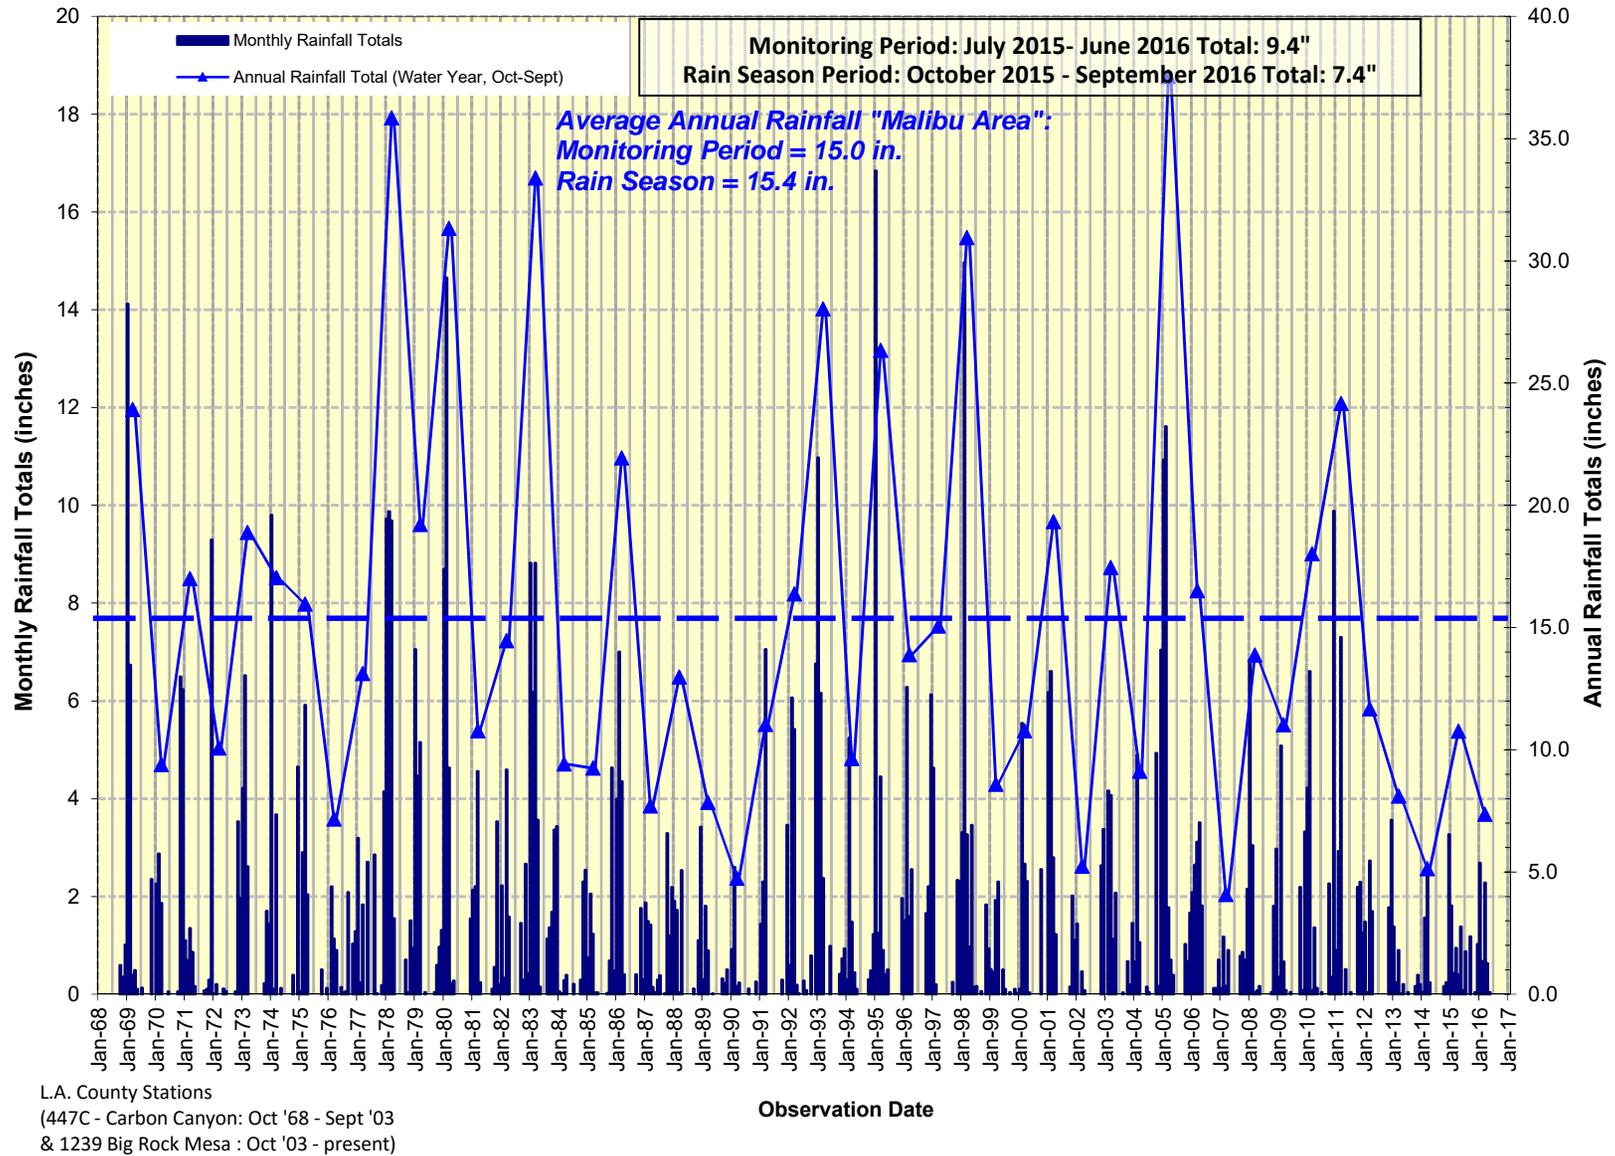
**RAINFALL GRAPH**  
 Malibu Road Landslide Assessment District  
 Malibu, California

A graph of historical monthly rainfall and average annual rainfall from October 1968 through September 30, 2016, is shown on Plate 3 - Rainfall Graph. Monthly rainfall totals from 1968 through 2004 were obtained from County of Los Angeles Department of Public Works (LADPW) Carbon Canyon Rain Station 447C and monthly rainfall totals from 2004 to the present were obtained from LADPW Big Rock Mesa Rain Gauge 1239.

Rainfall data indicate that approximately 9.4 inches of precipitation fell during the monitoring period from July 1, 2015, through June 30, 2016. The average annual rainfall from 1968 to 2016 in the "Malibu Area" for the monitoring period is approximately 15.0 inches.

Rainfall data are usually analyzed in terms of the annual "rain season" that covers the time period from October 1 through September 30. Rainfall for October 1, 2015, through September 30, 2016, was approximately 7.4 inches. This is approximately 48 percent of the average annual rainfall of 15.4 inches for the "rain seasons" between 1968 and 2016.

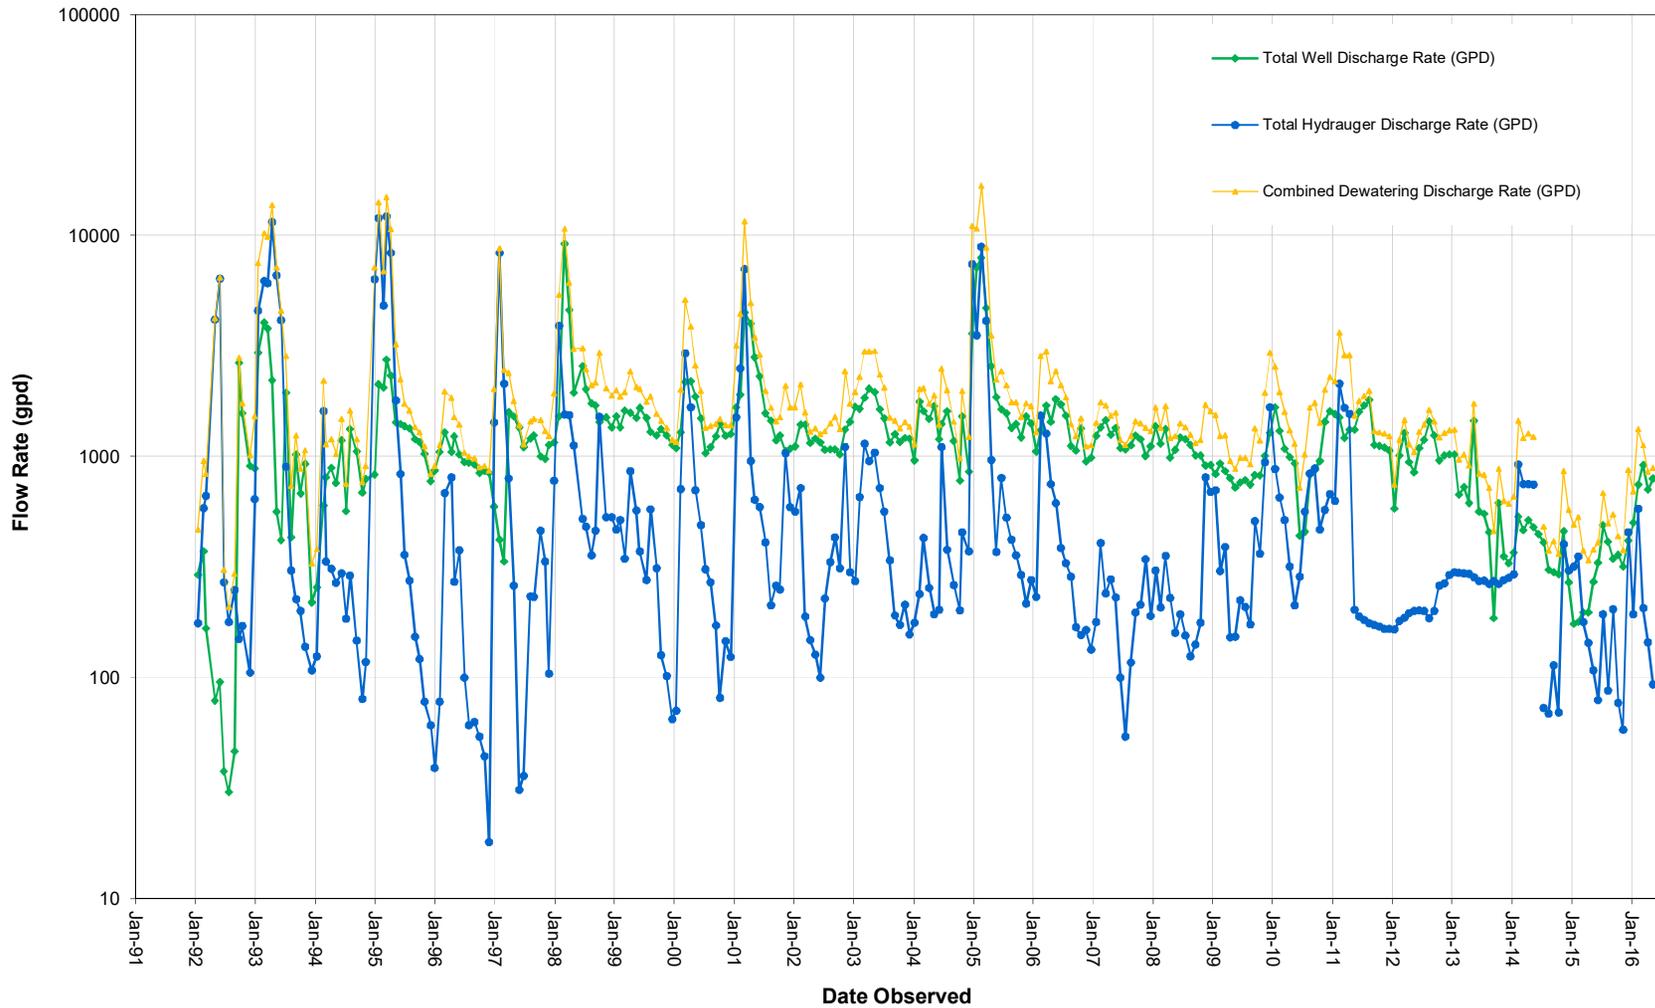
**TOTAL DISCHARGE - WELLS AND HYDRAUGERS**  
Malibu Road Landslide Assessment District  
Malibu, California

A combined graph of the total dewatering rate for the monitored dewatering wells and hydraugers is presented on Plate 4. Total dewatering production data for the measured hydraugers and wells indicates the following:

- The average total dewatering rate during the monitoring period was approximately 726 gpd. This represents a 49 percent increase in the average rate relative to the 486 gpd average recorded during the previous monitoring period.

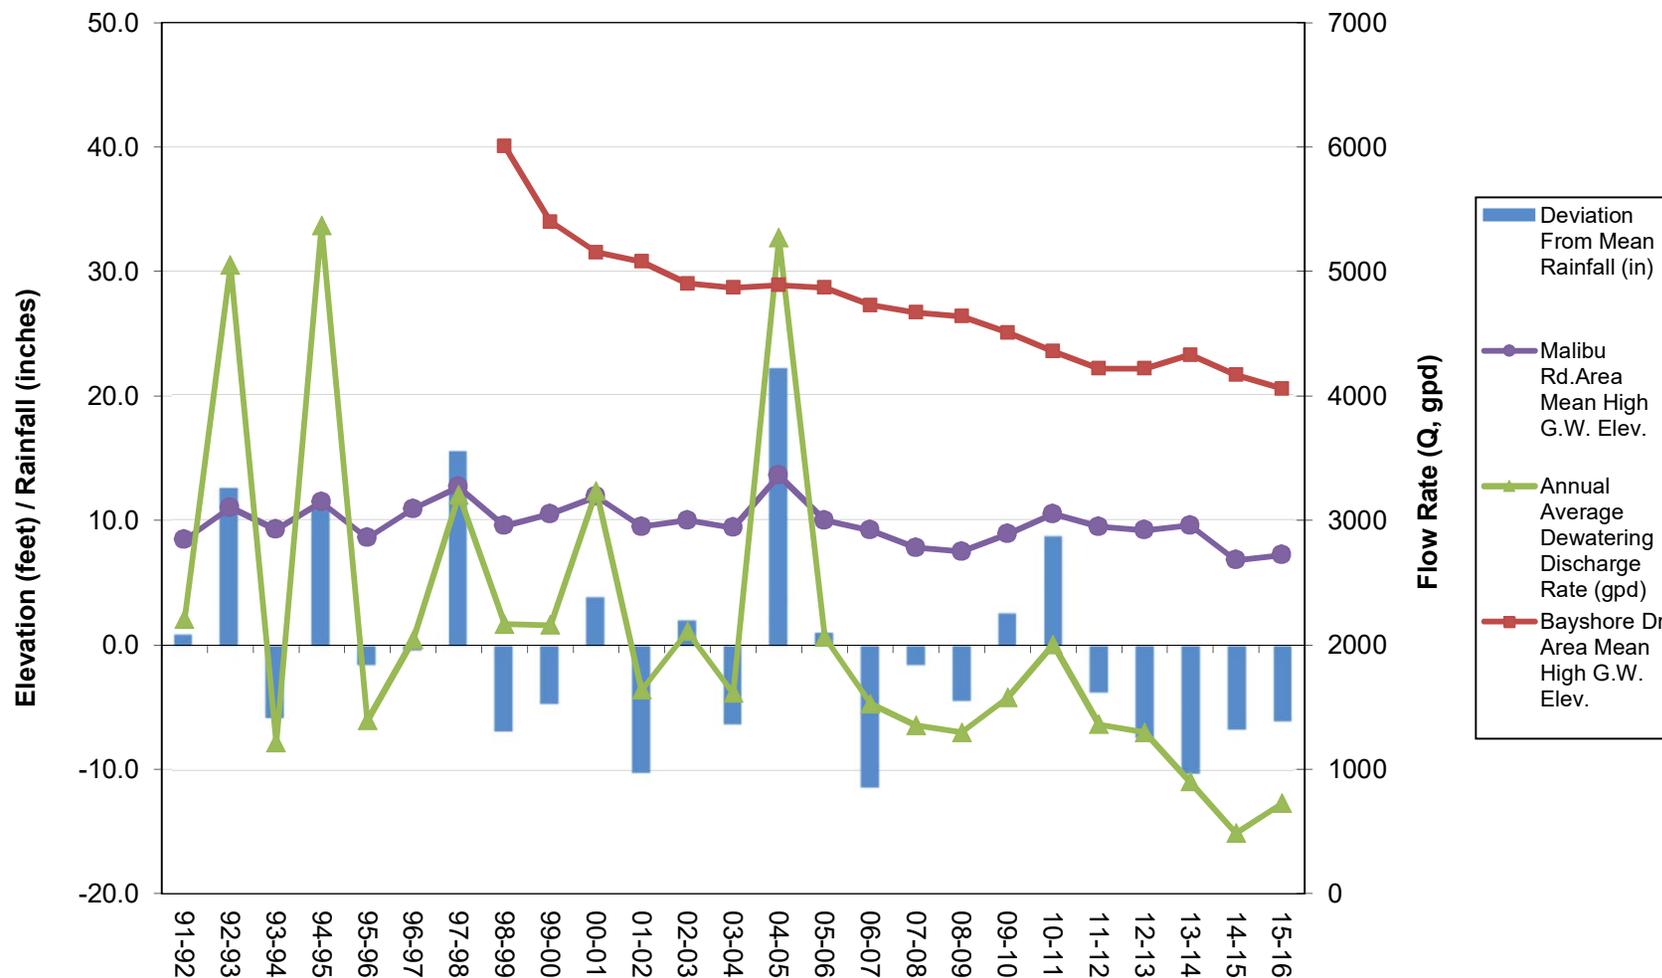
**GROUNDWATER LEVELS, DEWATERING, AND RAINFALL**  
 Malibu Road Landslide Assessment District  
 Malibu, California

Plate 5 – Groundwater Levels, Dewatering, and Rainfall shows the yearly magnitude of deviation of each years' rainfall relative to the mean annual rainfall. The graphic also shows the average annual dewatering output (gallons per day, gpd). The data illustrate that the average annual dewatering output has been decreasing with continued below average rainfall.

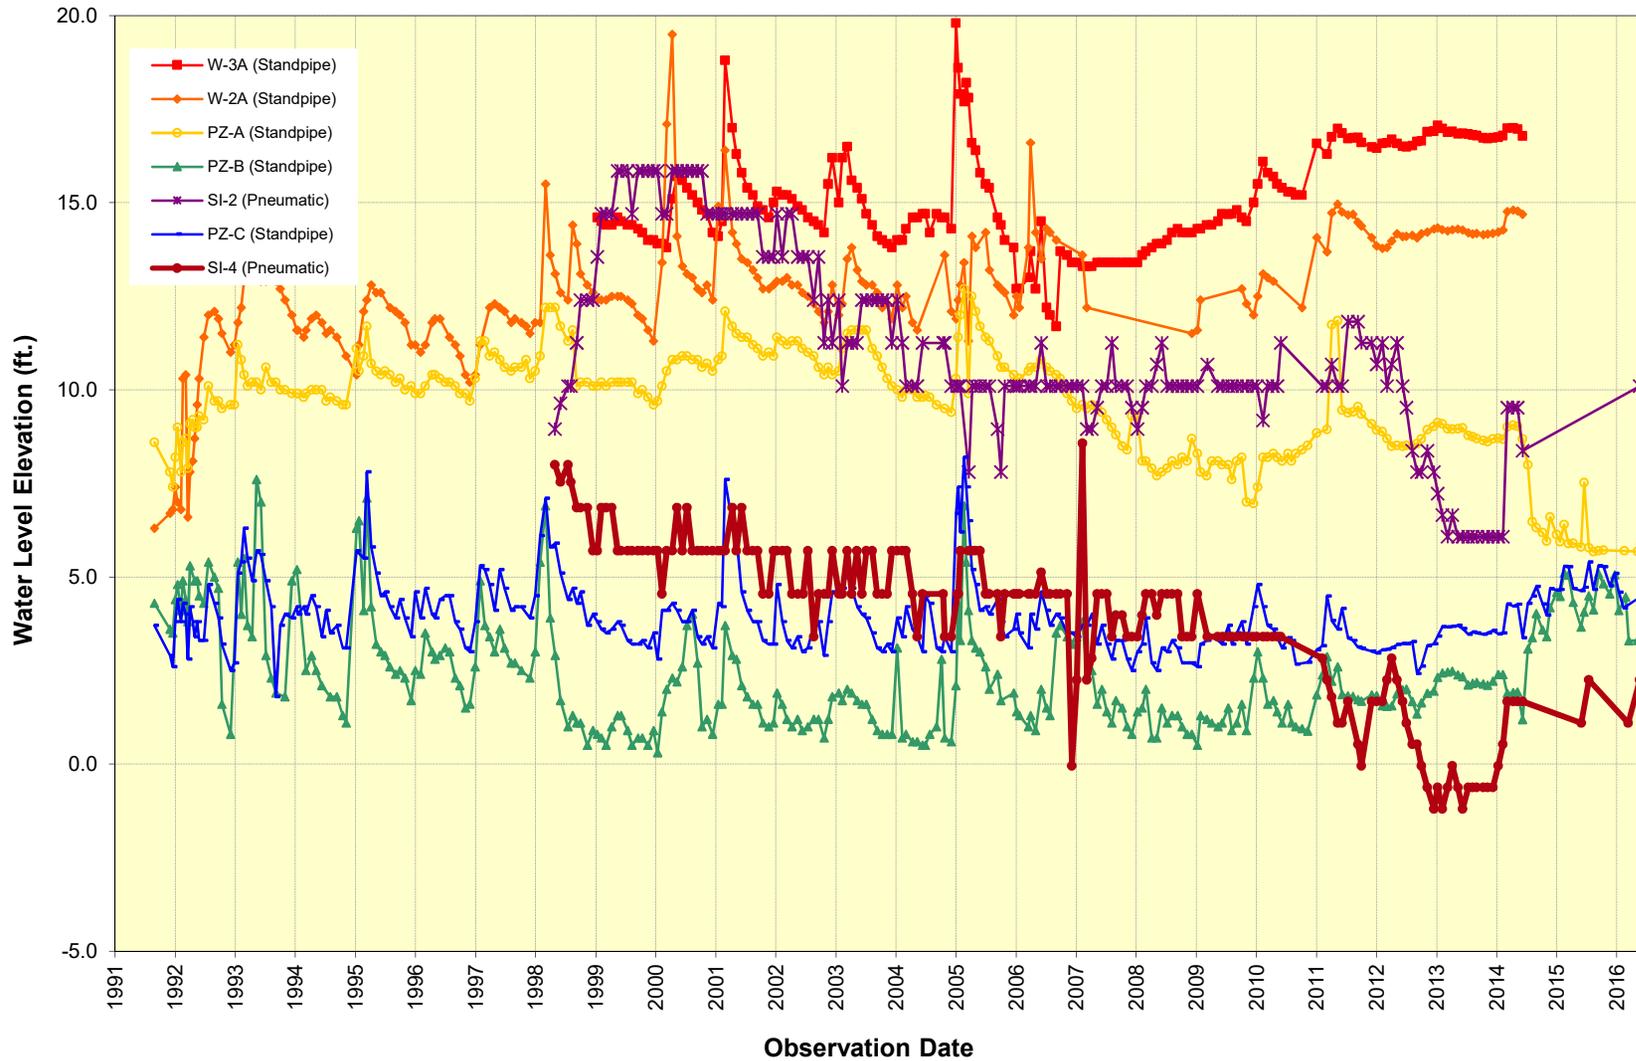
**GROUNDWATER HYDROGRAPH**  
Malibu Road (West End)  
Malibu Road Landslide Assessment District  
Malibu California

**Malibu Road.** Groundwater elevation data for the area along Malibu Road are presented on Plates A-3 and A-4. Groundwater levels for that area are monitored using standpipes PZ-A, -B, -C, -

D, -E, W-2A, and W-3A along with pneumatic piezometers installed in inclinometers SI-1, -1A, -2, -3, and -4. In general, groundwater levels declined slightly during the 2015-16 monitoring period. The calculated area average water level declined by 0.1 feet when compared to the area average for the 2014-15 monitoring period and is 2.4 feet below the mean area average for this area for the period of record. Water levels in individual standpipes declined slightly or remained approximately static over the monitoring year with temporary increases in response to rainfall events in January and March. No new data are presented for standpipes W-2A or W-3A because W-2A has been dry since July 2014 and W-3A is buried beneath soil creep from the bluff face. Pneumatic piezometers in inclinometers SI-1A, SI-2, and SI-4 were measured in March and June 2016, and all showed increased pore pressure readings subsequent to the rain events of early 2016. Pneumatic piezometers in inclinometers SI-1 and SI-3 are no longer functioning and no new data are presented.

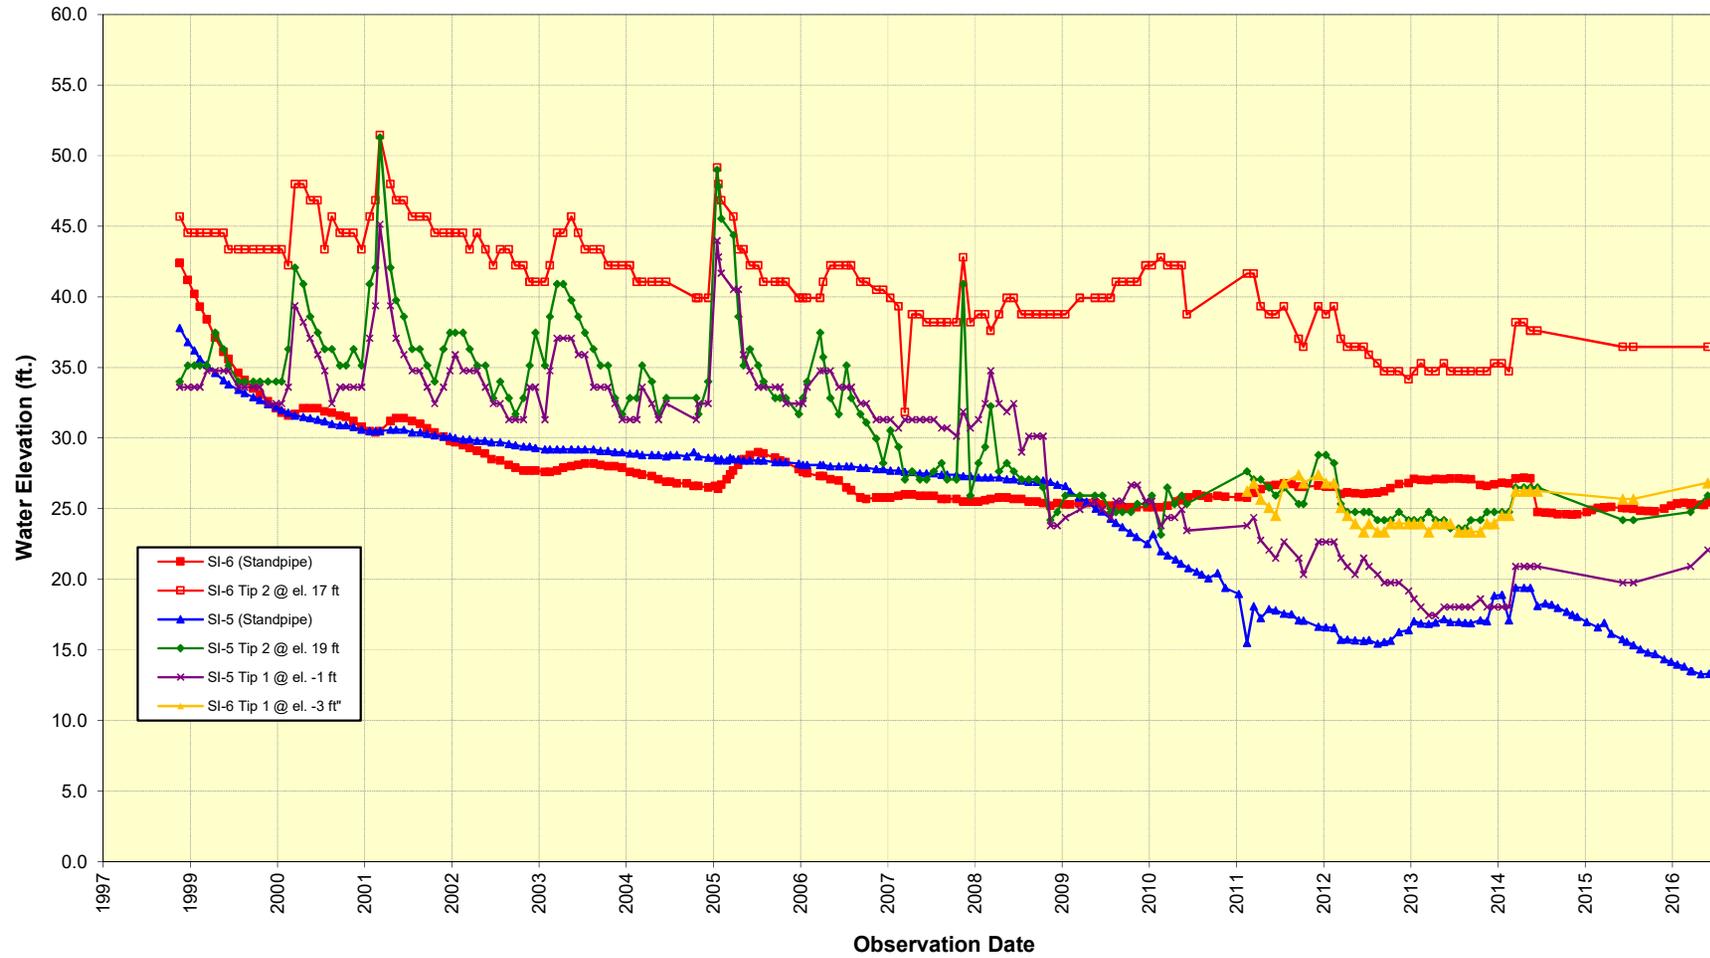
**GROUNDWATER HYDROGRAPH**  
**Bayshore Drive**  
Malibu Road Landslide Assessment District  
Malibu, California

**Bayshore Drive.** Groundwater elevation data for the area along Bayshore Drive are presented on Plate A-5. Groundwater levels for that area are monitored using standpipes SI-5 and SI-6 along with the two pneumatic piezometers installed with each standpipe. In general, groundwater levels declined during the 2015-16 monitoring period. The calculated area average water-level declined by 1.4 feet when compared to the area average for the 2014-15 monitoring year and is 6.7 feet below the mean area average for this area for the period of record (1991-2016). Water levels in standpipe SI-5 declined steadily during the 2015-16 monitoring year and reached an all-time low for the period of record in May and June 2016. Water levels in standpipe SI-6 remained approximately static over the course of the monitoring year, with fluctuations of less than 0.4 feet. Readings from both the shallow and deep pneumatic piezometers in standpipes SI-5 and SI-6 continue to record water elevation above the standpipe water levels, but also show a declining trend in water elevation consistent with the standpipe readings. Pneumatic water levels at SI-5 increased after the rainfall events of January and March 2016.

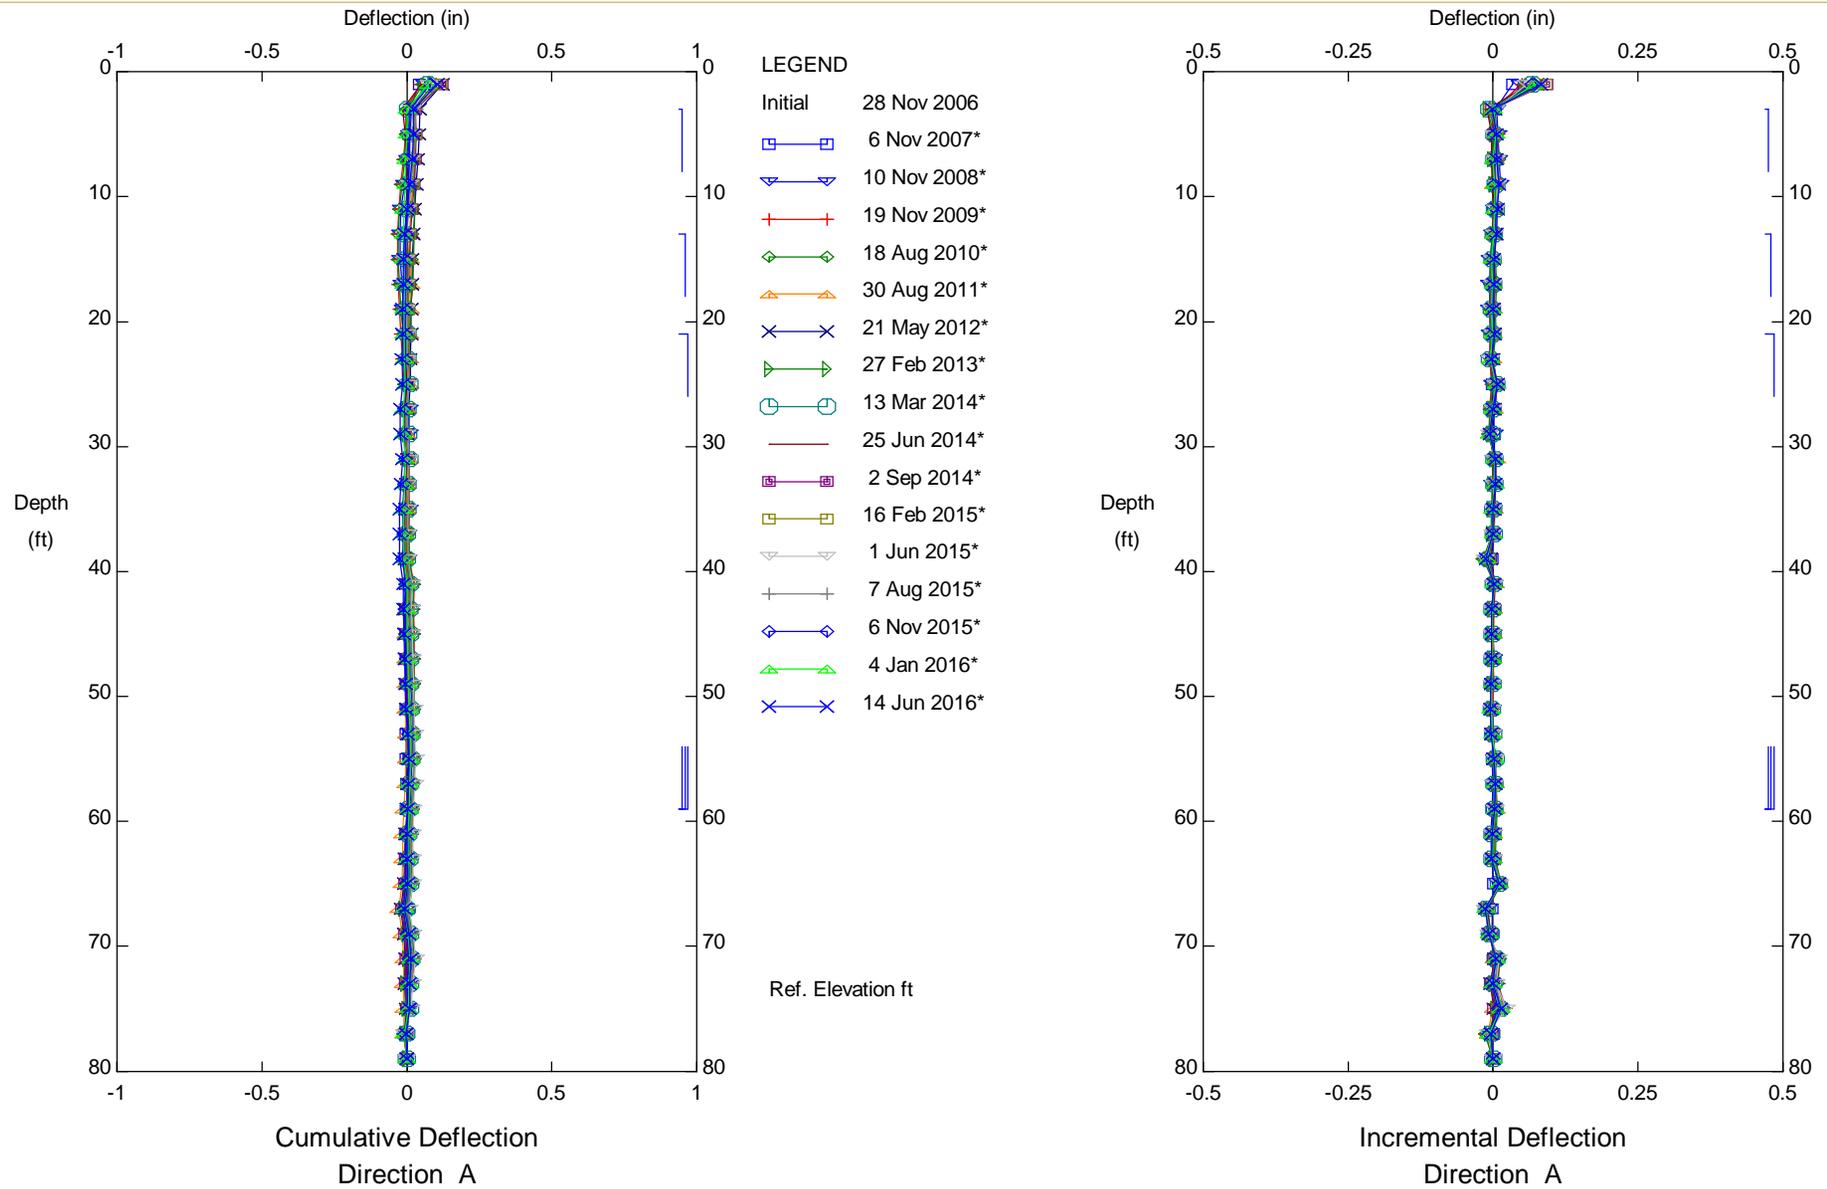
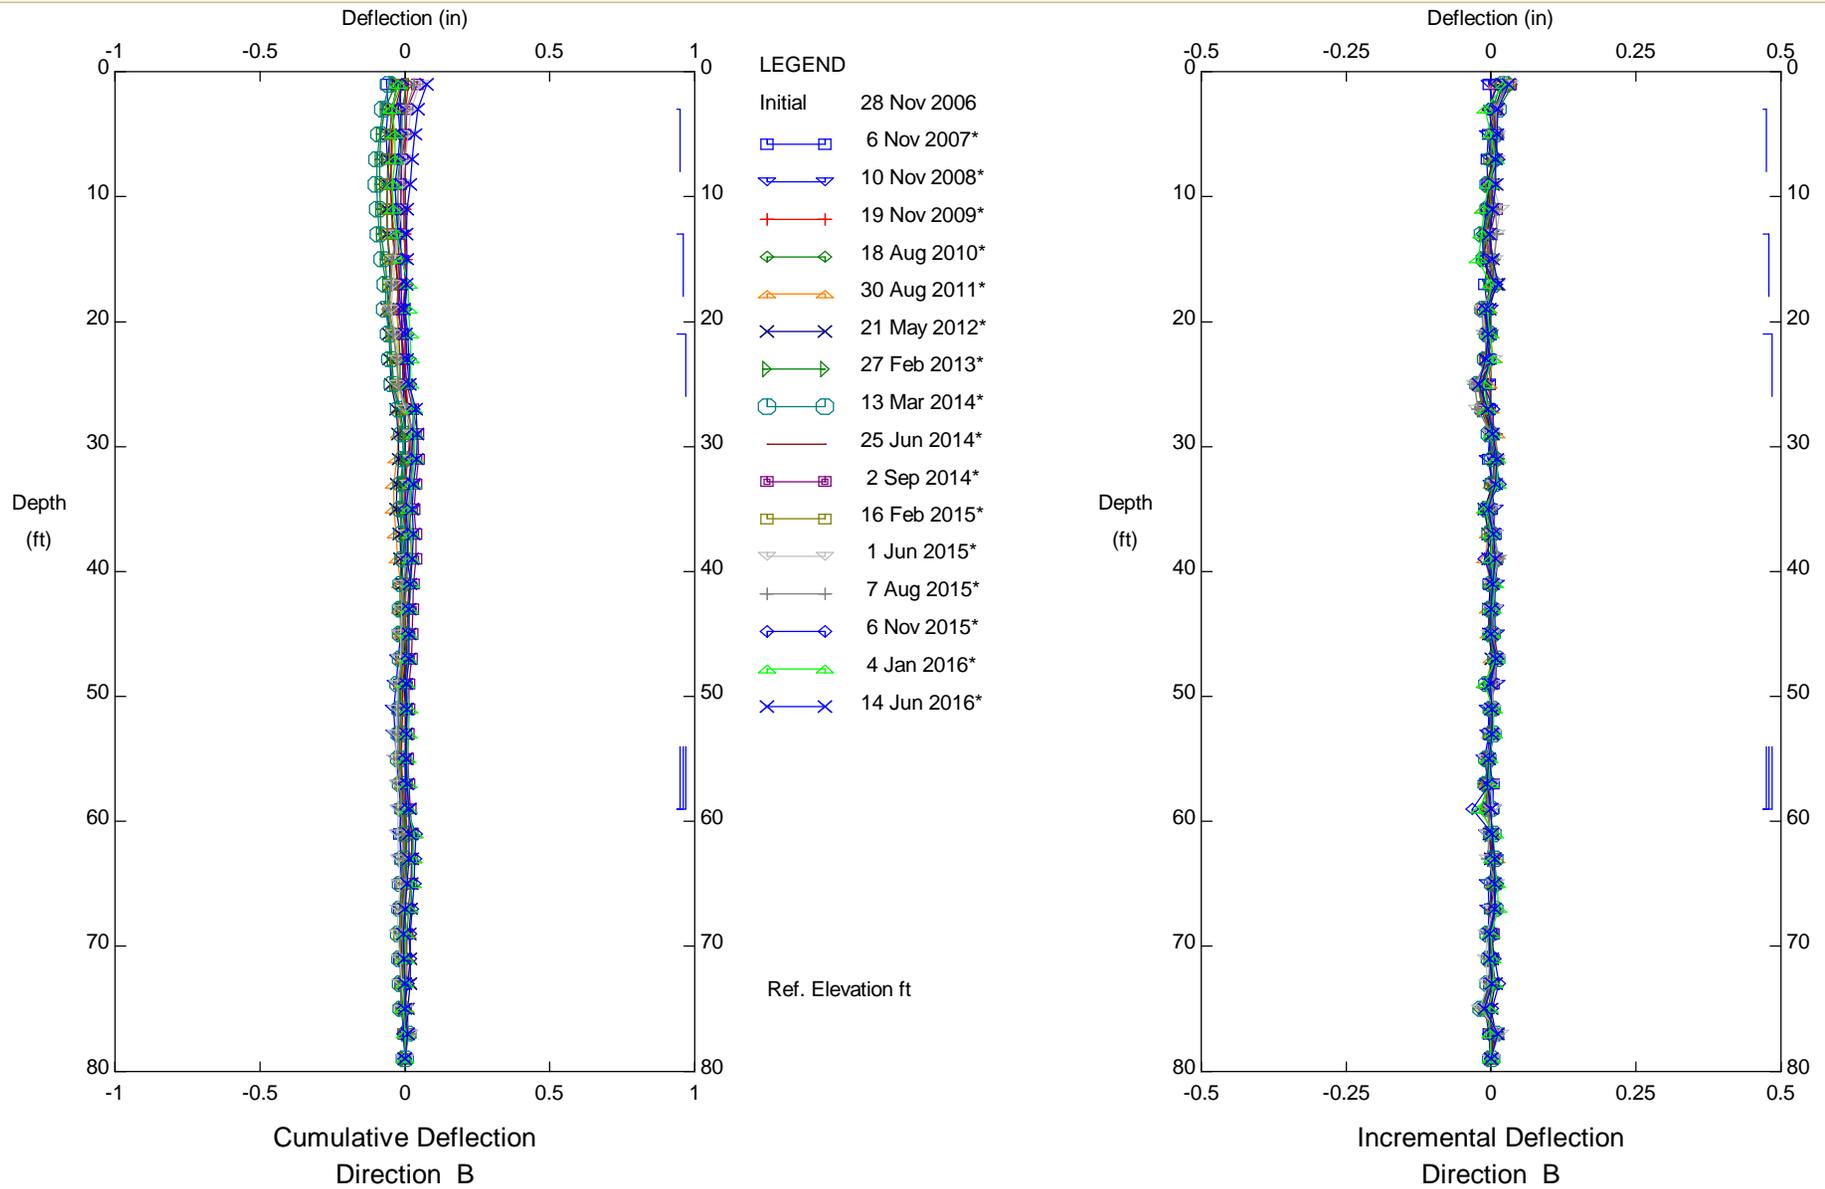
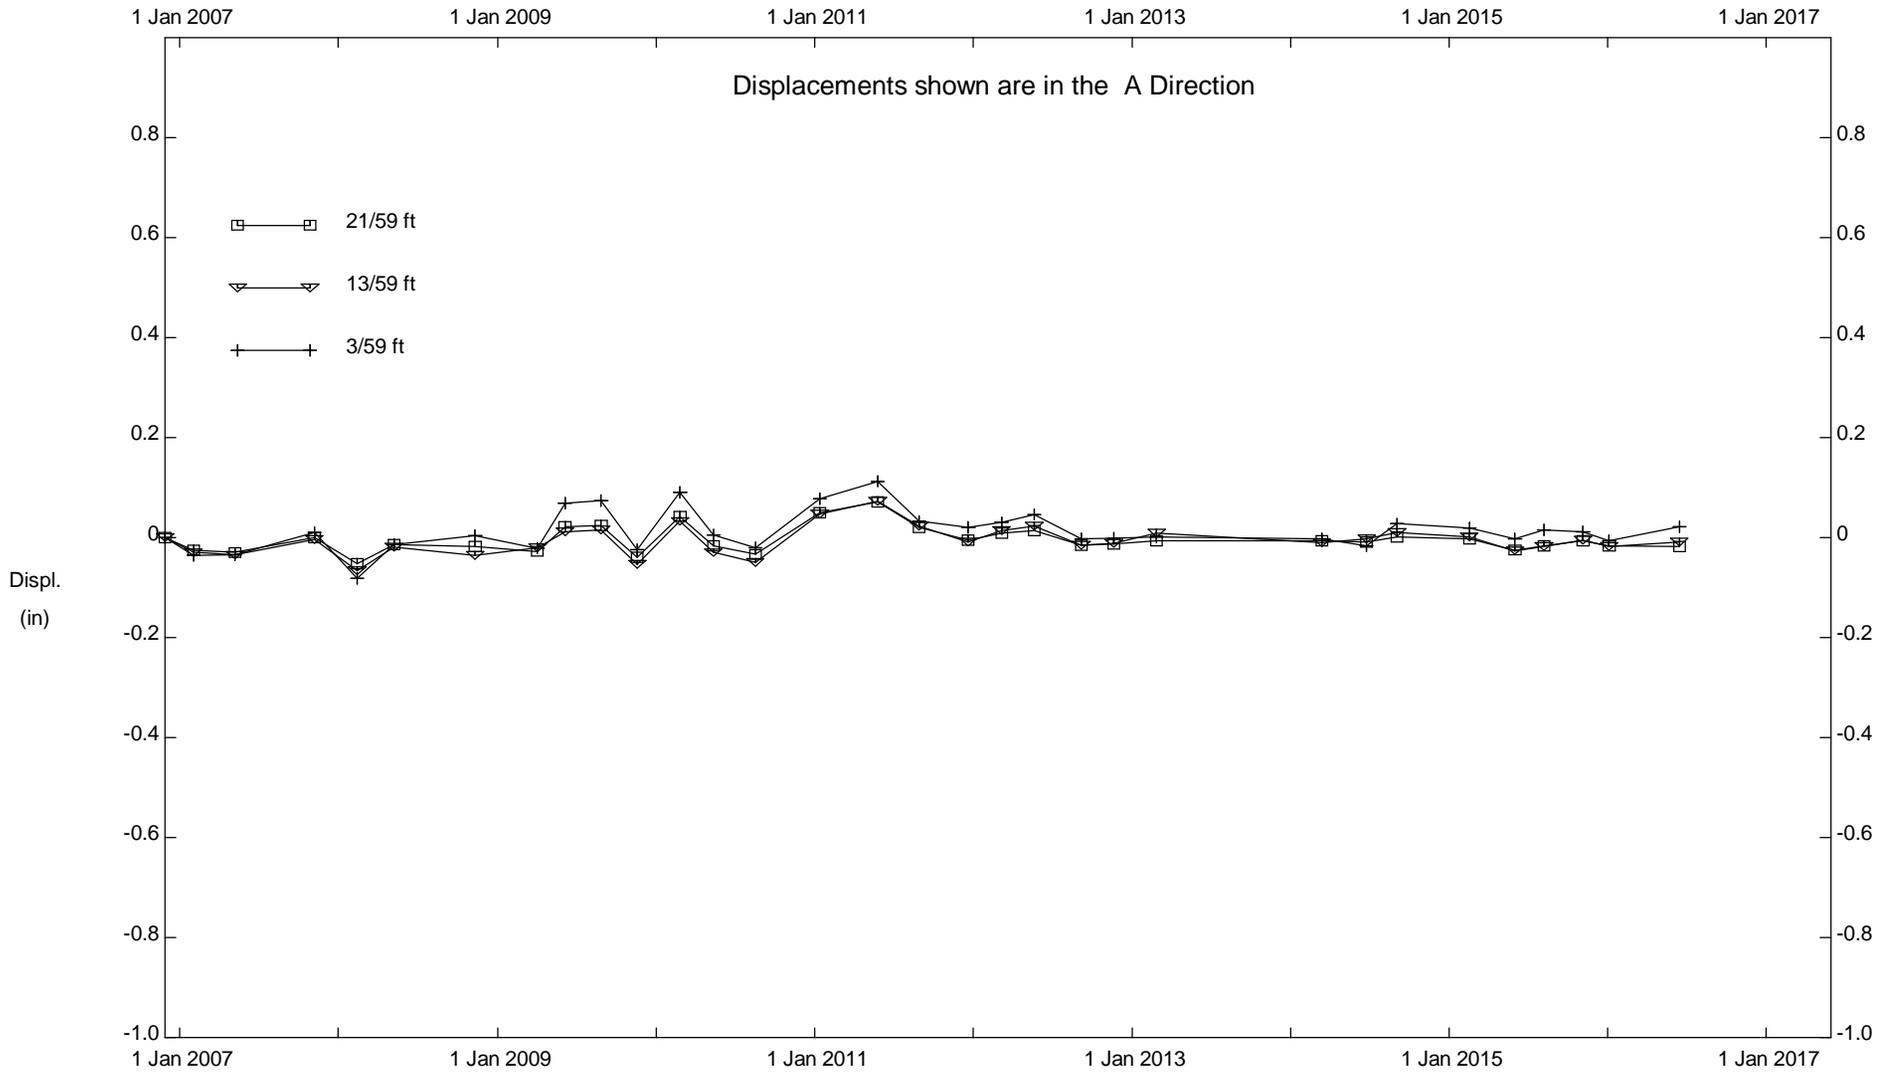
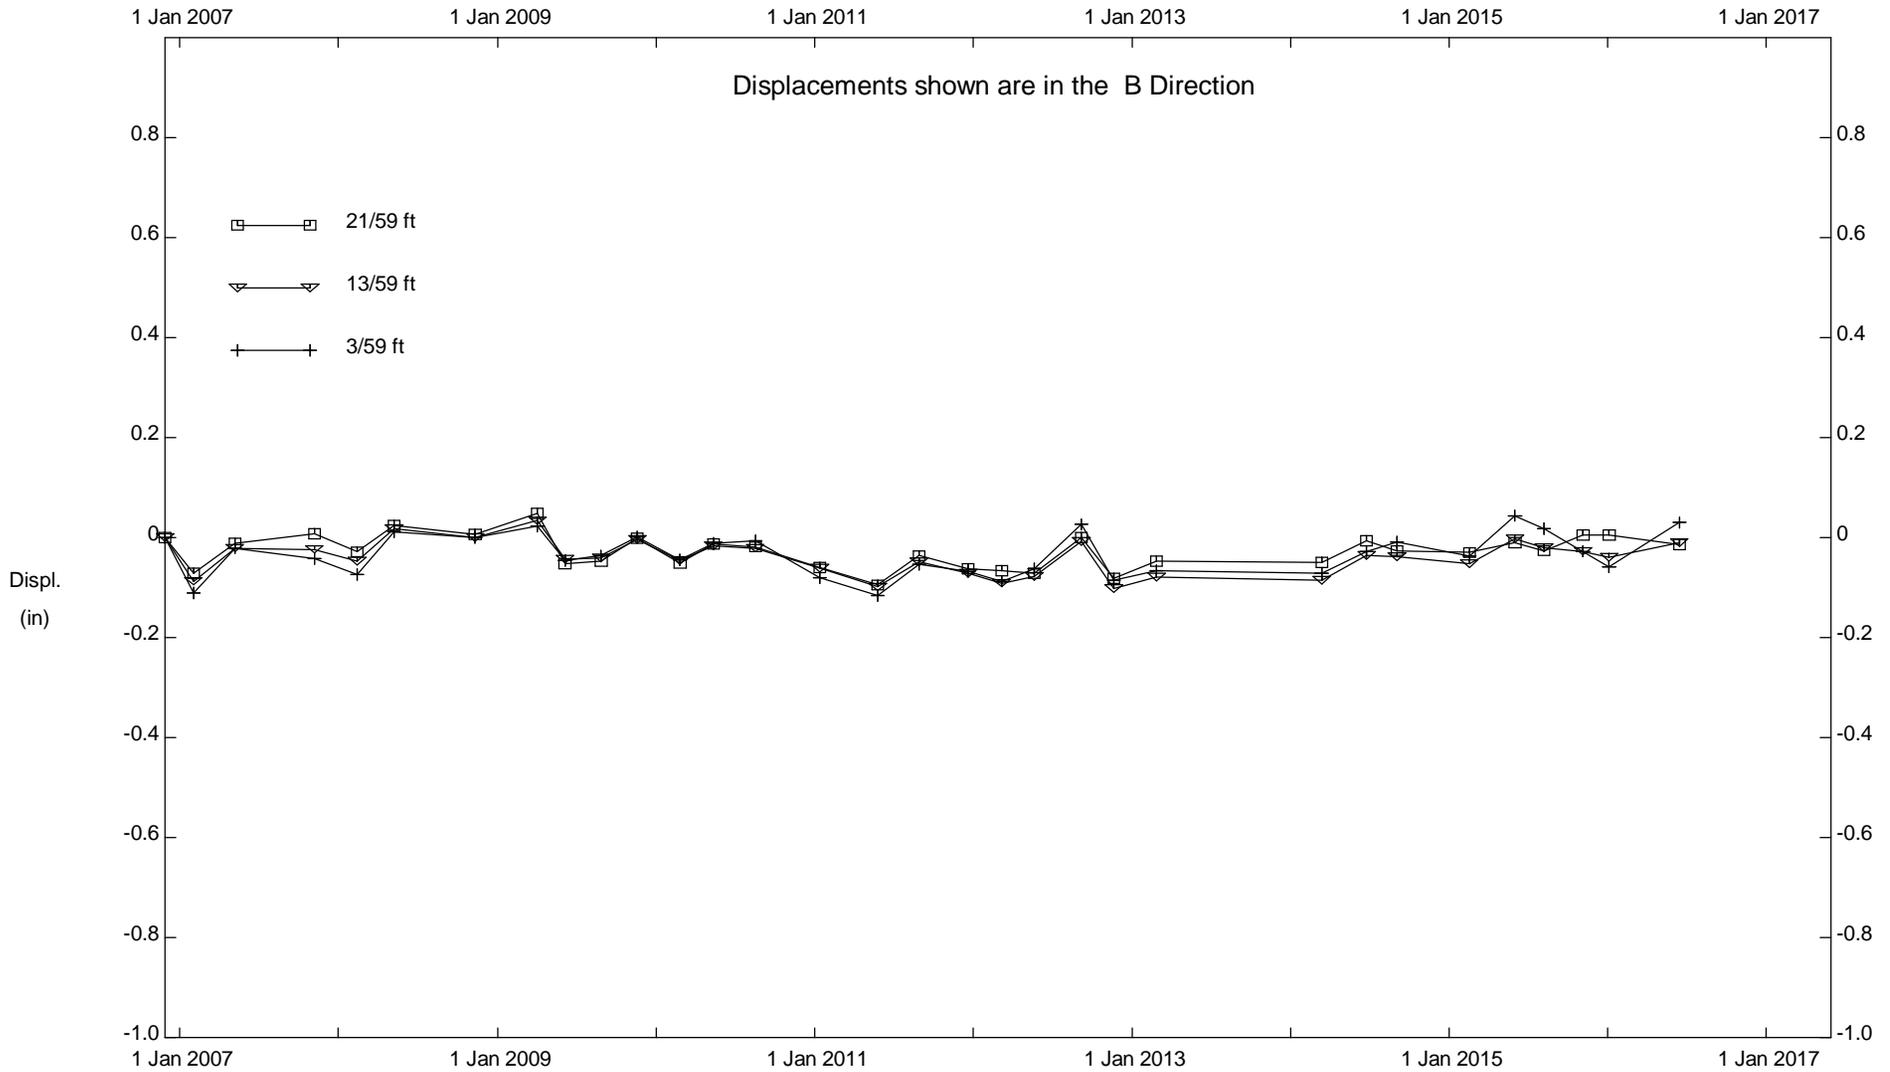
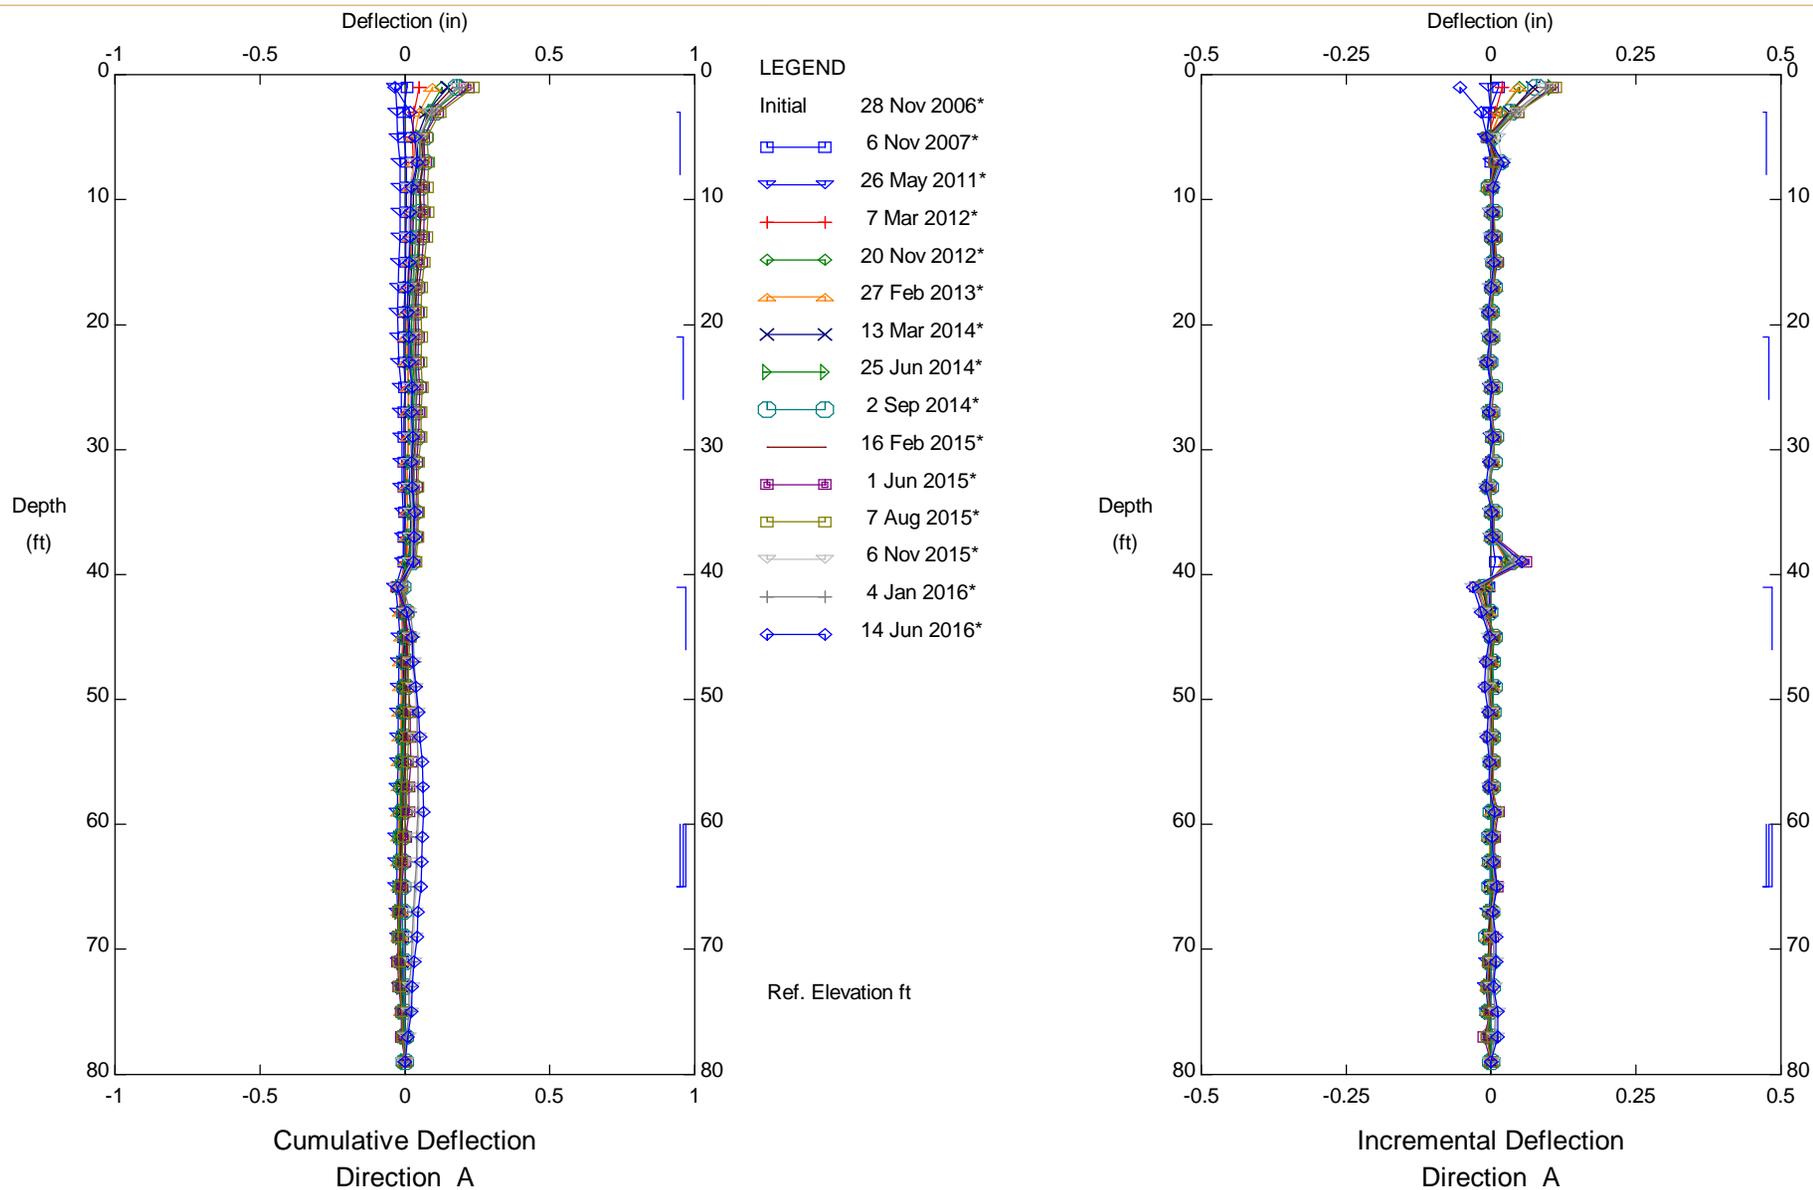
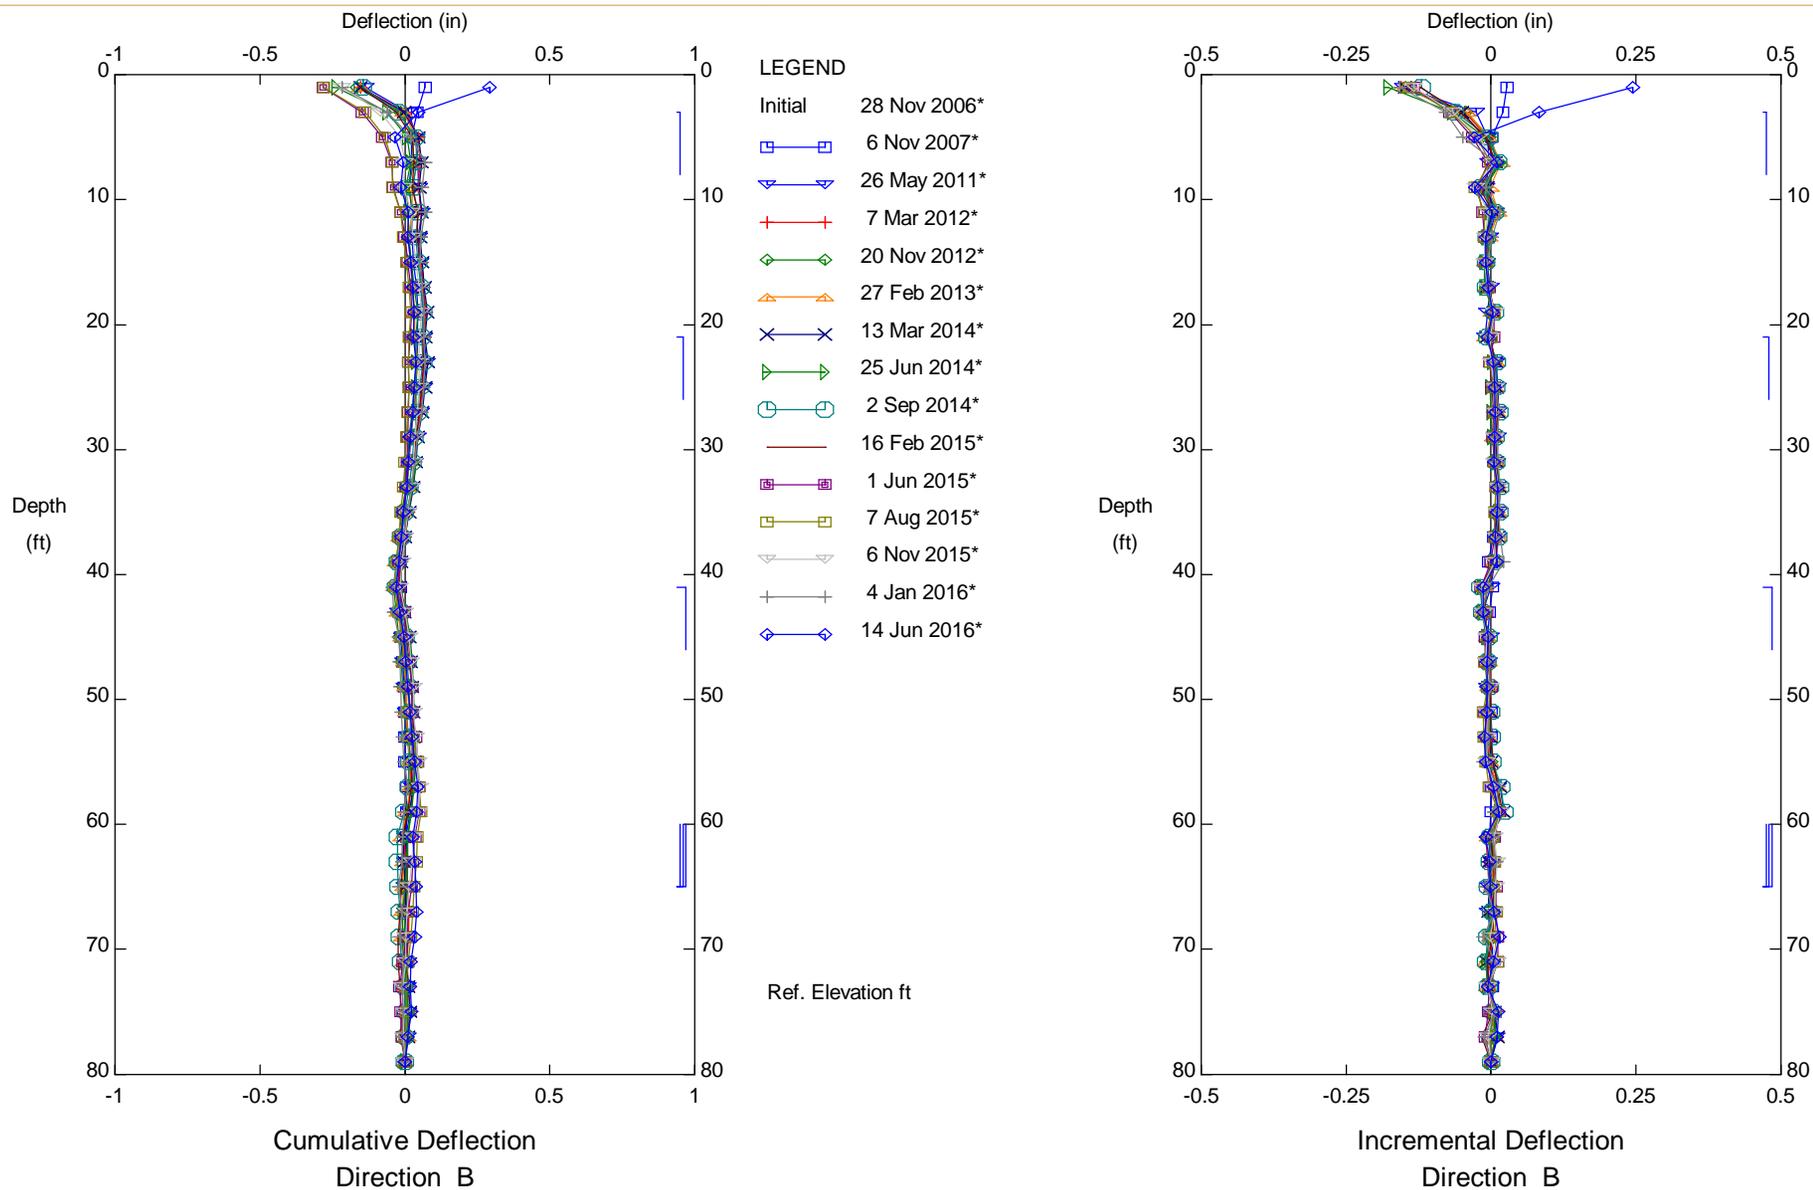
Inclinometers SI-5 and SI-6 are located on Bayshore Drive, upslope and outside the defined limit of the most recent 1998 movement. No detectable movement was observed during this monitoring year in SI-5 or SI-6. Profile changes to the top portion of inclinometer SI-6 are the result of ongoing damage to the casing from construction traffic currently working on Bayshore Drive. The vault and top of the casing have been crushed by heavy equipment.
