Annual Report, July 2016 Through June 2017 Calle Del Barco Landslide Assessment District Malibu, California

January 2018
Fugro Project No. 04.62160605
Document No. 04.62160605-PR-001(Rev.00)

City of Malibu

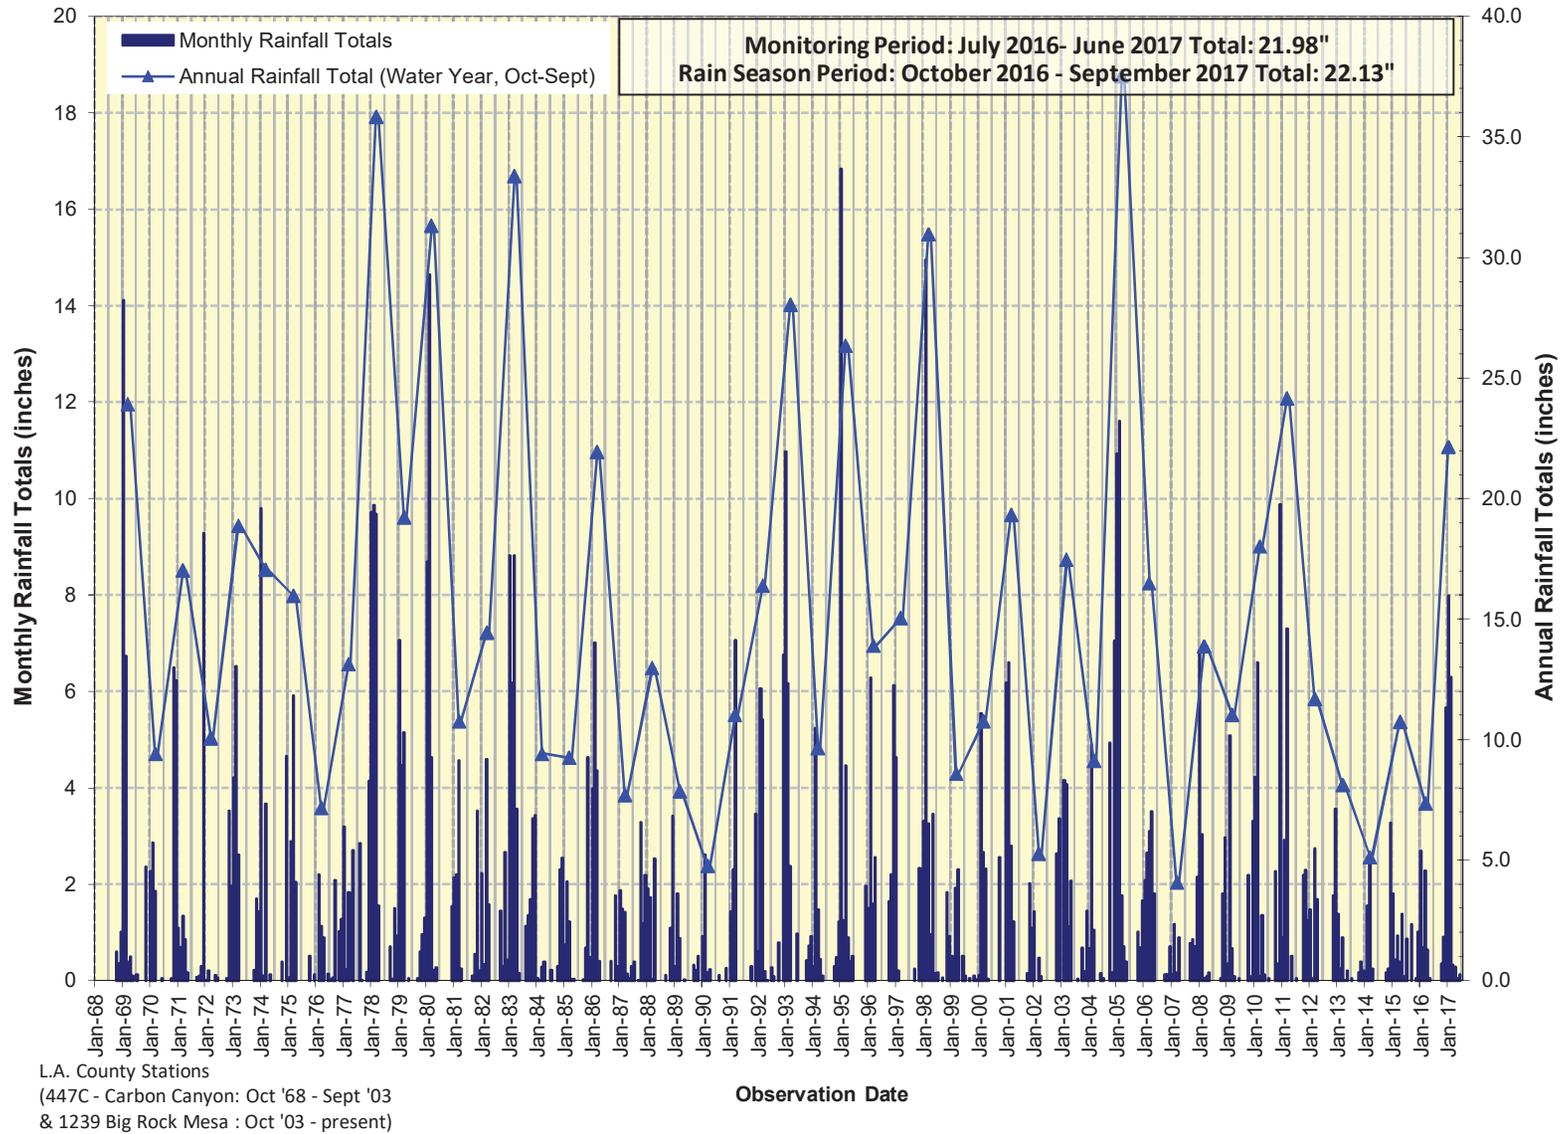
RAINFALL GRAPH

Rainfall data indicate that approximately 21.98 inches of precipitation fell during the monitoring period from July 1, 2016, through June 30, 2017. The average annual rainfall from 1968 to 2017 in the "Malibu Area" for the same months is approximately 15.6 inches.

However, rainfall data are usually analyzed in terms of the annual "rain season" that covers the time period between October 1 through September 30. Rainfall for October 1, 2016 through September 30, 2017, was approximately 22.13 inches. That is approximately 138 percent of the average annual rainfall of 16.0 inches for the "rain seasons" between 1968 and 2017.

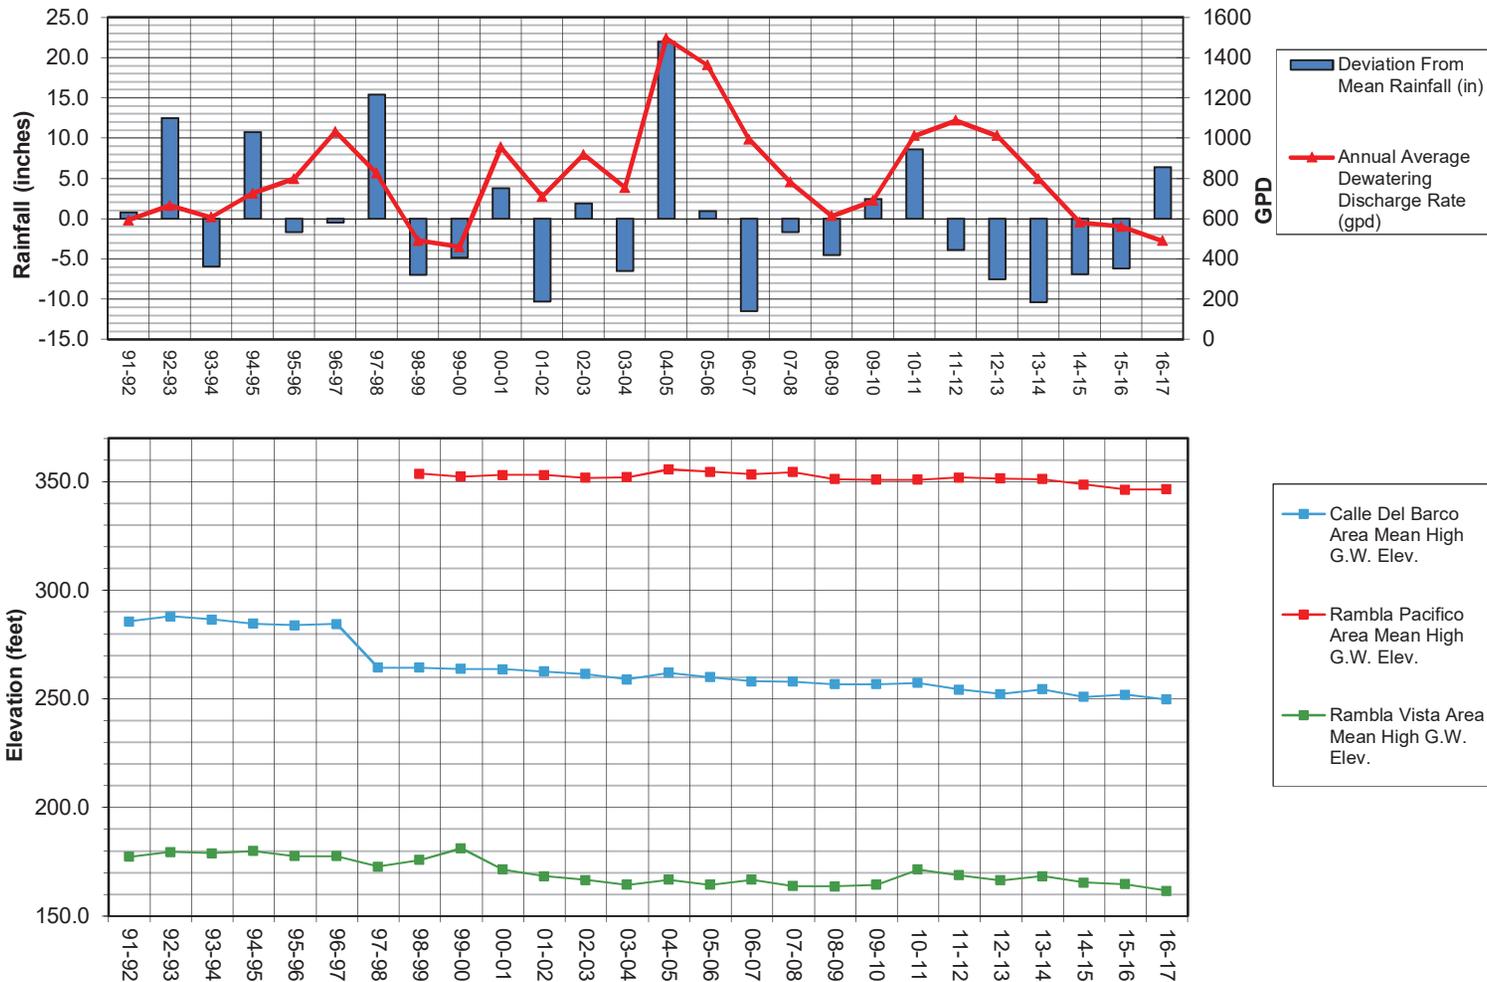
GROUNDWATER LEVELS, DEWATERING AND RAINFALL
 Calle del Barco Landslide Assessment District
 Malibu, California

Plate 5 – Groundwater Levels, Dewatering, and Rainfall shows the yearly magnitude of deviation of each years' rainfall relative to the mean annual rainfall. The graphic also shows the average annual dewatering output (gallons per day, gpd). The data illustrates that the average annual dewatering output has been decreasing with continued below average rainfall between 2011 and 2016. Despite above average rainfall in early 2017, measured groundwater levels within the District remained low. Subsequently, the total dewatering discharge continued to show a decreasing trend through June 2017.

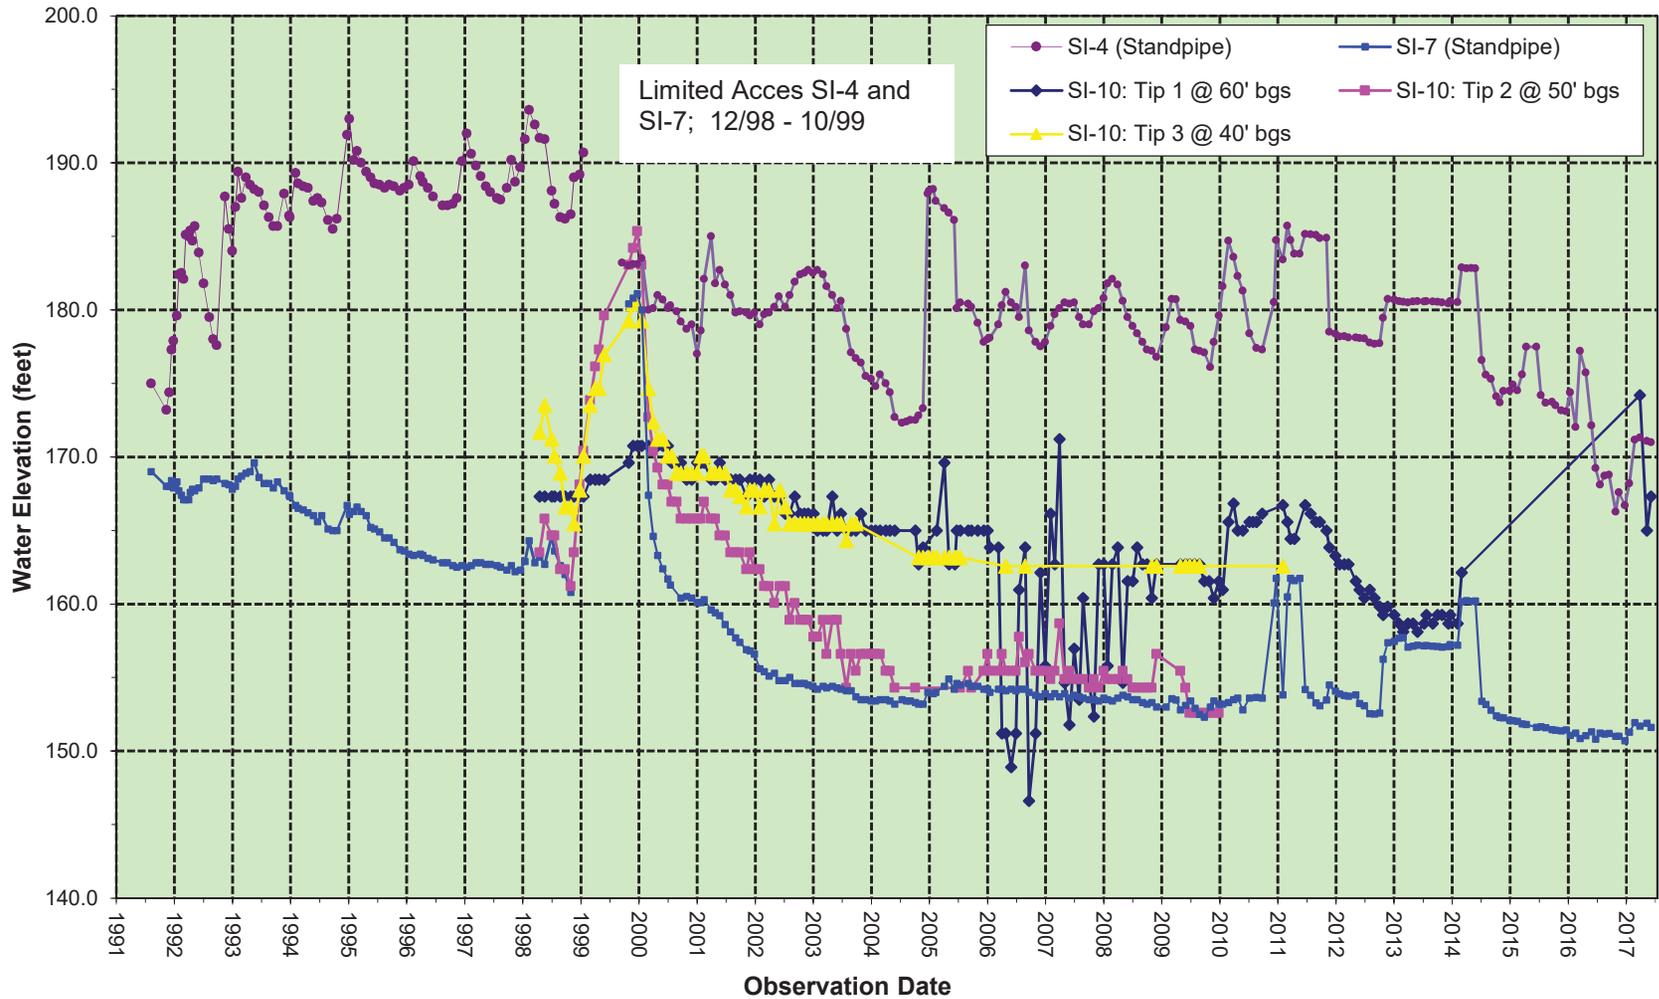
GROUNDWATER HYDROGRAPH
Rambla Vista
 Calle del Barco Landslide Assessment District
 Malibu, California

Rambla Vista. Groundwater elevation data for the Rambla Vista Area are presented in Plate A-3. Groundwater levels for this area are monitored using standpipes SI-7 and SI-4 and the pneumatic piezometers attached to Inclinator SI-10. In general, groundwater elevations in the Rambla Vista Area continued to decline during the 2016-2017 monitoring period. The calculated area average declined 2.6 feet when compared to the area average for the 2015-2016 monitoring period and is about 7.8 feet lower than the mean water level elevation for this area for the period of record (1991-2017).

Groundwater levels measured in standpipe SI-4 fell from July to November 2016 before rising through March 2017, likely as a result of increased rainfall. Groundwater elevations remained relatively stable from March to June 2017. Groundwater elevations in SI-7 have continued to decline and recorded all-time lows for the period of record on January 13, 2017, before slightly rising. Pore pressure readings in pneumatic piezometer SI-10 Tip 3 and Tip 4 measured 0 PSI. Pneumatic piezometer SI-10 Tip 3 has read 0 PSI since September 2006 and Tip 4 has read 0 PSI since installation. It is believed that Tip 3 and Tip 4 are functioning, but are reading zero due to the groundwater elevation being lower than the piezometer tip elevation. SI-10 Tip 2 is clogged and non-functional and was last readable in January 2010. SI-10 Tip 1 had been clogged from March 2014 to March 2017, but was discovered to be functioning again in April 2017.

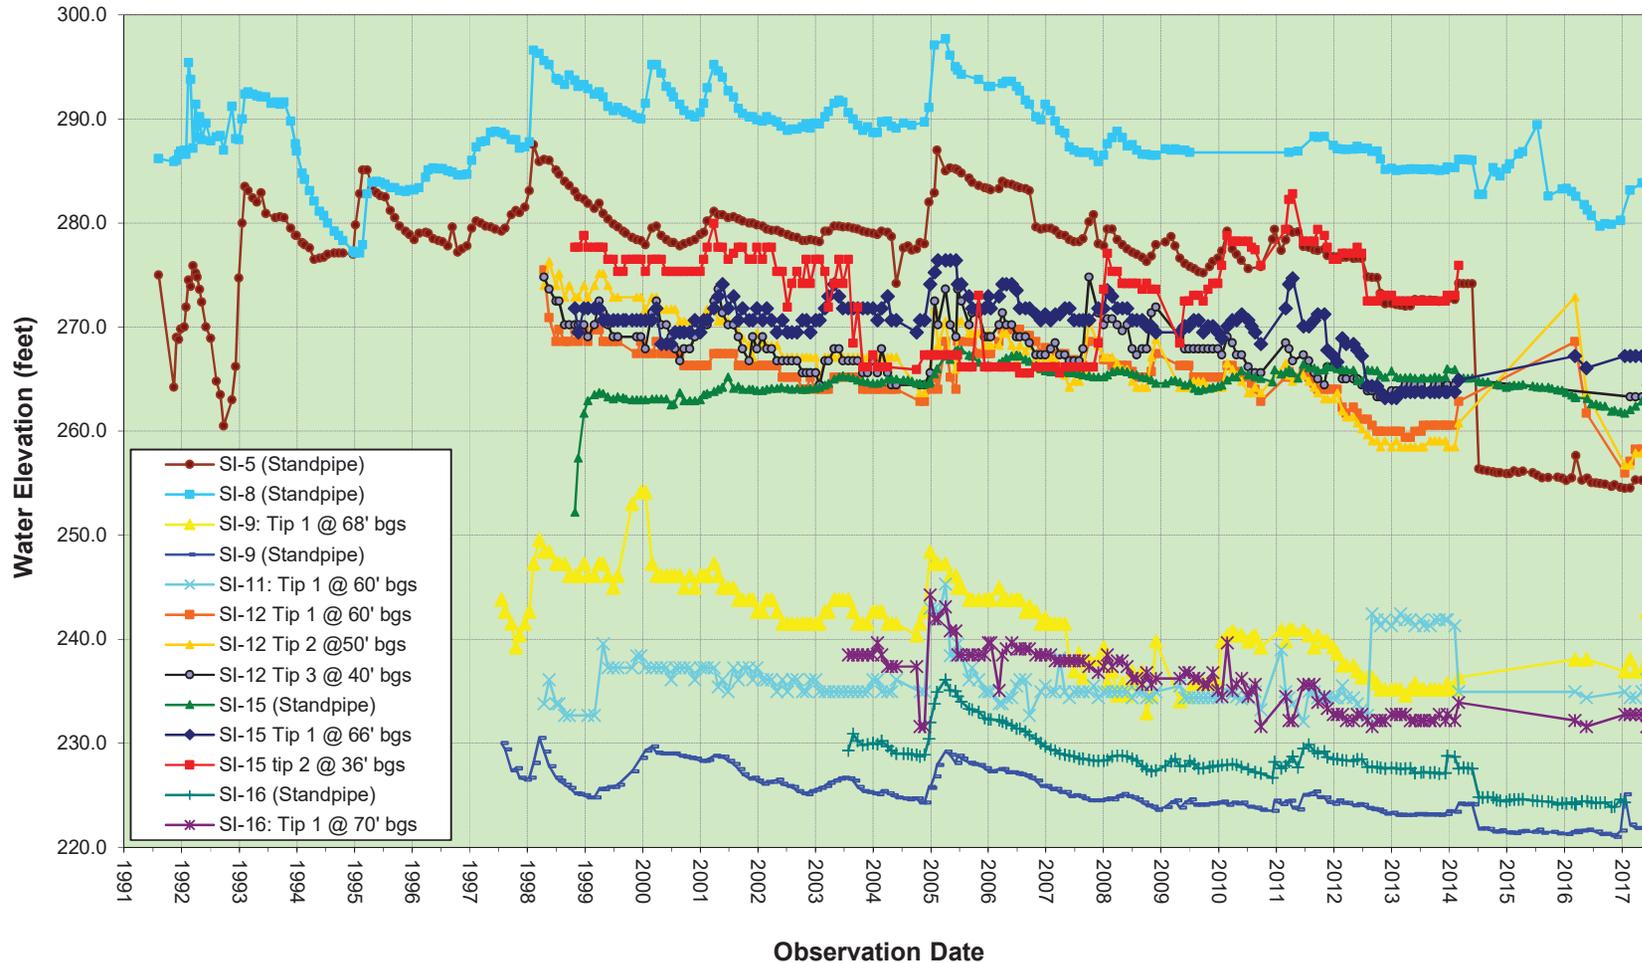
PLATE A-4

Calle Del Barco. Groundwater data for the Calle del Barco Area are presented on Plate A-4. Groundwater levels for this area are monitored using standpipe piezometers SI-5, SI-8, SI-9, SI-15, and SI-16 and pneumatic piezometers attached to inclinometers SI-9, SI-11, SI-12, SI-15, and SI-16. In general, groundwater elevations in the Calle del Barco Area for the 2016-2017 monitoring period decreased approximately 1.9 feet from the 2015-2016 monitoring period. The Calle del Barco area remains approximately 13.8 feet below the mean water level elevation for this area over the period of record.

Water levels in all of the individual standpipe piezometers trended lower or remained unchanged throughout the monitoring year except for some temporary rises following the rainfall events of December 2016 through February 2017. Pneumatic piezometers generally trended in a manner similar to the standpipes.

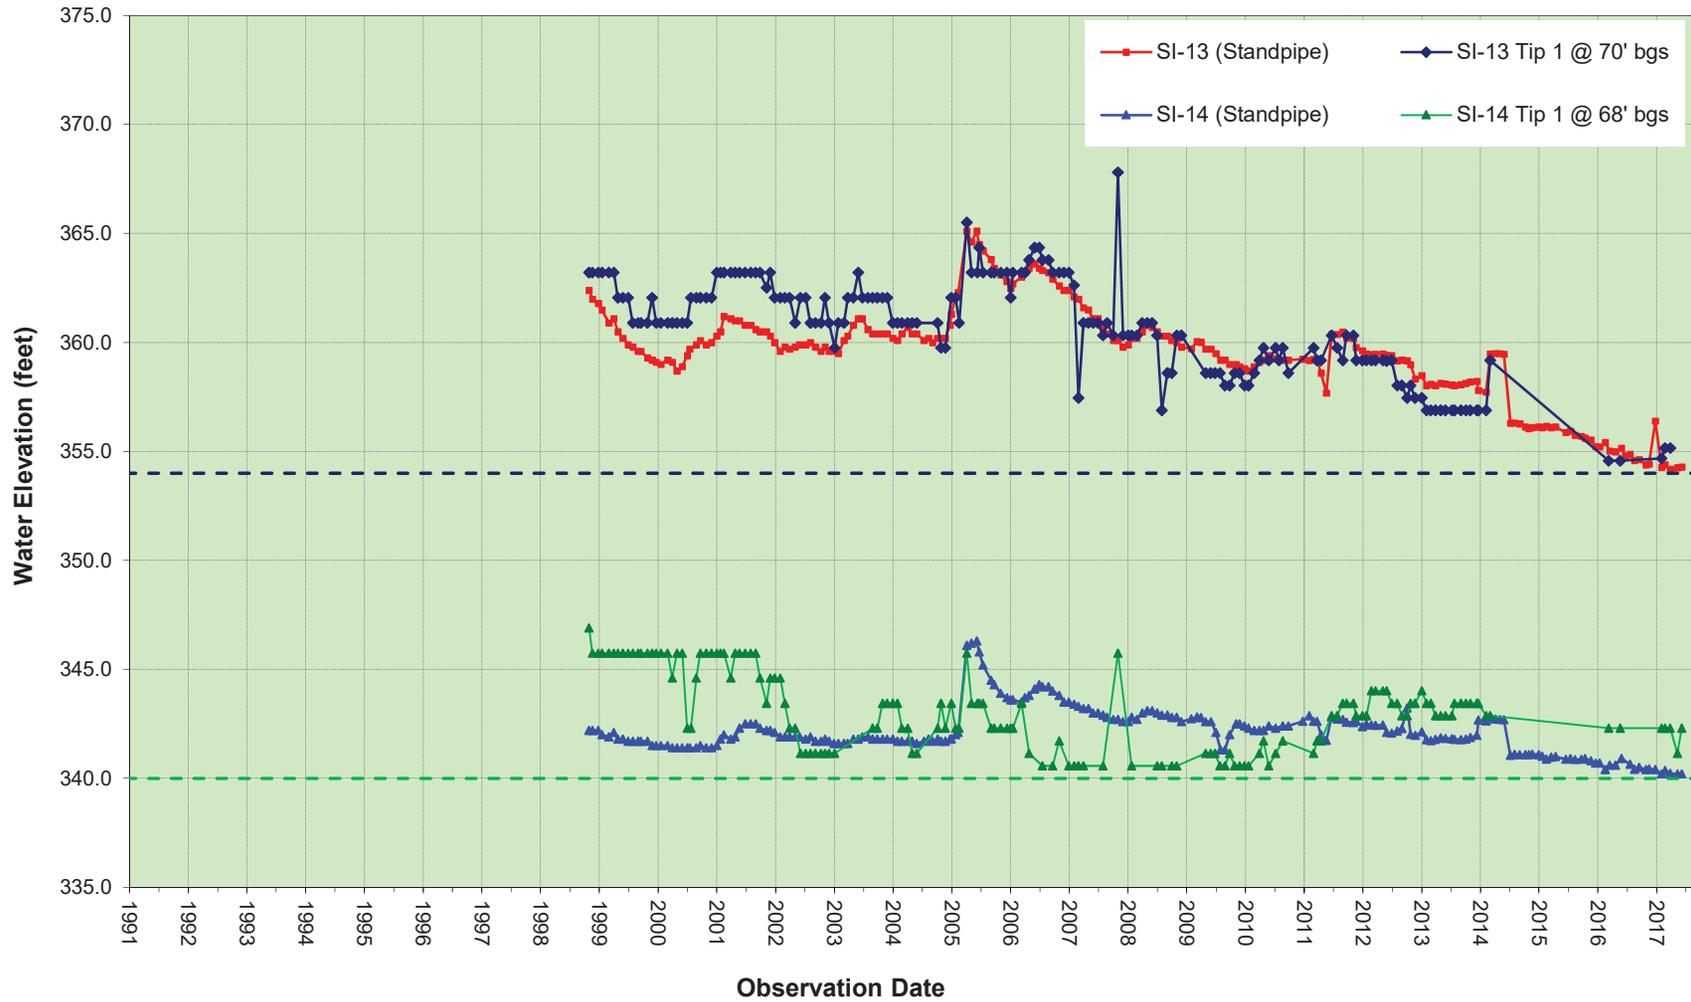
GROUNDWATER HYDROGRAPH
Rambla Pacifico
Calle del Barco Landslide Assessment District
Malibu, California

Rambla Pacifico. Groundwater data for the Rambla Pacifico Area are presented on Plate A-5. Groundwater levels for this area are monitored using standpipe piezometers SI-13 and SI-14 along with two pneumatic piezometers installed within each of those standpipes. In general, groundwater elevations in the Rambla Pacifico Area for the 2016-2017 monitoring period continued to decline. The calculated area average declined by 0.5 feet when compared to the 2015-2016 monitoring period and is 5.1 feet below the mean water level elevation for the area for the period of record.

Water levels in the individual standpipe piezometers continued to decline throughout the monitoring period and are at all-time lows for the period of record. SI-13 experienced a temporary jump in water elevation during the January reading, likely due to increased rainfall. Pneumatic Piezometers SI-13 Tip 1 and SI-14 Tip 1 continue to decline with trends that approximately correlate with their respective standpipe water levels. The shallow pneumatic piezometers (Tip 2) in both standpipes have been dry since installation and no data are reported. Dewatering well W-K, located within the Rambla Pacifico Area near SI-13 has a reported bottom elevation of 370 feet and has also been completely dry since December 2015.

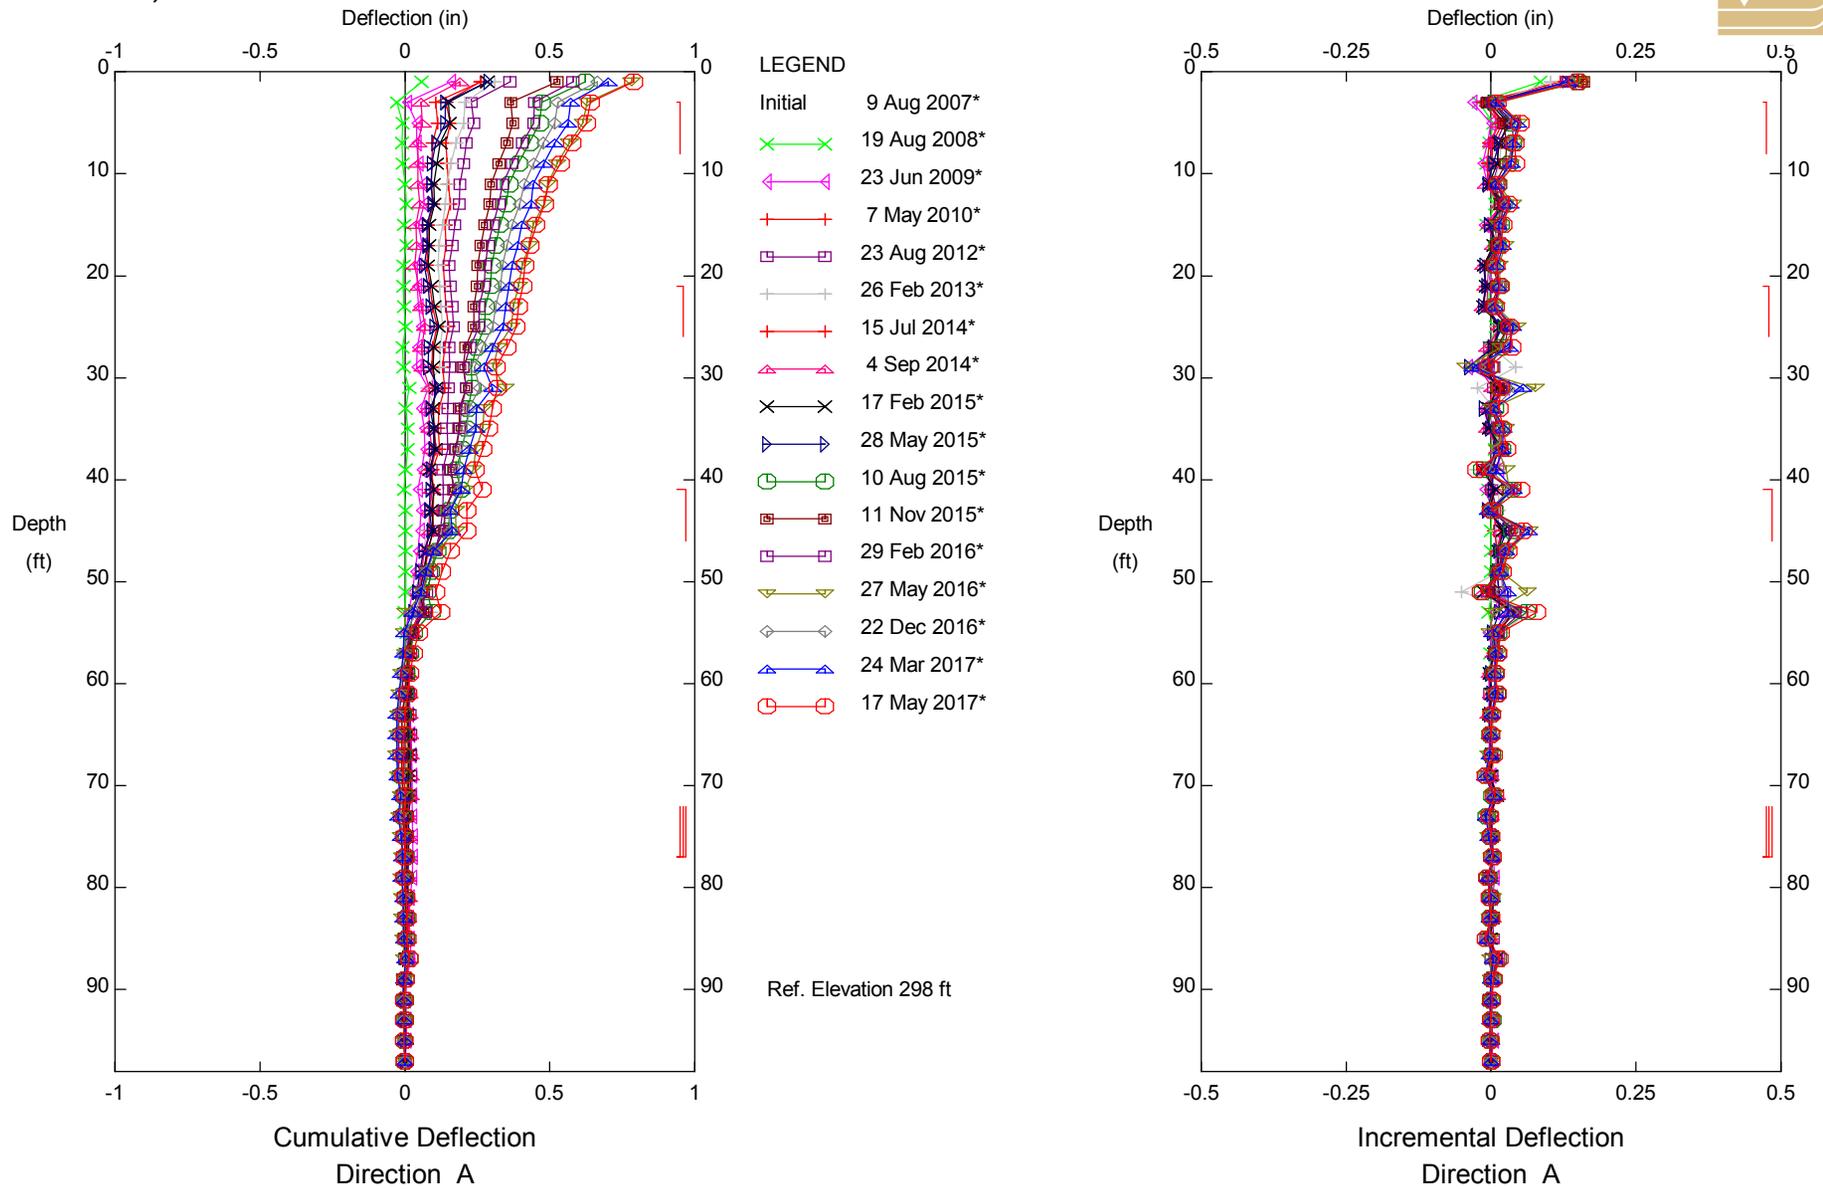
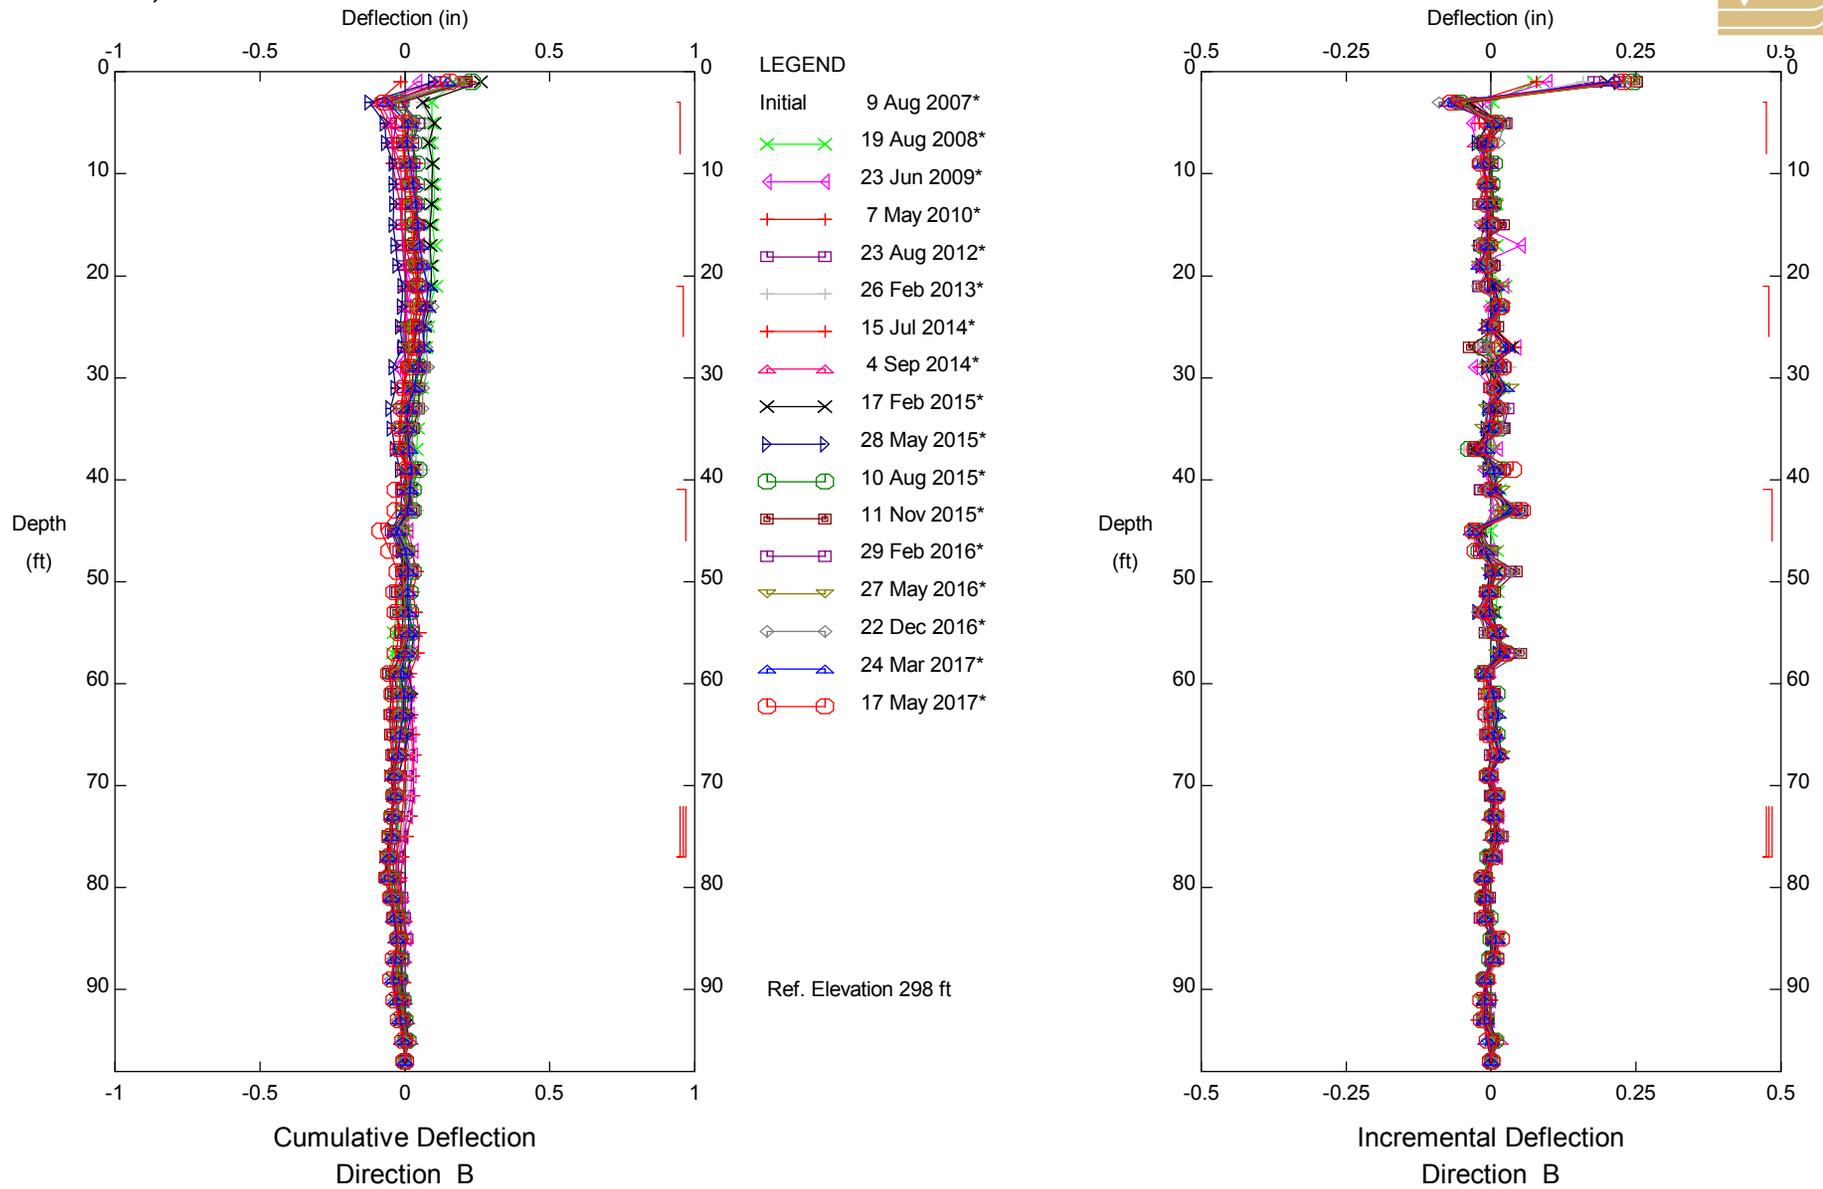
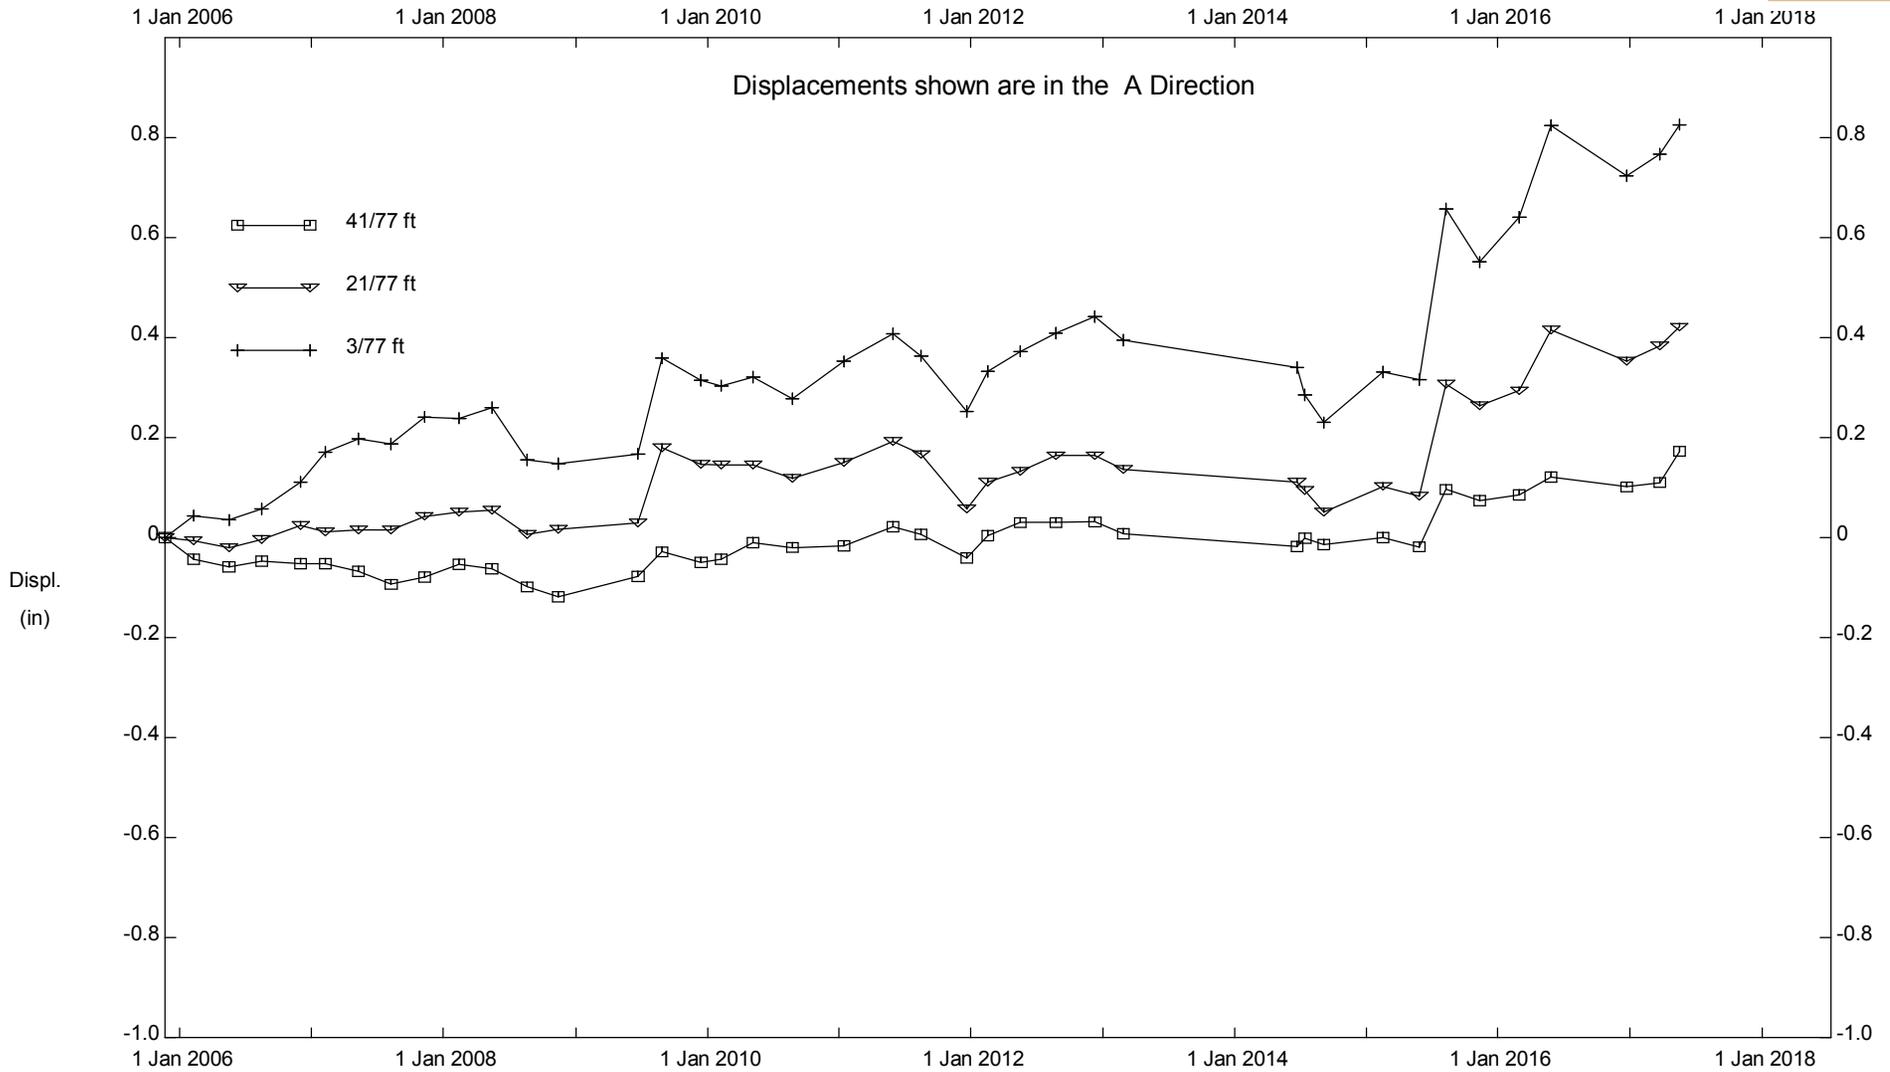
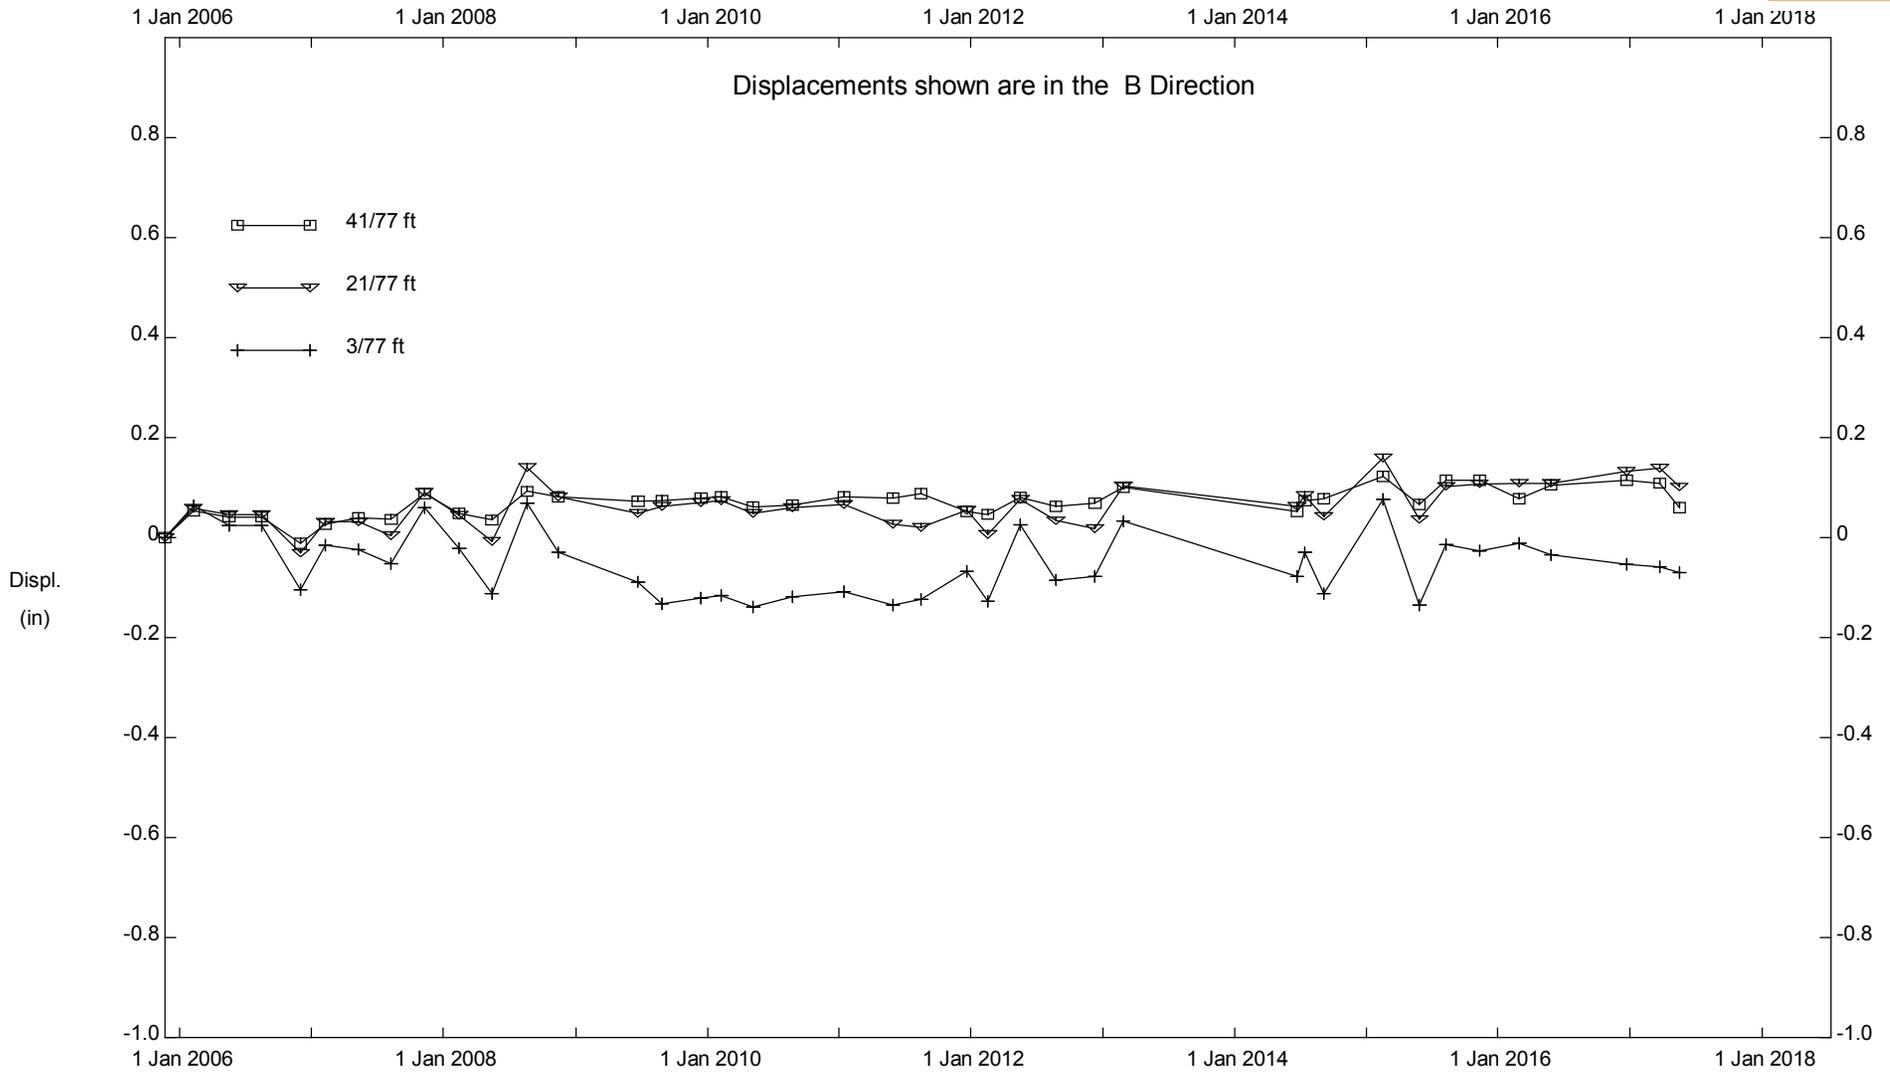
PLATE C-6a

Although the movement observed in inclinometers SI-9 and SI-16 has not produced new, observed distress in pavements or other development of which Fugro is aware, the movement is nevertheless quantifiable and can be defined by a clear trend.
