Annual Report, July 2016 Through June 2017 Calle Del Barco Landslide Assessment District Malibu, California

January 2018
Fugro Project No. 04.62160605
Document No. 04.62160605-PR-001(Rev.00)

City of Malibu

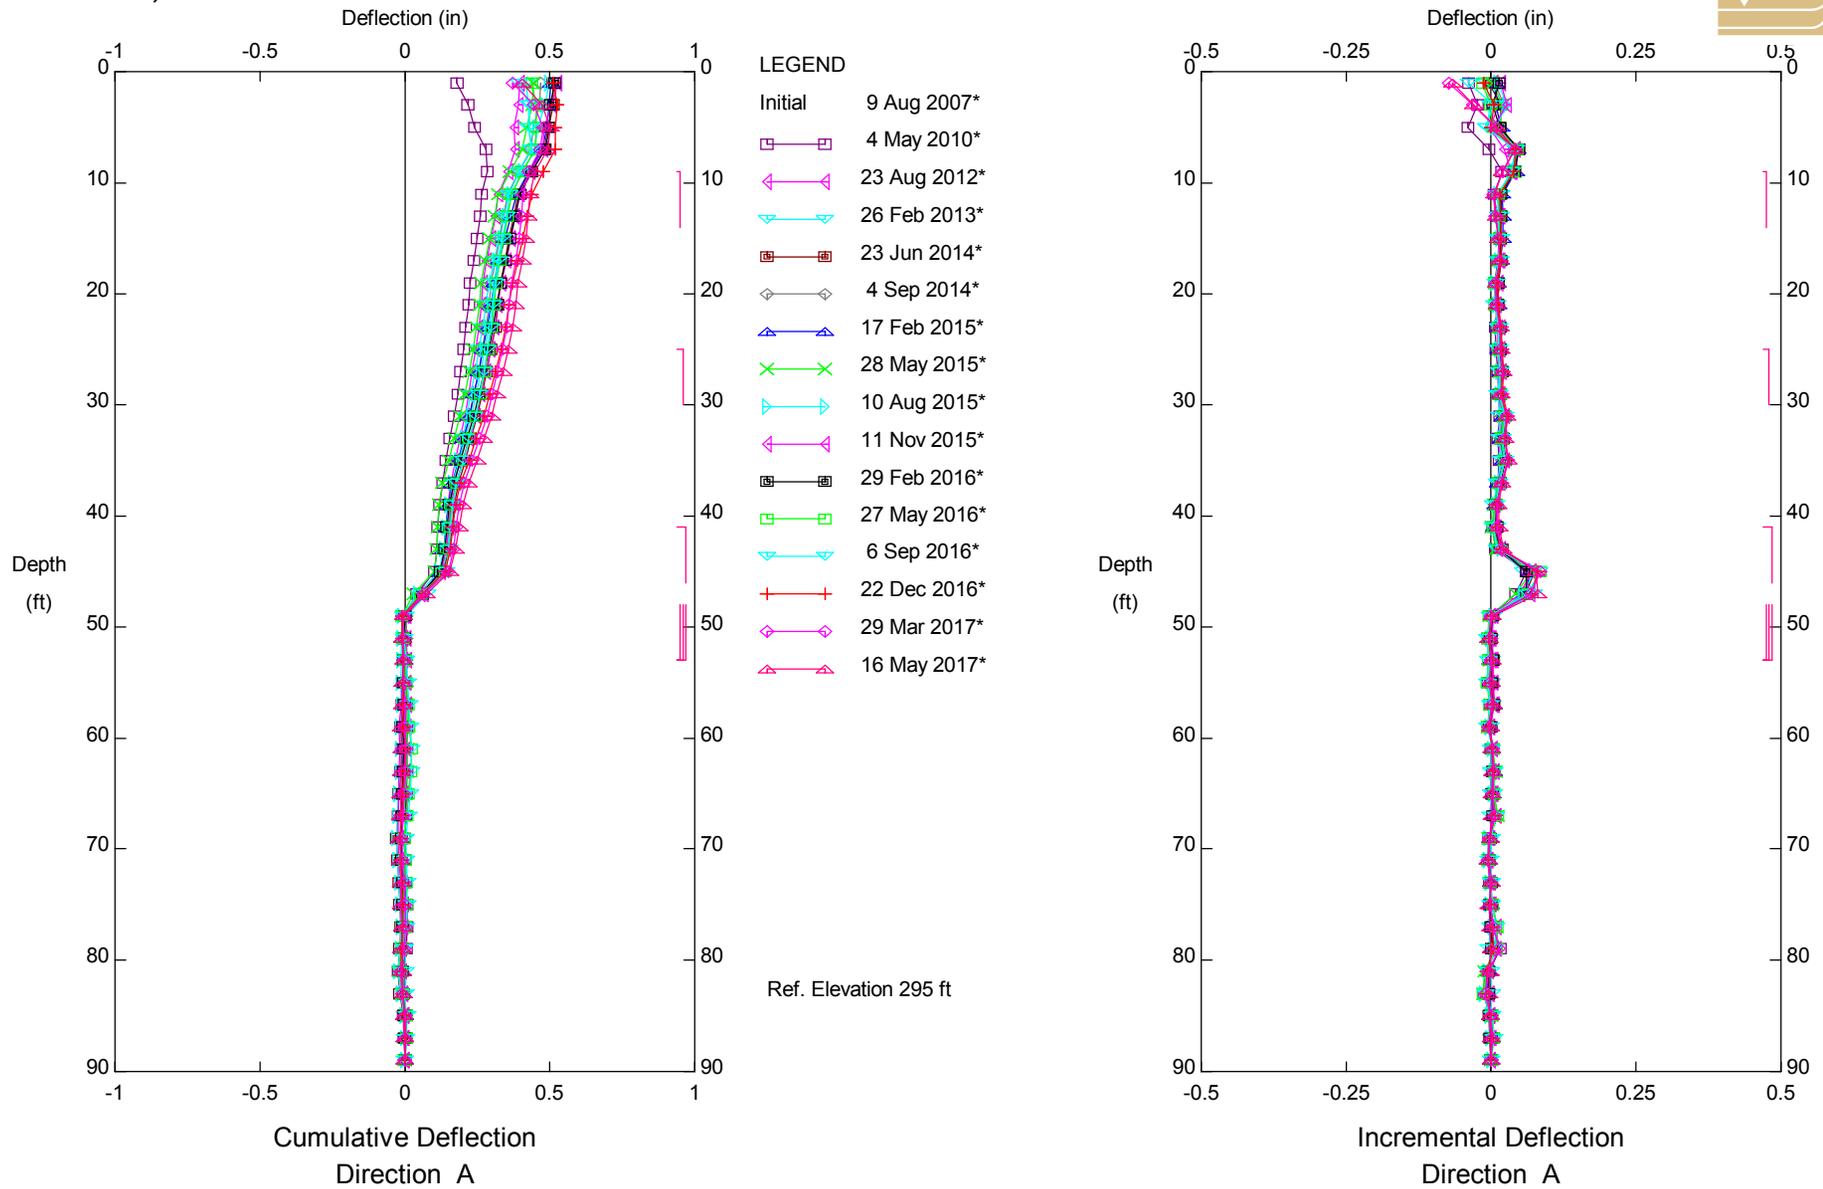
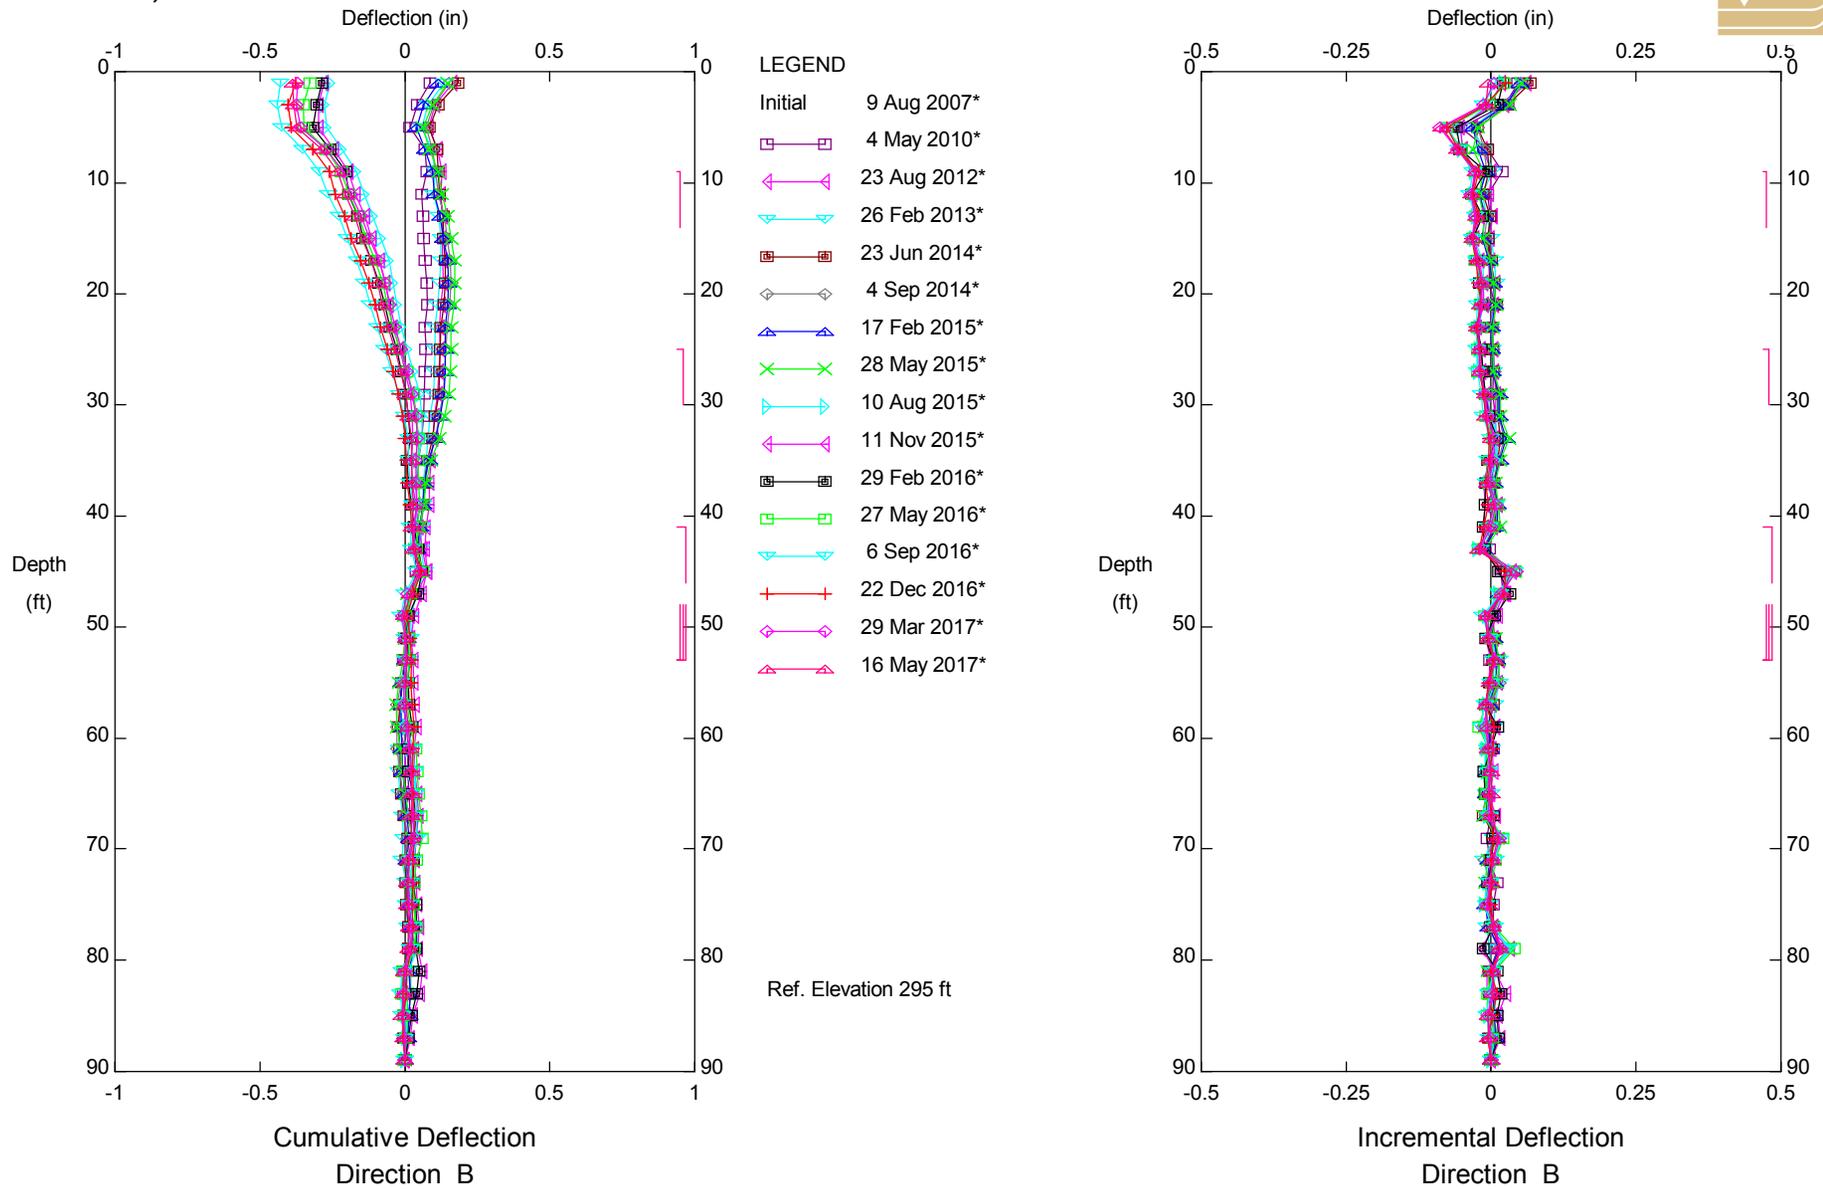
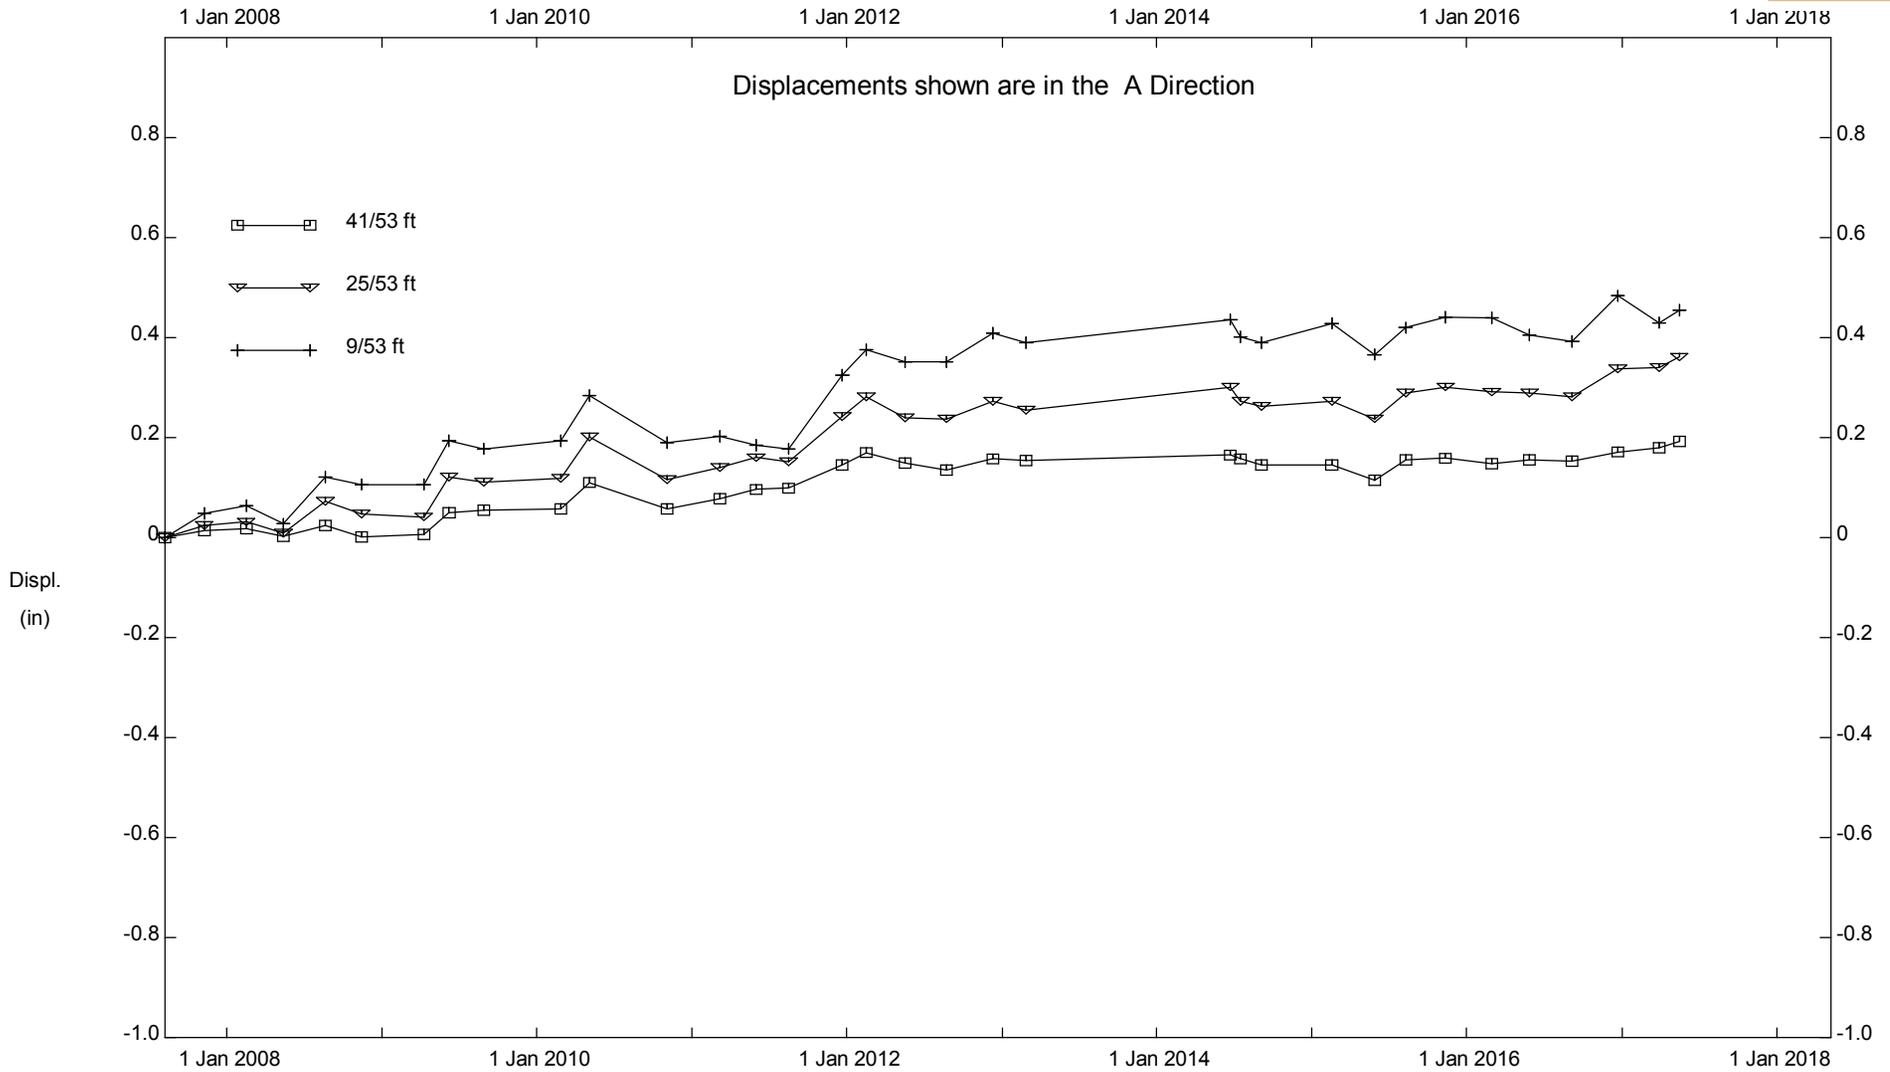
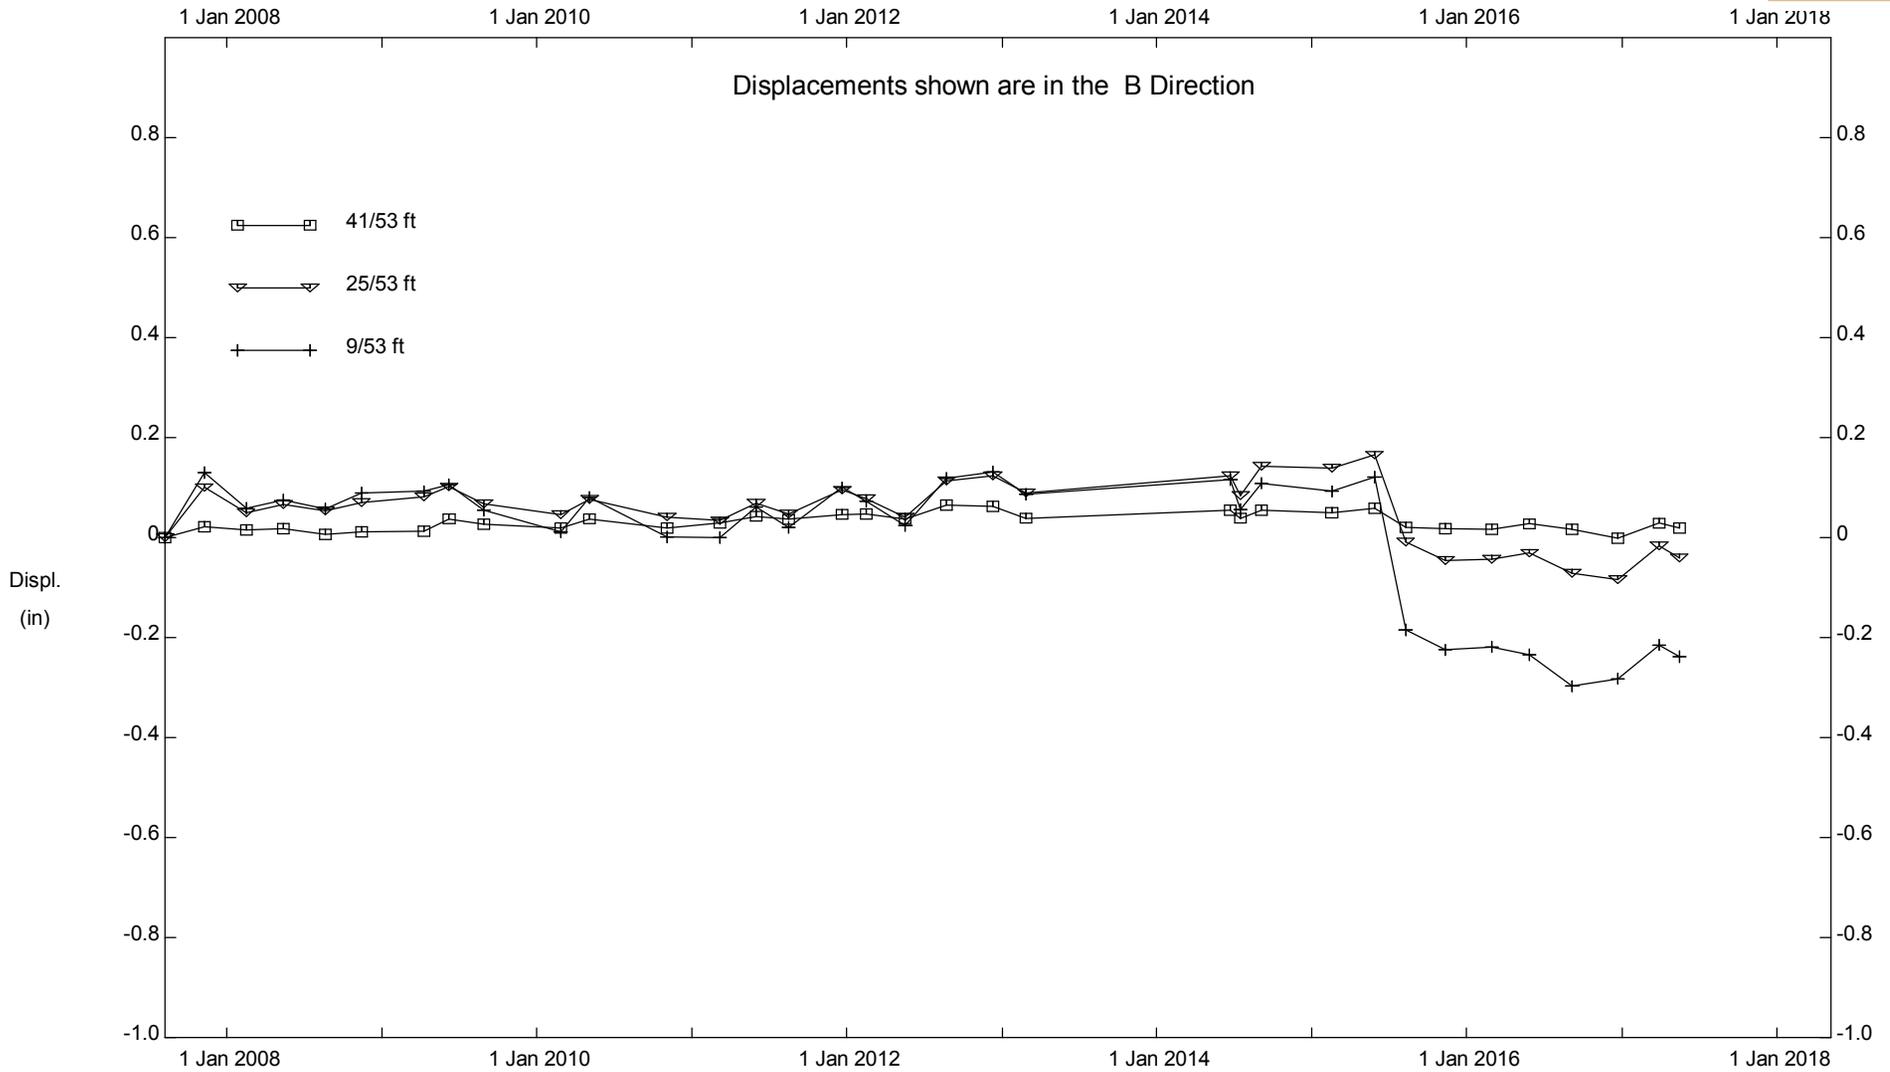
Assessment District 98-2, Inclinometer SI-16
 City of Malibu

Although the movement observed in inclinometers SI-9 and SI-16 has not produced new, observed distress in pavements or other development of which Fugro is aware, the movement is nevertheless quantifiable and can be defined by a clear trend.
