### Annual Report July 2017 Through June 2018 Malibu Road Landslide Assessment District Malibu, California

March 2019  
Fugro Project No. 04.62160604  
Document No. 04.62160604-PR-002(Rev.00)

City of Malibu

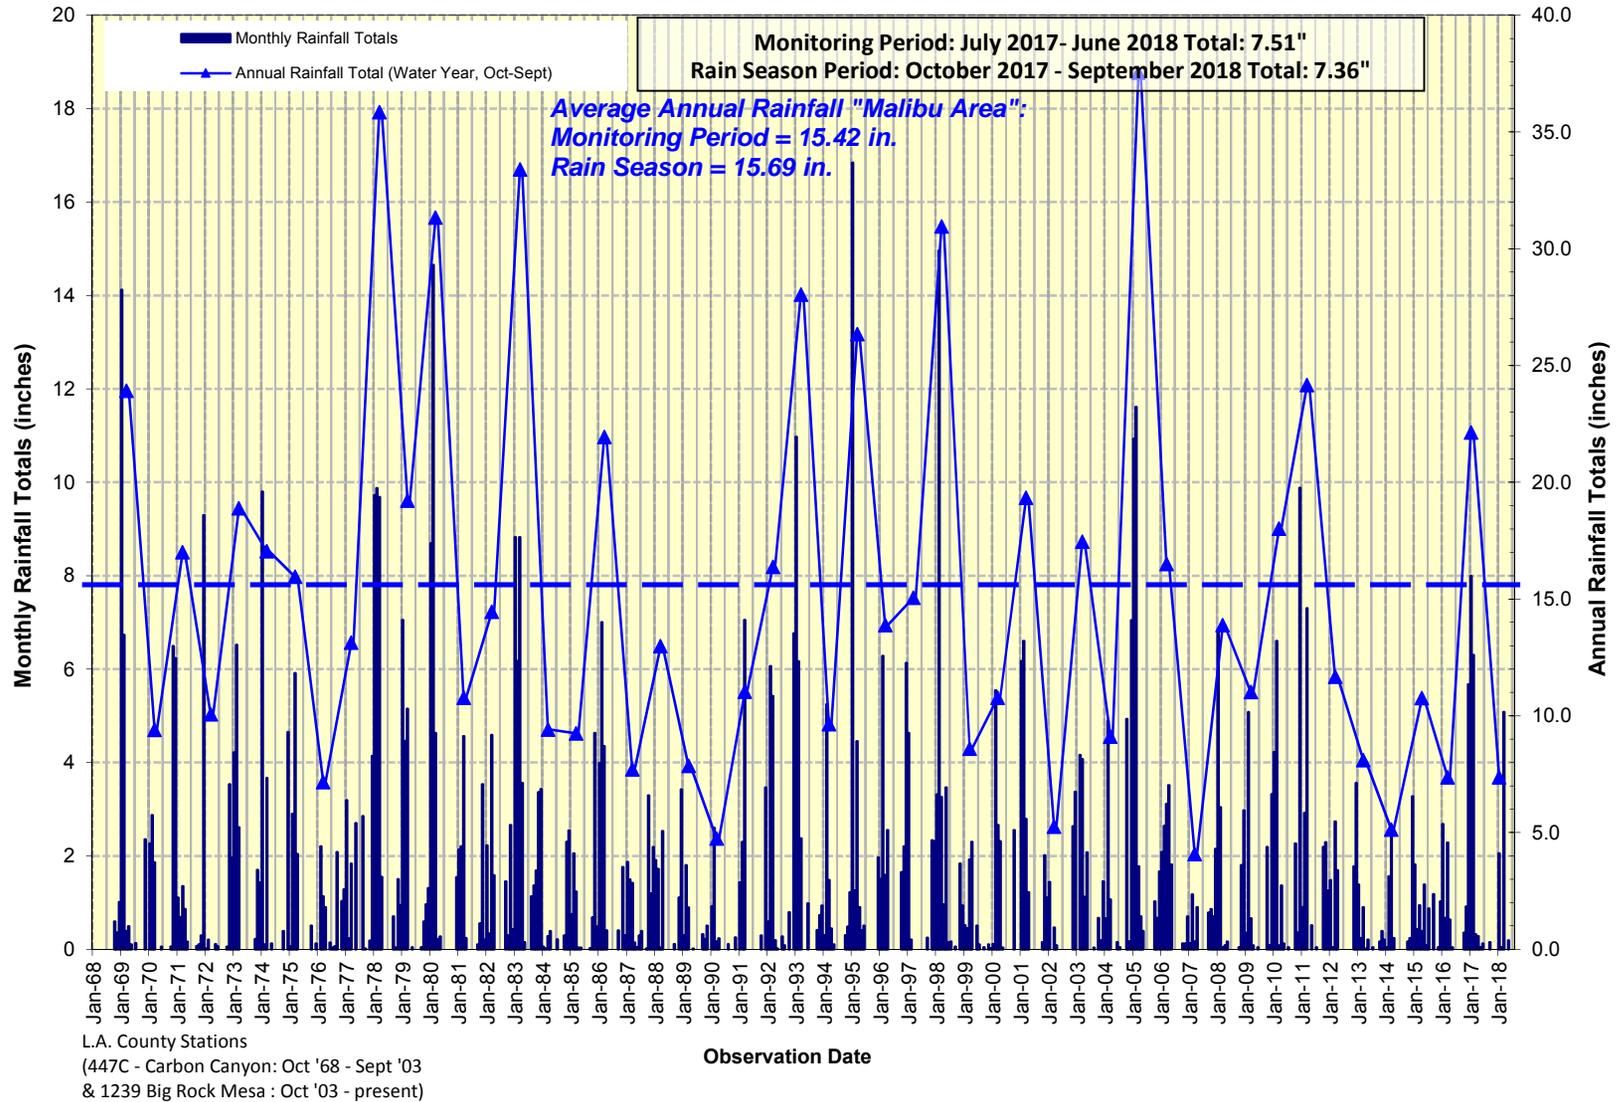
**RAINFALL GRAPH**  
 Malibu Road Landslide Assessment District  
 Malibu, California

A graph of historical monthly rainfall and average annual rainfall from October 1968 through June 30, 2018 is shown on Plate 3 - Rainfall Graph. Monthly rainfall totals from 1968 through 2004 were obtained from County of Los Angeles Department of Public Works (LADPW) Carbon Canyon Rain Station 447C and monthly rainfall totals from 2004 to the present were obtained from LADPW Big Rock Mesa Rain Gauge 1239.

Rainfall data indicate that approximately 7.51 inches of precipitation fell during the monitoring period from July 1, 2017, through June 30, 2018. The average annual rainfall from 1968 to 2018 in the "Malibu Area" for the same months is approximately 15.4 inches.

However, rainfall data is usually analyzed in terms of the annual "rain season" that covers the time period between October 1 through September 30. Rainfall for October 1, 2017, through September 30, 2018, was approximately 7.36 inches. That is approximately 47 percent of the average annual rainfall of approximately 15.7 inches for the "rain seasons" between 1968 and 2018.

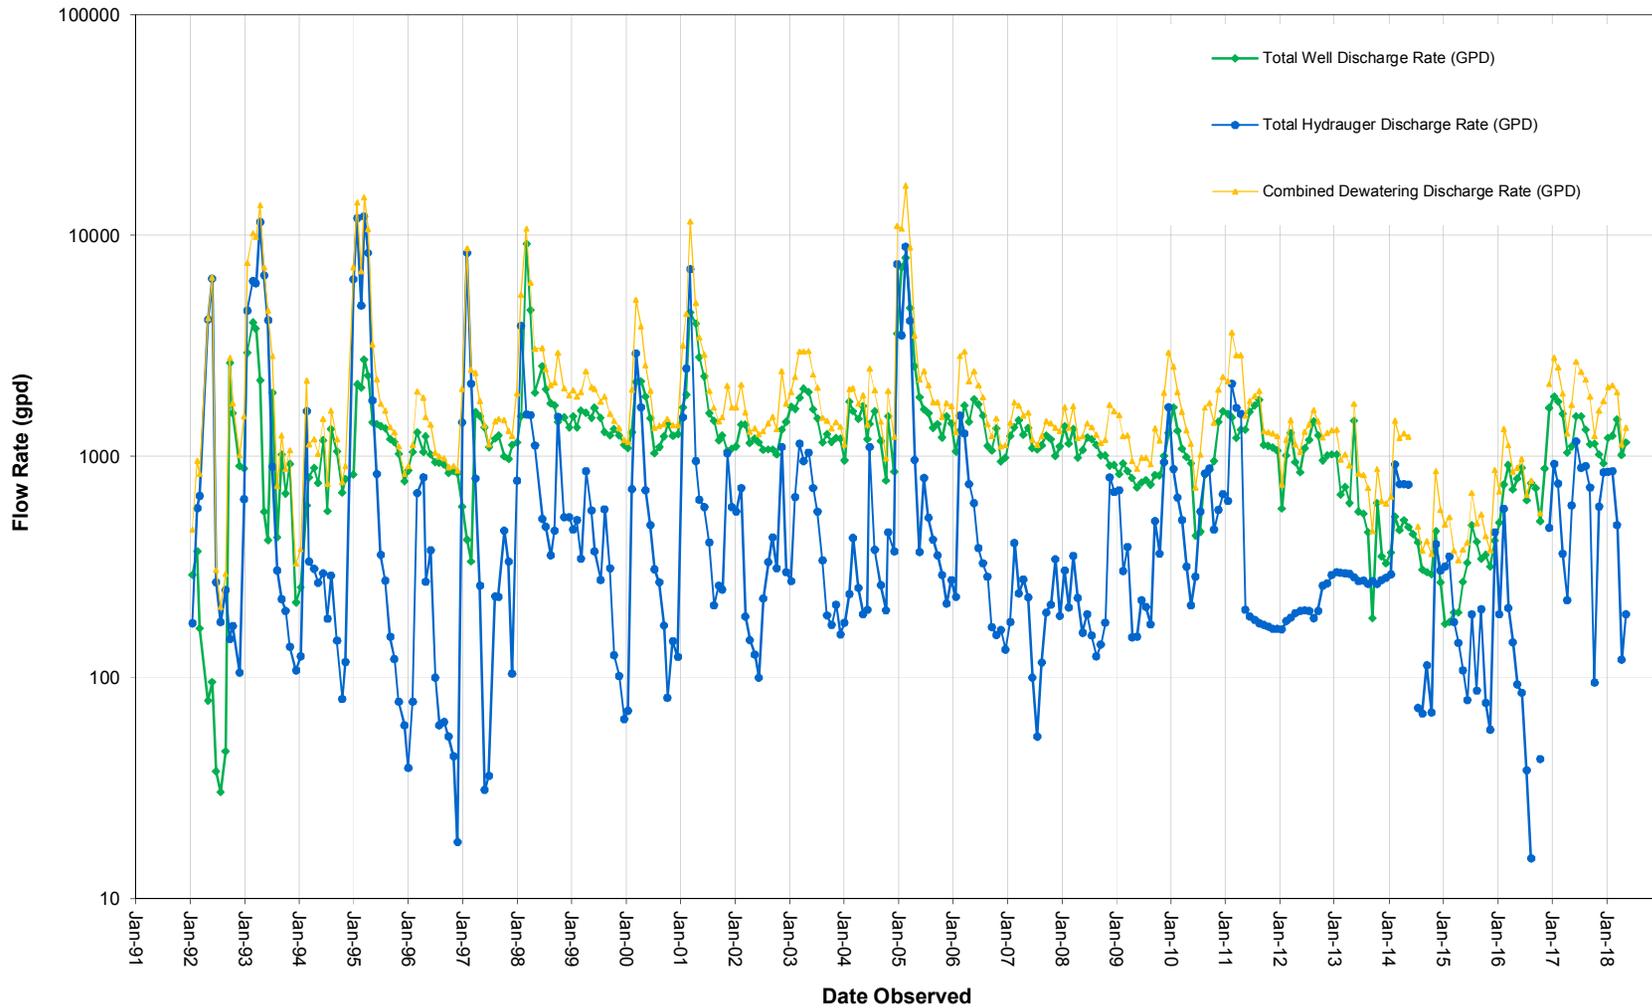
**TOTAL DISCHARGE - WELLS AND HYDRAUGERS**  
Malibu Road Landslide Assessment District  
Malibu, California

A combined graph of the total dewatering rate for the monitored dewatering wells and hydraugers is presented on Plate 4. Total dewatering production data for the measured hydraugers and wells indicates that the average total dewatering rate during the monitoring period was approximately 1871 gpd. This represents a 22 percent increase in the average rate relative to the 1533 gpd average recorded during the previous monitoring period.

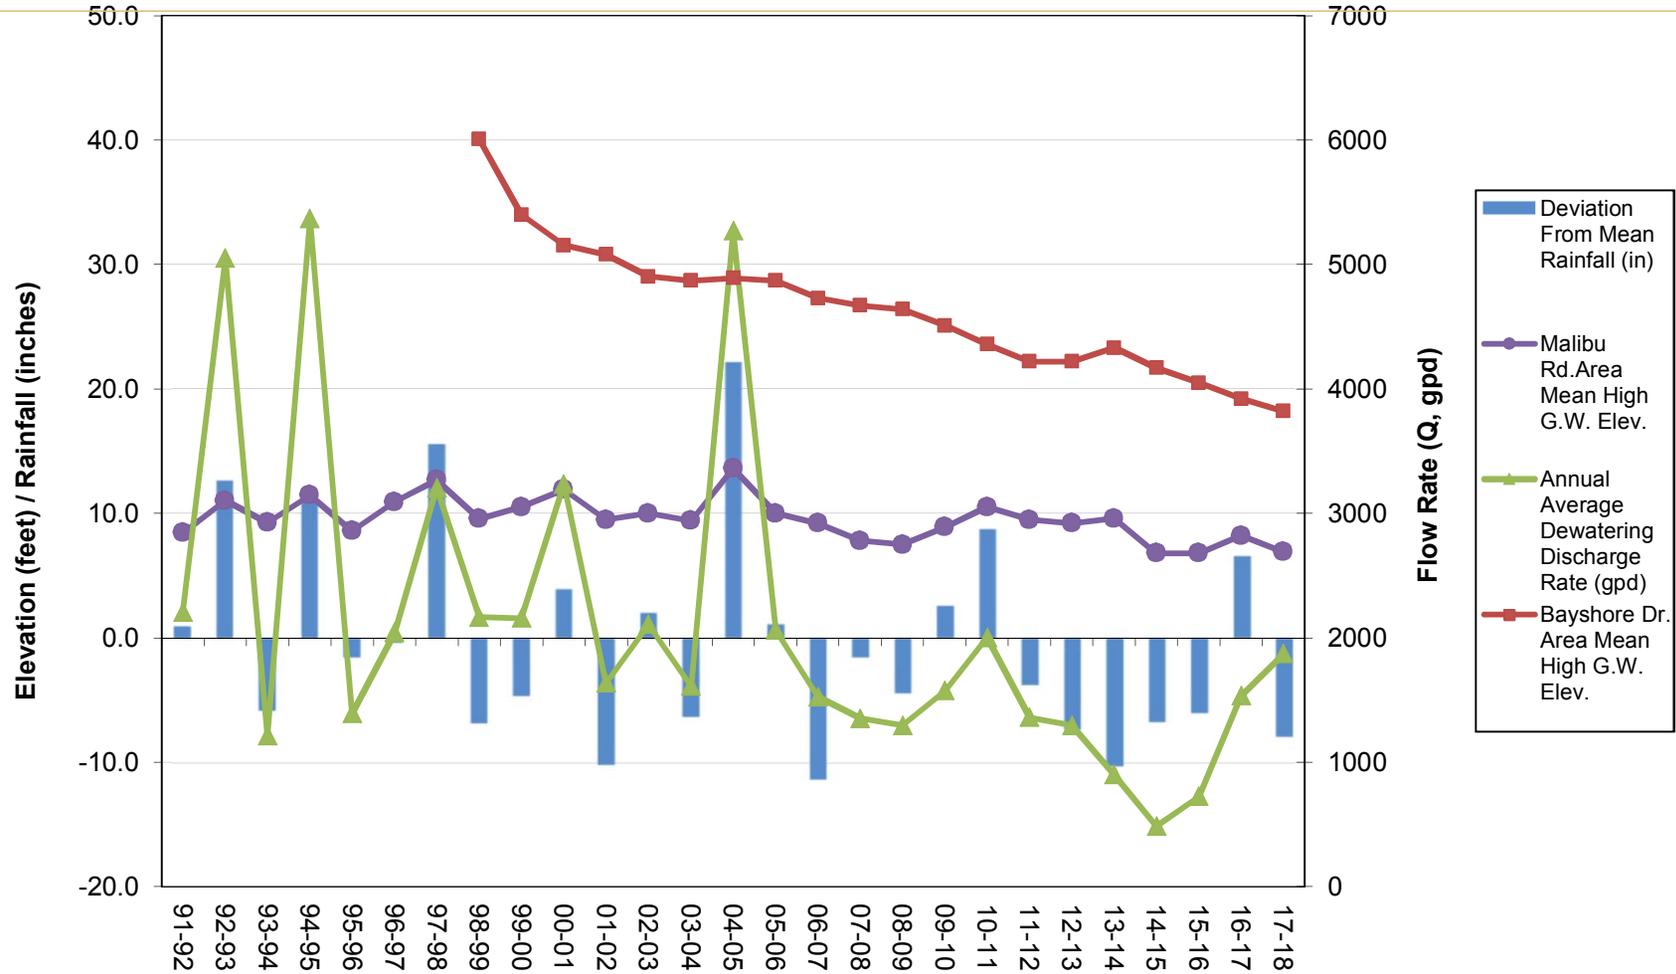
**GROUNDWATER LEVELS, DEWATERING, AND RAINFALL**  
 Malibu Road Landslide Assessment District  
 Malibu, California

Plate 5 – Groundwater Levels, Dewatering, and Rainfall shows the yearly magnitude of deviation of each years' rainfall relative to the mean annual rainfall. The graphic also shows the average annual dewatering output in gallons per day (gpd). The data illustrates that the average annual dewatering output is generally consistent with average rainfall.

\* Graph shows the mean value of the highest groundwater elevations recorded for each standpipe piezometer during the monitoring year.

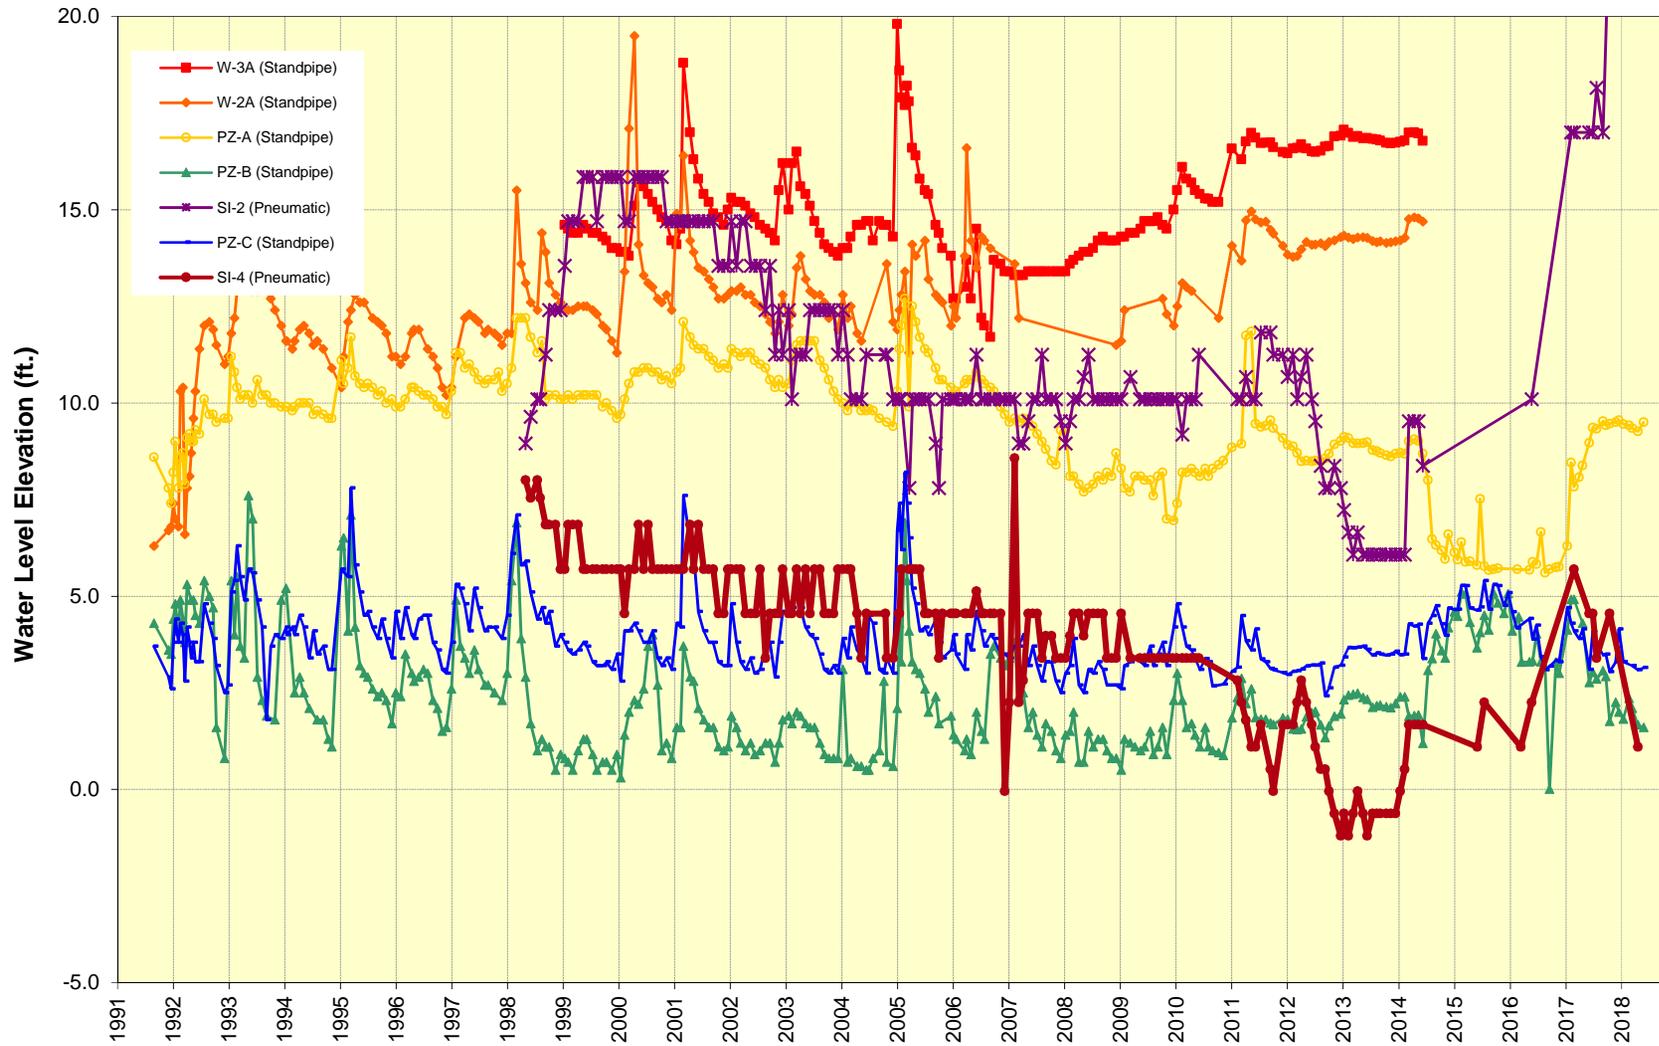
**GROUNDWATER HYDROGRAPH**  
 Malibu Road (West End)  
 Malibu Road Landslide Assessment District  
 Malibu, California

**Malibu Road.** Groundwater elevation data for the area along Malibu Road are presented on Plates A-3 and A-4. Groundwater levels for that area are monitored using standpipes PZ-A, -B, -C, -D, -E, W-2A, and W-3A along with pneumatic piezometers installed in inclinometers SI-1, -1A, -2, -3, and -4. Groundwater levels increased slightly during the 2017-18 monitoring period. The calculated area average water level increased by 0.1 feet when compared to the area average for the 2016-17 monitoring period and is 1.9 feet below the mean area average for this area for the period of record. Except for PZ-A, water levels in individual standpipes declined slightly or remained approximately static over the monitoring year.

Groundwater levels measured in PZ-A between 2015 and 2017 were low compared to historical water levels. Average groundwater elevation measured in PZ-A for the 2017-2018 monitoring period, while increasing by 2.5 feet from the 2016-2017 monitoring period, are consistent with elevations observed before 2014.

No new data are presented for standpipes W-2A or W-3A because W-2A has been dry since July 2014 and W-3A is buried beneath soil creep from the bluff face.

\*Note: W-3A uncovered in Jan. '99 and covered in 2014, presumably due to soil creep  
 W-2A has been dry since July 2014

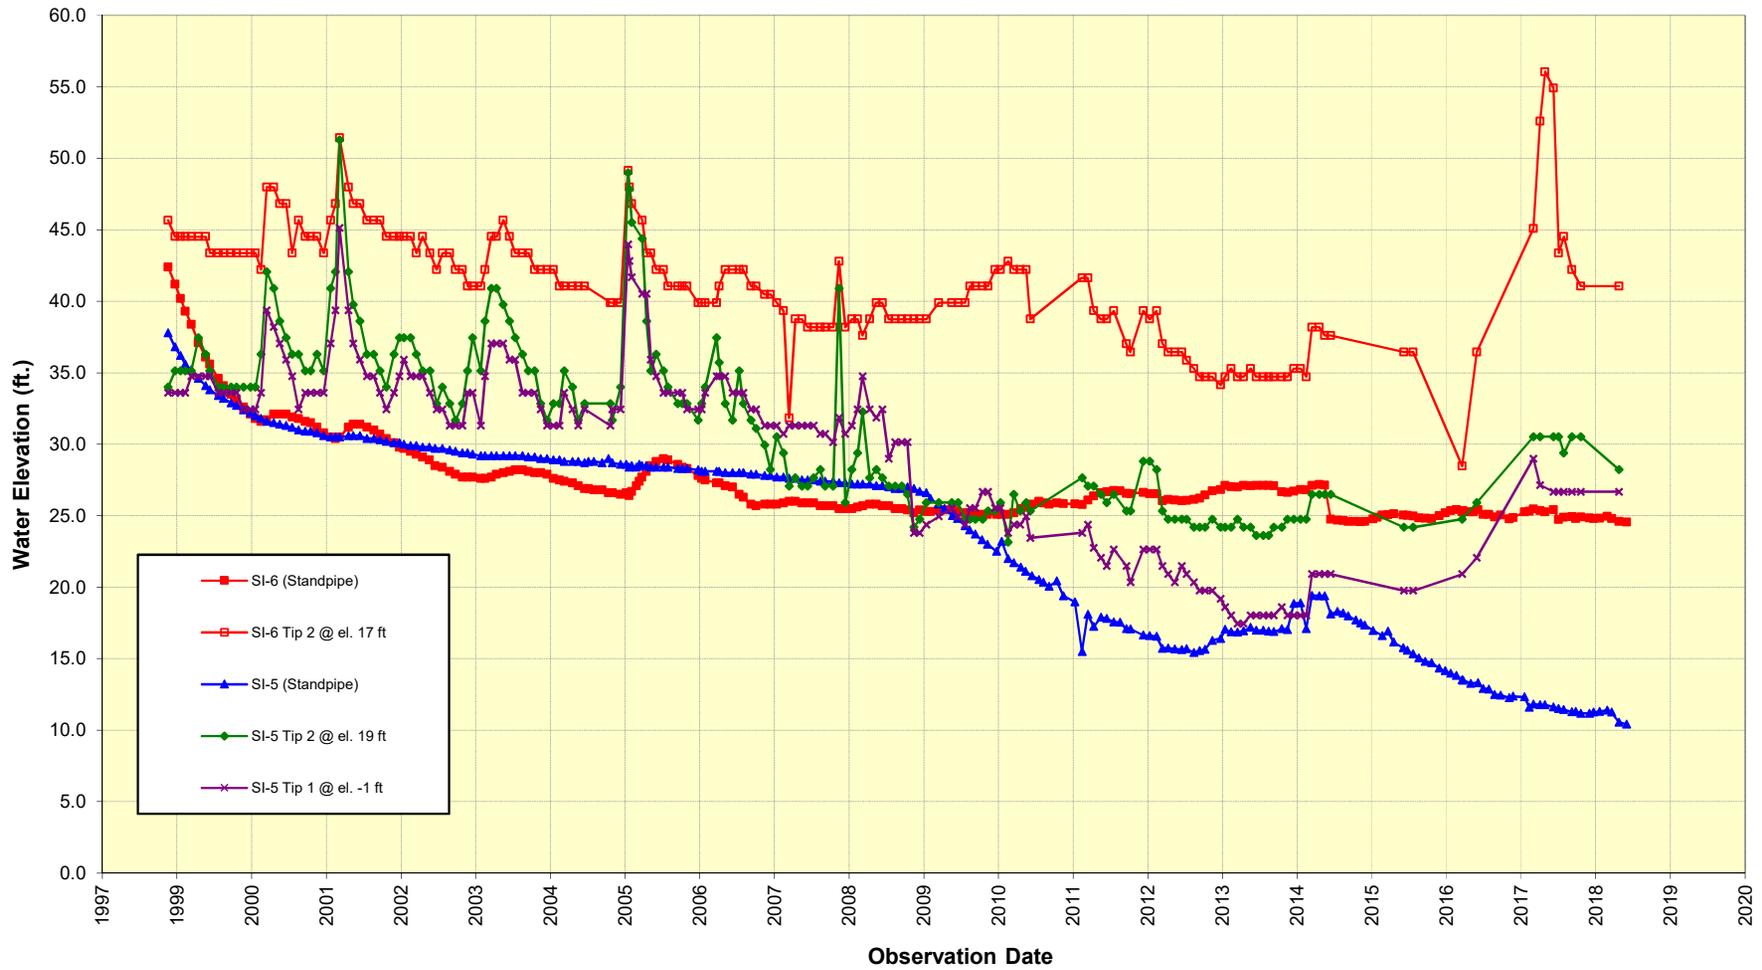
**GROUNDWATER HYDROGRAPH**  
**Bayshore Drive**  
Malibu Road Landslide Assessment District  
Malibu, California

**Bayshore Drive.** Groundwater elevation data for the area along Bayshore Drive are presented on Plate A-5. Groundwater levels for that area are monitored using standpipes SI-5 and SI-6 along with the two pneumatic piezometers installed with each standpipe. In general, groundwater levels declined during the 2017-18 monitoring period. The calculated area average water-level declined by 0.7 feet when compared to the area average for the 2016-17 monitoring year and is 7.6 feet below the mean area average for this area for the period of record (1991-2018). Water levels in standpipe SI-5 declined steadily during the 2017-18 monitoring year and reached an all-time low for the period of record in June 2018. Water levels in standpipe SI-6 remained approximately static over the course of the monitoring year, with fluctuations of less than 1 foot. Readings from both the shallow and deep pneumatic piezometers in standpipes SI-5 and SI-6 continue to record water elevation above the standpipe water levels and showed more of a response to the rainfall events of January and March 2018 than was seen in the standpipes.

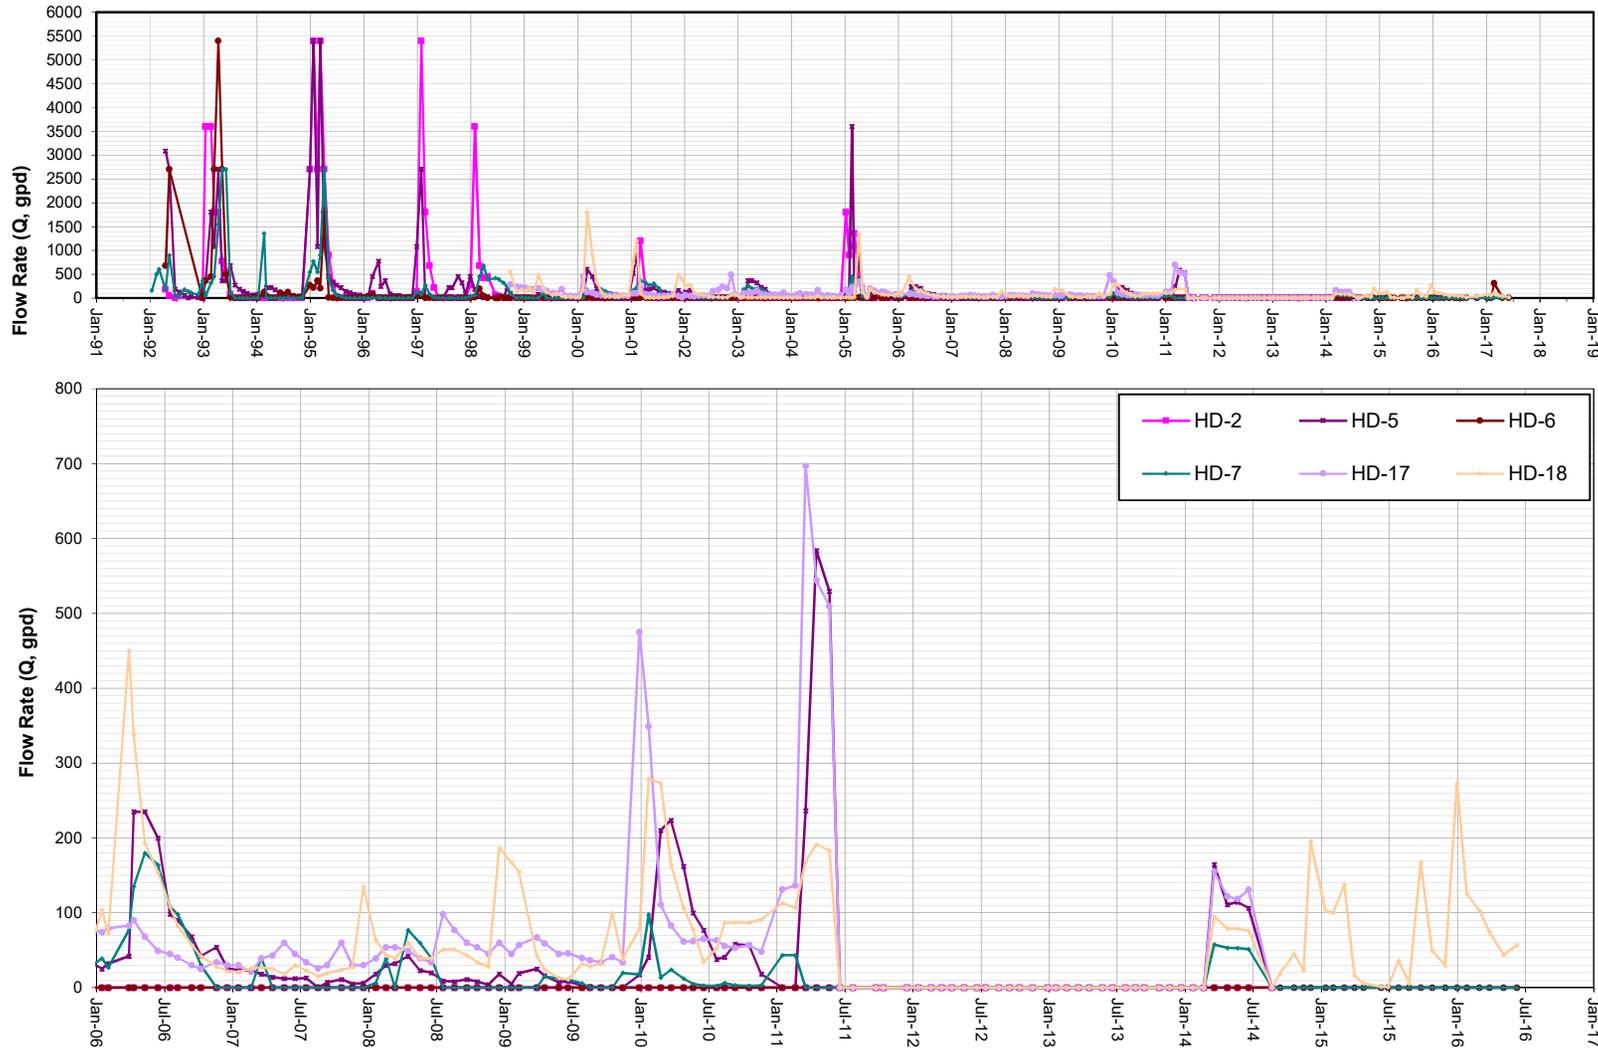
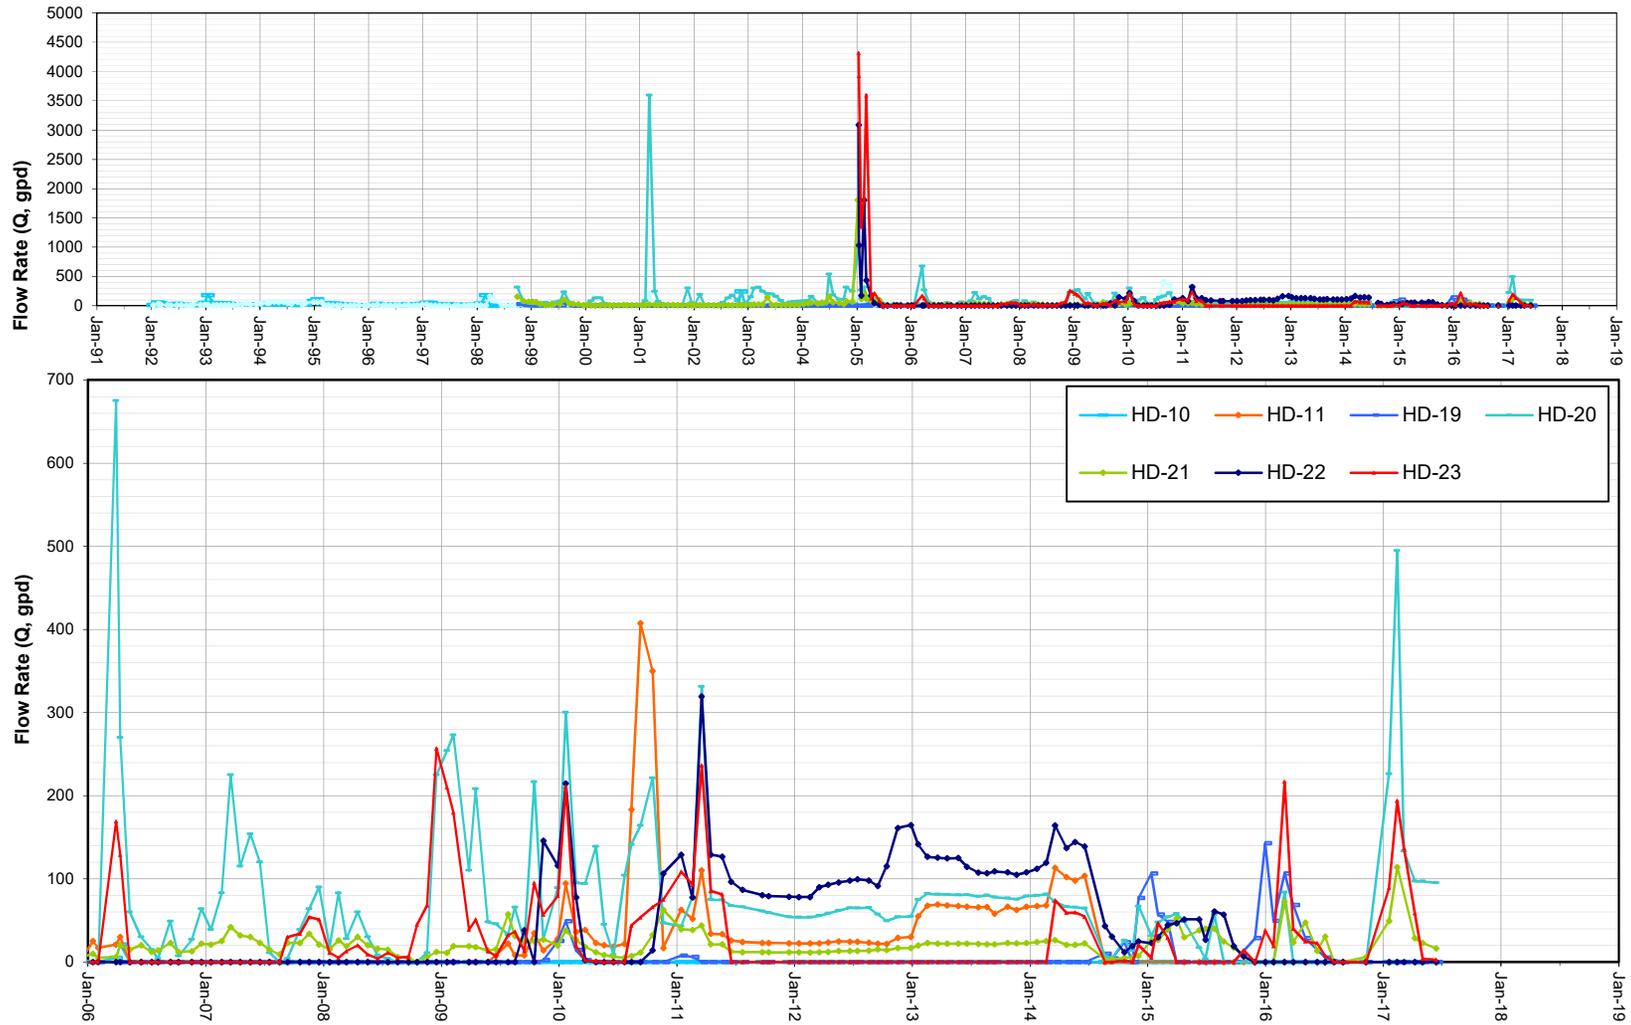
Graphs of individual production rates for individual hydraugers are included in Appendix B. Data for the hydraugers indicate that the average production rate for all hydraugers over the monitoring period is approximately 646 gpd. This represents an increase of approximately 83 percent from the average production rate of 353 gpd for the previous monitoring period.

The increase in hydrauger production can be attributed to hydrauger HD-8, which experienced greater than normal output between July 2017 and March 2018. The reason for the observed increase in production in HD-8 is not known. Readings taken after March 2018 indicate that dewatering production from HD-8 has returned to normal levels.
