### Annual Report July 2018 Through June 2019 Calle Del Barco Landslide Assessment District Malibu, California

November 2019  
Fugro Project No. 04.62160605  
Document No. 04.62160605-PR-003(Rev.00)

City of Malibu

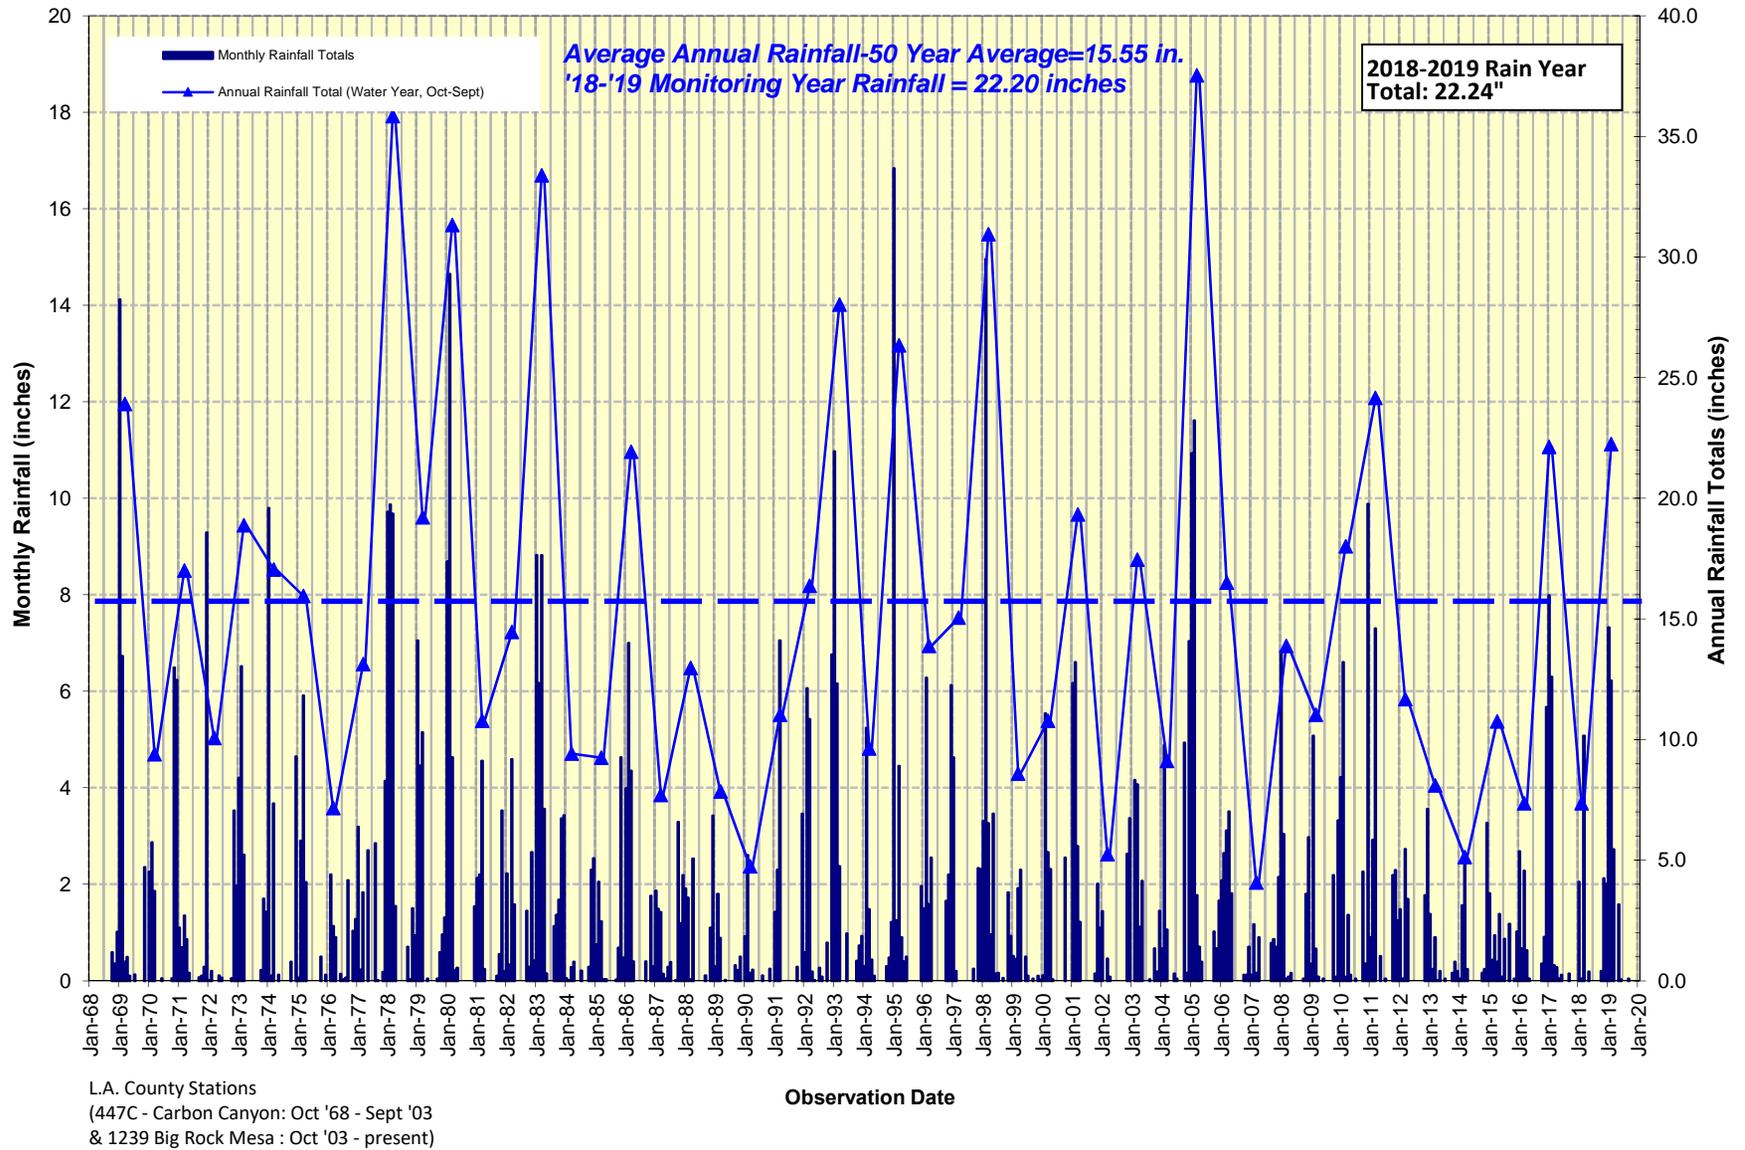
**RAINFALL GRAPH**  
 Calle Del Barco Landslide Assessment District  
 Malibu, California

A graph of historical monthly rainfall and average annual rainfall from October 1968 through September 30, 2019, is shown on Plate 3 - Rainfall Graph. Monthly rainfall totals from 1968 through 2004 were obtained from County of Los Angeles Department of Public Works (LADPW) Carbon Canyon Rain Station 447C and monthly rainfall totals from 2004 to the present were obtained from LADPW Big Rock Mesa Rain Gauge 1239.

Rainfall data indicate that approximately 22.20 inches of precipitation fell during the monitoring period from July 1, 2018, through June 30, 2019. The average annual rainfall from 1968 to 2019 in the "Malibu Area" for the same months is approximately 15.55 inches.

However, rainfall data are usually analyzed in terms of the annual "rain season" that covers the time period between October 1 through September 30. Rainfall for October 1, 2018 through September 30, 2019, was approximately 22.24 inches. That is approximately 40 percent higher than the average annual rainfall of 15.88 inches for the "rain seasons" between 1968 and 2019.

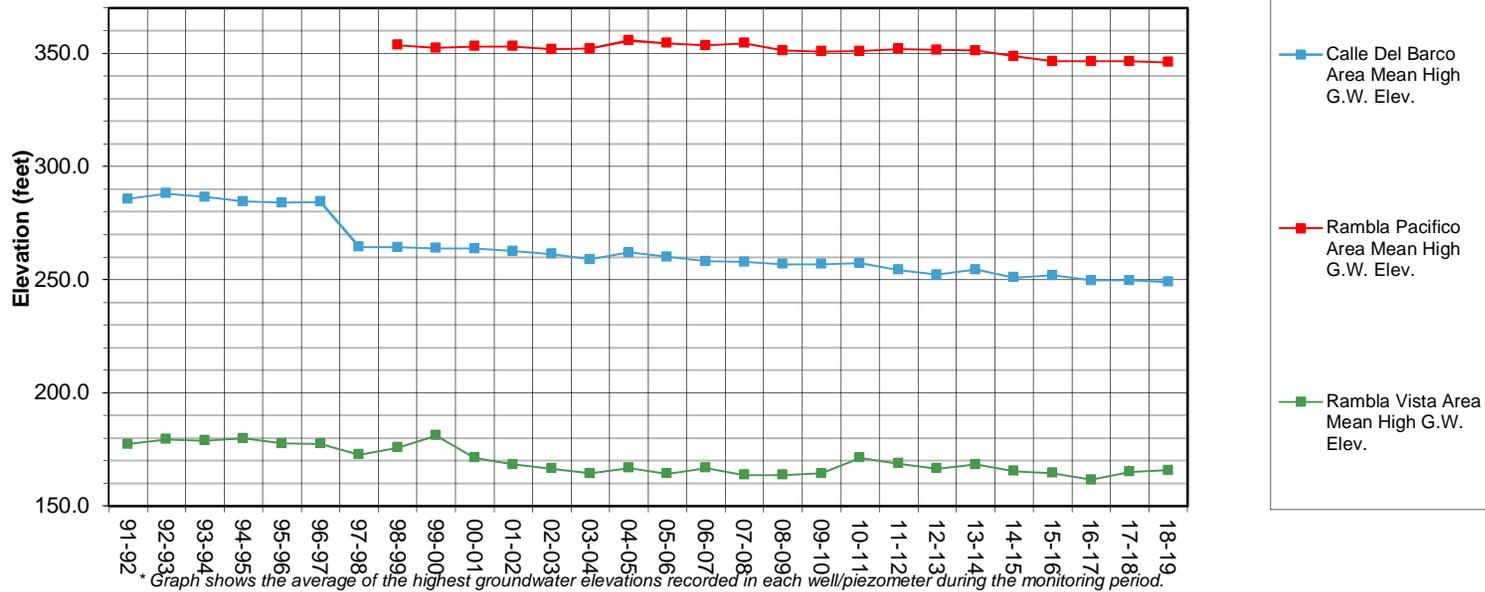
**GROUNDWATER LEVELS, DEWATERING AND RAINFALL**  
 Calle del Barco Landslide Assessment District  
 Malibu, California

Plate 5 – Groundwater Levels, Dewatering, and Rainfall shows the yearly magnitude of deviation of each years' rainfall relative to the mean annual rainfall. The graphic also shows the average annual dewatering output in gallons per day (gpd). The data illustrate that the average annual dewatering output is generally consistent with average rainfall.
