**Annual Report  
July 2018 Through June 2019  
Malibu Road Landslide Assessment  
District  
Malibu, California**

November 2019  
Fugro Project No. 04.62160604  
Document No. 04.62160604-PR-003(Rev.00)

City of Malibu

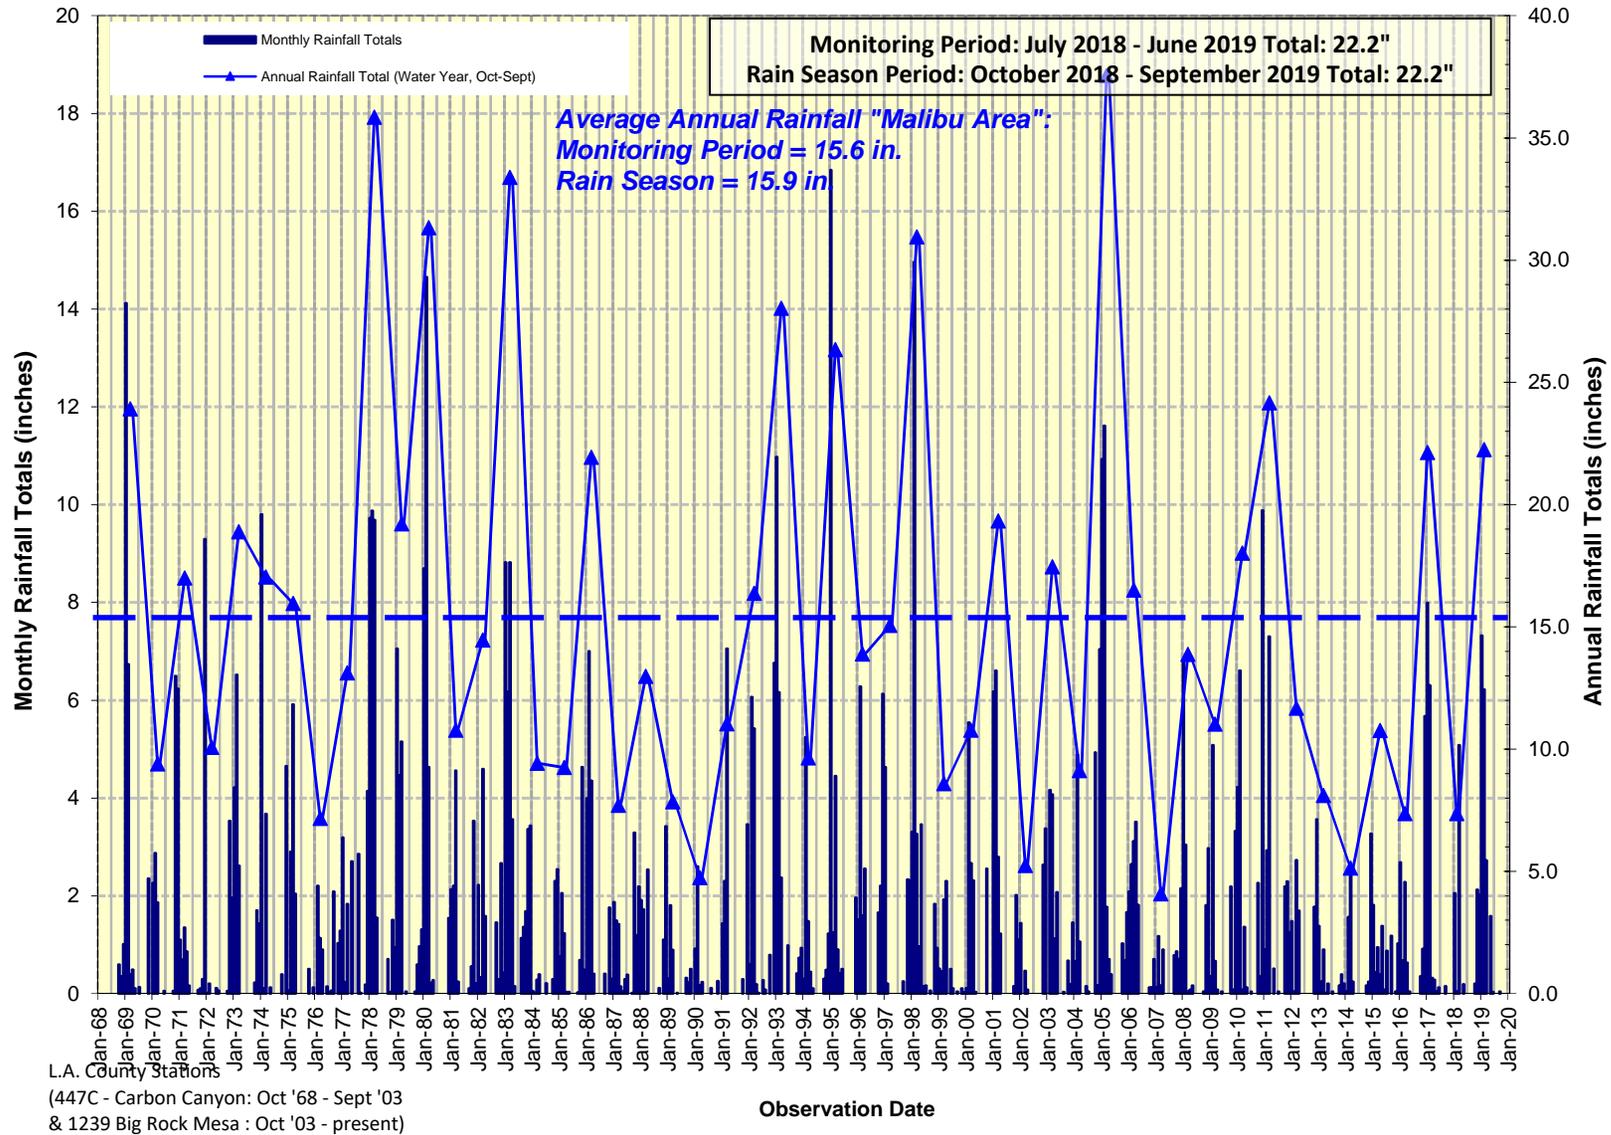
**RAINFALL GRAPH**  
 Malibu Road Landslide Assessment District  
 Malibu, California

Rainfall data indicate that approximately 22.20 inches of precipitation fell during the monitoring period from July 1, 2018, through June 30, 2019. The average annual rainfall from 1968 to 2019 in the "Malibu Area" for the same months is approximately 15.58 inches.

However, rainfall data is usually analysed in terms of the annual "rain season" that covers the time period between October 1 through September 30. Rainfall for October 1, 2018, through September 30, 2019, was approximately 22.24 inches. That is approximately 130 percent of the average annual rainfall of approximately 15.55 inches for the "rain seasons" between 1968 and 2019.

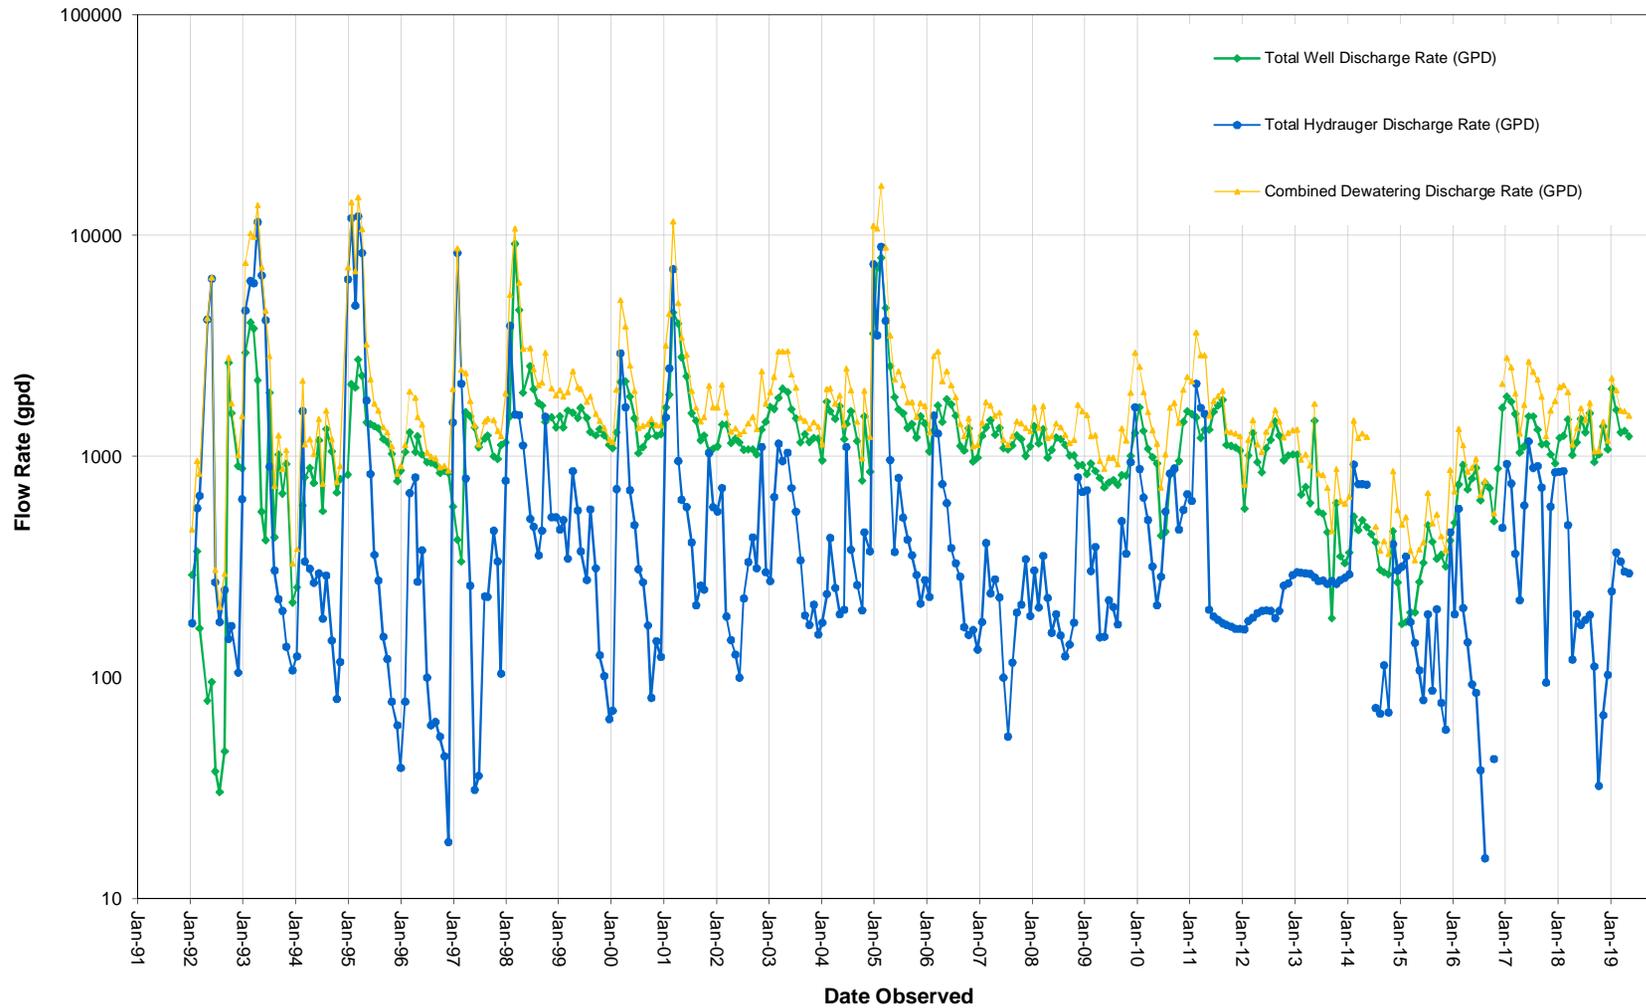
**TOTAL DISCHARGE - WELLS AND HYDRAUGERS**  
Malibu Road Landslide Assessment District  
Malibu, California

A combined graph of the total dewatering rate for the monitored dewatering wells and hydraugers is presented on Plate 4. Total dewatering production data for the measured hydraugers and wells indicates that the average total dewatering rate during the monitoring period was approximately 1553 gpd. This represents a 17 percent decrease in the average rate relative to the 1871 gpd average recorded during the previous monitoring period.

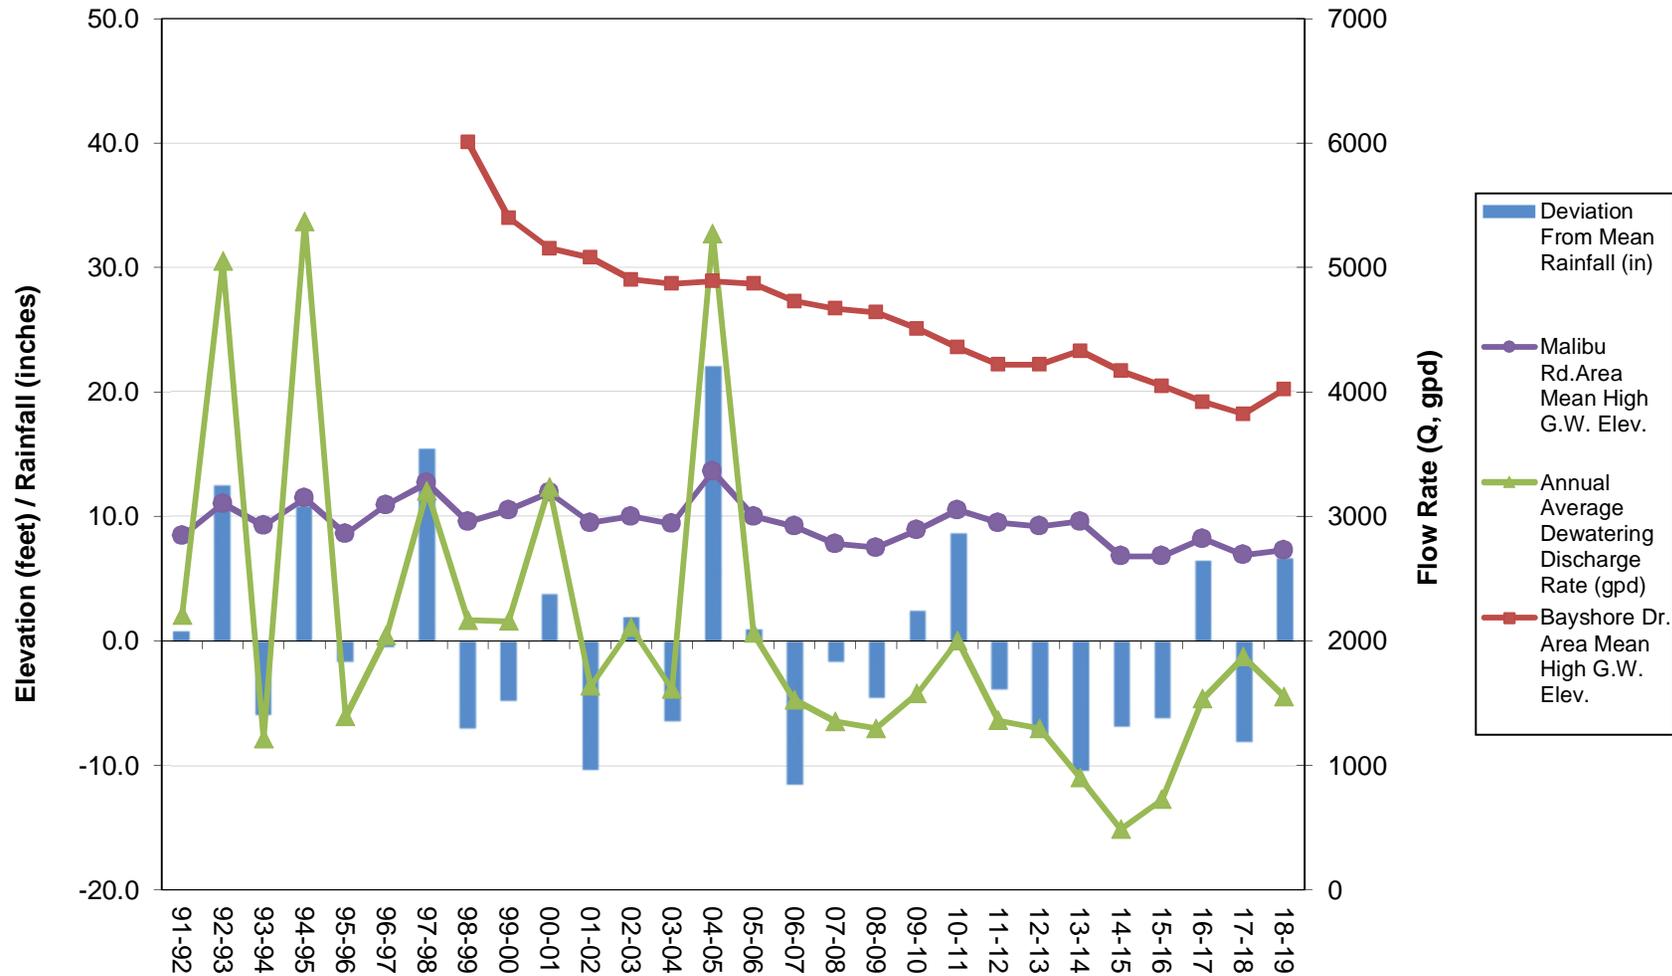
**GROUNDWATER LEVELS, DEWATERING, AND RAINFALL**  
 Malibu Road Landslide Assessment District  
 Malibu, California

Plate 5 – Groundwater Levels, Dewatering, and Rainfall shows the yearly magnitude of deviation of each year's rainfall relative to the mean annual rainfall. The graphic also shows the average annual dewatering output in gallons per day (gpd). The data illustrates that the average annual dewatering output is generally consistent with average rainfall.

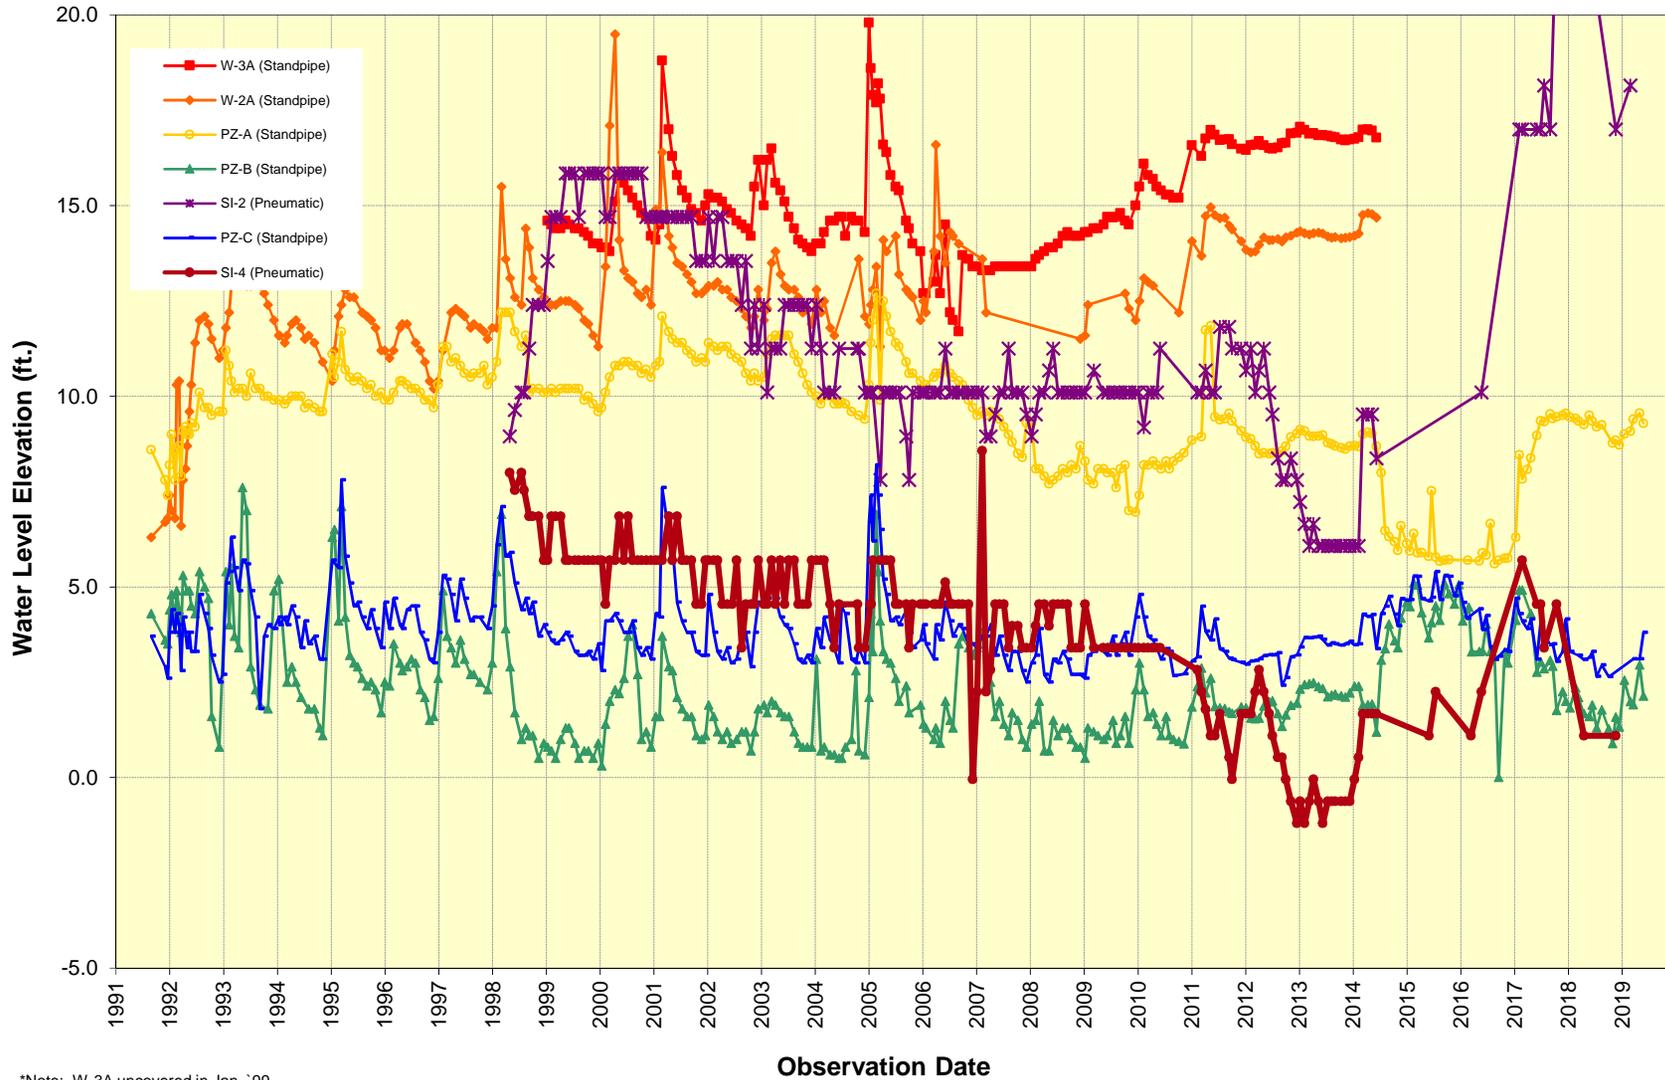
**GROUNDWATER HYDROGRAPH**  
 Malibu Road (West End)  
 Malibu Road Landslide Assessment District  
 Malibu, California

**Malibu Road.** Groundwater elevation data for the area along Malibu Road are presented on Plates A-3 and A-4. Groundwater levels for that area are monitored using standpipes PZ-A, -B, -C, -D, -E, W-2A, and W-3A along with pneumatic piezometers installed in inclinometers SI-1, -1A, -2, -3, and -4. Groundwater levels decreased slightly during the 2018 - 2019 monitoring period. The calculated area average water level decreased by 0.2 feet when compared to the area average for the 2017-18 monitoring period and is 2.0 feet below the mean area average for this area for the period of record. Except for PZ-E, water levels in individual

standpipes declined over the monitoring year. Water levels in PZ-E increased by 0.5 feet over the monitoring year.

No new data are presented for standpipes W-2A or W-3A because W-2A has been dry since July 2014 and W-3A is buried beneath soil creep from the bluff face.

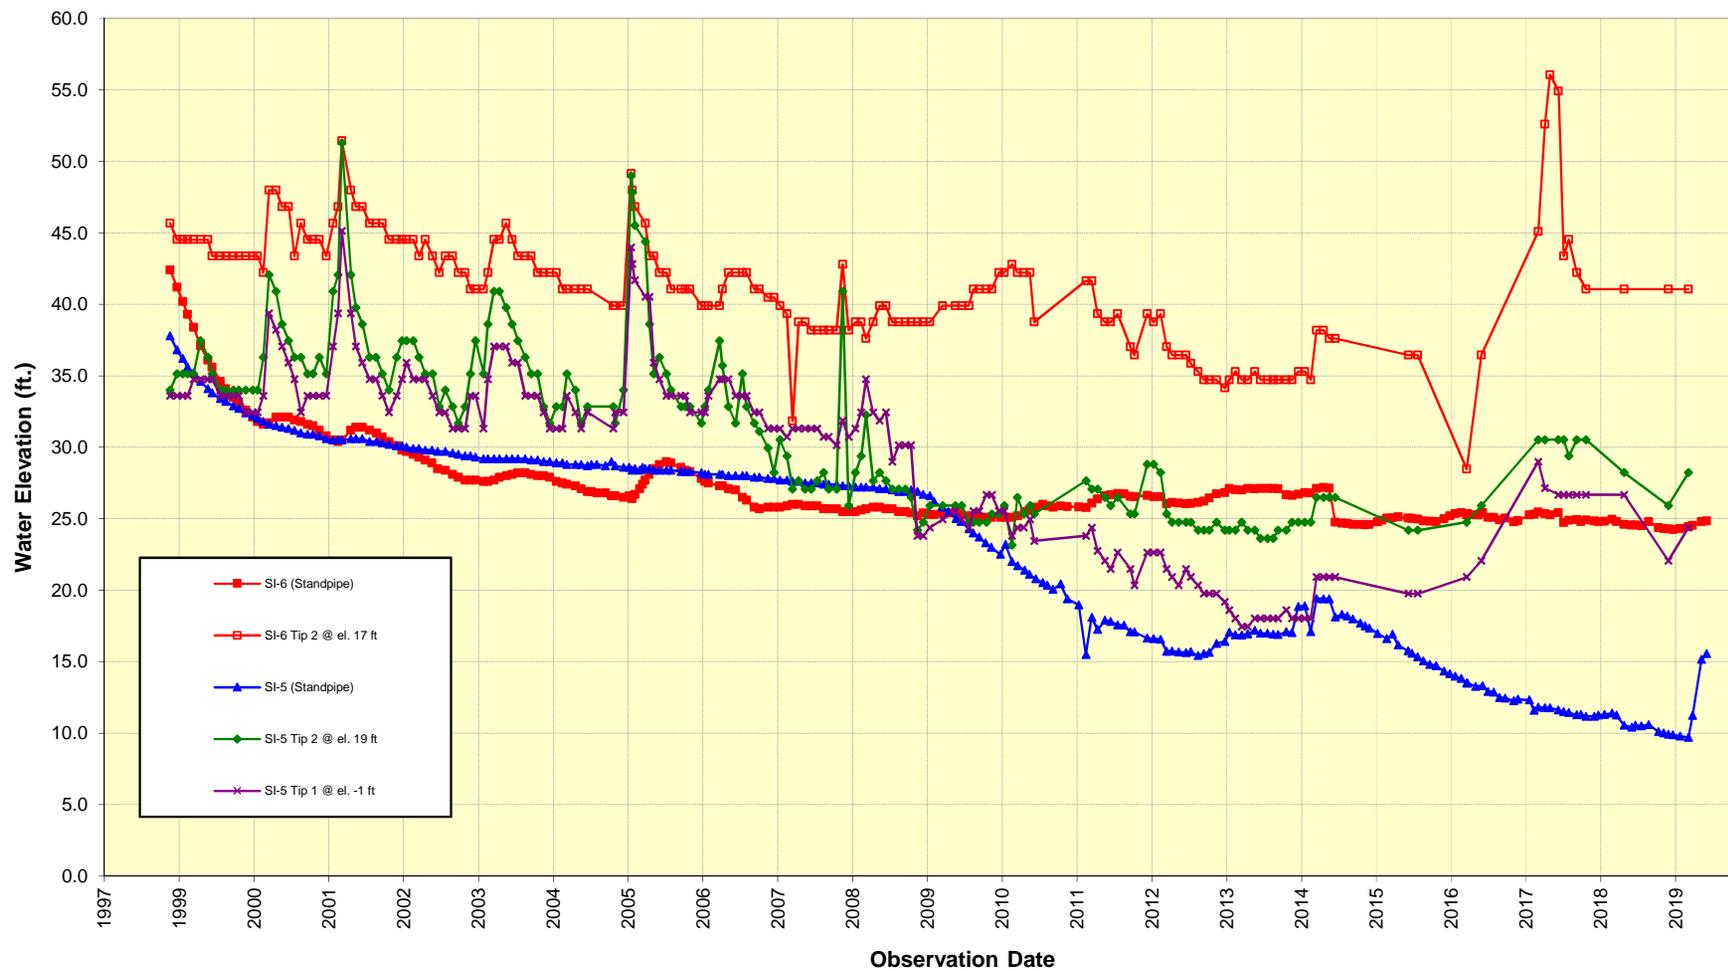
**GROUNDWATER HYDROGRAPH**  
**Bayshore Drive**  
 Malibu Road Landslide Assessment District  
 Malibu, California

**Bayshore Drive.** Groundwater elevation data for the area along Bayshore Drive are presented on Plate A-5. Groundwater levels for that area are monitored using standpipes SI-5 and SI-6 along with the two pneumatic piezometers installed with each standpipe. In general, groundwater levels declined during the 2018 - 2019 monitoring period. The calculated area average water-level declined by 0.2 feet when compared to the area average for the 2017 - 2018 monitoring year and is 7.4 feet below the mean area average for this area for the period of record (1991 - 2019). Water levels in standpipe SI-5 declined steadily reached an all-time low for the period of record in March 2019, before rising slightly. Water levels in standpipe SI-6 remained approximately static over the course of the monitoring year, with fluctuations of less than 1 foot. Readings from both the shallow and deep pneumatic piezometers in standpipes SI-5 and SI-6 continue to record water elevation above the standpipe water levels.
