Annual Report July 2019 Through June 2020 Calle Del Barco Landslide Assessment District Malibu, California

August 2020
Fugro Project No. 04.62160605
Document No. 04.62160605-PR-004(Rev.00)

City of Malibu

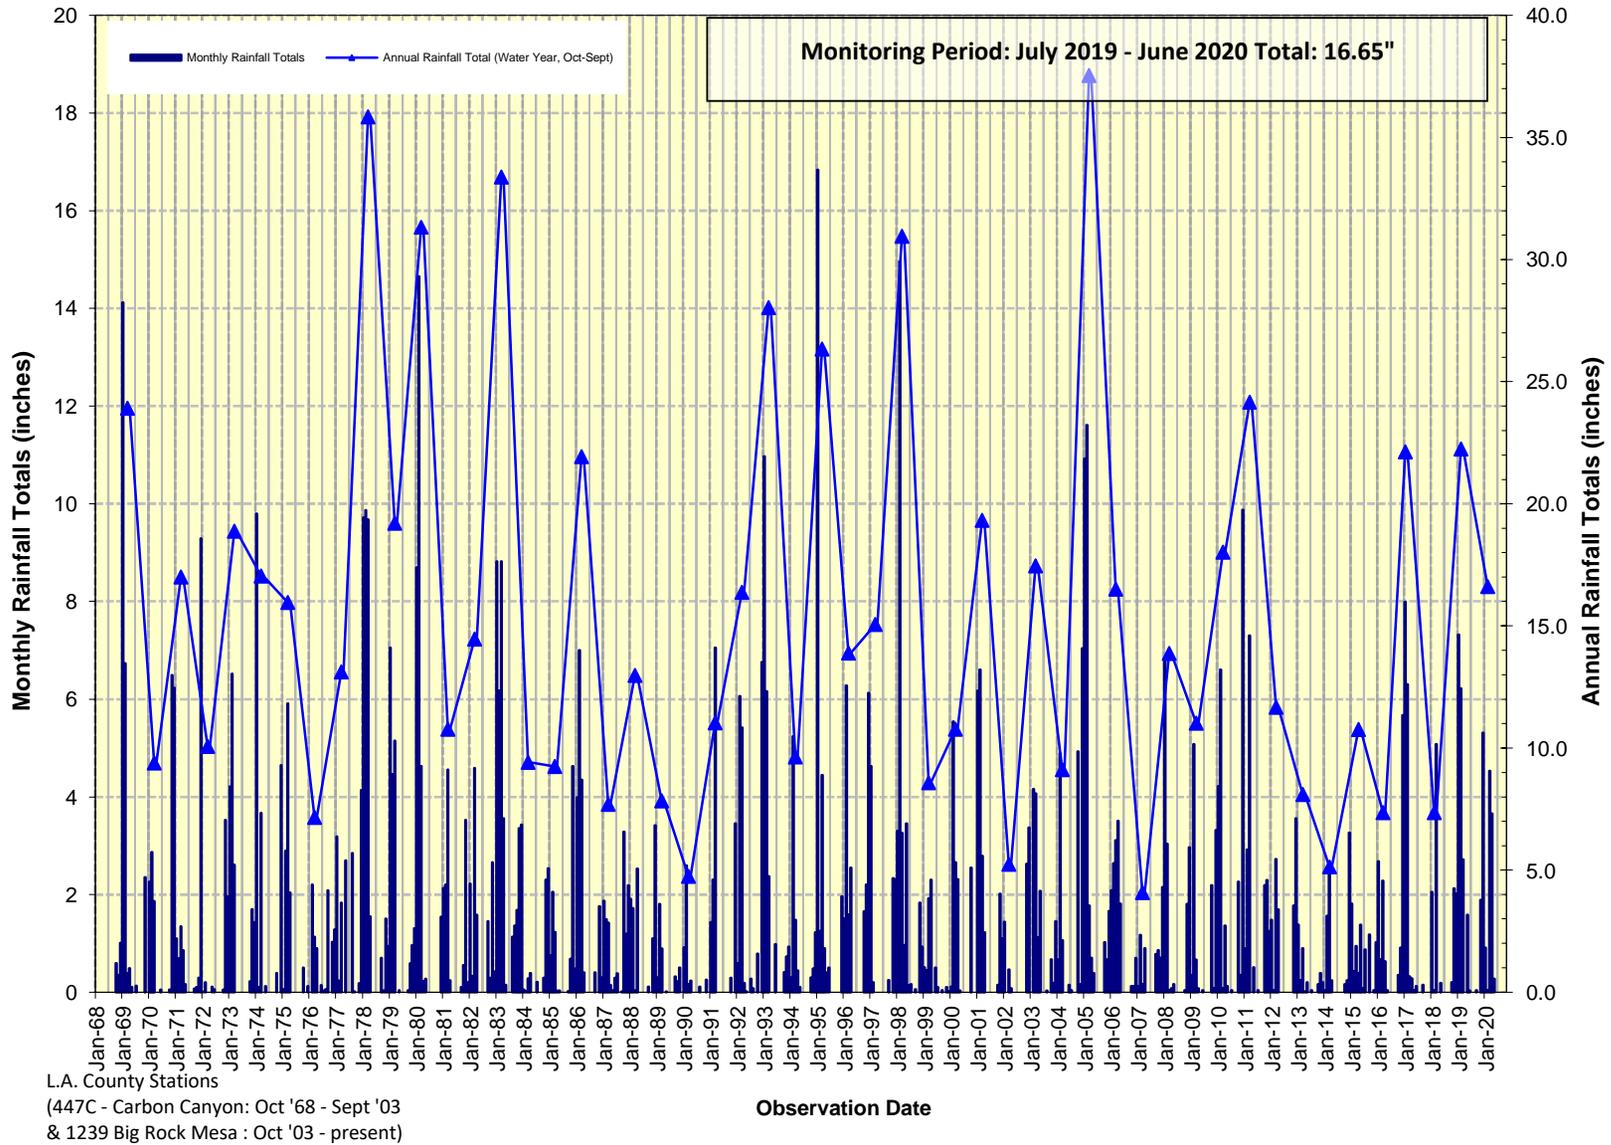
RAINFALL GRAPH
 Calle del Barco Landslide Assessment District
 Malibu, California

A graph of historical monthly rainfall and average annual rainfall from October 1968 through June 30, 2020, is shown on Plate 3 - Rainfall Graph. Monthly rainfall totals from 1968 through 2004 were obtained from County of Los Angeles Department of Public Works (LADPW) Carbon Canyon Rain Station 447C and monthly rainfall totals from 2004 to the present were obtained from LADPW Big Rock Mesa Rain Gauge 1239.

Rainfall data indicate that approximately 16.65 inches of precipitation fell during the monitoring period from July 1, 2019, through June 30, 2020. This approximation is derived from rainfall data that is annually monitored between October 1 through September 30. This year's precipitation is approximately 107 percent of the average annual rainfall from 1968 to 2020 in the "Malibu Area" of approximately 15.57 inches.

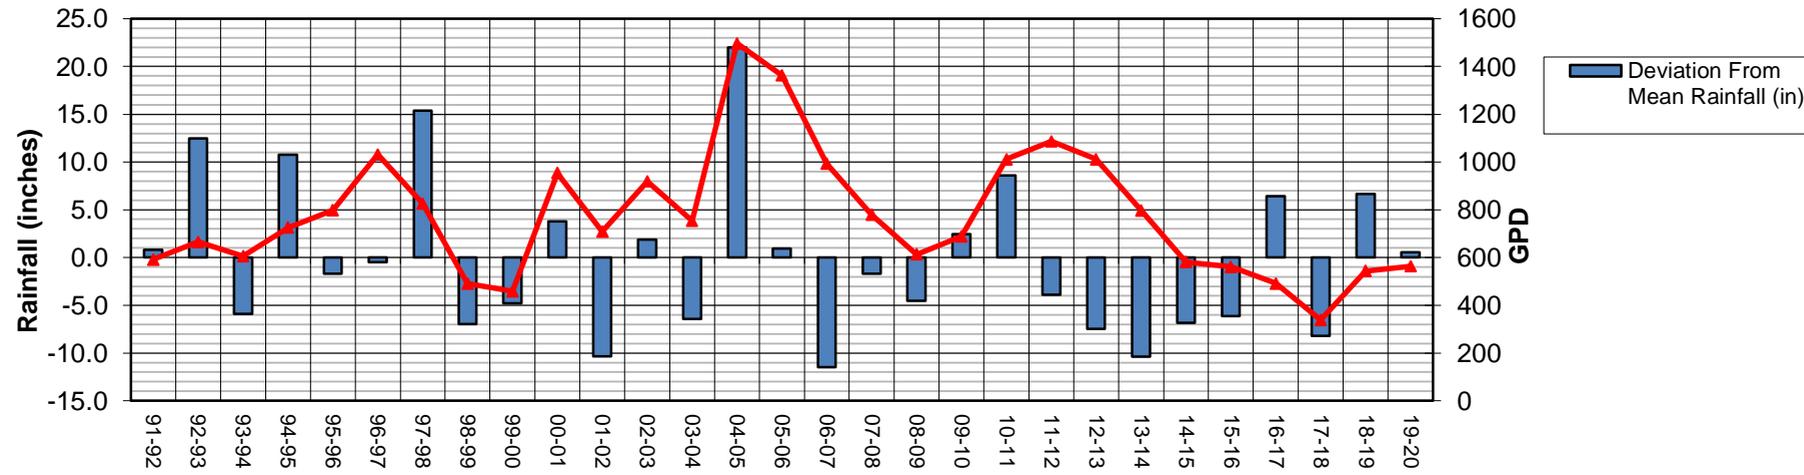
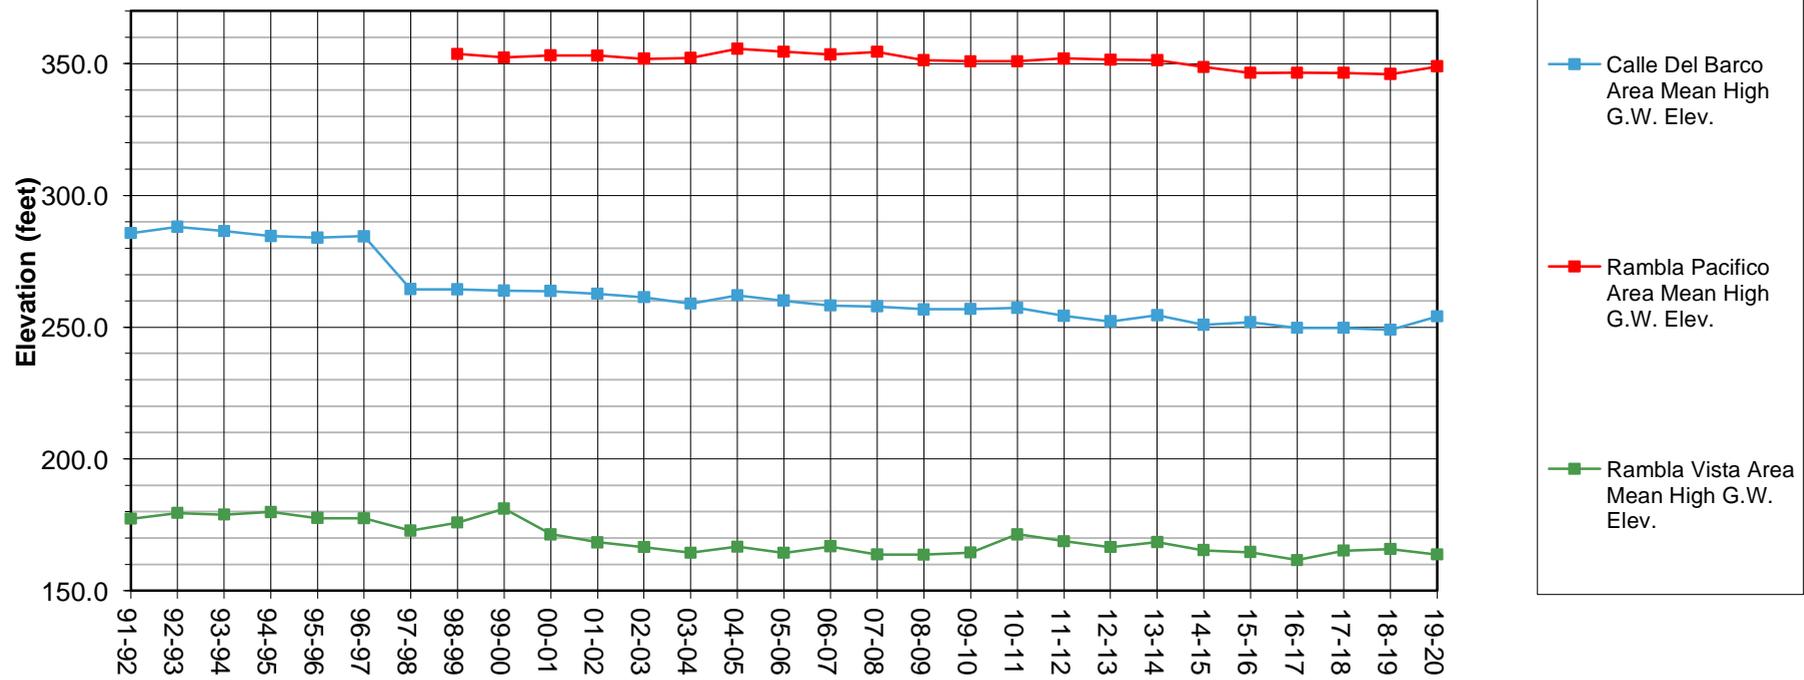
GROUNDWATER LEVELS, DEWATERING AND RAINFALL
 Calle del Barco Landslide Assessment District
 Malibu, California

Plate 5 – Groundwater Levels, Dewatering, and Rainfall shows the yearly magnitude of deviation of each years' rainfall relative to the mean annual rainfall. The graphic also shows the average annual dewatering output in gallons per day (gpd). The data illustrate that the average annual dewatering output is generally consistent with average rainfall.

* Graph shows the average of the highest groundwater elevations recorded in each well/piezometer during the monitoring period.

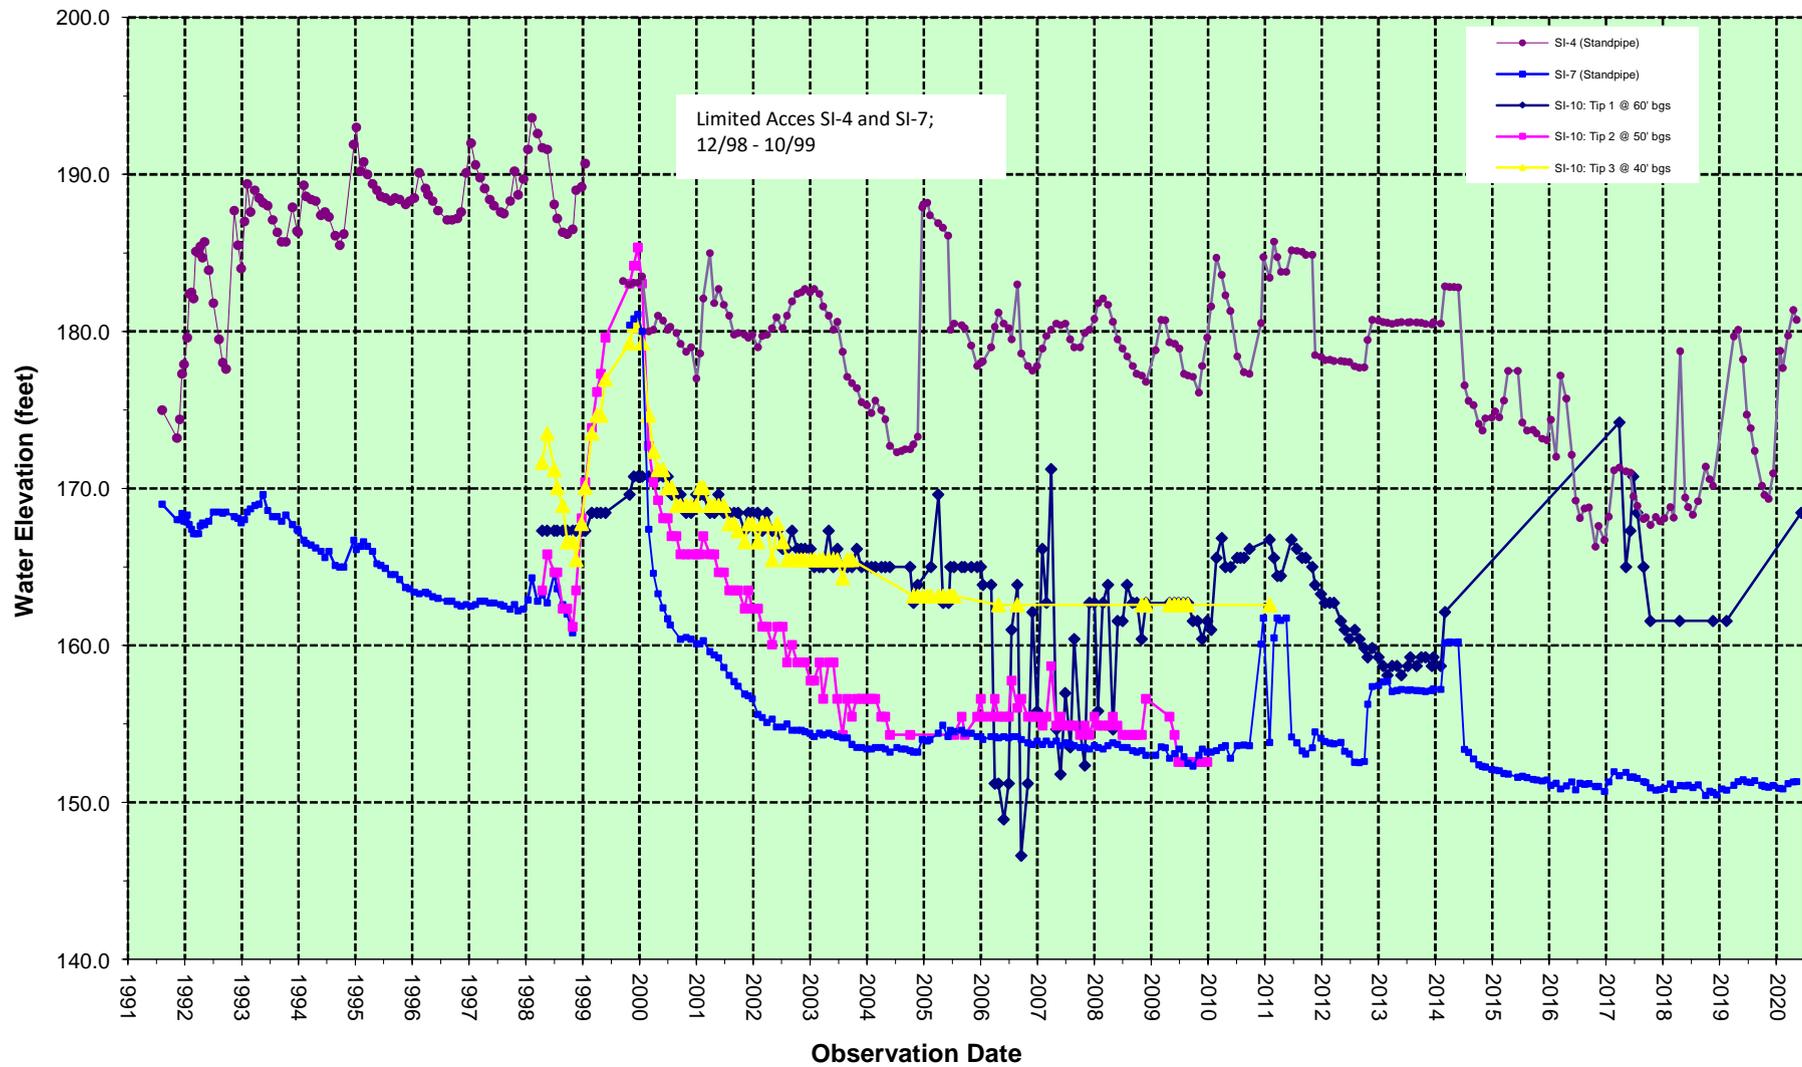
GROUNDWATER HYDROGRAPH
Rambla Vista
Calle del Barco Landslide Assessment District
Malibu, California

Rambla Vista. Groundwater elevation data for the Rambla Vista Area are presented in Plate A-3. Groundwater levels for this area are monitored using standpipes SI-4 and SI-7 and the pneumatic piezometers attached to Inclinometer SI-10. In general, groundwater elevations in the Rambla Vista Area increased slightly during the 2019 - 2020 monitoring period. The calculated area average water-level increased by 1.0 foot in comparison to the area average for the 2018 - 2019 monitoring year and is 4.2 feet below the mean area average for this area for the period of record (1991 - 2020).

Groundwater elevations in SI-7 remained relatively static, varying by less than 0.5 foot during the 2019-2020 monitoring year.
