Annual Report July 2019 Through June 2020 Malibu Road Landslide Assessment District Malibu, California

August 2020
Fugro Project No. 04.62160604
Document No. 04.62160604-PR-004(Rev.00)

City of Malibu

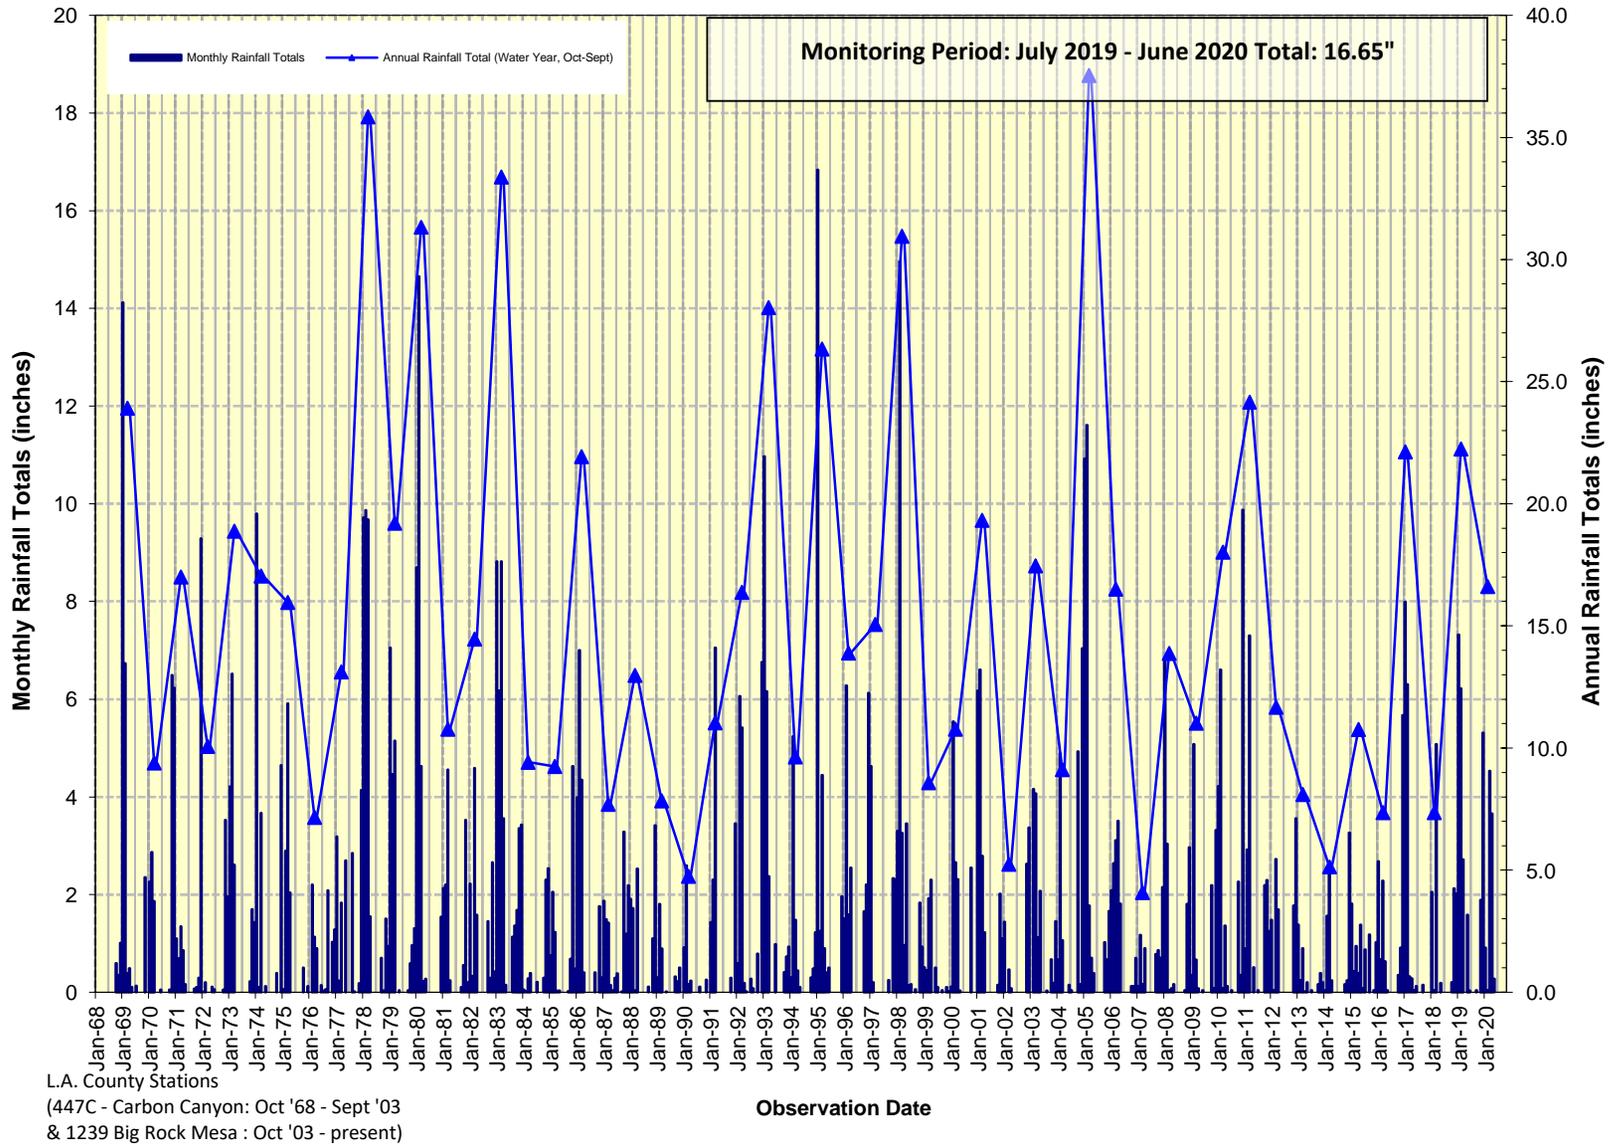
RAINFALL GRAPH
 Malibu Road Landslide Assessment District
 Malibu, California

A graph of historical monthly rainfall and average annual rainfall from October 1968 through June 30, 2020 is shown on Plate 3 - Rainfall Graph. Monthly rainfall totals from 1968 through 2004 were obtained from County of Los Angeles Department of Public Works (LADPW) Carbon Canyon Rain Station 447C and monthly rainfall totals from 2004 to the present were obtained from LADPW Big Rock Mesa Rain Gauge 1239.

Rainfall data indicate that approximately 16.61 inches of precipitation fell during the monitoring period from July 1, 2019, through June 30, 2020. This approximation is derived from rainfall data that is annually monitored between October 1 through September 30. This year's precipitation is approximately 107 percent of the average annual rainfall from 1968 to 2020 in the "Malibu Area" of approximately 15.57 inches.

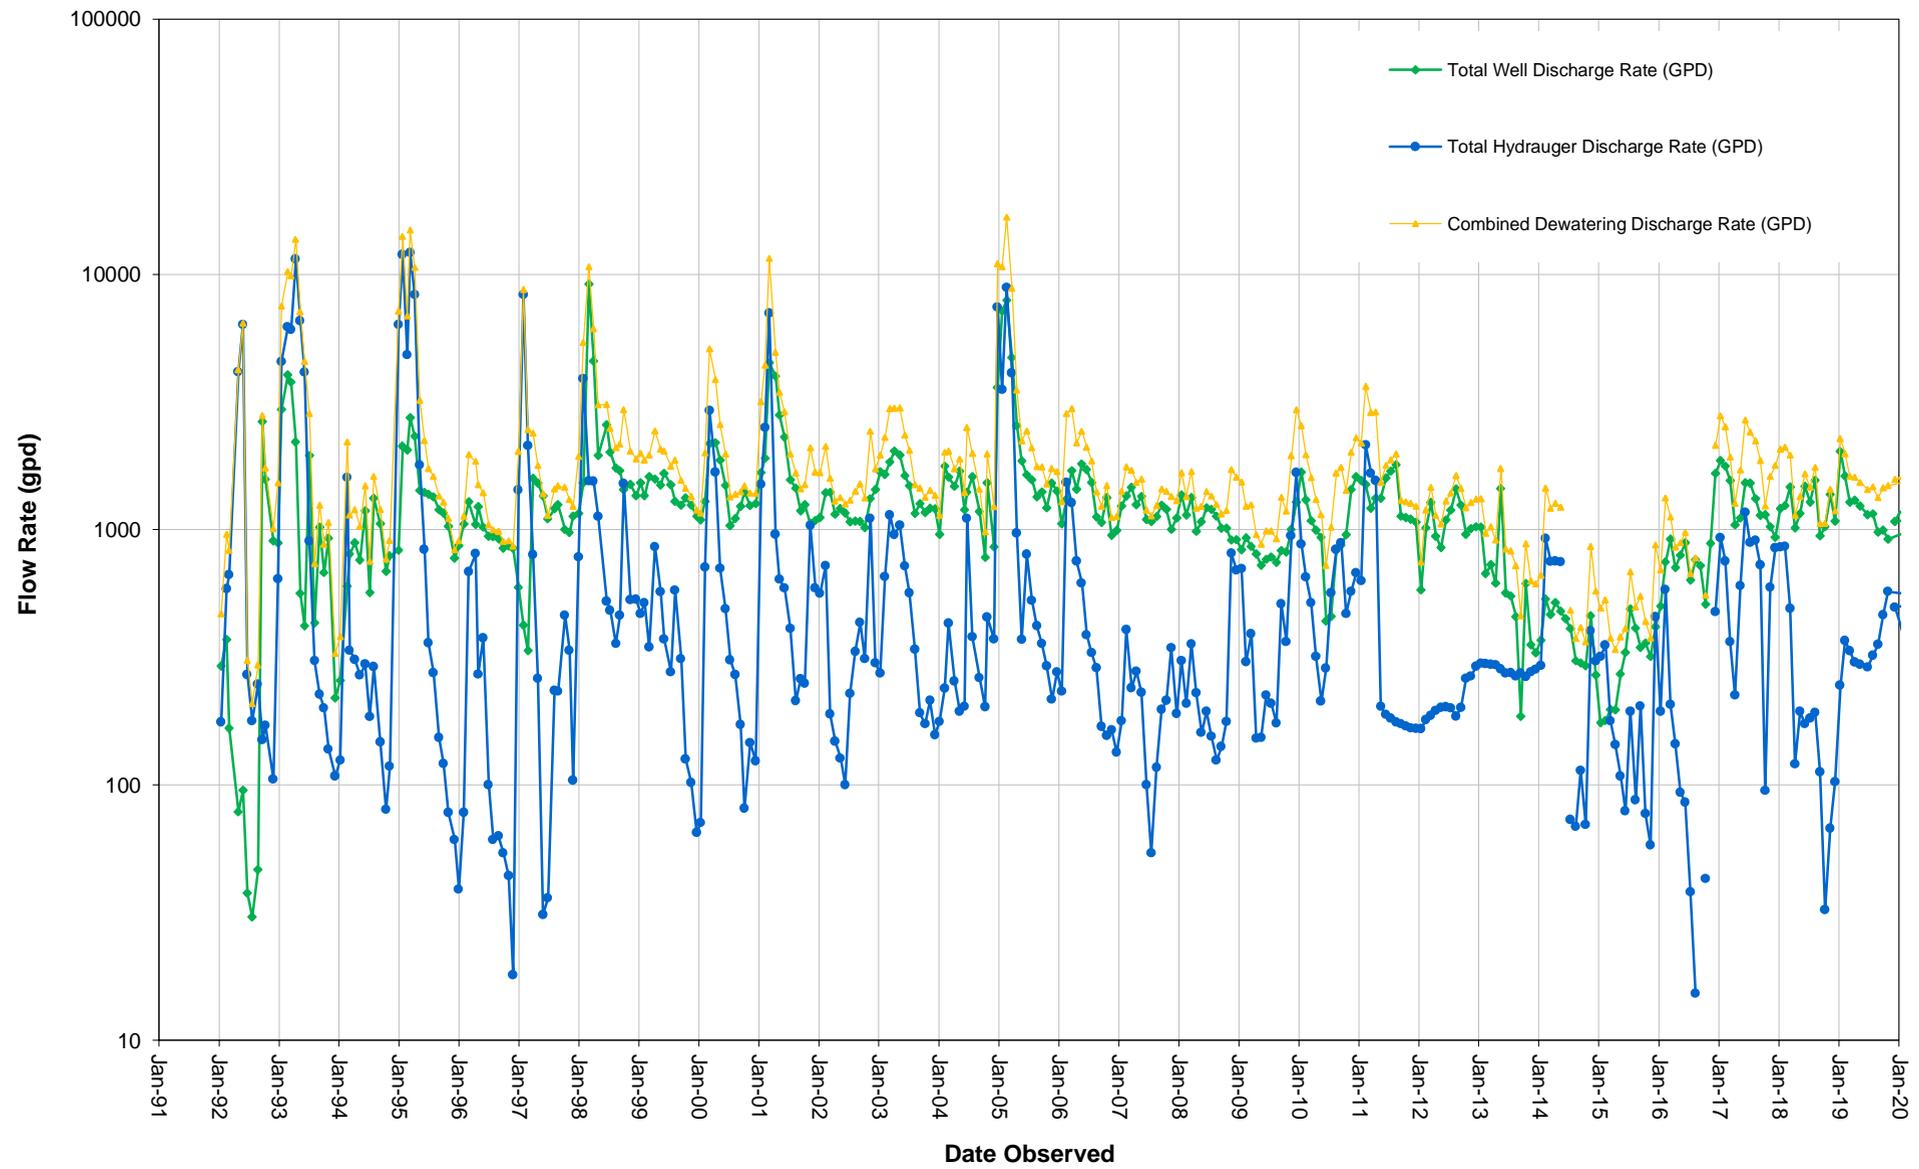
TOTAL DISCHARGE - WELLS AND HYDRAUGERS
Malibu Road Landslide Assessment District
Malibu, California

A combined graph of the total dewatering rate for the monitored dewatering wells and hydraugers is presented on Plate 4. Total dewatering production data for the measured hydraugers and wells indicates that the average total dewatering rate during the monitoring period was approximately 1555 gpd. This rate stays consistent with the previous monitoring period's average rate of 1553 gpd.

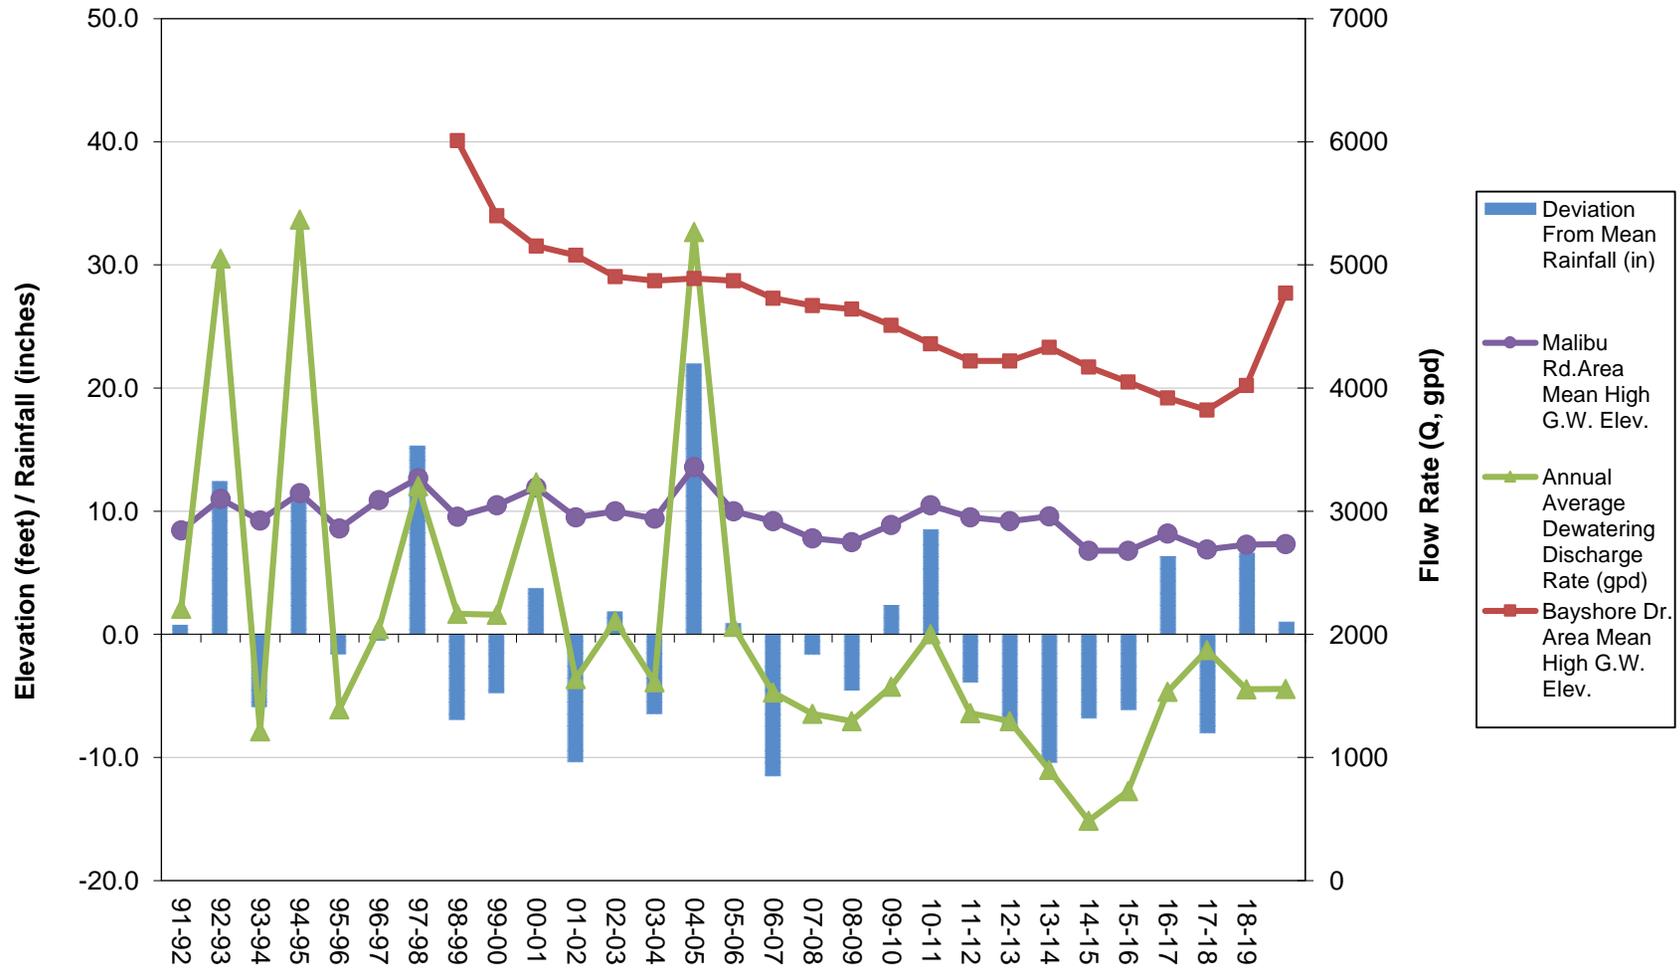
GROUNDWATER LEVELS, DEWATERING, AND RAINFALL
 Malibu Road Landslide Assessment District
 Malibu, California

Plate 5 – Groundwater Levels, Dewatering, and Rainfall shows the yearly magnitude of deviation of each year's rainfall relative to the mean annual rainfall. The graphic also shows the average annual dewatering output in gallons per day (gpd). The data illustrates that the average annual dewatering output is generally consistent with average rainfall.

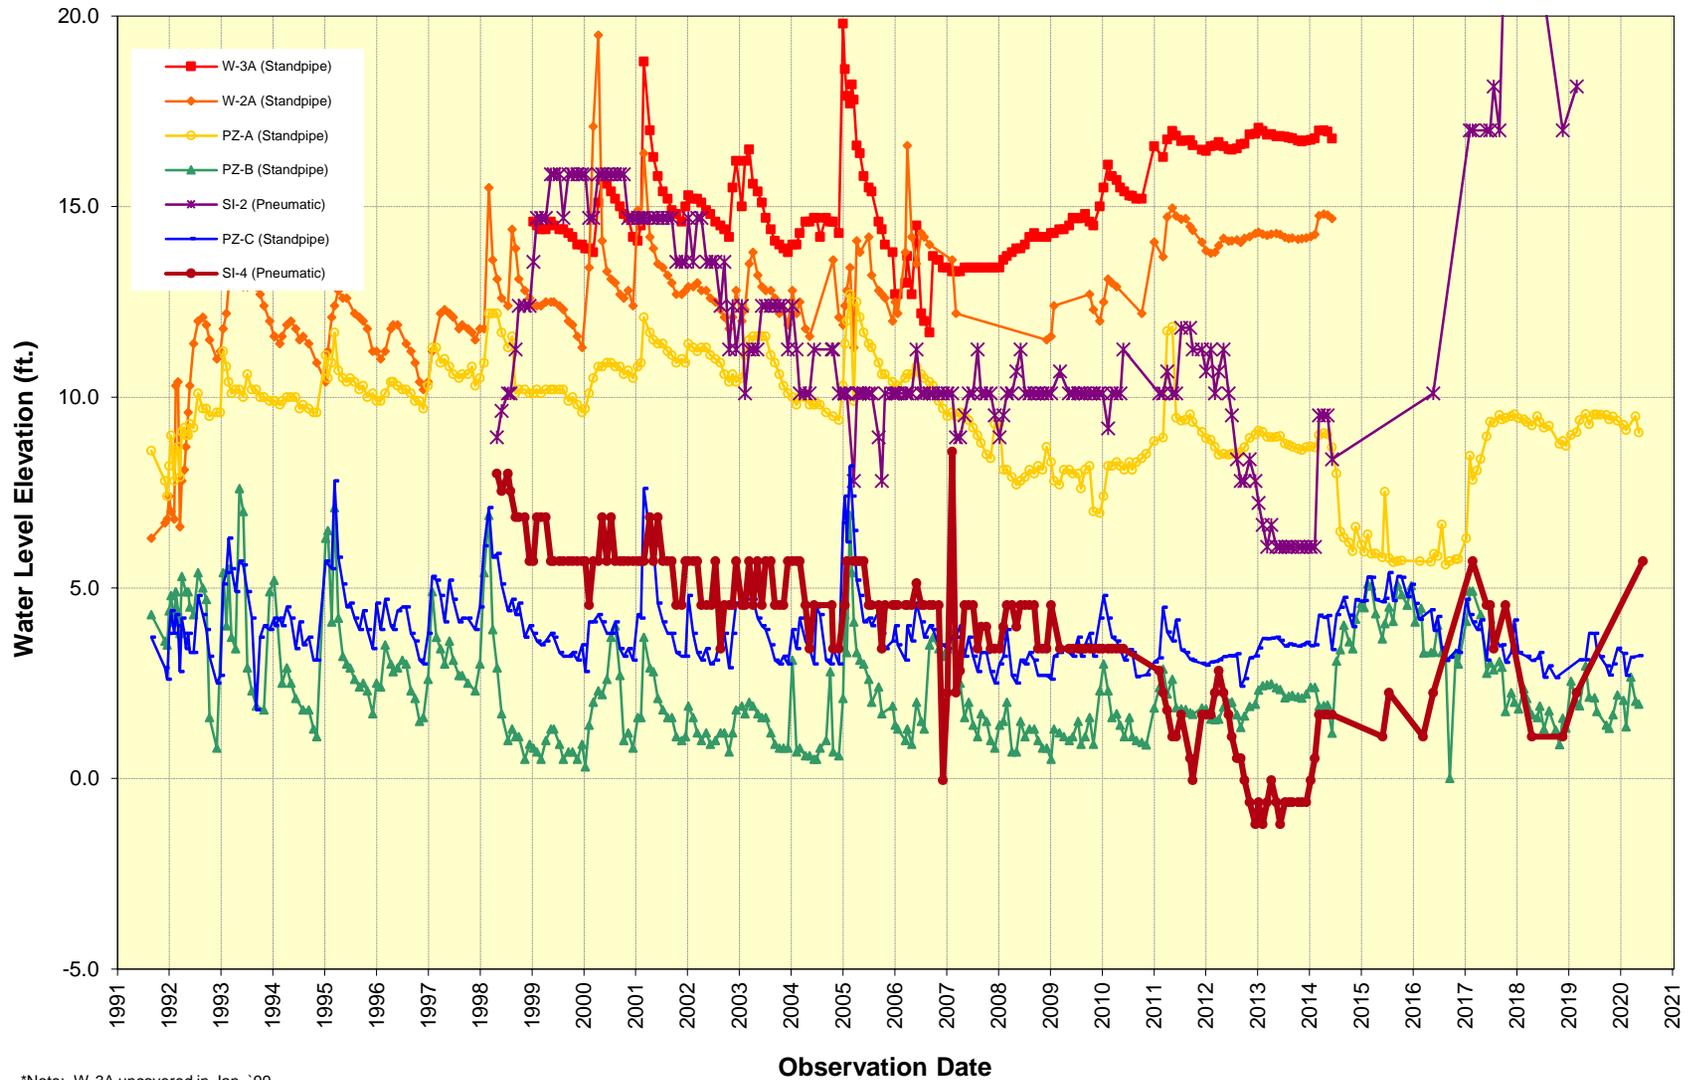
GROUNDWATER HYDROGRAPH
 Malibu Road (West End)
 Malibu Road Landslide Assessment District
 Malibu, California

Malibu Road. Groundwater elevation data for the area along Malibu Road are presented on Plates A-3 and A-4. Groundwater levels for that area are monitored using standpipes PZ-A, -B, -C, -D, -E, W-2A, along with pneumatic piezometers installed in inclinometers SI-1, -1A, -2, -3, and -4. Groundwater levels increased during the 2019 - 2020 monitoring period. The calculated area average water level increased by 0.4 feet when compared to the area average for the 2019 - 2020 monitoring period and is 1.6 feet below the mean area average for this area for the period of record.

No new data are presented for standpipes W-2A or W-3A because W-2A has been dry since July 2014 and W-3A is buried beneath soil creep from the bluff face.

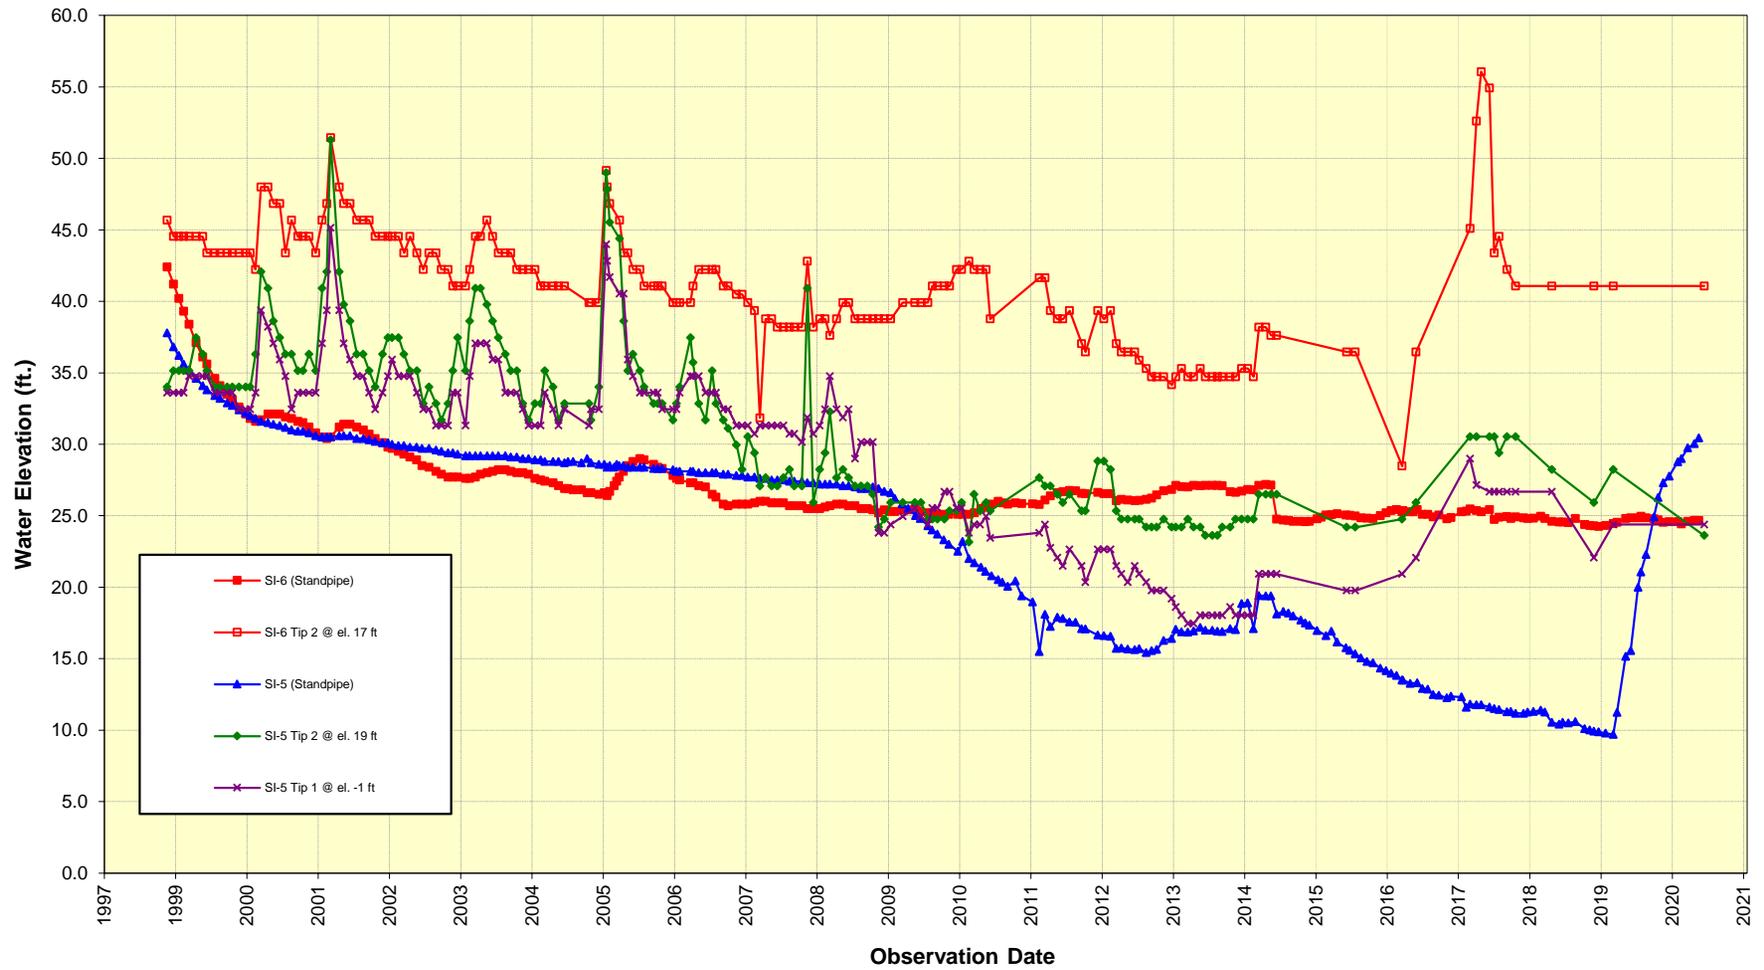
GROUNDWATER HYDROGRAPH
Bayshore Drive
Malibu Road Landslide Assessment District
Malibu, California

Bayshore Drive. Groundwater elevation data for the area along Bayshore Drive are presented on Plate A-5. Groundwater levels for that area are monitored using standpipes SI-5 and SI-6 along with the two pneumatic piezometers installed with each standpipe. In general, groundwater levels increased during the 2019 - 2020 monitoring period. The calculated area average water-level increased by 7.8 feet when compared to the area average for the 2019 - 2020 monitoring year and is 0.4 feet above the mean area average for this area for the period of record (1991 - 2020). Water levels in standpipe SI-5 increased steadily since the onset of the 2019 Q2 monitoring period. Water levels in standpipe SI-6 remained approximately static over the course of the monitoring year, with fluctuations of less than 0.5 feet. Readings from both the shallow and deep pneumatic piezometers in standpipes SI-5 and SI-6 continue to record water elevation above the standpipe water levels.
