FY20/21 Maintenance and Monitoring

AD98-3, Malibu Road

Yeh Project No.: 220-278

Subject: Annual Monitoring and Maintenance Report FY20/21, City of Malibu Assessment District 98-3, Malibu Road, Malibu, CA

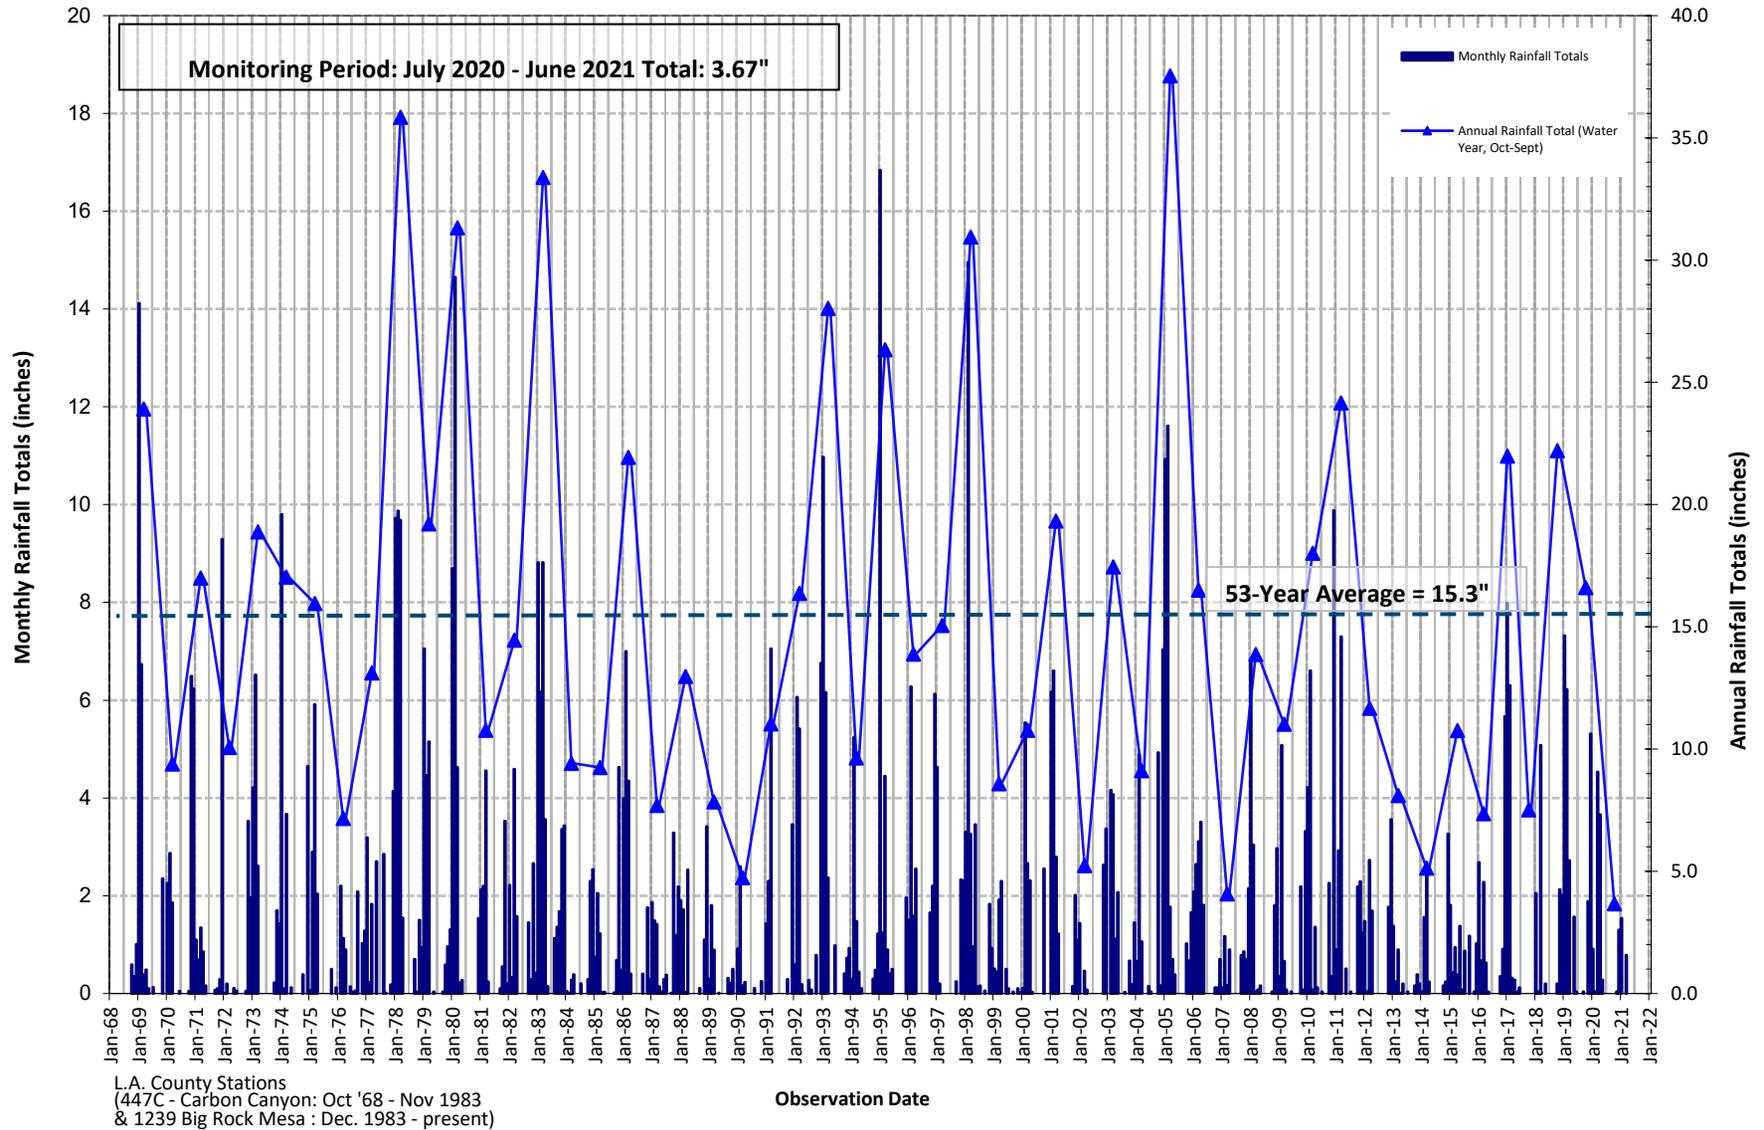
RAINFALL GRAPH
 Landslide Assessment Districts
 Malibu, California

Yeh obtained rainfall data for the 2020-2021 monitoring year from the Big Rock Mesa Rain Gauge #1239 operated by the Los Angeles County Department of Public Works. Plate 3 - Rainfall Graph displays historical monthly and average annual rainfall for the Big Rock Mesa area from October 1968 through June 2021. Prior to 1984, rainfall data was obtained from the Carbon Canyon Rain Gauge #447C and after 1984 from the onsite Big Rock Mesa Rain Gauge #1239. Rainfall for Big Rock Mesa area for the 2020-2021 monitoring year totaled 3.67 inches, which is 11.7 inches below the 53-year area average of 15.3 inches.

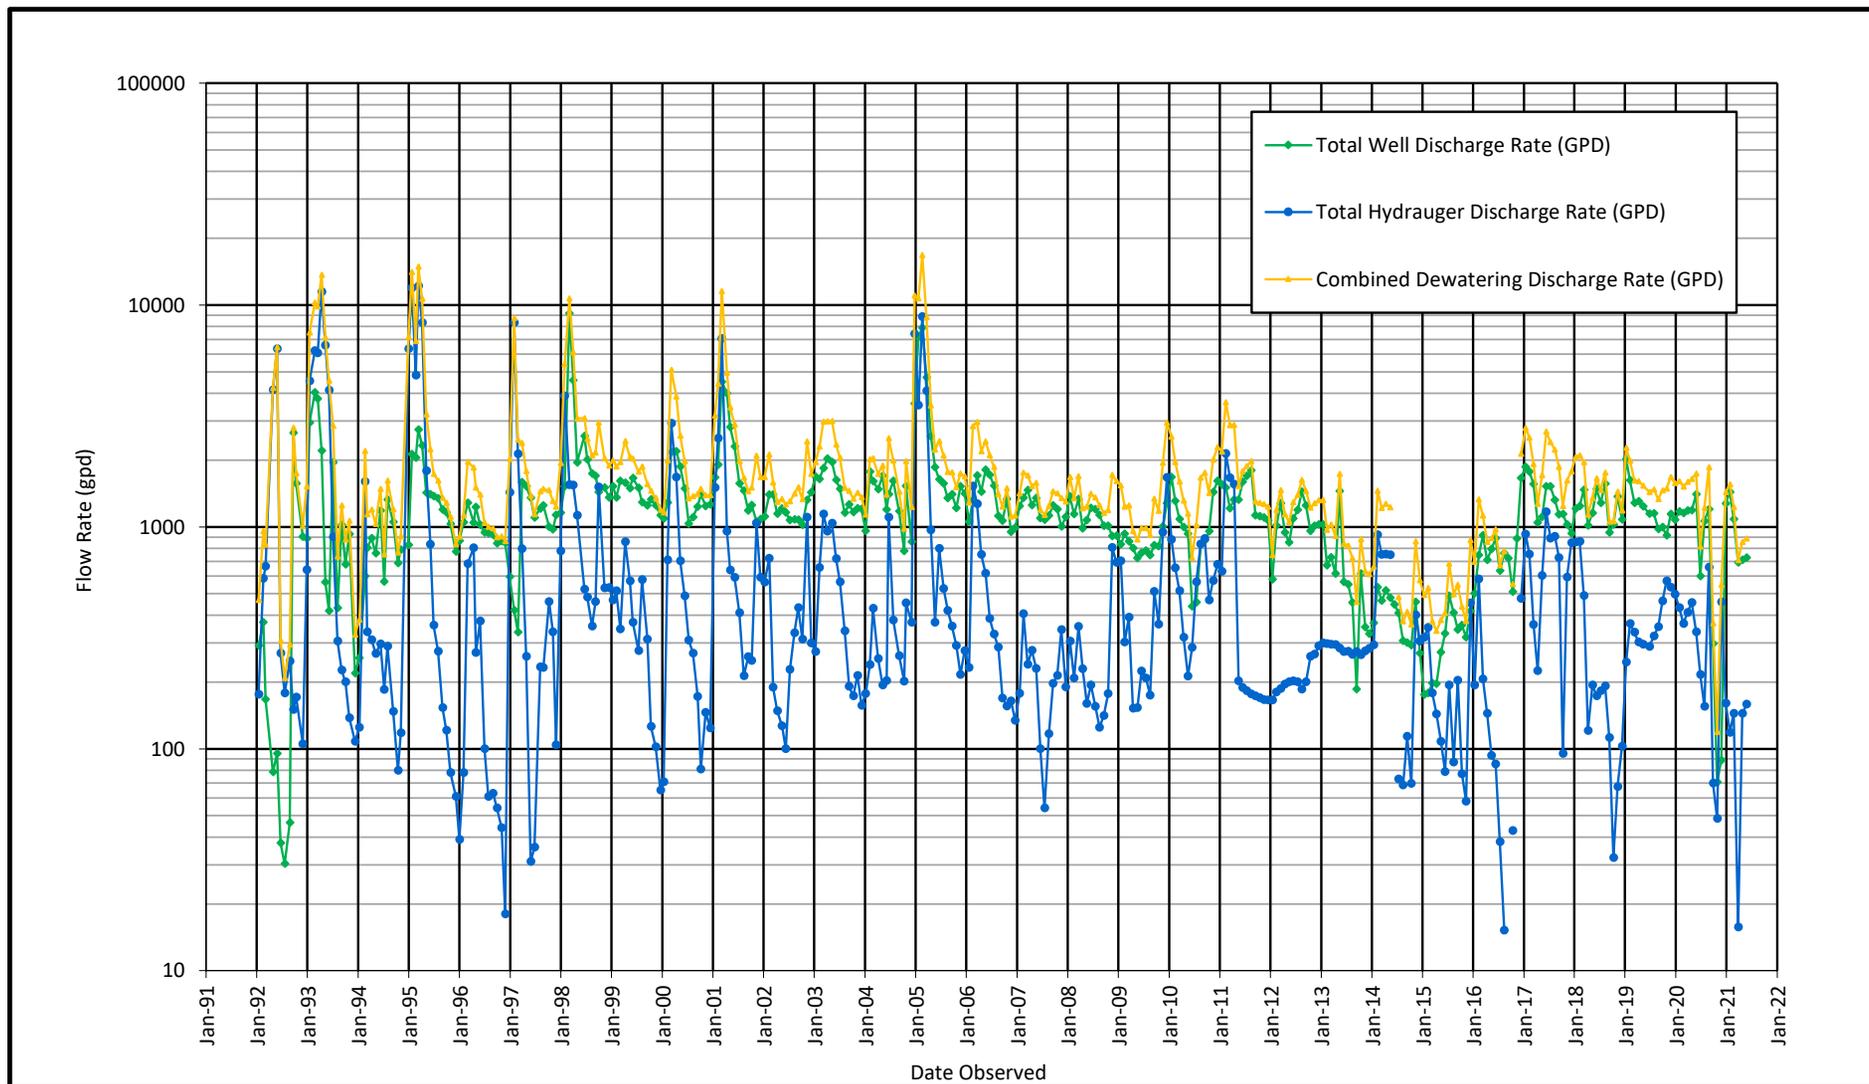
TOTAL DISCHARGE - WELLS AND HYDRAUGERS
Malibu Road Landslide Assessment District
Malibu, California

Yeh tracks dewatering production for actively pumping dewatering wells installed throughout the assessment district and passive horizontal drains (hydraugers) installed in the bluff along Malibu Road. During the 2020-2021 monitoring year total dewatering production from all facilities averaged 966 gpd a decrease of 37% from the previous monitoring years' total average production of 1,545 gpd. These values represented a decrease of 52% less than the historical production average of 2,023 gpd calculated from 1991 to present and 82% less than the maximum average annual production of 5,369 gpd recorded during the 1994-1995 monitoring year.

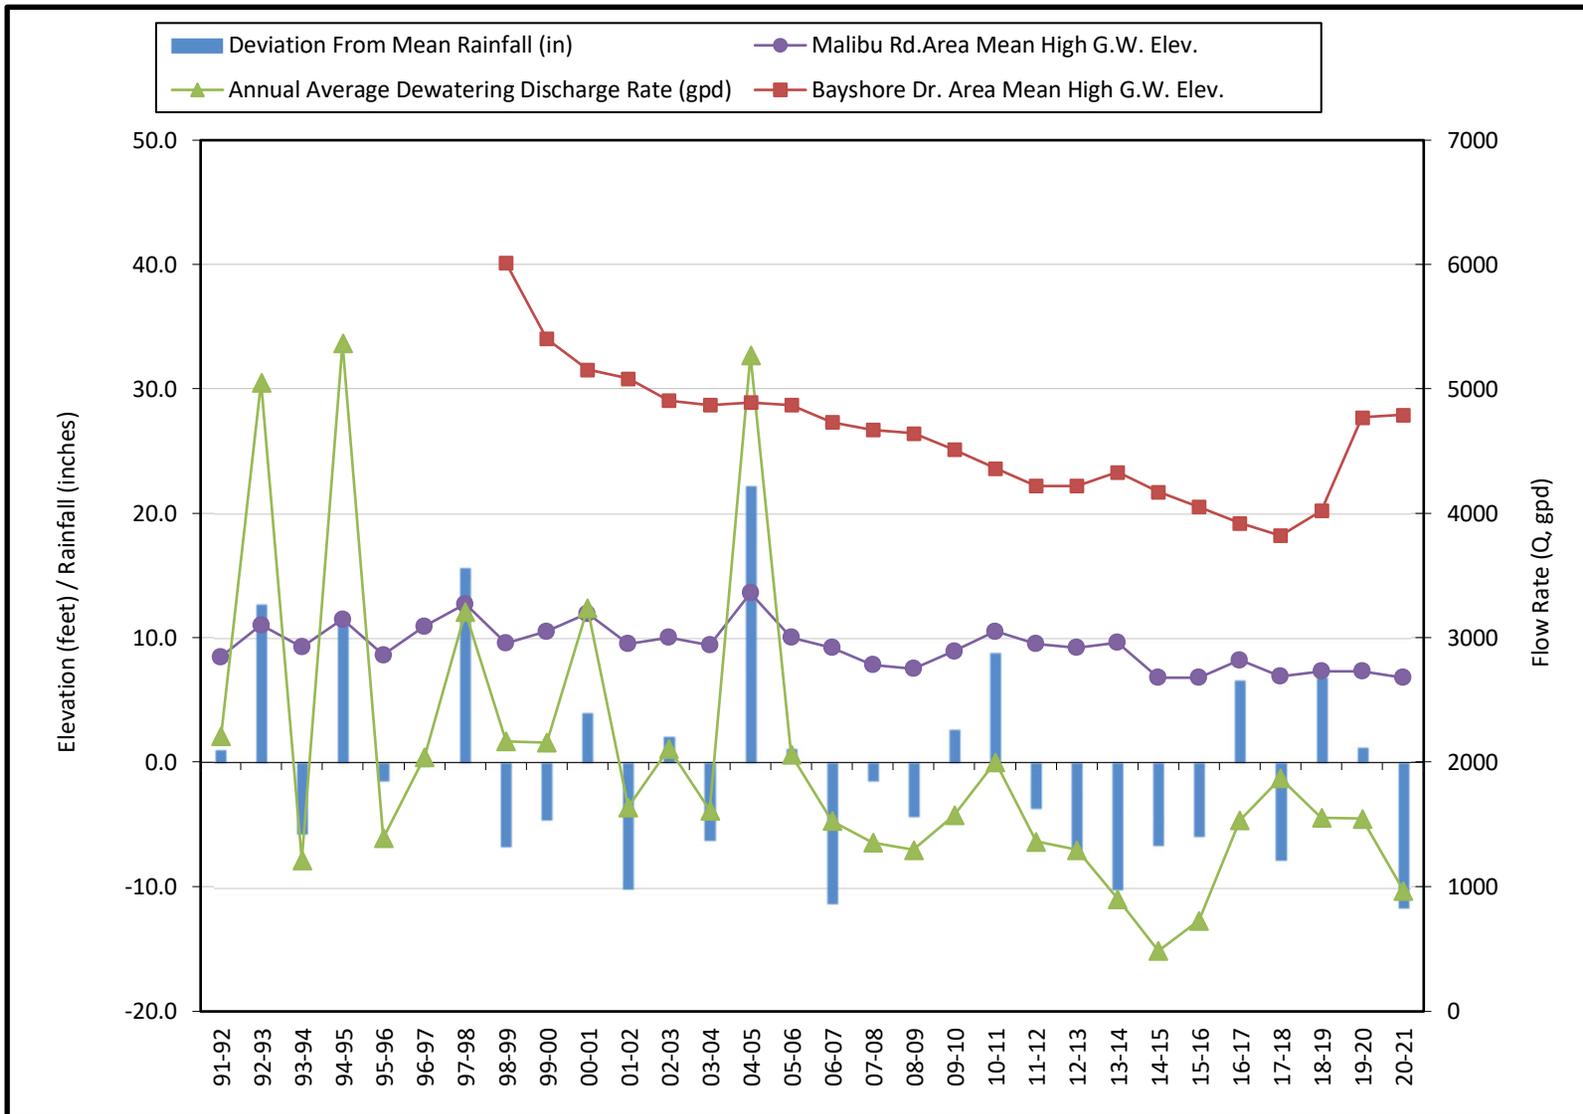
GROUNDWATER LEVELS, DEWATERING, AND RAINFALL
 Malibu Road Landslide Assessment District
 Malibu, California

Plate 5 – Summary of Groundwater Levels, Dewatering, and Rainfall shows annual rainfall deviation from the 53-year mean and compares rainfall changes to total dewatering output. Dewatering production typically reacts to rainfall totals. During the 2020-2021 monitoring year, total dewatering production decreased in response to well below average rainfall.

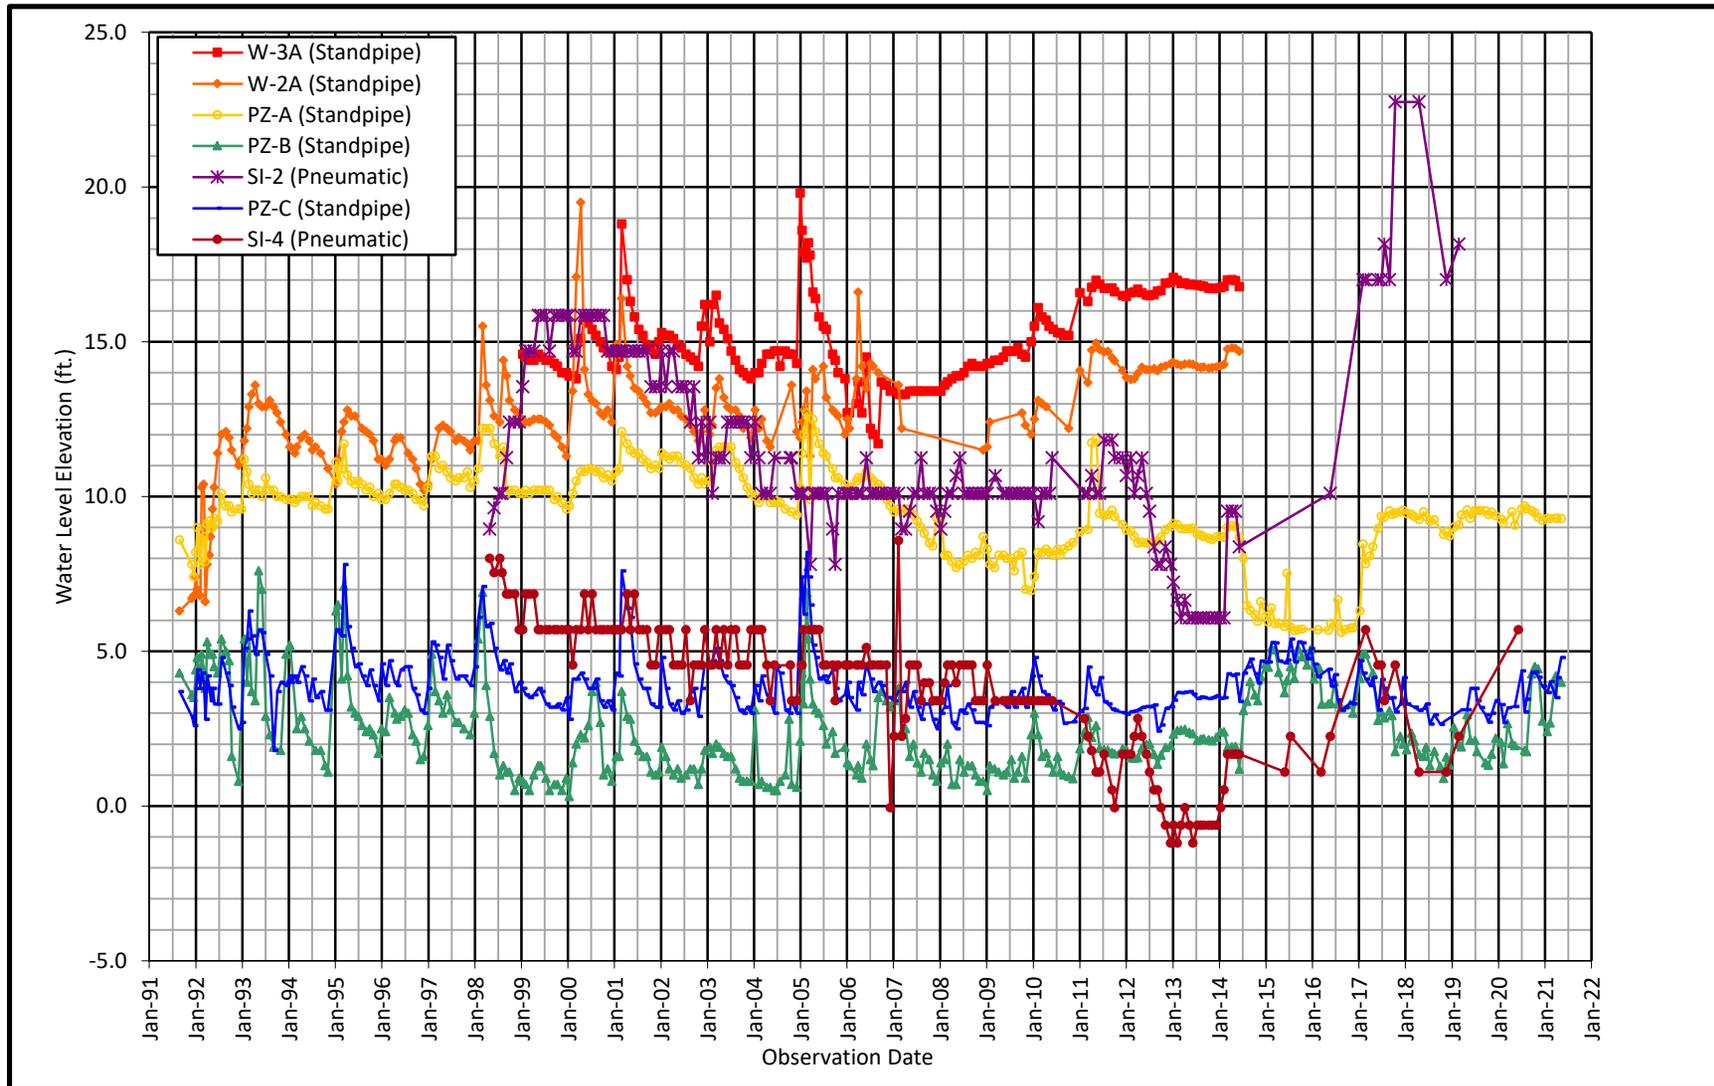
GROUNDWATER HYDROGRAPH
 Malibu Road (West End)
 Malibu Road Landslide Assessment District
 Malibu, California

Five standpipes are in use for groundwater level monitoring in the Malibu Road area. The average groundwater level for the Malibu Road area remained relatively unchanged relative to the prior monitoring year, increasing by 0.2 feet. Groundwater levels measured within individual standpipes maintained consistent levels with some variations in response to rainfall and tidal influence.

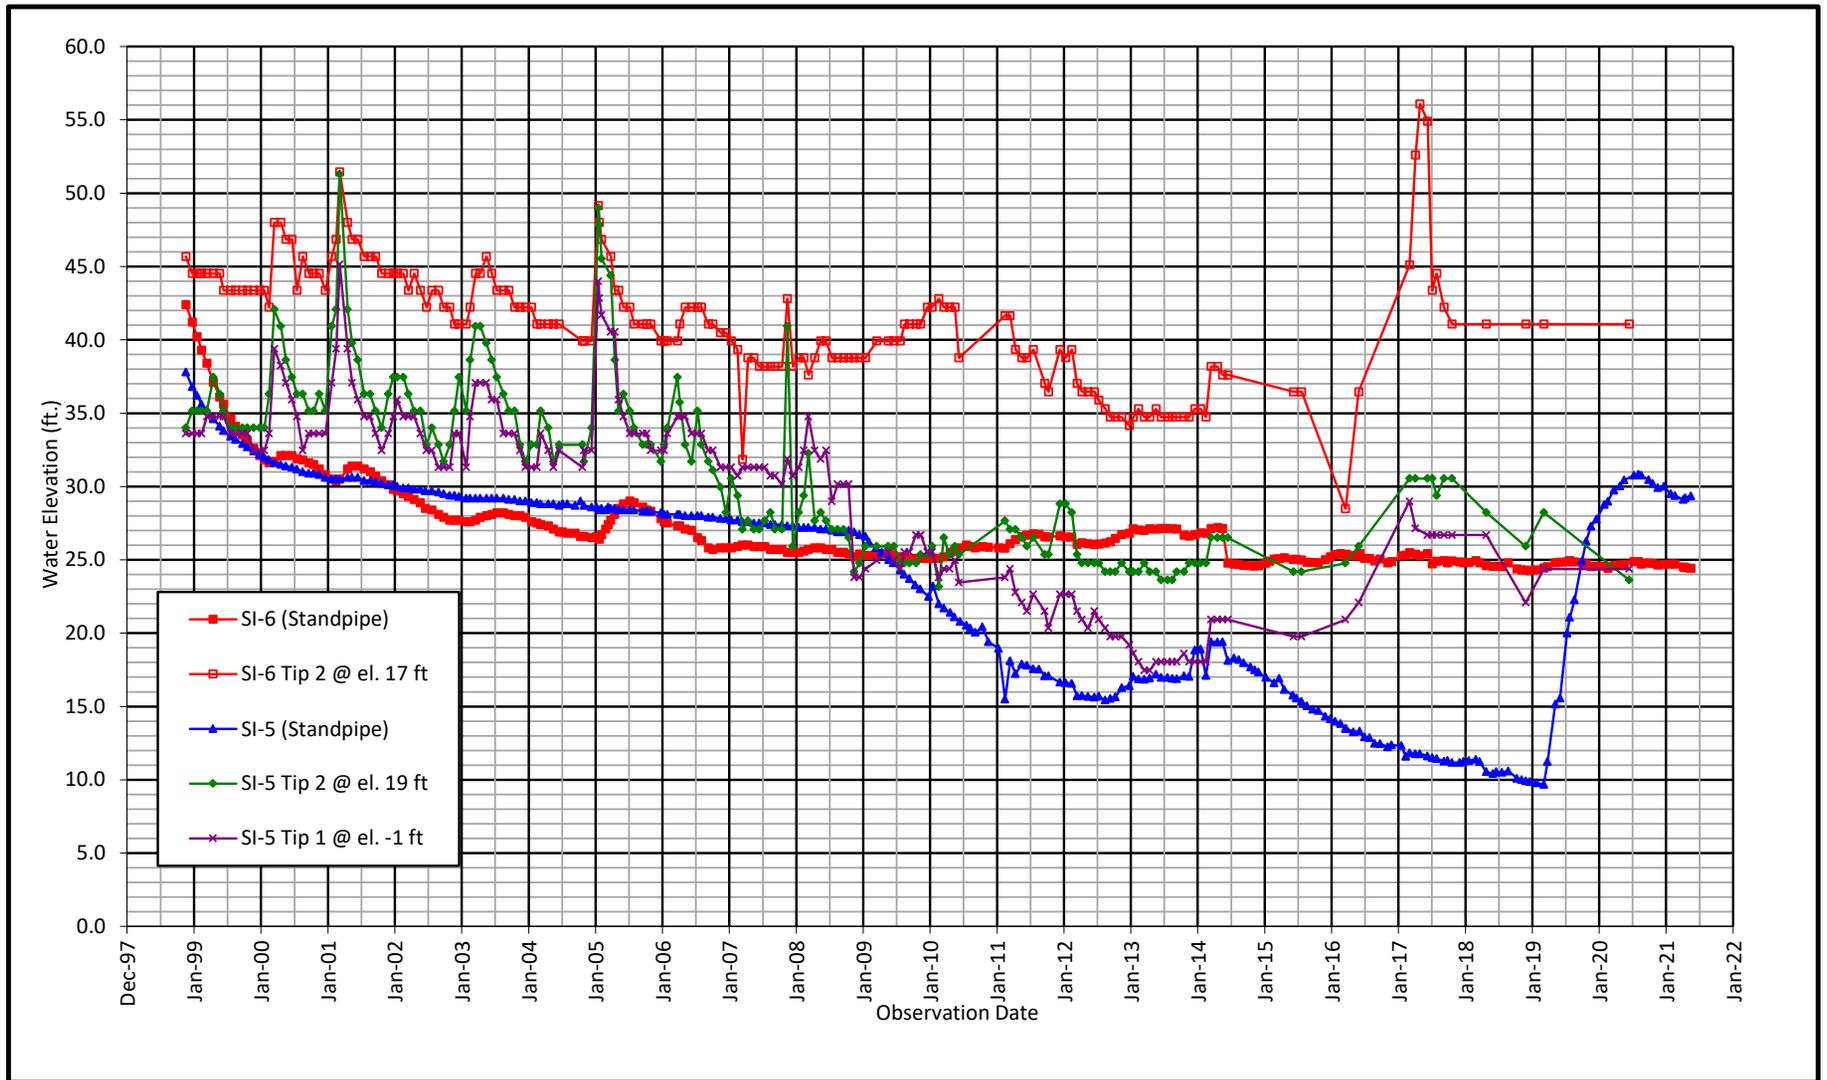
GROUNDWATER HYDROGRAPH
Bayshore Drive
Malibu Road Landslide Assessment District
Malibu, California

Two standpipes are in use for groundwater level monitoring in the Bayshore Drive Area. The average groundwater level for the Bayshore Drive Area increased by 1.7 feet since the prior monitoring year. The increase reflects a water level change in SI-5 which had shown an increasing trend since March 2019 and throughout the prior monitoring year. During the FY20/21 monitoring year, the water level in SI-5 decreased by 1.4 feet with a decreasing trend since July 2020. Water levels in SI-6 remained relatively unchanged.
