FY21/22 Maintenance and Monitoring

AD98-2, Calle del Barco

City of Malibu, California

Subject: Annual Monitoring and Maintenance Report FY21/22, City of Malibu Assessment District 98-2, Calle del Barco, Malibu, CA

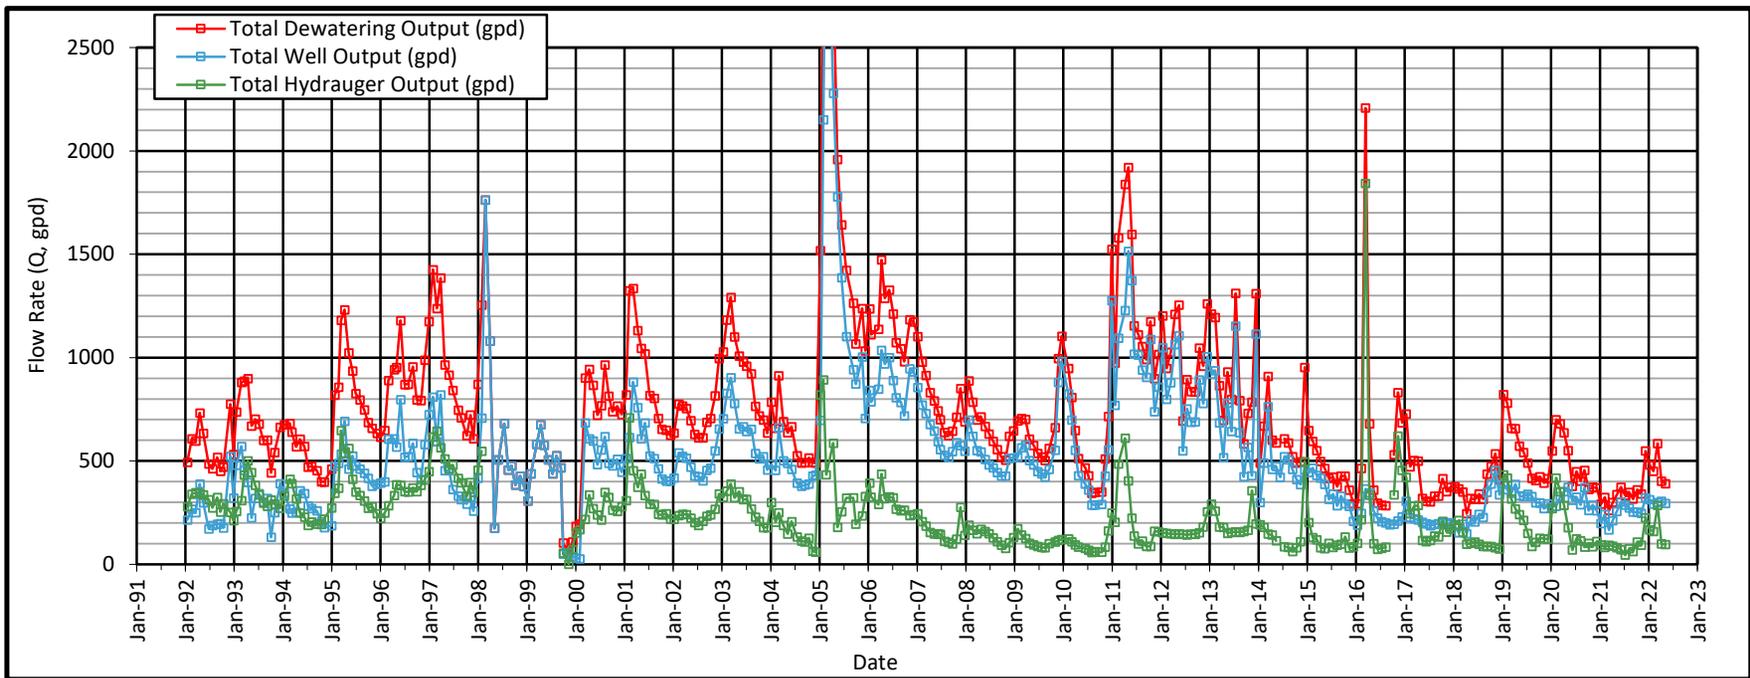
TOTAL DISCHARGE - WELLS AND HYDRAUGERS
 Calle del Barco Landslide Assessment District
 Malibu, California

During the 2021-2022 monitoring year, the average total well production was 287 gpd which is 8% higher than last year's average production of 265 gpd and 45% less than the historical production average of 522 gpd calculated from 1992 to present. These values are 76% less than the maximum annual average production of 1,182 gpd recorded during the 2004-2005 monitoring year.

Well production typically varies in response to rainfall totals. The dewatering well production decrease over this monitoring year is consistent with the historically low rainfall totals and extended drought conditions at the project.

During the 2021-2022 monitoring year, the average monthly hydrauger production was 124 gpd which is approximately 32% more than last year's average monthly production of 94 gpd and 45% less than the historical average production calculated from 1992 to present of 225 gpd. These values are 73% less than the maximum average annual production of 455 gpd recorded during the 1996-1997 monitoring year.

Hydrauger production typically varies in response to rainfall totals. The increase in average hydrauger production over this monitoring year from the previous monitoring year is primarily due to an increase in production at HD-13 following the December rainfall events. The

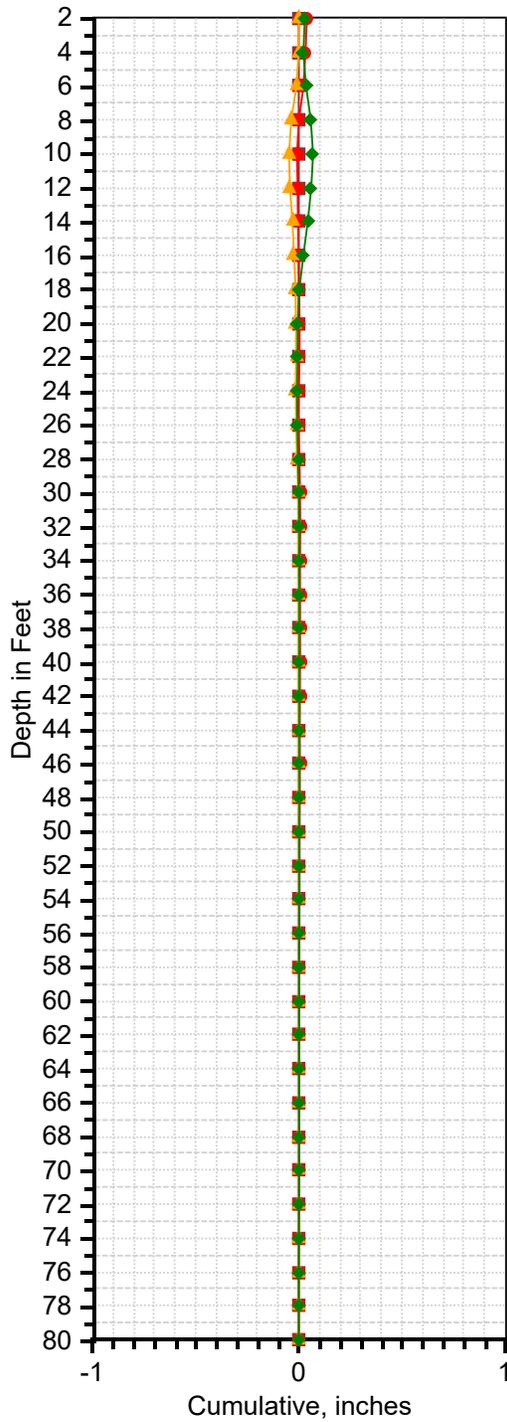
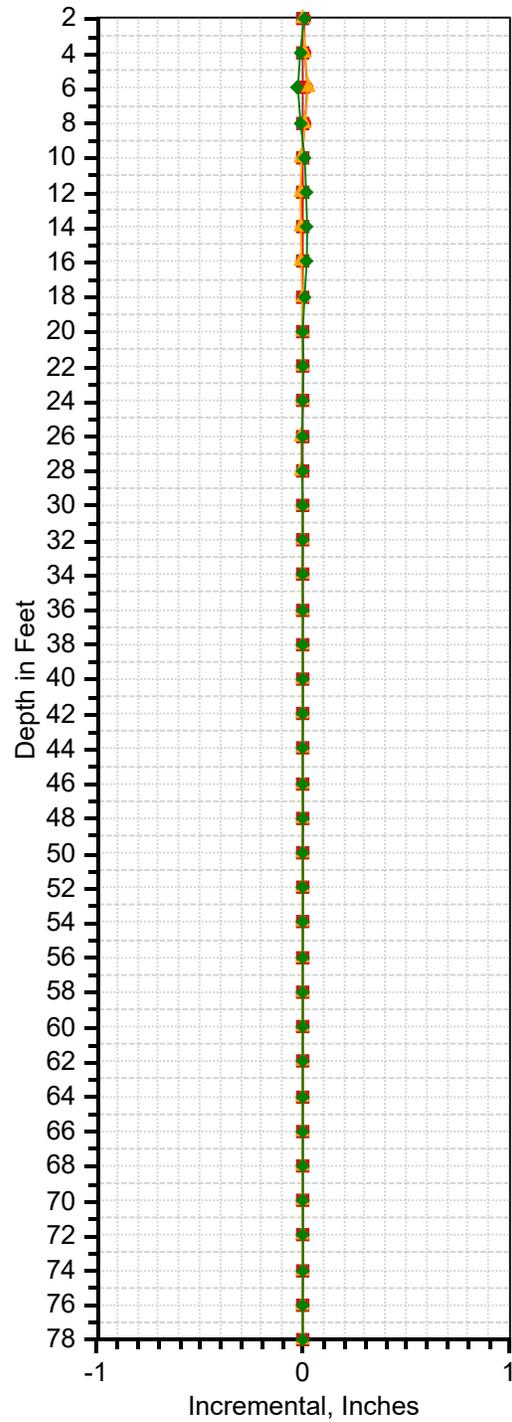
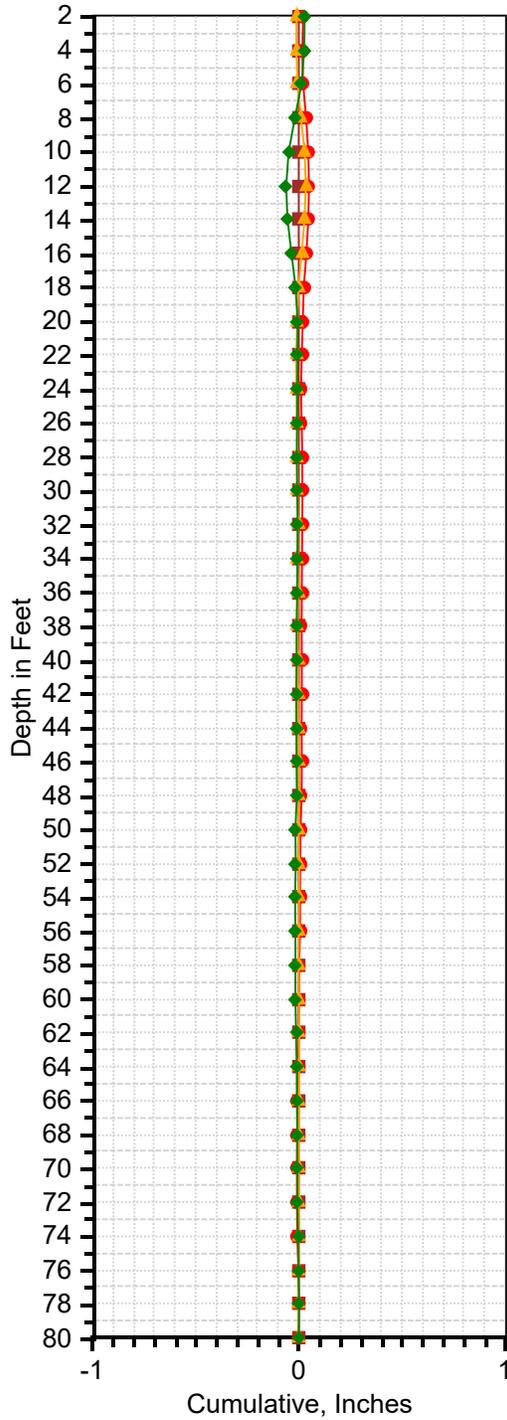
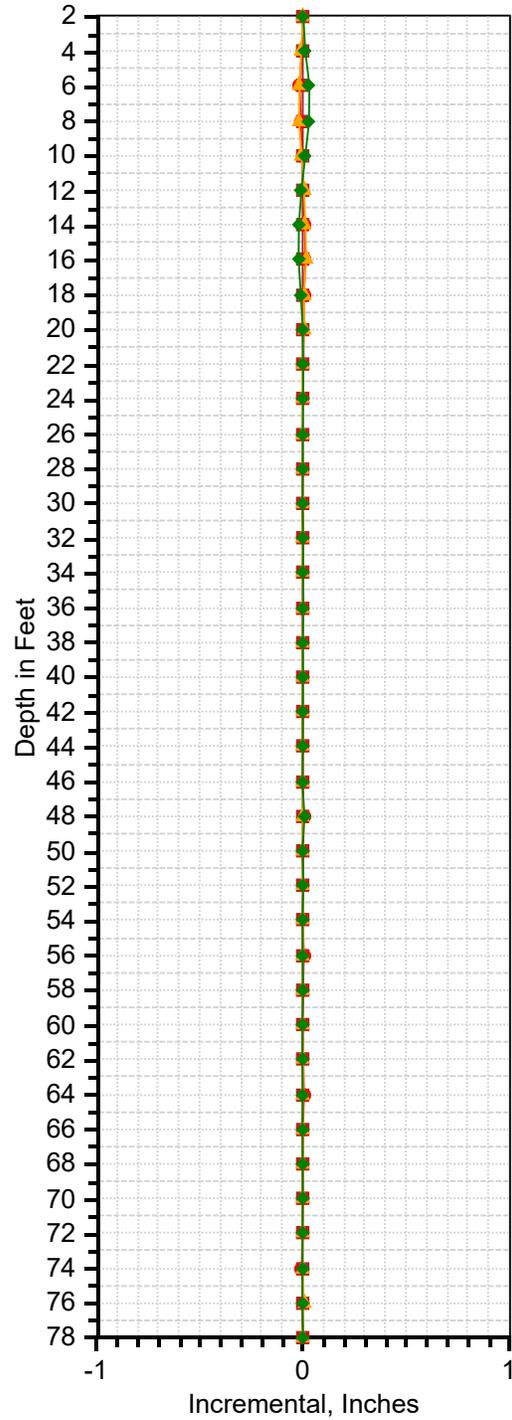
SI-13 A Direction

There are two inclinometers currently surveyed in the Rambla Pacifico Region; SI-13 and SI-14. Neither of the inclinometers displayed discernable shear-type displacement. SI-13 displayed up to about 0.08 inches of apparent deformation above a depth of 20 feet. This is consistent with previously noted “bowing” in the upper portion of the casing, which could be caused by backfill settlement. This type of casing deformation had been detected on SI-13 since installation in 1998. Additional survey methods would be required to exclude or identify a specific cause of the apparent deformation.
