FY21/22 Maintenance and Monitoring

AD98-3, Malibu Road

City of Malibu, California

Subject: Annual Monitoring and Maintenance Report FY21/22, City of Malibu Assessment District 98-3, Malibu Road, Malibu, CA

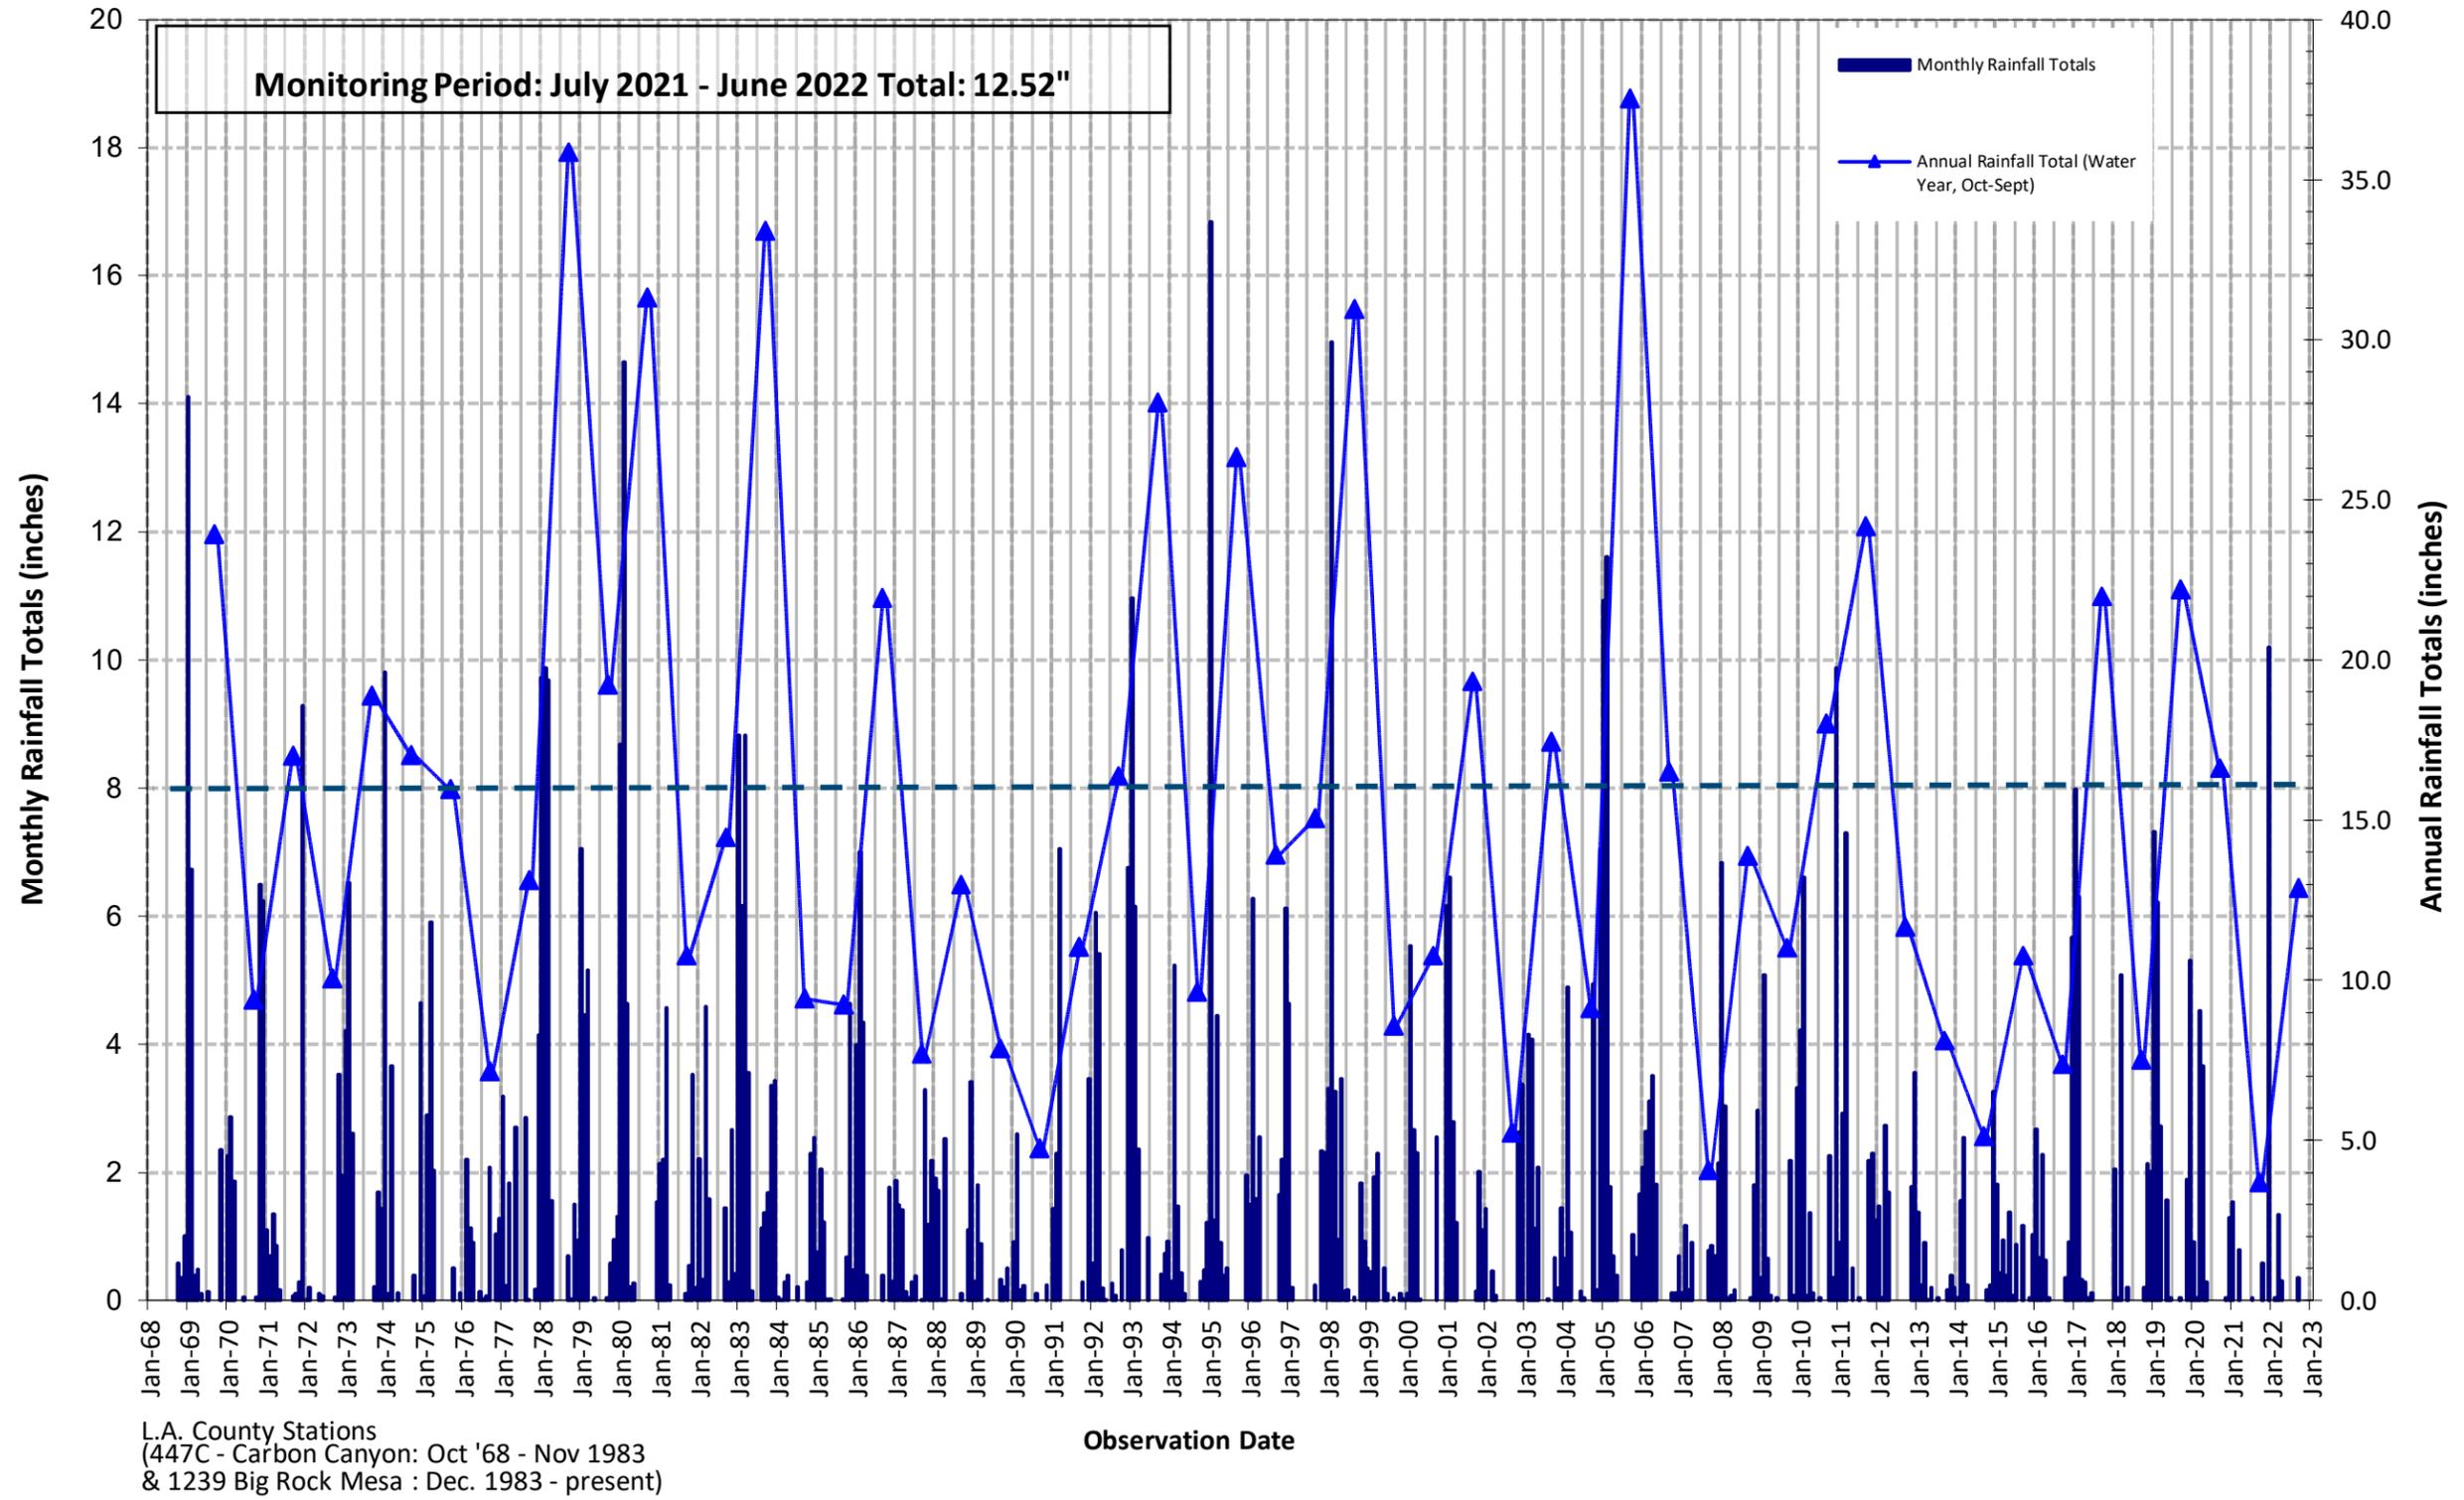
RAINFALL GRAPH
 Malibu Road Landslide Assessment District
 Malibu, California

Yeh obtained rainfall data for the 2021-2022 monitoring year from the Big Rock Mesa Rain Gauge #1239 operated by the Los Angeles County Department of Public Works. Plate 3 - Rainfall Graph displays historical monthly and average annual rainfall for the Malibu Road area from October 1968 through September 2022. Prior to 1984, rainfall data was obtained from the Carbon Canyon Rain Gauge #447C and after 1984 from the Big Rock Mesa Rain Gauge #1239. Recorded rainfall for the Malibu Road area over monitoring year totaled 12.52 inches, which is 2.8 inches below the 54-year area average of 15.3 inches. Approximately 10.20 of the 12.52 total inches were received in a series of rain events in December 2021 with a single event on December 29 and 30 that recorded 5.71-inches. Other rainfall events included 1.34-inches of rainfall in March with all other months receiving a total of from 0 to 0.6 inches. Plate 5 –Groundwater levels, Dewatering and Rainfall shows annual rainfall deviation from the 54-year mean and compares rainfall changes to total dewatering output and the annual mean high groundwater levels for each area. Dewatering production typically reacts to rainfall totals. During the 2021-2022 monitoring year, total dewatering production decreased in response to continued below-average rainfall and due to lowered dewatering production during well maintenance.

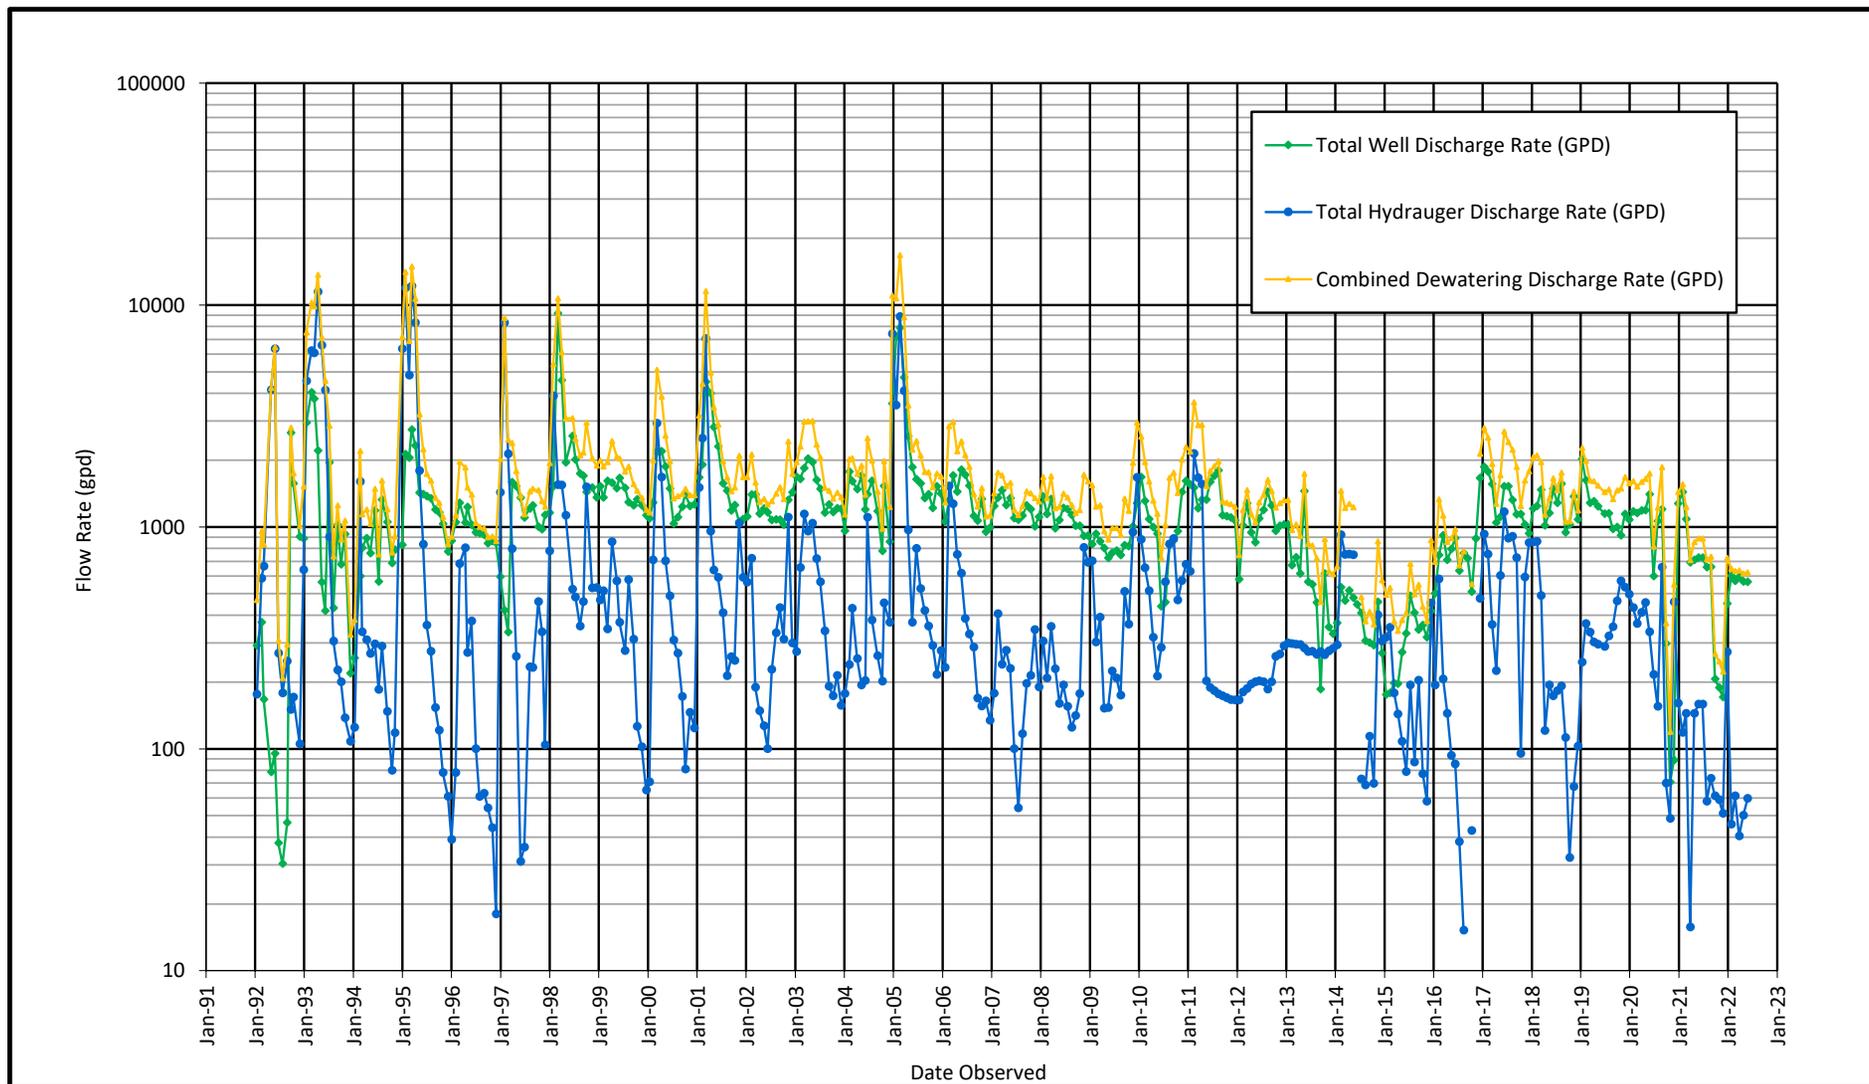
TOTAL DISCHARGE - WELLS AND HYDRAUGERS
Malibu Road Landslide Assessment District
Malibu, California

During the 2021-2022 monitoring year, the average total well production was 497 gpd which is 35-percent lower than last year's average production of 770 gpd and 37-percent less than the historical production average of 1,198 gpd calculated from 1991 to present and 83-percent less than the maximum average annual production of 2,930 gpd recorded during the 2004-2005 monitoring year.

Well production typically varies in response to rainfall totals. The dewatering well production decrease over this monitoring year is consistent with the historically low rainfall totals and extended drought conditions at the project. In addition to continued drought conditions, dewatering wells W-3, W-4, W-5, W-6, W-9 and W-10 have recorded periods of no production due to maintenance and repairs as detailed on Plate 2.

During the 2021-2022 monitoring year, the average monthly hydrauger production was 83 gpd which is approximately 58-percent less than last year's average monthly production of 196 gpd and 89-percent less than the historical production average of 777 gpd calculated from 1991 to present and 98-percent less than the maximum average annual production of 3,925 gpd recorded during the 1994-1995 monitoring year. Over the monitoring year, 76-percent of all hydrauger production was from 3 hydrauvers with four other hydrauvers producing intermittently. Hydrauger production was highest in January in response to December rainfall. The decrease in average annual hydrauger production is consistent with historically low annual rainfall. Decrease in flow may also be due in part to degradation, clogging by soil and mineralization of the hydrauvers; however, this is difficult to assess given the concurrent ongoing drought conditions.

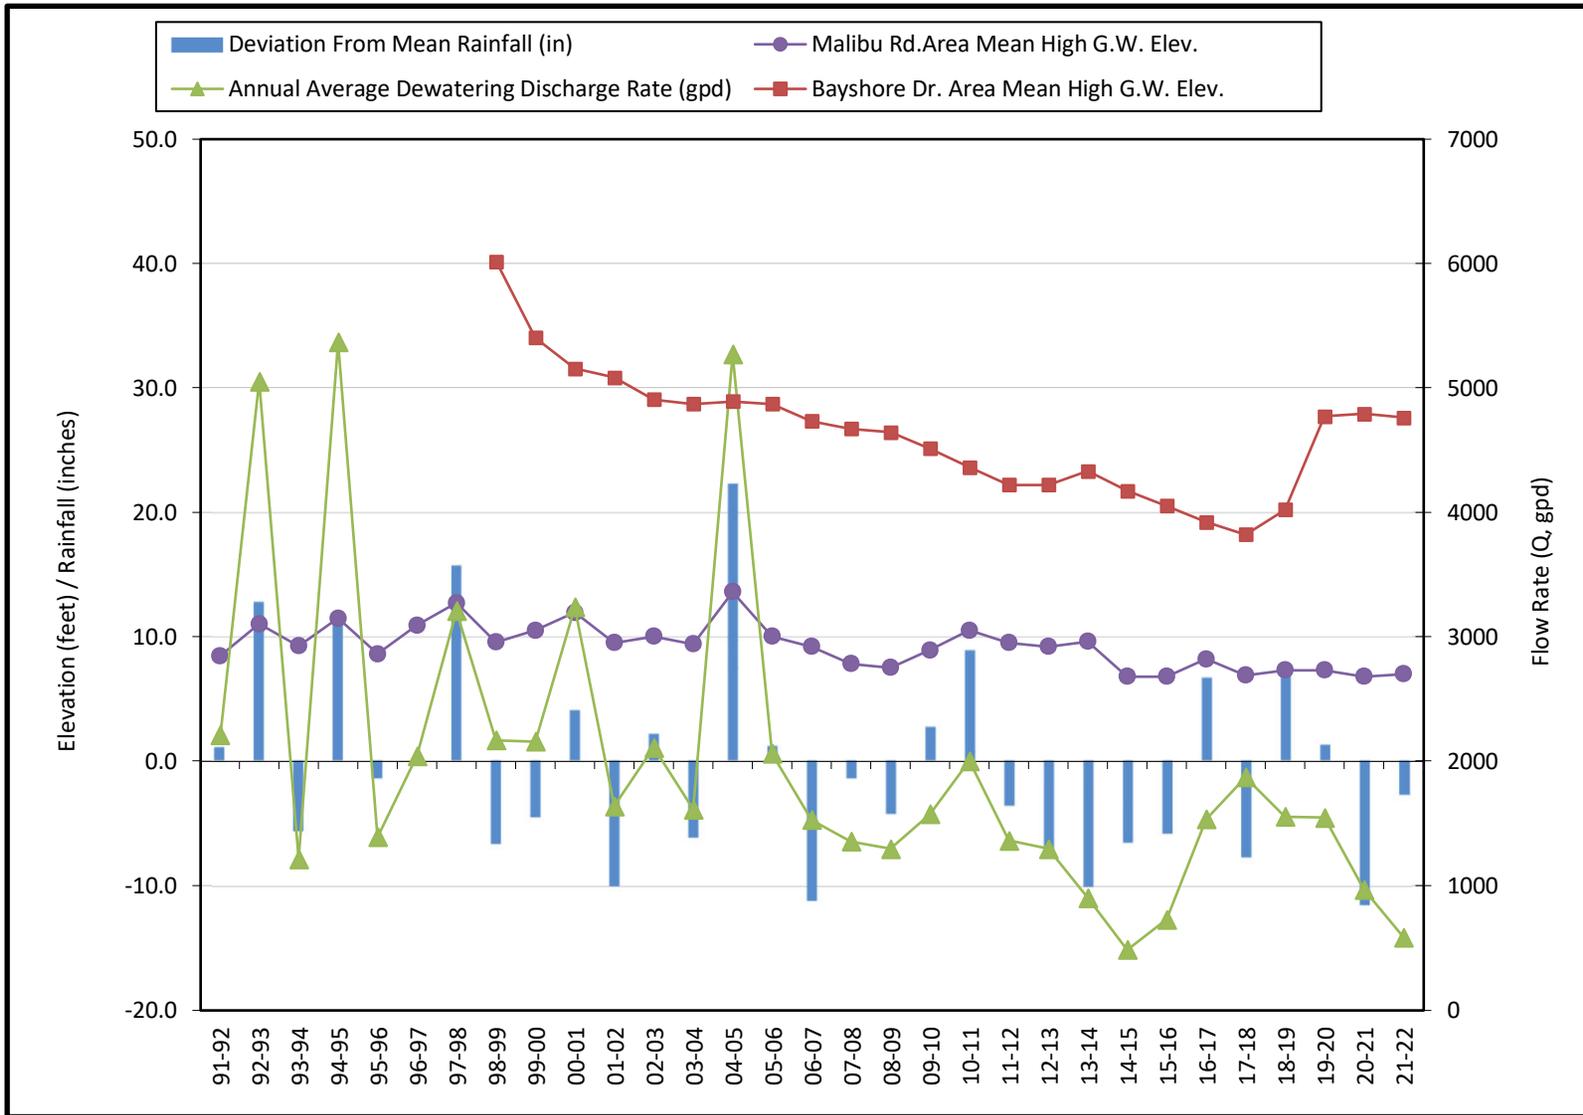
GROUNDWATER LEVELS, DEWATERING, AND RAINFALL
 Malibu Road Landslide Assessment District
 Malibu, California

Five standpipes are in use for groundwater level monitoring in the Malibu Road area. The average groundwater level for the Malibu Road area remained relatively unchanged relative to the prior monitoring year, decreasing by 0.2 feet. Groundwater levels measured within individual standpipes maintained consistent with some variations in response to rainfall and tidal influence.

Two standpipes are in use for groundwater level monitoring in the Bayshore Drive Area. The average groundwater level for the Bayshore Drive Area decreased by 0.2 feet since the prior monitoring year. The decrease reflects water level changes in SI-5 which had shown an increasing trend since March 2019 until approximately July 2020. During the FY21/22 monitoring year, the water level in SI-5 decreased by 3 feet with a decreasing trend since July 2020 except for an increase in December 2021 to January 2022. Water levels in SI-6 remained relatively unchanged. Yeh is coordinating additional data collection and troubleshooting activities to evaluate the reason for the rise in water level in SI-5.

* Graph shows the mean value of the highest groundwater elevations recorded for each standpipe piezometer during the monitoring year.
