FY20/21 Maintenance and Monitoring

AD98-2, Calle del Barco

Yeh Project No.: 220-277

Subject: Annual Monitoring and Maintenance Report FY20/21, City of Malibu Assessment District 98-2, Calle del Barco, Malibu, CA

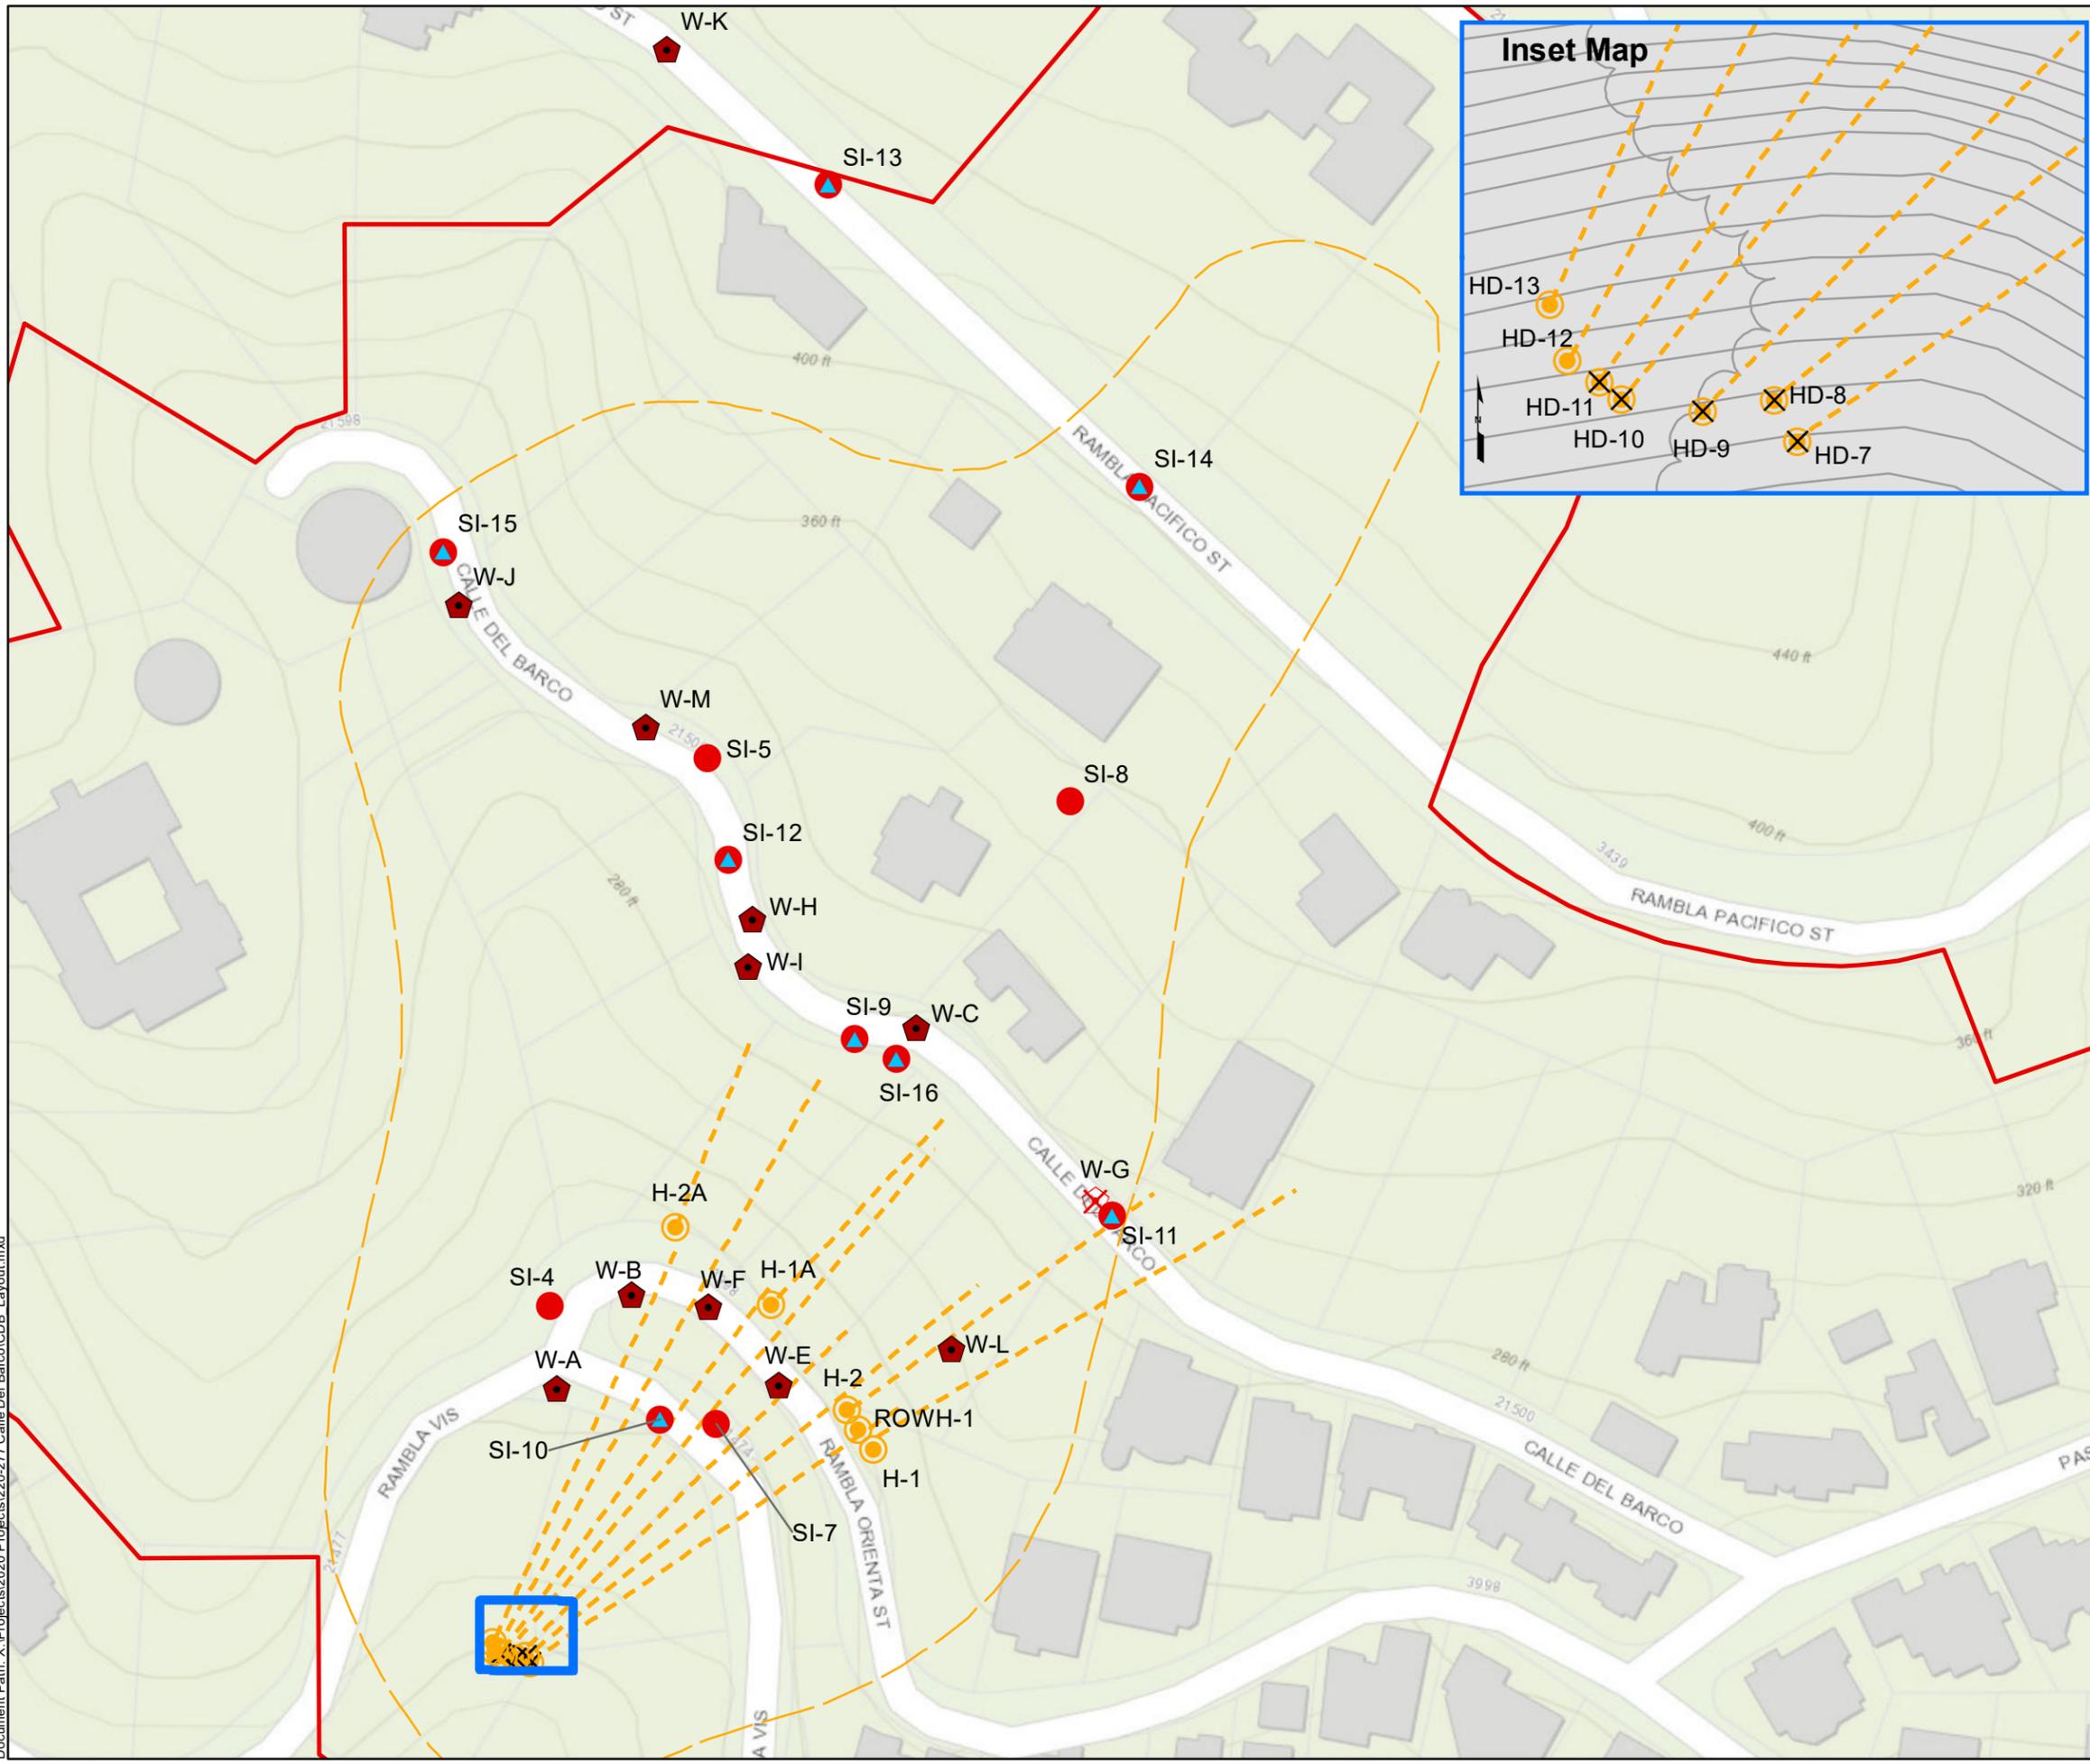
**CALLE DEL BARCO LANDSLIDE
ASSESSMENT DISTRICT
MALIBU, CALIFORNIA
MONITORING INSTRUMENTATION
AND
DEWATERING FACILITIES MAP**

Groundwater levels were measured approximately monthly in 8 standpipe piezometers shown on Plate 1. Groundwater level data and hydrographs for individual standpipes are presented in Appendix A for the FY20/21 monitoring year. Water levels are acquired by lowering an electric probe into the standpipe to contact the groundwater surface and manually record the depth to water.

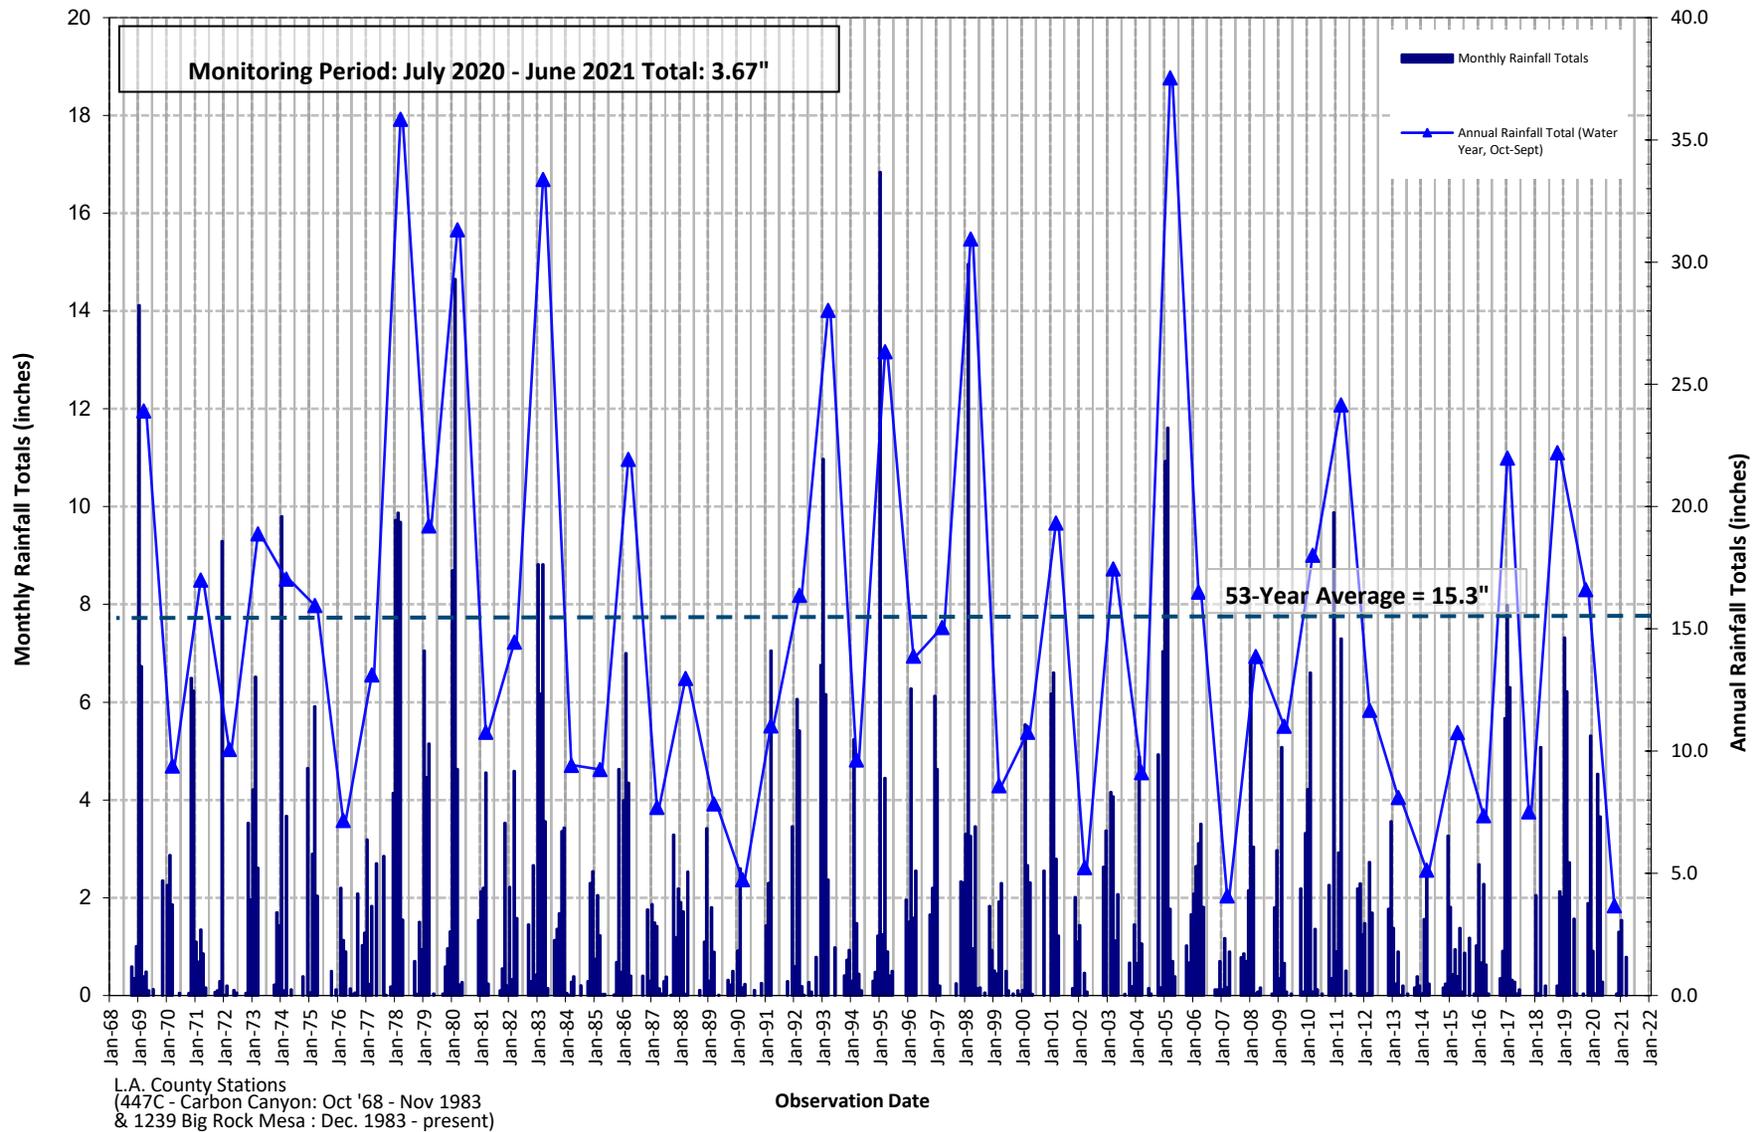
RAINFALL GRAPH
 Landslide Assessment Districts
 Malibu, California

#447C and after 1984 from the onsite Big Rock Mesa Rain Gauge #1239. Rainfall for Big Rock Mesa area for the 2020-2021 monitoring year totaled 3.67 inches, which is 11.7 inches below the 53-year area average of 15.3 inches.

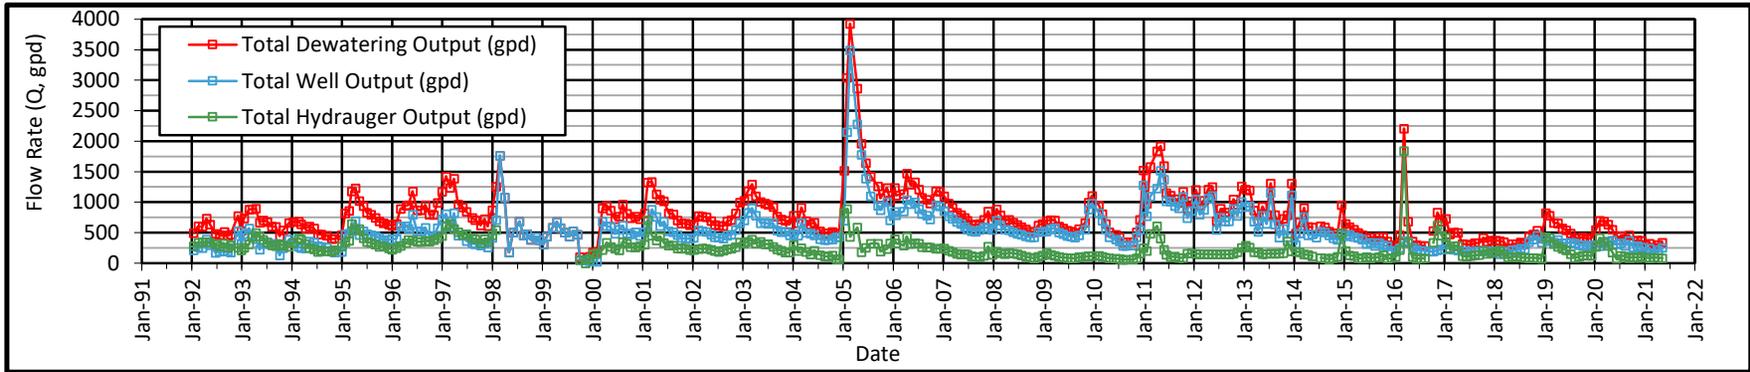
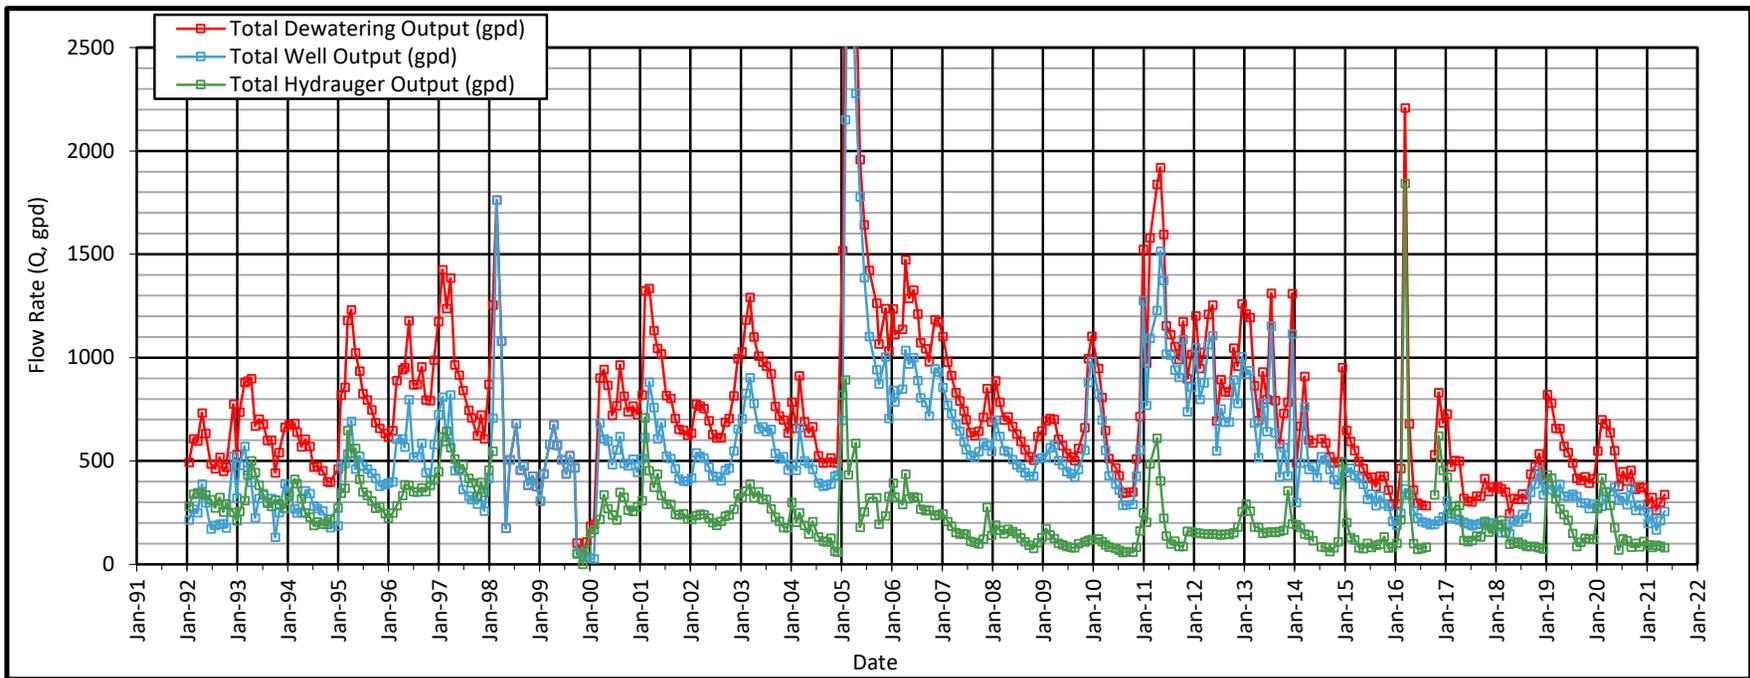
TOTAL DISCHARGE - WELLS AND HYDRAUGERS
 Calle del Barco Landslide Assessment District
 Malibu, California

During the 2020-2021 monitoring year, the average total well production was 265 gpd which is 16% lower than last year's average production of 314 gpd and 41% less than the historical production average of 529 gpd calculated from 1992 to present. These values are 78% less than the maximum annual average production of 1,182 gpd recorded during the 2004-2005 monitoring year.

During the 2020-2021 monitoring year, the average monthly hydrauger production was 94 gpd which is approximately 54% less than last year's average monthly production of 203 gpd and 59% less than the historical average production calculated from 1992 to present of 229 gpd. These values are 79% less than the maximum average annual production of 455 gpd recorded during the 1996-1997 monitoring year.

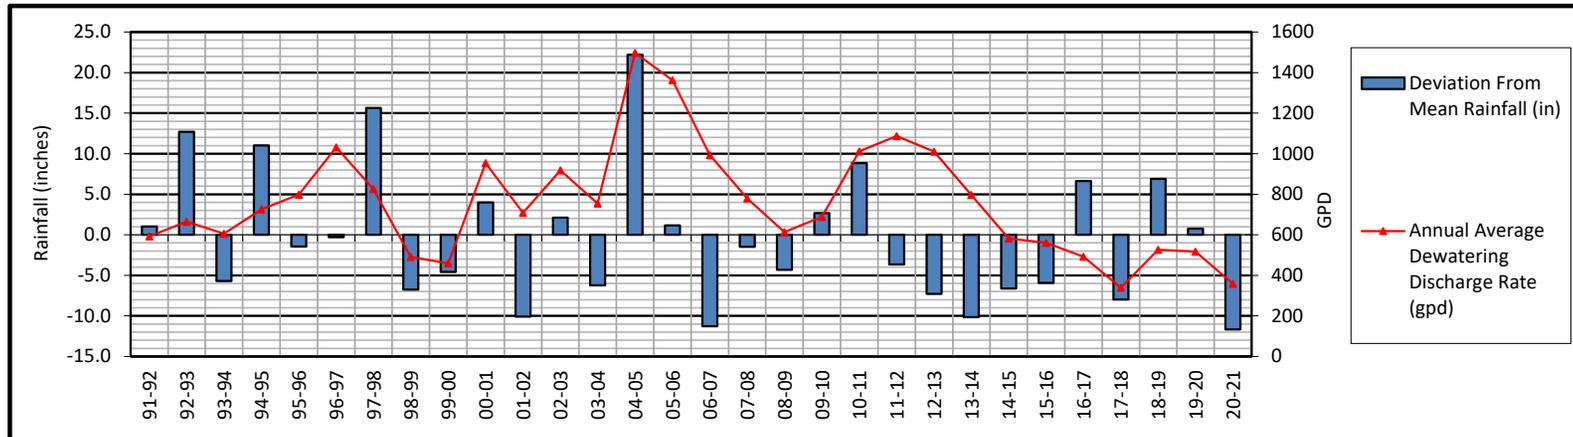
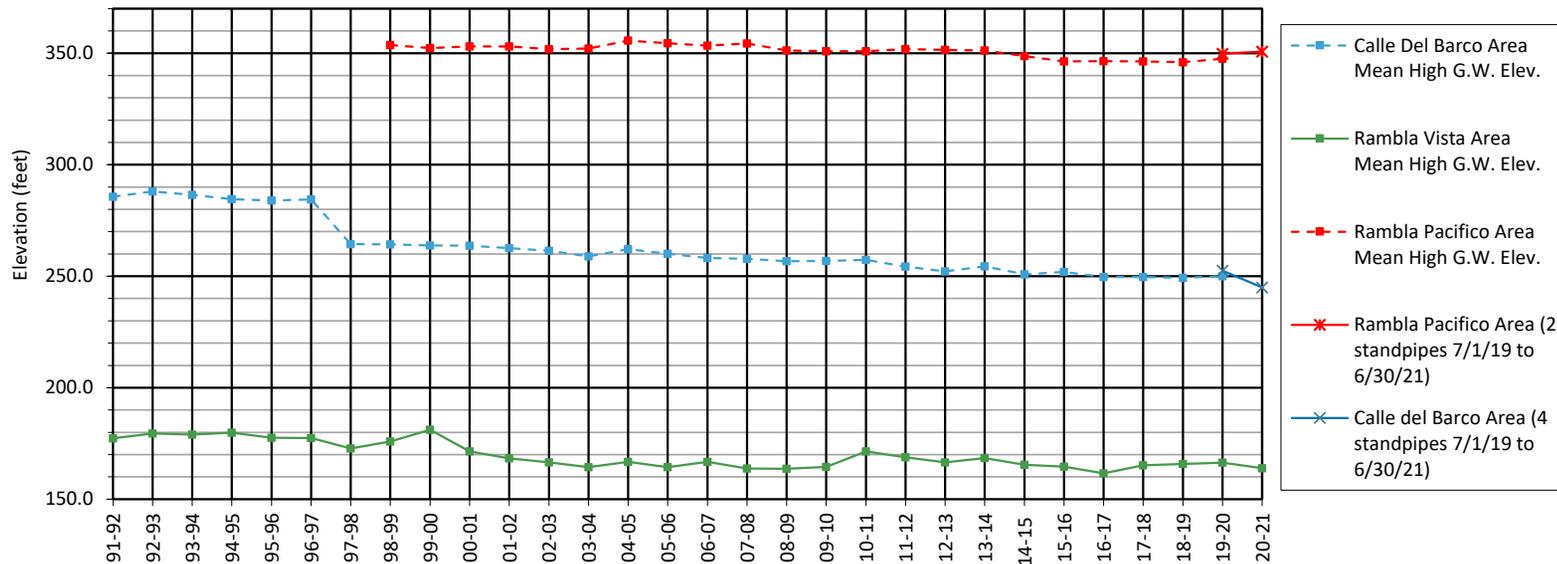
GROUNDWATER LEVELS, DEWATERING AND RAINFALL
 Calle del Barco Landslide Assessment District
 Malibu, California

Plate 5 – Summary of Groundwater Levels, Dewatering, and Rainfall shows annual rainfall deviation from the 53-year mean and compares rainfall changes to total dewatering output. Dewatering production typically reacts to rainfall totals. During the 2020-2021 monitoring year, total dewatering production decreased in response to well below average rainfall.

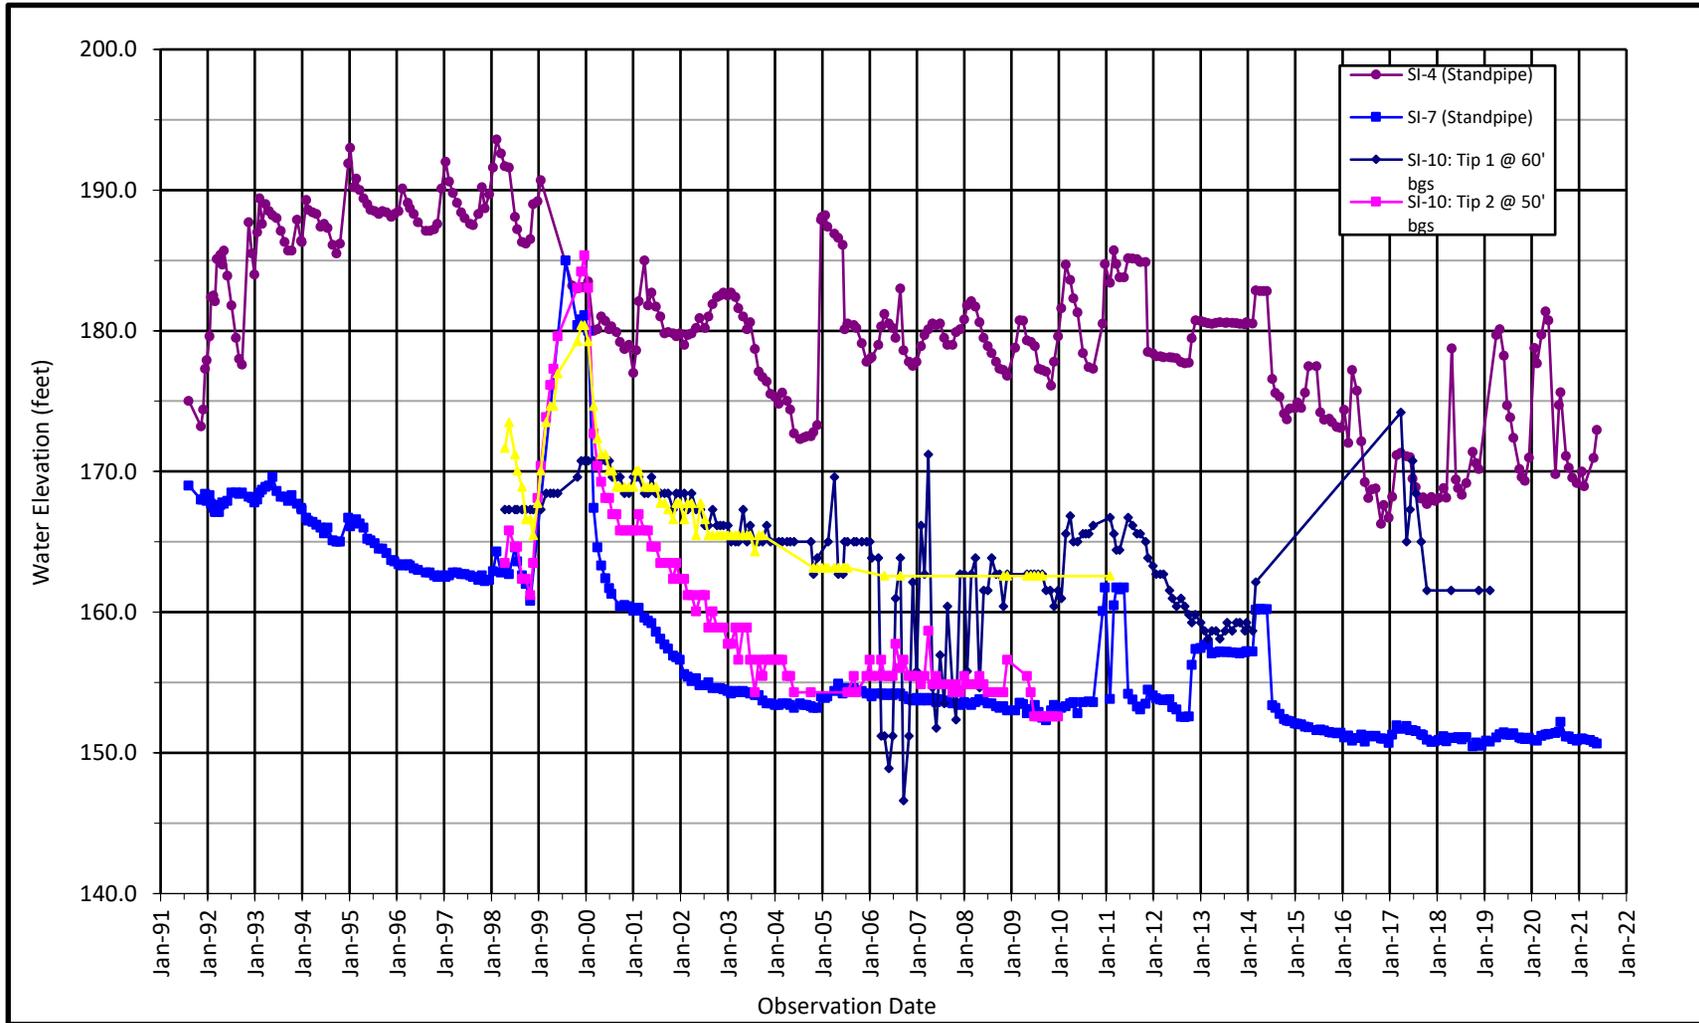
GROUNDWATER HYDROGRAPH
Rambla Vista
Calle del Barco Landslide Assessment District
Malibu, California

Two standpipes are in use for groundwater level monitoring in the Rambla Vista Region. The average groundwater level for the Rambla Vista Region decreased by 1.9 feet since the prior monitoring year. Annual average groundwater levels measured in SI-7 remained consistent and measurements in SI-4 decreased by 3.7 feet.

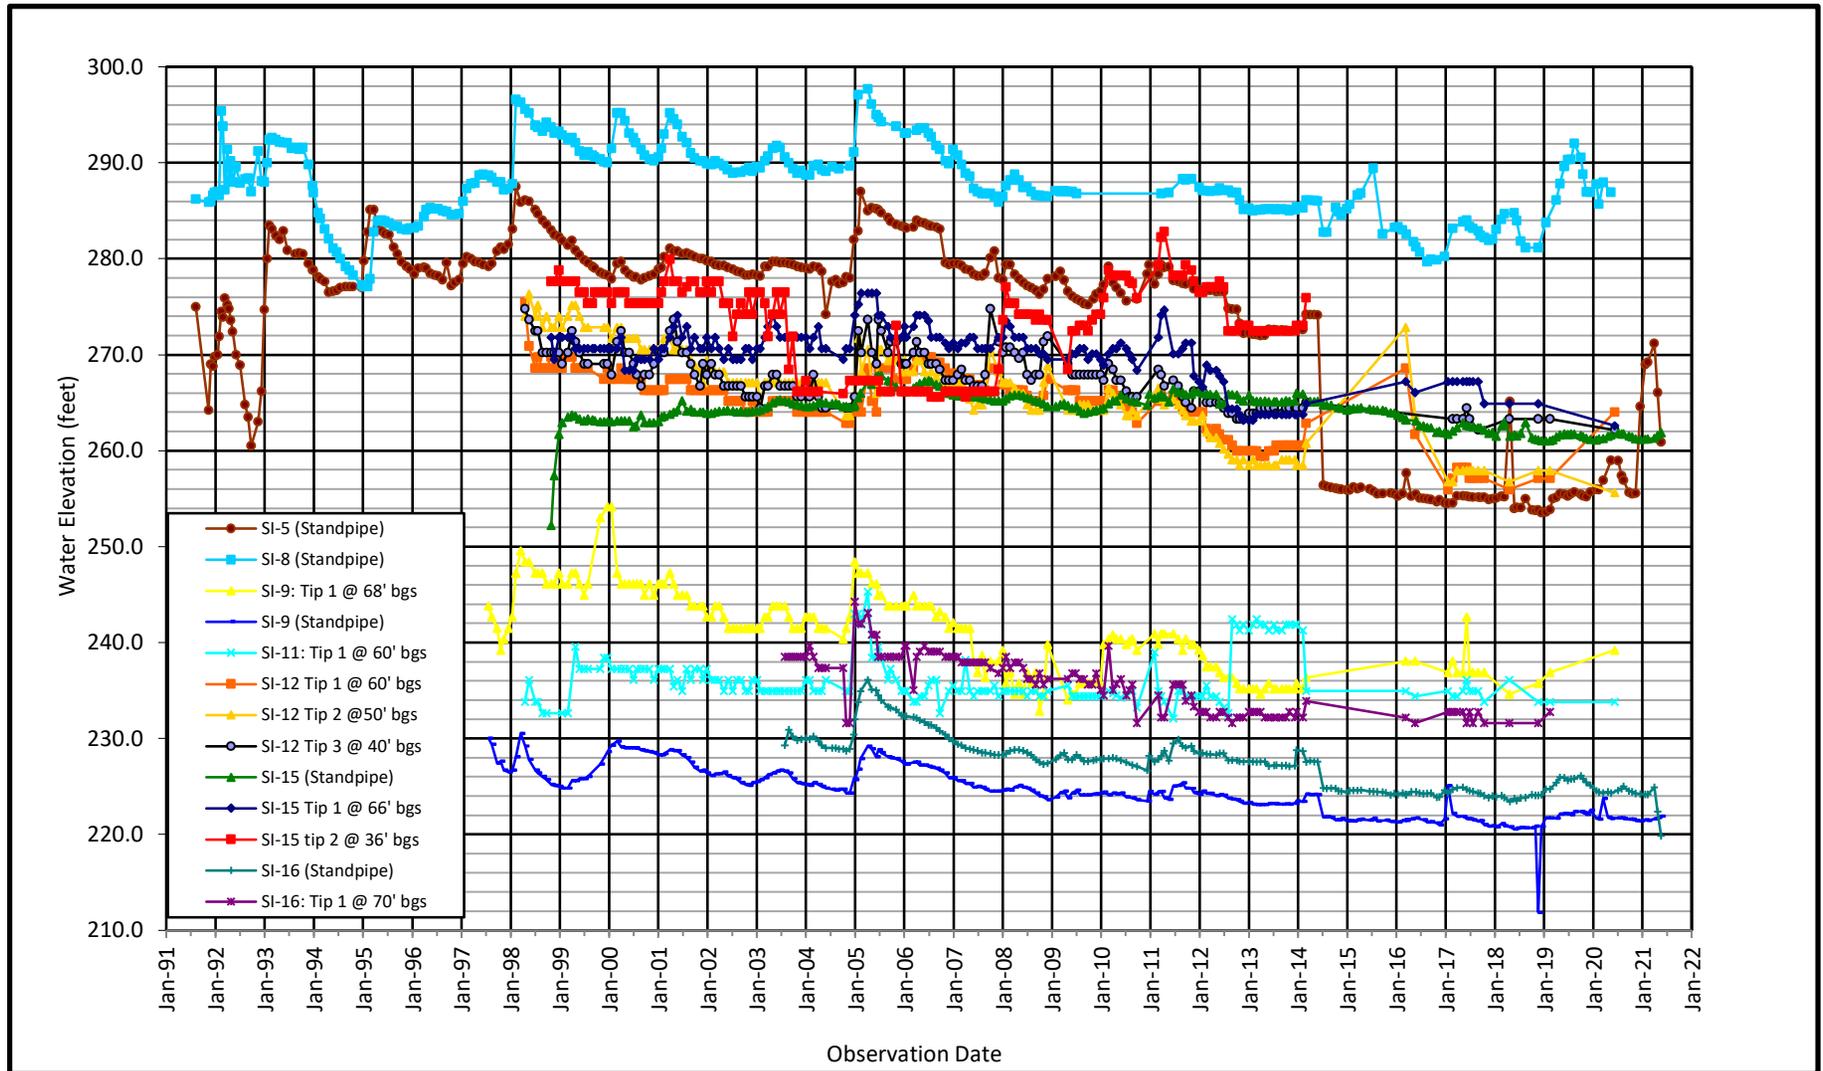
GROUNDWATER HYDROGRAPH

Five standpipes are in use for groundwater level monitoring in the Calle Del Barco region; however, results from the FY20/21 monitoring year include only 4 locations as SI-8 was not able to be accessed due to private property limitations. During the FY20/21 monitoring year, the calculated average for the measured 4 locations increased by 1.0 foot since the prior monitoring year. The rise reflects a temporary water level increase in SI-5 of 15.6-feet between December 2020 and April 2021 that coincides with the mechanical failure of nearby dewatering well W-M. The pump in dewatering well W-M was replaced on May 13, 2021 and water levels in SI-5 have steadily decreased by 10.3 feet as of June 9, 2021. The peak average for the same data set decreased by 7.5 feet as compared to the prior monitoring year.

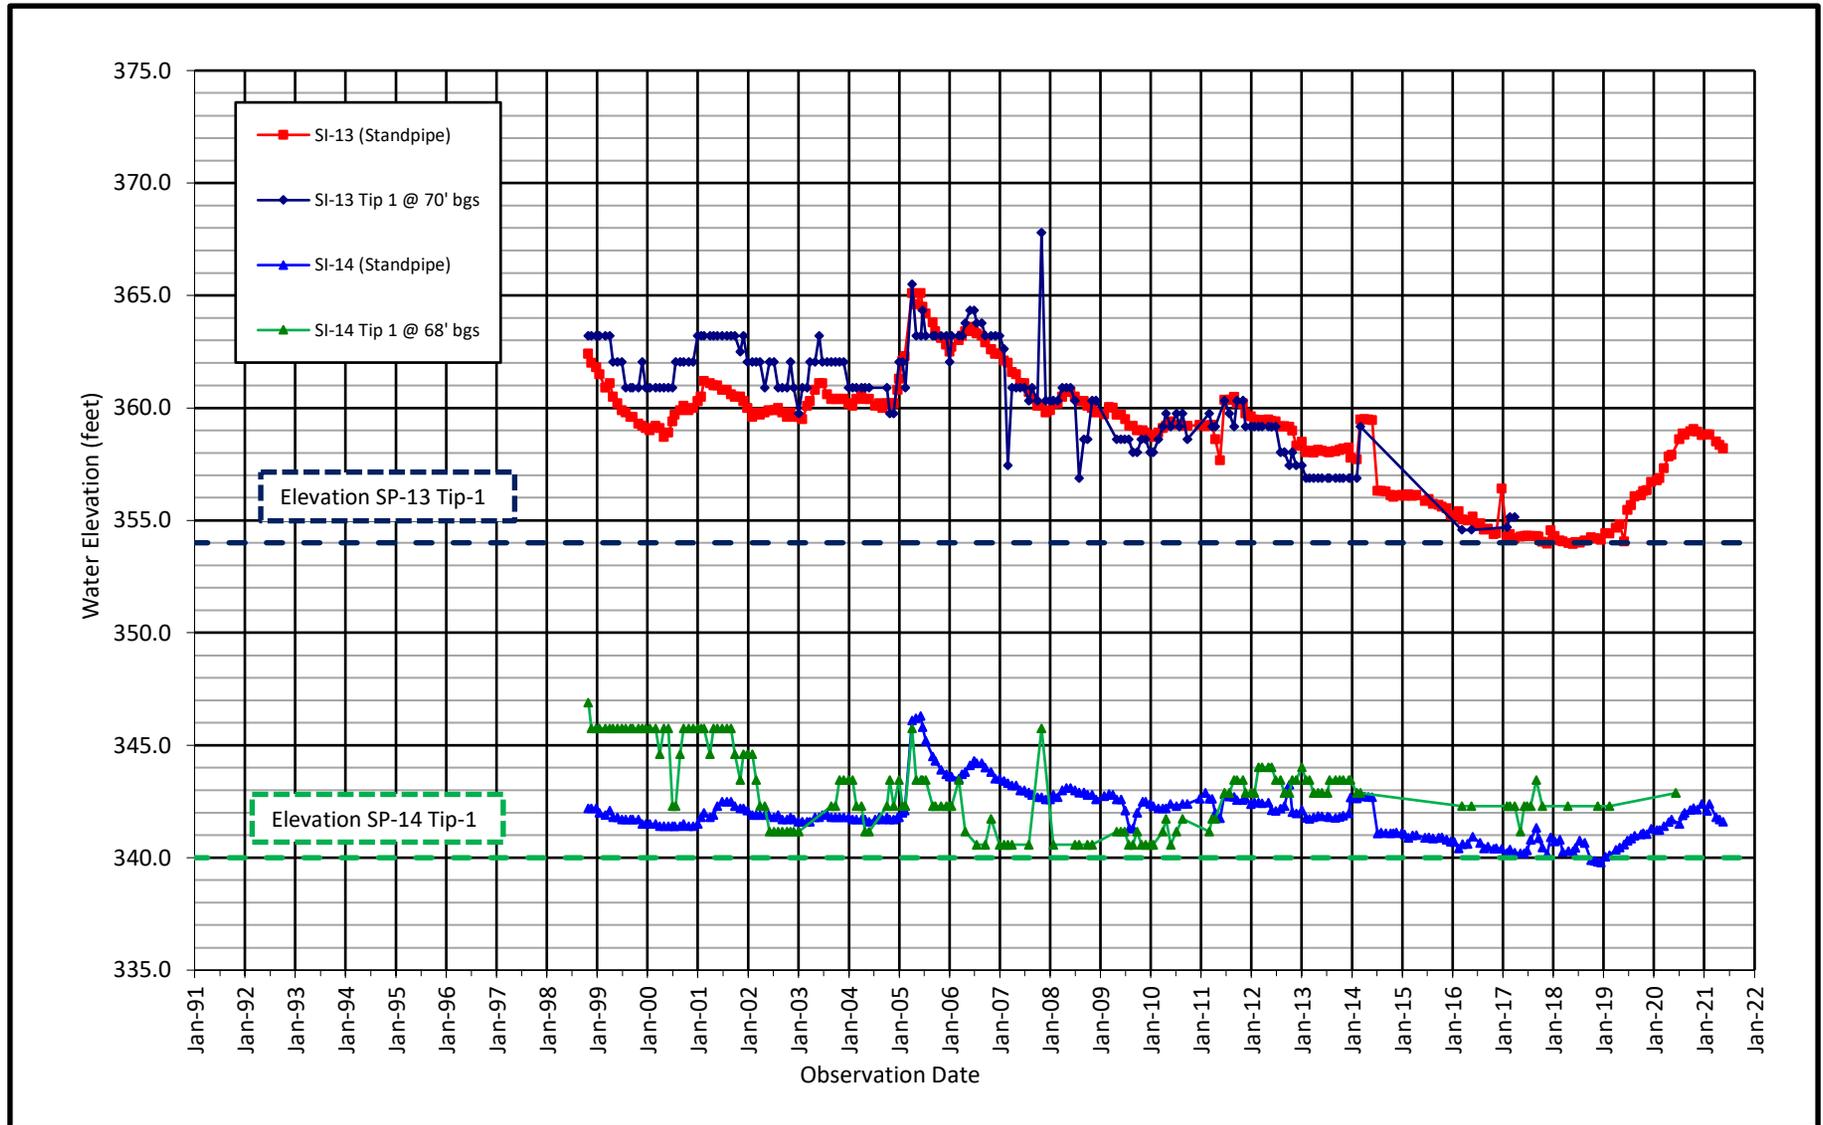
GROUNDWATER HYDROGRAPH

Two standpipes are in use for groundwater level monitoring in the Rambla Pacifico Region. Average groundwater levels within the Rambla Pacifico Region increased by 1.5-feet since the previous monitoring year. Water levels within individual standpipes SI-13 and SI-14 had both steadily increased since approximately 2018. Standpipe SI-13 had risen approximately 4.8-feet and SI-14 had risen approximately 2.5-feet. Measurements at both locations show declining water levels over the monitoring year since December 2020.

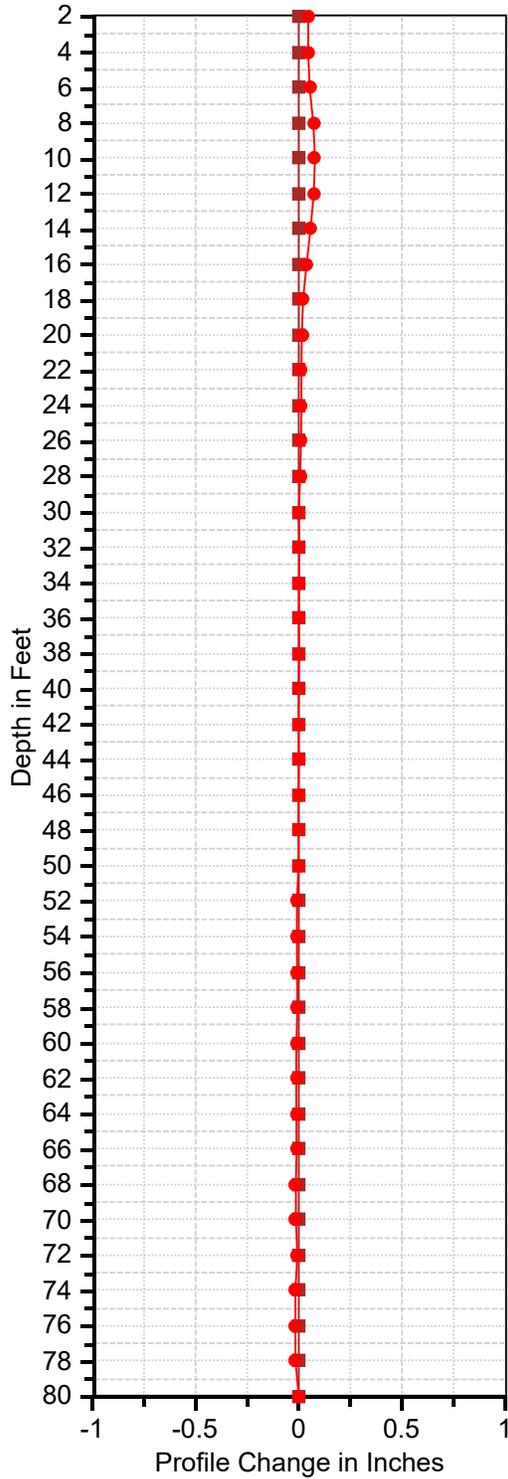
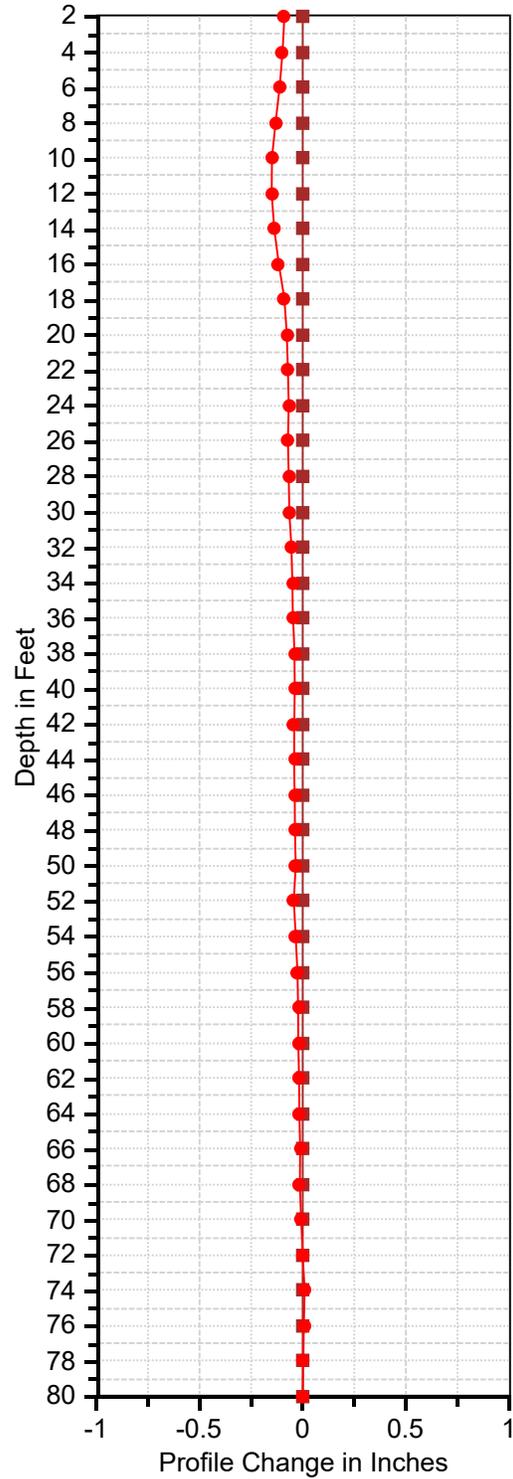
CDB SI-13 A

There are two inclinometers currently surveyed in the Rambla Pacifico Region; SI-13 and SI-14. Neither of the inclinometers displayed quantifiable shear-type displacement. SI-13 displayed up to about 0.2 inches of deformation above a depth of 20 feet. This is consistent with previously noted “bowing” in the upper portion of the casing, which could be caused by settlement of casing backfill. Additional survey methods would be required to exclude or identify a specific cause of the apparent deformation.
