FY22/23 Maintenance and Monitoring

AD98-2, Calle del Barco

Yeh Project No.: 220-277

Subject: Annual Monitoring and Maintenance Report FY22/23, City of Malibu Assessment District 98-2, Calle del Barco, Malibu, CA

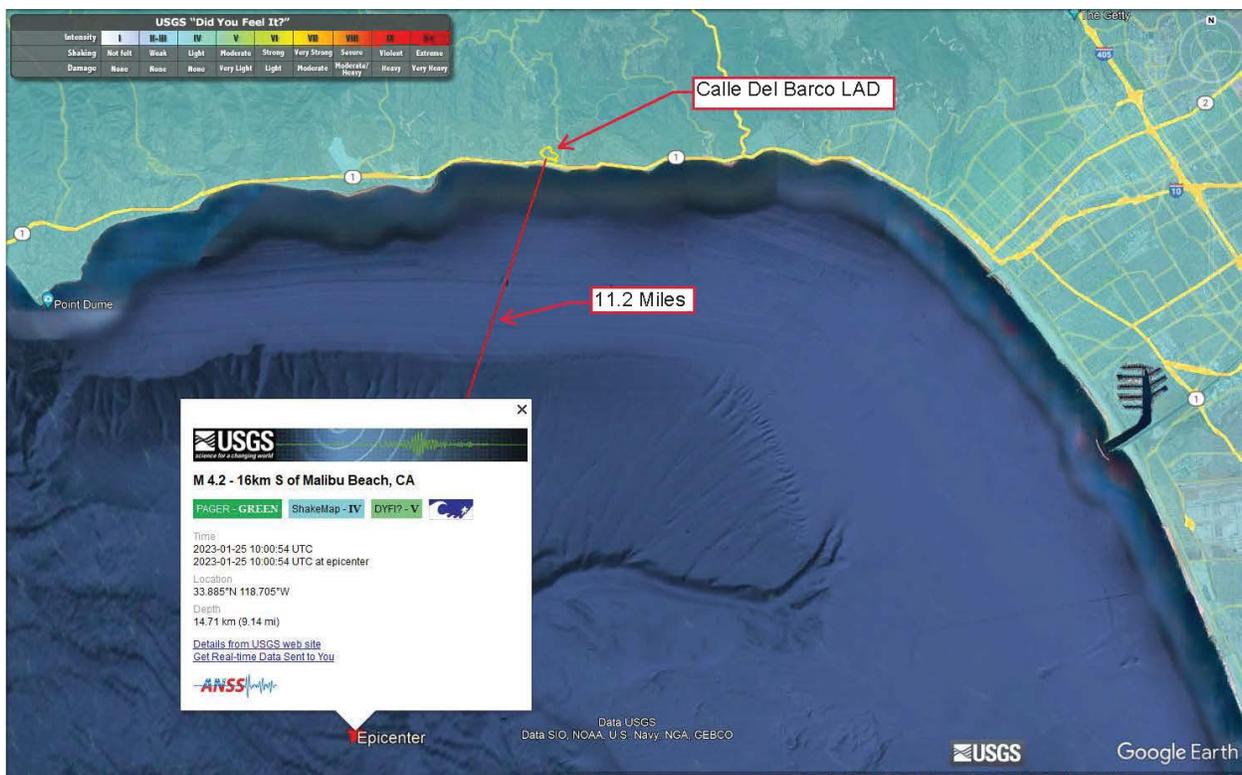
Figure 2: Epicenter of January 25, 2023 M4.2 EQ relative to Calle Del Barco LAD

One earthquake with a magnitude of 4.0 or greater was recorded within a 100-mile radius of the project area. On January 25, 2023, a M 4.2 event occurred approximately 16 kilometers south of Malibu Beach, a M 3.6 aftershock occurred approximately 3 minutes later. The epicenters were located approximately 11.2 miles south-southwest from the Calle Del Barco LAD boundary.

Yeh personnel performed post-earthquake observations and measurements. No movement secondary to the earthquake was interpreted on the inclinometers surveyed. Yeh staff did not observe surface displacements related to the earthquake and is unaware of reports of damage local to the Calle Del Barco Landslide AD resulting from the earthquake.

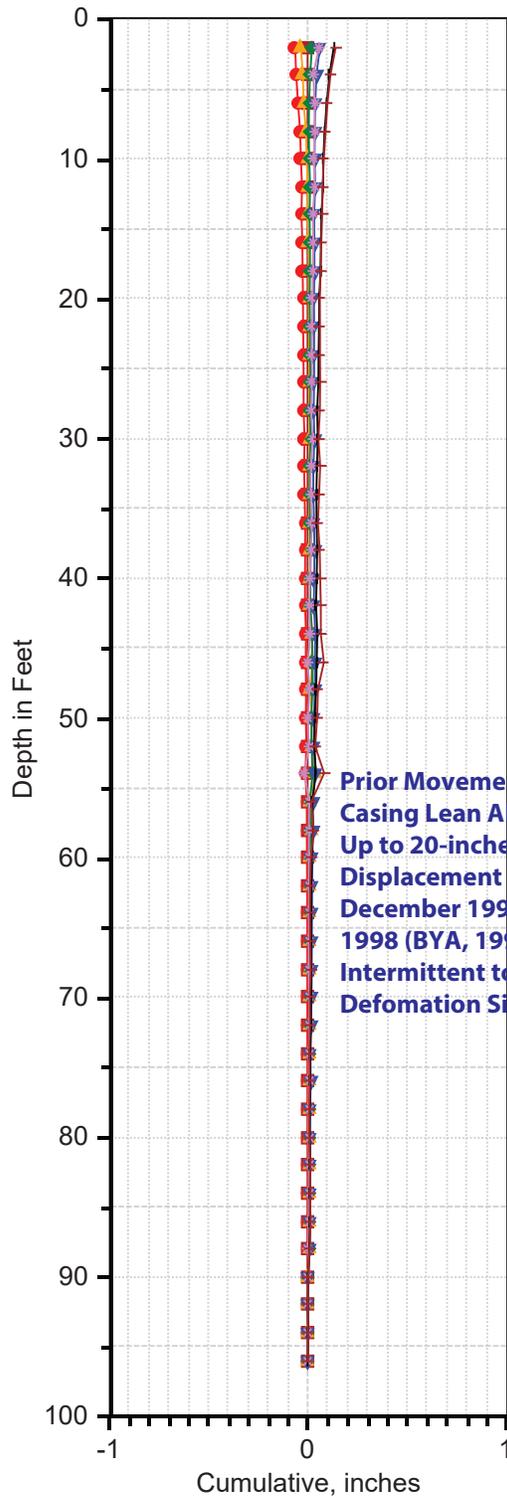
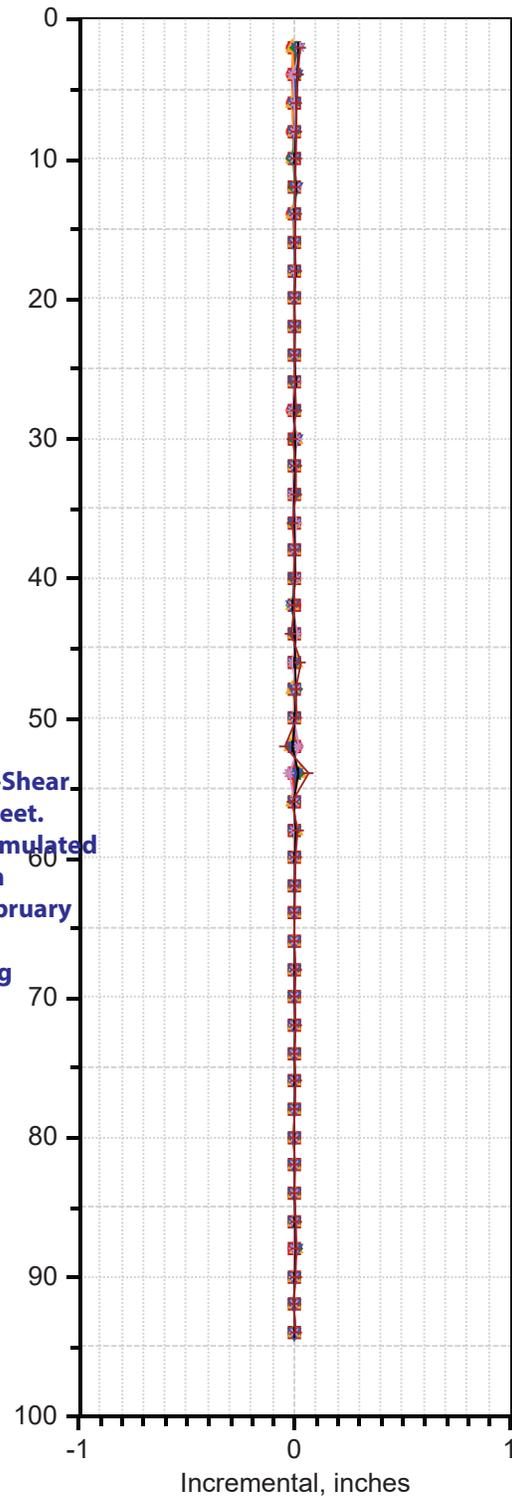
Prior Movement is Non-Shear
Casing Lean Above 60-feet.
Up to 20-inches of Accumulated
Displacement between
December 1997 and February
1998 (BYA, 1998).
Intermittent to Creeping
Deformation Since 1998

Plot Type: Cumulative and Incremental		Plot Direction: A-Direction	
Depth of Survey (ft): 96		Baseline Date: 5/3/21	
Install Date: <12/1997		Interpreted Movement Since Baseline (in): 0	
Installed Depth (ft): 100		Interpreted Movement Monitoring Year (in): 0

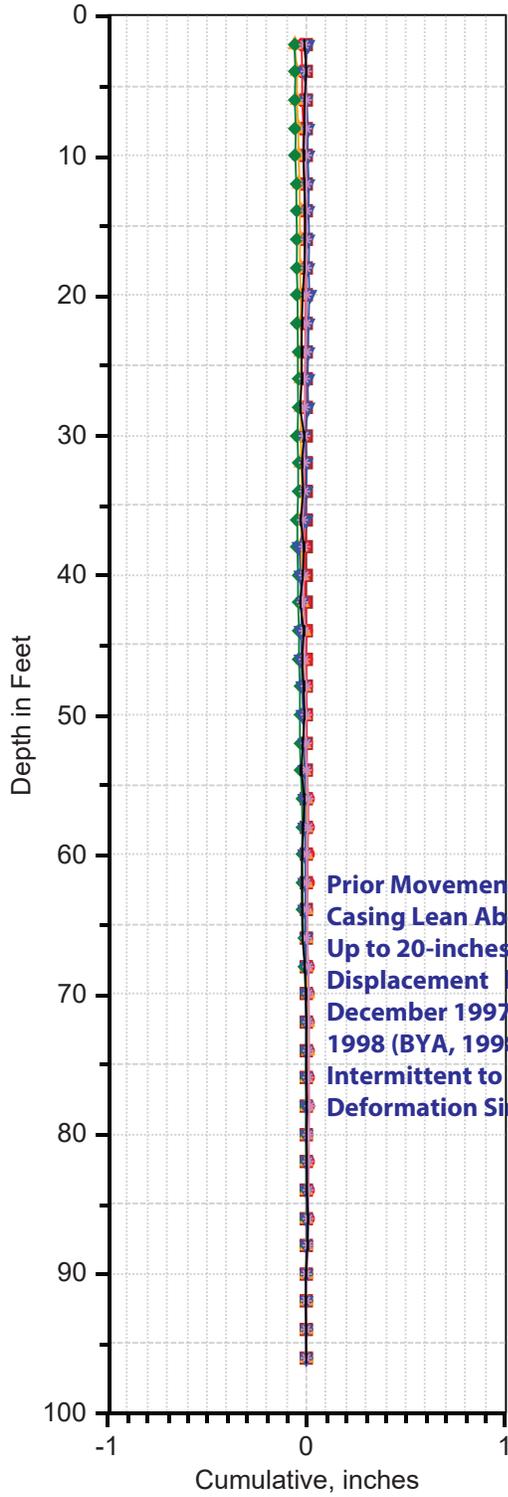
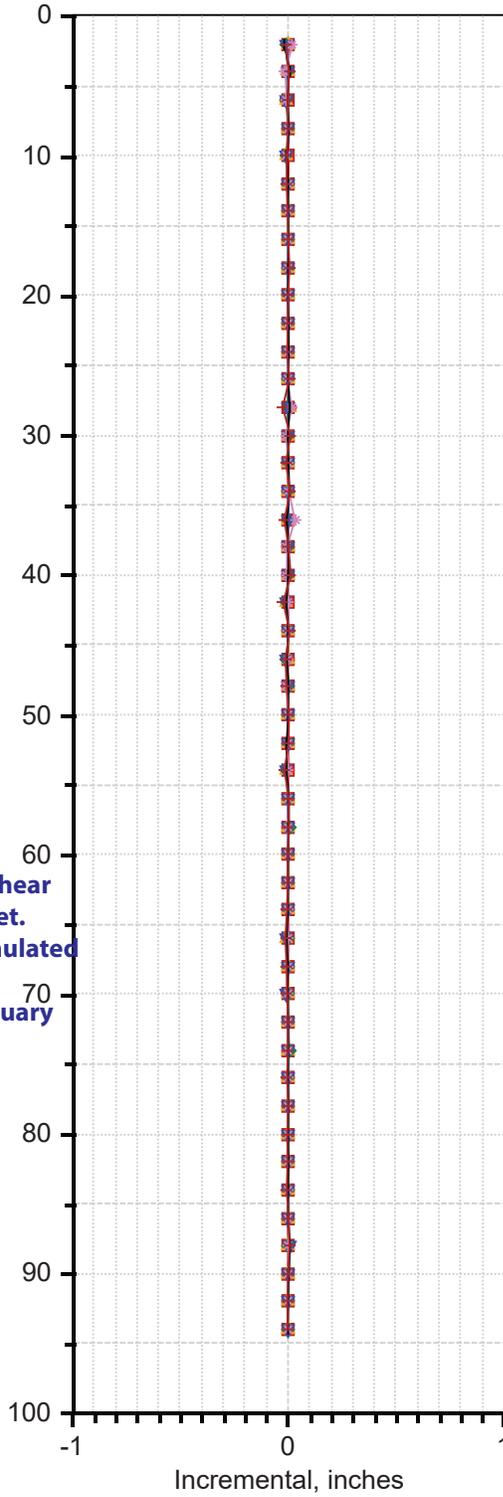
Prior Movement is Non-Shear
Casing Lean Above 60-feet.
Up to 20-inches of Accumulated
Displacement between
December 1997 and February
1998 (BYA, 1998).
Intermittent to Creeping
Deformation Since 1998

Plot Type: Cumulative and Incremental		Plot Direction: B-Direction	
Depth of Survey (ft): 96		Baseline Date: 5/3/21	
Install Date: <12/1997		Interpreted Movement Since Baseline (in): 0	
Installed Depth (ft): 100		Interpreted Movement Monitoring Year (in): 0

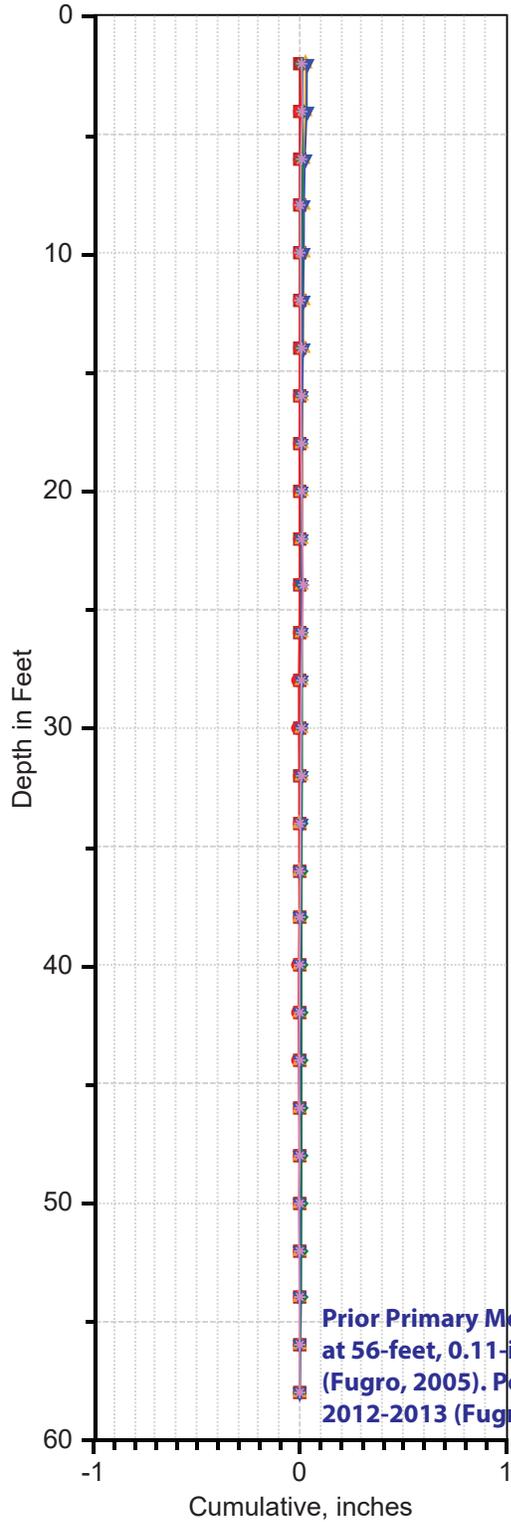
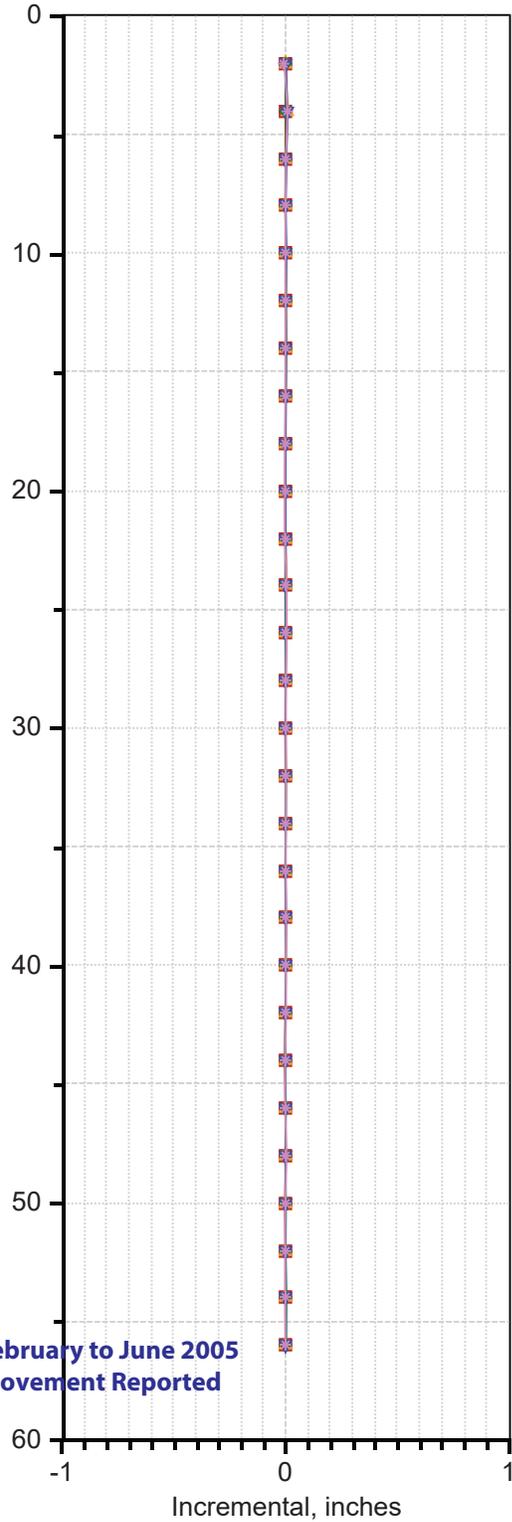
Prior Primary Movement
at 56-feet, 0.11-inches February to June 2005
(Fugro, 2005). Possible Movement Reported
2012-2013 (Fugro, 2013)
