# **FY22/23 Maintenance and Monitoring**

**AD98-3, Malibu Road**

**City of Malibu, California**

**Subject: Annual Monitoring and Maintenance Report FY22/23, City of Malibu Assessment District 98-3, Malibu Road, Malibu, CA**

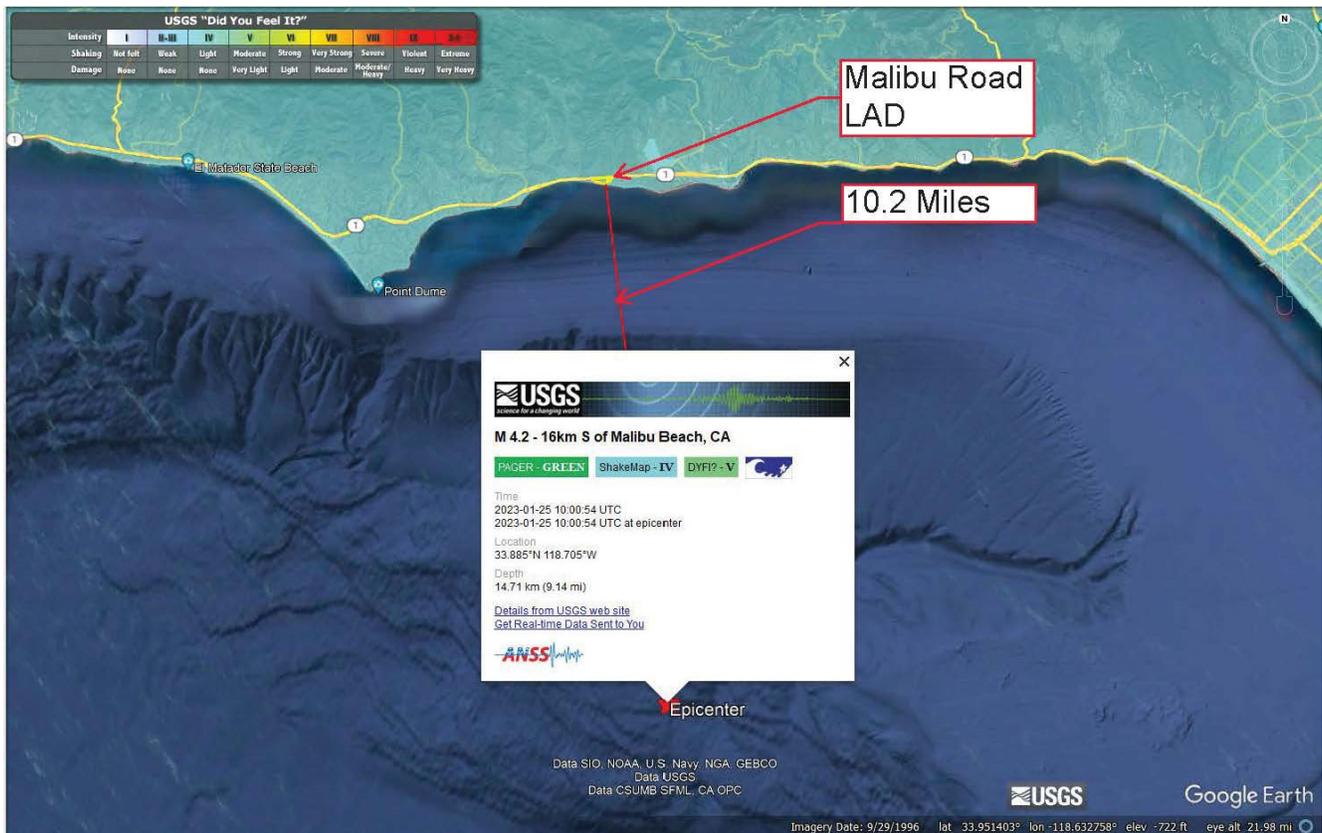
Figure 2: Epicenter of January 25, 2023 M4.2 EQ relative to Malibu Road LAD

One earthquake with a magnitude of 4.0 or greater was recorded within a 100-mile radius of the project area. On January 25, 2023, a M 4.2 event occurred approximately 16 kilometers south of Malibu Beach, a M 3.6 aftershock occurred approximately 3 minutes later. The epicenters were located approximately 10.2 miles south from the Malibu Road LAD boundary.

Yeh personnel performed post-earthquake observations and surveyed inclinometers SI-1A, -2A and -4A on January 30, 2023. No movement secondary to the earthquake was interpreted on the inclinometers surveyed. Yeh staff did not observe surface displacements related to the earthquake and is unaware of any reports of damage local to the Malibu Road Landslide AD resulting from the earthquake.

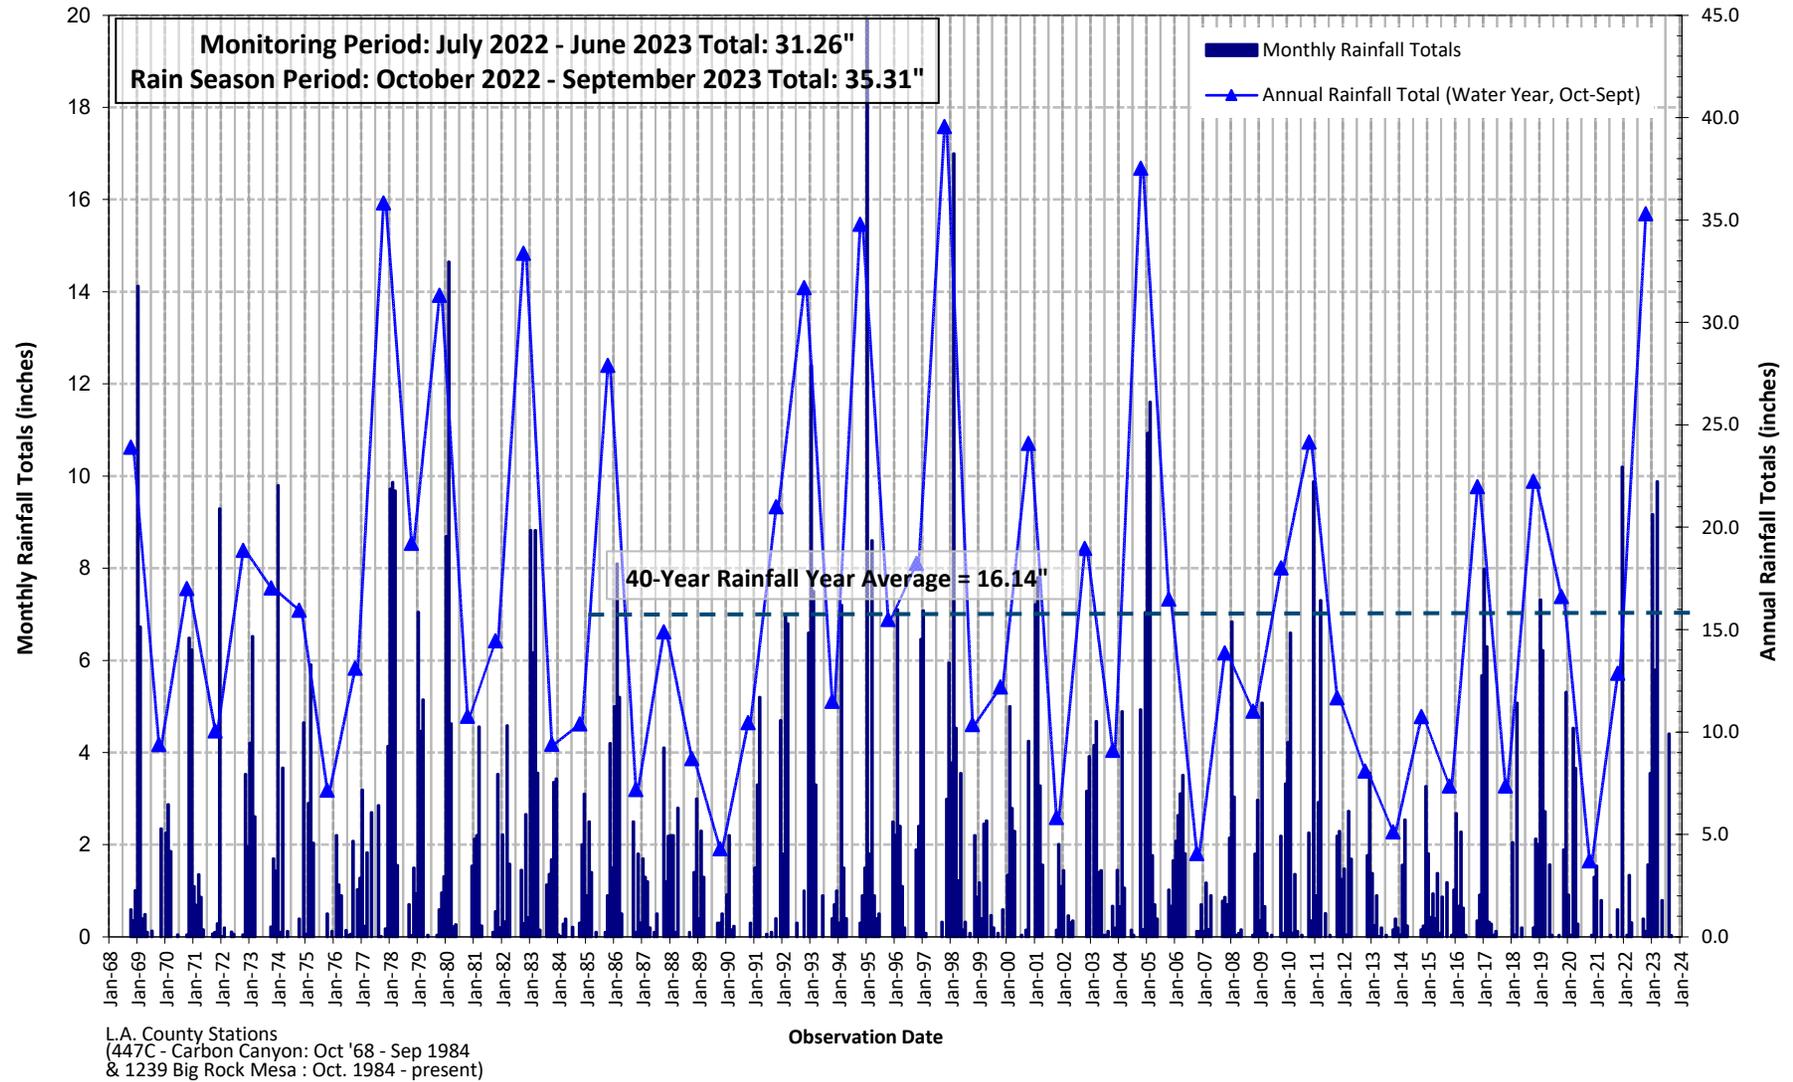
**RAINFALL GRAPH**  
 Landslide Assessment Districts  
 Malibu, California

Plate 2 - Rainfall Graph displays historical monthly and average annual rainfall from October 1968 through September 2023. Recorded rainfall over the monitoring year totaled 31.26 inches, which is 15.12 inches above the 40-year Big Rock Mesa Rain Gauge running average of 16.14 inches and was the most annual rainfall recorded since 2005.

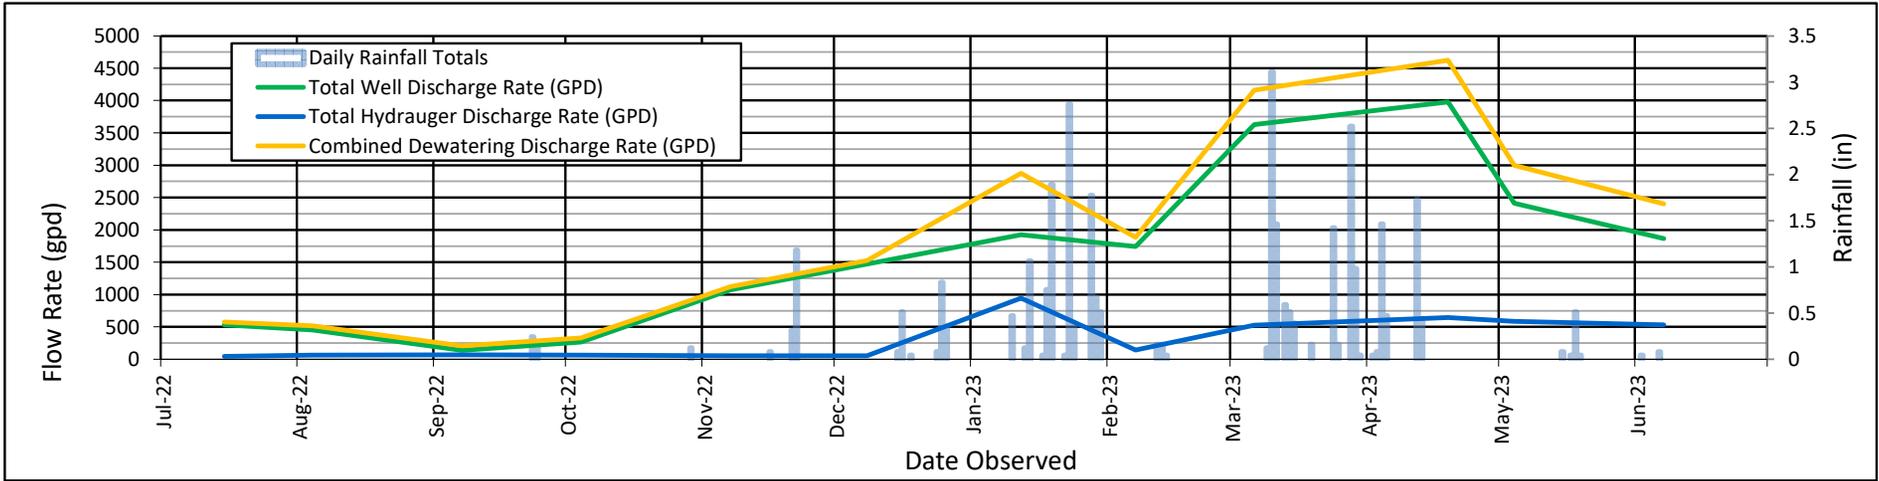
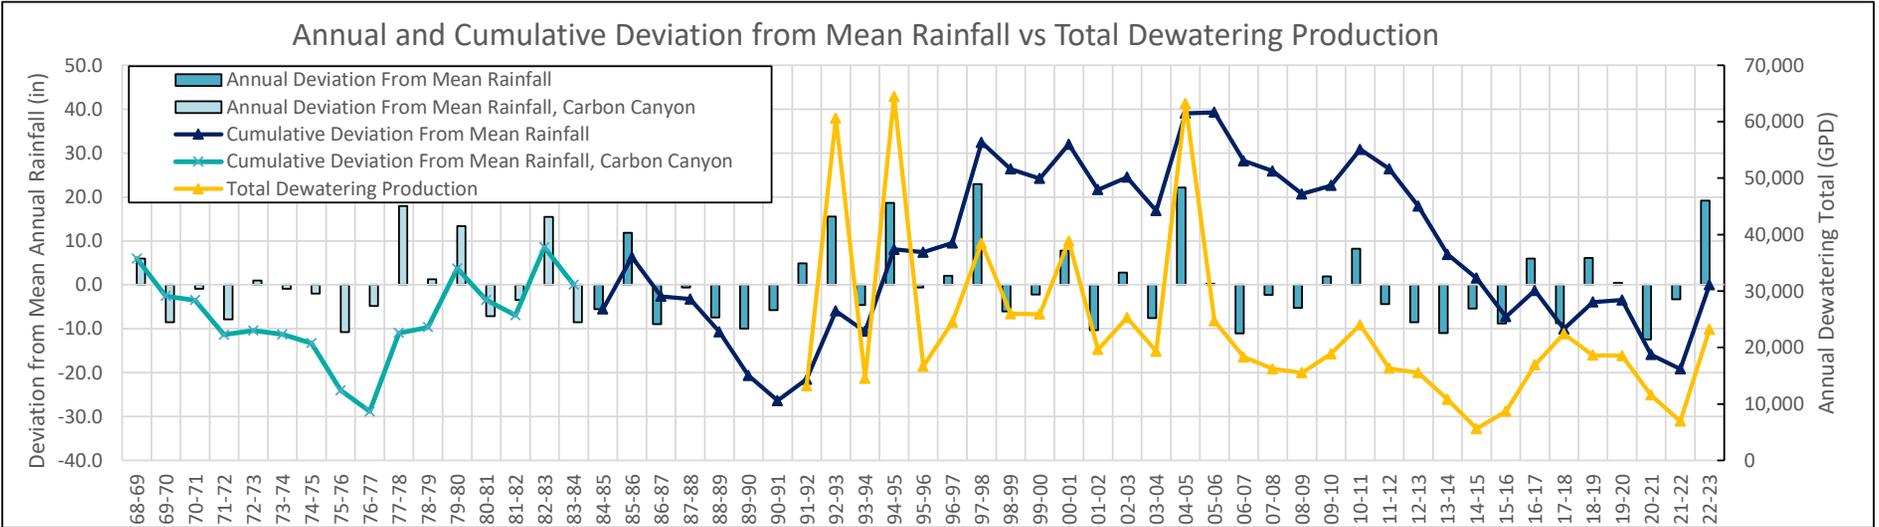
**DISCHARGE VS RAINFALL**

Plate 4 – Annual and Cumulative Deviation from Mean Rainfall vs Total Dewatering Production, shows rainfall deviation from the 40-year mean and compares rainfall amounts to total dewatering output changes. Total Discharge vs Daily Rainfall Totals compares daily rainfall amounts to dewatering output over the monitoring year.

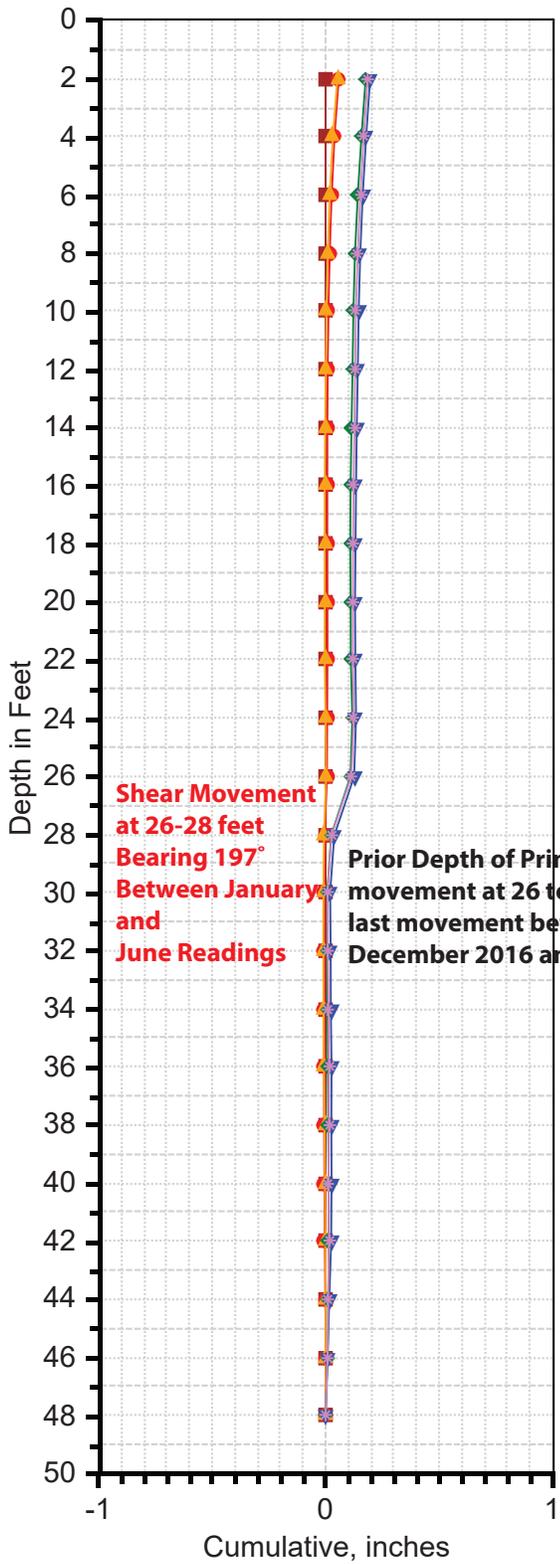
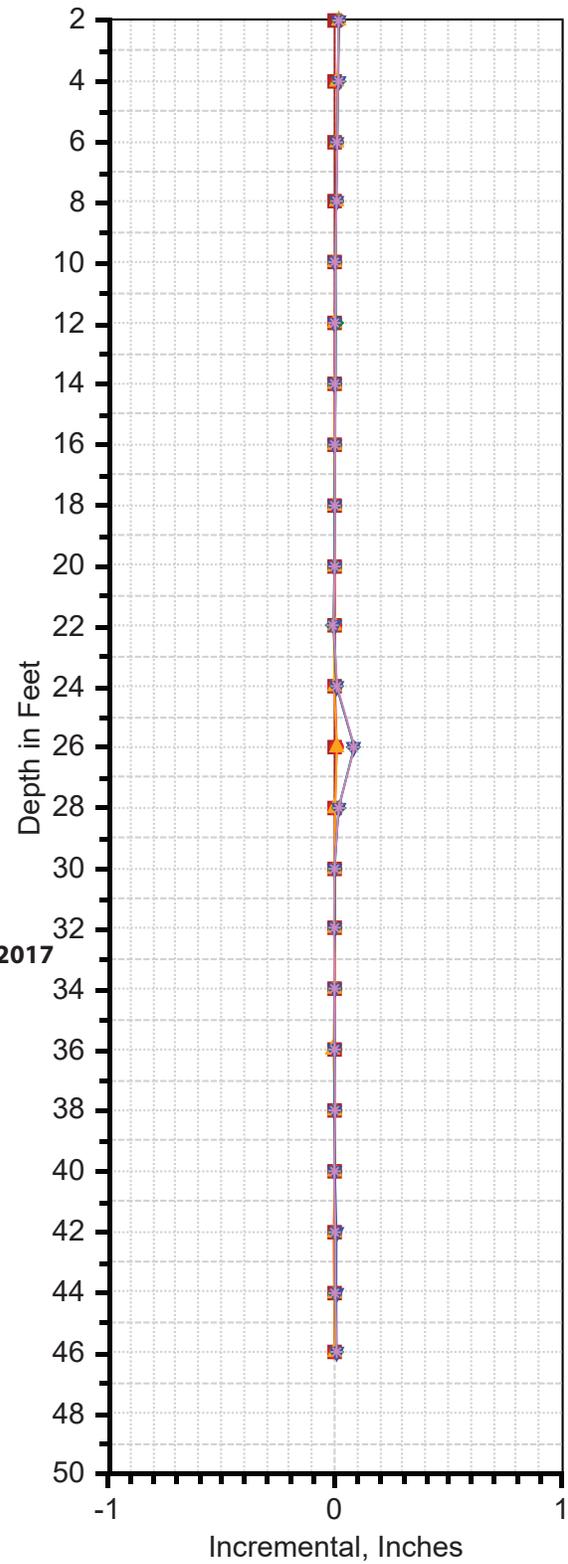
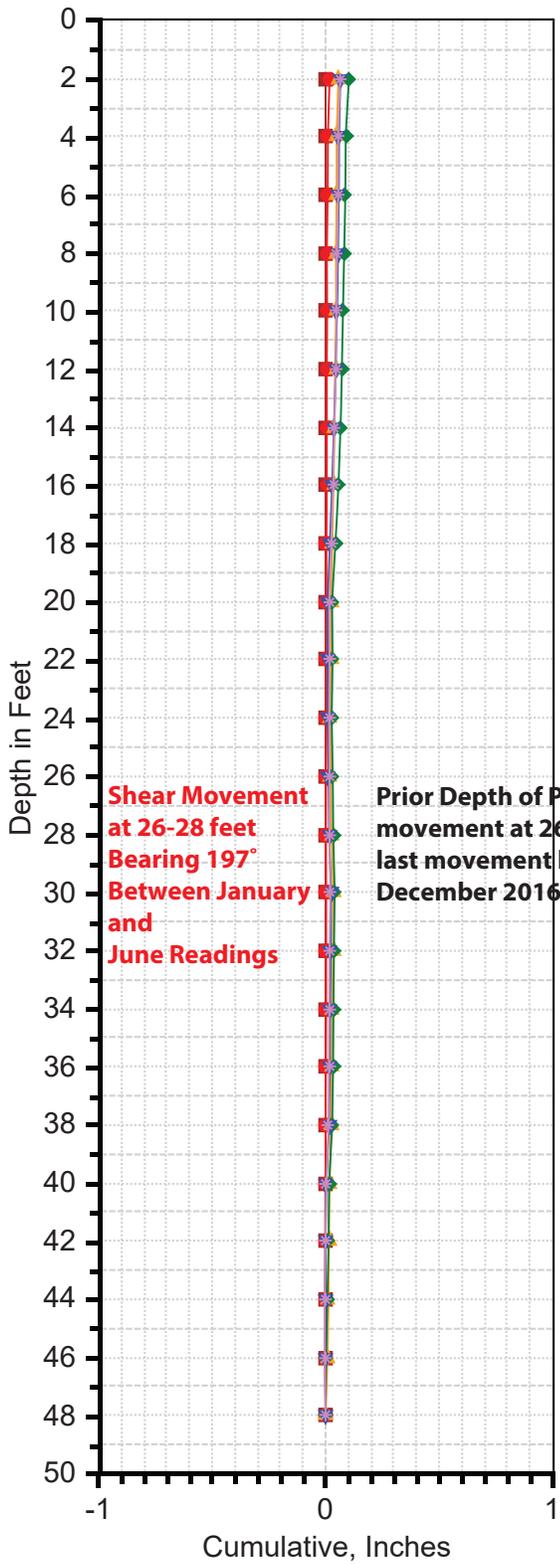
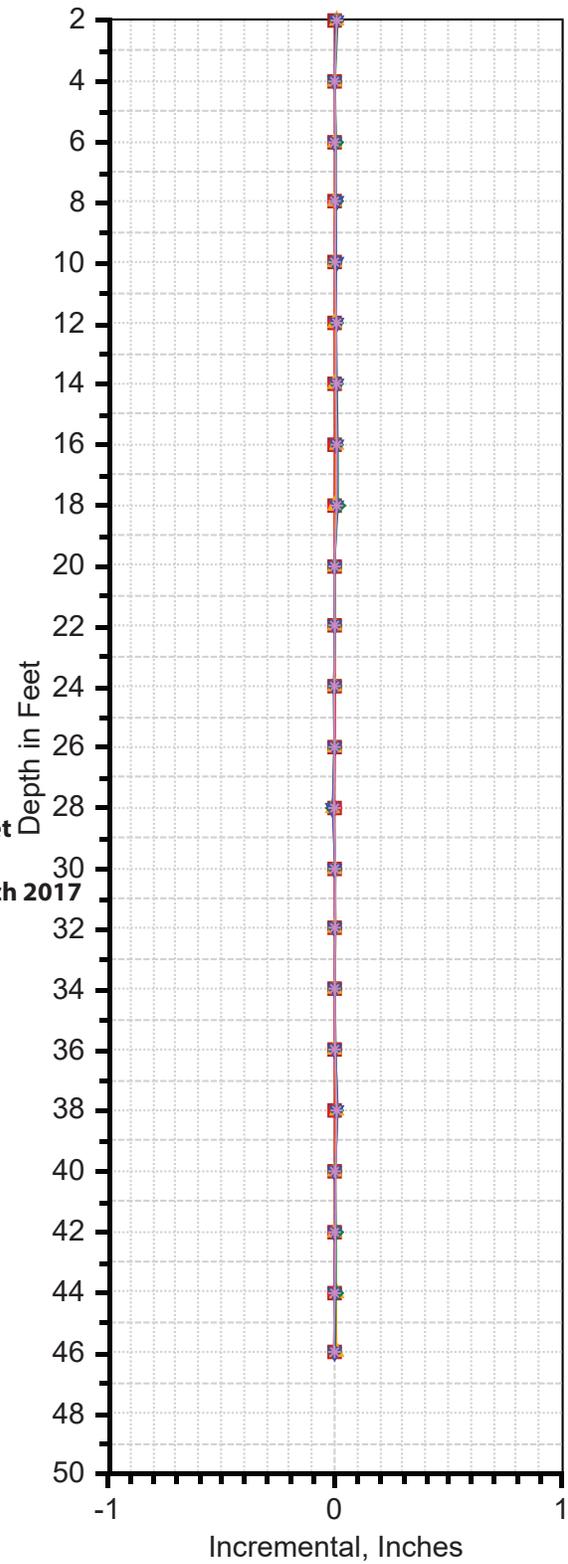
During the current monitoring year, shear-type movement was detected in inclinometers SI-1A, -2A and 4A between the Q1 and Q2 surveys; however, no movement was recorded in SI-5 and SI-6 as presented in Table 5. After the Q2 survey, inclinometers were surveyed on an accelerated schedule and no additional movement has been detected.

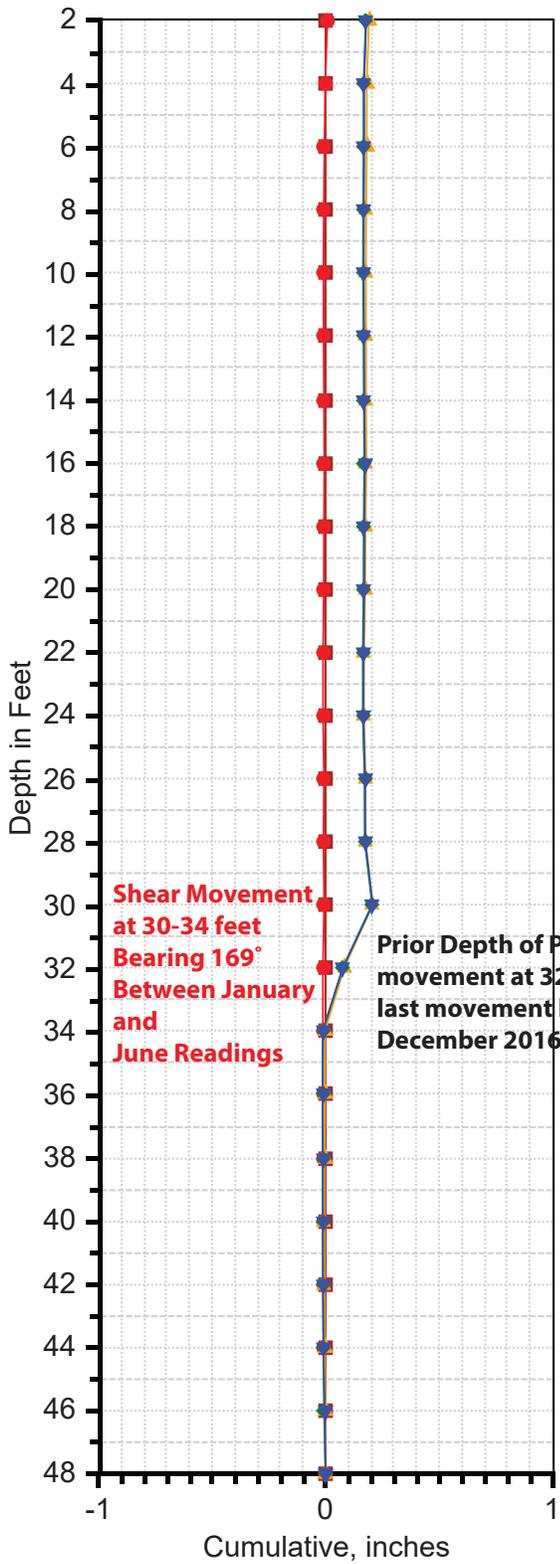
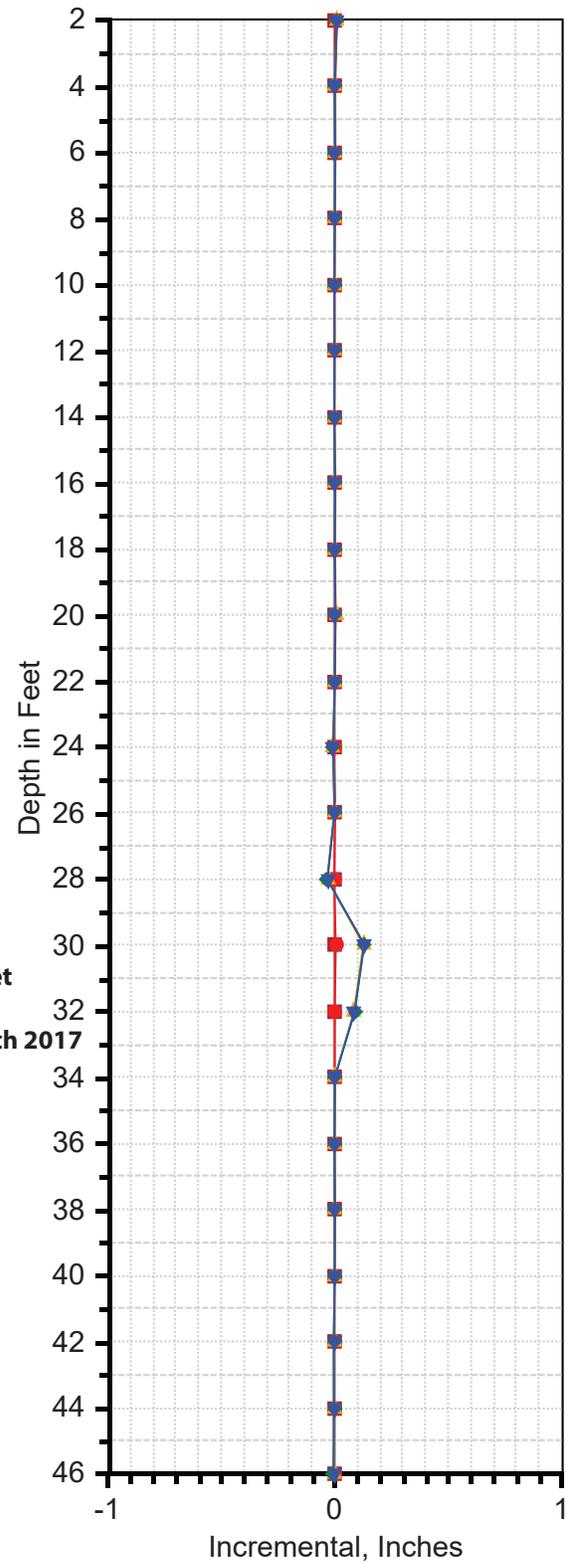
Shear Movement at 30-34 feet Bearing 169° Between January and June Readings

Prior Depth of Primary movement at 32 to 34 feet last movement between December 2016 and March 2017
