FY23/24 Maintenance and Monitoring

AD98-2, Calle del Barco

Yeh Project No.: 220-277

Subject: Annual Monitoring and Maintenance Report FY23/24, City of Malibu Assessment District 98-2, Calle del Barco, Malibu, CA

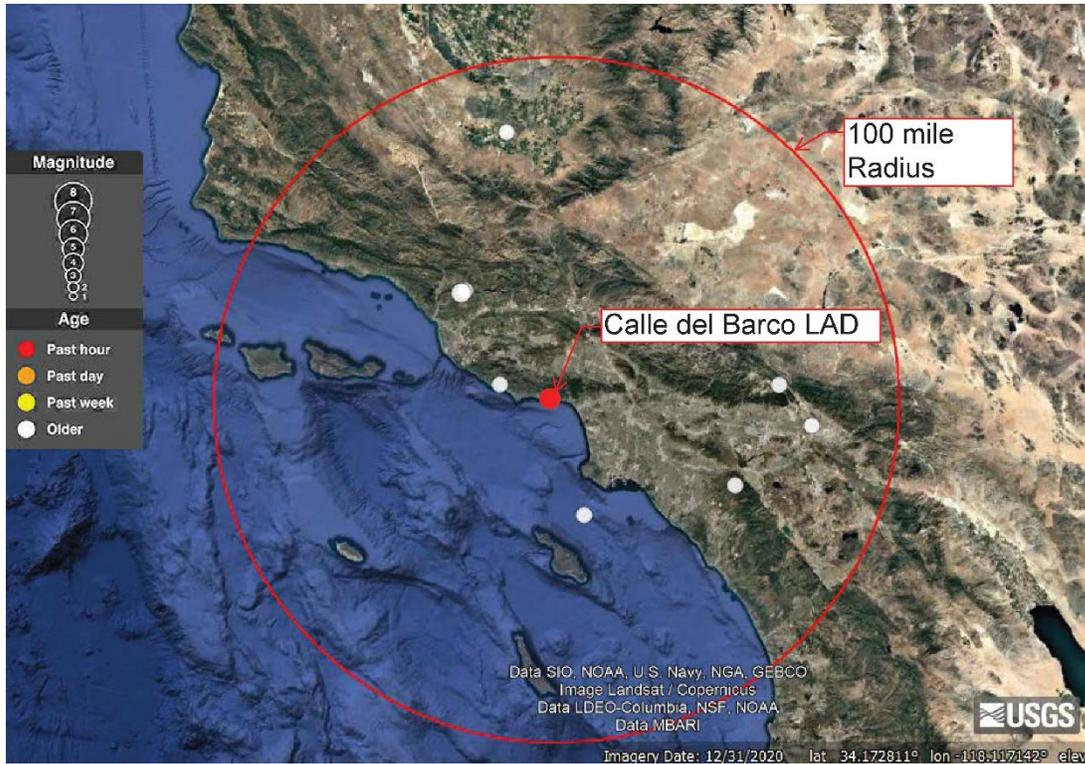
Figure 2: M4.0+ earthquakes within 100-miles of Calle del Barco LAD between 7/1/2023 and 6/30/2024

Eight earthquakes with a magnitude of 4.0 or greater were recorded within a 100-mile radius of the project area (See Figure 2). Earthquake magnitudes ranged from M4.09 to M5.08 with epicentral distances ranging from 17 to 80 miles. The largest event was reported as M5.08 that occurred August 20, 2023 and was located 40 miles to the northwest, near Ojai, CA.

Yeh personnel performed post-earthquake observations and measurements that included surveying of key inclinometers and/or field observations of the ground surface made during scheduled monitoring and maintenance before and after the earthquake events. Measured movement from inclinometer surveys discussed in Section 2.2 of this report do not necessarily appear to be attributed to seismic activity. Yeh staff did not observe surface displacements related specifically to the earthquakes and is unaware of any reports of damage local to the Calle del Barco Landslide AD resulting from the earthquakes.

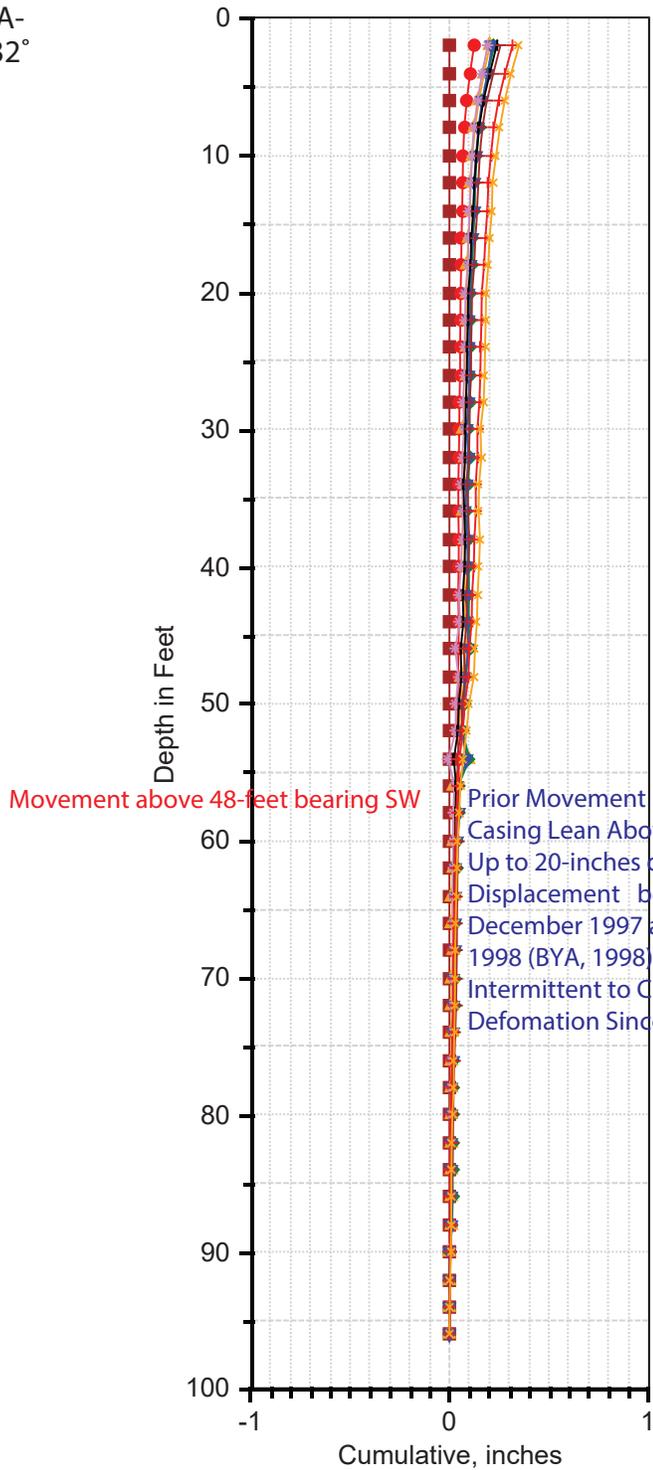
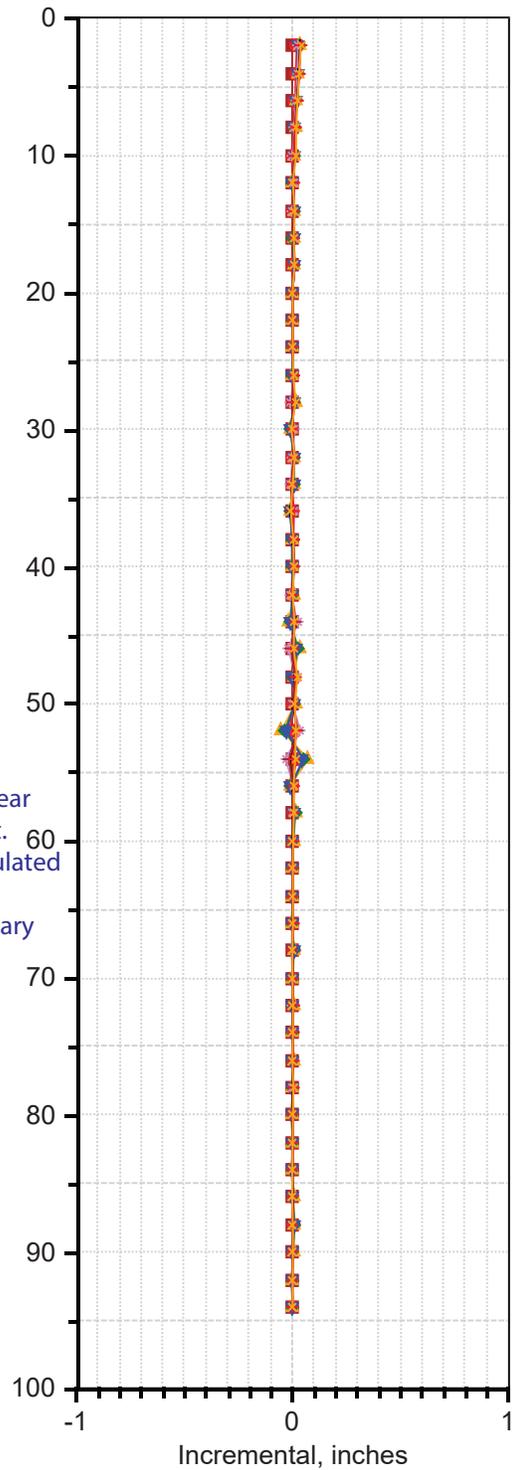
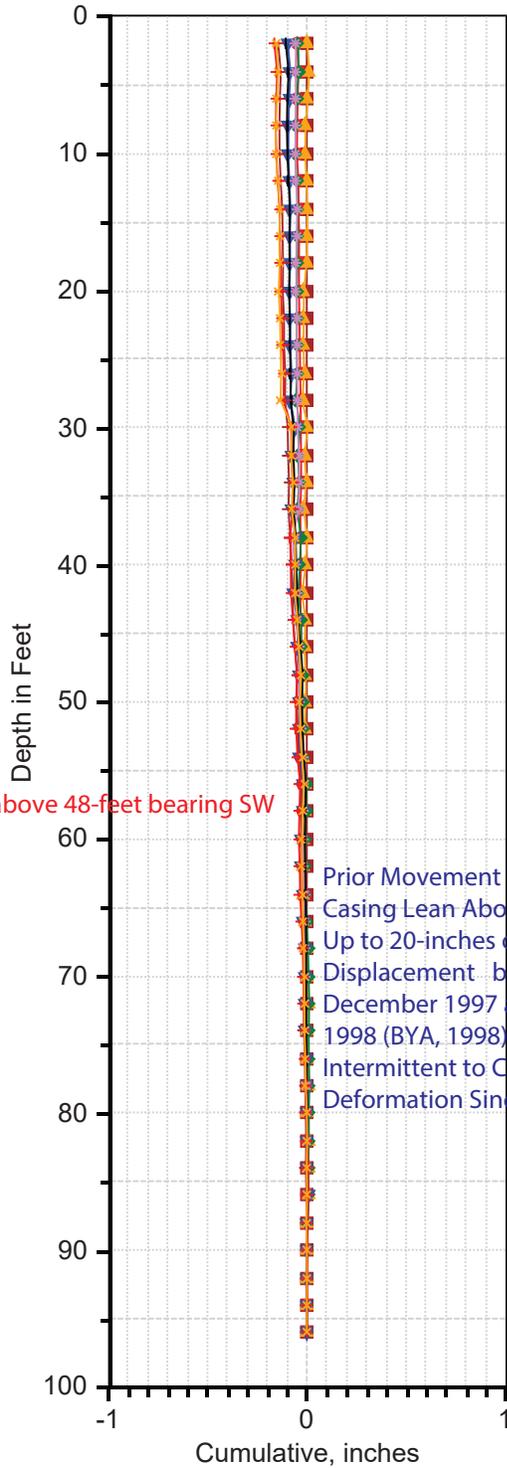
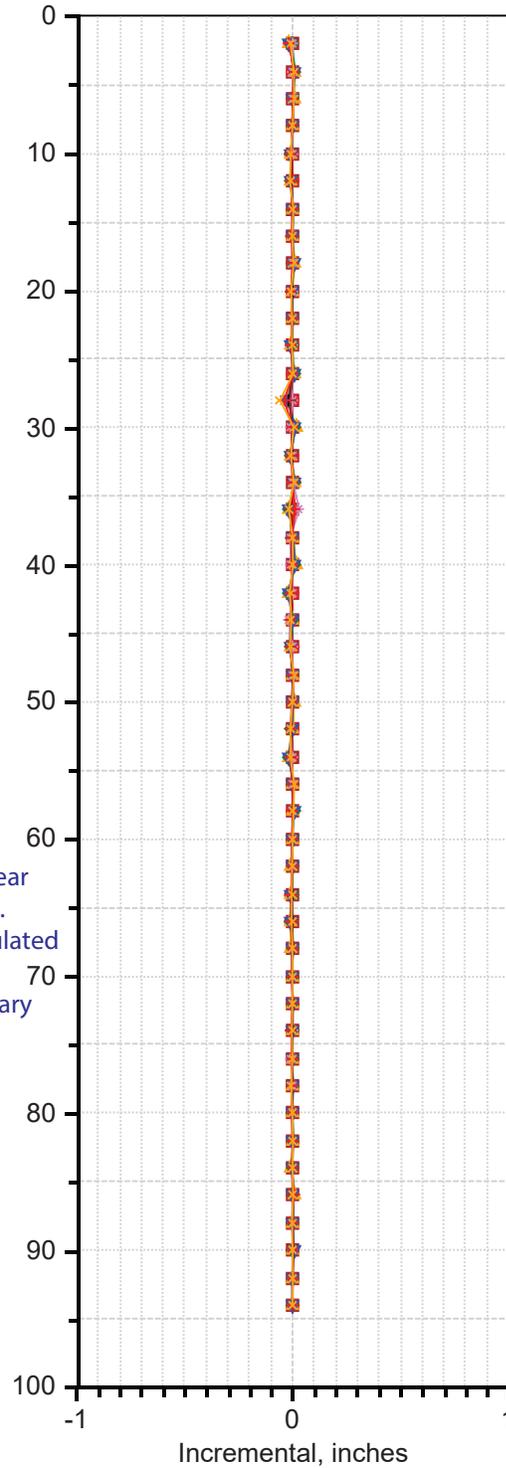
Movement above 48-feet bearing SW
 Prior Movement is Non-Shear
 Casing Lean Above 60-feet.
 Up to 20-inches of Accumulated
 Displacement between
 December 1997 and February
 1998 (BYA, 1998).
 Intermittent to Creeping
 Defomation Since 1998

Movement above 48-feet bearing SW

Prior Movement is Non-Shear
Casing Lean Above 60-feet.
Up to 20-inches of Accumulated
Displacement between
December 1997 and February
1998 (BYA, 1998).
Intermittent to Creeping
Deformation Since 1998
