Project No. 220-276

City of Malibu  
23825 Stuart Ranch Rd.  
Malibu, California 90265

**Subject: Interim Report of Dewatering System Status and Summary of Collected Data following Palisades Fire, City of Malibu Assessment District 98-1 - Big Rock Mesa, Malibu, CA**

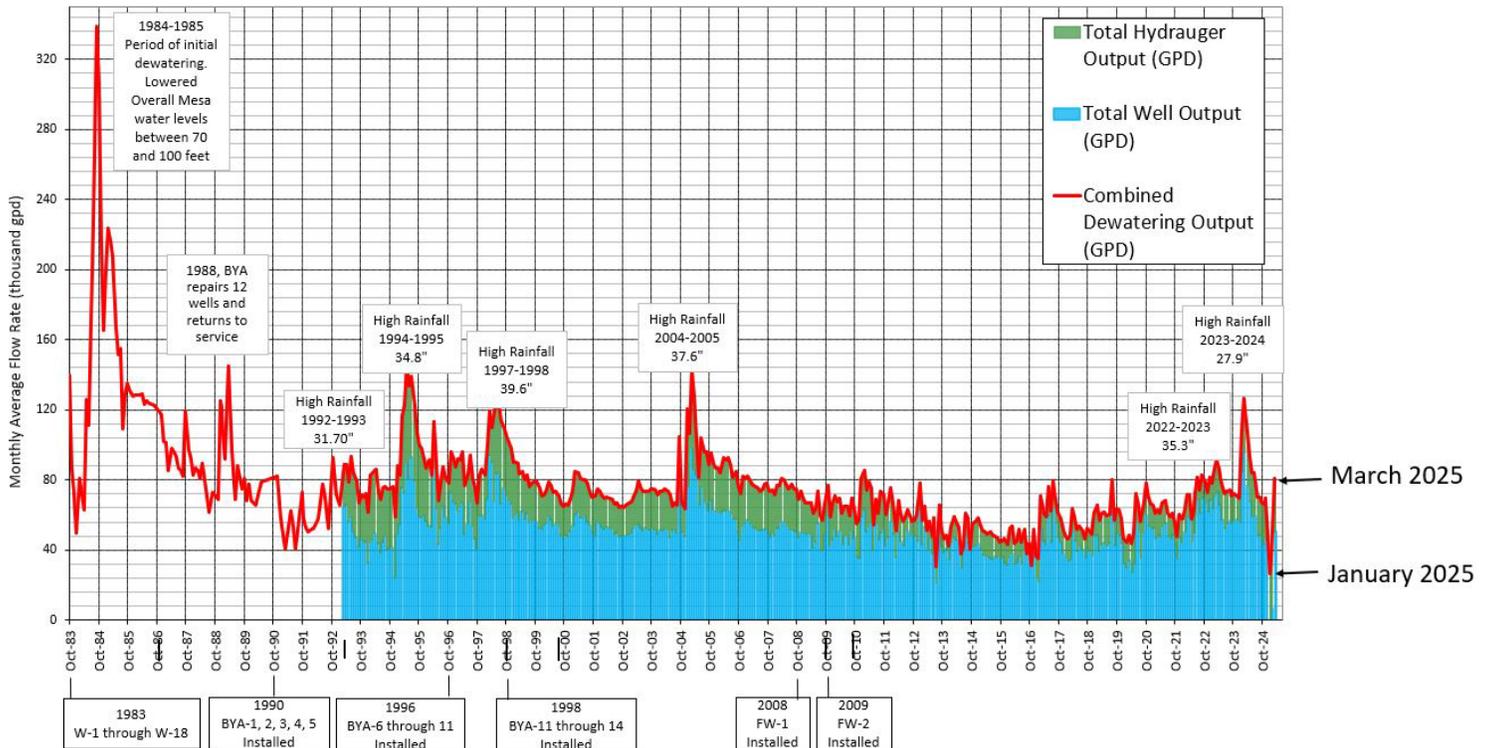
**Figure 1: Historical Average Dewatering Output (Wells and Hydraugers)**

Total dewatering production for the most recent month and including dewatering wells and hydraugers is approximately 76,773 gallons per day (GPD) as shown in Table 1. Figure 1 presents a historical graph of total discharge from 1983 through March 31, 2025.

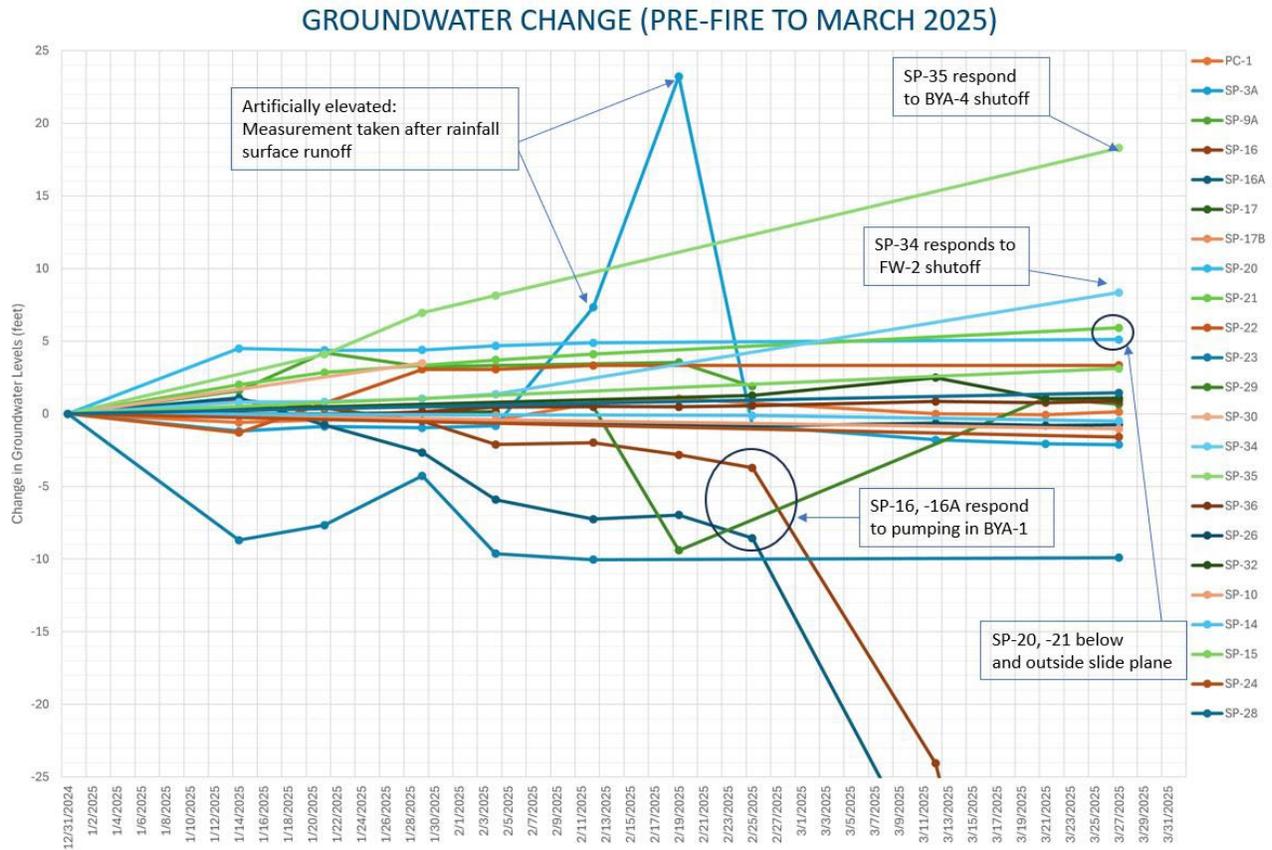
**Figure 2: Groundwater Change (December 2024 through March 2025)**

Figure 2 plots the change in water level measurements with respect to a December 2024 baseline that was the last measurement obtained prior to the fire. Historic groundwater hydrographs by sub-region are attached as Appendix A that include measured data through March 31, 2025.

Groundwater level increases measured in SP-34, 35, and 9a and decreases within SP-16, 16a are within the cone of influence of nearby dewatering wells and their water level responds directly with pumping. Water levels changes in the remaining standpipes are too small to infer causation between decreased pumping versus normal seasonal fluctuations.

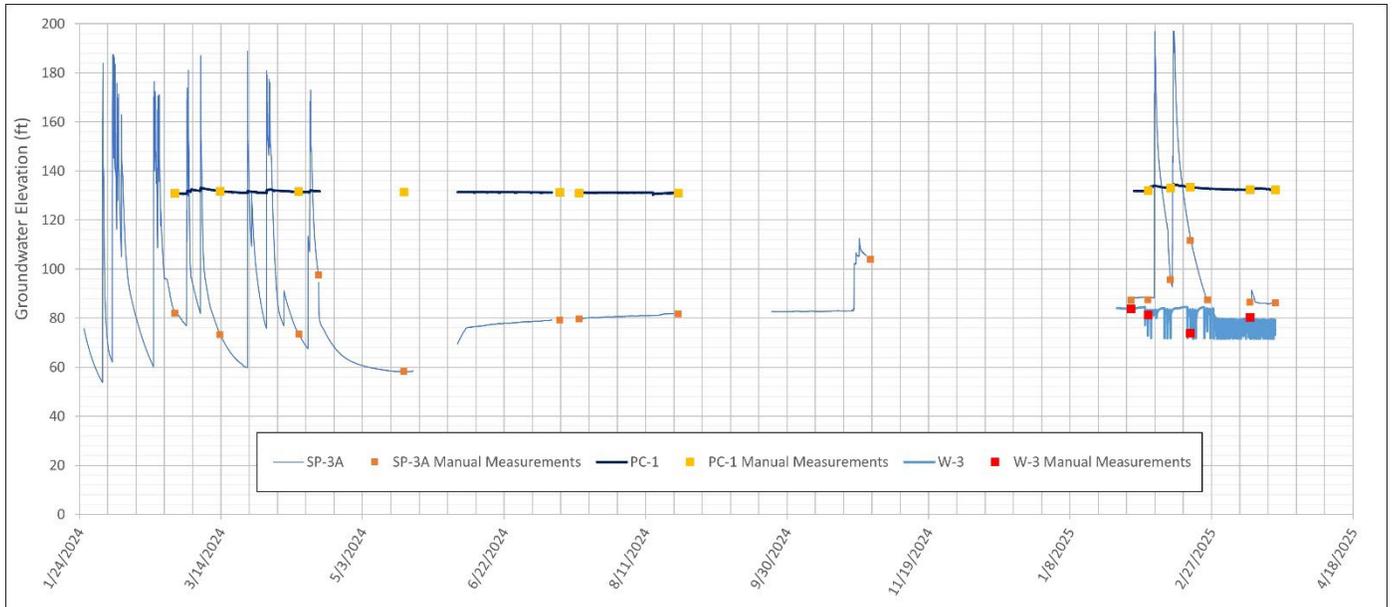
Figure 3: Groundwater Transducer Data

Monthly groundwater levels in Standpipe SP-3A fluctuated in response to February rainfall and rose approximately 24.4-feet within the casing following February rain. This has been observed to be the result of surface runoff directly filling the casing during rainfall. Water levels in SP-3A relative to pre-fire December 2024 declined by 2.1-feet. Monthly water levels in PC-1 remained essentially unchanged with a slight increase of 0.1-feet. This elevation change is too small to infer causation resulting from decreased pumping versus normal seasonal fluctuations. Figure 3 presents plots of water elevation transducer data for PC-1 and SP-3A and W-3:
