**ANNUAL REPORT
JULY 2009 THROUGH JUNE 2010
CALLE DEL BARCO
LANDSLIDE ASSESSMENT DISTRICT
MALIBU, CALIFORNIA**

Prepared for:
CITY OF MALIBU

May 2011
Fugro Job No. 04.B3399005

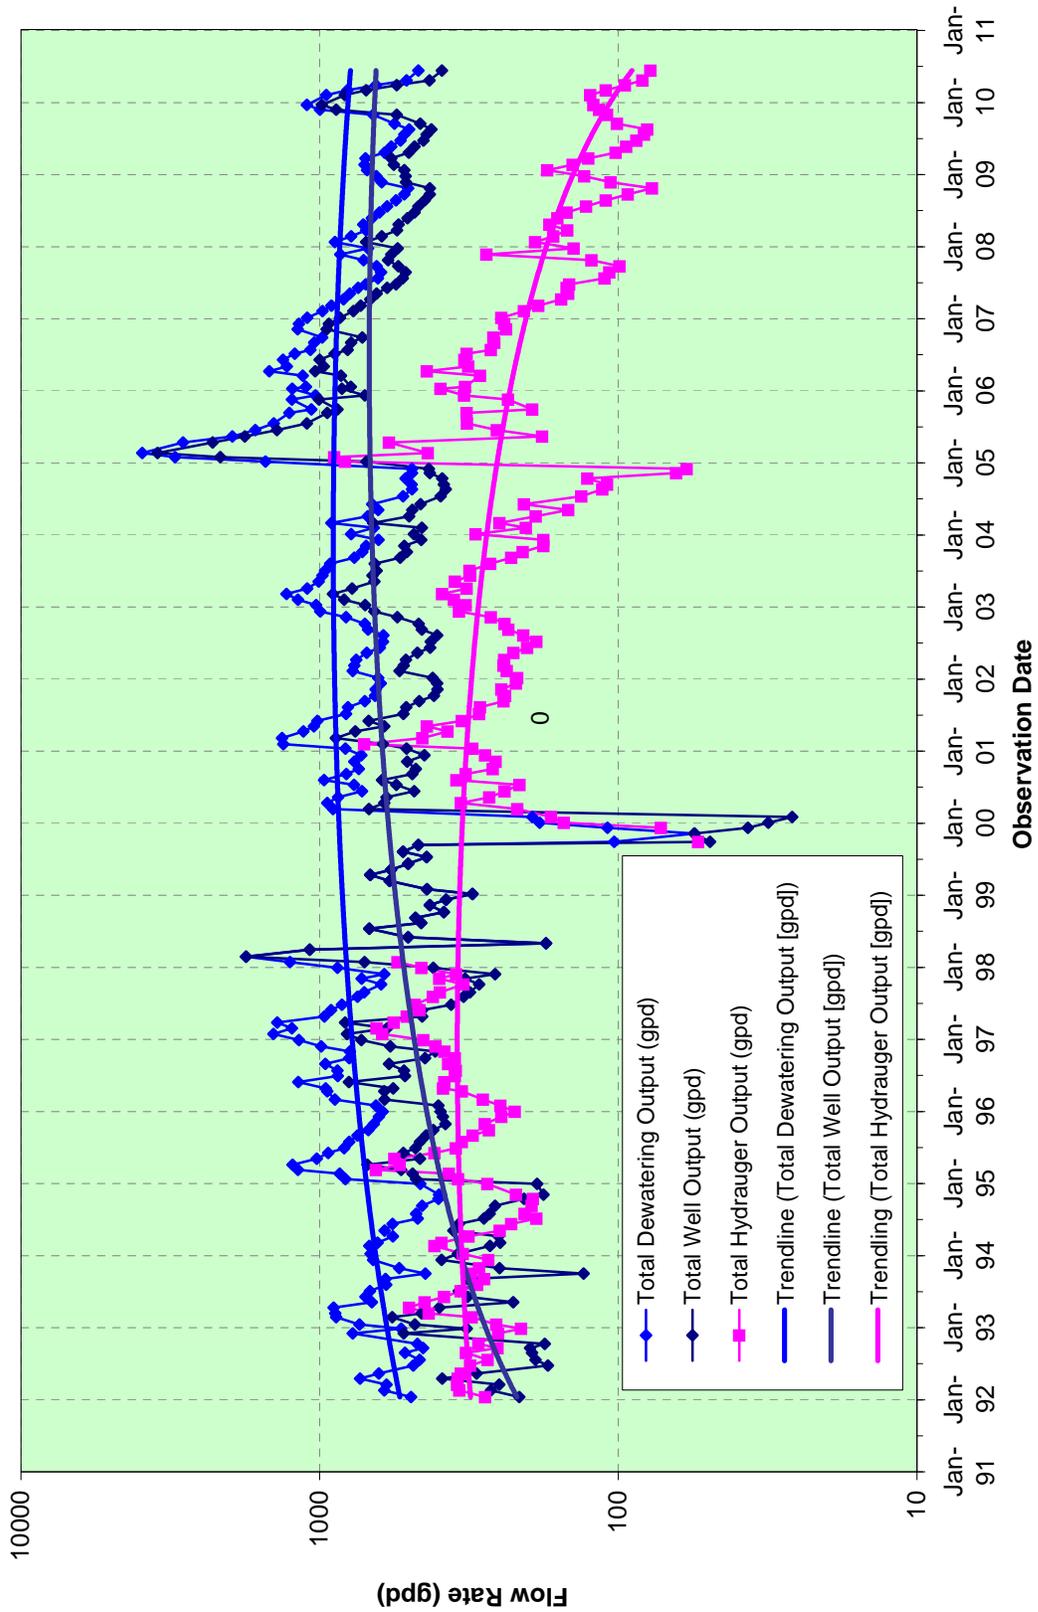
DEWATERING GRAPH
Calle Del Barco
(Total Output - All Wells & Hydaugers)

The average total well production rate for this monitoring period was approximately 590 gallons per day (gpd). This represents an increase of about 19 percent from the previous monitoring period of 494 gpd. A graph of the production rate for all dewatering wells is presented on Plate 4. Graphs showing production rates of individual wells are provided in Appendix B.

The average hydrauger production rate for all hydraugers over the monitoring period was approximately 99 gpd. This represents a decrease of approximately 16 percent over last year's hydrauger production rate of 119 gpd.

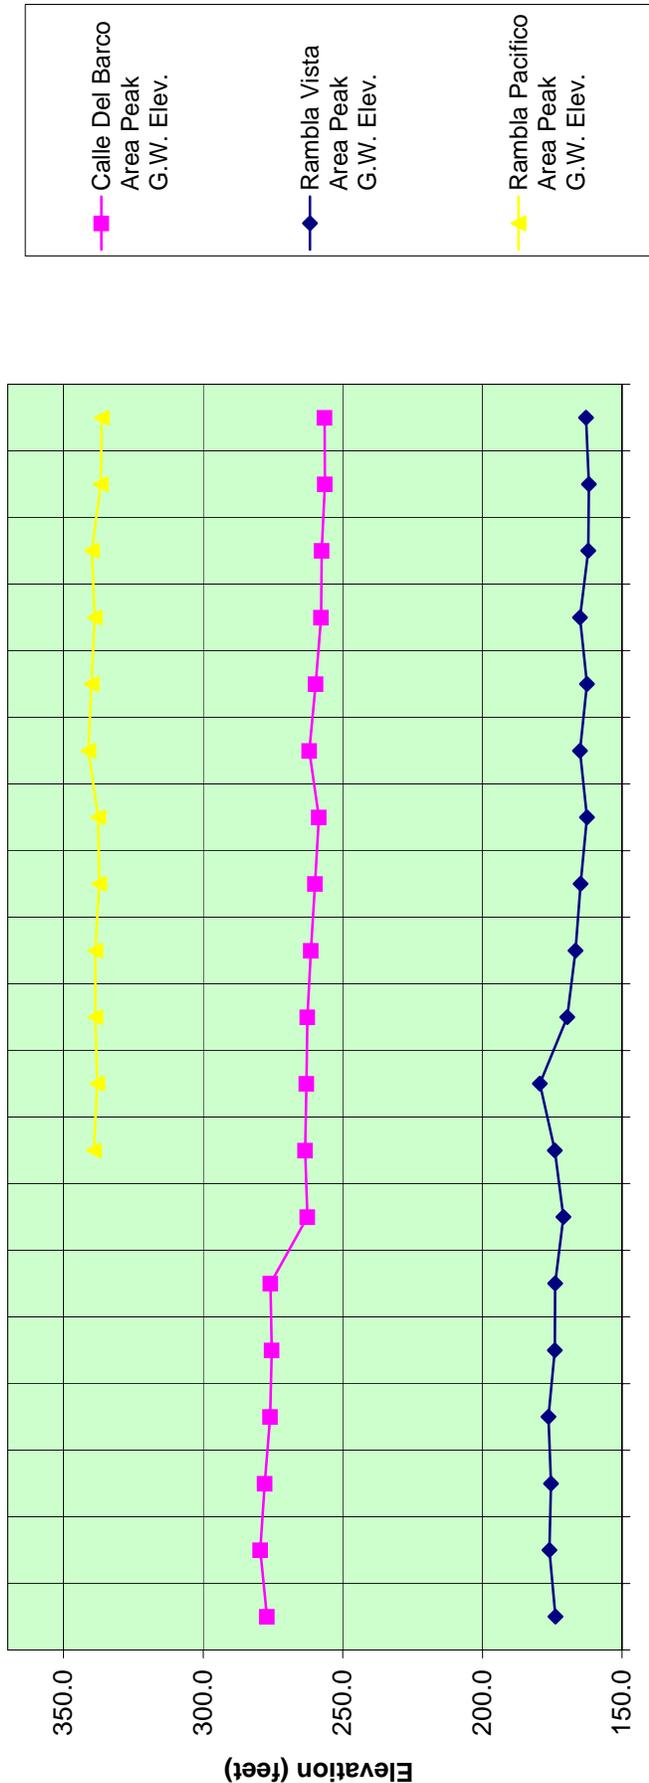
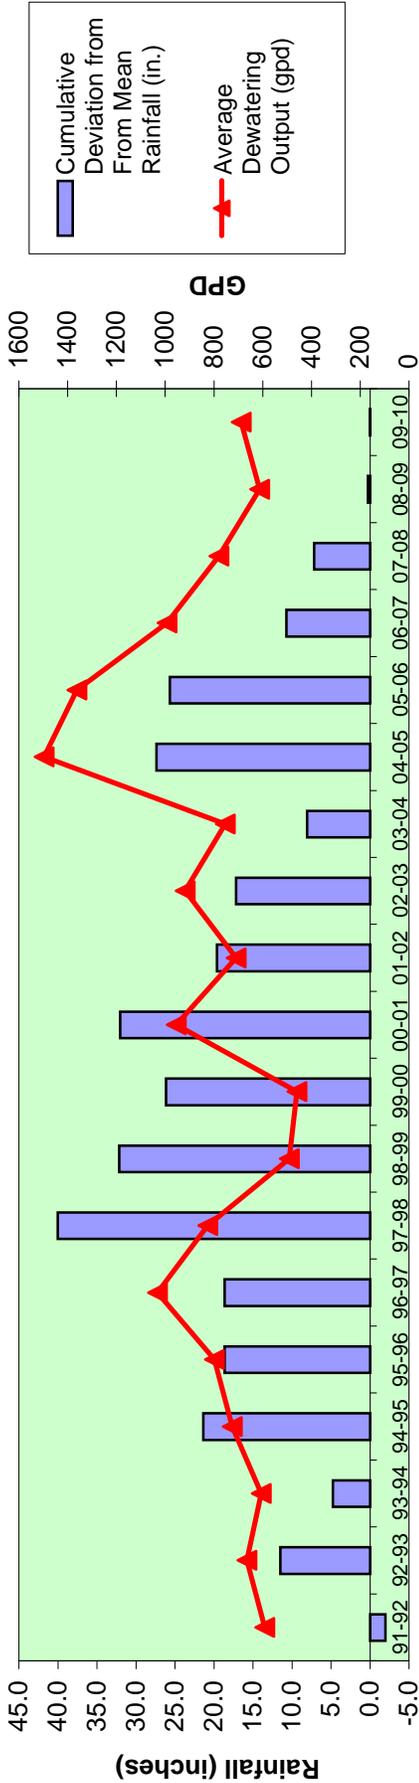
SUMMARY GRAPH
 Calle Del Barco
 Groundwater Levels, Dewatering, & Rainfall

- Slope inclinometer readings indicate no significant ground movement.
- Additional dewatering facilities are recommended in order to increase the dewatering capacity of the landslide stabilization system. Plate 5 indicates decreased production from hydraugers. Over time, hydraugers become clogged and less efficient at removal of water by gravity. Replacement hydraugers should be considered for Rambla Orienta.

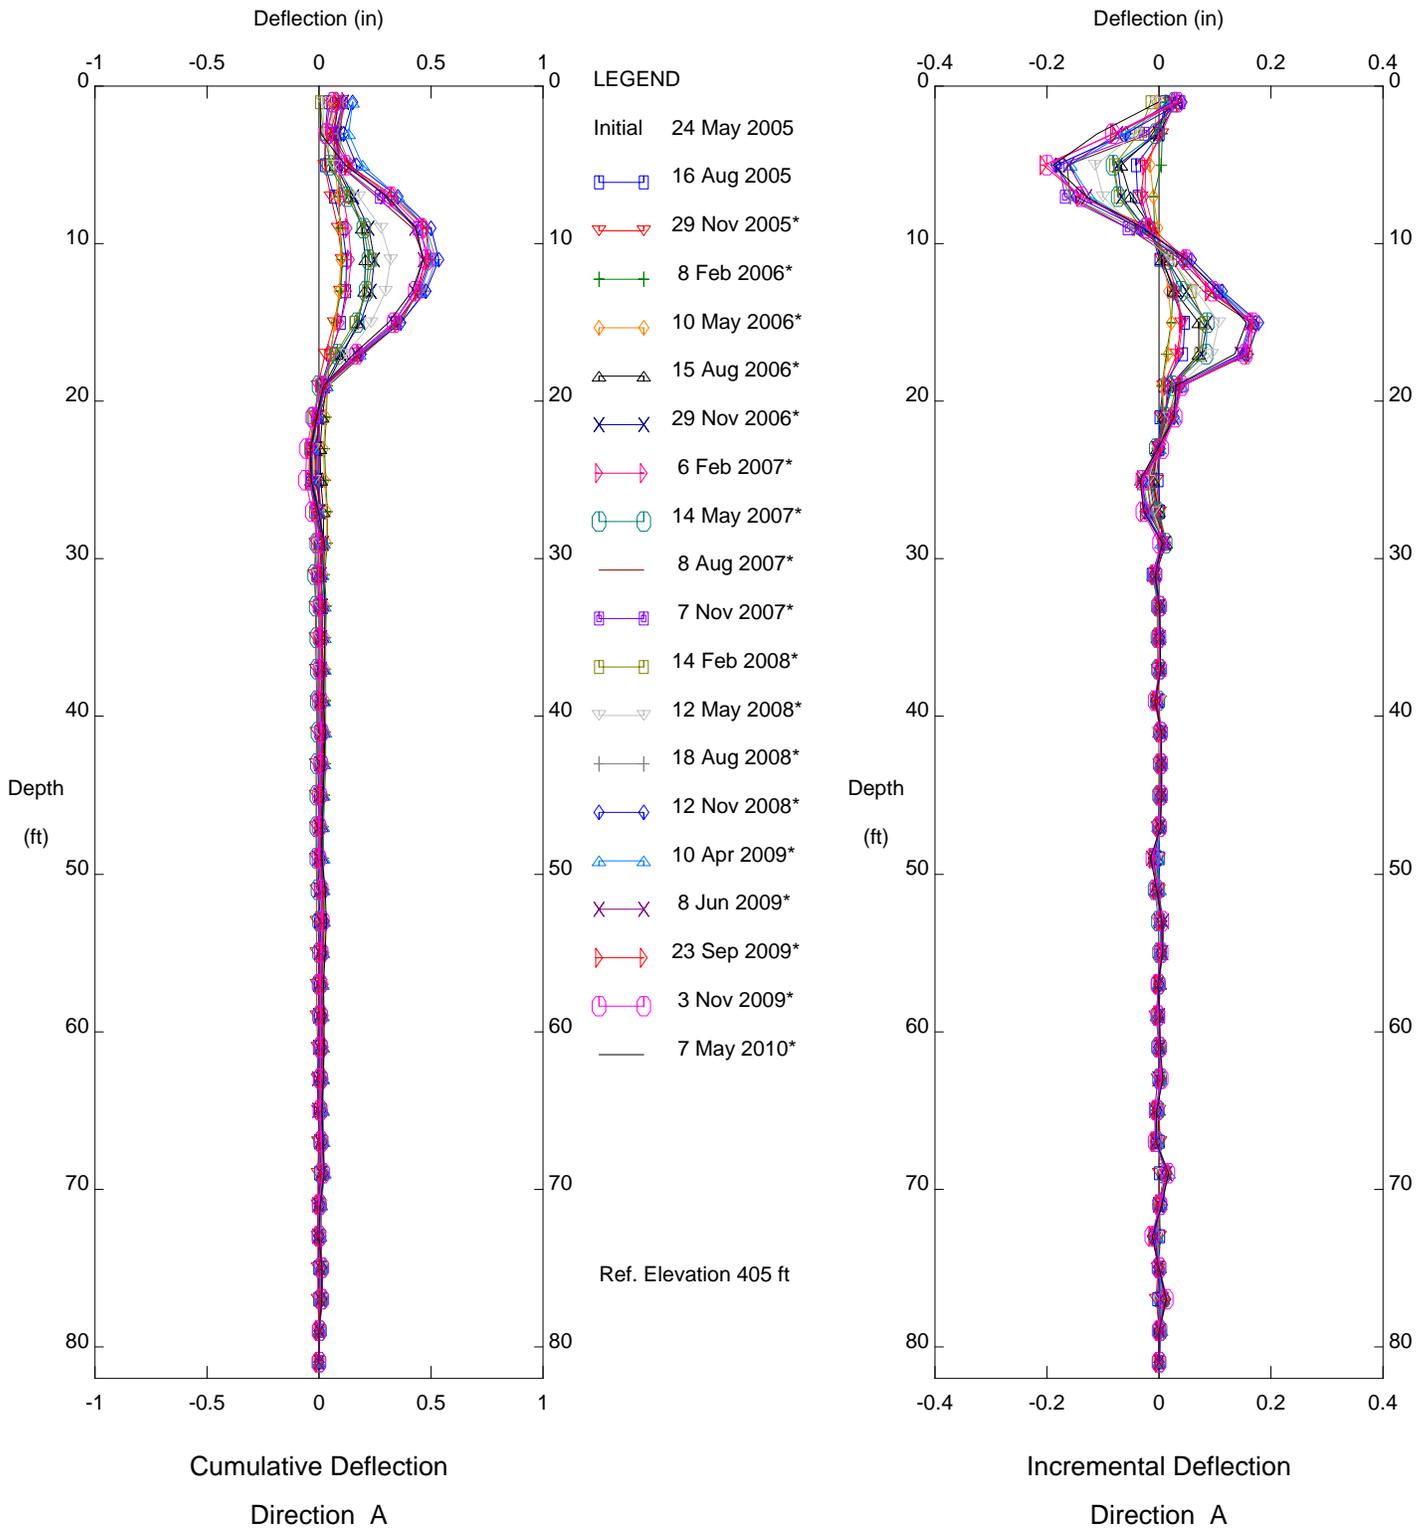
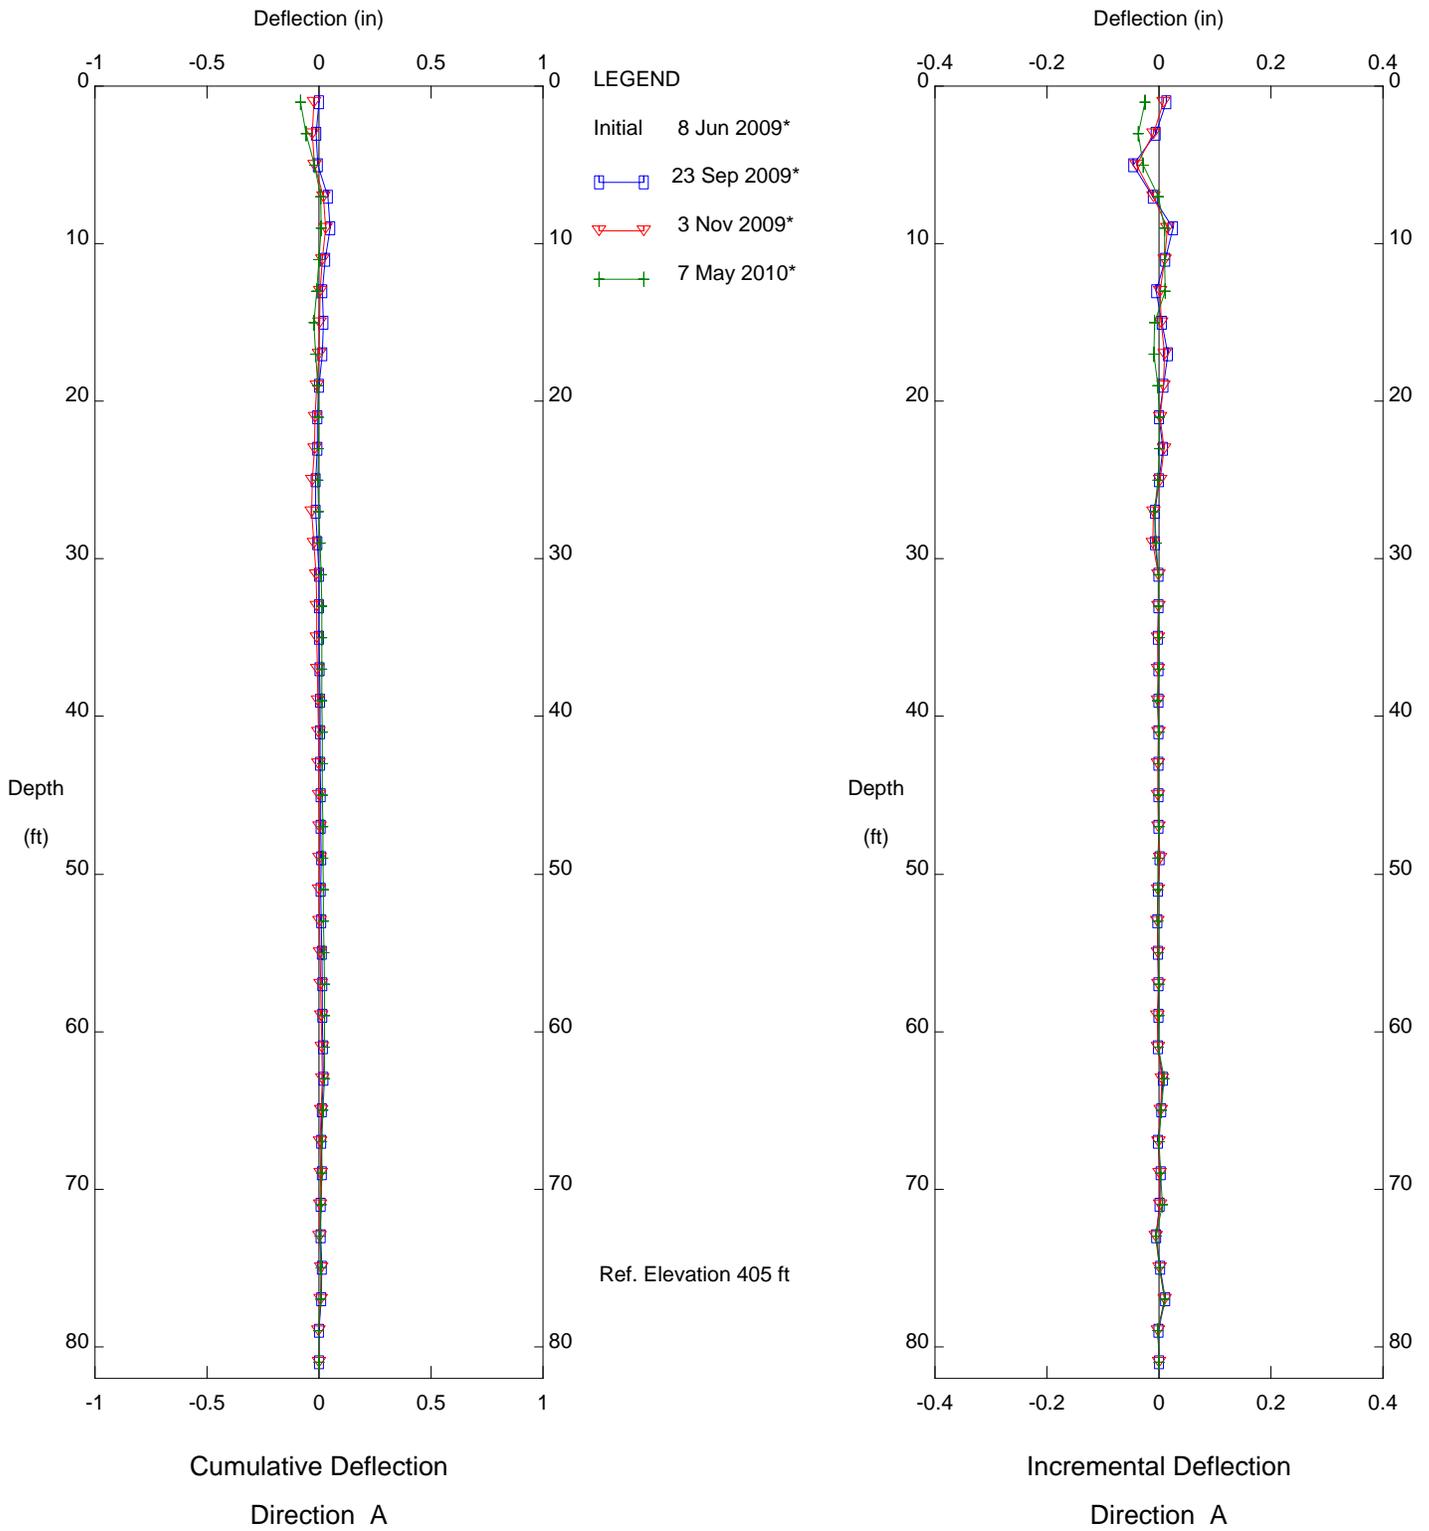
CALLE DEL BARCO, Inclinometer SI-13

During previous years, SI-13 (located on Rambla Pacifico above and outside the deep landslide) showed a variable pattern of compression in the upper 30 feet. However, no significant observable lateral displacement has been associated with this compression. This slope inclinometer may need to be replaced or the City may wish to consider other types of monitoring observations in order to further monitor or characterize conditions in that area.
