**ANNUAL REPORT  
JULY 2010 THROUGH JUNE 2011  
CALLE DEL BARCO  
LANDSLIDE ASSESSMENT DISTRICT  
MALIBU, CALIFORNIA**

Prepared for:  
CITY OF MALIBU

November 2011  
Fugro Job No. 04.B3399005

Subject: Annual Report, July 2010 through June 2011, Calle del Barco Landslide Assessment District, Malibu, California

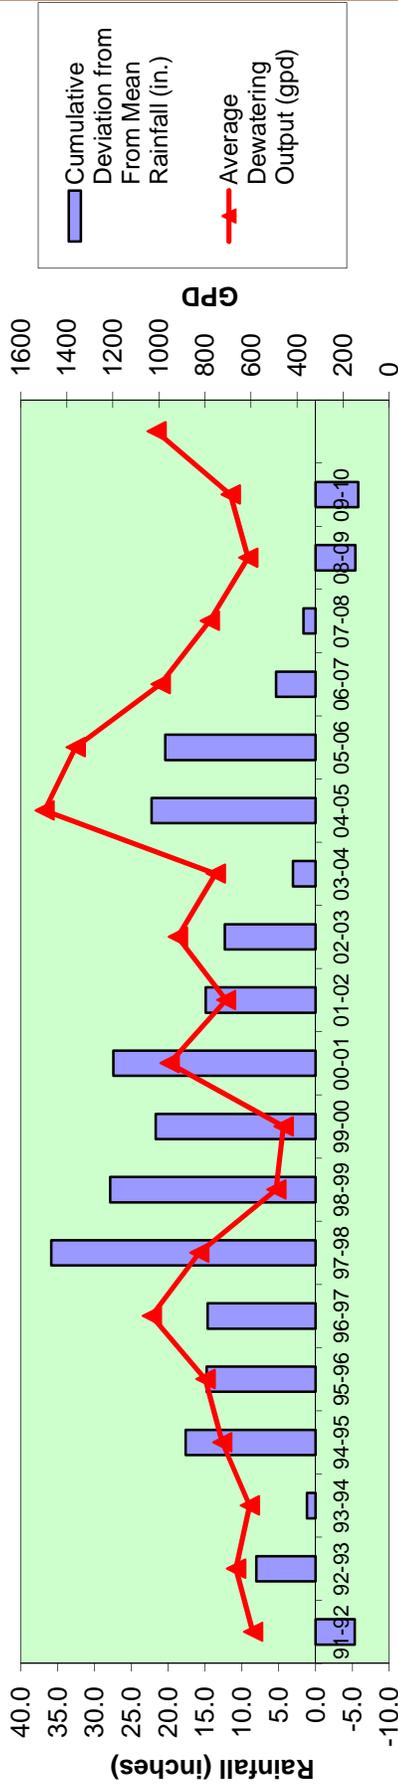
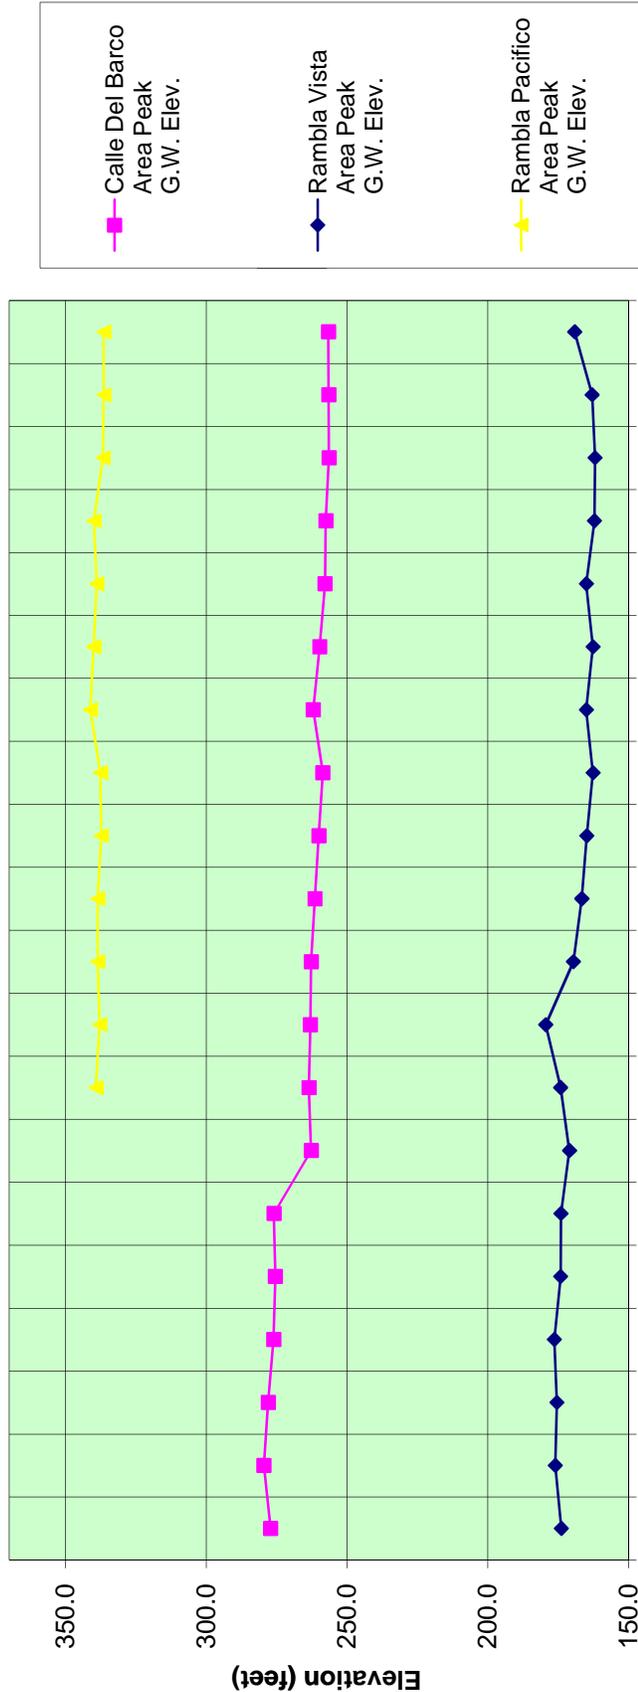
**SUMMARY GRAPH**

- Slope inclinometer readings indicate no significant ground movement.
- Additional dewatering facilities are recommended in order to increase the dewatering capacity of the landslide stabilization system. Plate 5 indicates decreased production from hydraugers. Over time, hydraugers become clogged and less efficient at removal of water by gravity. Replacement hydraugers should be considered for Rambla Orienta.

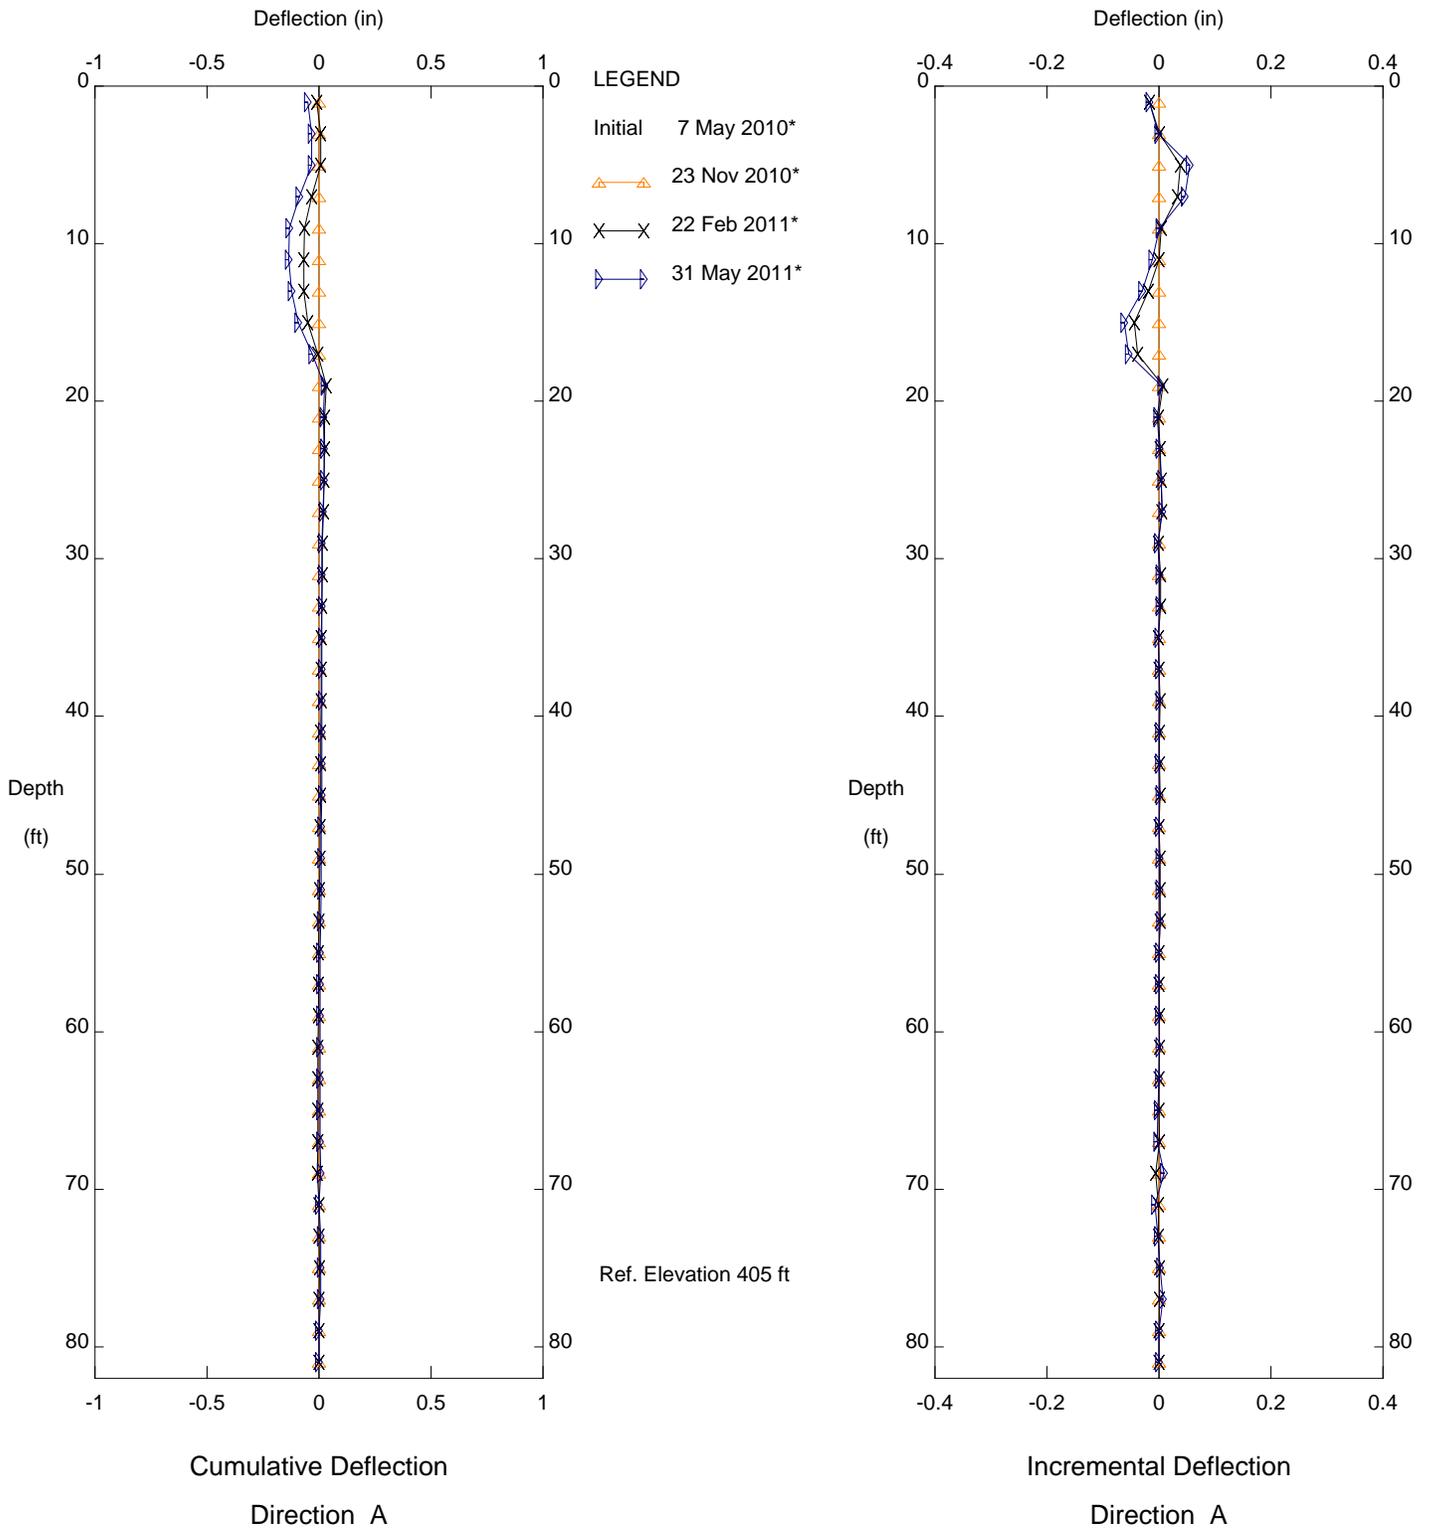
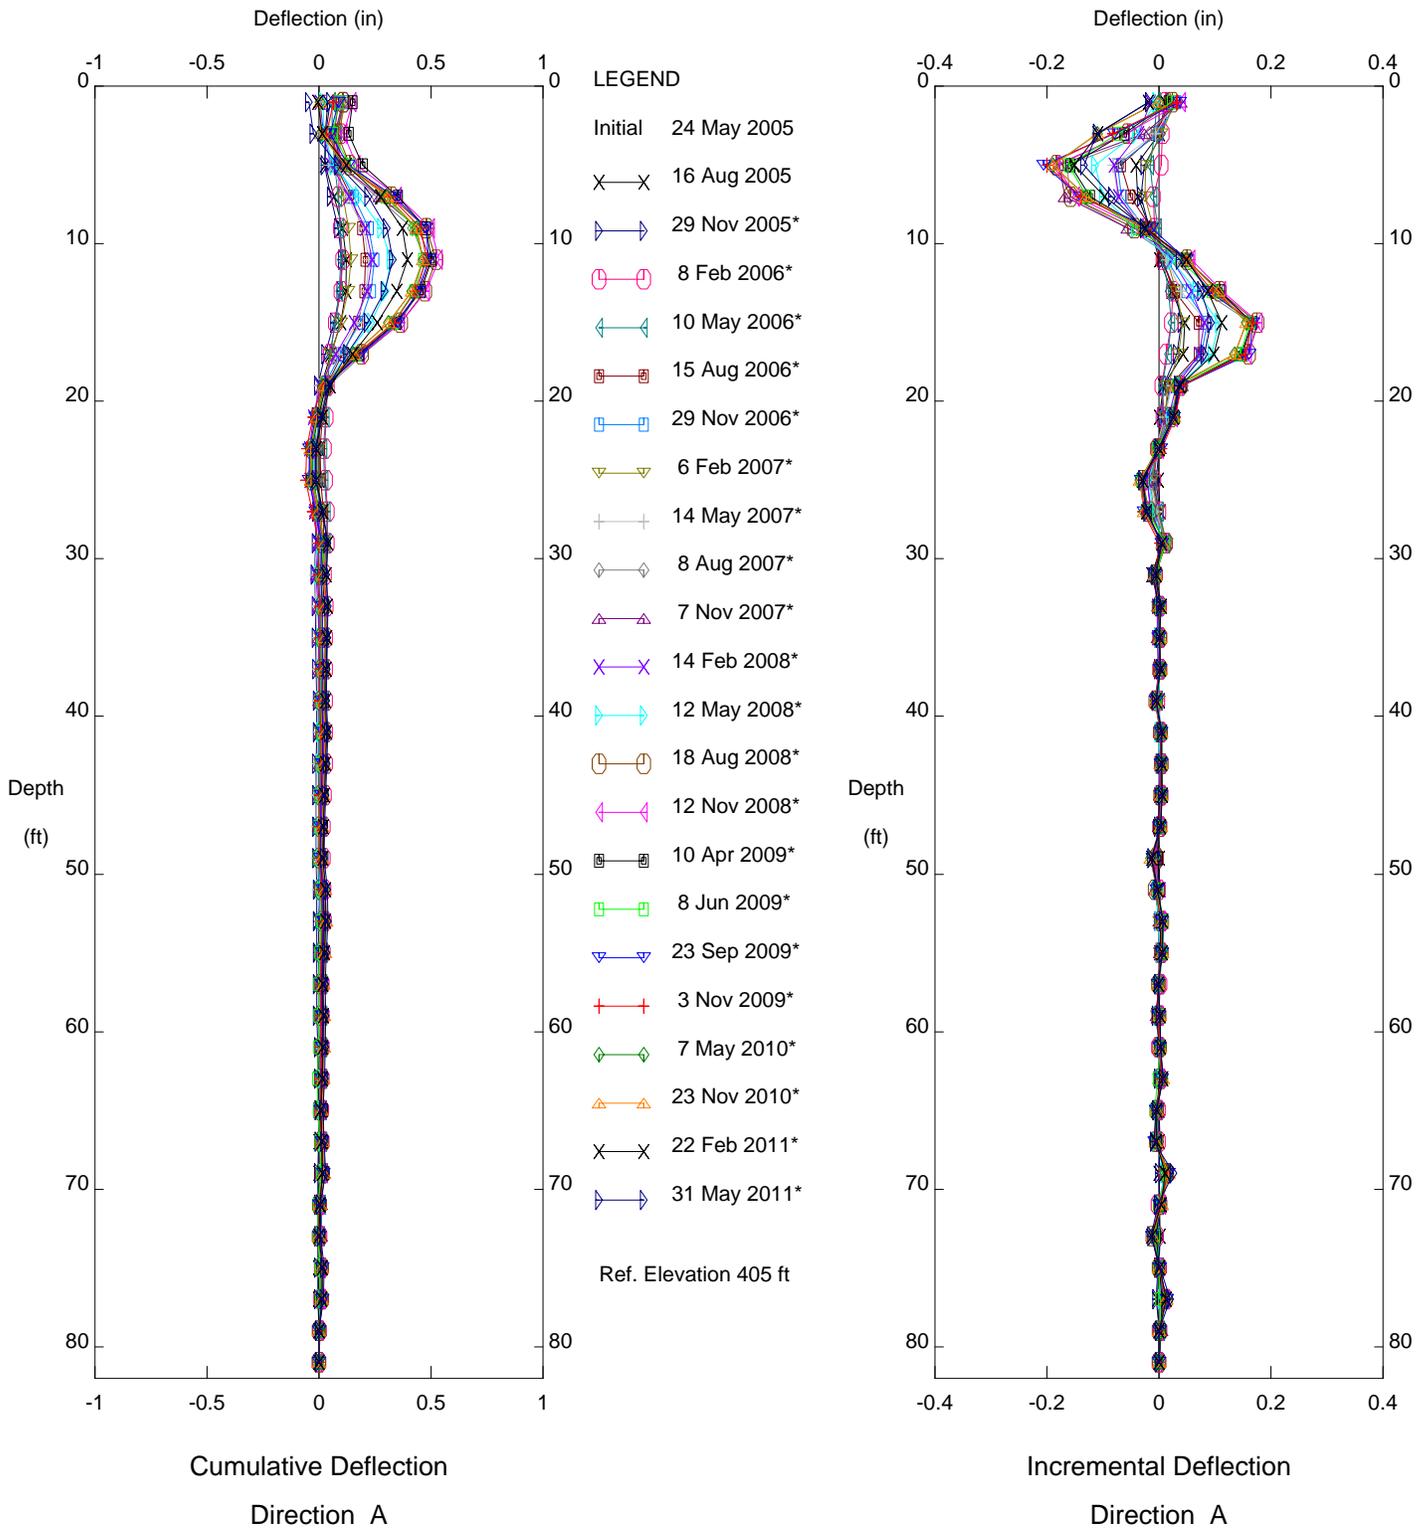
CALLE DEL BARCO, Inclinometer SI-13

During previous years, SI-13 (located on Rambla Pacifico above and outside the deep landslide) showed a variable pattern of compression in the upper 30 feet. However, no significant observable lateral displacement has been associated with this compression. If it appears that lateral movement is occurring, or distress is observed outside the current defined limits of the deep slide, the City may wish to consider replacing the inclinometer or adding other types of monitoring observations in order to monitor or characterize conditions in that area.
