**ANNUAL REPORT
JULY 2008 THROUGH JUNE 2009
CALLE DEL BARCO
LANDSLIDE ASSESSMENT DISTRICT
MALIBU, CALIFORNIA**

Prepared for:
CITY OF MALIBU

October 2009
Fugro Job No. 3399.005

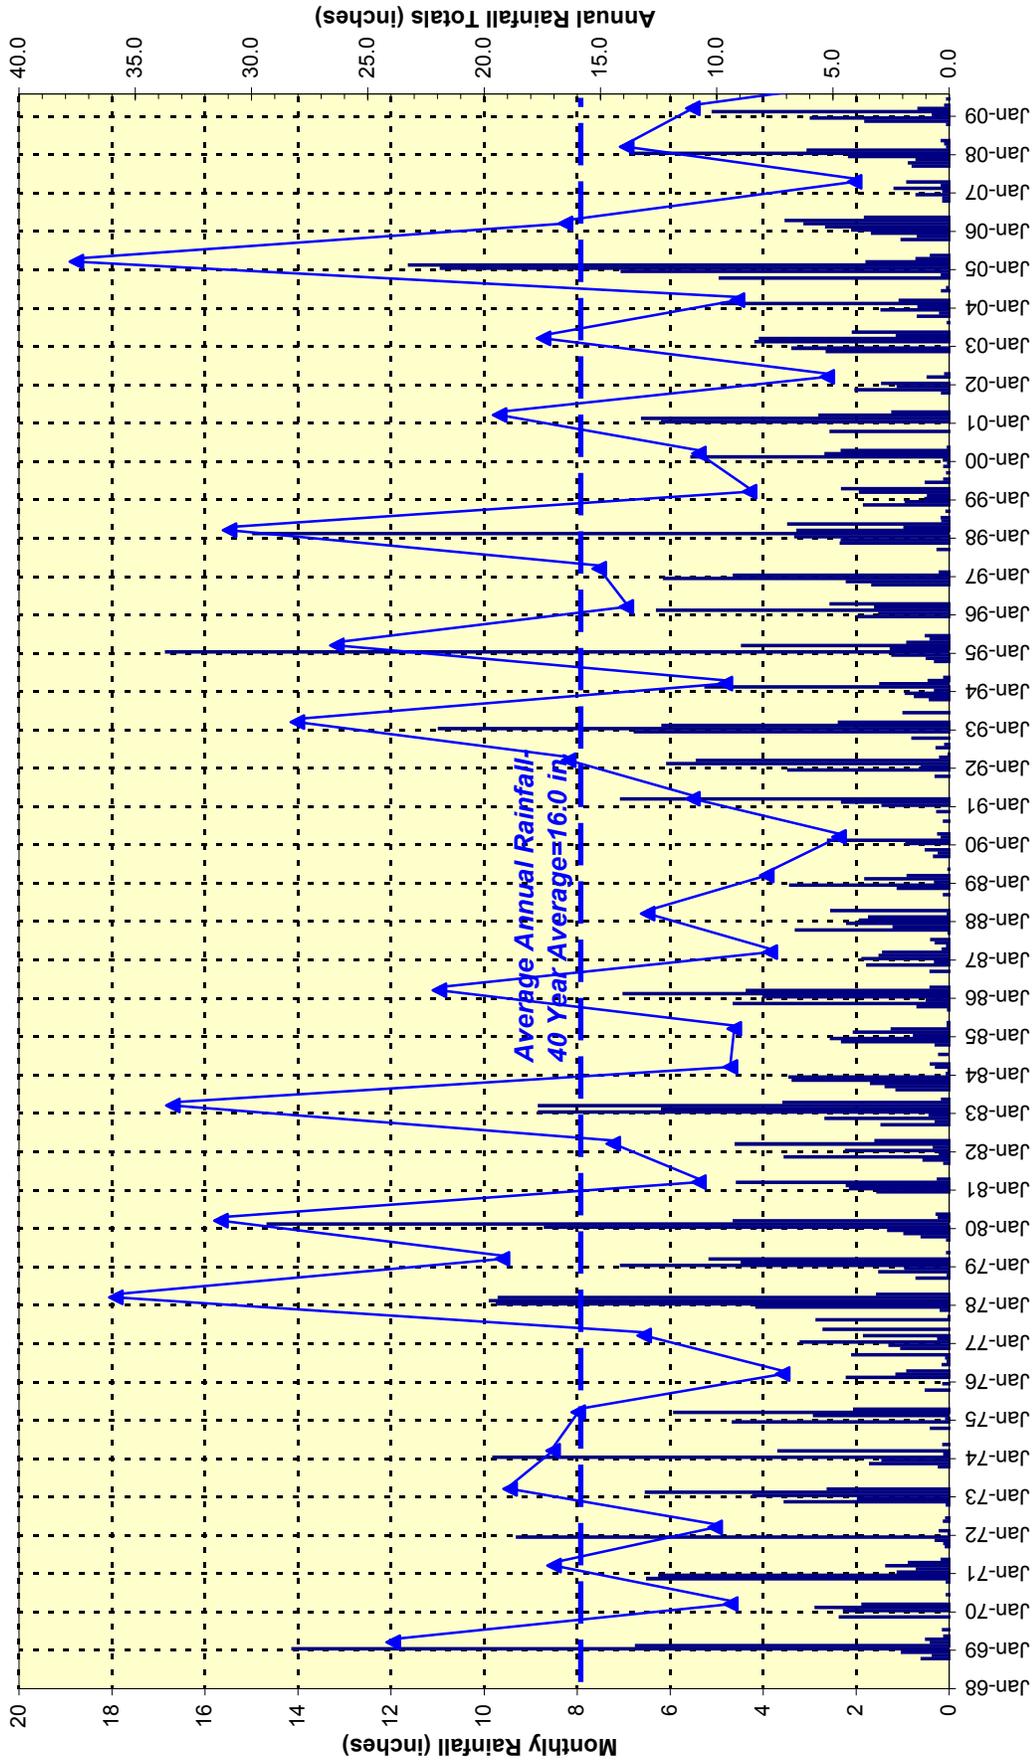
MALIBU AREA - MONTHLY & ANNUAL RAINFALL
 2008 through 2009 Annual Report
 Calle del Barco Landslide Assessment District
 Malibu, California

Rainfall data indicate that approximately 11.02 inches of precipitation fell during the monitoring period from July 2008 through June 2009. The average rainfall total from 1968 to 2009 in the Malibu area for the period July through June is approximately 16.02 inches.

Rainfall data is usually analyzed in terms of the annual "rain season" from October 1 through September 30. Rainfall for October 1, 2008 through June 30, 2009, was approximately 11.02 inches. This is approximately 69 percent of the average rainfall total of 16.02 inches for the rain seasons of 1968 through 2009.

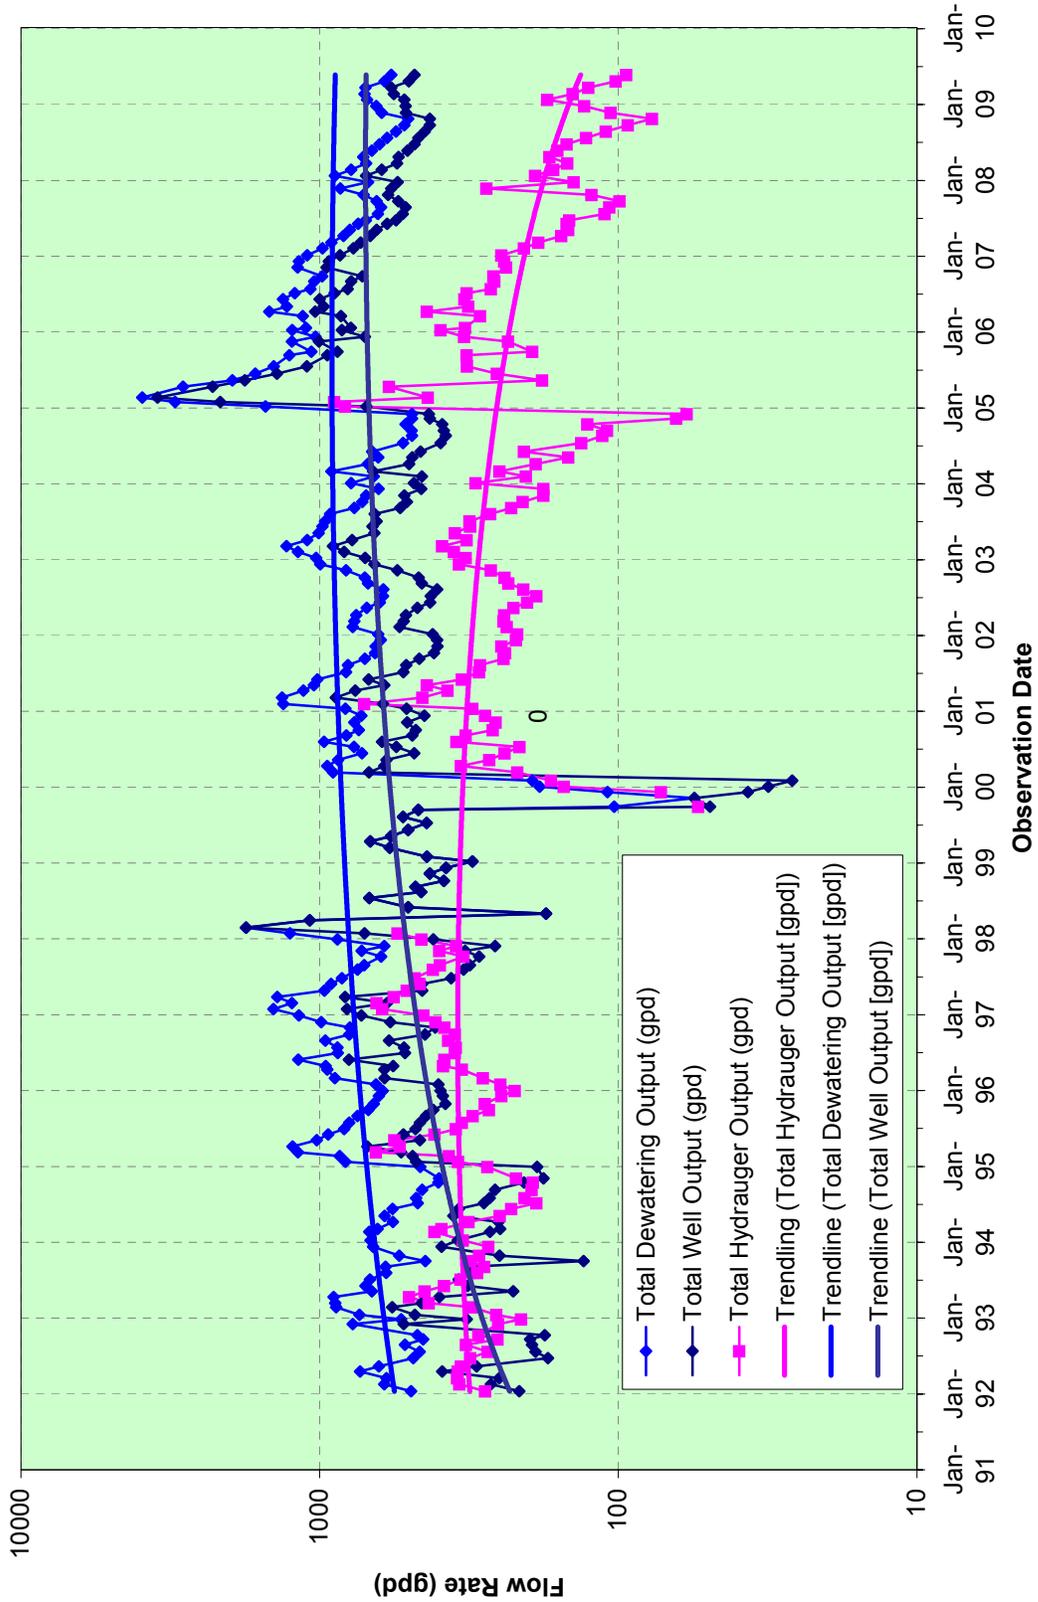
DEWATERING GRAPH
(Total Output - All Wells & Hydaugers)
2008 through 2009 Annual Report
Calle del Barco Landslide Assessment District
Malibu, California

The total production rate for all hydraugers from August 1991 through June 2007 is depicted on Plate 4. Hydrauger production rates for individual hydraugers are presented on Plate B-4 (Appendix B). Additional data regarding hydraugers and production rates are included in Appendix B.

The average hydrauger production rate for all hydraugers over the monitoring period was approximately 153 gpd. This represents a decrease of approximately 29 percent over last year's hydrauger production rate of 214 gpd.

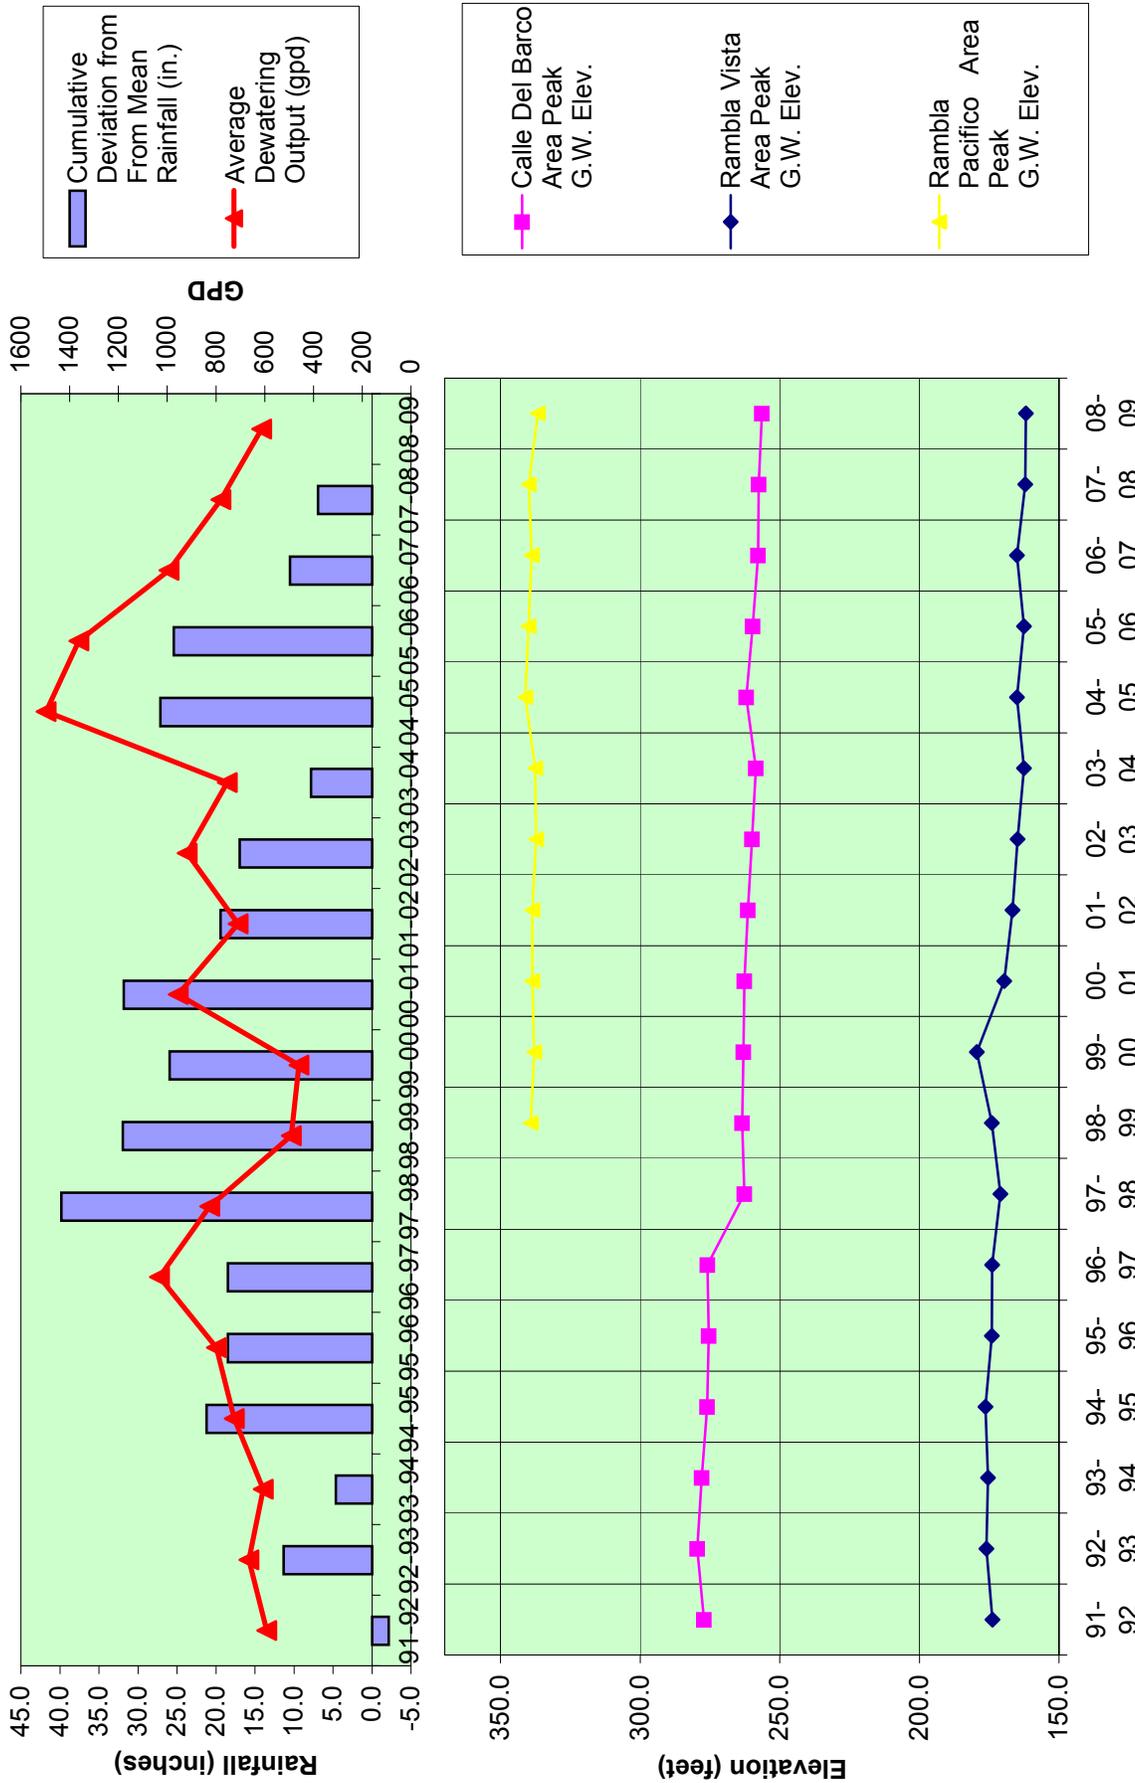
SUMMARY GRAPH
Groundwater Levels, Dewatering, & Rainfall
2008 through 2009 Annual Report
 Calle del Barco Landslide Assessment District
 Malibu, California

- Additional dewatering facilities are recommended in order to increase the dewatering capacity of the landslide stabilization system. Plate 5 indicates decreased production from hydraugers. Over time, hydraugers become clogged and less efficient at removal of water by gravity. Replacement hydraugers should be considered for Rambla Orienta.

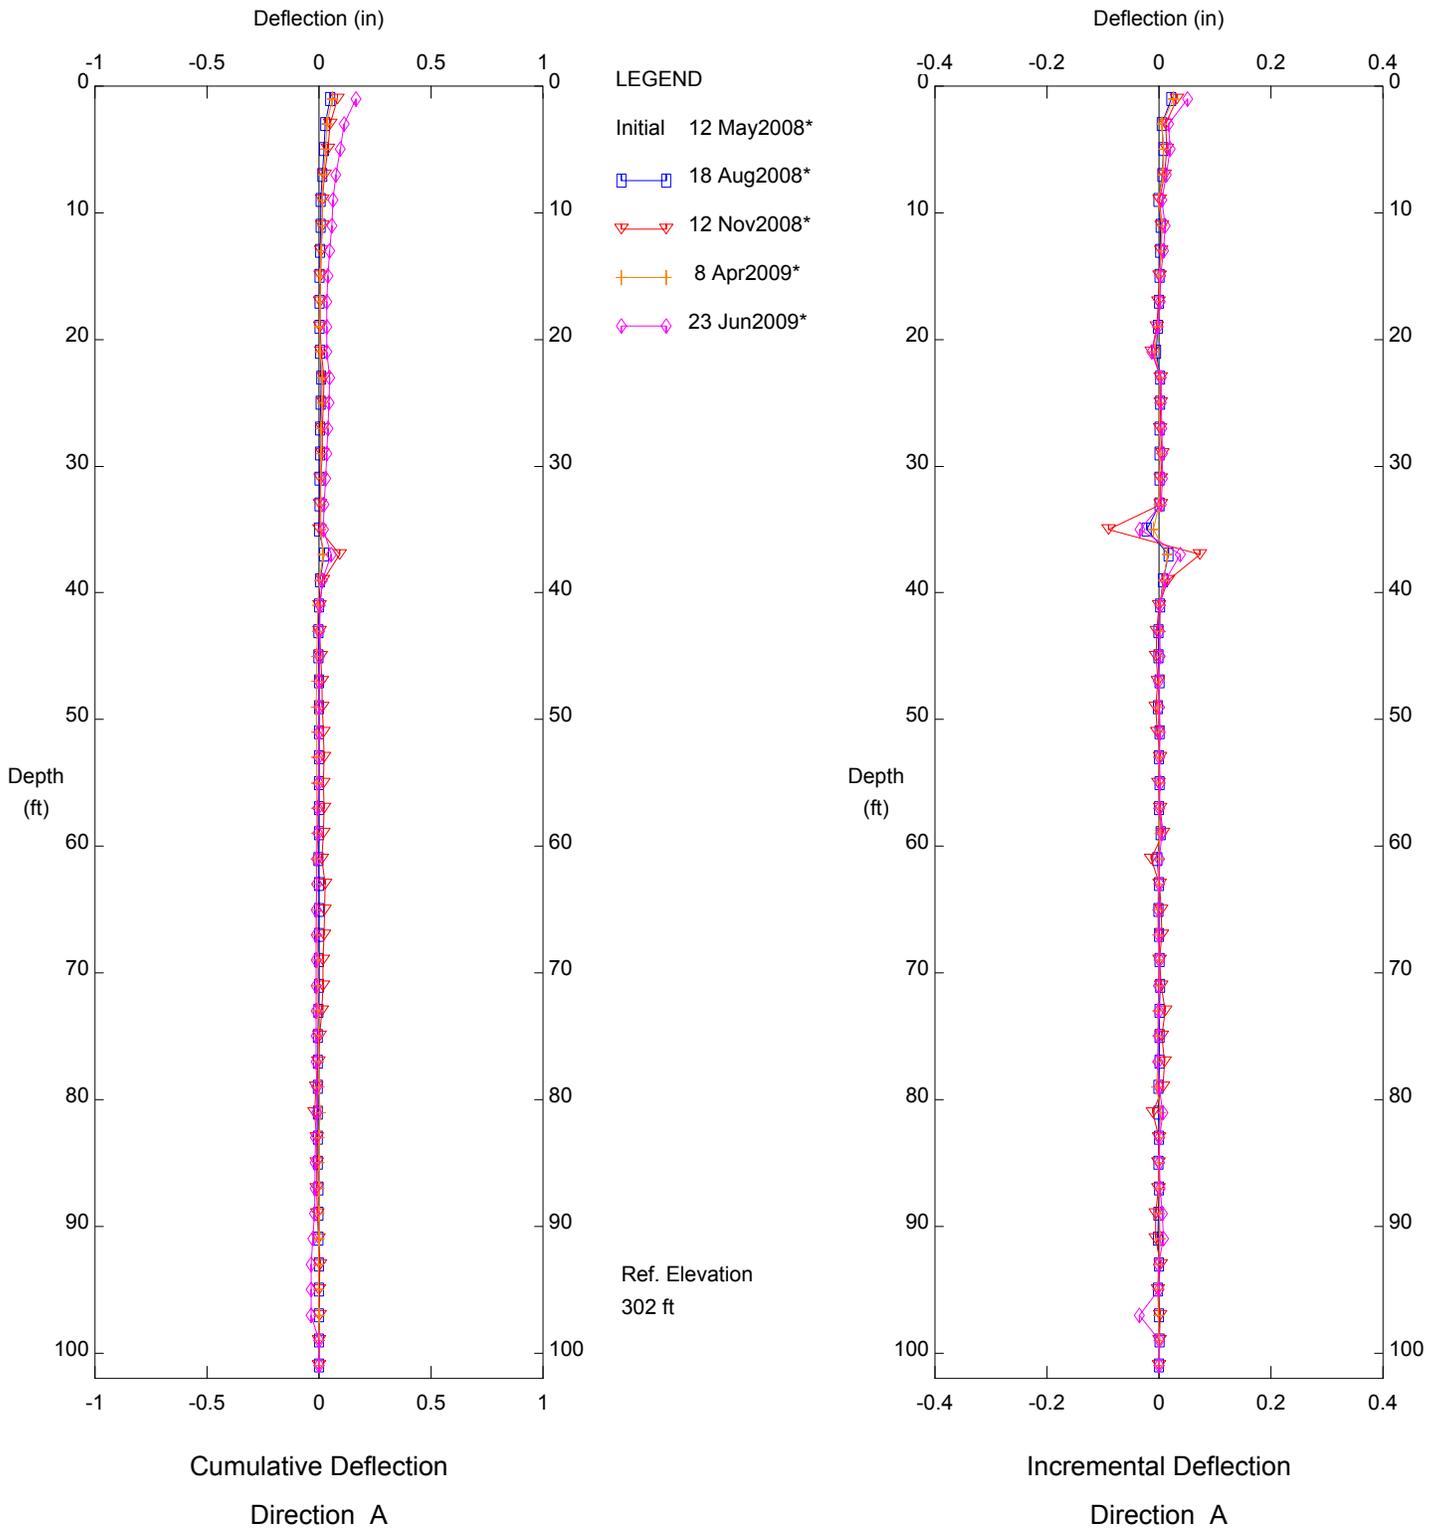
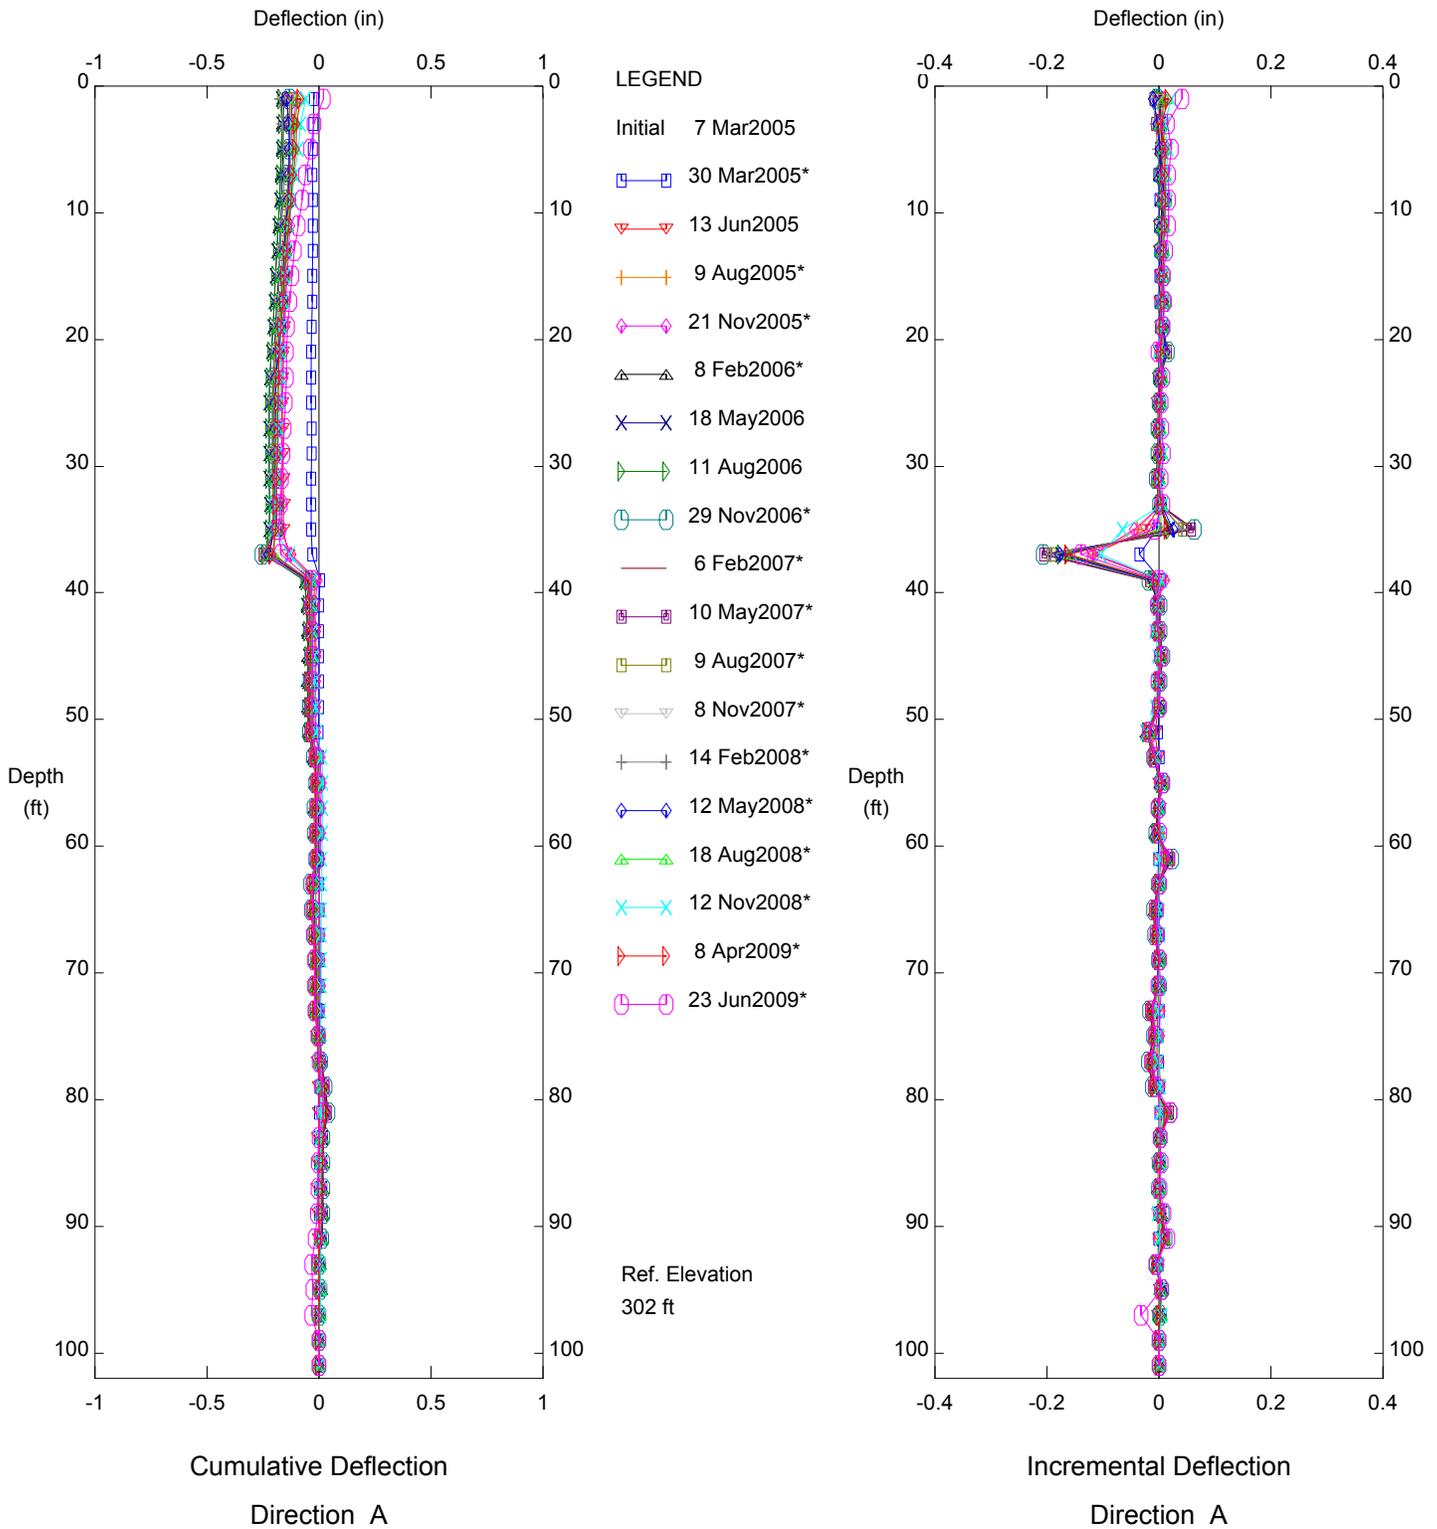
CALLE DEL BARCO, Inclinometer SI-5

- Slope inclinometer readings indicate no significant ground movement; less than 0.1 inches movement was observed in two slope inclinometers during the monitoring period. This movement in SI-5 and SI-9 is close to the reliable accuracy of the instrument.

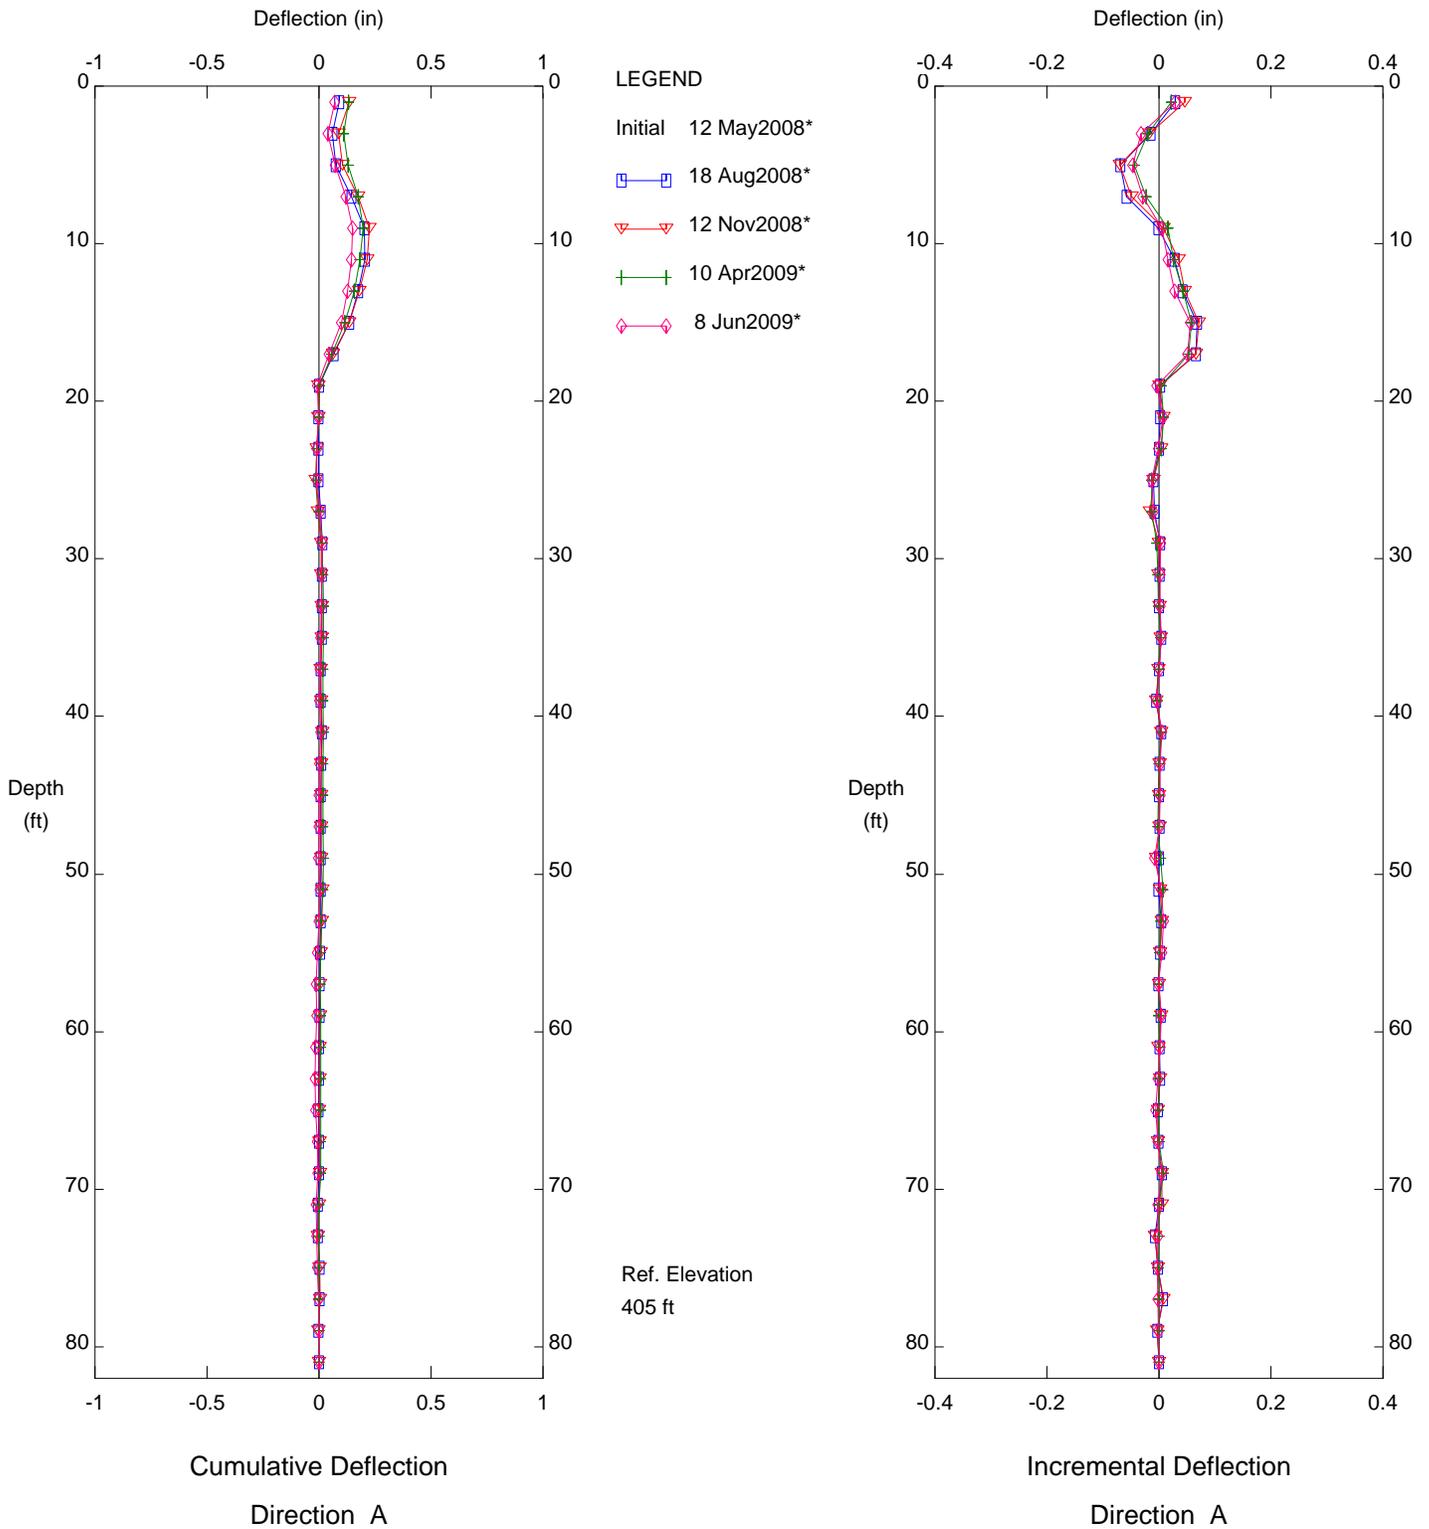
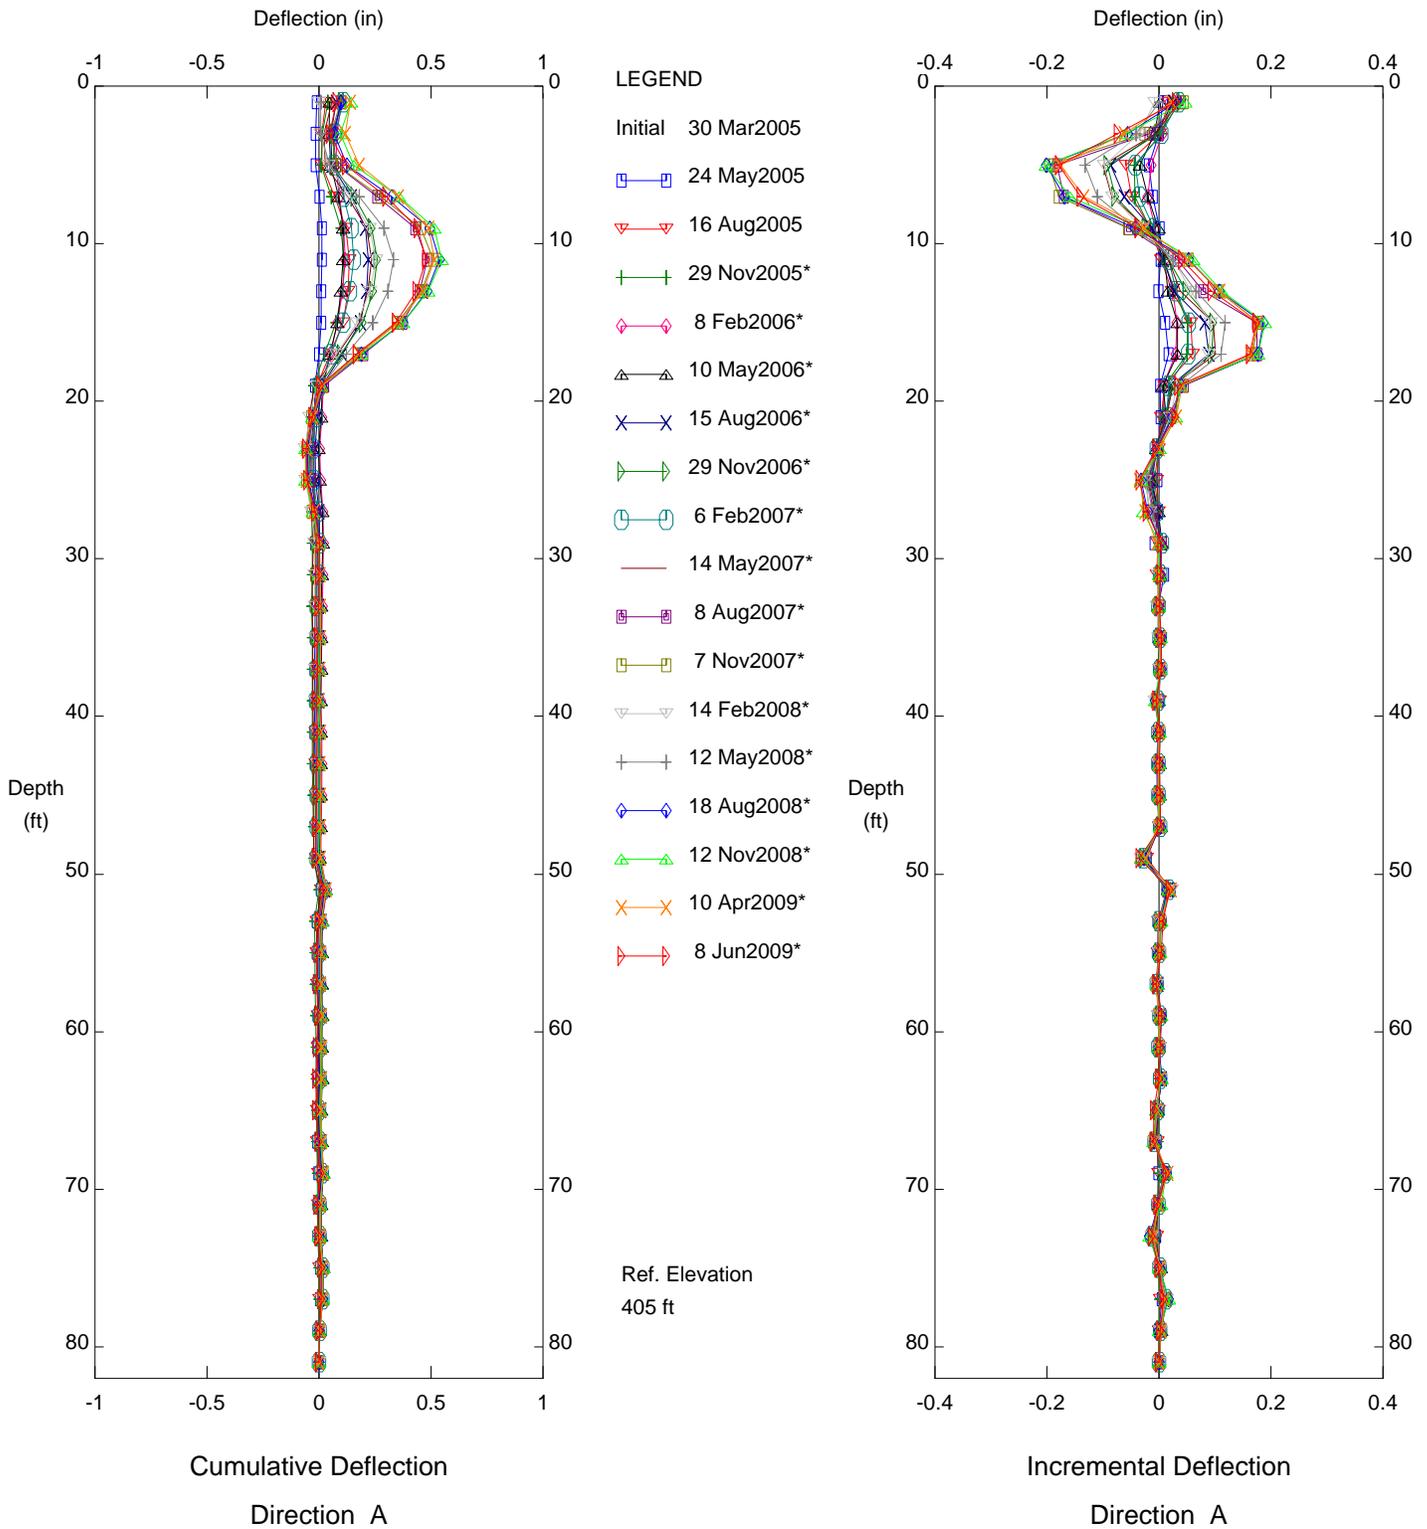
CALLE DEL BARCO, Inclinometer SI-13

During previous years, SI-13 (located on Rambla Pacifico above and outside the deep landslide) showed a variable pattern of compression in the upper 30 feet. However, no significant observable lateral displacement has been associated with this compression. This slope inclinometer may need to be replaced or the City may wish to consider other types of monitoring observations in order to further monitor or characterize conditions in that area.
