**ANNUAL REPORT
JULY 2012 THROUGH JUNE 2013
MALIBU ROAD LANDSLIDE ASSESSMENT DISTRICT
MALIBU, CALIFORNIA**

Prepared for:
CITY OF MALIBU

January 2014
Fugro Project No. 04.B3399004

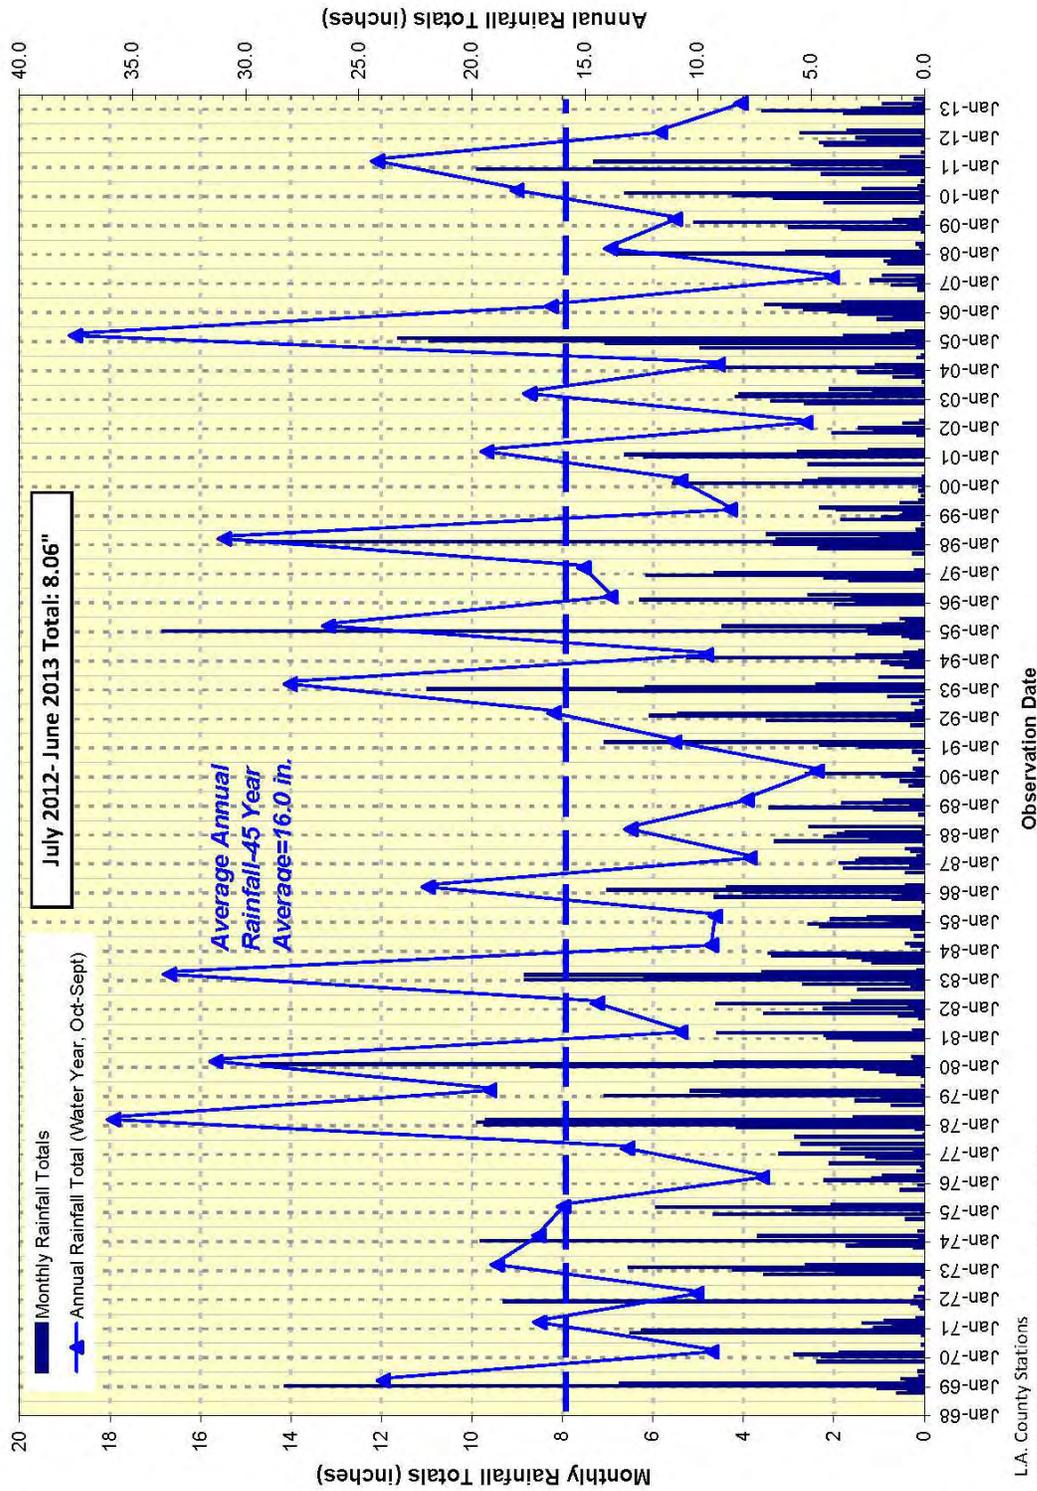
RAINFALL GRAPH
 Malibu Road Landslide Assessment District
 Malibu, California

Rainfall totals were tabulated based on recorded values from the Los Angeles County Rainfall Station 1239 - located at Big Rock Mesa. A graph of historical monthly rainfall and average annual rainfall is shown on Plate 3 - Rainfall Graph.

Rainfall data indicate that approximately 8.06 inches of precipitation fell during the monitoring period from July 2012 through June 2013. The average annual rainfall from 1968 to 2012 in the Malibu area for the monitoring period July through June is approximately 16.0 inches.

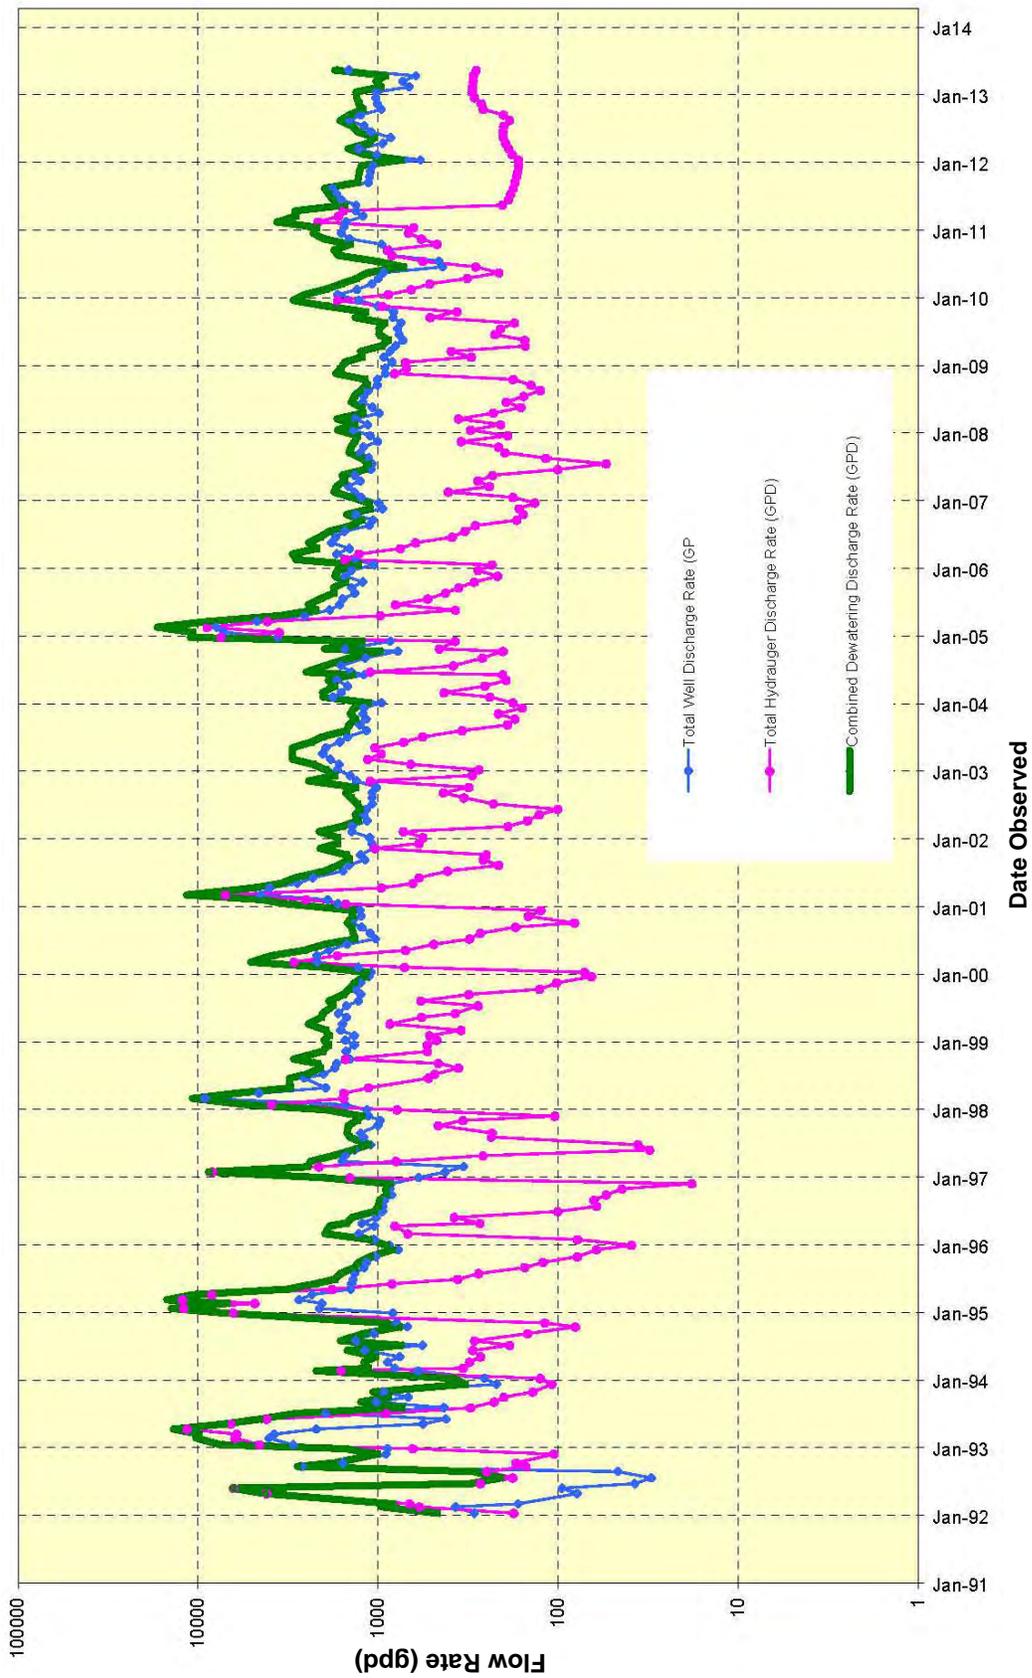
TOTAL DISCHARGE - WELLS AND HYDRAUGERS
Malibu Road Landslide Assessment District
Malibu, California

A graph of the production rate for all dewatering wells is presented on Plate 4. Graphs showing production rates of individual wells are provided in Appendix B. Production data for the dewatering wells indicates the following:

- The average total well production rate for this monitoring period was approximately 1,038 gallons per day (gpd). That represents a decrease of about 12 percent from the previous monitoring period of 1,168 gpd.

- The average production rate for all hydraugers over the monitoring period is approximately 256 gpd. This represents an increase of approximately 43 percent from the average production rate of 179 gpd for the previous monitoring period.

- The average total dewatering rate during the monitoring period was approximately 1,294 gpd. This represents a 4 percent decrease in the average rate relative to the 1,347 gpd average recorded during the previous monitoring period.

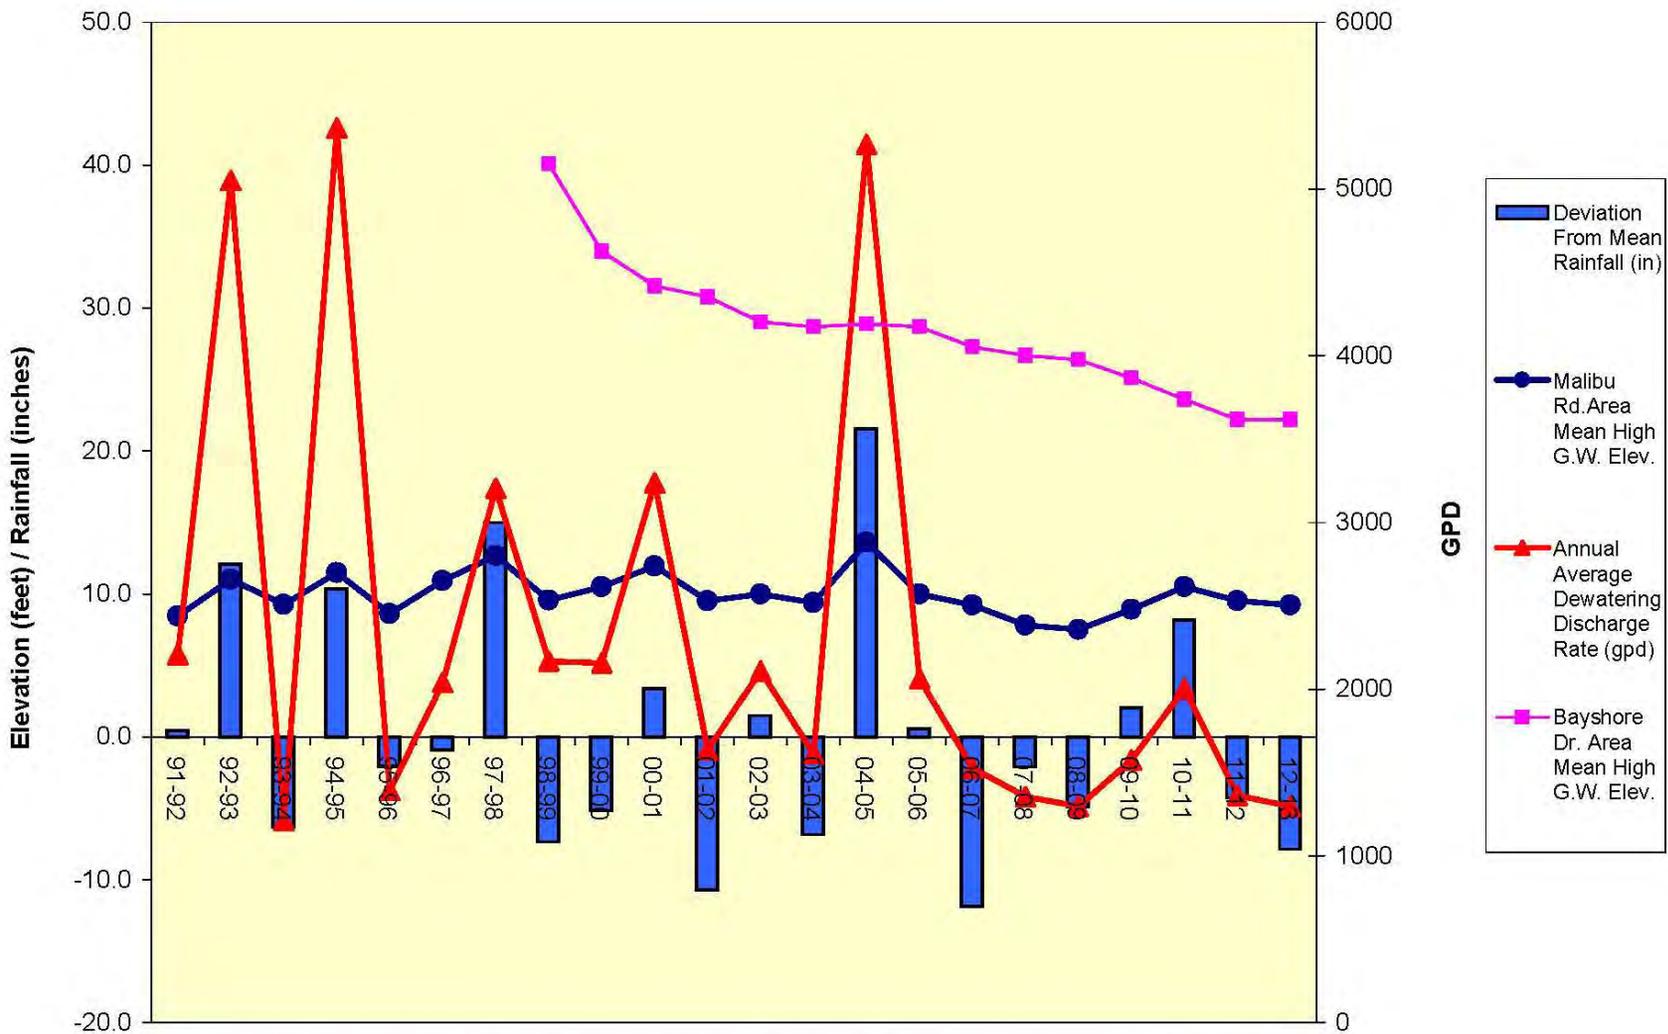
GROUNDWATER LEVELS, DEWATERING, AND RAINFALL
 Malibu Road Landslide Assessment District
 Malibu, California

A summary graph of mean high groundwater elevations for Malibu Road is presented on Plate 5 - Groundwater Levels, Dewatering, and Rainfall. Plate 5 also shows the average dewatering output (gpd) and the yearly deviation from the mean annual rainfall. The mean annual rainfall used for the chart was computed using all of the data from 1988 through the present. This graph illustrates that since 2010-2011, annual rainfall has been generally decreasing. During the same period, the average dewatering output has been decreasing.

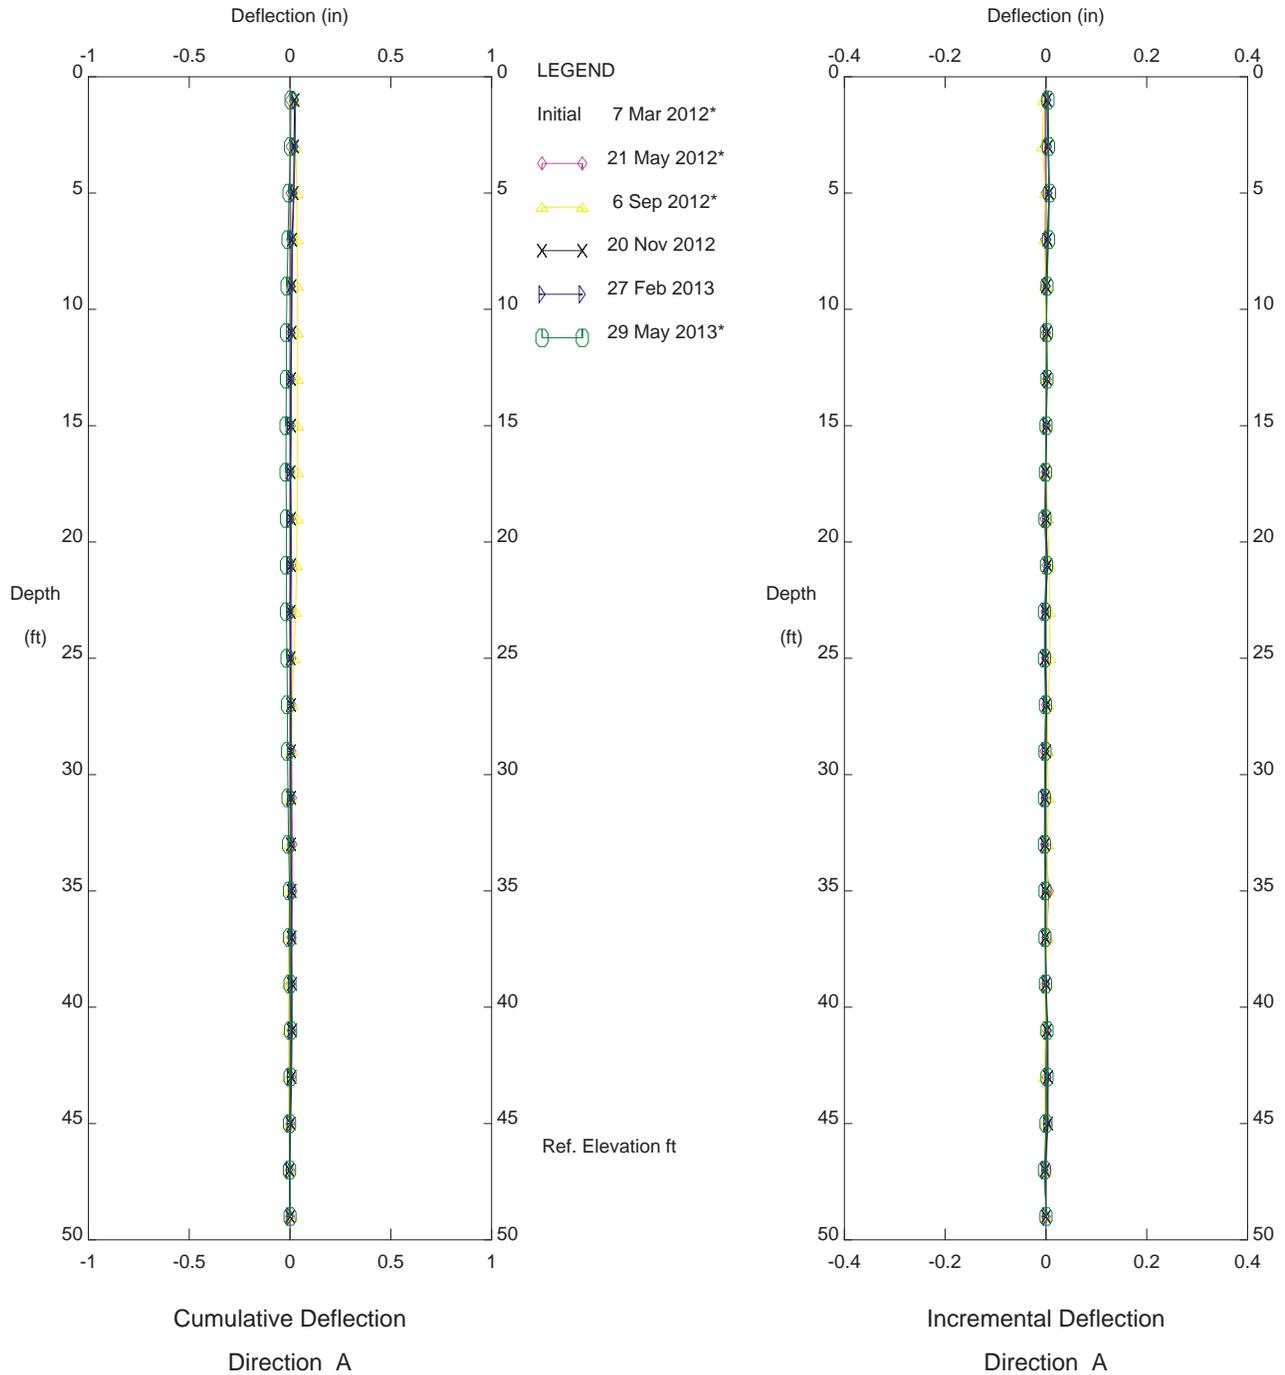
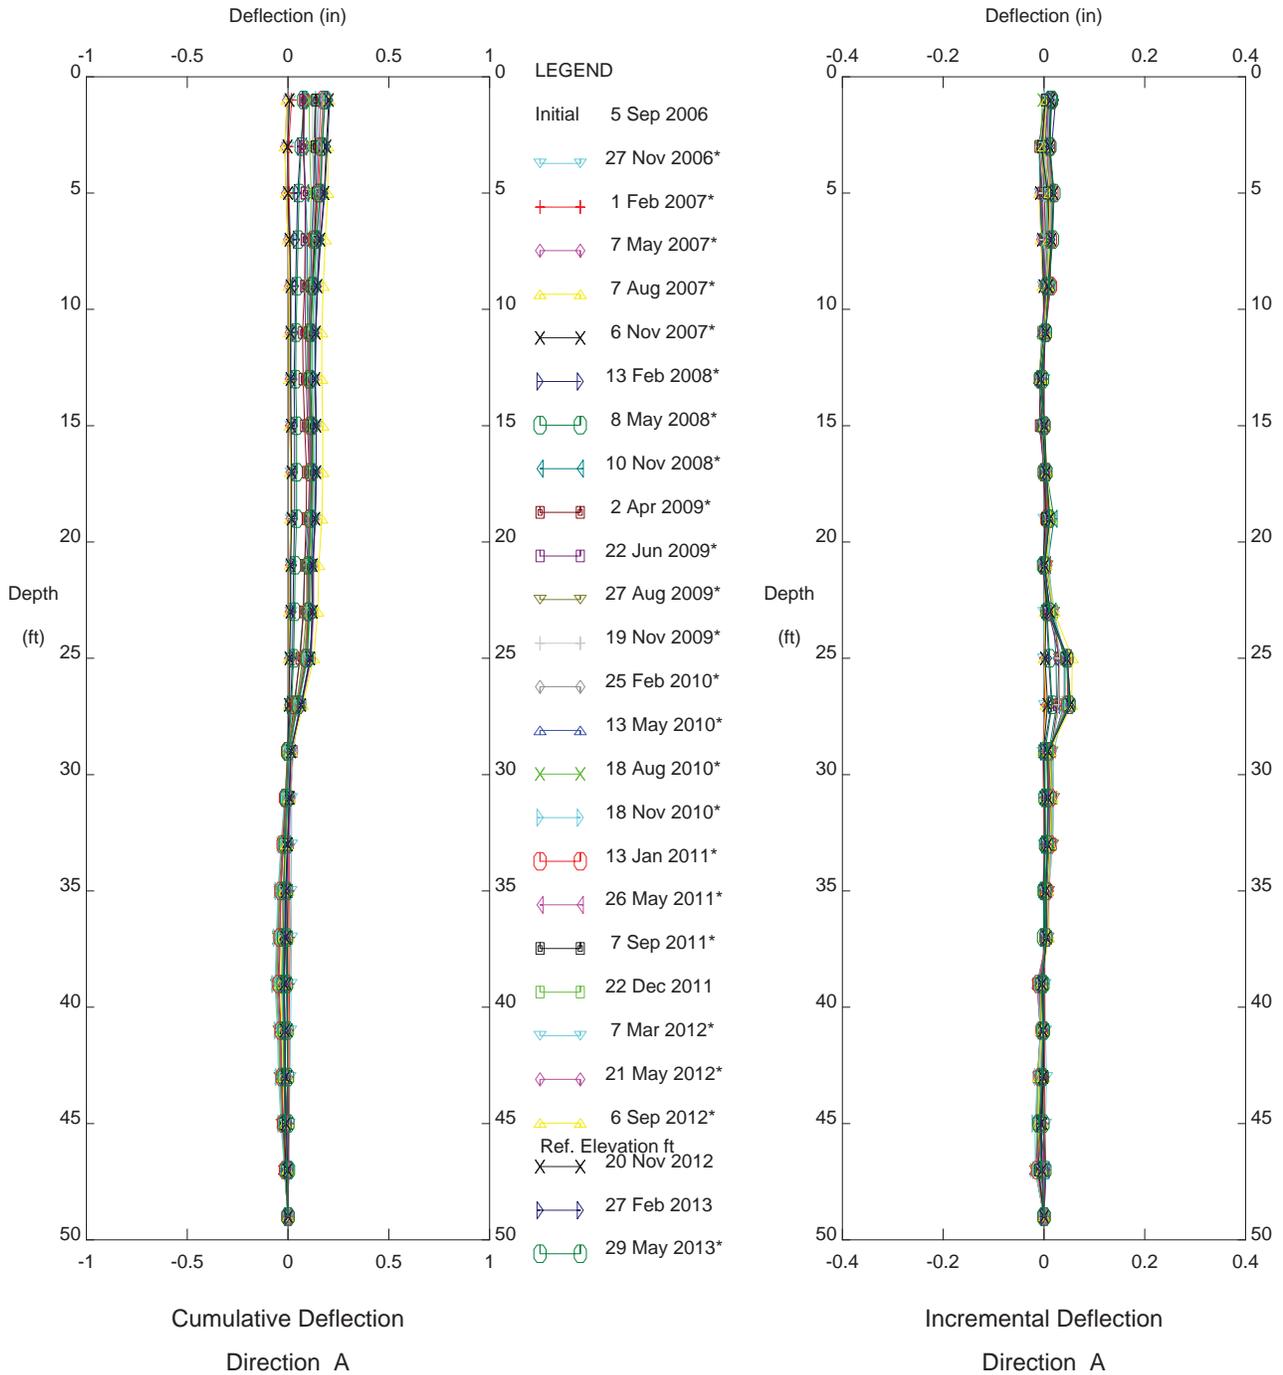
MALIBU ROAD, Inclinometer SI-1A

SI-1A was installed in August 2006 and has a baseline reading from September 2006. SI-2A was installed in September of the 2010-2011 monitoring year with a baseline reading in May 2011. Therefore, the first plot of SI-2A shows the current year readings, while the second plot shows the readings of SI-2 from 2005-2008. SI-4A was installed in August 2012 as a replacement for SI -4 and has a baseline reading from September 2012.

Interpretation of inclinometer data along Malibu Road shows no clearly defined interpreted movement during the 2012-2013 monitoring year.

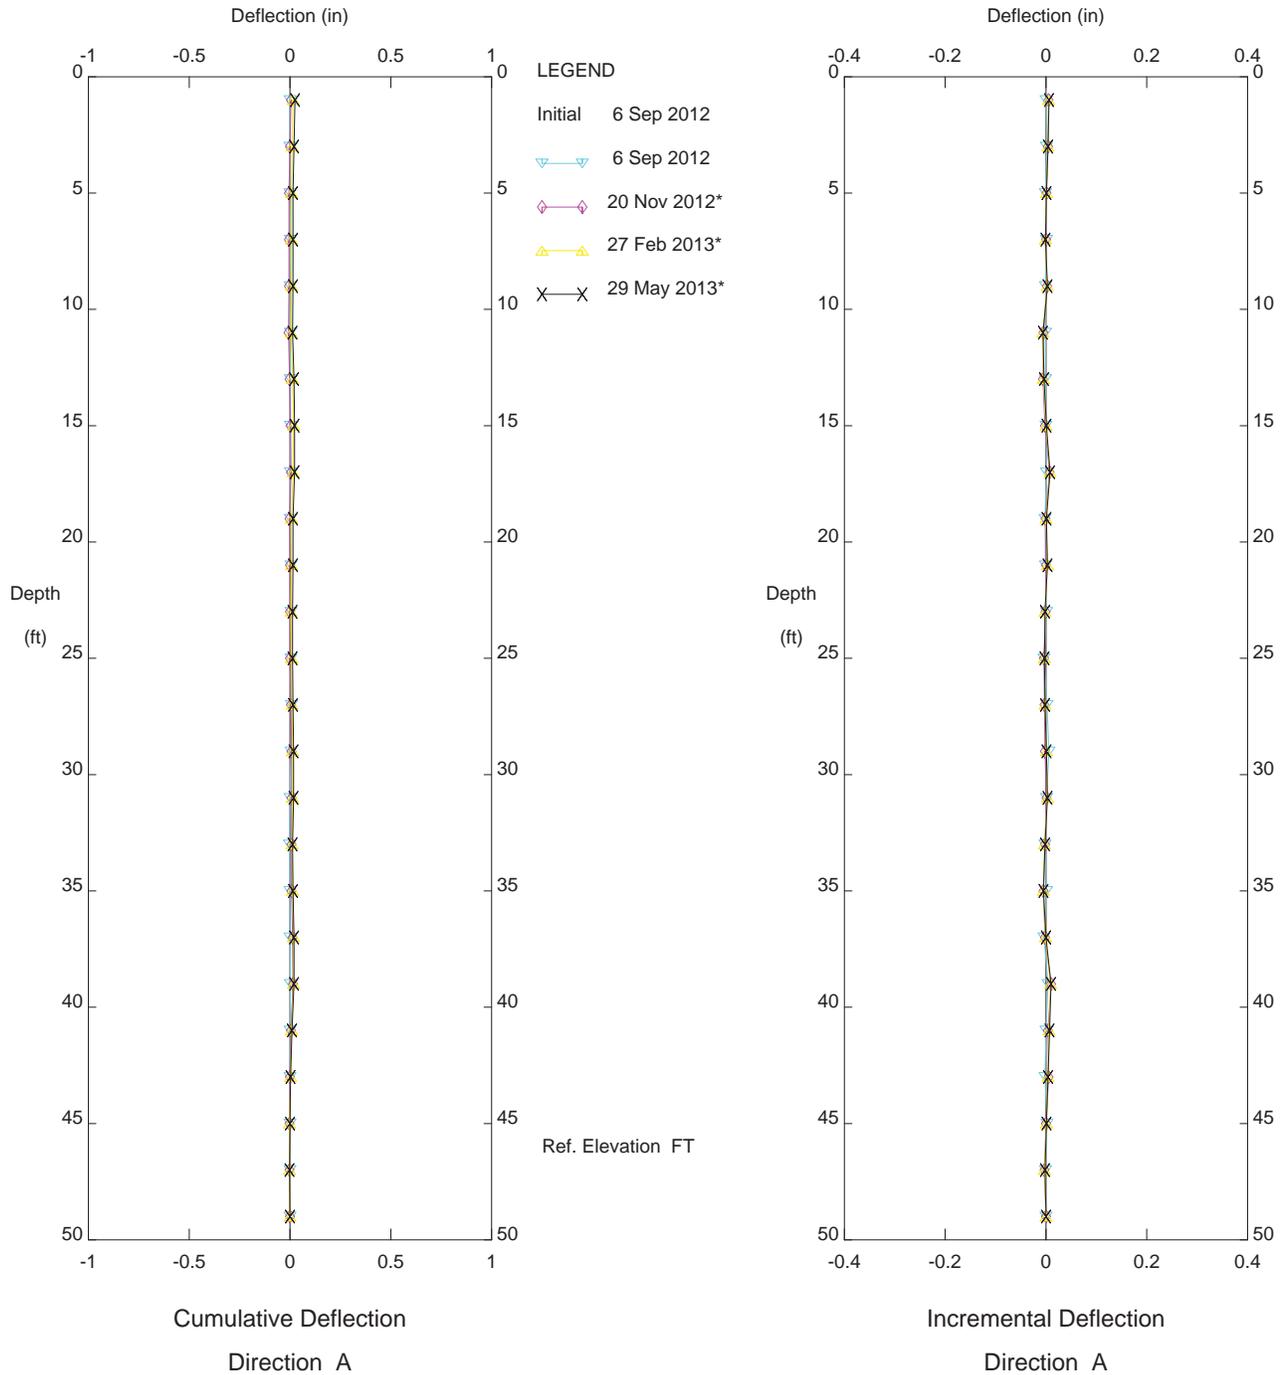
MAL-RD, Inclinometer SI4A

A replacement inclinometer, SI-4A, was installed in August 2012 to replace SI-4, which had become difficult to read below approximately 30 feet.

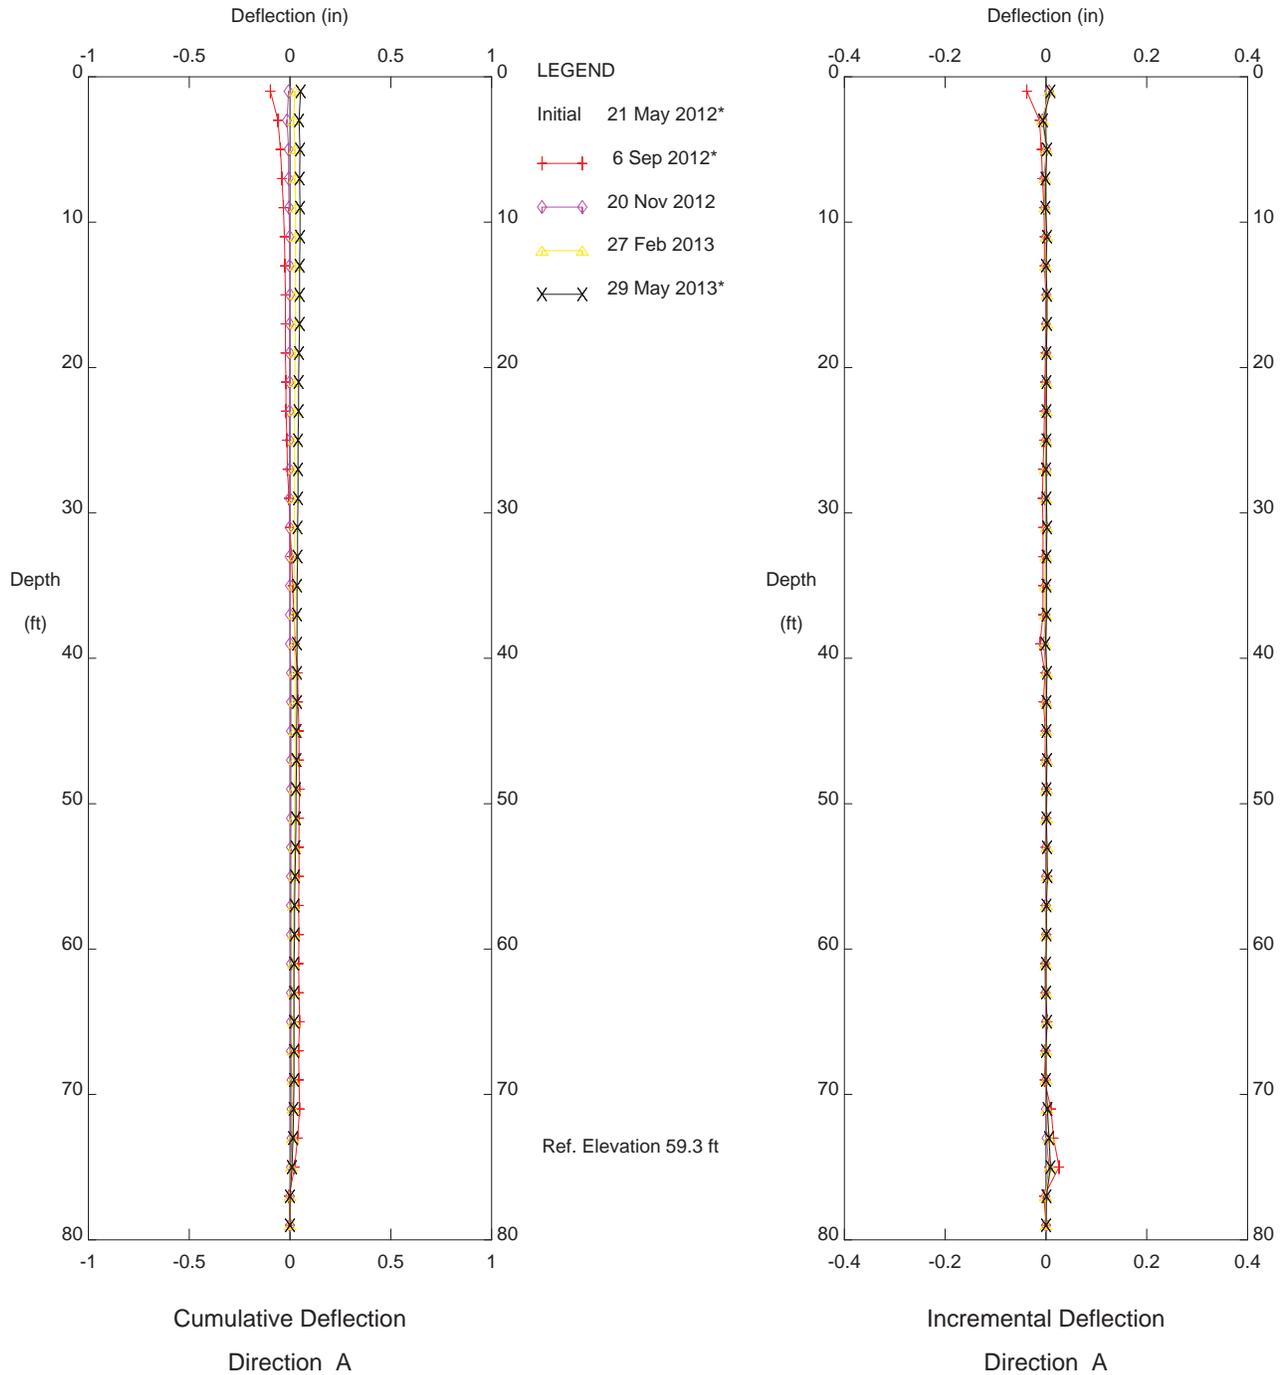
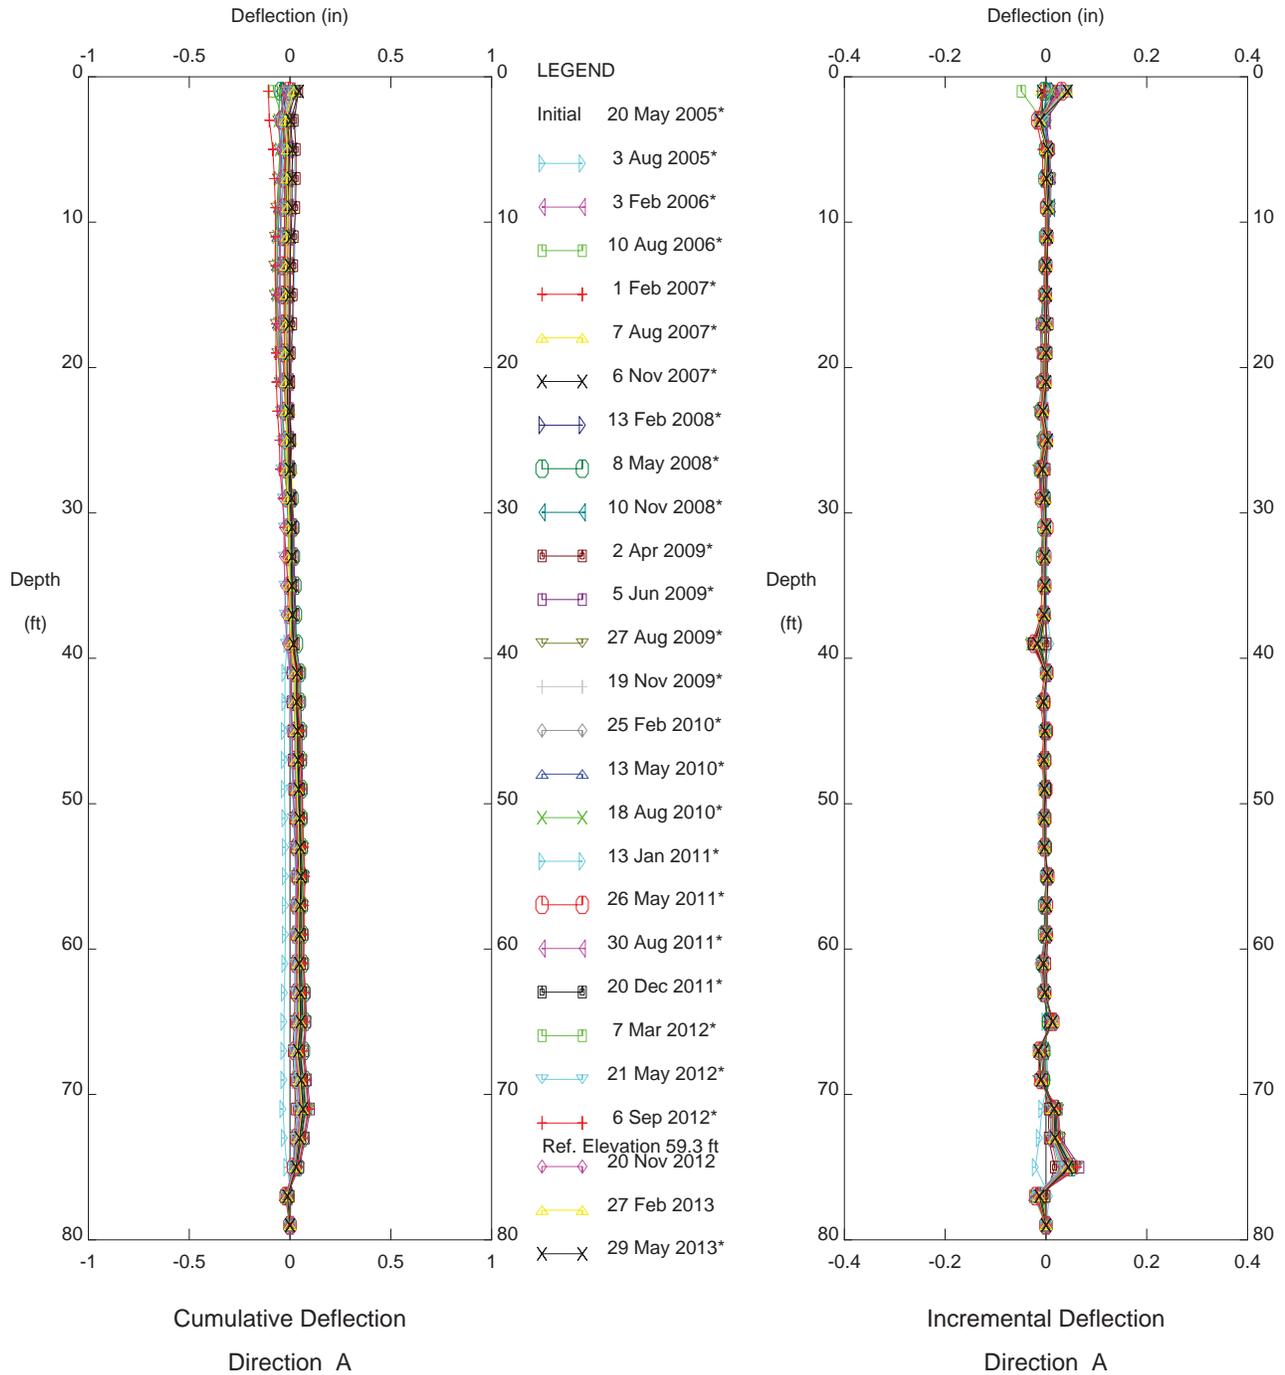
MALIBU ROAD, Inclinometer SI-5

Inclinometers SI-5 and SI-6 are located on Bayshore Drive, upslope and outside the defined limit of the most recent 1998 movement. No significant movement was observed during this monitoring year in SI-5 or SI-6.
