**ANNUAL REPORT  
JULY 2011 THROUGH JUNE 2012  
MALIBU ROAD LANDSLIDE ASSESSMENT DISTRICT  
MALIBU, CALIFORNIA**

Prepared for:  
CITY OF MALIBU

September 2012  
Fugro Project No. 04.B3399004

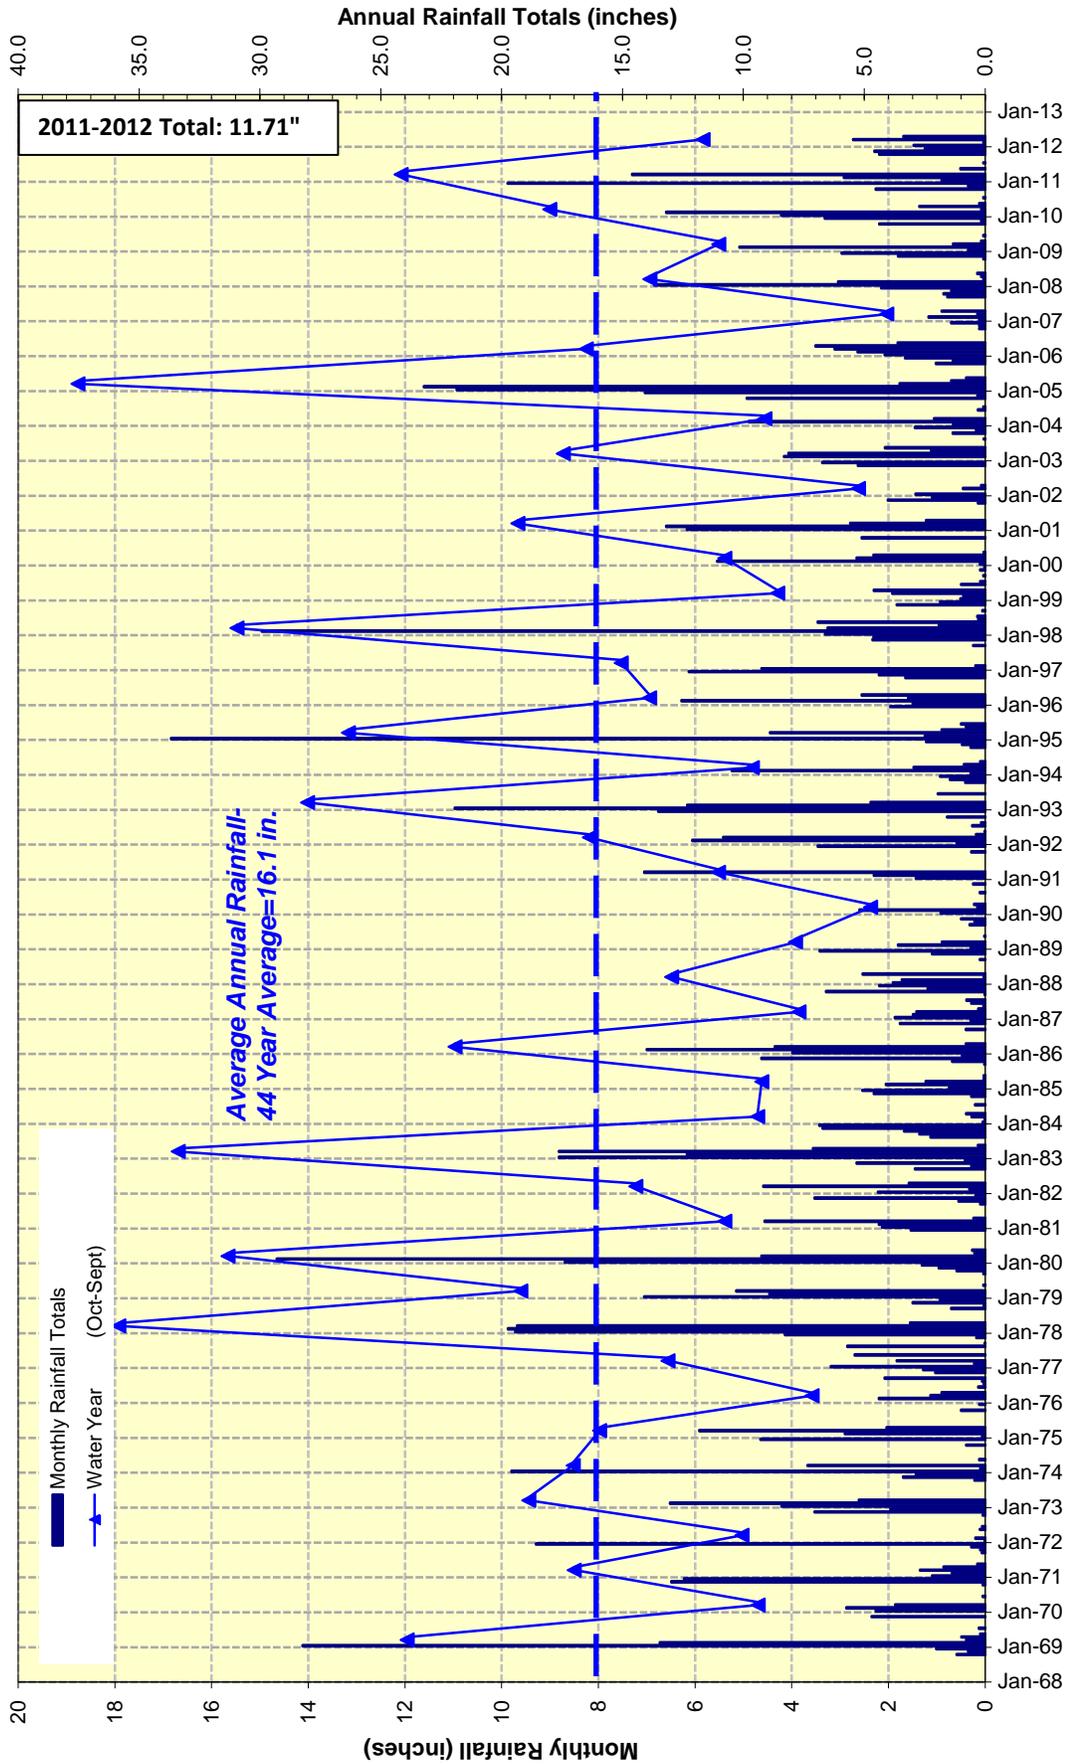
**RAINFALL GRAPH**  
 Malibu Road Landslide Assessment District  
 Malibu, California

Rainfall data indicate that approximately 11.71 inches of precipitation fell during the monitoring period from July 2011 through June 2012. The average annual rainfall from 1968 to 2012 in the Malibu area for the monitoring period July through June is approximately 16.1 inches.

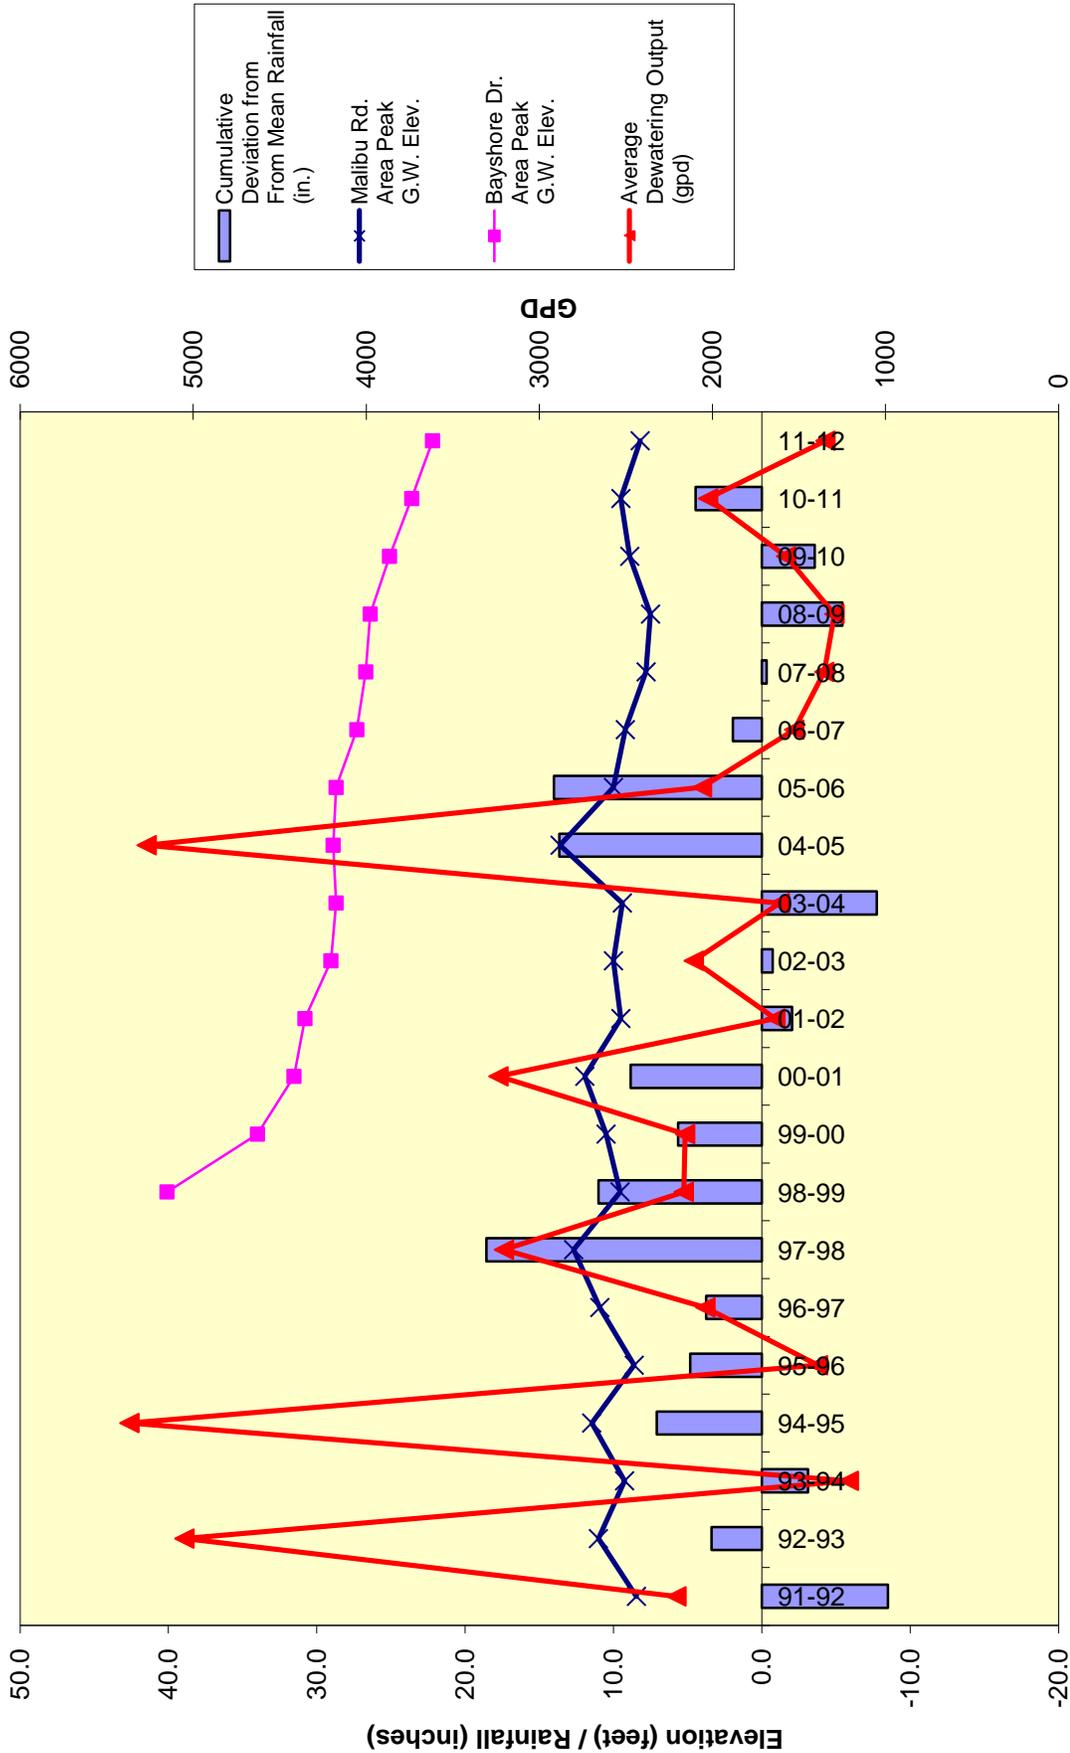
**SUMMARY GRAPH**  
**Groundwater Levels, Dewatering, & Rainfall**  
 Malibu Road Landslide Assessment District  
 Malibu, California

A summary graph of normalized peak groundwater elevations for Malibu Road is presented on the bottom graph of Plate 5. The top graph on Plate 5 shows the average dewatering output (gpd) and the cumulative departure from the mean rainfall. The average annual rainfall used for the chart was computed using all of the data from 1988 through the present. This graph illustrates that although annual rainfall has been generally increasing since 2008, the average dewatering output has been decreasing.

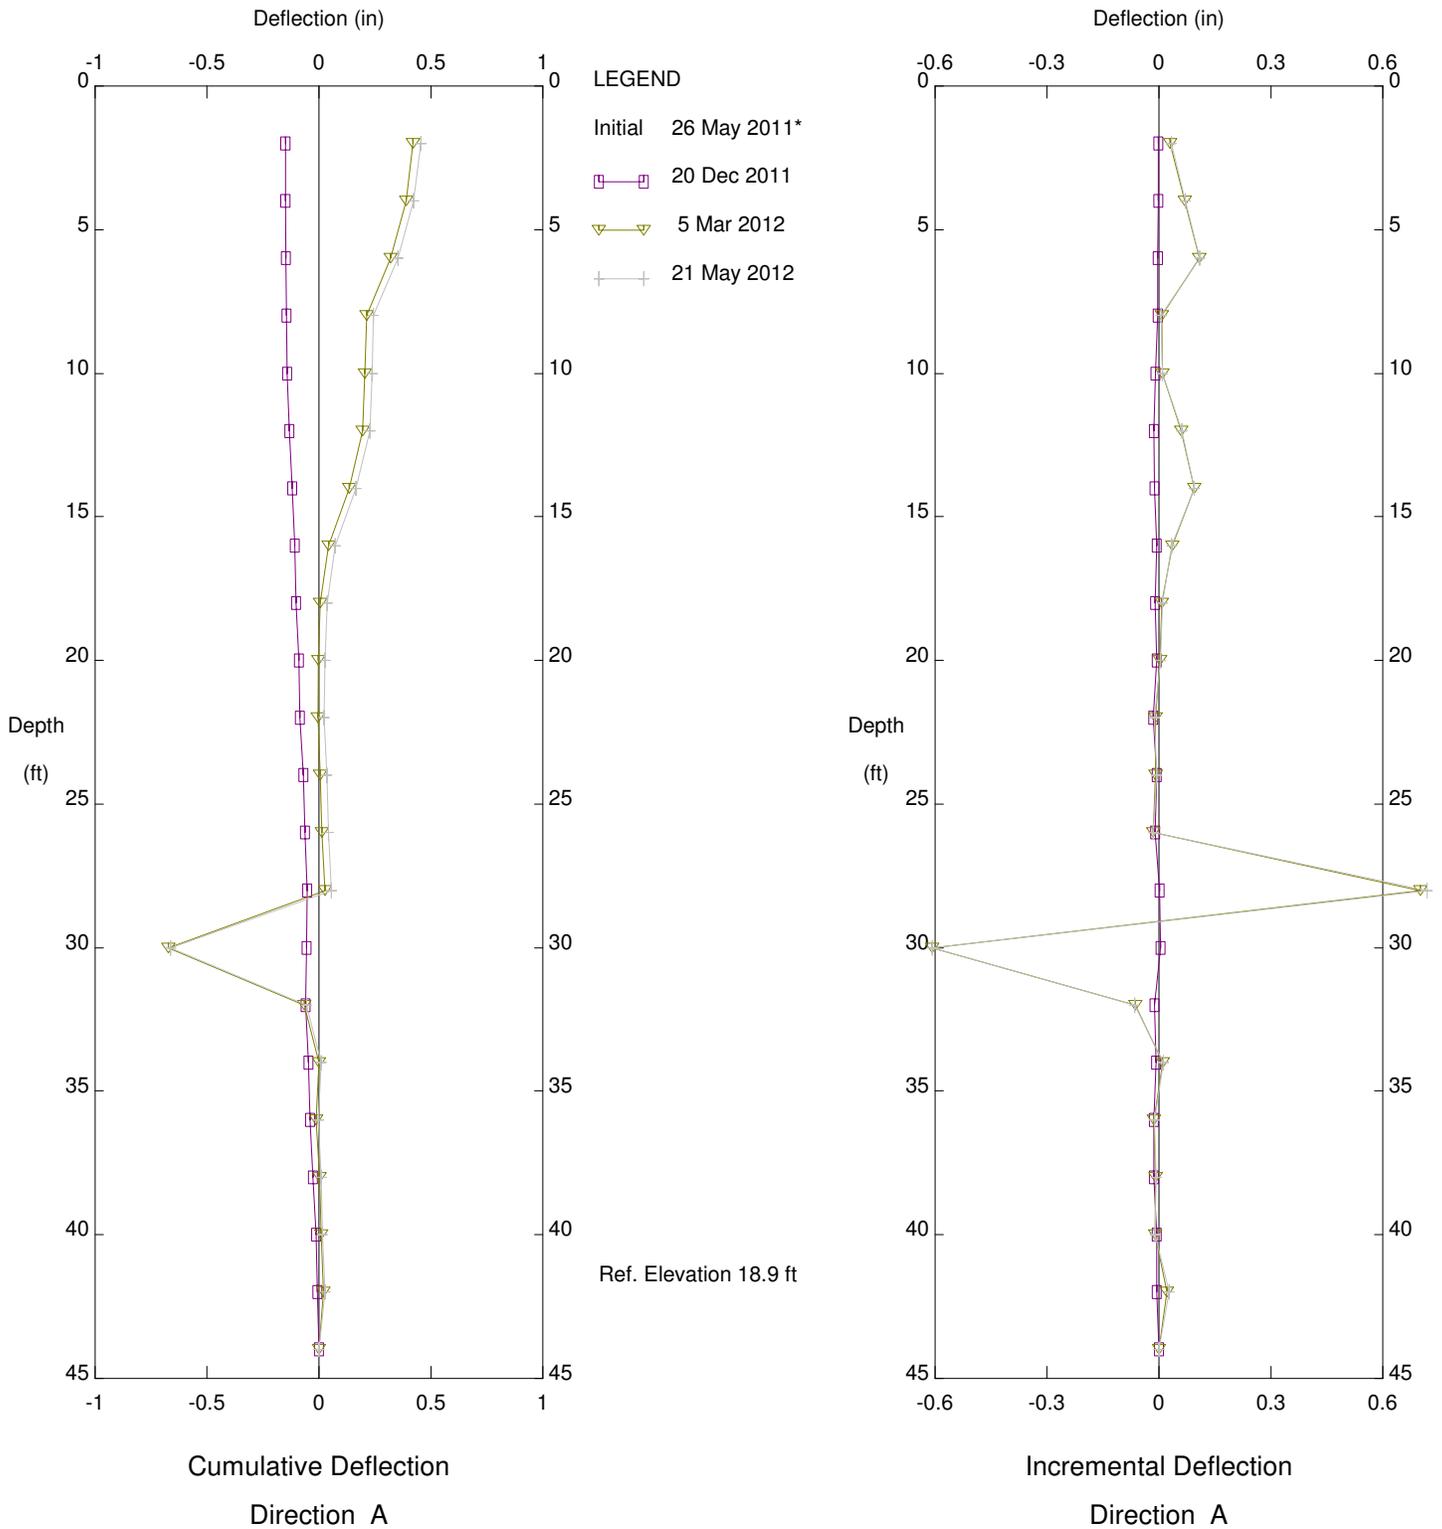
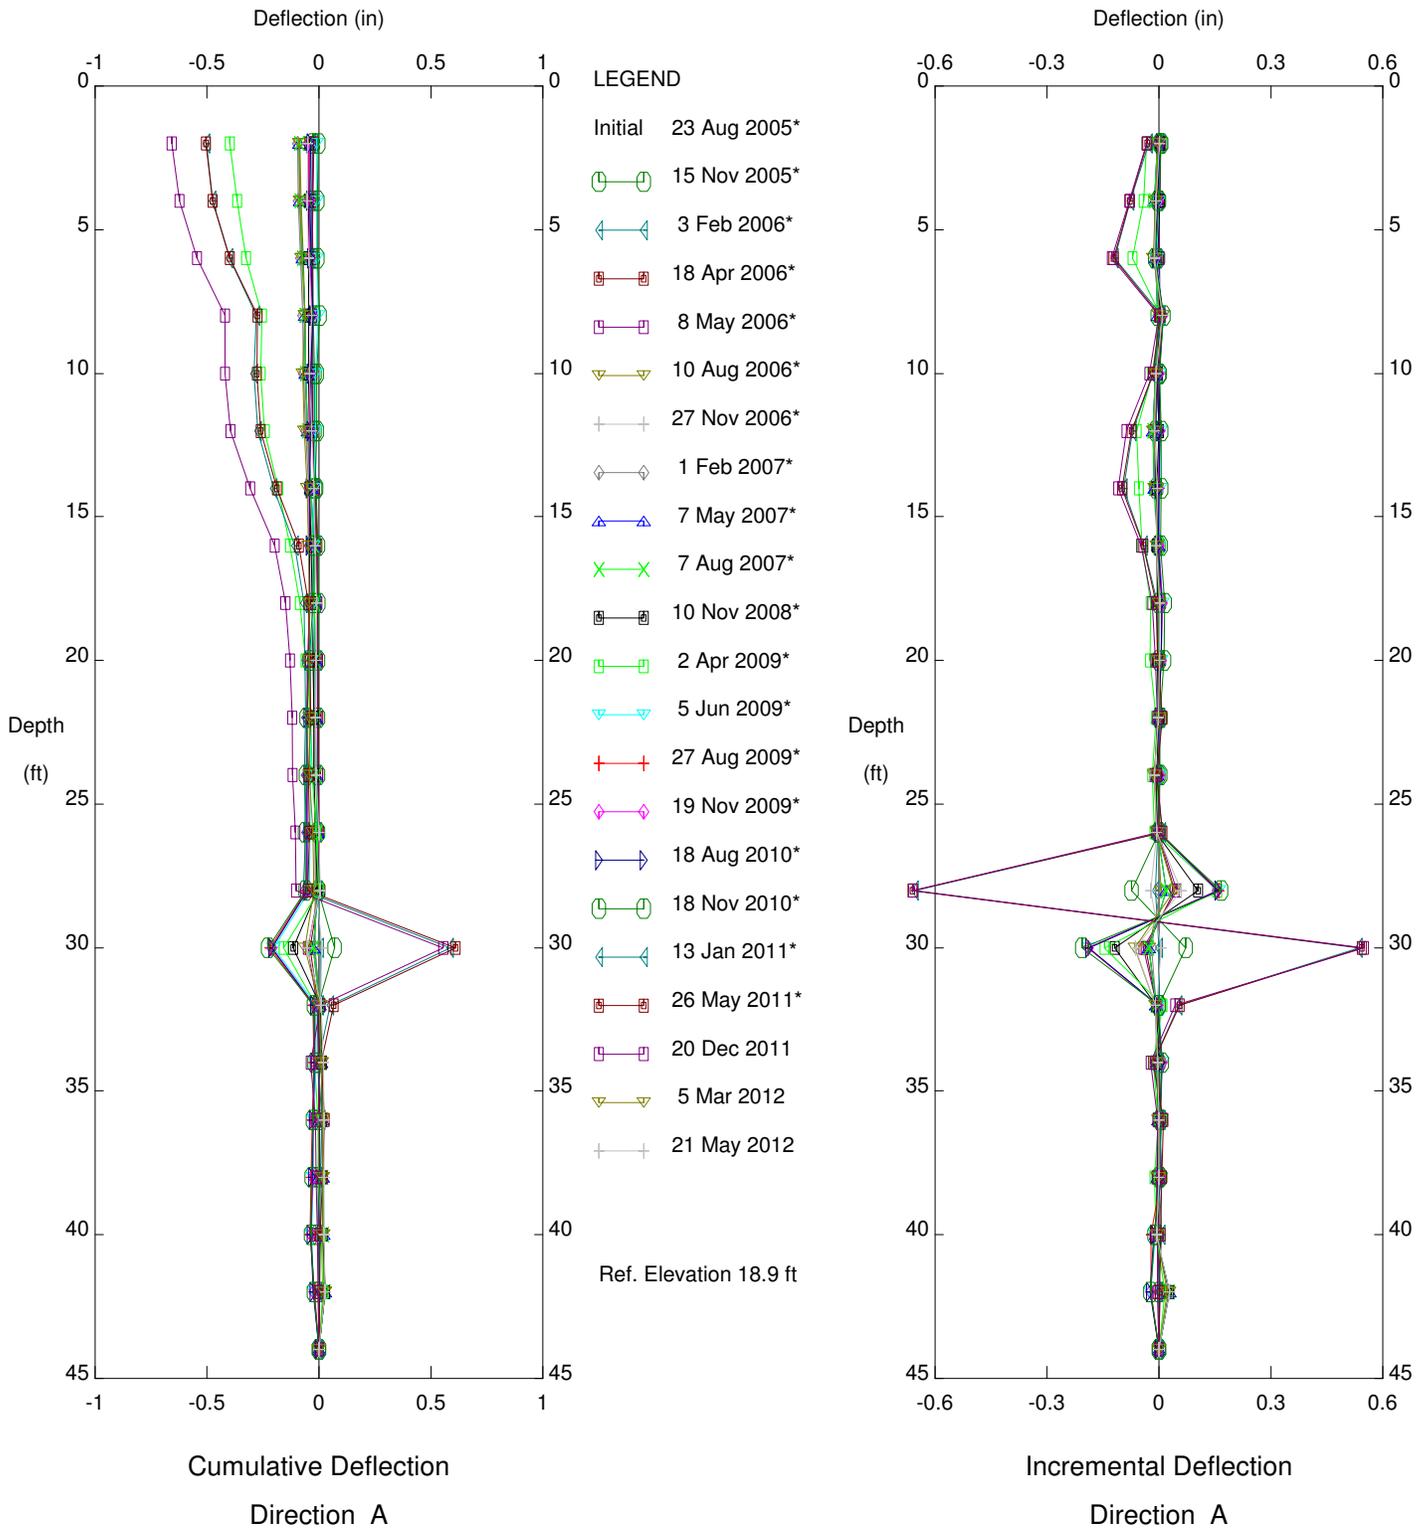
MALIBU ROAD, Inclinometer SI-4

Interpretation of inclinometer data along Malibu Road shows no significant movement during the 2011-2012 monitoring year except for SI-4, which showed significant movement at a depth of approximately 30 feet. There continues to be difficulty obtaining data below 28 feet in SI-4, indicating that SI-4 is expected to "shear off" soon. A replacement inclinometer is proposed for the summer of 2012.

A replacement inclinometer has been proposed to replace SI-4, which has become difficult to read below approximately 30 feet, that replacement slope inclinometer will be named SI-4A and installed in August of 2012.

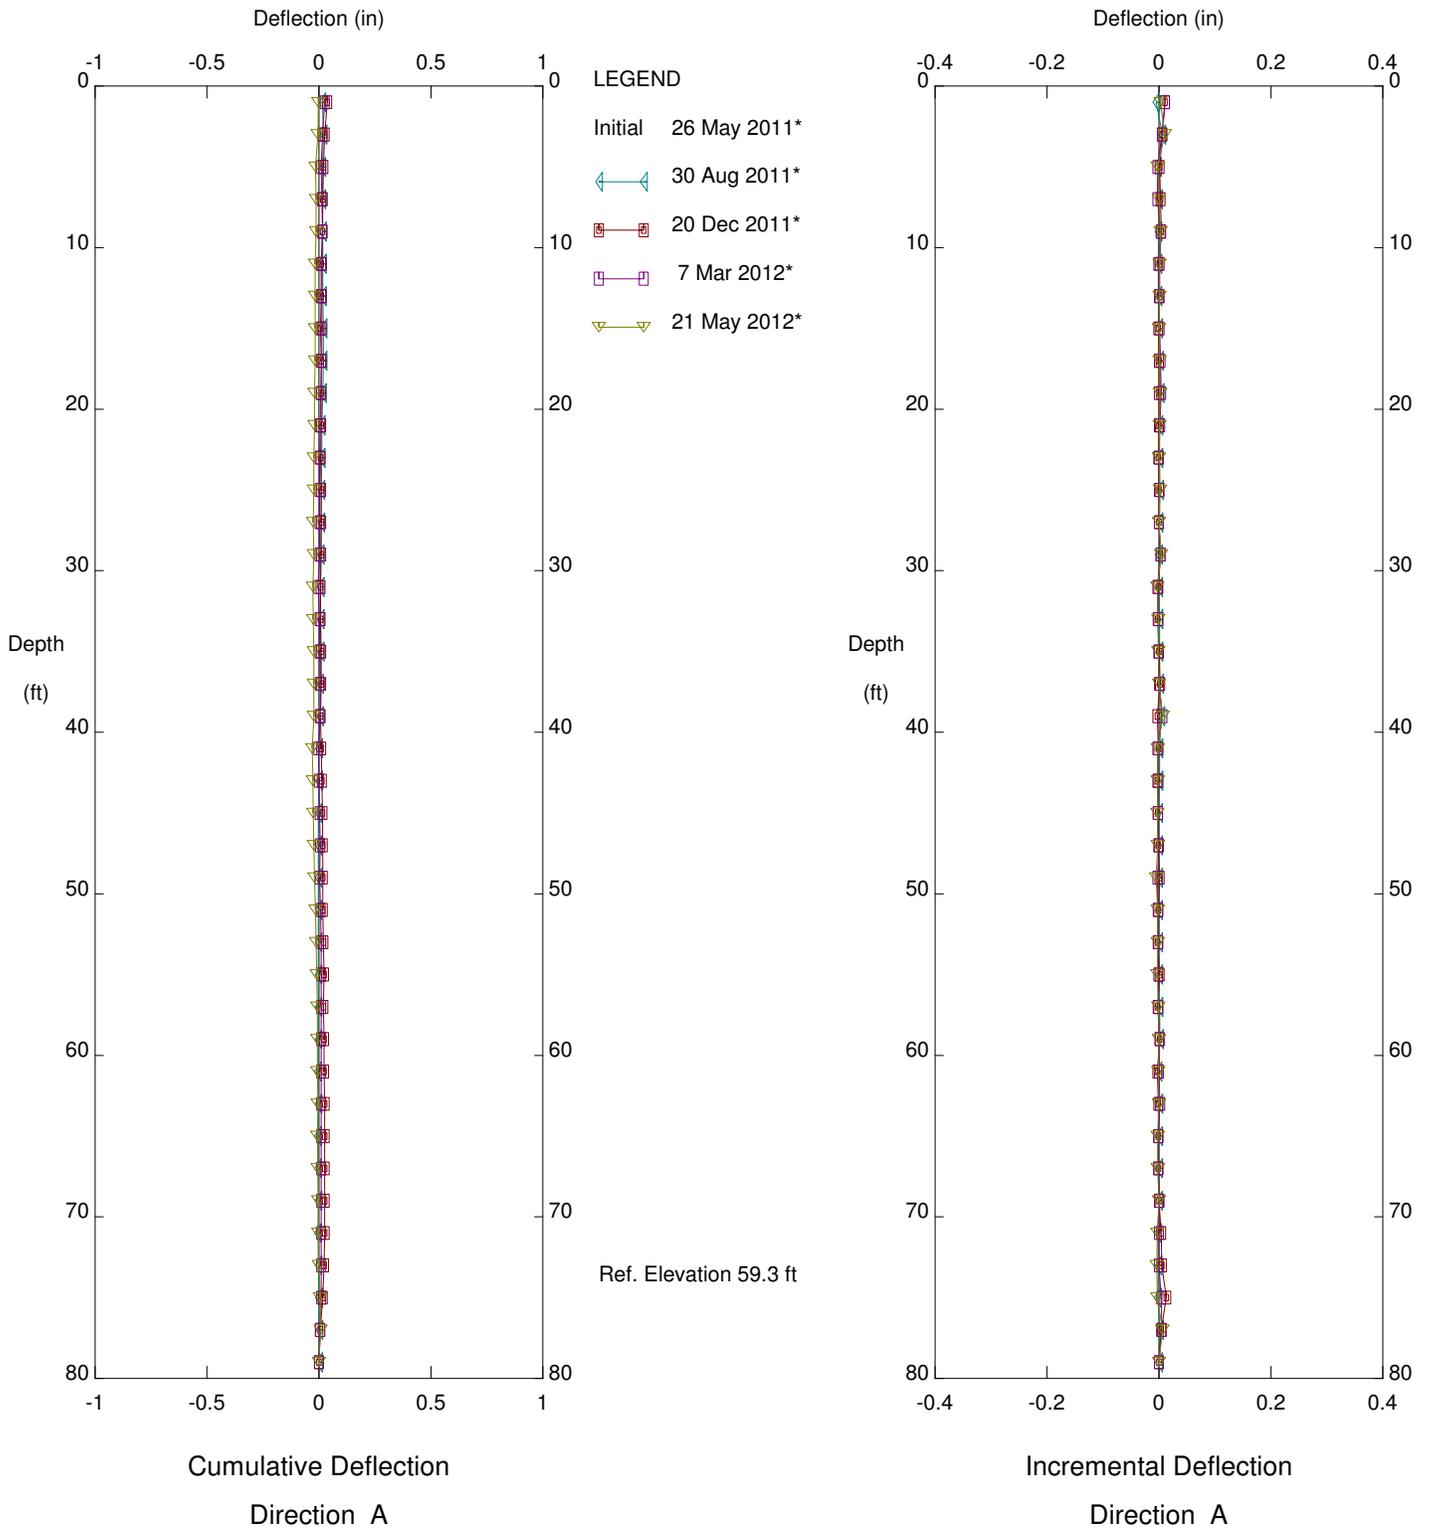
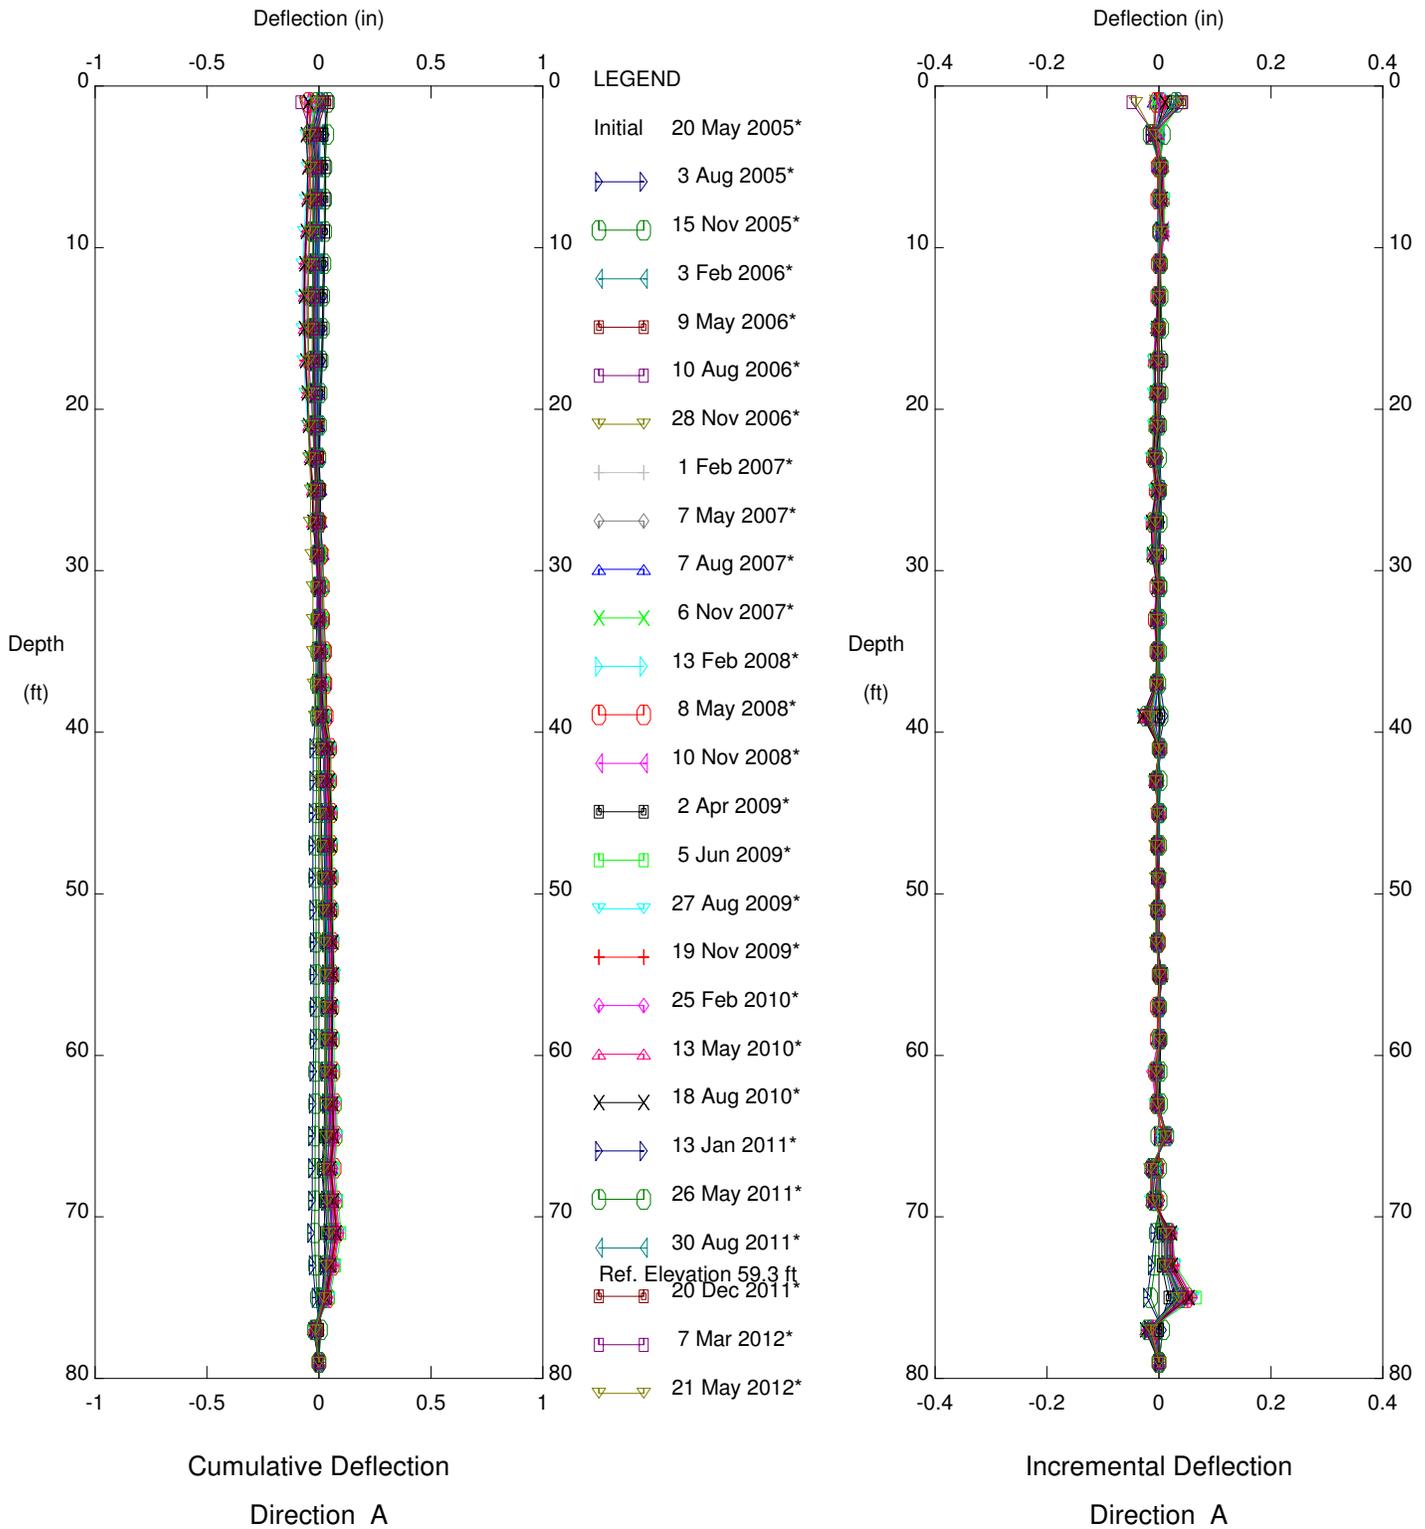
MALIBU ROAD, Inclinometer SI-5

Inclinometers SI-5 and SI-6 are located on Bayshore Drive, upslope and outside the defined limit of the most recent 1998 movement. No significant movement was observed during this monitoring year in SI-5 or SI-6.
