**ANNUAL REPORT  
JULY 2010 THROUGH JUNE 2011  
MALIBU ROAD LANDSLIDE ASSESSMENT DISTRICT  
MALIBU, CALIFORNIA**

Prepared for:  
CITY OF MALIBU

August 2011  
Fugro Project No. 04.B3399004

Subject: Annual Report, July 2010 through June 2011, Malibu Road Landslide Assessment District

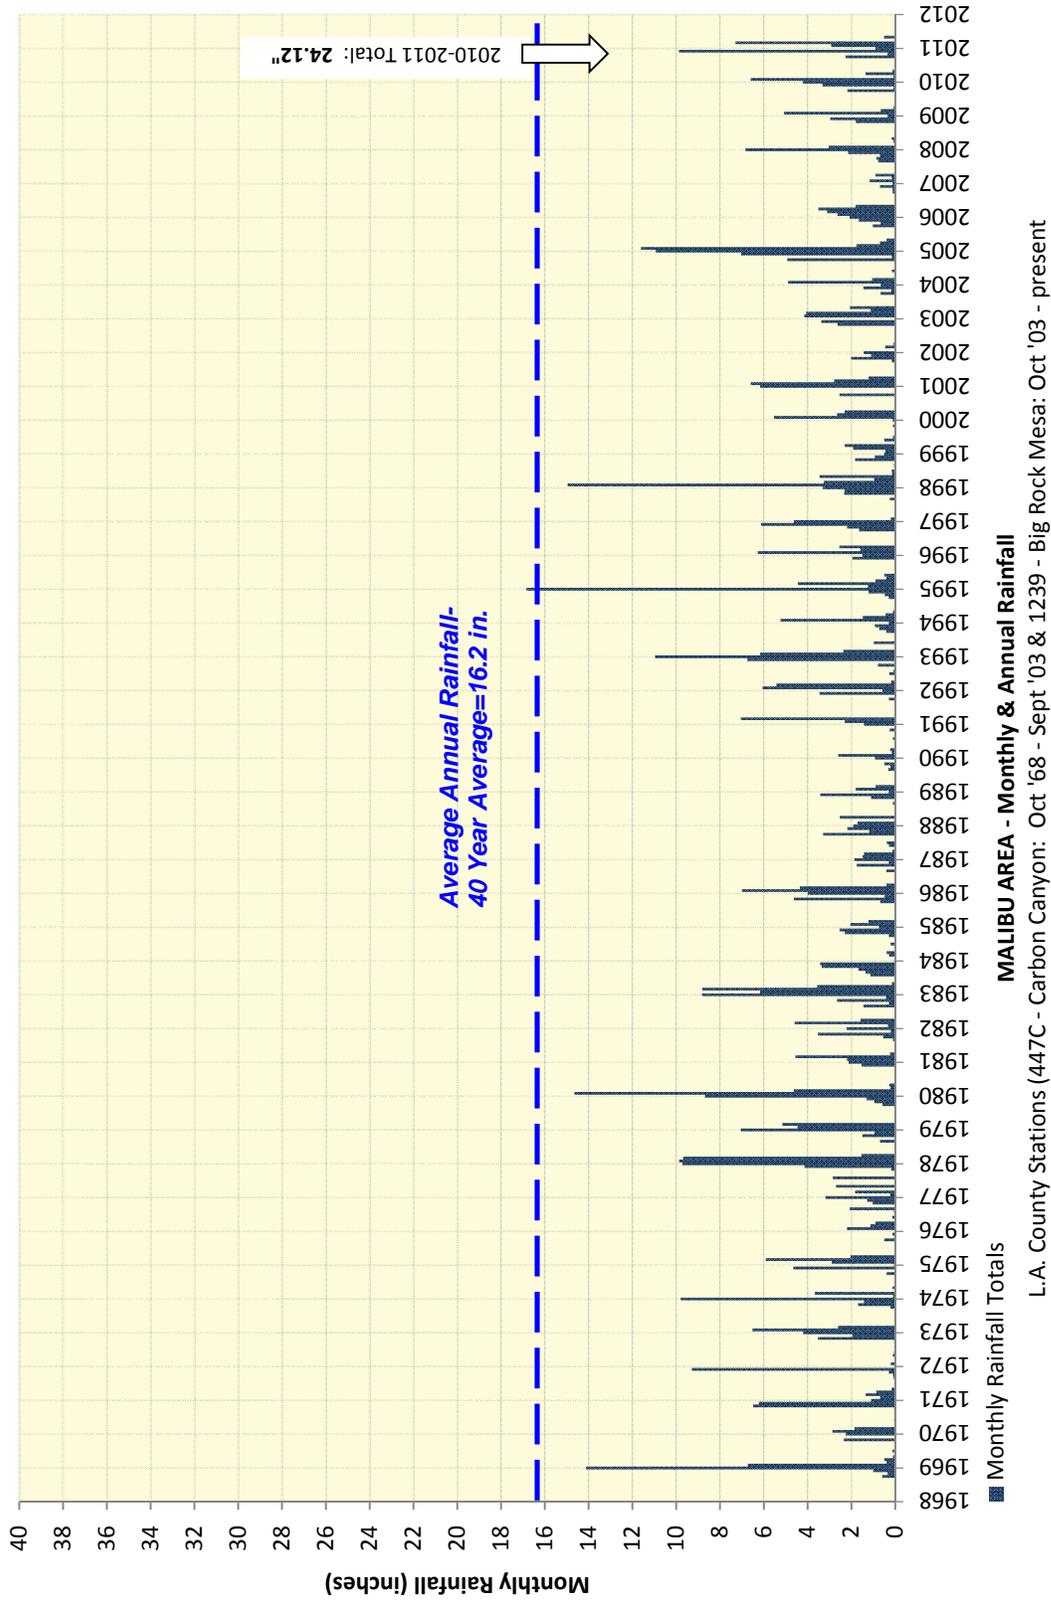
**RAINFALL GRAPH**  
Malibu Road Landslide Assessment District  
Malibu, California

Rainfall data indicate that approximately 24.16 inches of precipitation fell during the monitoring period from July 2010 through June 2011. The average rainfall total from 1968 to 2011 in the Malibu area for the period July through June is approximately 16.24 inches.

Rainfall data is usually analyzed in terms of the annual "rain season" that covers the time period October 1 through September 30. Rainfall for October 1, 2010, through June 30, 2011, was approximately 24.12 inches. This is approximately 141 percent of the average rainfall total of 16.24 inches for the rain seasons of 1968 through 2011.

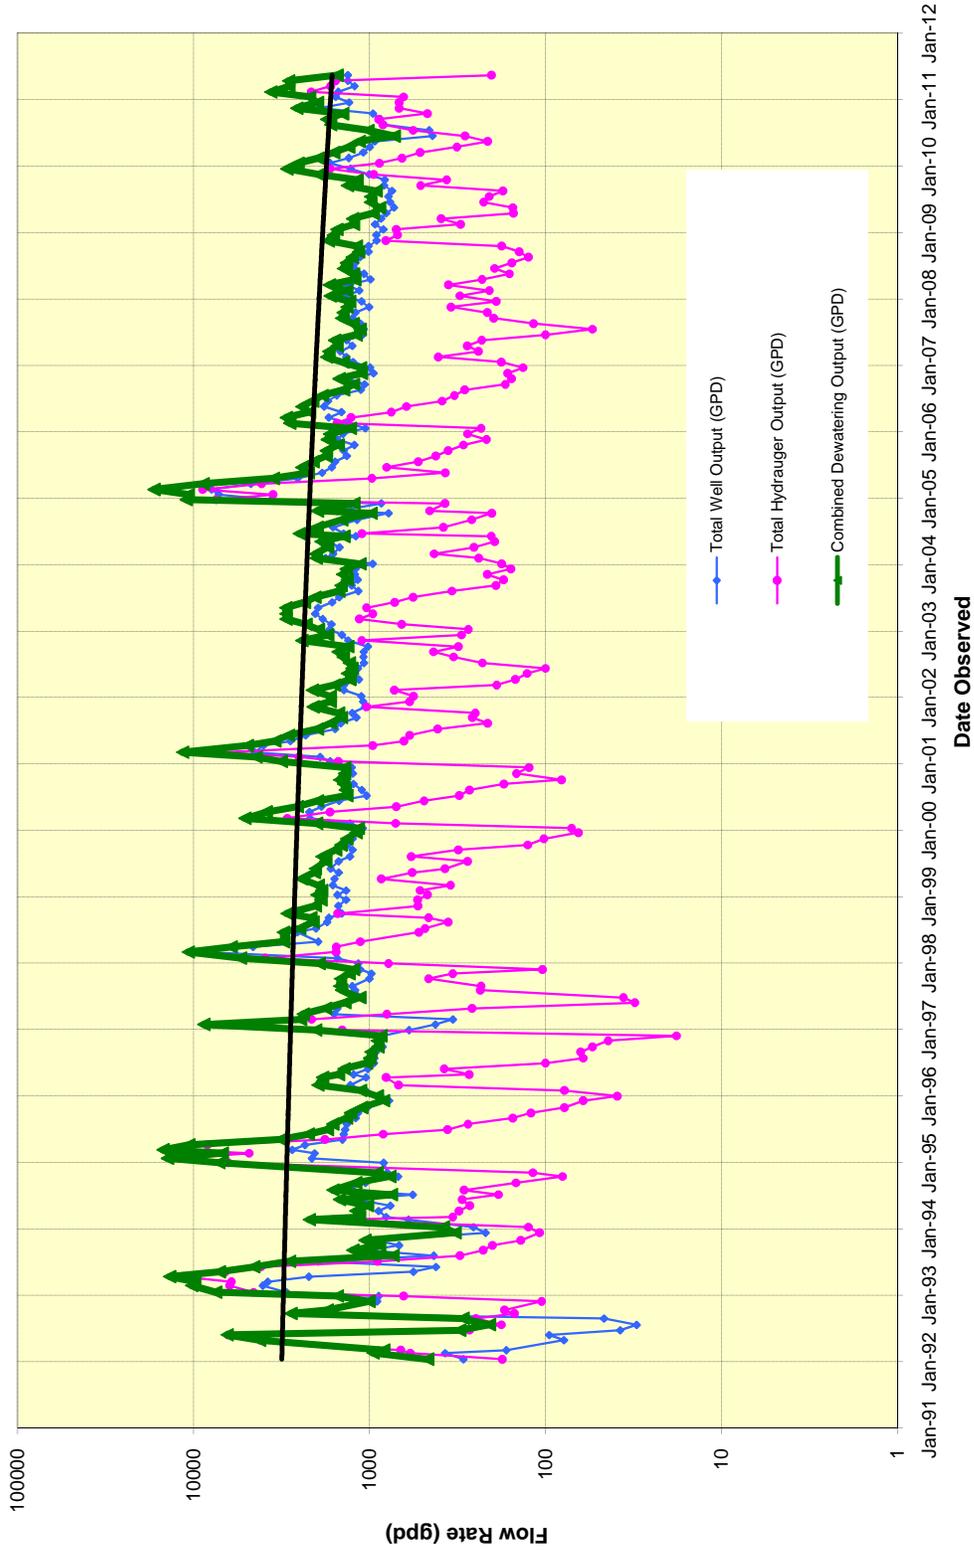
**DEWATERING GRAPH**  
Malibu Road  
(Total Output - All Wells & Hydraugers)

- The average total dewatering rate during the monitoring period was approximately 2,025 gpd. This represents a 29 percent increase in the average rate relative to the 1,574 gpd average recorded during the previous monitoring period.

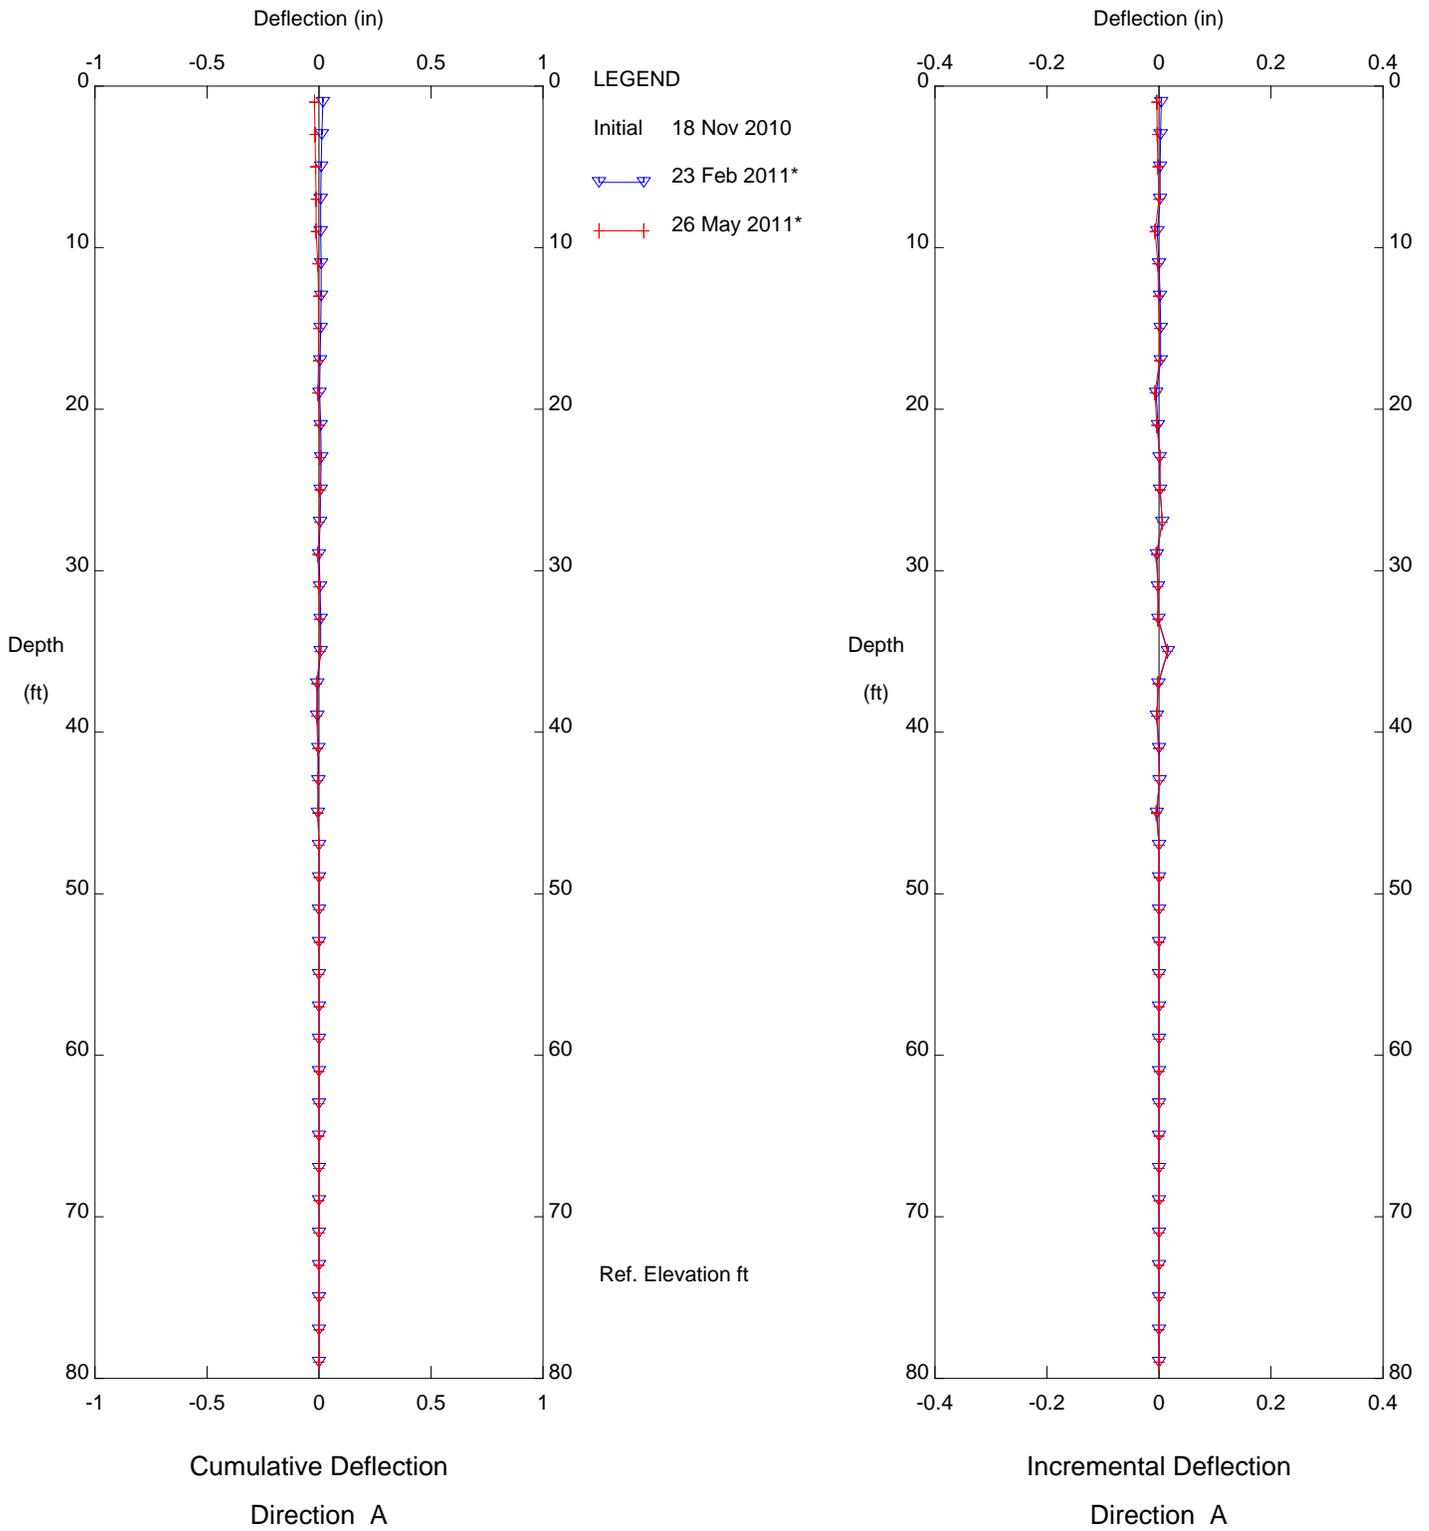
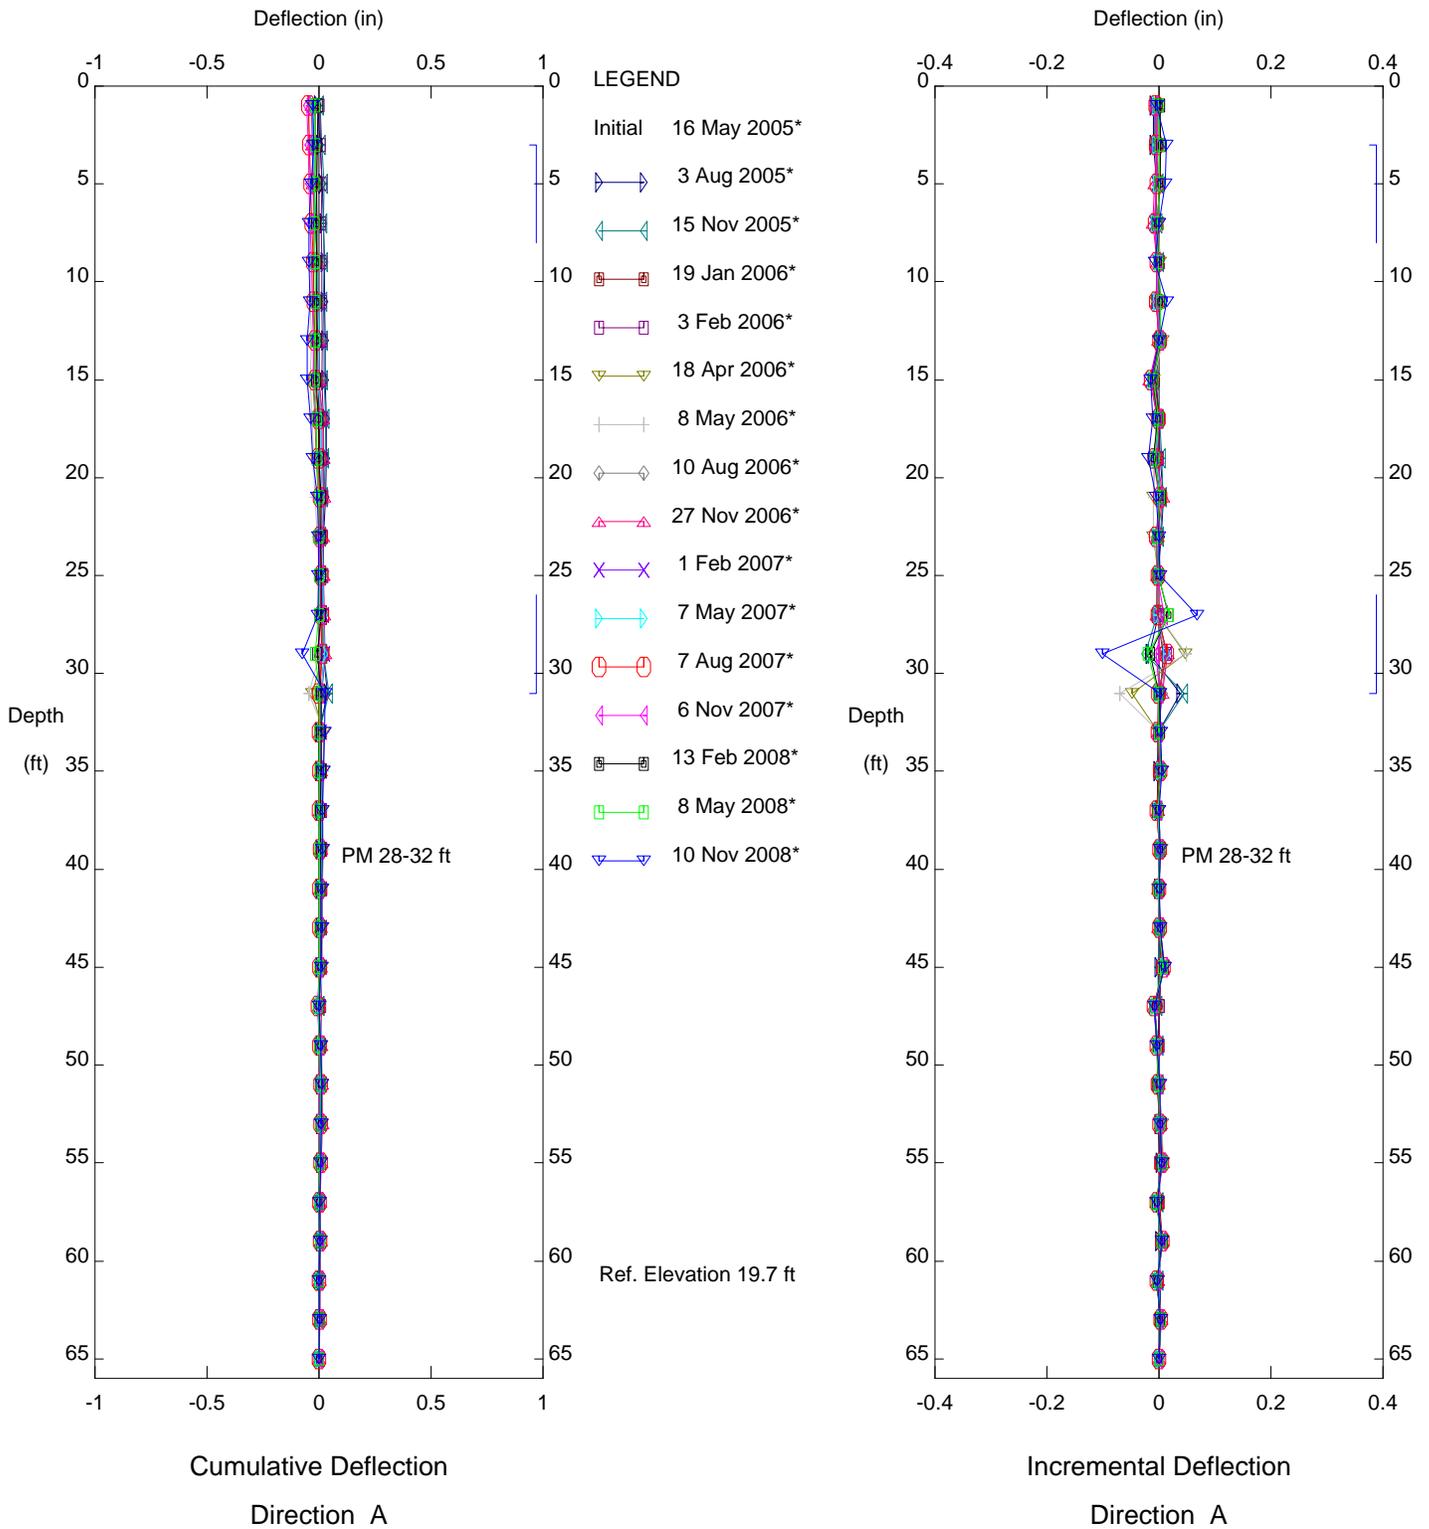
MAL-RD, Inclinator SI-2A

November 2010. Therefore, the first plot of SI-2A shows the current year readings, while the second plot shows the readings of SI-2 from 2005-2010.

A replacement inclinometer, SI-2A, was installed during the first quarter of the 2010-2011 monitoring year to replace SI-2, which was sheared off during the previous monitoring

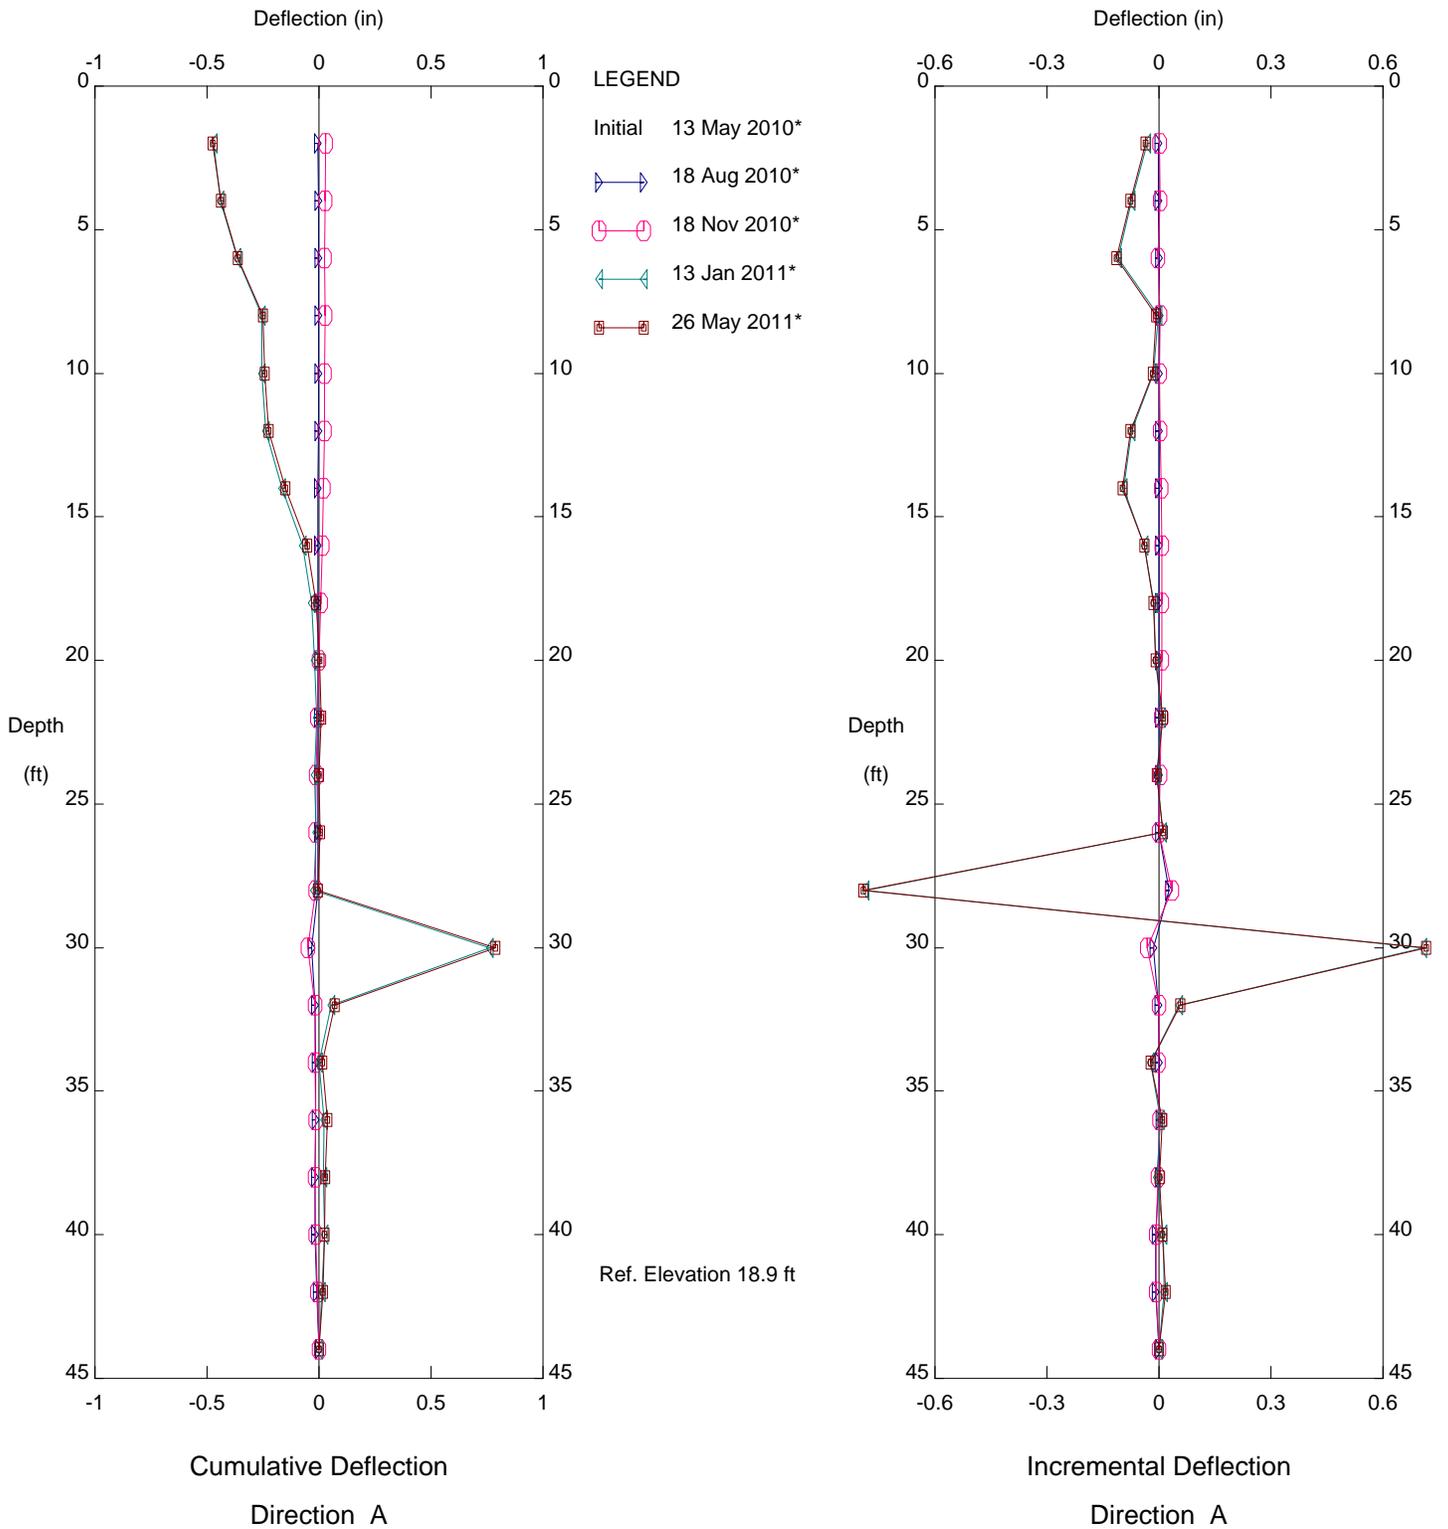
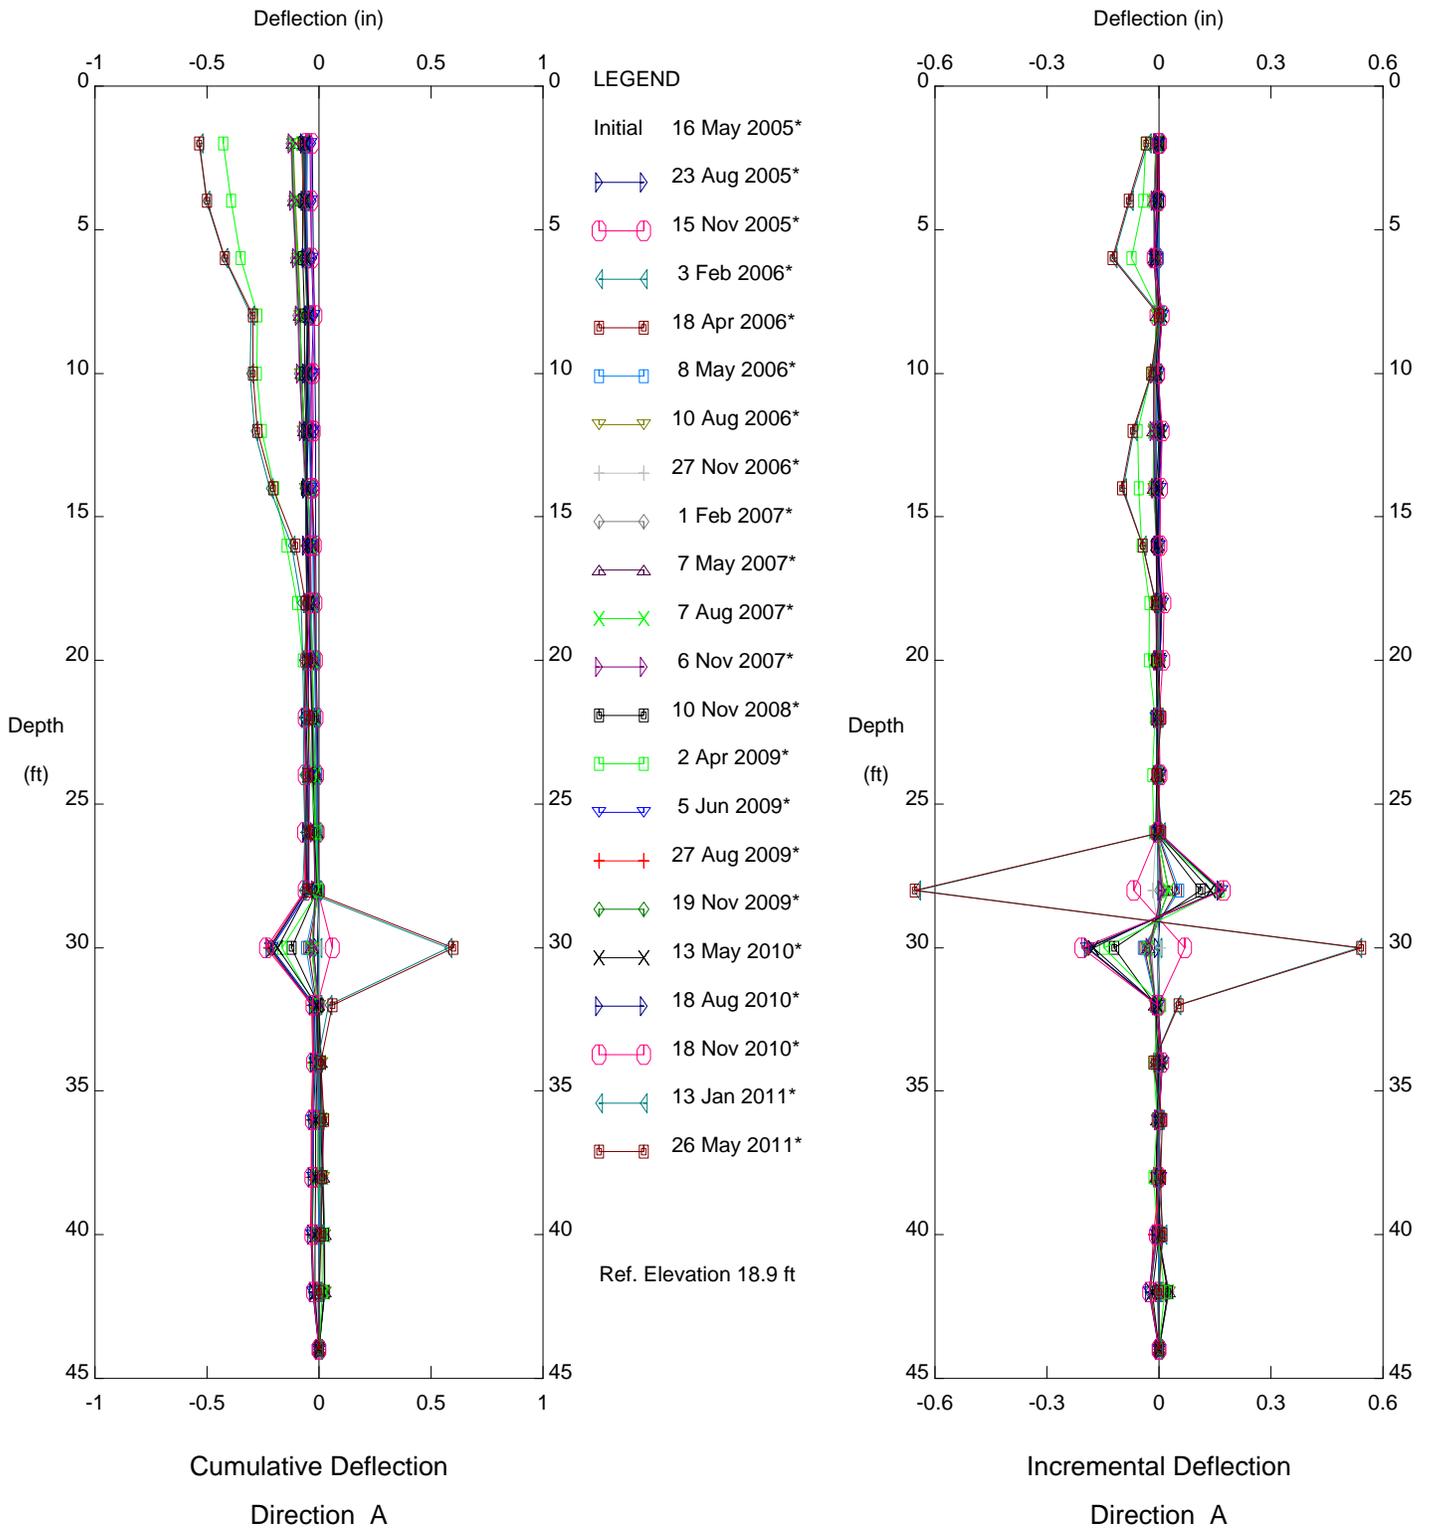
MALIBU ROAD, Inclinometer SI-4

Interpretation of inclinometer data along Malibu Road shows no significant movement during the 2010-2011 monitoring year except for SI-4, which showed significant movement at a depth of approximately 30 feet. There continues to be difficulty obtaining data below 28 feet in SI-4, indicating that SI-4 is expected to “shear off” in the winter of 2011. A replacement inclinometer is proposed for Fall of 2011.

year. A replacement inclinometer is proposed for the first quarter of the 2010-2011 monitoring year to replace SI-4, which has become difficult to read below approximately 30 feet, or SI-3, which was sheared off during the 2004 to 2005 monitoring year.

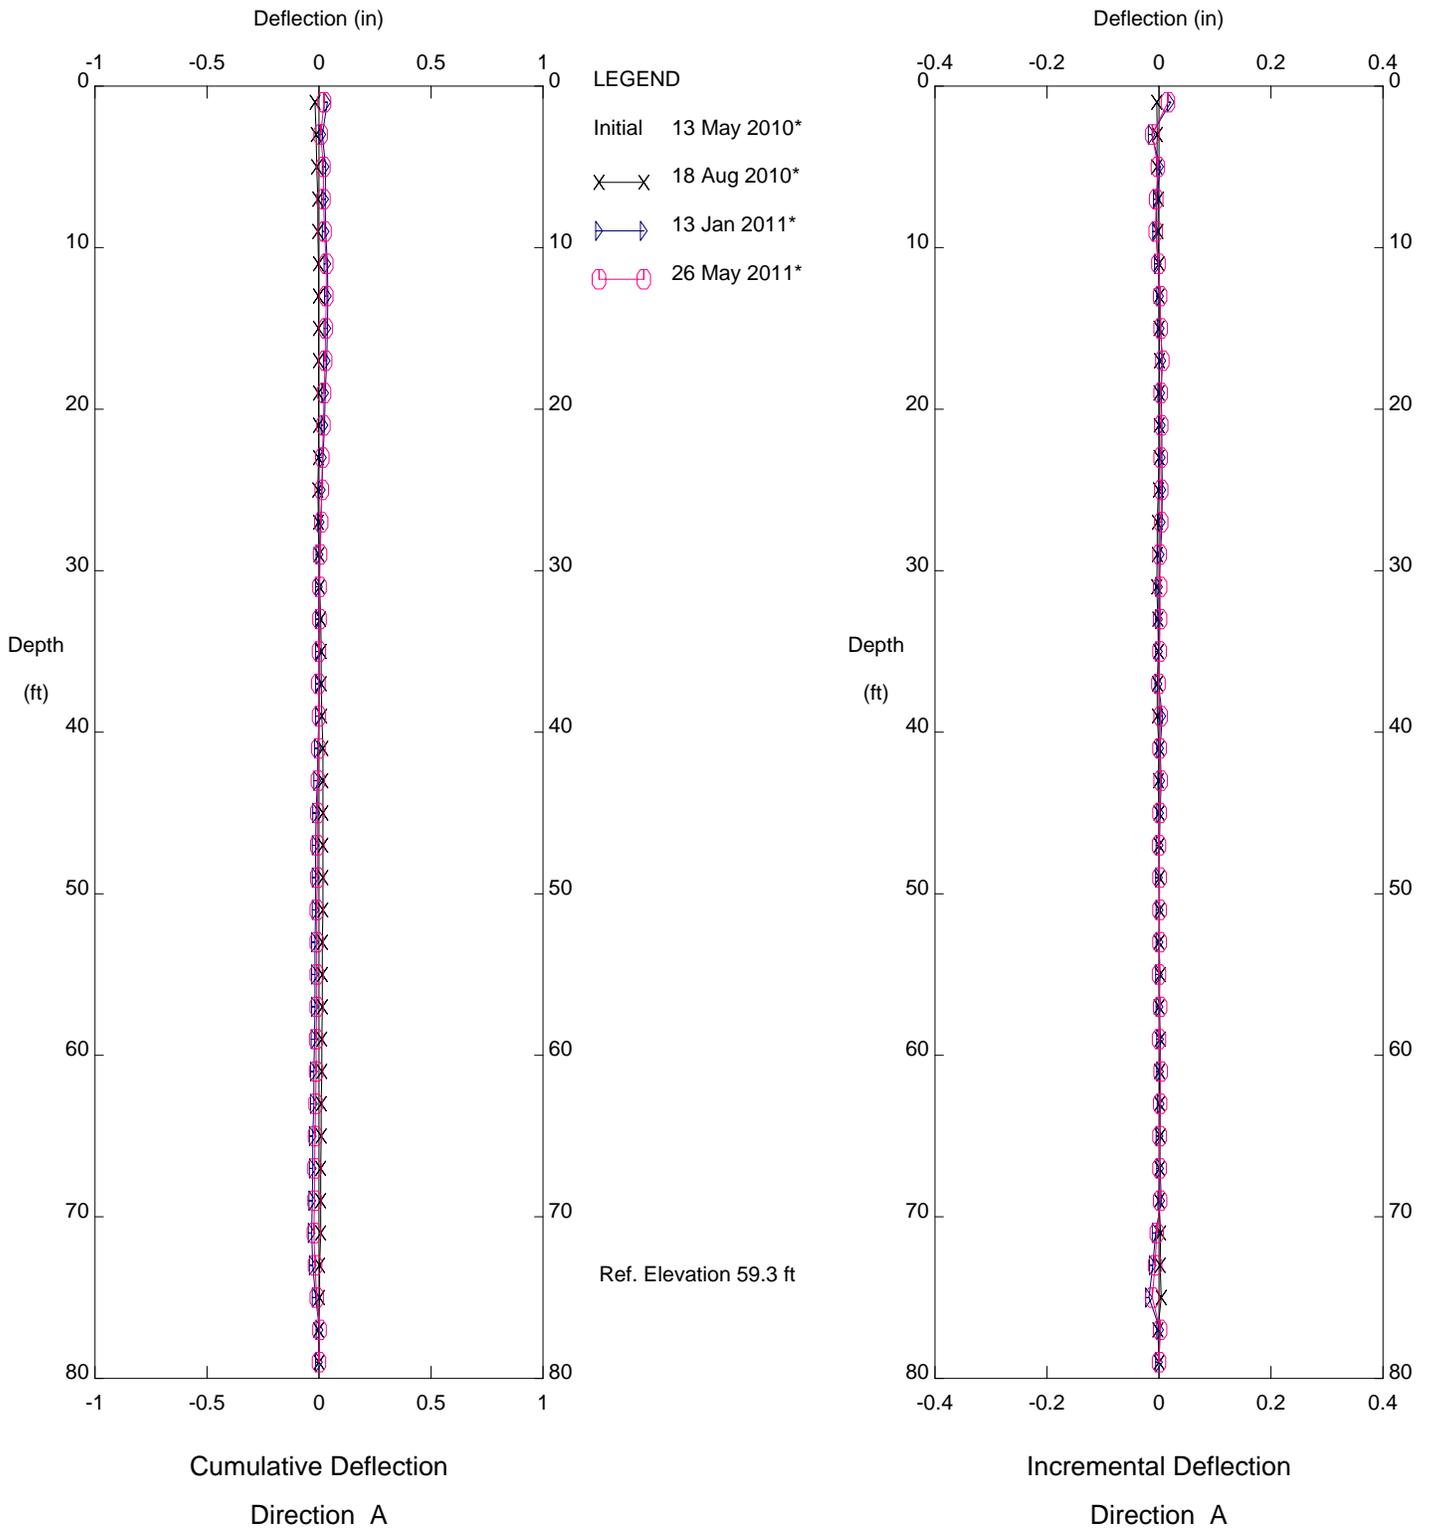
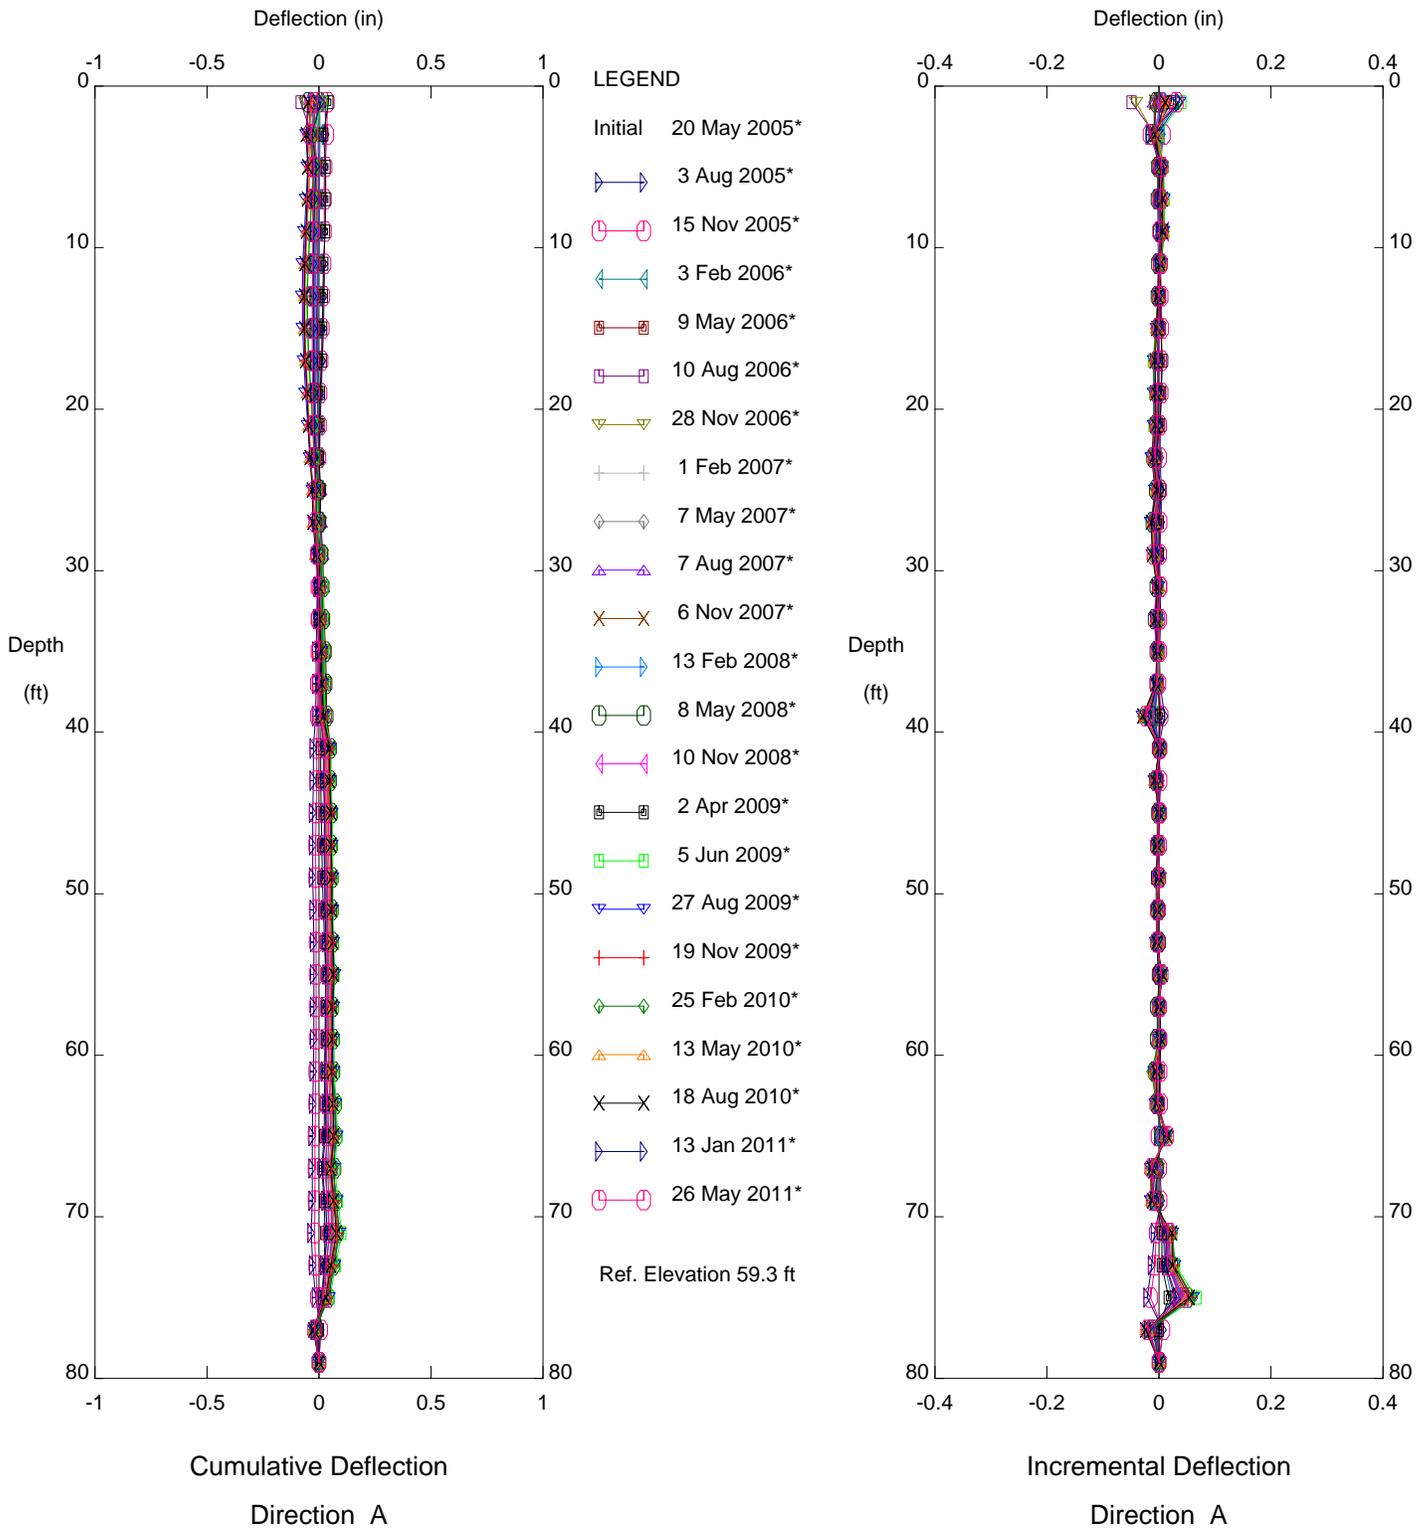
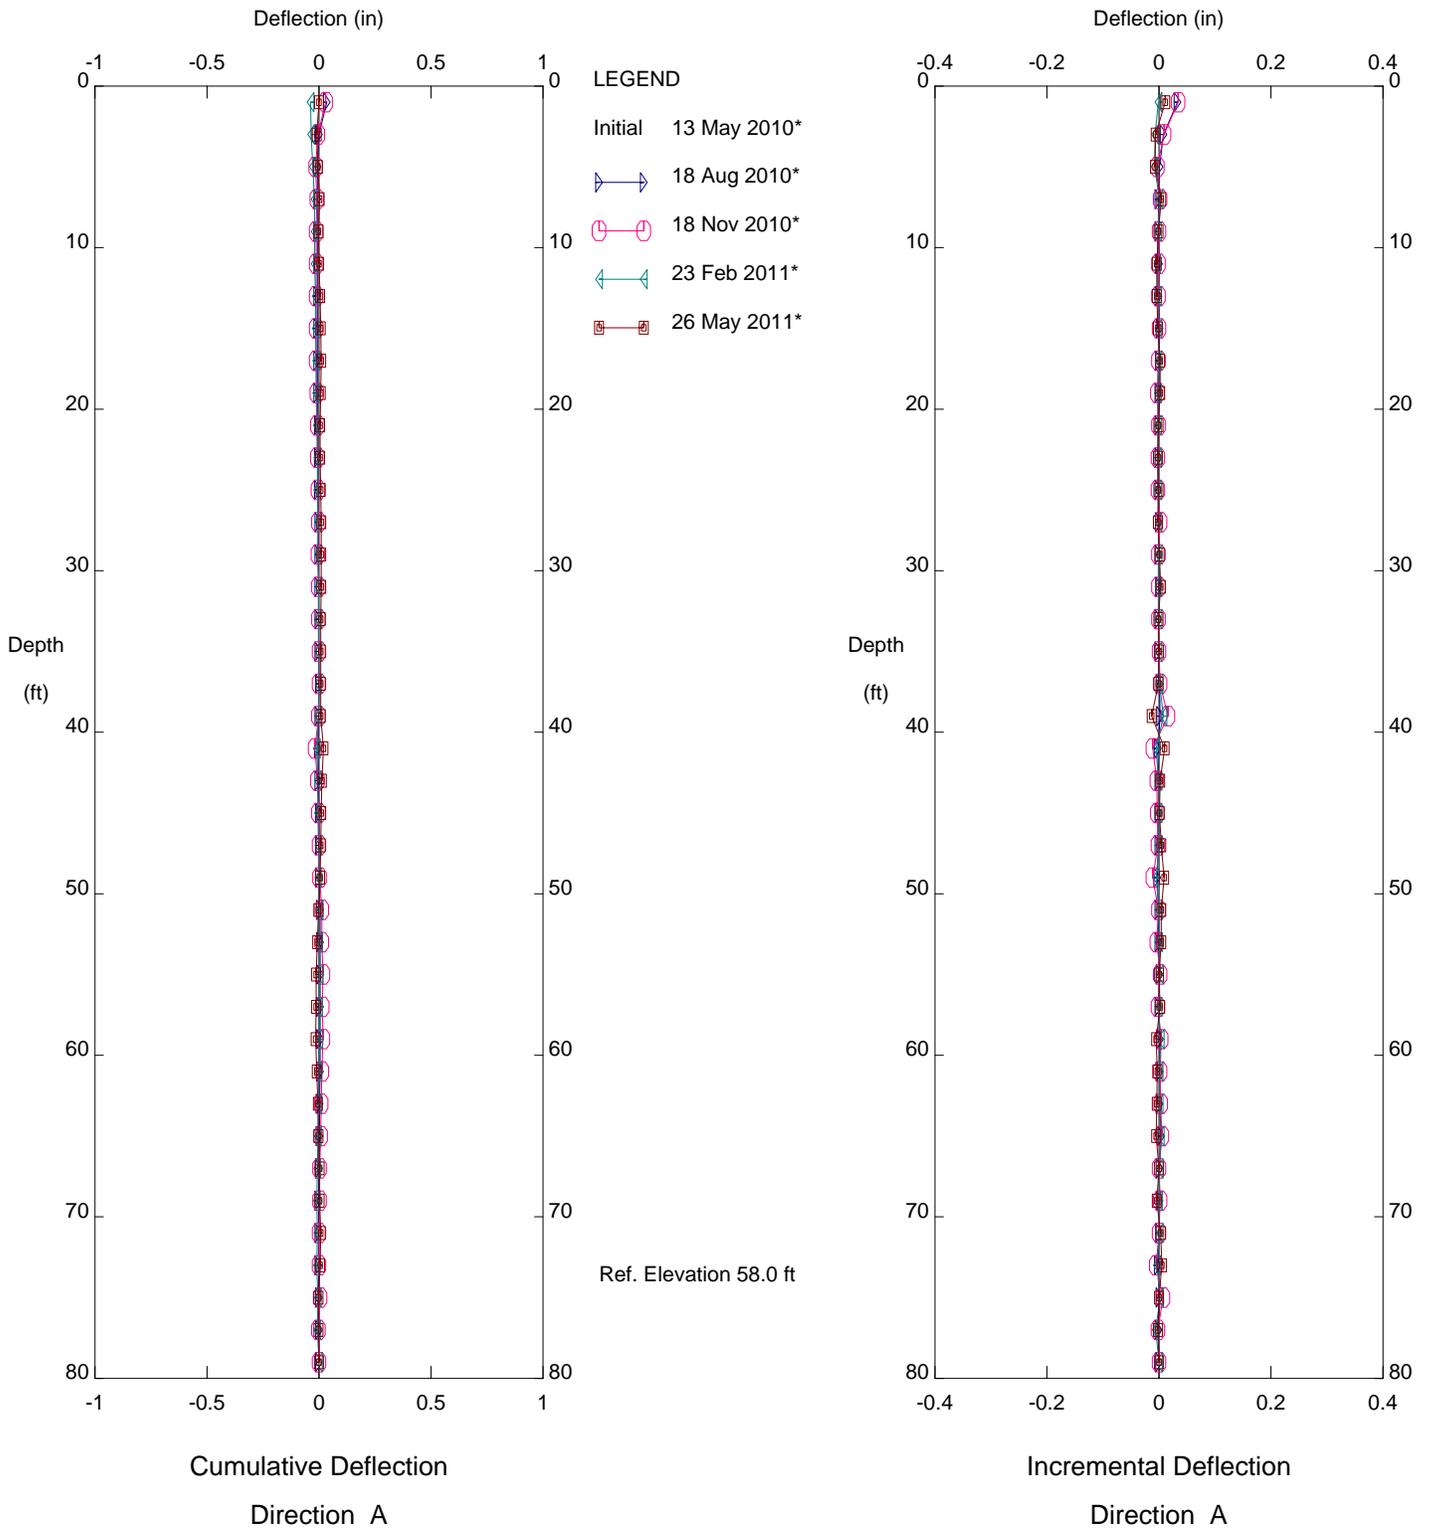
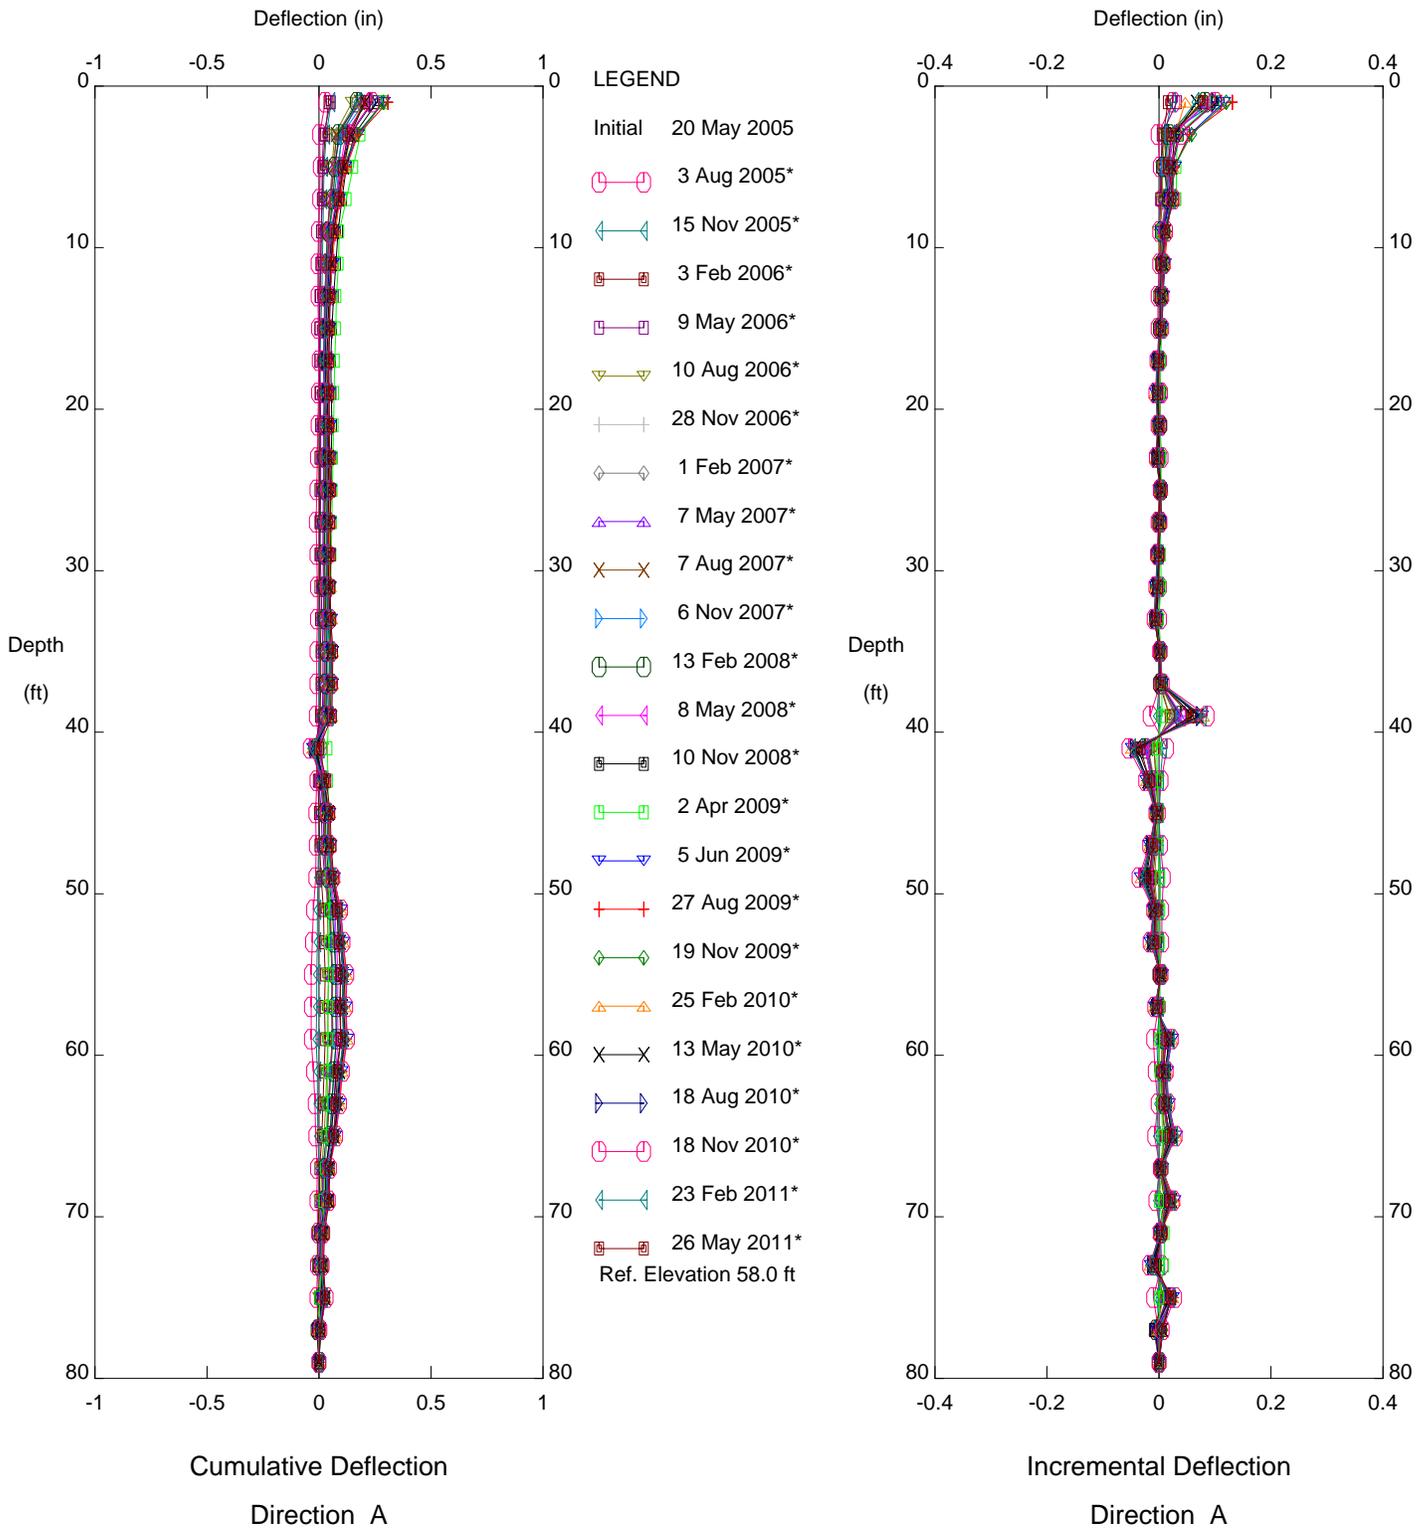
Inclinometers SI-5 and SI-6 are located on Bayshore Drive, upslope and outside the defined limit of the most recent 1998 movement. No significant movement was observed during this monitoring year in SI-5 or SI-6.
