**ANNUAL REPORT
JULY 2009 THROUGH JUNE 2010
MALIBU ROAD LANDSLIDE ASSESSMENT DISTRICT
MALIBU, CALIFORNIA**

Prepared for:
CITY OF MALIBU

March 2011
Fugro Project No. 04.B3399004

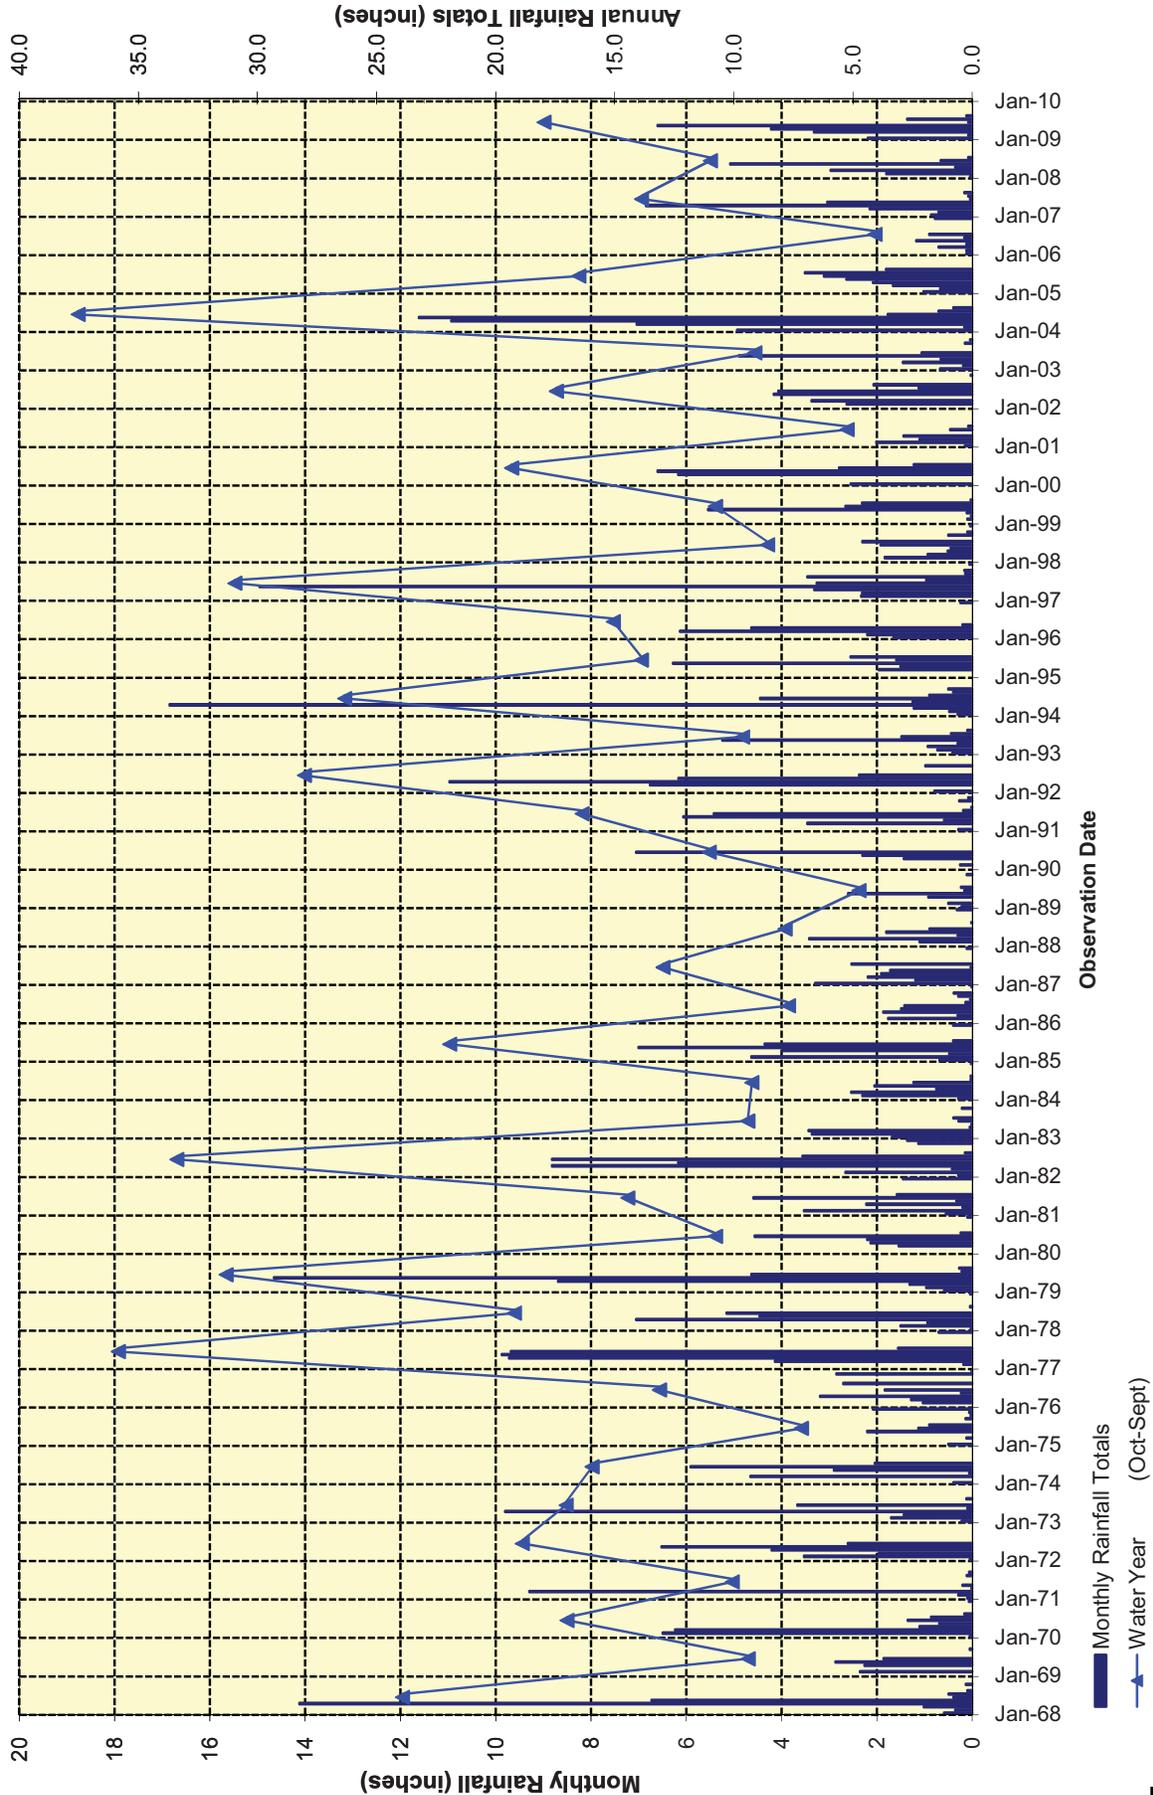
RAINFALL GRAPH
 Malibu Road Landslide Assessment District
 Malibu, California

Rainfall data indicate that approximately 17.97 inches of precipitation fell during the monitoring period from July 2009 through June 2010. The average rainfall total from 1968 to 2010 in the Malibu area for the period July through June is approximately 16.05 inches.

Rainfall data is usually analyzed in terms of the annual "rain season" that covers the time period October 1 through September 30. Rainfall for October 1, 2009, through June 30, 2010, was approximately 17.97 inches. This is approximately 107 percent of the average rainfall total of 16.8 inches for the rain seasons of 1968 through 2010.

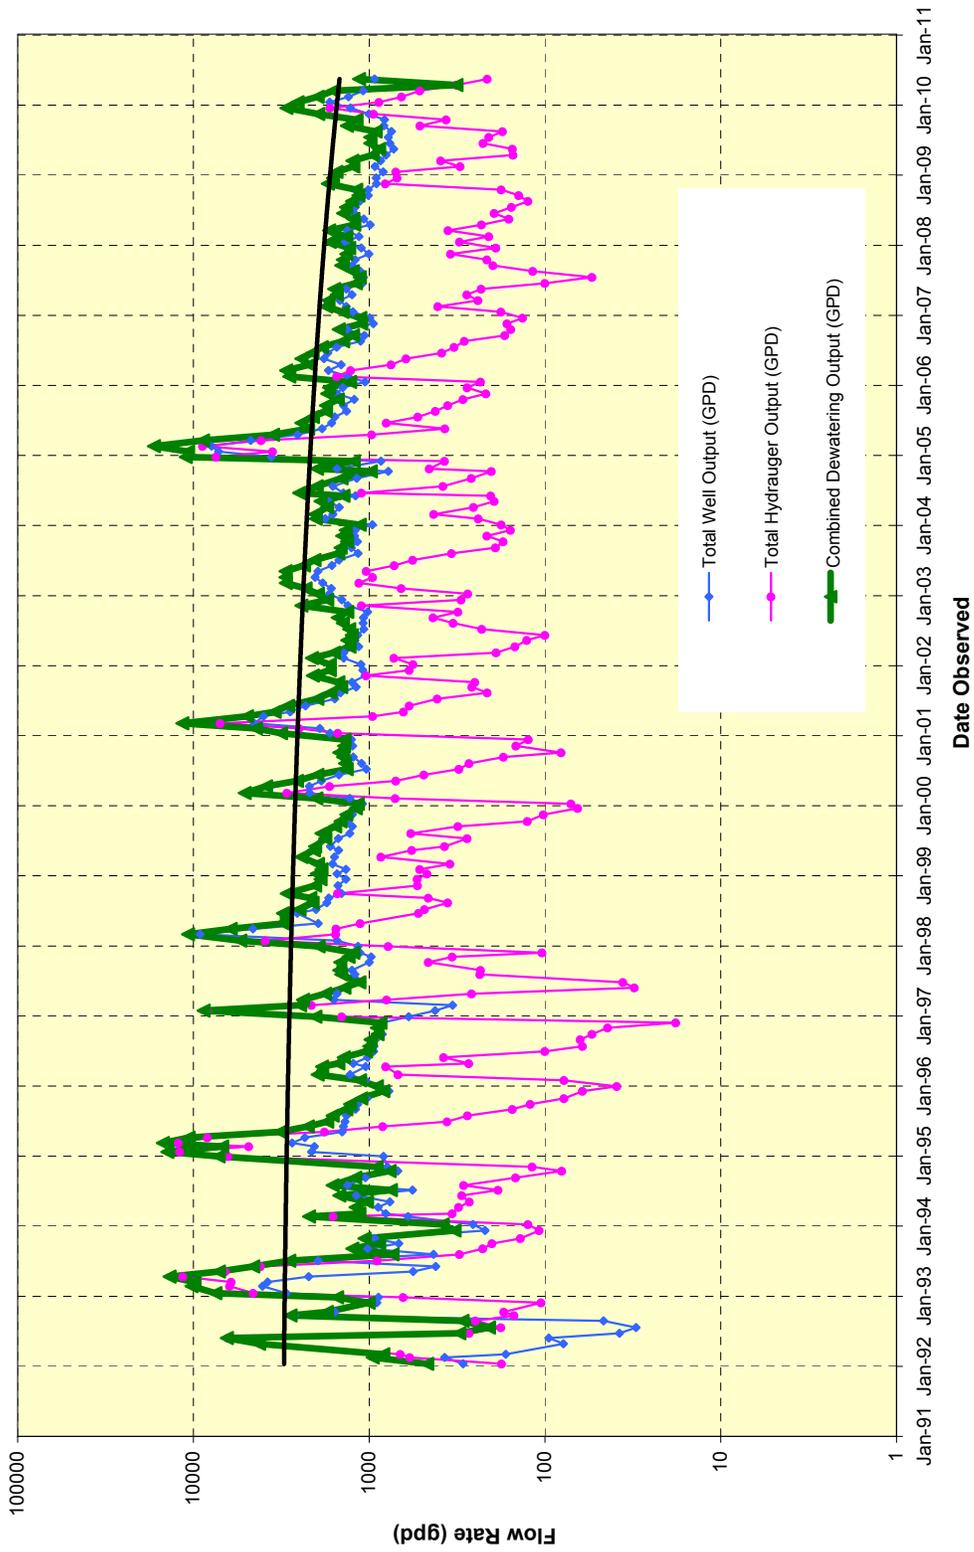
DEWATERING GRAPH
Malibu Road
(Total Output - All Wells & Hydraugers)

A combined graph of the total dewatering rate for all dewatering wells and hydraugers is presented on Plate 4. Total dewatering production data for the hydraugers and wells indicates the following:

- The average total dewatering rate during the monitoring period was approximately 1,574 gpd. This represents a 21.5 percent increase in the average rate relative to the 1,295 gpd average recorded during the previous monitoring period.

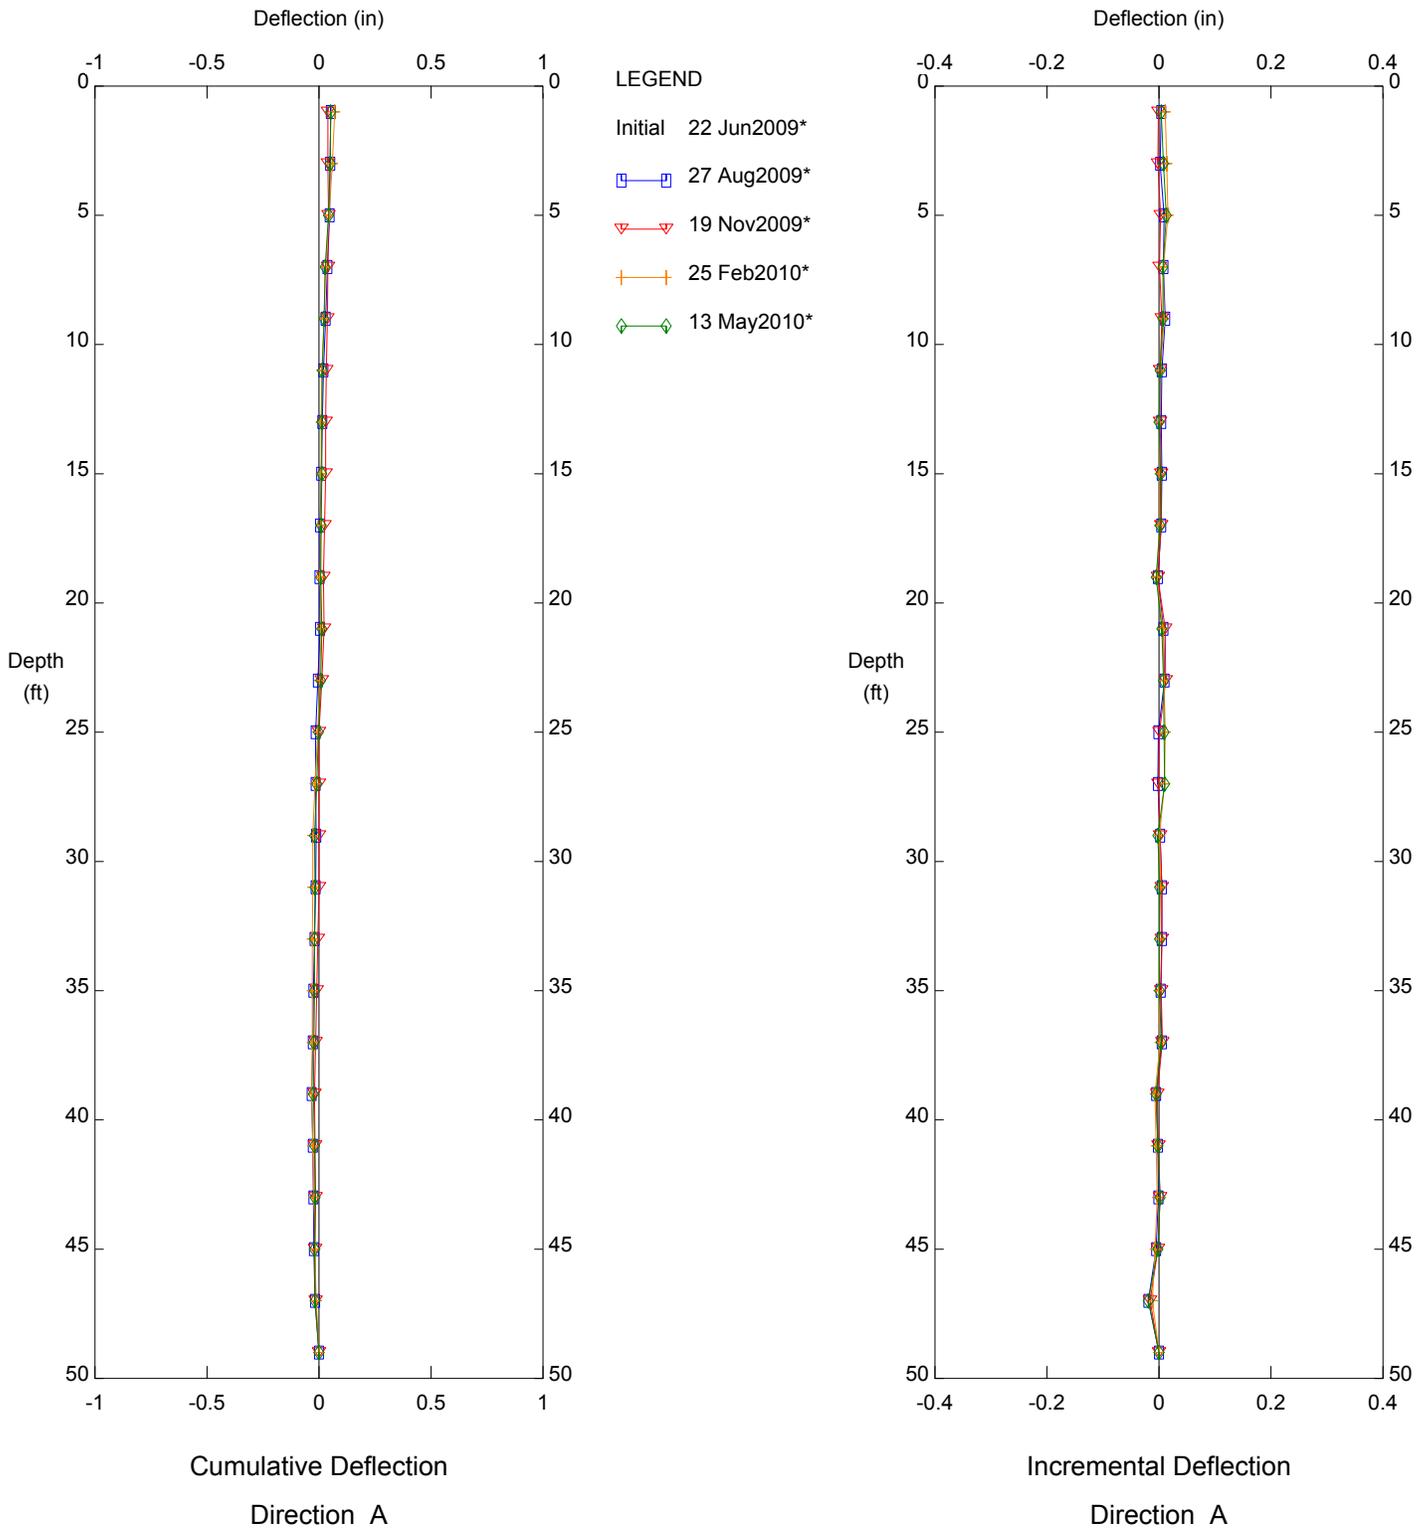
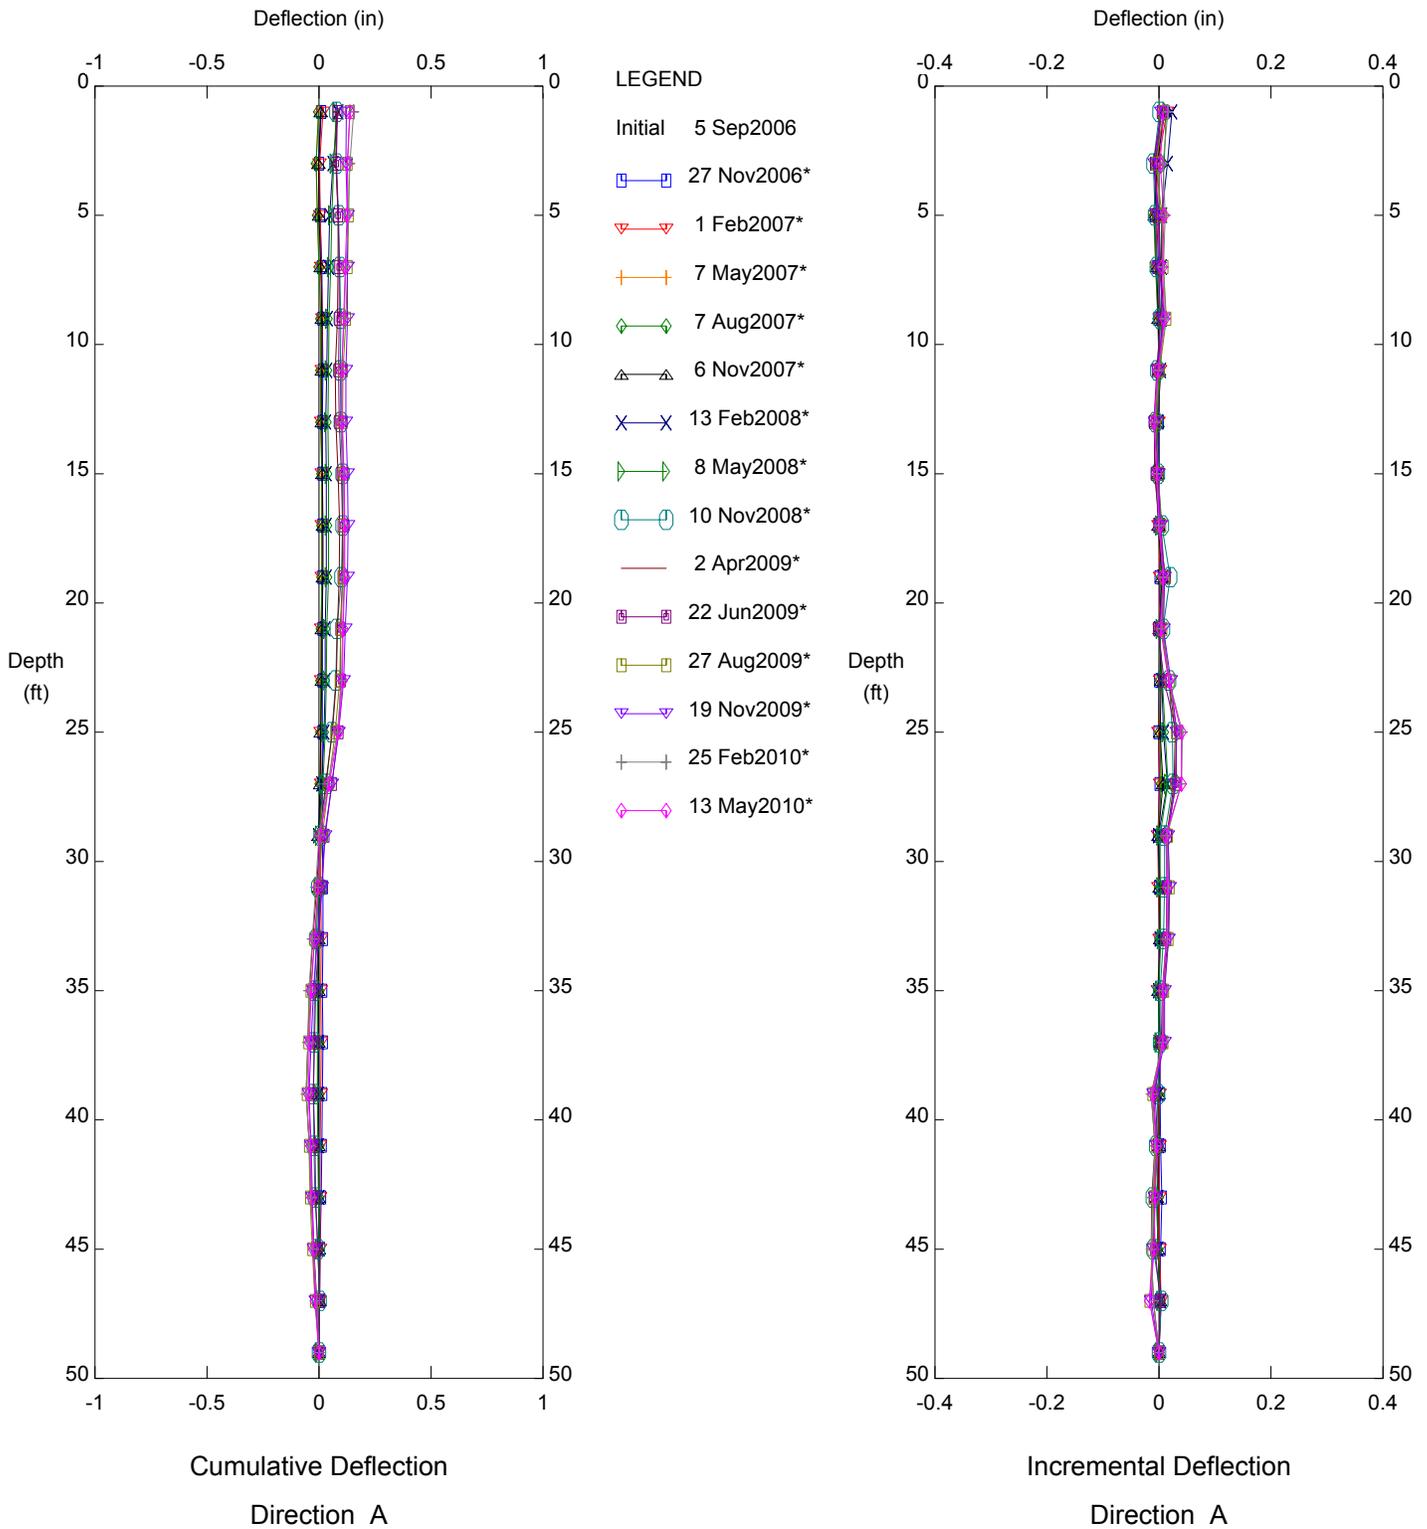
MAL-RD, Inclinometer SI1A

Interpretation of inclinometer data along Malibu Road for SI-1A and SI-4 shows no significant movement during the 2009-2010 monitoring year. There was difficulty obtaining data below 28 feet in SI-2, indicating that SI-2 was "sheared off" in the winter of 2009. A replacement inclinometer was installed during the fall of 2010.

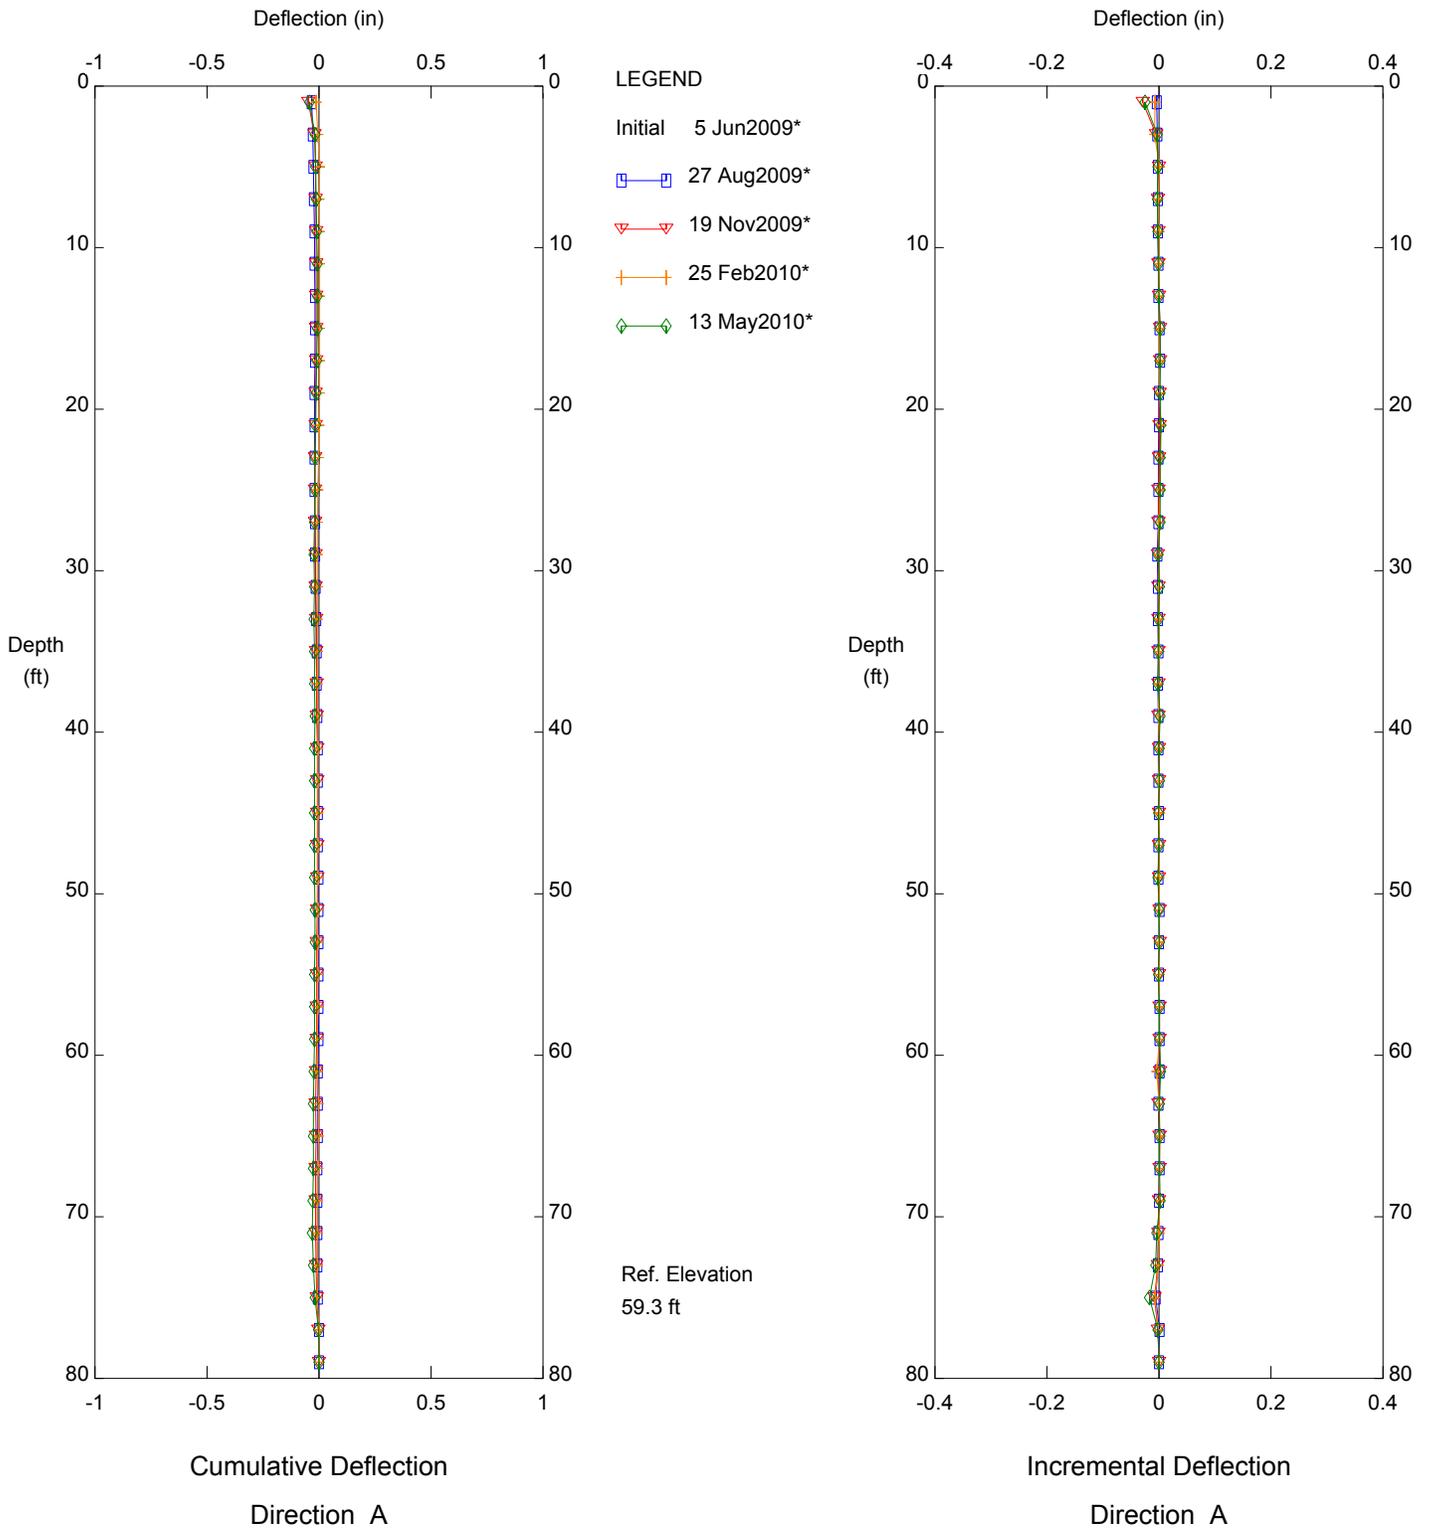
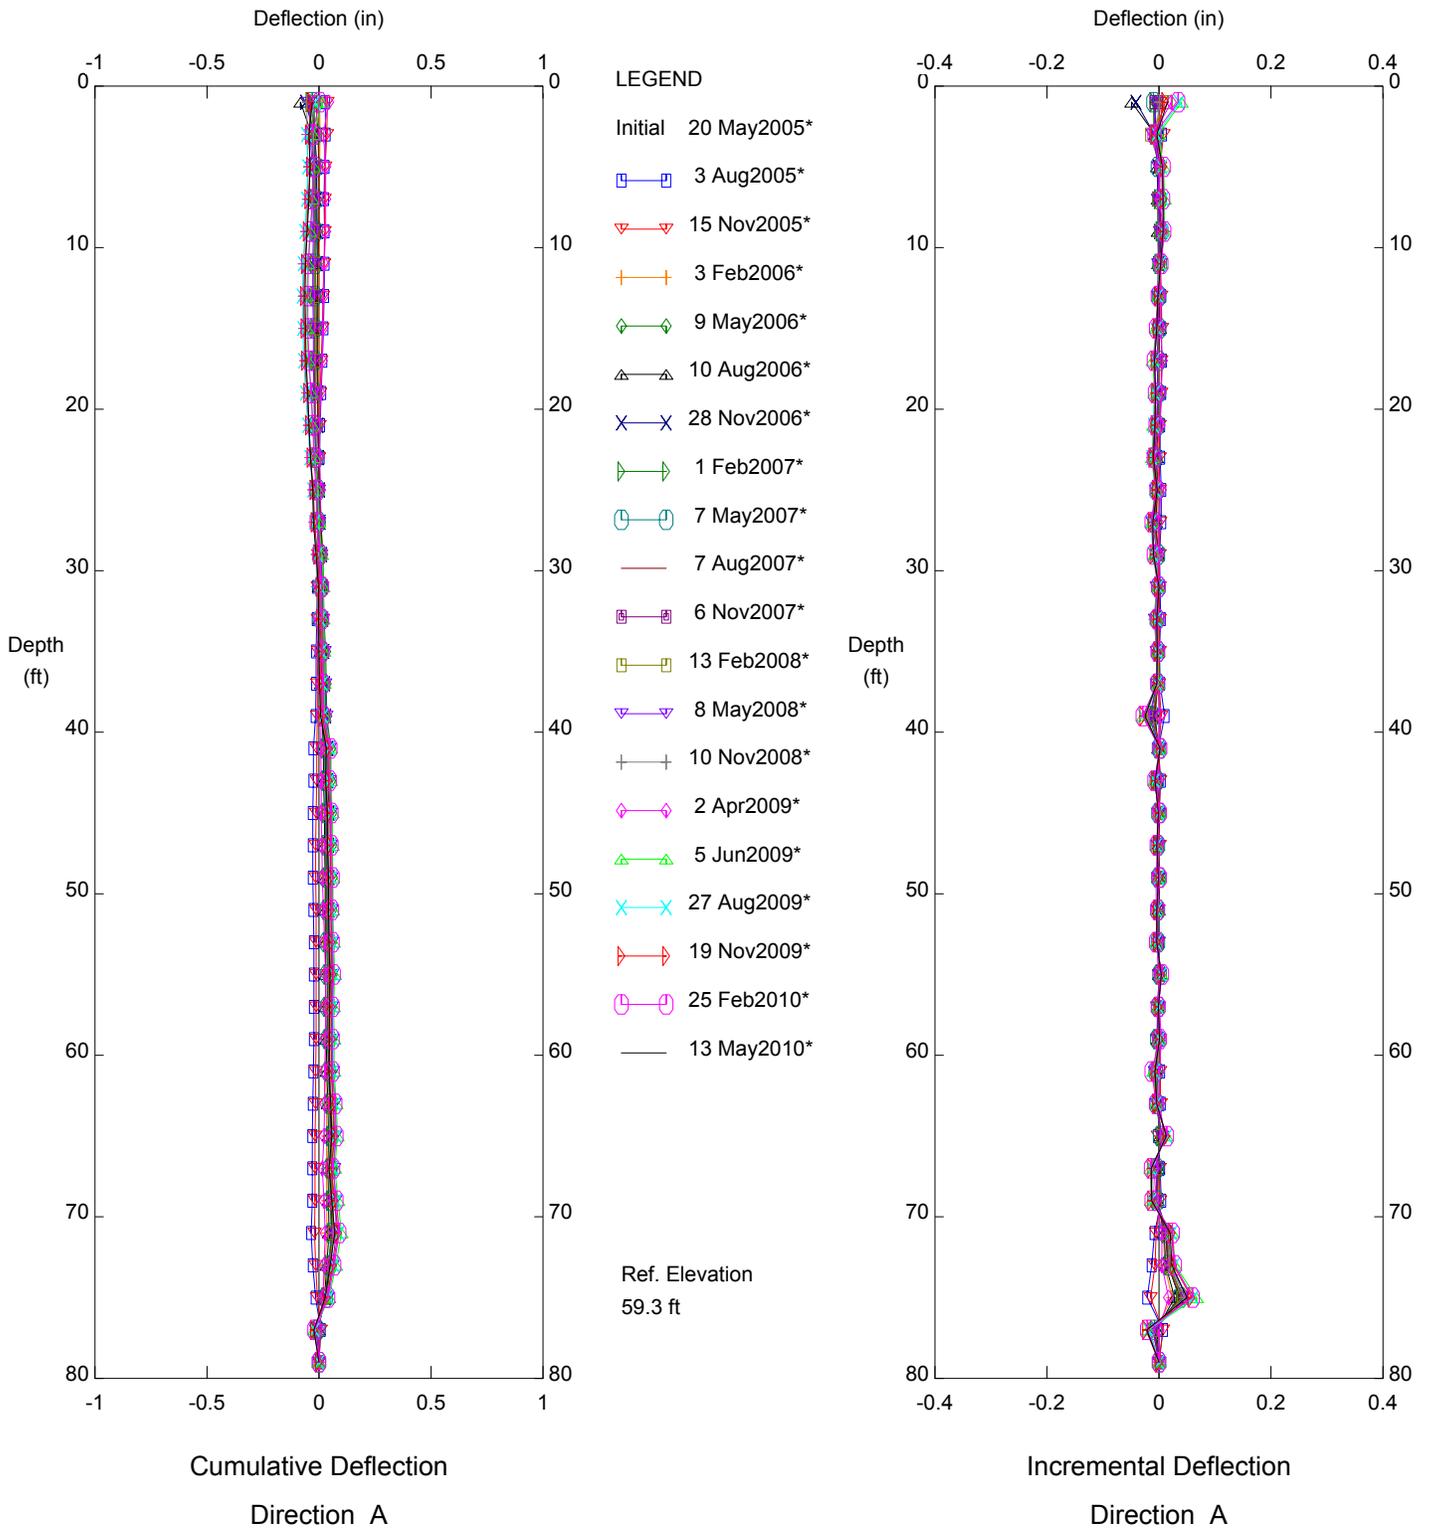
MALIBU ROAD, Inclinometer SI-5

Inclinometers SI-5 and SI-6 are located on Bayshore Drive, upslope and outside the defined limit of the most recent 1998 movement. No significant movement was observed during this monitoring year in SI-5 or SI-6.
