**ANNUAL REPORT
JULY 2008 THROUGH JUNE 2009
MALIBU ROAD LANDSLIDE ASSESSMENT DISTRICT
MALIBU, CALIFORNIA**

Prepared for:
CITY OF MALIBU

October 2009
Fugro Project No. 3399.004

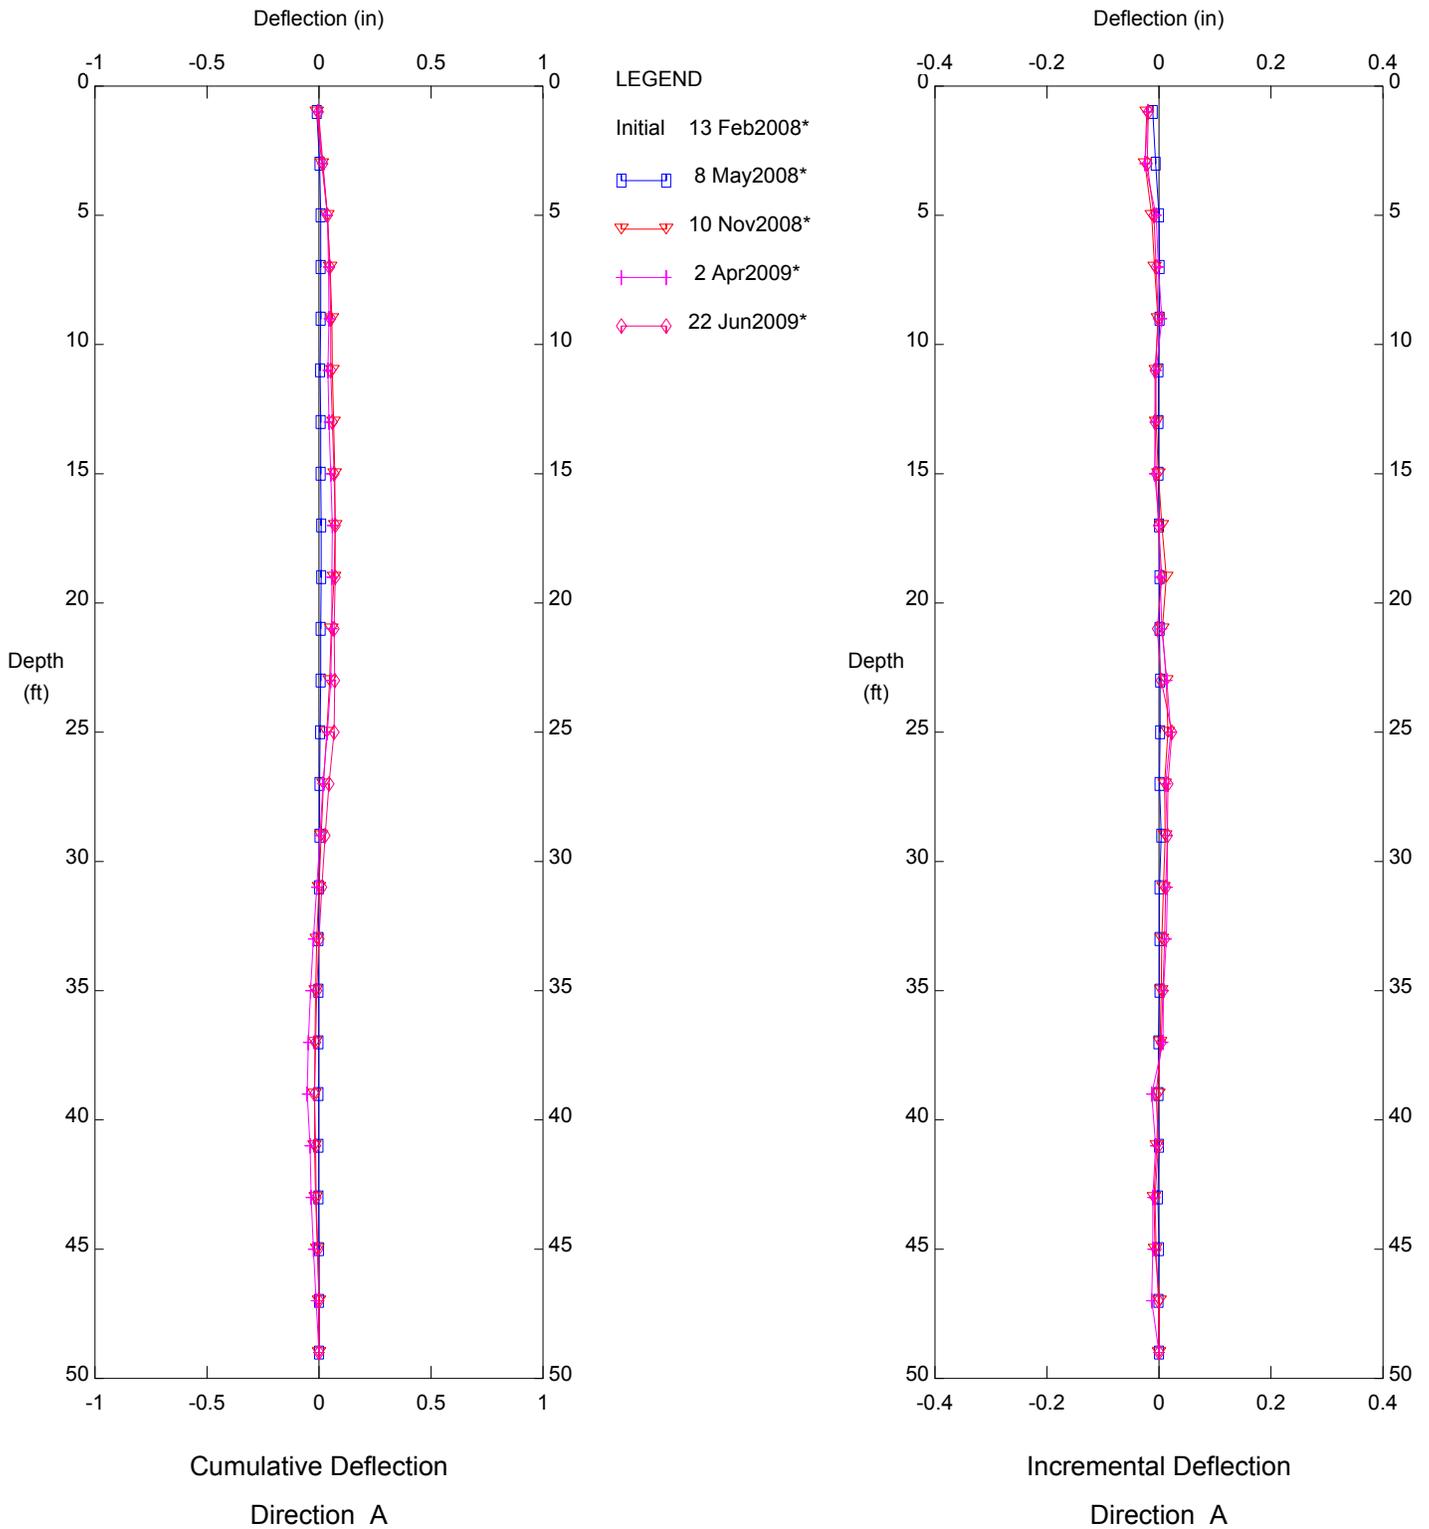
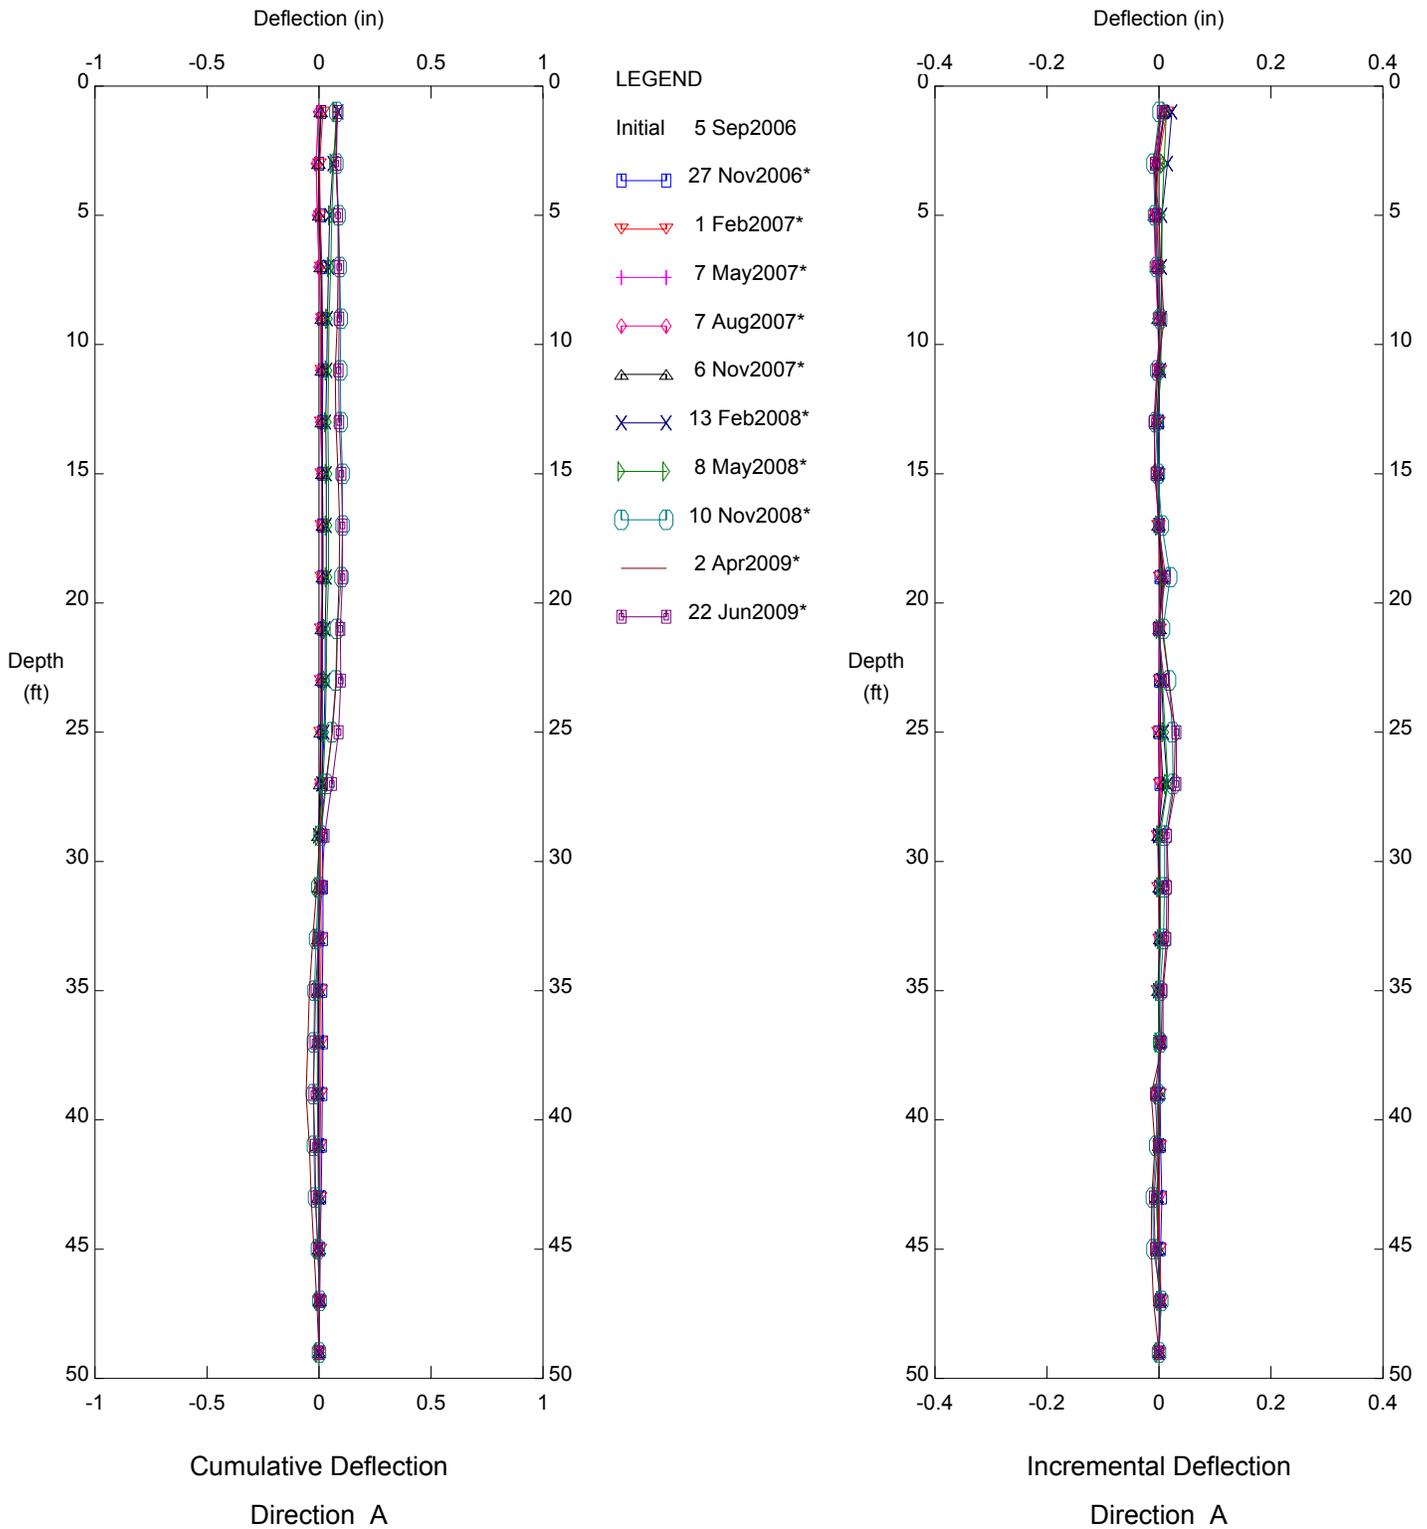
MAL-RD, Inclinometer SI1A

Interpretation of inclinometer data along Malibu Road for SI-1A and SI-4 shows no significant movement during the 2008-2009 monitoring year. There was difficulty obtaining data below 28 feet in SI-2, indicating that SI-2 was "sheared off" in the winter of 2009. However, less than 0.1 inches was recorded during the monitoring period, which is less than the reliable accuracy of the instrument. Therefore, deformation, which made the SI impassable with the probe can, most likely attributed to previous movement, as summarized on Plate C-1.

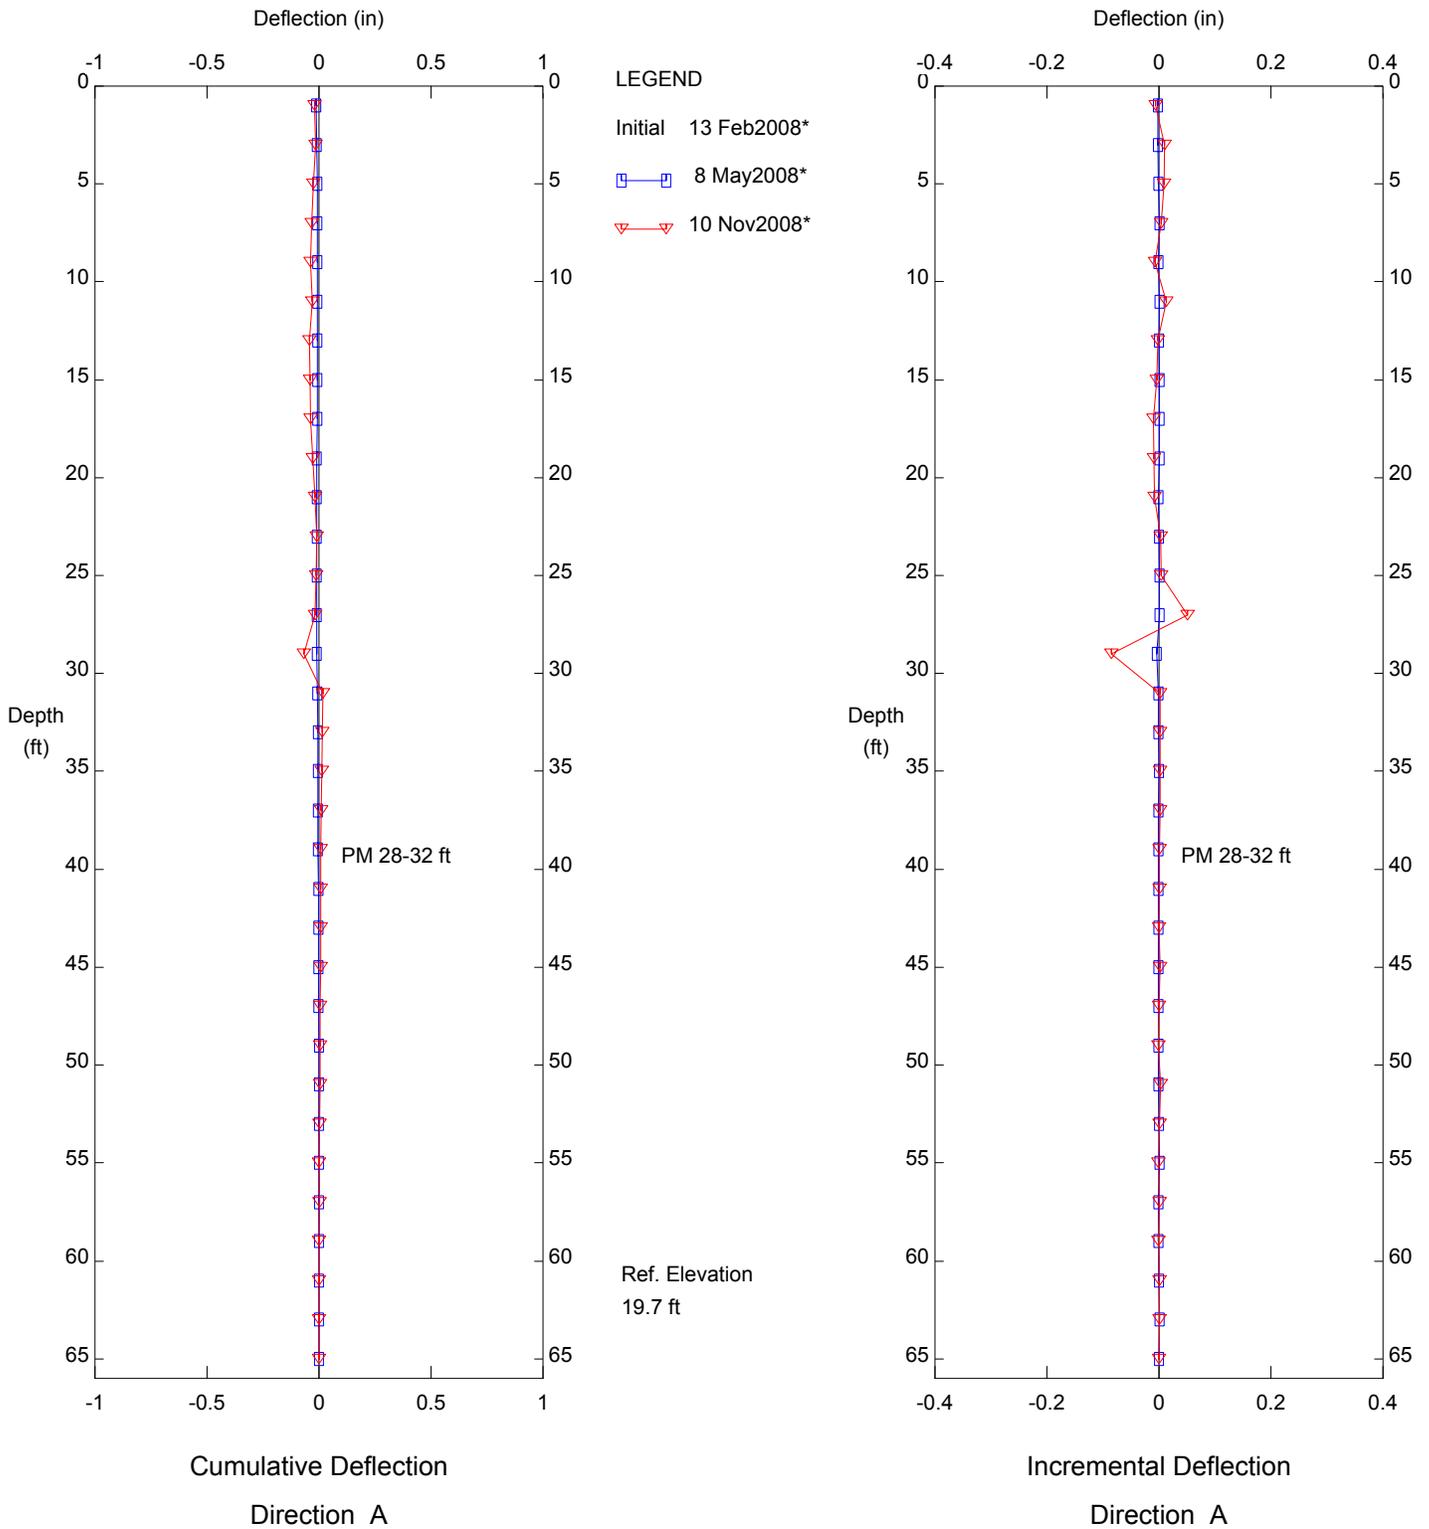
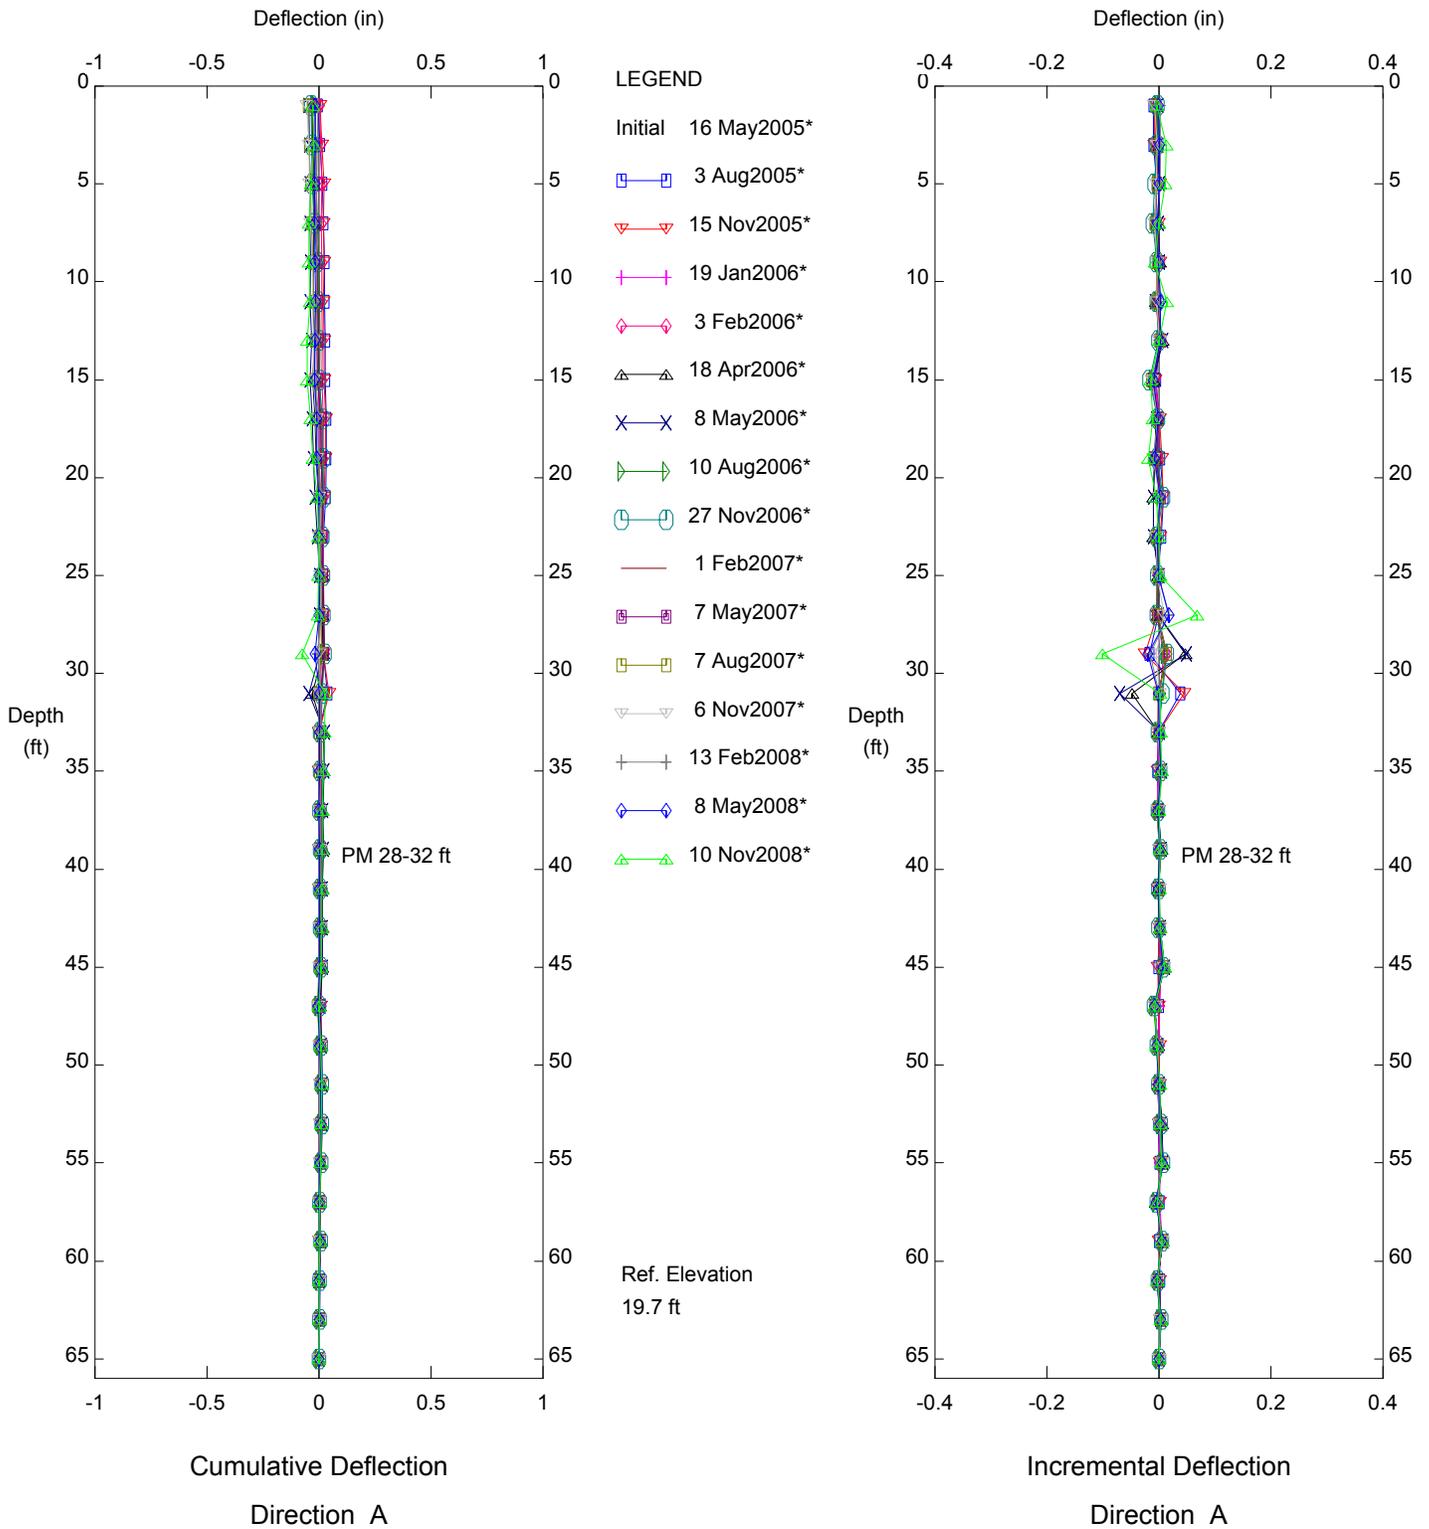
MALIBU ROAD, Inclinometer SI-2

- Groundwater levels in the assessment district area were below normal levels.
- Readings for the five slope inclinometers show no significant movement during the 2008 to 2009 monitoring year, except for limited movement in SI-2 which resulted in the "shearing off" of the inclinometer. A new inclinometer is proposed for 2010-2011 to replace SI-2 and SI-3 on Malibu Road`.

A new slope inclinometer is proposed for the 2010-2011 monitoring period to replace SI-2 and SI-3 because they became impassable due to cumulative deformation in 2009 and 2005 respectively.

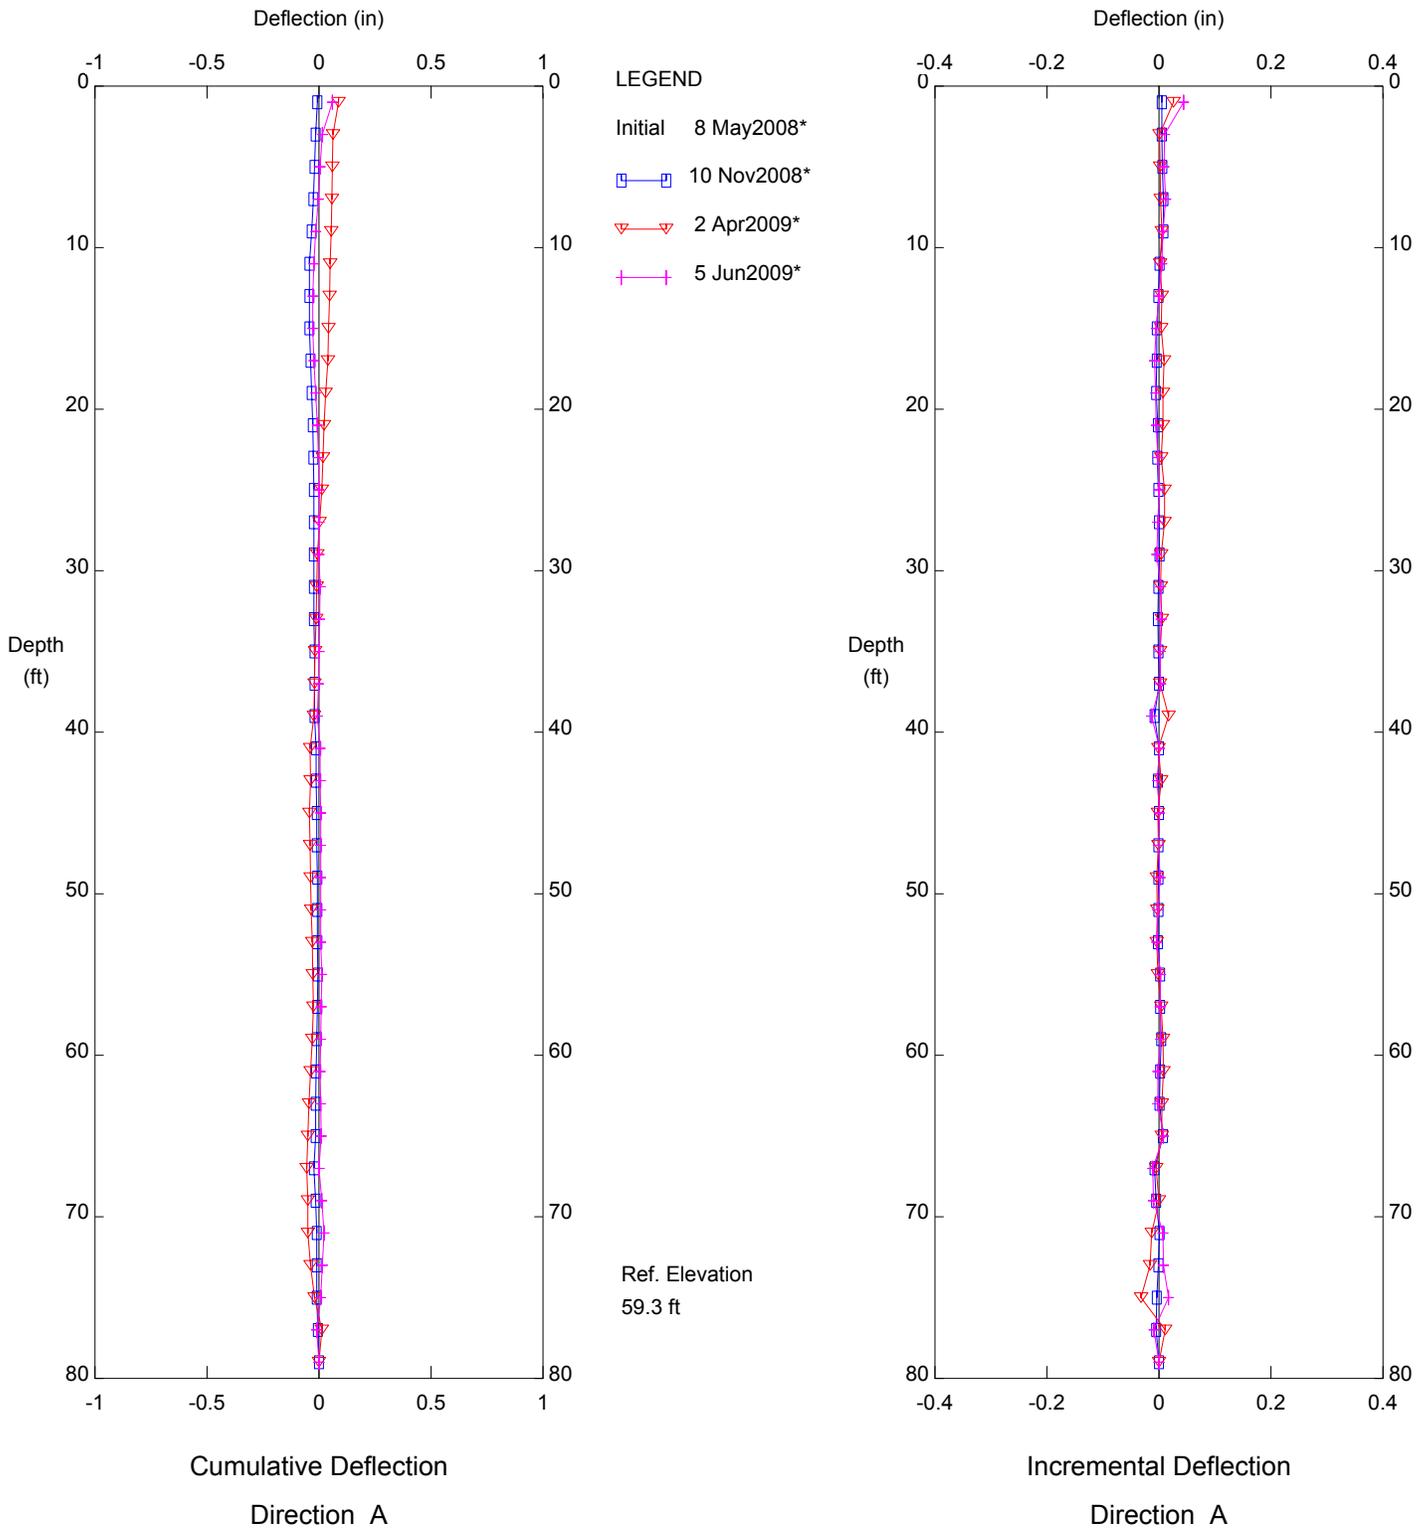
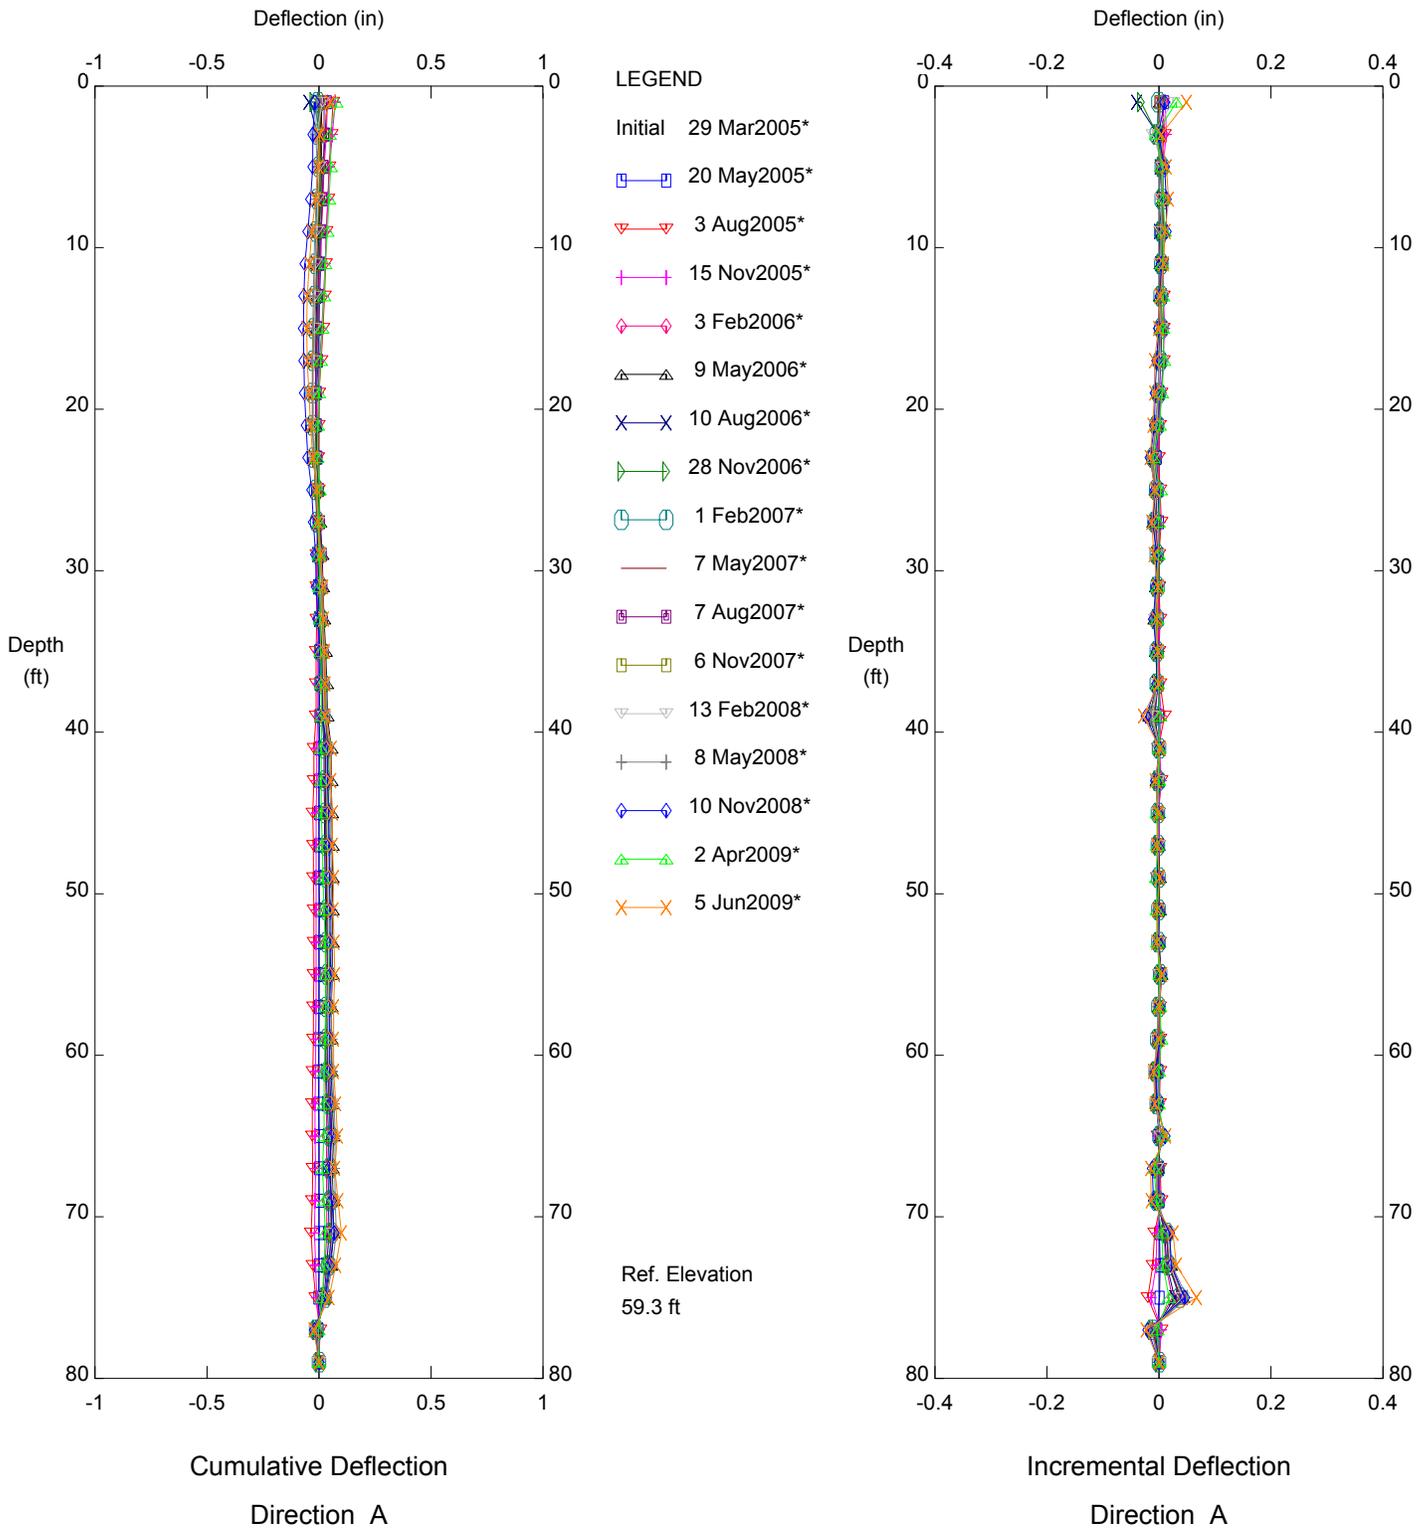
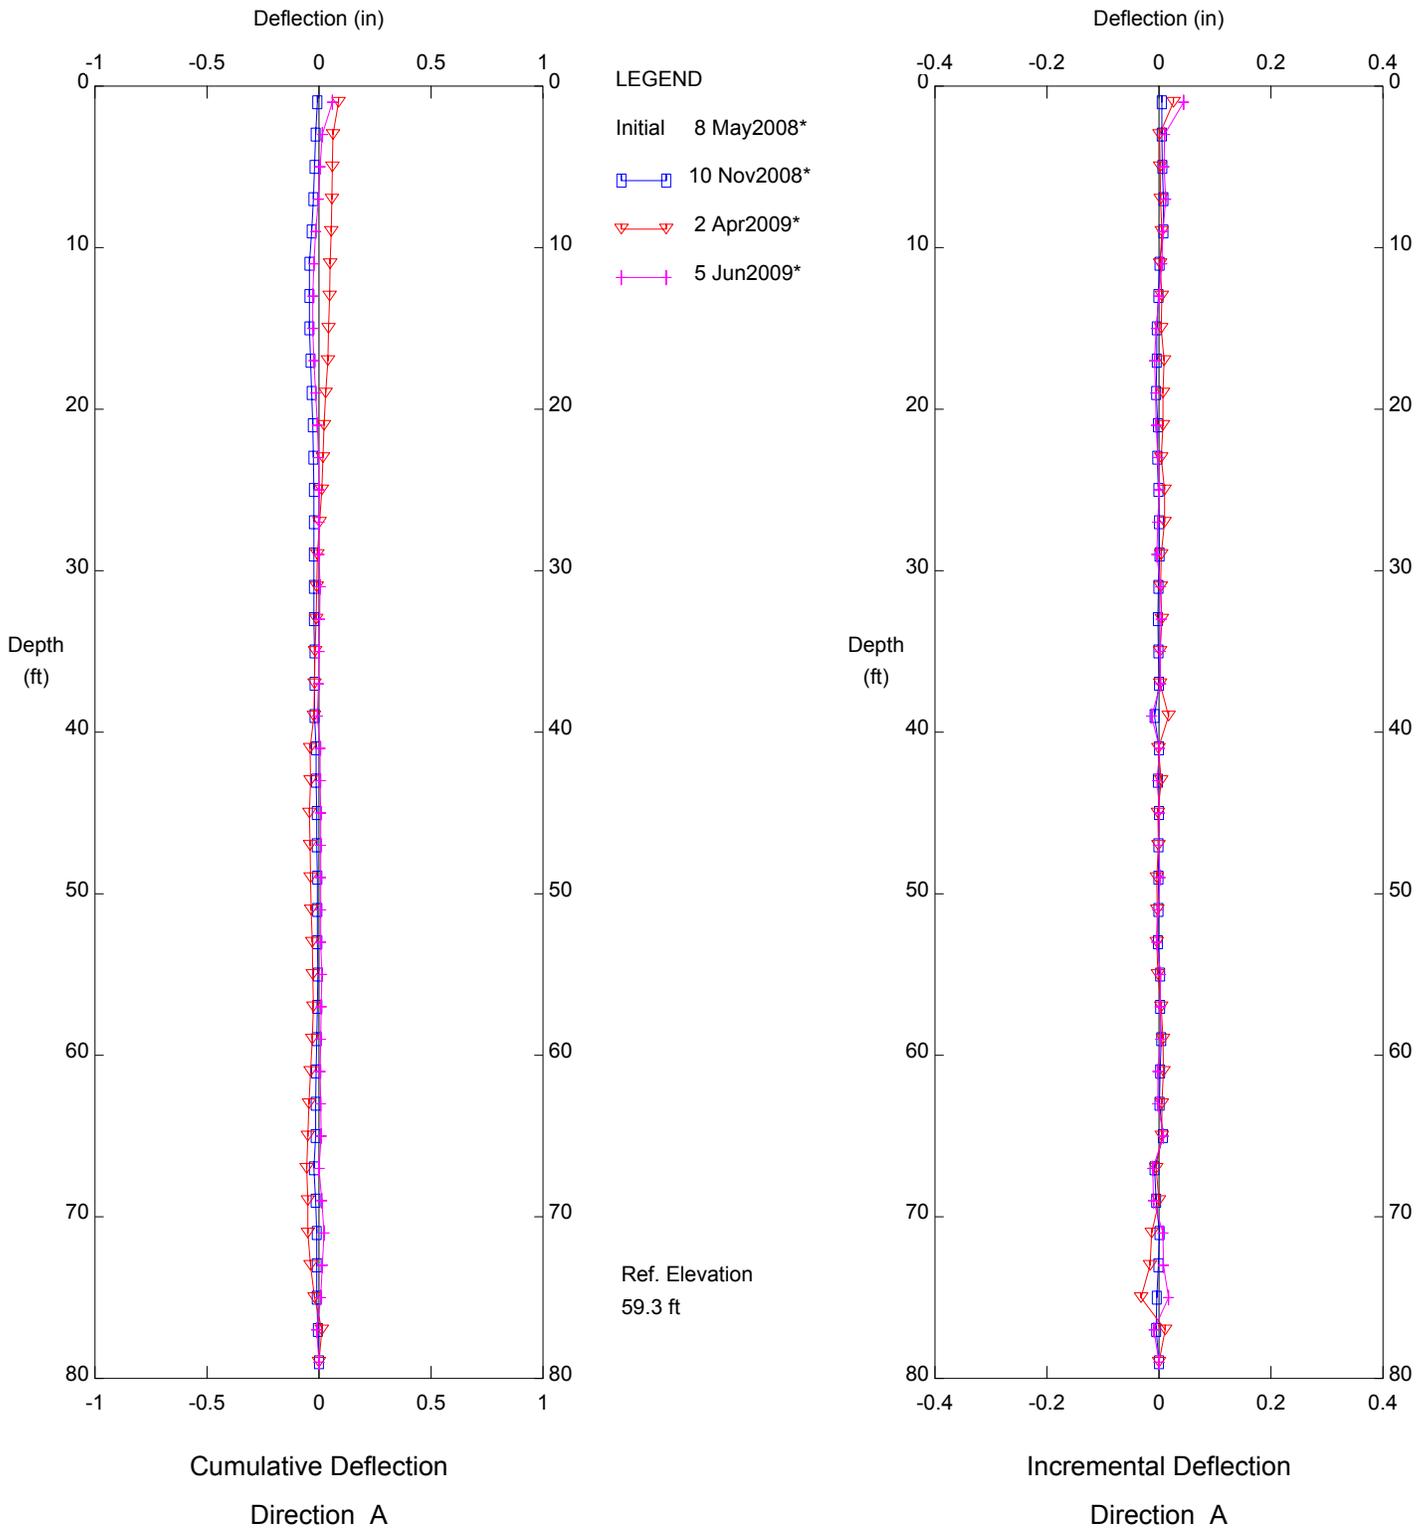
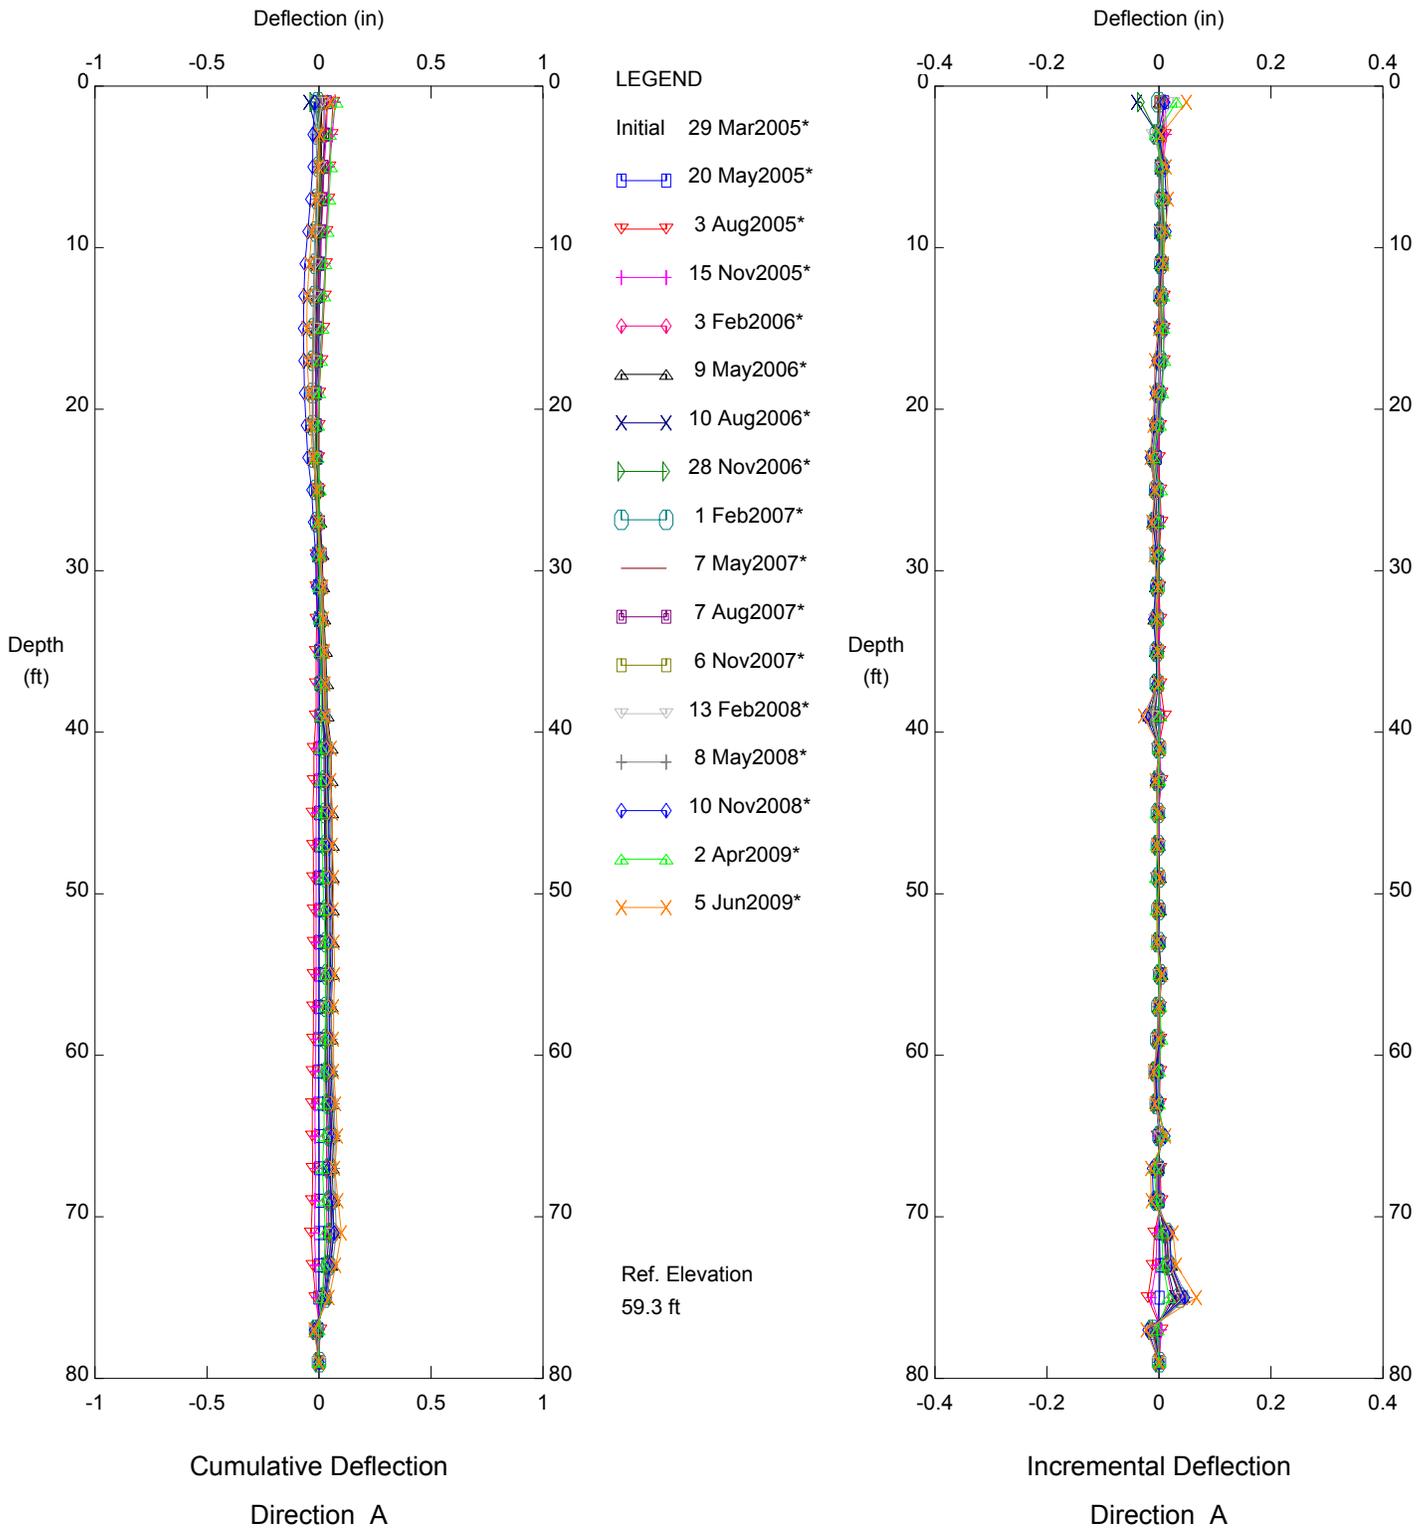
MALIBU ROAD, Inclinometer SI-5

Inclinometers SI-5 and SI-6 are located on Bayshore Drive, upslope and outside the defined limit of the most recent 1998 movement. No significant movement was observed during this monitoring year in SI-5 or SI-6.
