**ANNUAL REPORT
JULY 2012 THROUGH JUNE 2013
CALLE DEL BARCO
LANDSLIDE ASSESSMENT DISTRICT
MALIBU, CALIFORNIA**

Prepared for:
CITY OF MALIBU

January 2014
Fugro Job No. 04.B3399005

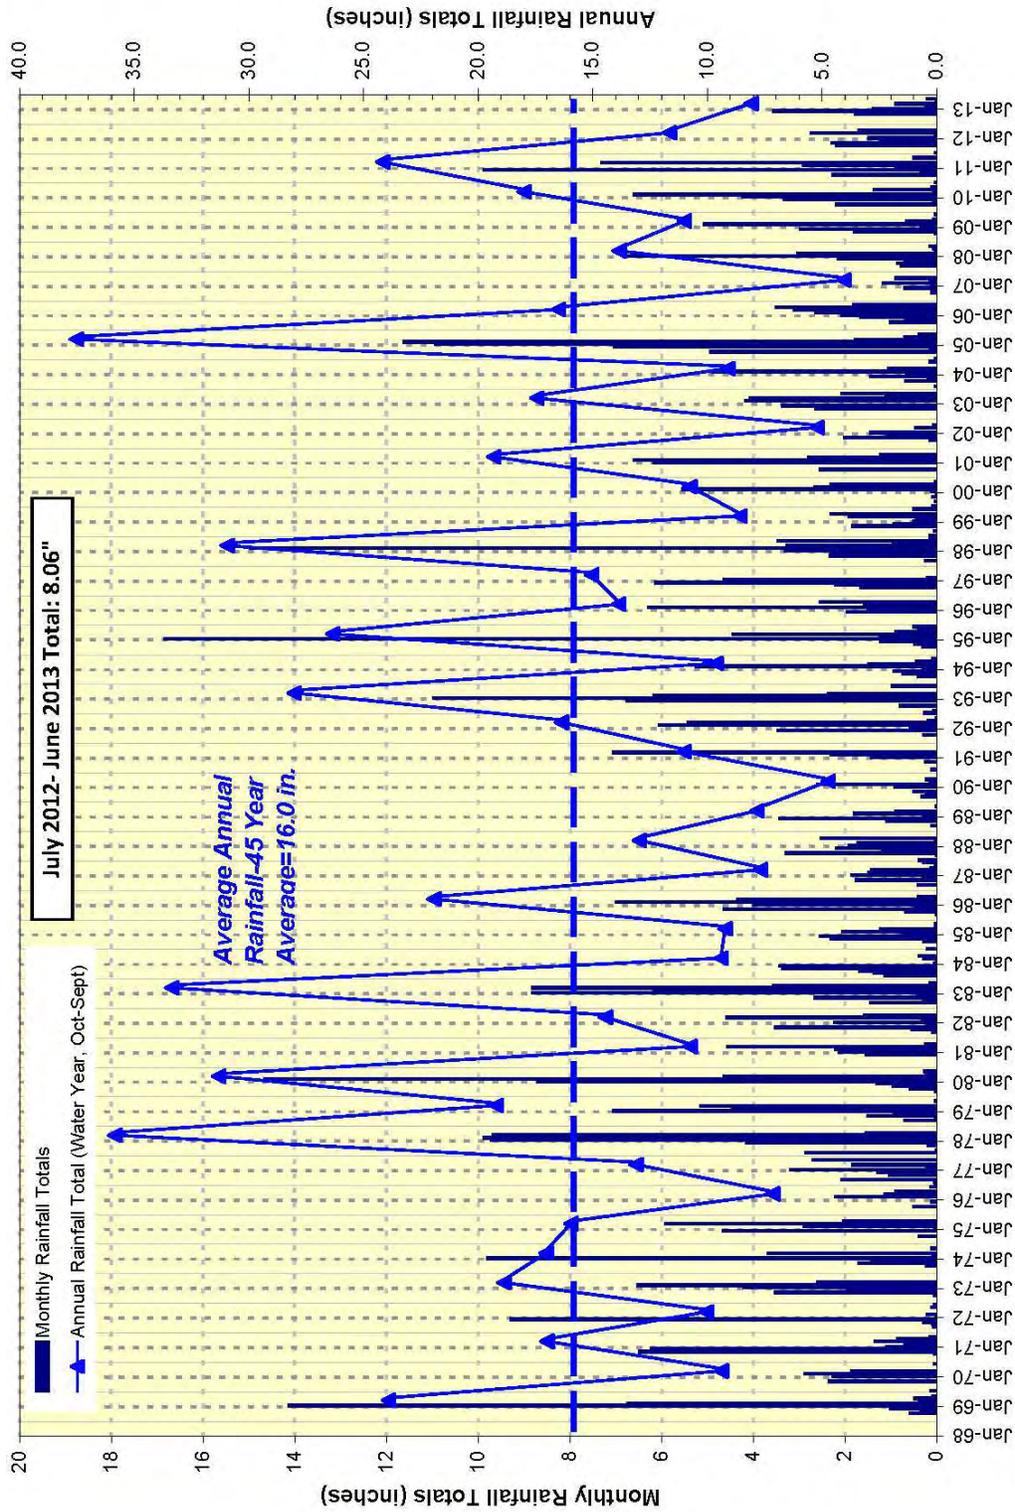
RAINFALL GRAPH
 Calle del Barco Landslide Assessment District
 Malibu, California

Rainfall totals were tabulated based on recorded values from the Los Angeles County Rainfall Station 1239 located at Big Rock Mesa. A graph of historical monthly rainfall and average annual rainfall is shown on Plate 3, Rainfall Graph.

Rainfall data indicate that approximately 8.06 inches of precipitation fell during the monitoring period from July 2012 through June 2013. The average annual rainfall from 1968 to 2012 in the Malibu area for the monitoring period July through June is approximately 16.0 inches.

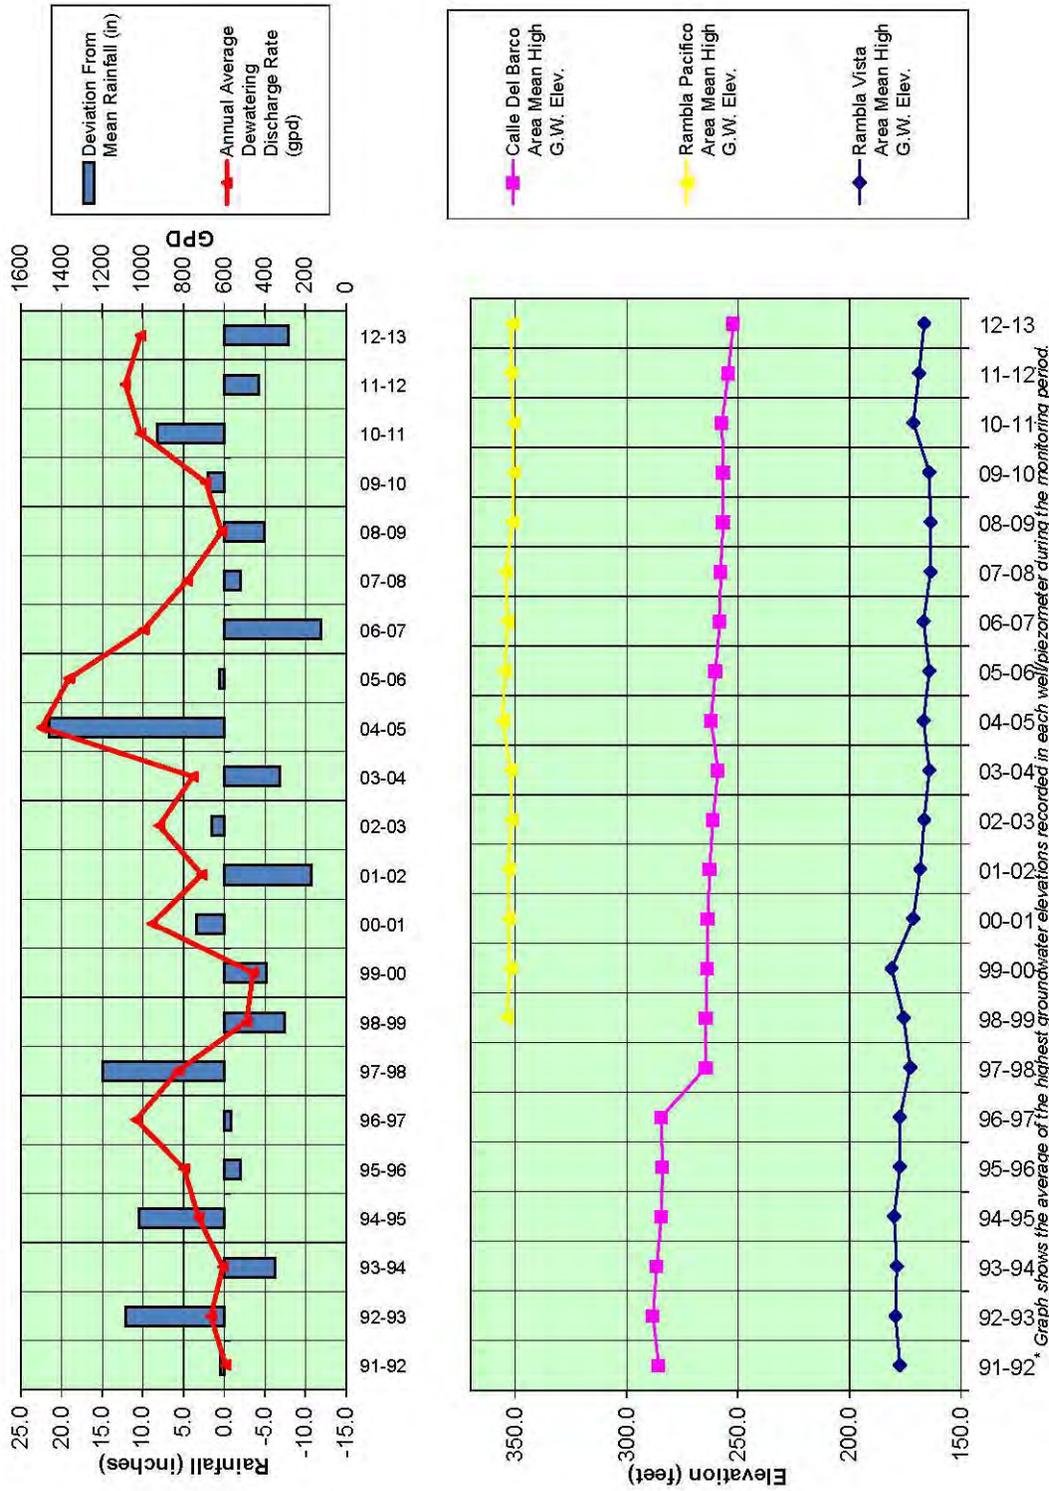
GROUNDWATER LEVELS, DEWATERING, AND RAINFALL
 Calle del Barco Landslide Assessment District
 Malibu, California

A summary graph of mean high groundwater elevations for the District is presented on Plate 5. Plate 5 also shows the average dewatering output (gpd) and the yearly magnitude of deviation from the mean annual rainfall. The average annual rainfall used for the chart was computed using all of the data from 1988 through the present. This graph illustrates that since 2010-2011, annual rainfall has been generally decreasing. During the same period, the average dewatering output has been decreasing.

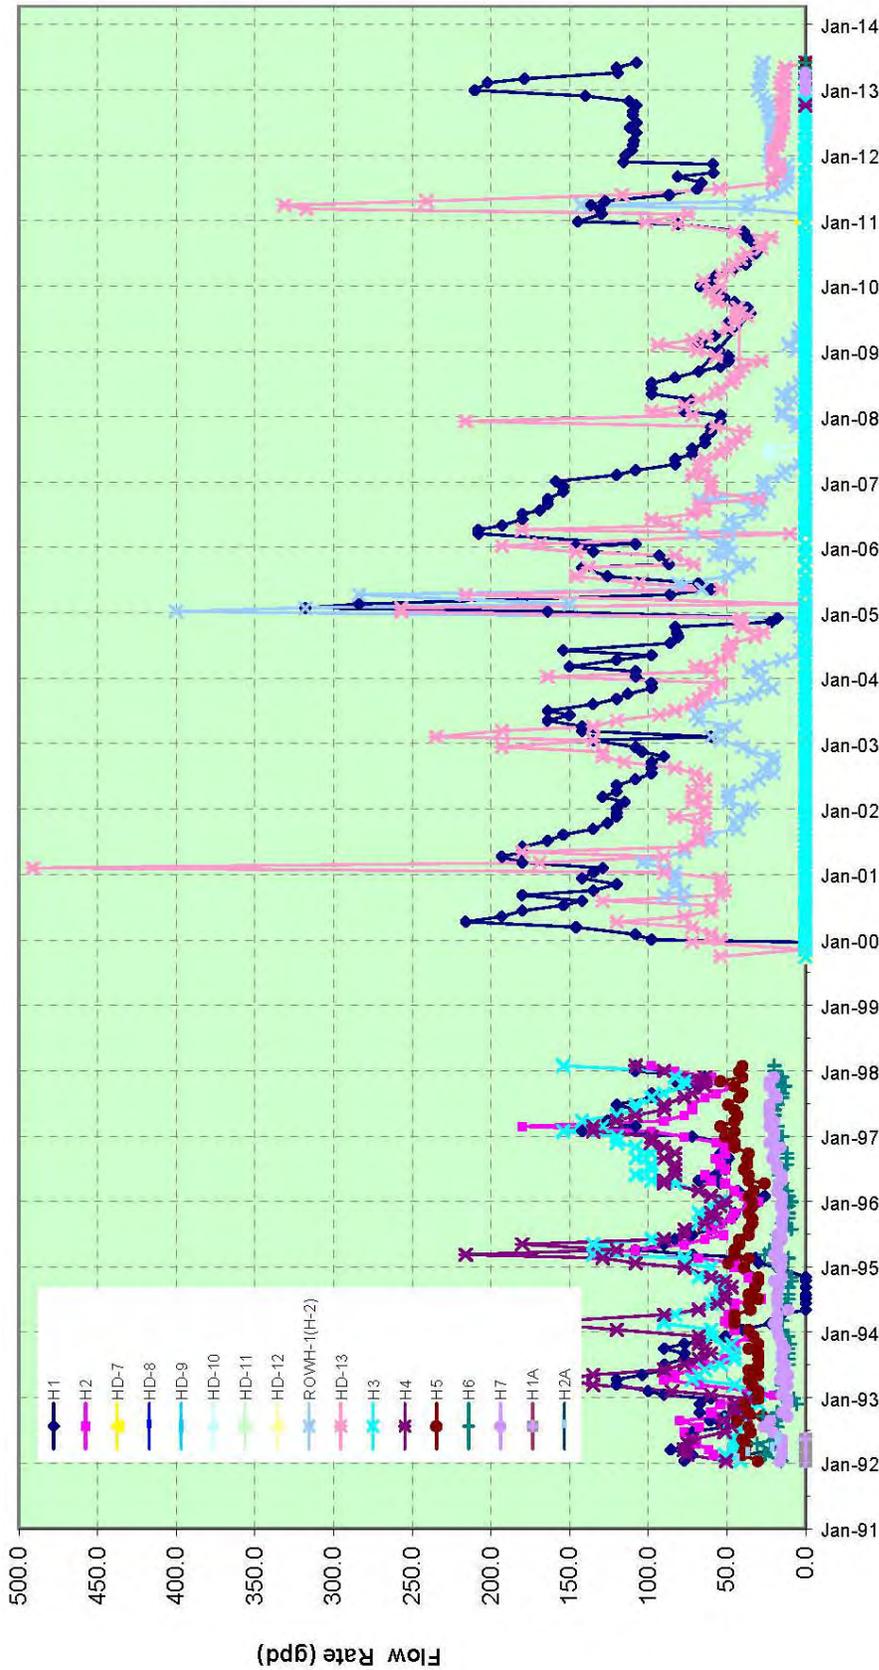
HYDRAUGER GRAPH
Discharge Rate for all Hydragers
Calle del Barco Landslide Assessment District
Malibu, California

The total production rate for all hydraugers from August 1991 through June 2013 is depicted on Plate 4. Hydrauger production rates for individual hydraugers are presented on Plate B-4 (Appendix B). Additional data regarding hydraugers and production rates are included in Appendix B.

The average hydrauger production rate for all hydraugers over the monitoring period was approximately 185 gpd. This represents approximately 101 percent of last year's hydrauger production rate of 183 gpd.

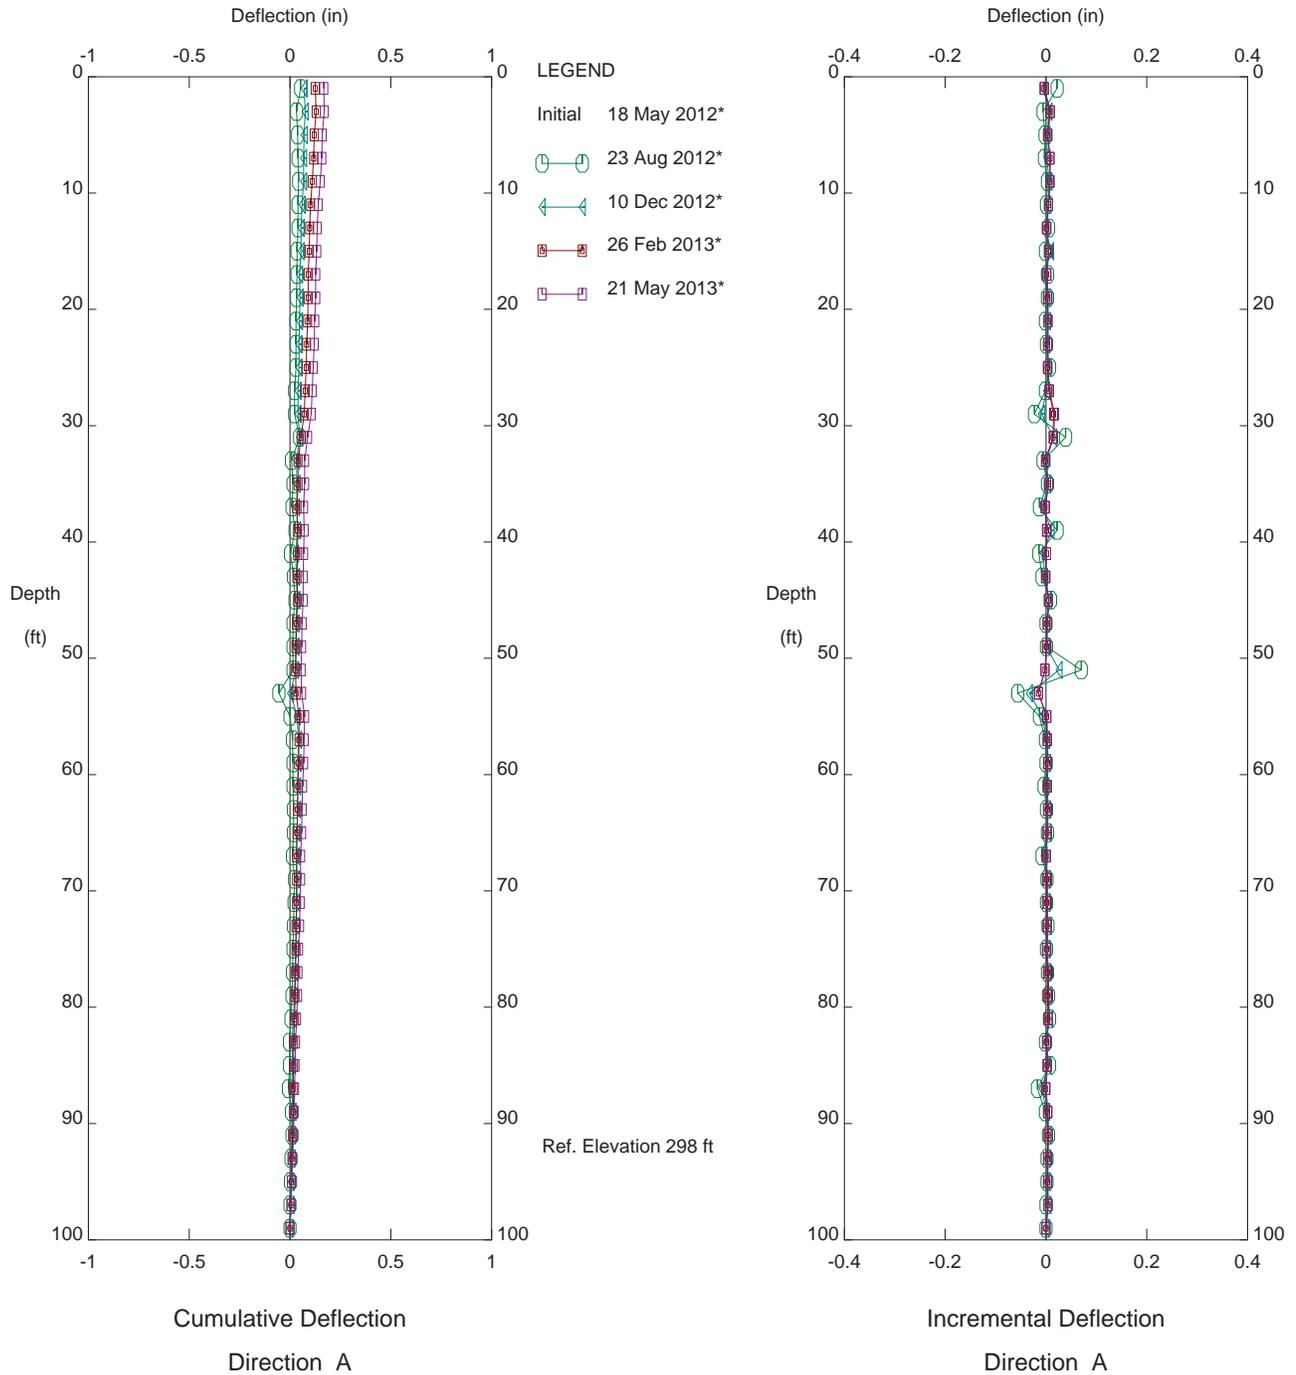
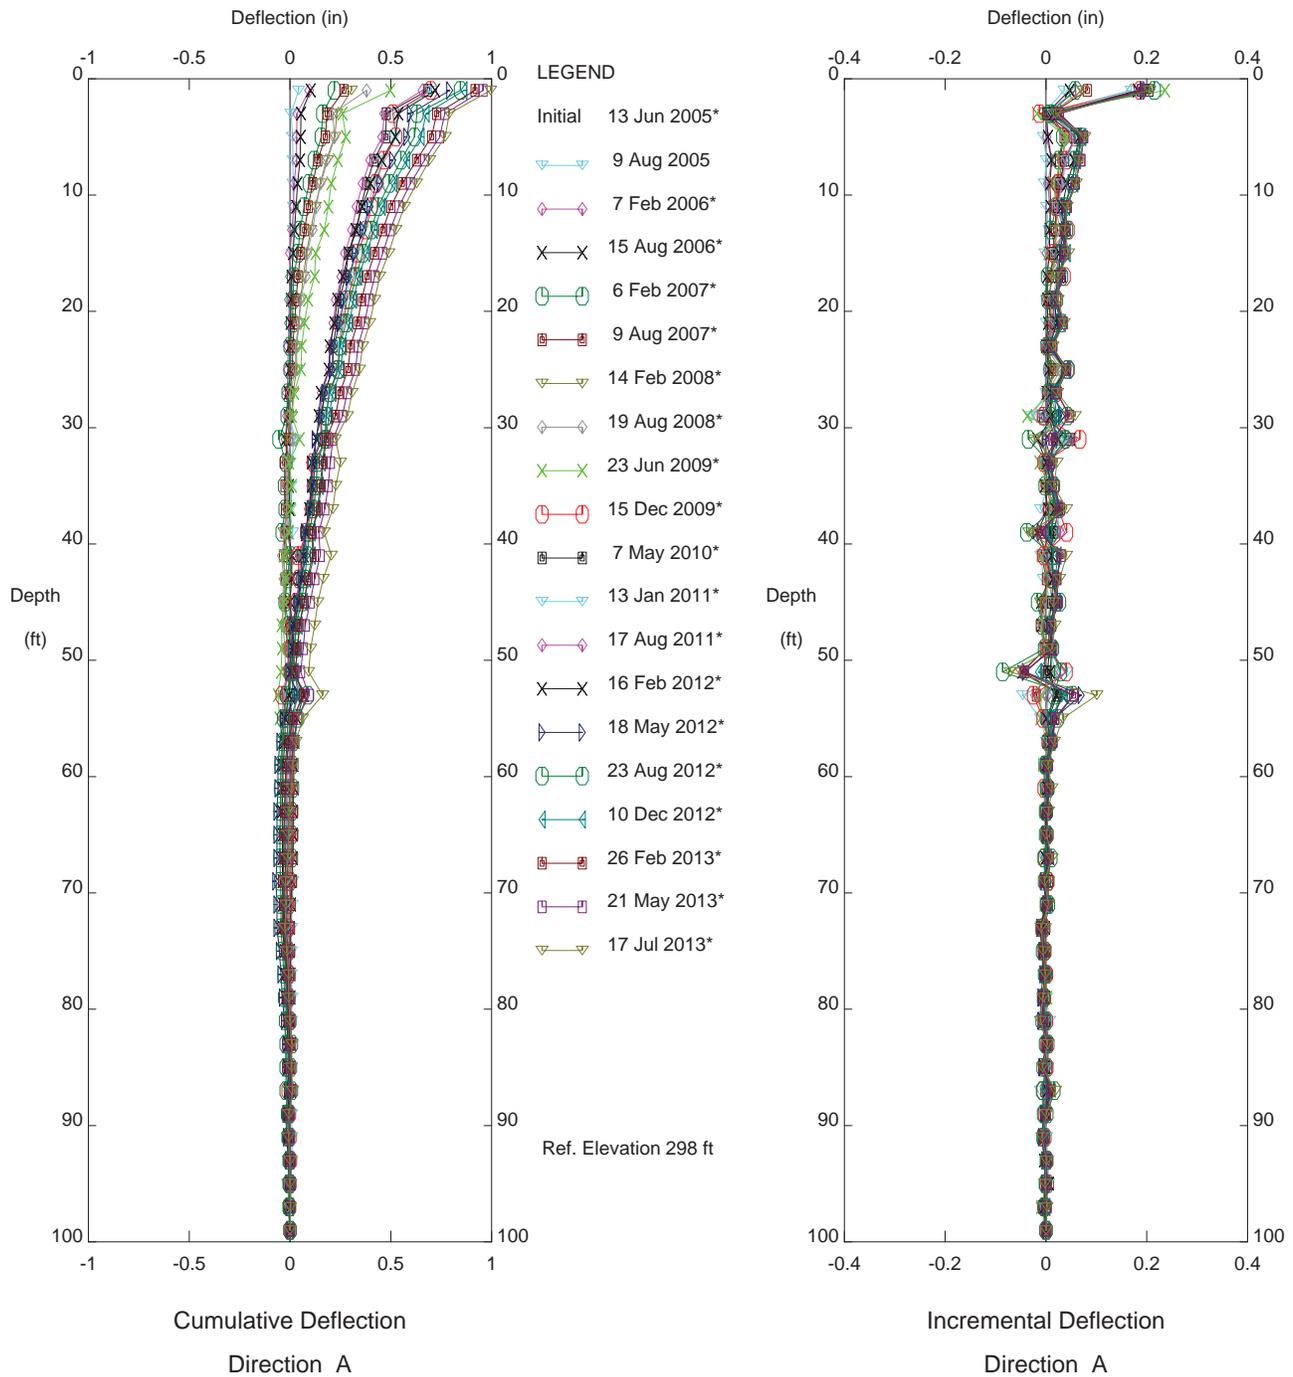
CALLE DEL BARCO, Inclinometer SI-9

Inclinometer SI-9 exhibits a pattern of movement measured at the ground surface at a rate of between 0.1 and 0.2 inch/year since 2005, resulting in approximately 1 inch of cumulative displacement since the 2004-05 monitoring period. Movement of the inclinometer appears to be both translational at specific depths between 30 and 55 feet and rotational about a hinge point at about 55 feet below the ground surface.

While the movement observed in inclinometers SI-9 and SI-16 has not produced observed distress in pavements or other development of which Fugro is aware, the movement is nevertheless quantifiable and can be defined by a clear trend.

- Slope inclinometer readings indicate a maximum localized displacement at the ground surface of about 0.15 inch (SI-9) and 0.2 inch (SI-16) located on Calle del Barco with the majority of inclinometers indicating no significant ground movement. These values are slightly above the average annual displacement for each inclinometer location since 2005.

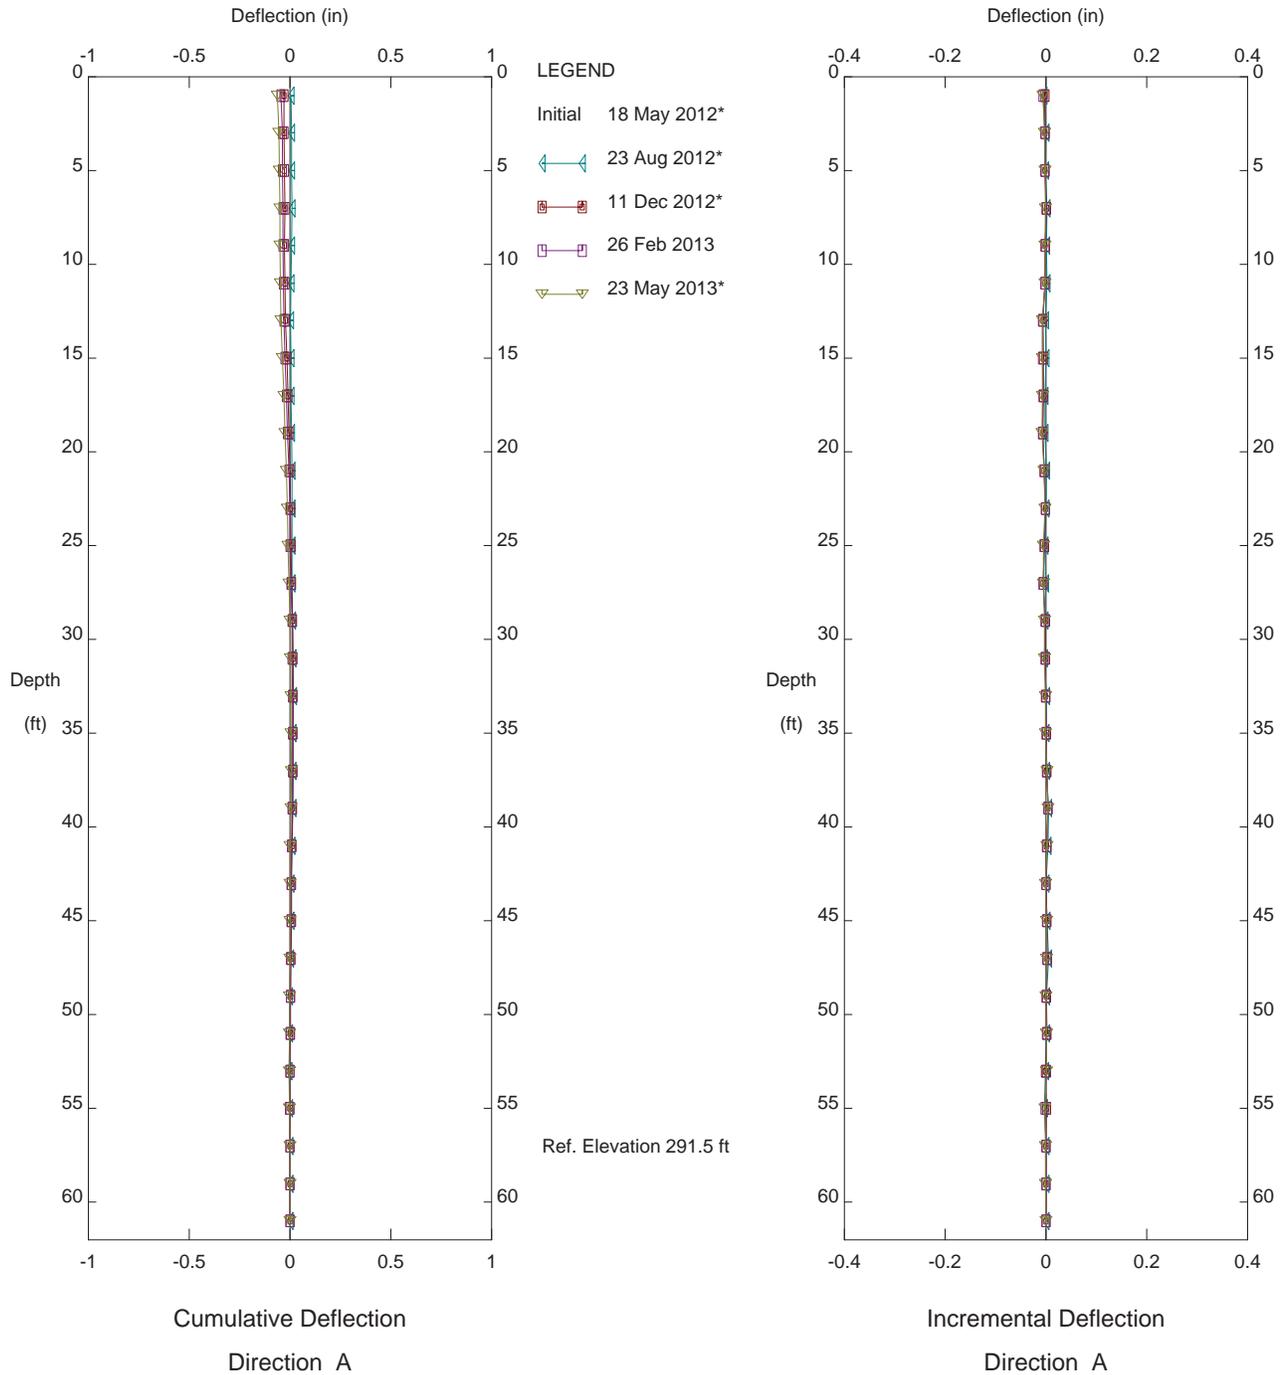
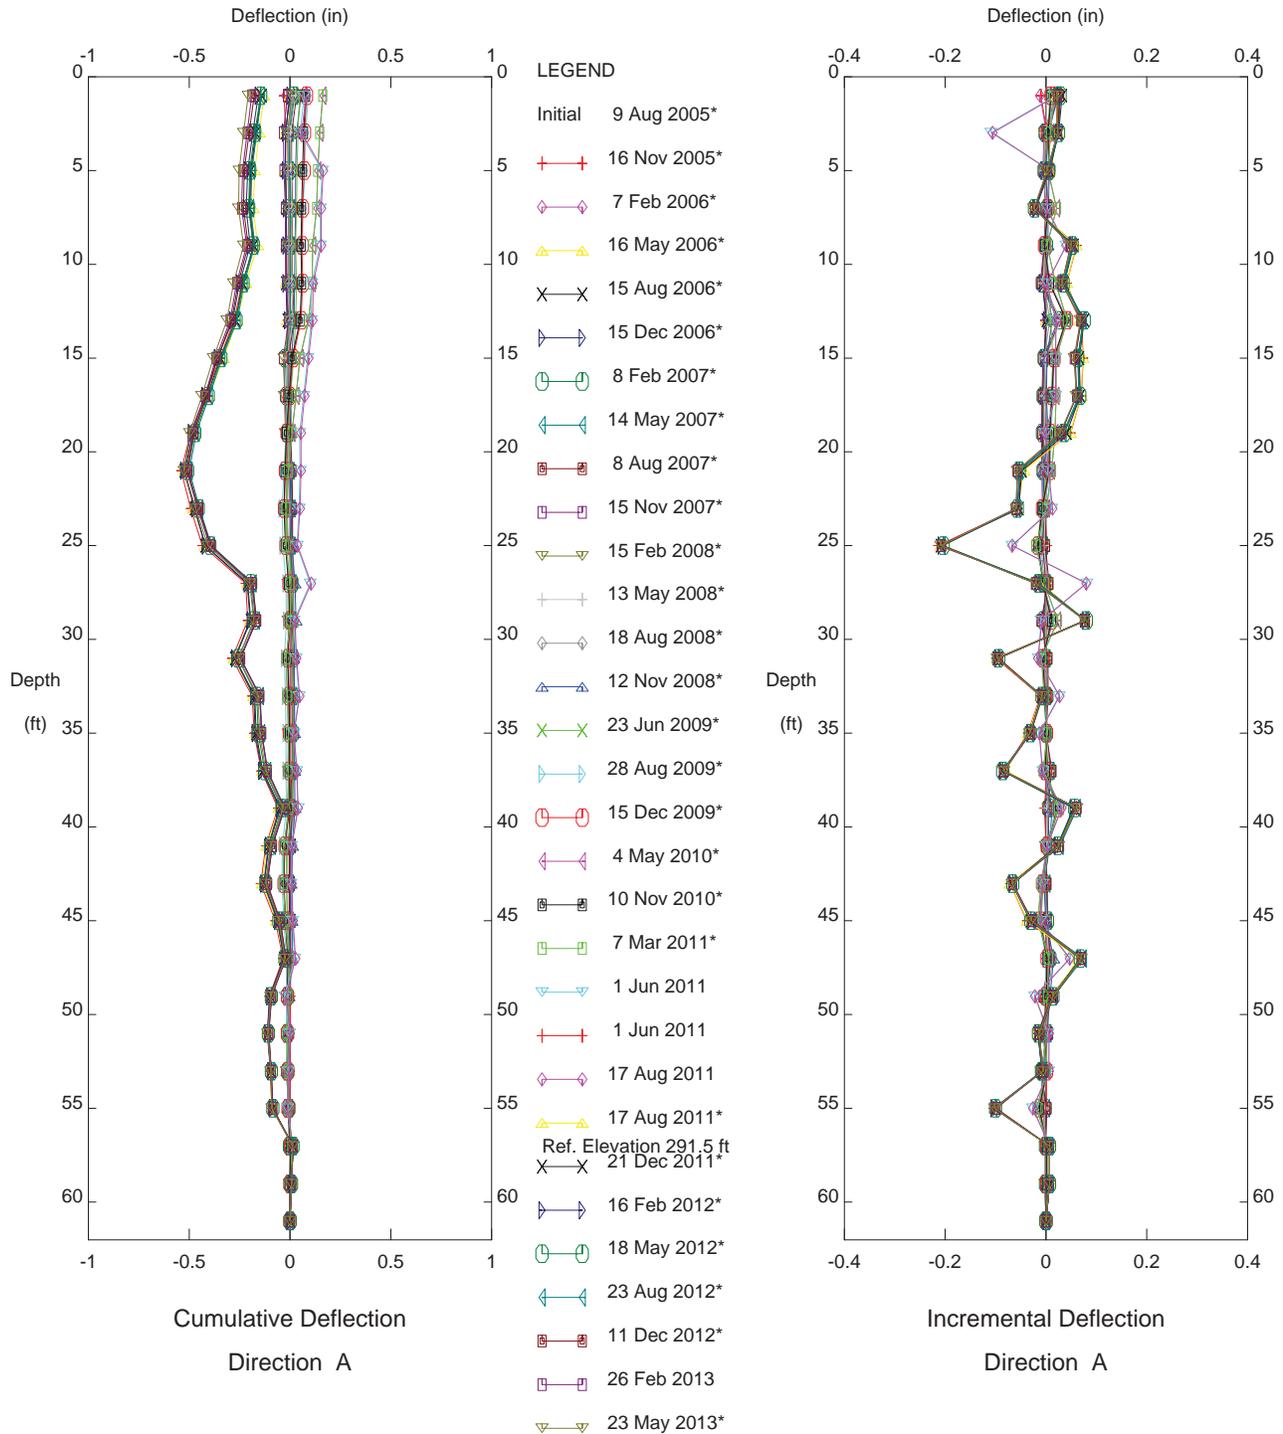
CALLE DEL BARCO, Inclinometer SI-11

Inclinometer SI-11 exhibits a maximum displacement of about 0.5 inch at a depth of about 20 feet since the 2004-05 monitoring period. Movement has been recorded to a lesser magnitude throughout the upper 57 feet of the subsurface profile.

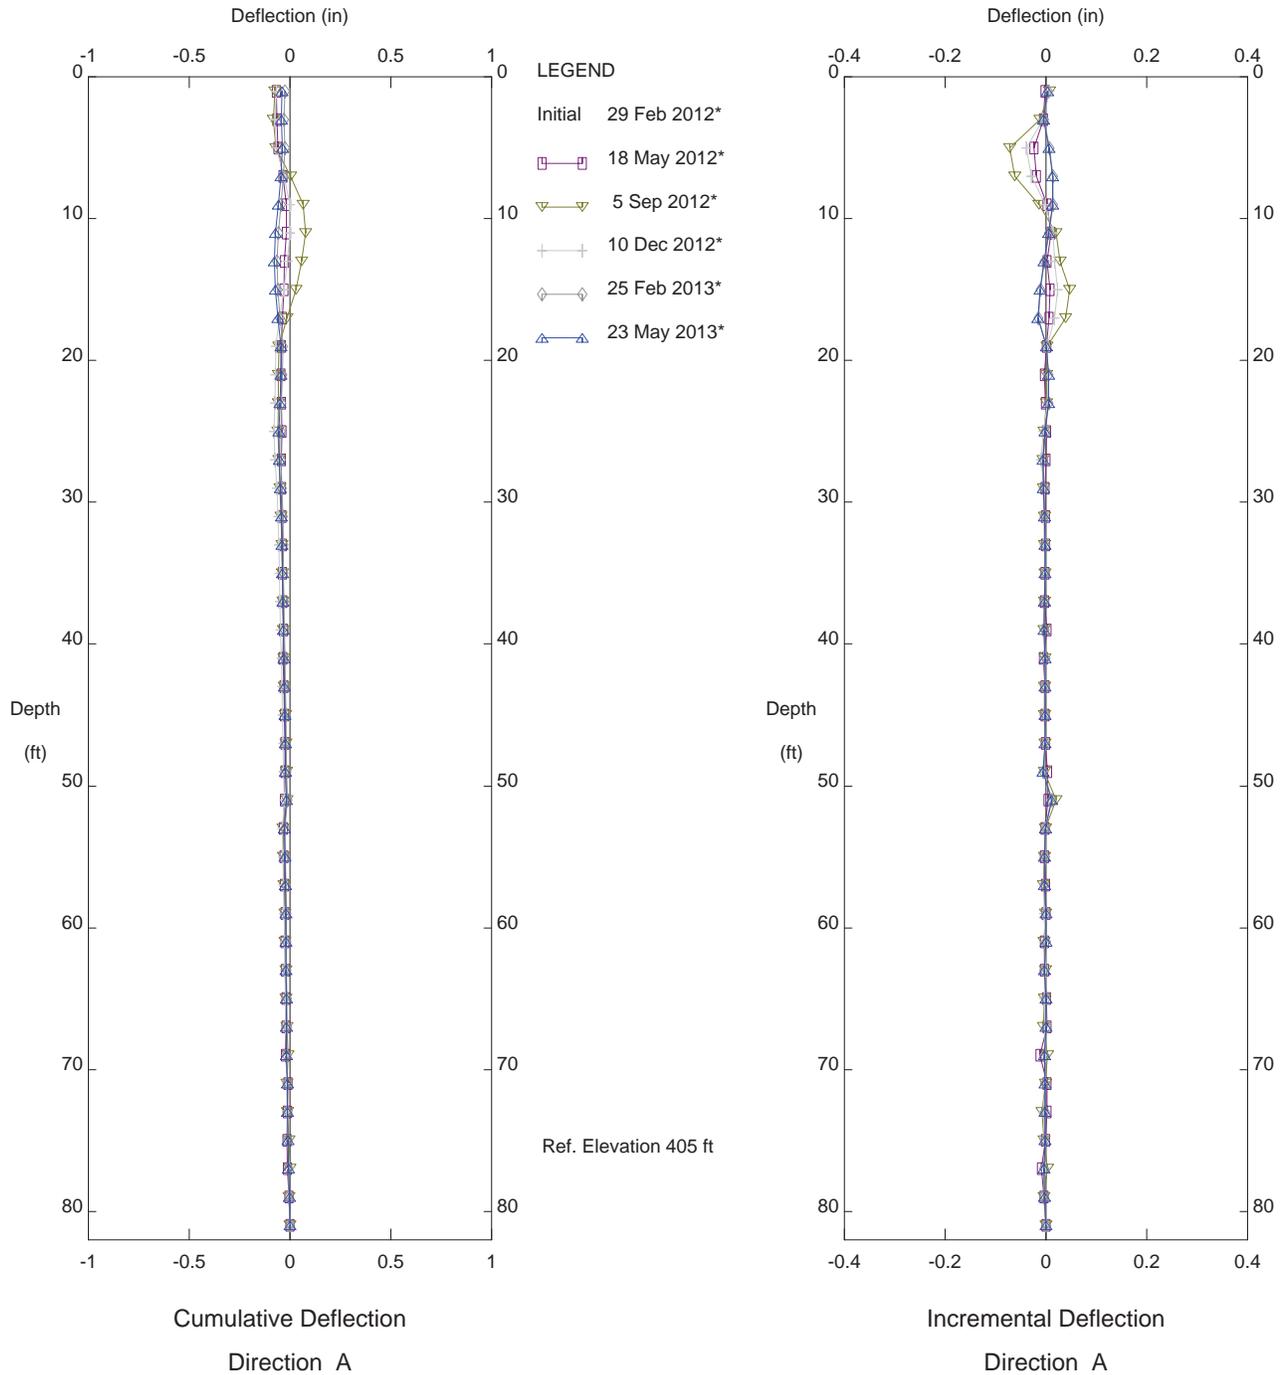
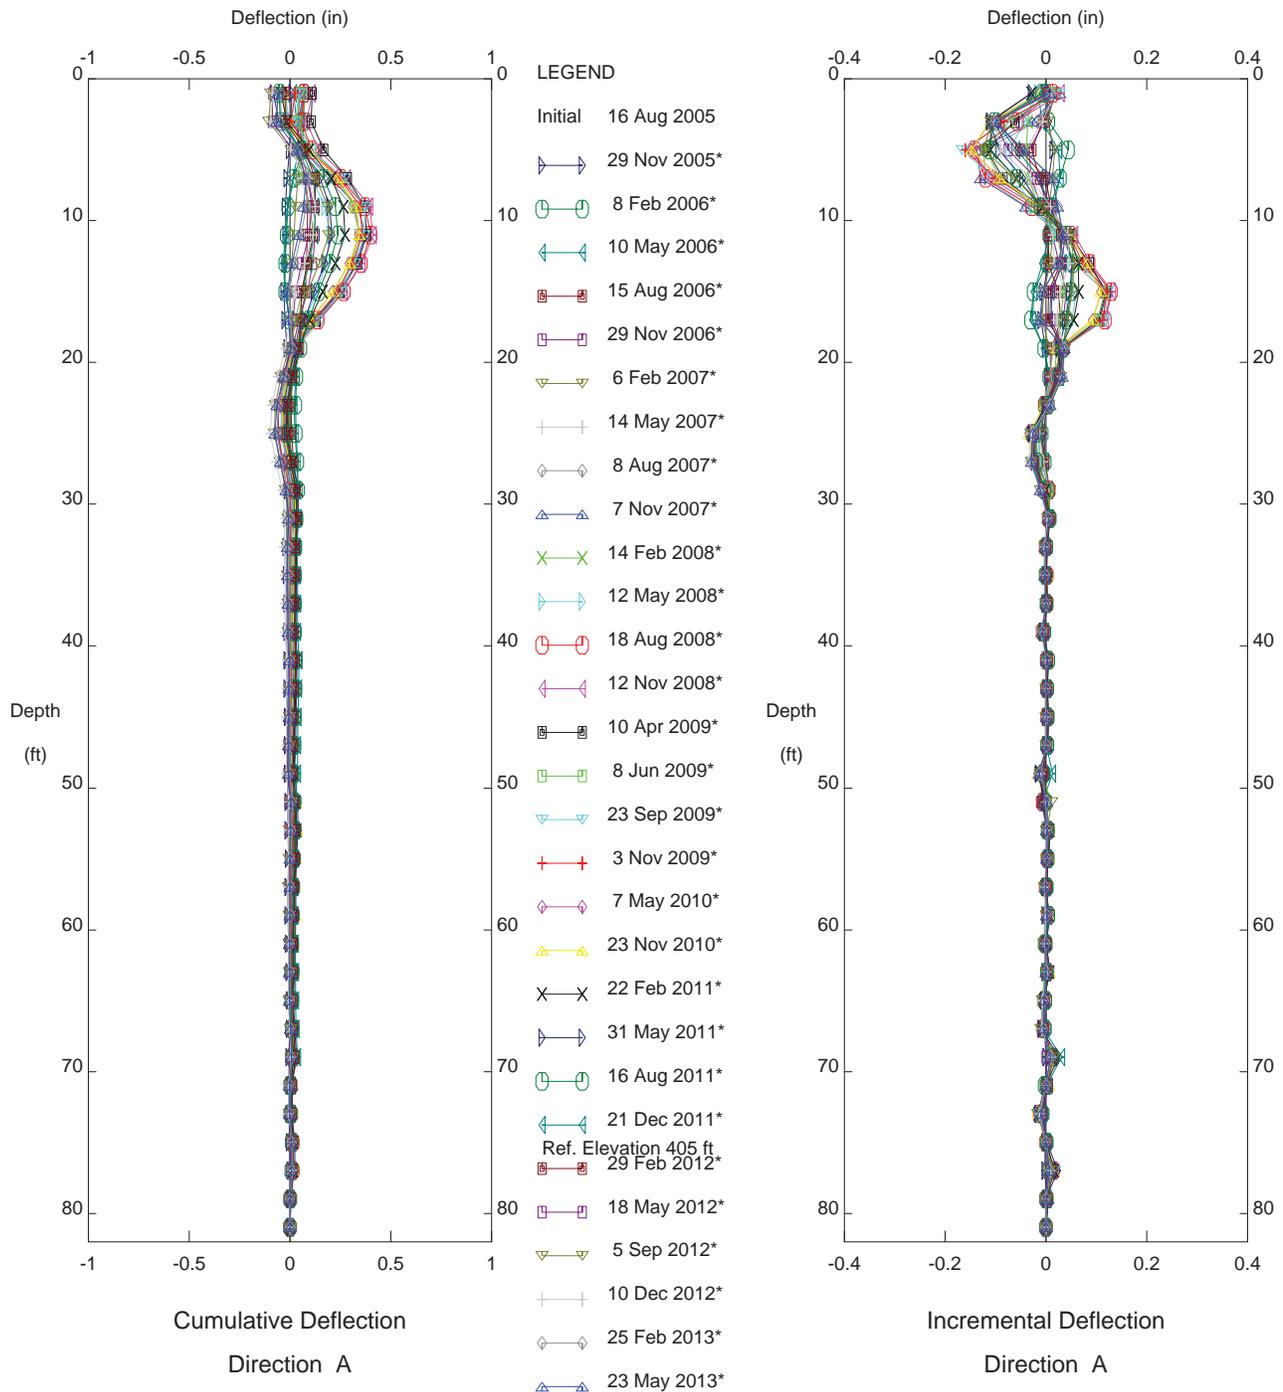
CALLE DEL BARCO, Inclinometer SI-13

Inclinometer SI-13 exhibits a maximum displacement of about 0.5 inch at a depth of about 10 feet since the 2004-05 monitoring period. Movement has been recorded to a lesser magnitude throughout the upper 30 feet of the subsurface profile.

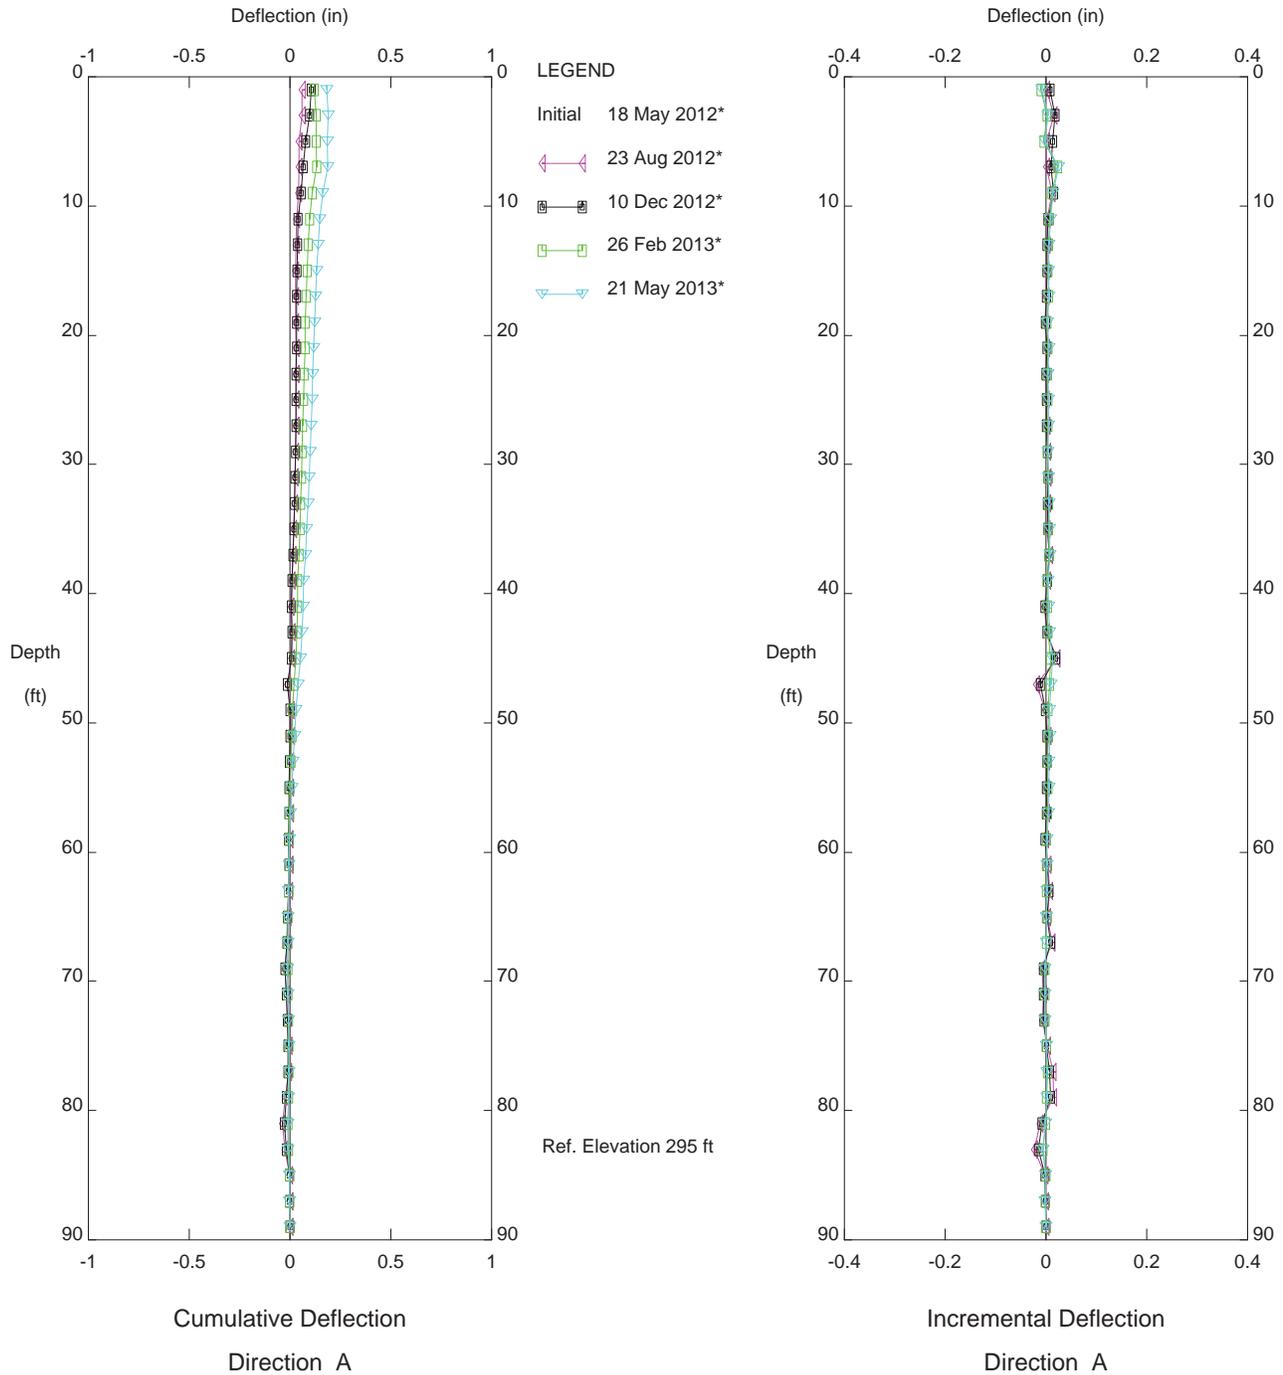
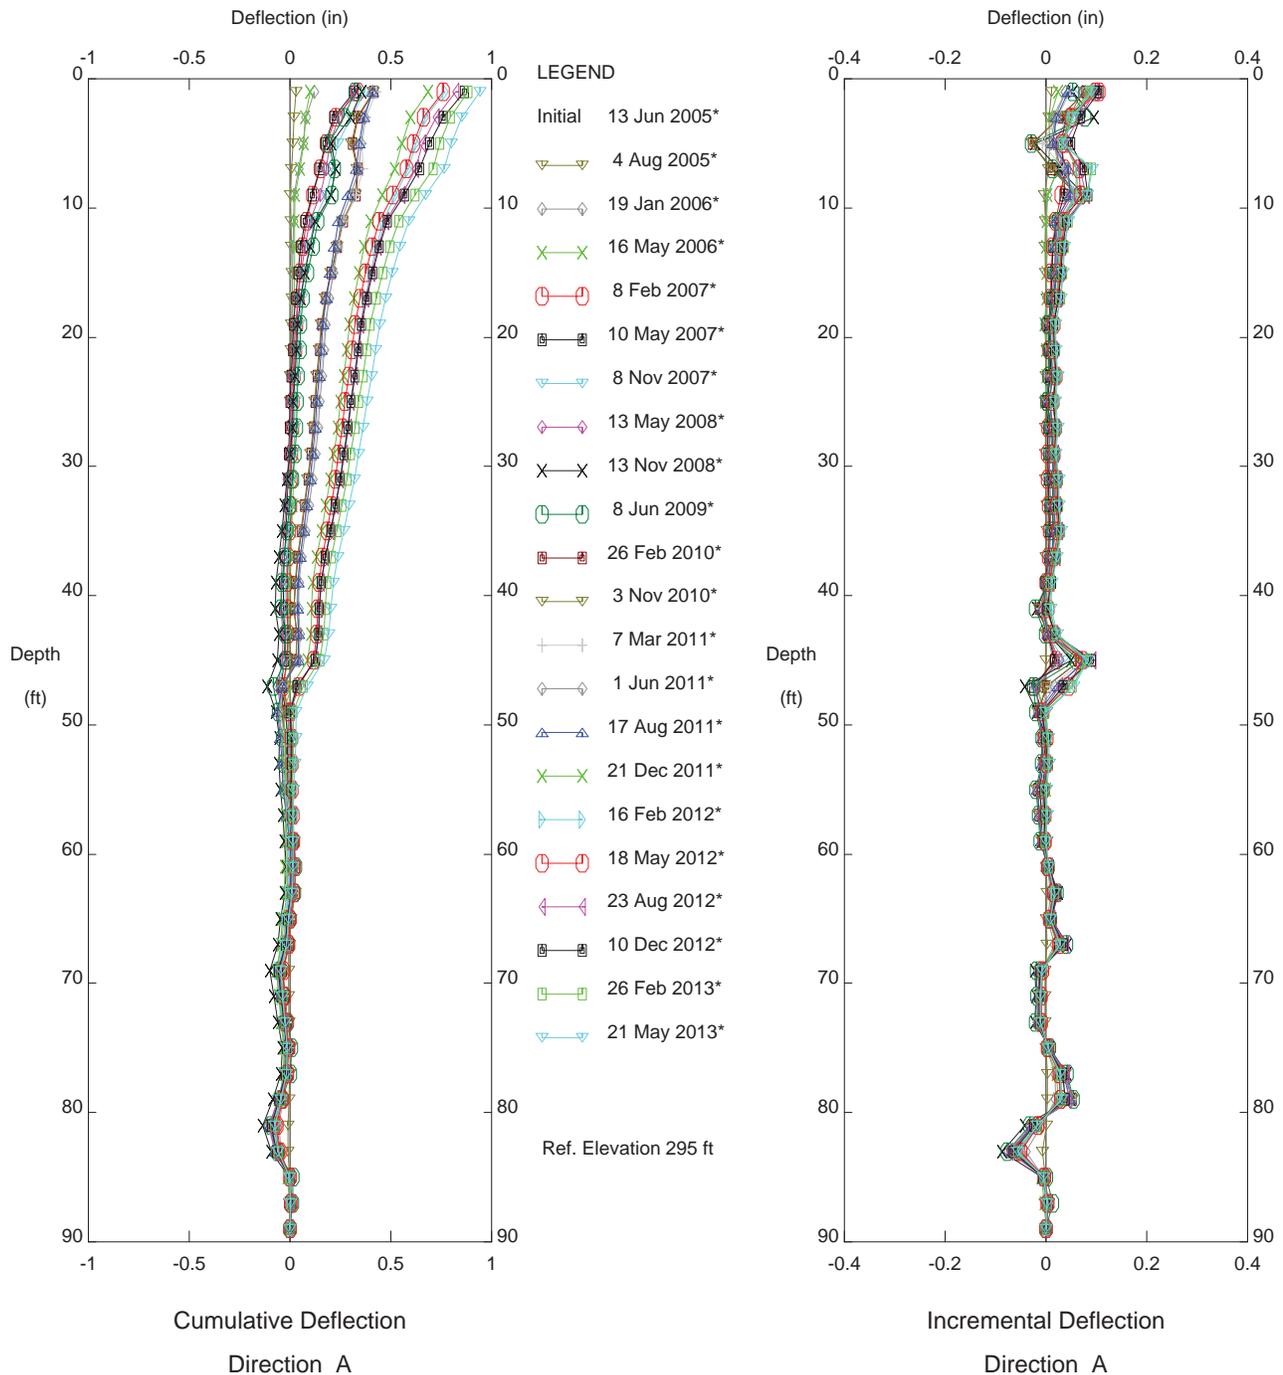
CALLE DEL BARCO, Inclinometer SI16

Inclinometer SI-16 exhibits a pattern of movement measured at the ground surface at rates up to 0.35 inch/year since 2005, resulting in approximately 1 inch of cumulative displacement at the ground surface since the 2004-05 monitoring period. Movement of the inclinometer appears to be both translational at specific depths between 0 to 10 feet and between 40 and 85 feet and rotational about a hinge point at about 50 feet below the ground surface. This is similar to the movement observed in inclinometer SI-9 located in close proximity to SI-16.
