TREE REPORT

Whole Foods In The Park City of Malibu

January 2009

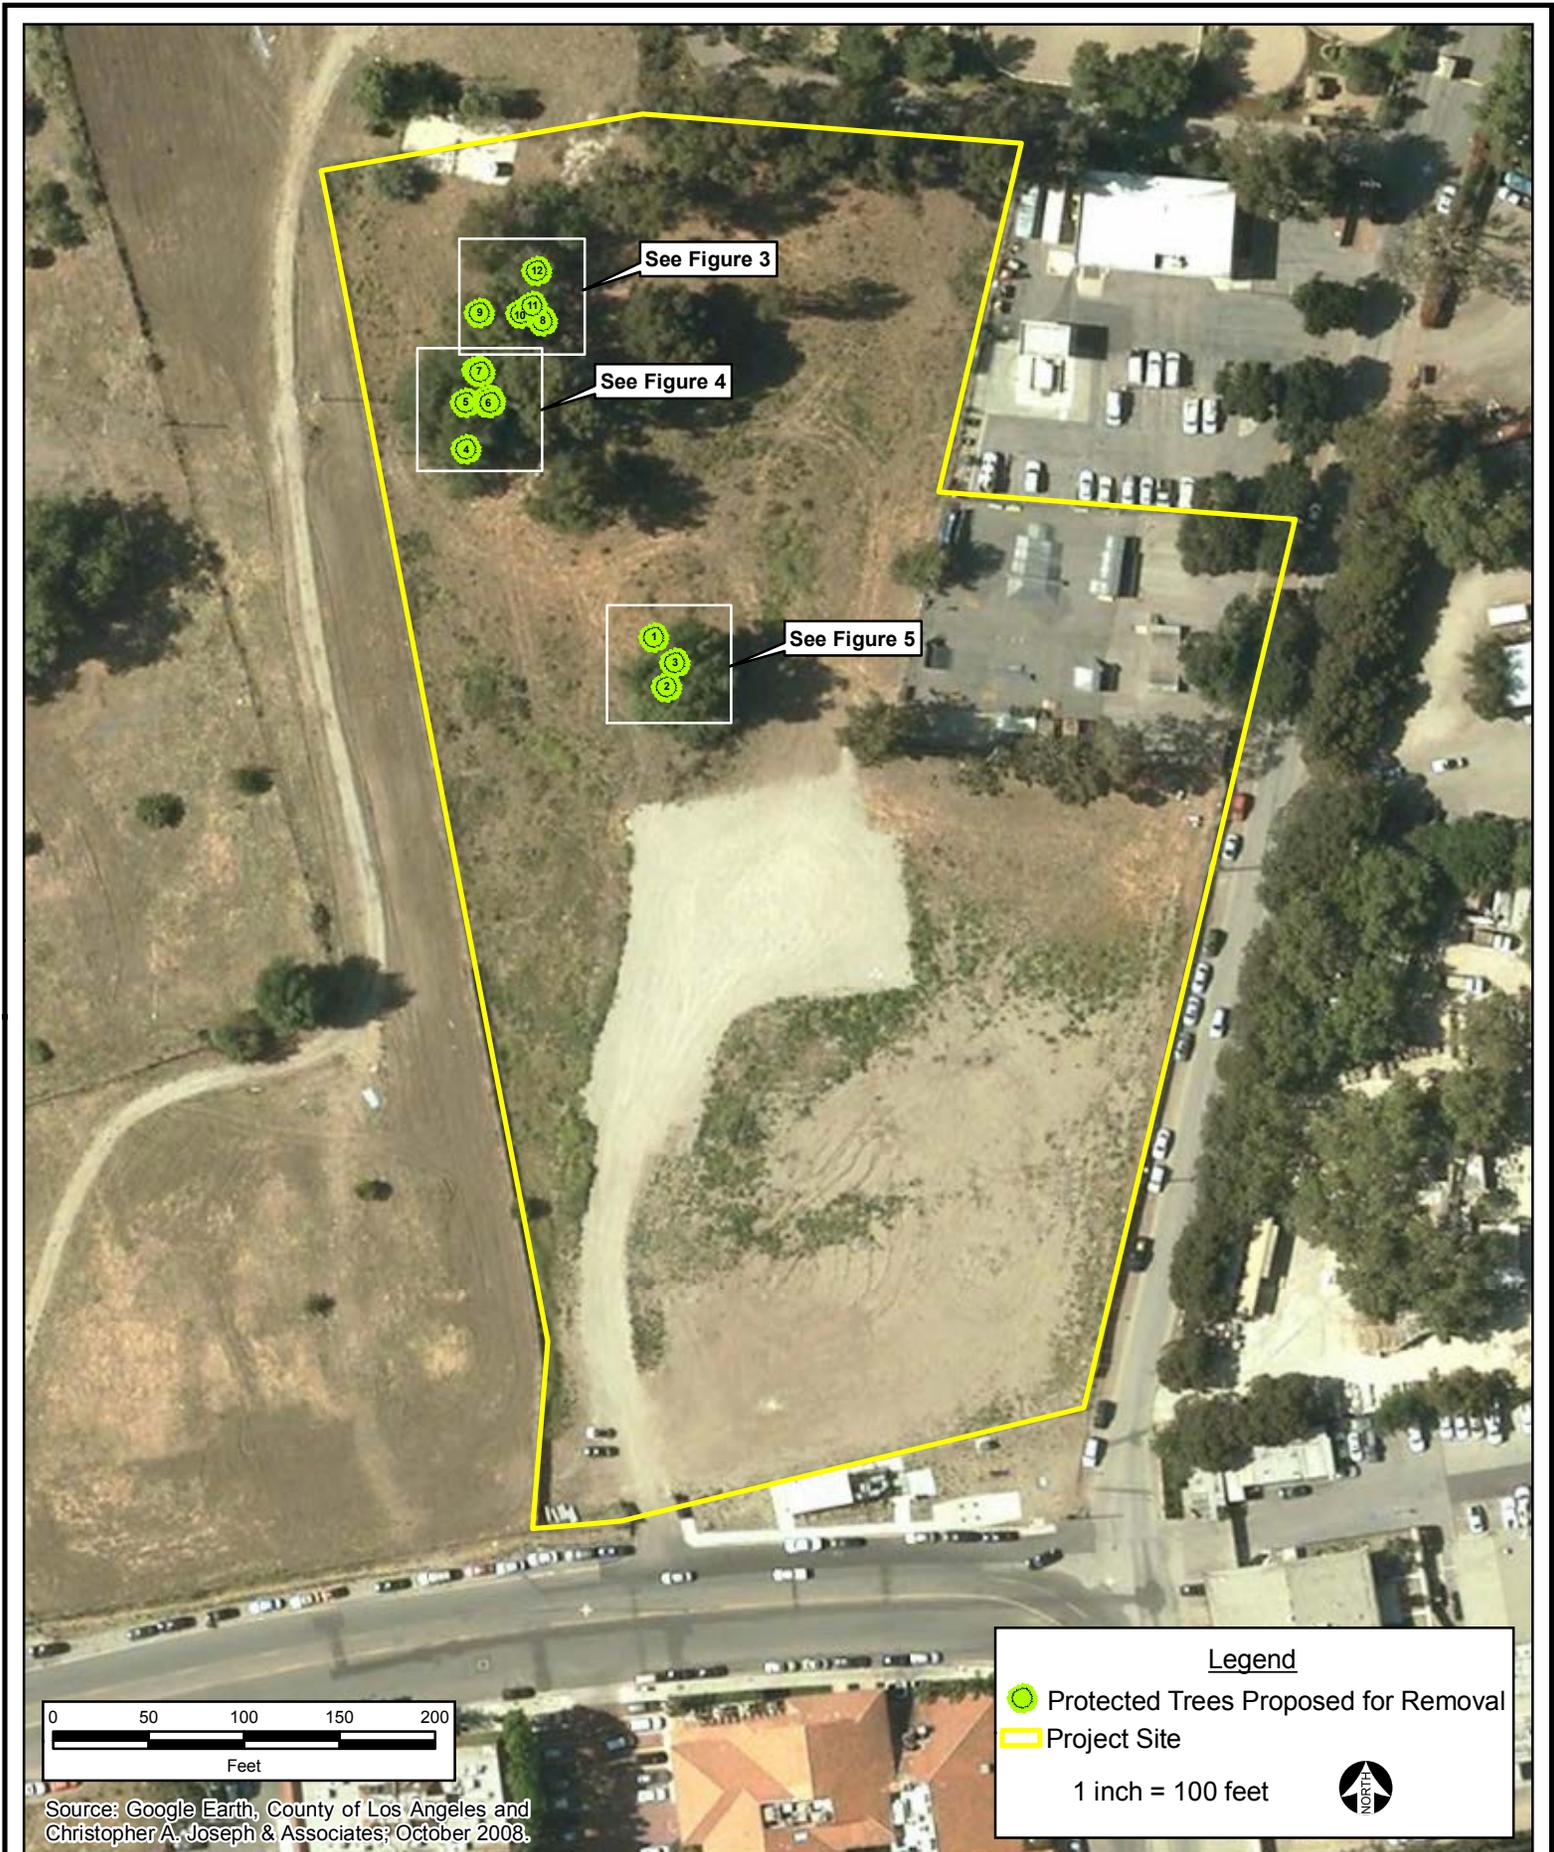
The 12 Western Sycamores on-site were clustered into three groups, one located in the north-central portion of the site, and two located in the northwest corner of the site (Figure 2). The DBH of these trees ranged from nine to 28 inches, and four were multi-trunked (Table 1). Half of these trees exhibited an above-average (B) health and

aesthetic rating, and the other half exhibited an average (C) health and a below average/poor (D) aesthetic rating (Table 1). The majority of the trees exhibiting the lower health and aesthetic ratings are located in the northwest corner of the site and appear to have been damaged by fire in the past and/or are suffering from termite damage. Nearly all of the trees exhibited signs of Anthracnose, a fungal infection common to sycamores, which rarely causes permanent damage but can cause cankers or defoliation.¹ The canopy extent for the protected trees on-site ranged from a radius of zero (where two trees were adjacent to each other) to 43.5 feet; Figures 3 through 5 depict the trunk diameter and canopy extent measurements for each protected tree.
