Native Tree Assessment and Tree Protection Plan

**Rancho Malibu Resort
4000 Malibu Canyon Road, Malibu, CA**

February 2012

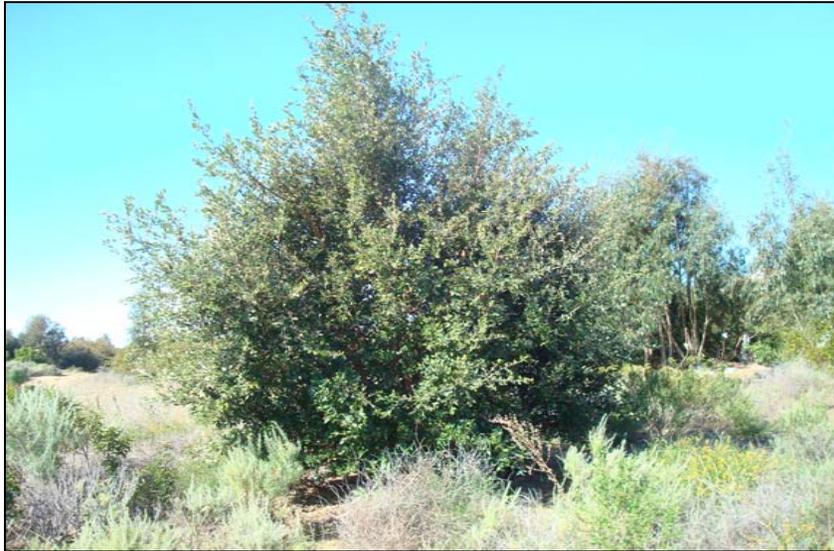
The project site does not contain any native trees that meet the City's requirements for protection. Native trees were observed on site, however, none meet the size criteria for protection or were within the project boundaries. One oak meeting the size criteria was observed on site, but was identified as a cork oak (*Quercus suber*) that is native to southwestern Europe and northern Africa (Bringham, 2005). Three native qualifying California walnuts were observed to the east and outside the project boundary.

Photo 1. View of cork oak tree (*Quercus suber*) located on bluff top.

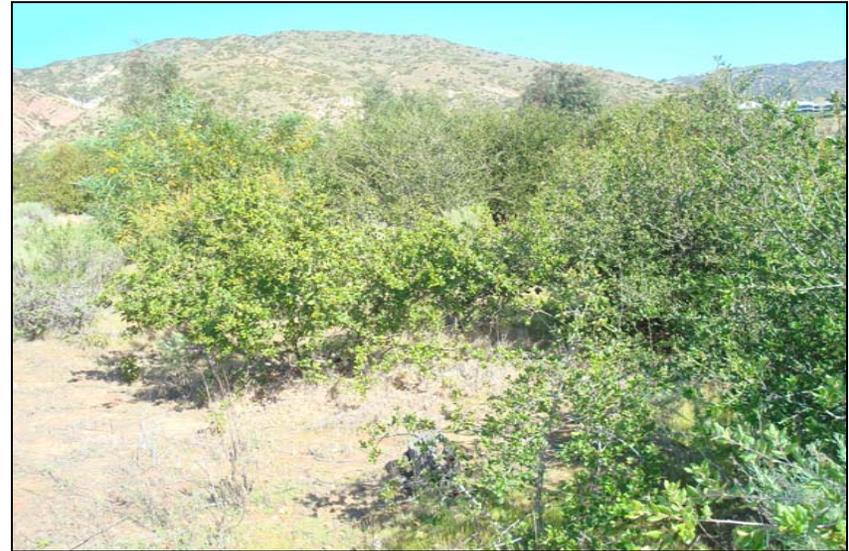
Native trees that were observed but did not meet the City's criteria for protection were coast live oak (*Quercus agrifolia*), walnut and toyon. The majority of coast live oaks were observed as basal re-sprouts in row crops from the previous nursery. The coast live oaks appear to have been burned and subsequently cut at the base.

Photo 2. View of coast live oak trees re-sprouting from burnt and cut bases located on bluff top.

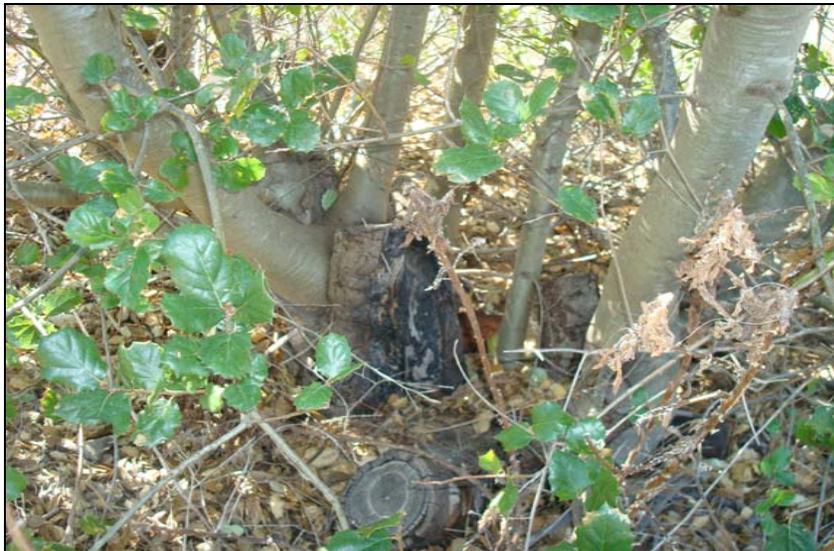
Photo 3. View of base of coast live oak trees.

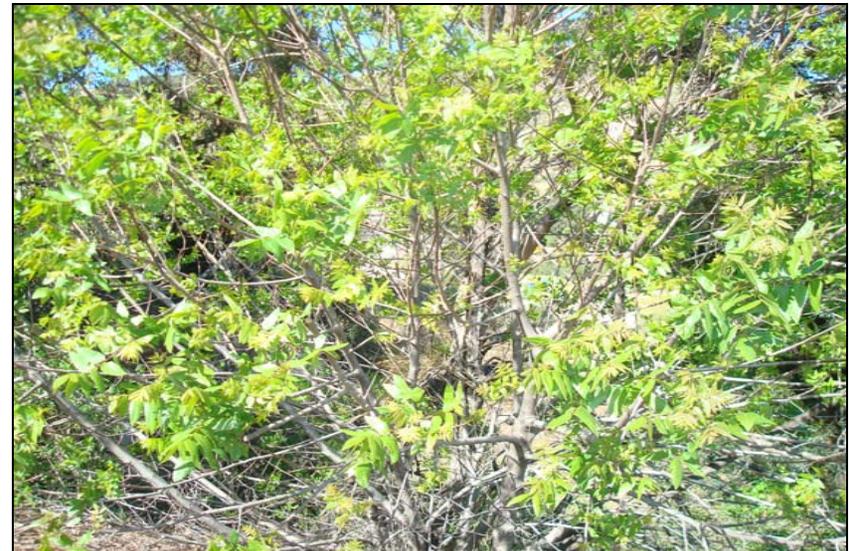
Six walnut trees observed within the project boundary were multi-trunked and did not meet the City's minimum combined 2-trunk 8-inch DBH requirement for protection. With the exception of one walnut along the eastern boundary, which was in declining health and had broken limbs, the trees were generally healthy with new shoot growth and no sign of disease.

Photo 4. View of walnut tree within project boundary that did not meet size criteria for protection

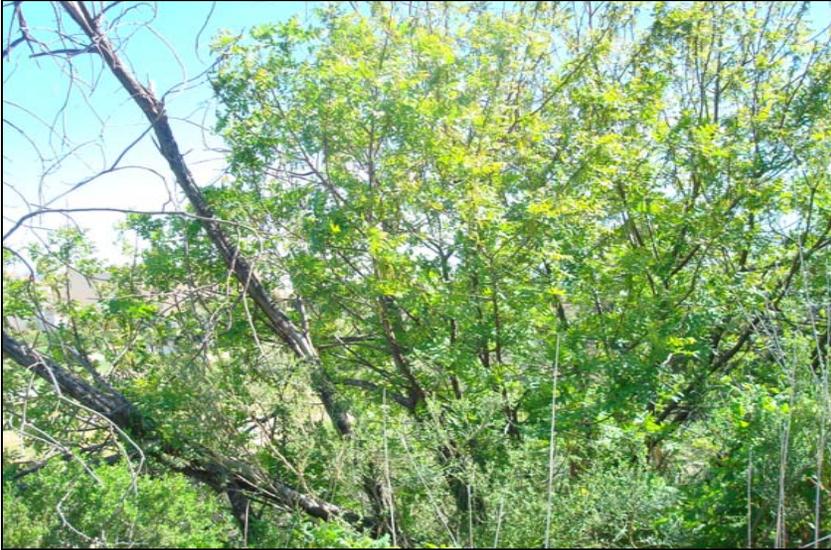
Photo 5. View of walnut tree located outside the project site boundary to the east.

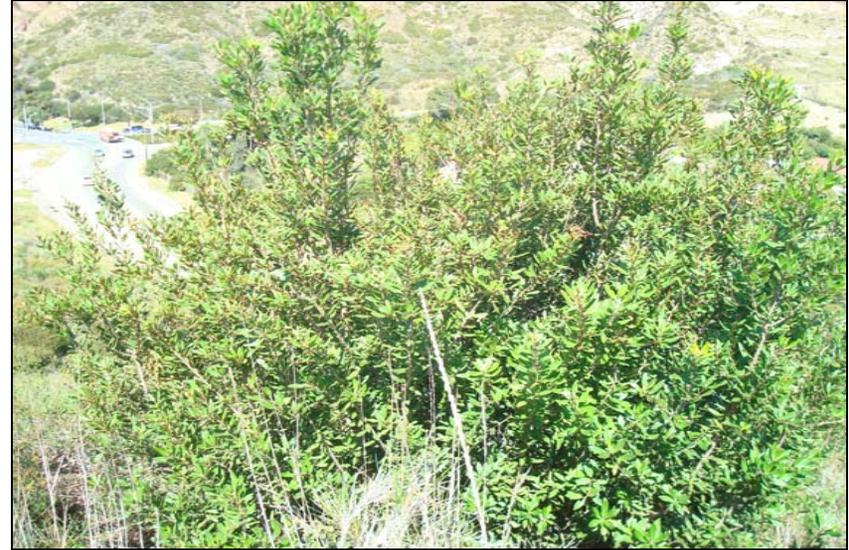
Numerous toyon were observed on the bluff top and scattered throughout the coastal sage scrub on the north and northeast facing slopes. None of the toyon meet the City's minimum combined 2-trunk 8-inch DBH requirement for protection, but were generally healthy with new shoot growth and no sign of disease.

Photo 6. View of toyon on bluff edge above steep north facing slope.

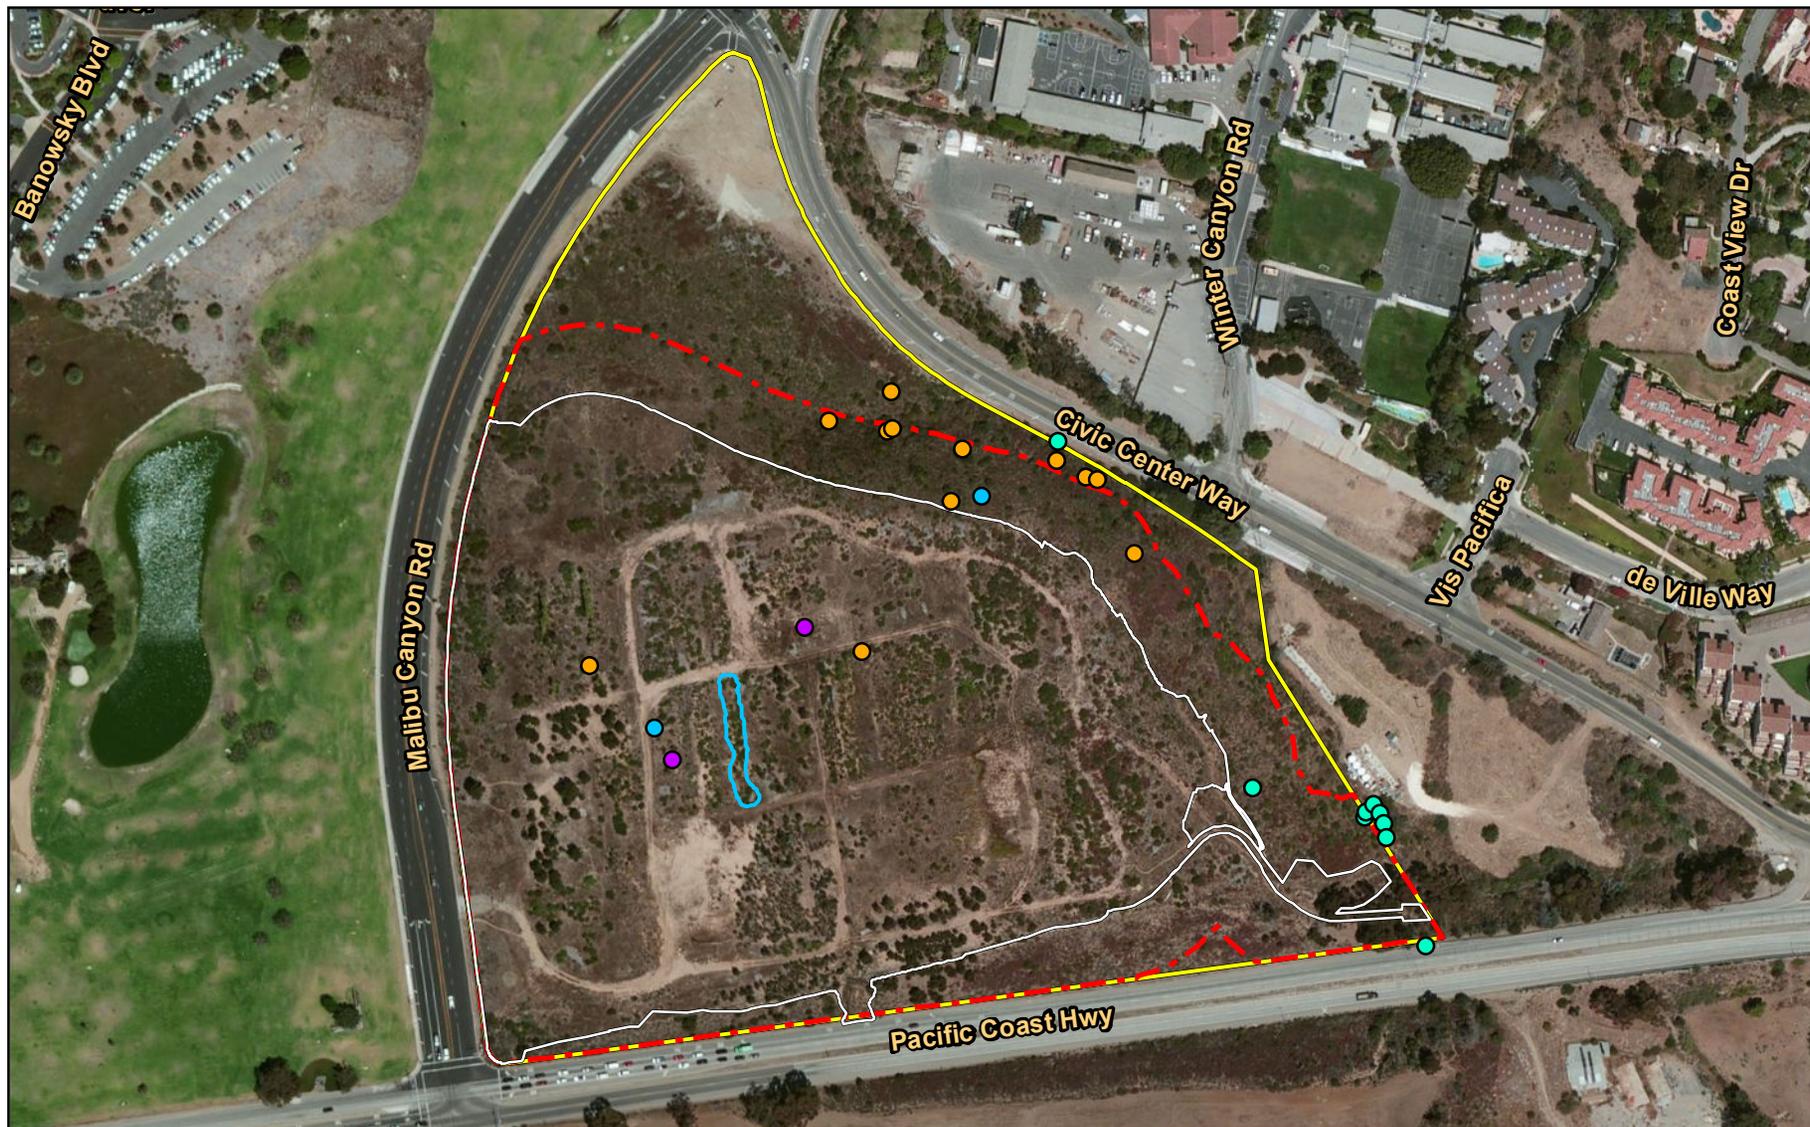
Native Tree Map

*Please note: no native trees within the project boundary meet the size criteria for protection.
