### Annual Report, July 2016 Through June 2017 Malibu Road Landslide Assessment District Malibu, California

January 2018  
Fugro Project No. 04.62160604  
Document No. 04.62160604-PR-001(Rev.00)

City of Malibu

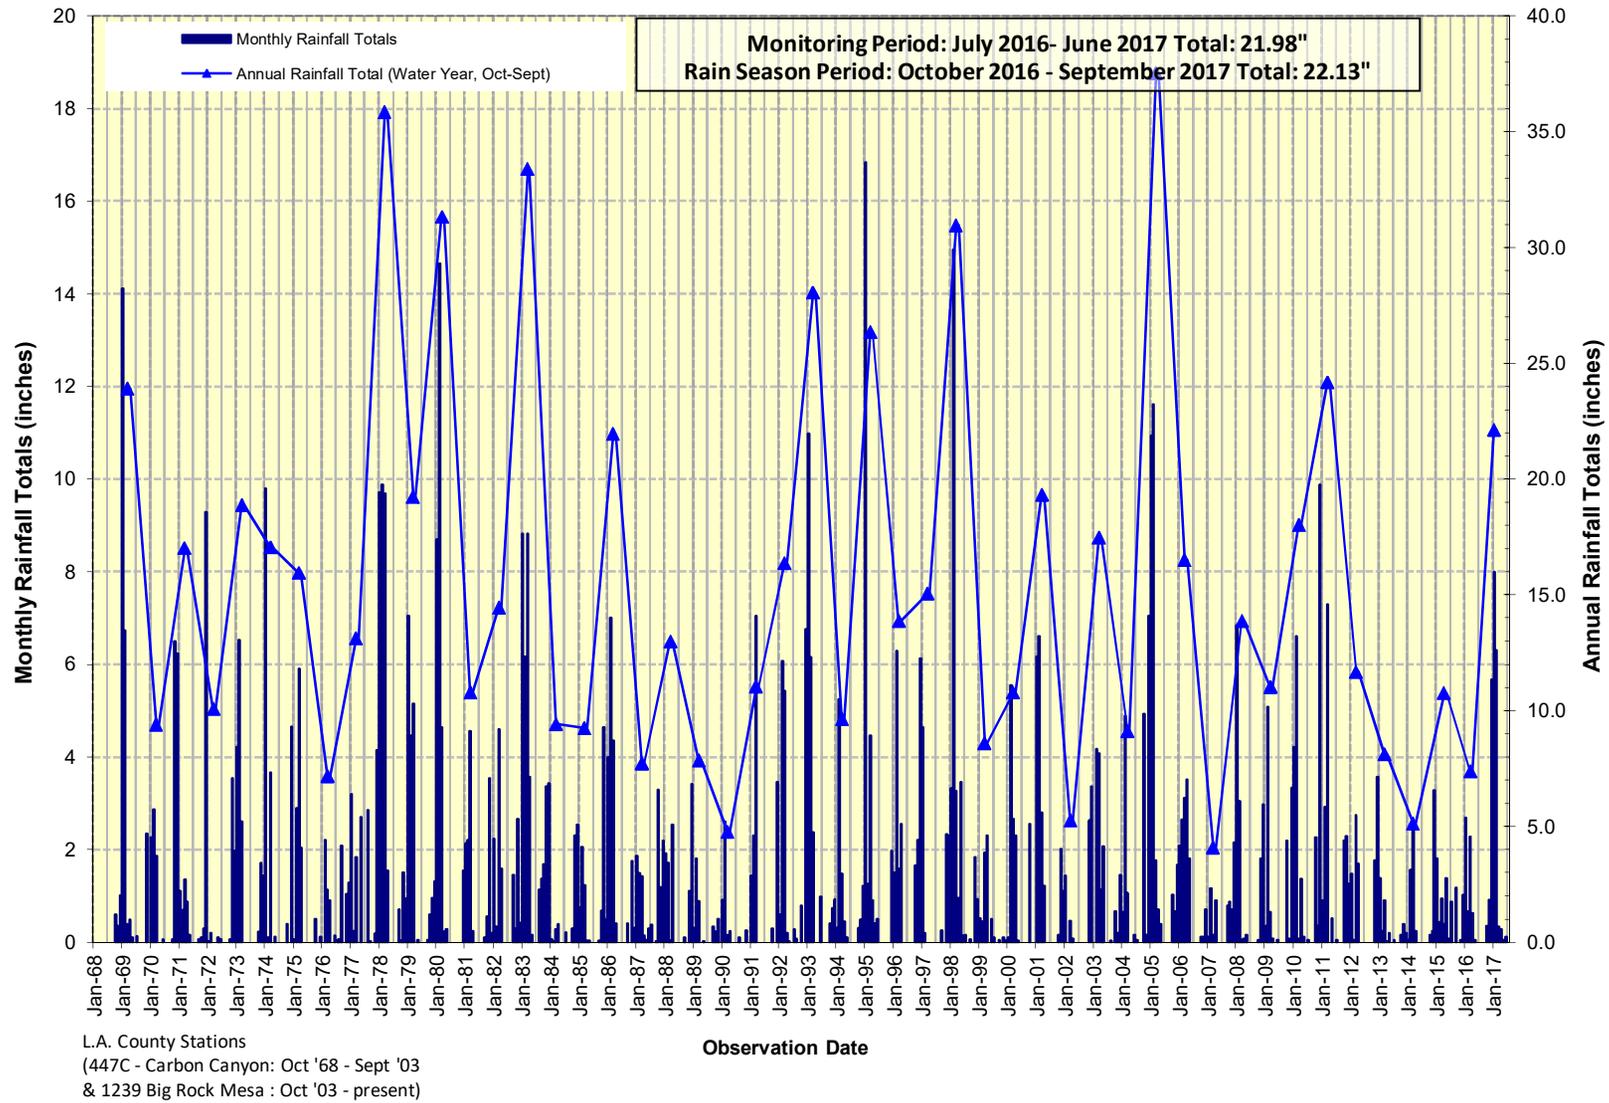
**RAINFALL GRAPH**  
 Malibu Road Landslide Assessment District  
 Malibu, California

Rainfall data indicate that approximately 21.98 inches of precipitation fell during the monitoring period from July 1, 2016 through June 30, 2017. The average annual rainfall from 1968 to 2017 in the "Malibu Area" for the same months is approximately 15.6 inches.

However, rainfall data are usually analyzed in terms of the annual "rain season" that covers the time period between October 1 through September 30. Rainfall for October 1, 2016 through September 30, 2017, was approximately 22.13 inches. That is approximately 138 percent of the average annual rainfall of 16.0 inches for the "rain seasons" between 1968 and 2017.

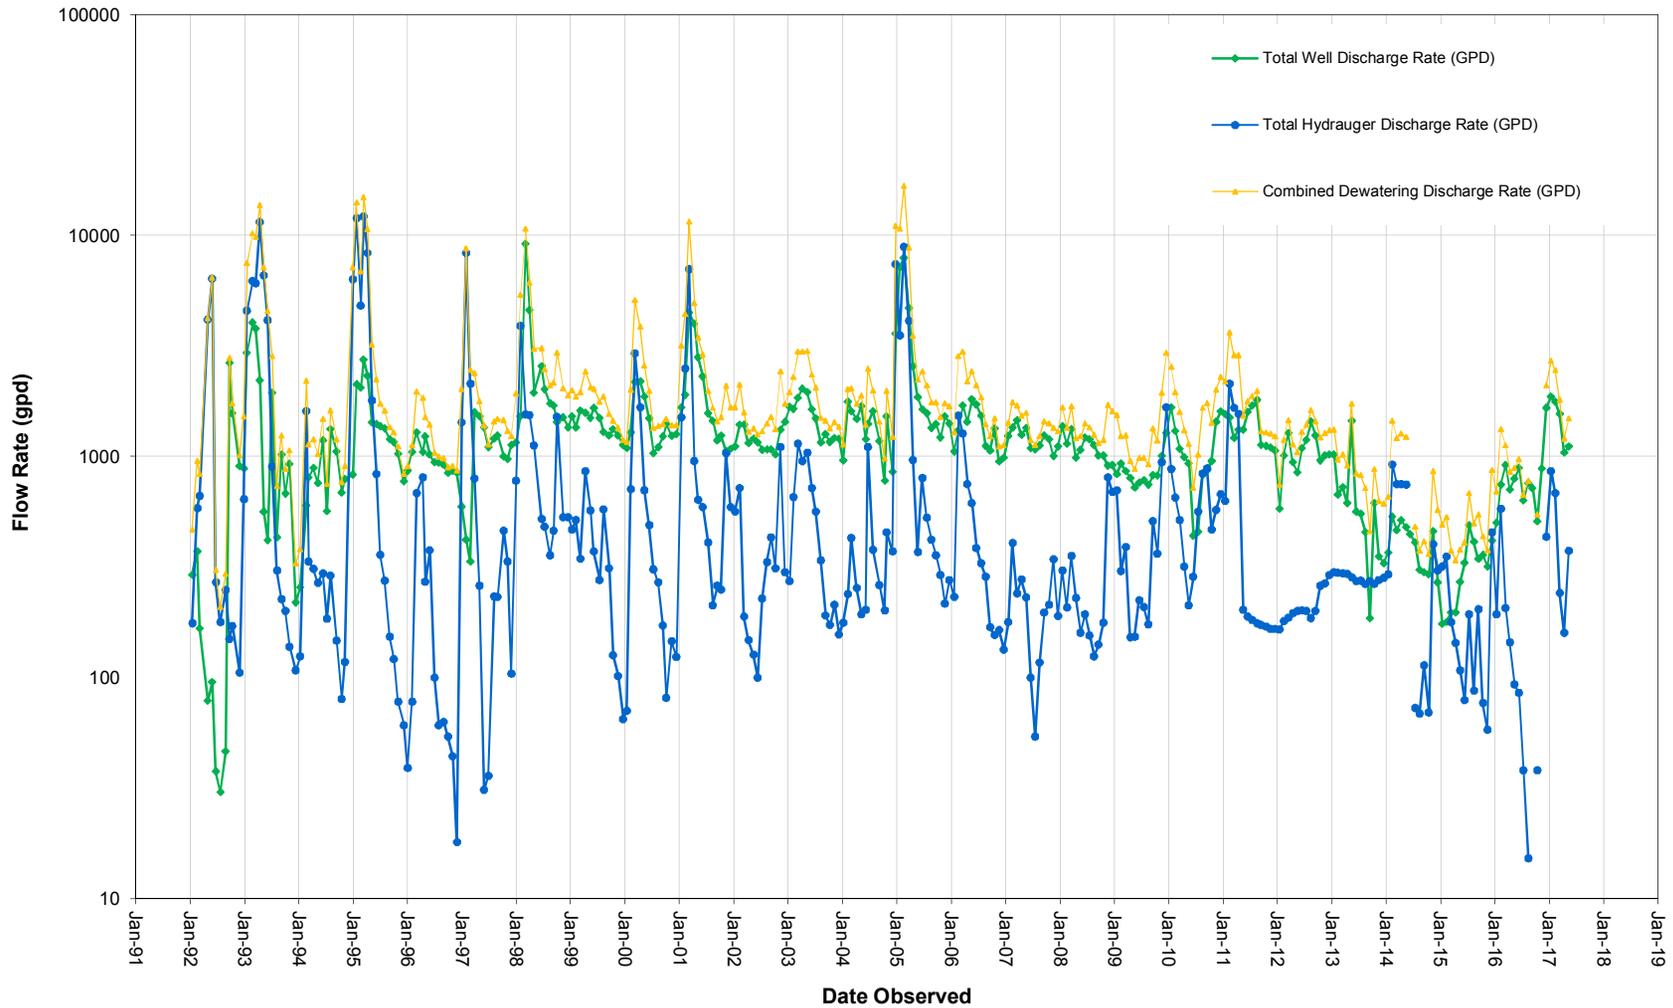
**TOTAL DISCHARGE - WELLS AND HYDRAUGERS**  
Malibu Road Landslide Assessment District  
Malibu, California

A combined graph of the total dewatering rate for the monitored dewatering wells and hydraugers is presented on Plate 4. Total dewatering production data for the measured hydraugers and wells indicates the following:

- The average total dewatering rate during the monitoring period was approximately 1474 gpd. This represents a 103 percent increase in the average rate relative to the 726 gpd average recorded during the previous monitoring period.

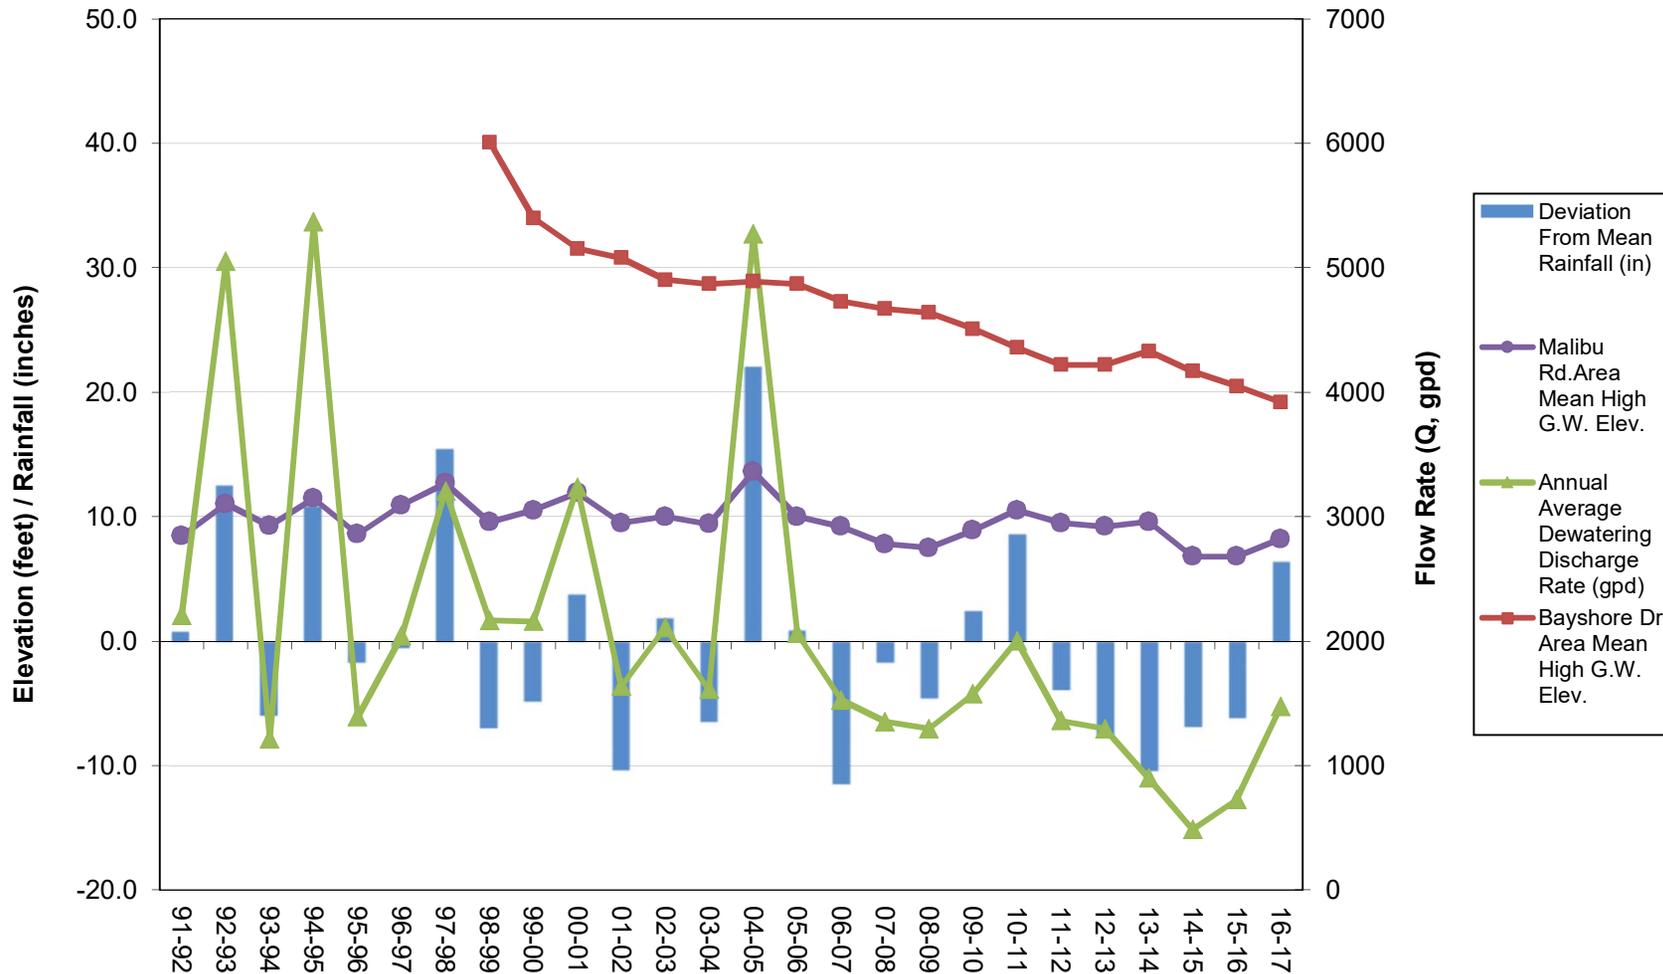
**GROUNDWATER LEVELS, DEWATERING, AND RAINFALL**  
 Malibu Road Landslide Assessment District  
 Malibu, California

Plate 5 – Groundwater Levels, Dewatering, and Rainfall shows the yearly magnitude of deviation of each years' rainfall relative to the mean annual rainfall. The graphic also shows the average annual dewatering output (gallons per day, gpd). The data illustrates that the average annual dewatering output is generally consistent with average rainfall.

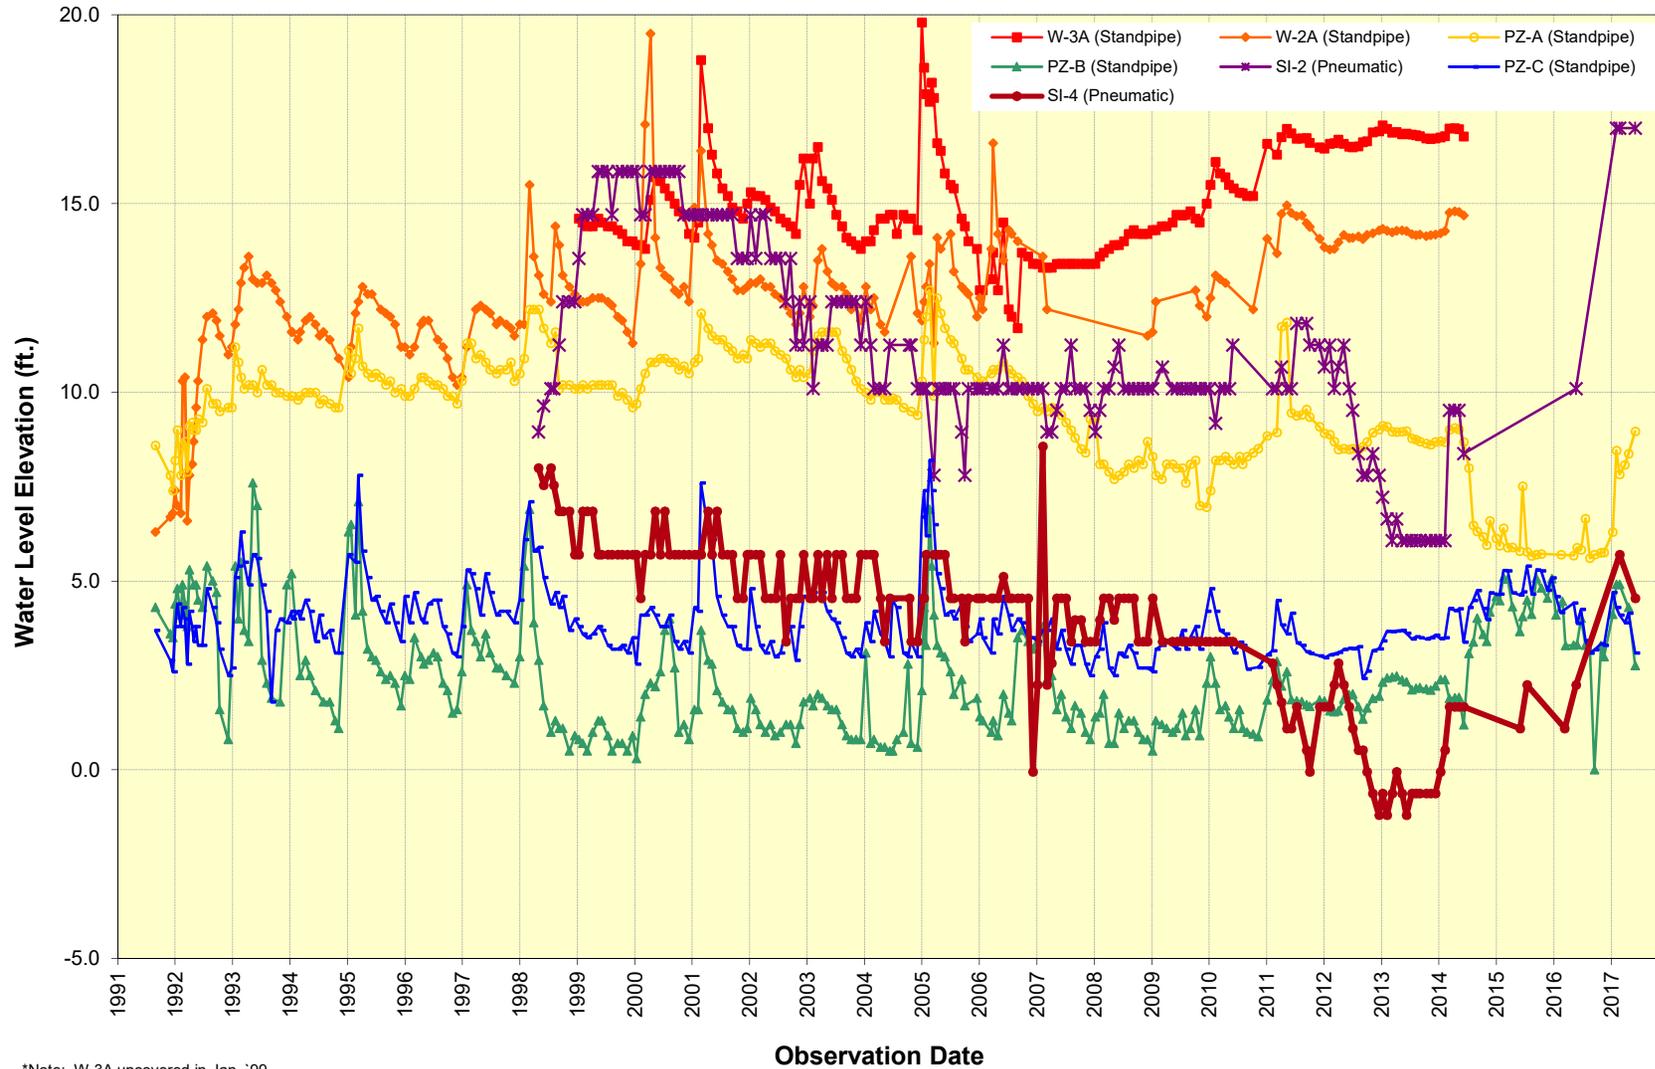
**GROUNDWATER LEVEL INFORMATION**  
 Malibu Road (West End)  
 Malibu Road Landslide Assessment District  
 Malibu, California

**Malibu Road.** Groundwater elevation data for the area along Malibu Road are presented on Plates A-3 and A-4. Groundwater levels for that area are monitored using standpipes PZ-A, -B, -C, -D, -E, W-2A, and W-3A along with pneumatic piezometers installed in inclinometers SI-1, -1A, -2, -3, and -4. In general, groundwater levels increased slightly during the 2016-17 monitoring period. The calculated area average water level increased by 0.3 feet when compared to the area average for the 2015-16 monitoring period and is 2.0 feet below the mean area average for this area for the period of record. Water levels in individual standpipes declined slightly or remained approximately static over the monitoring year with temporary increases in response to rainfall events in January and February. No new data are presented for standpipes W-2A or W-3A because W-2A has been dry since July 2014 and W-3A is buried beneath soil creep from the bluff face. Pneumatic piezometers in inclinometers SI-1A, SI-2, all showed increased pore pressure readings subsequent to the rain events of early 2017. Pneumatic piezometers in inclinometers SI-1 and SI-3 are no longer functioning and no new data are presented.

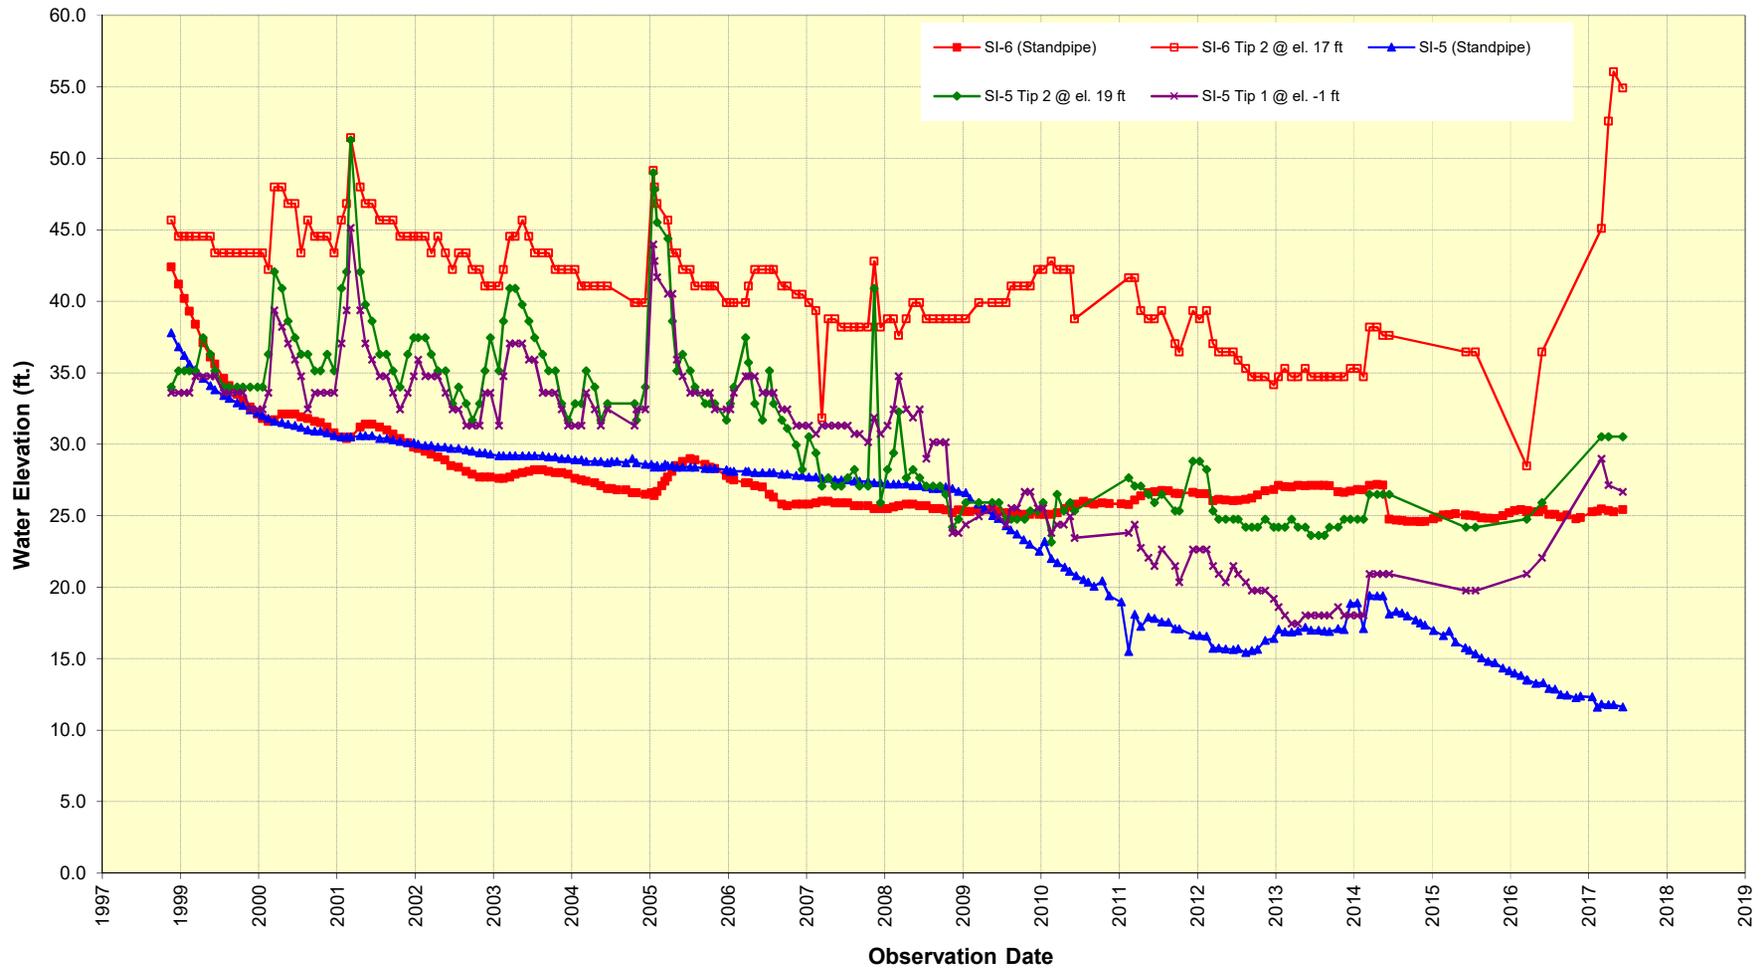
**GROUNDWATER HYDROGRAPH  
LEVEL INFORMATION**  
Malibu Road Landslide Assessment District  
Malibu, California

**Bayshore Drive.** Groundwater elevation data for the area along Bayshore Drive are presented on Plate A-5. Groundwater levels for that area are monitored using standpipes SI-5 and SI-6 along with the two

pneumatic piezometers installed with each standpipe. In general, groundwater levels declined during the 2016-17 monitoring period. The calculated area average water-level declined by 1 foot when compared to the area average for the 2015-16 monitoring year and is 7.3 feet below the mean area average for this area for the period of record (1991-2017). Water levels in standpipe SI-5 declined steadily during the 2016-17 monitoring year and reached an all-time low for the period of record in February and June 2017. Water levels in standpipe SI-6 remained approximately static over the course of the monitoring year, with fluctuations of less than 1 foot. Readings from both the shallow and deep pneumatic piezometers in standpipes SI-5 and SI-6 continue to record water elevation above the standpipe water levels and showed more of a response to the rainfall events of January and February 2017 than was seen in the standpipes.

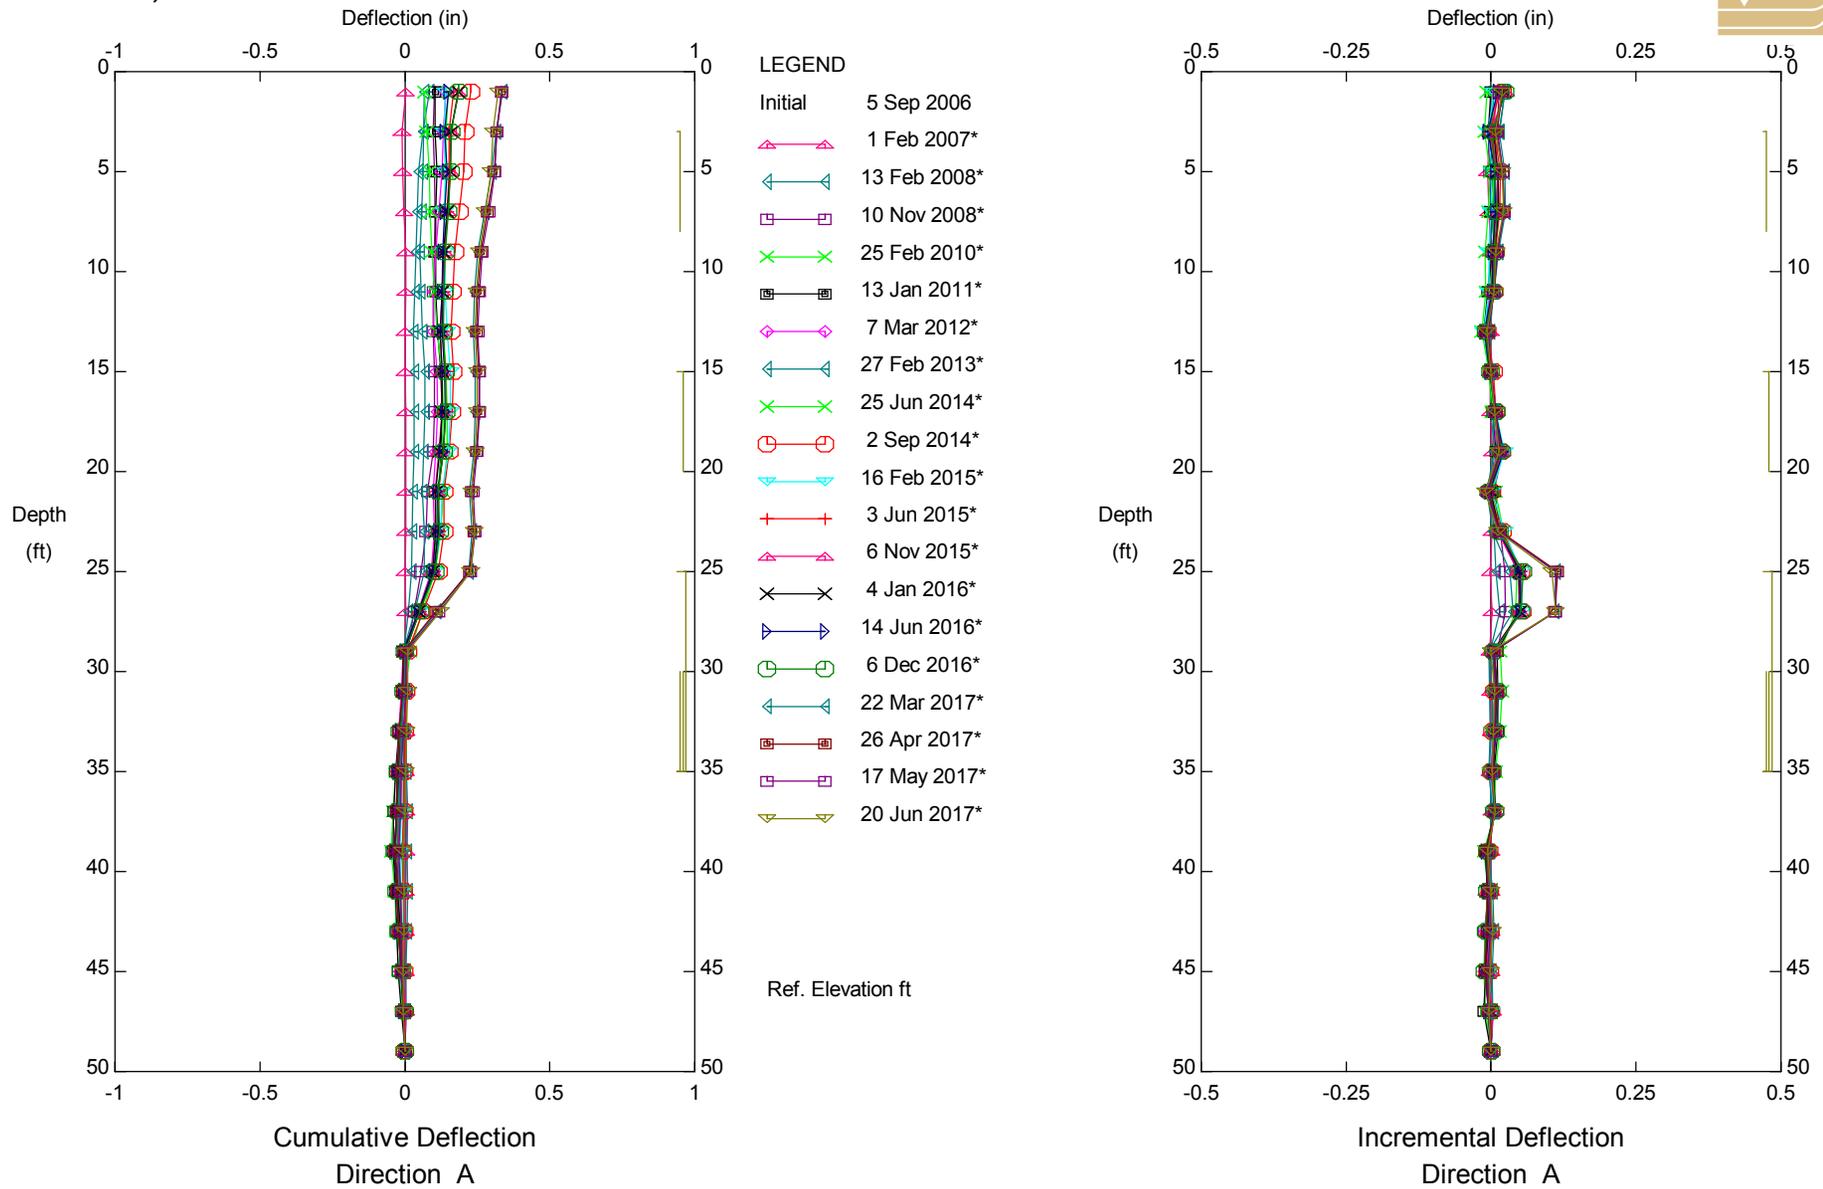
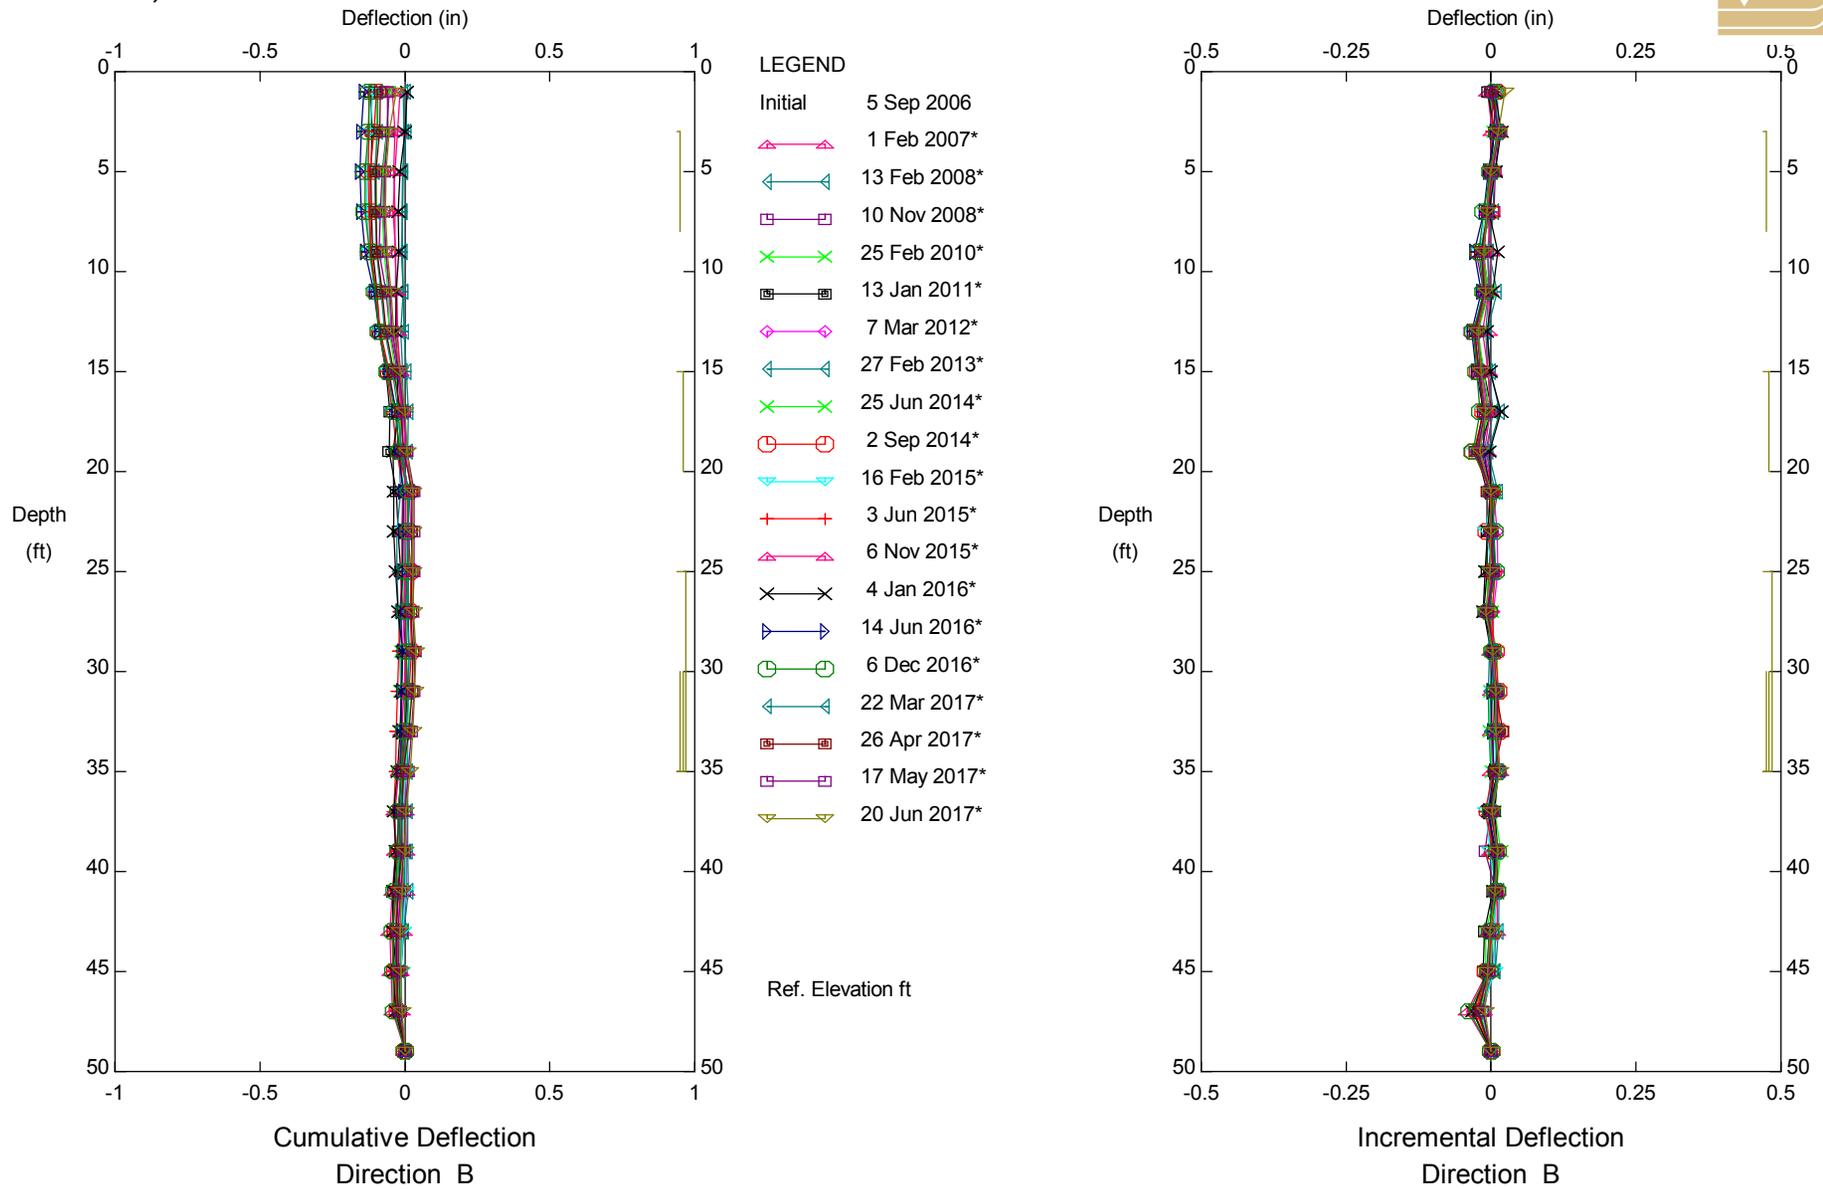
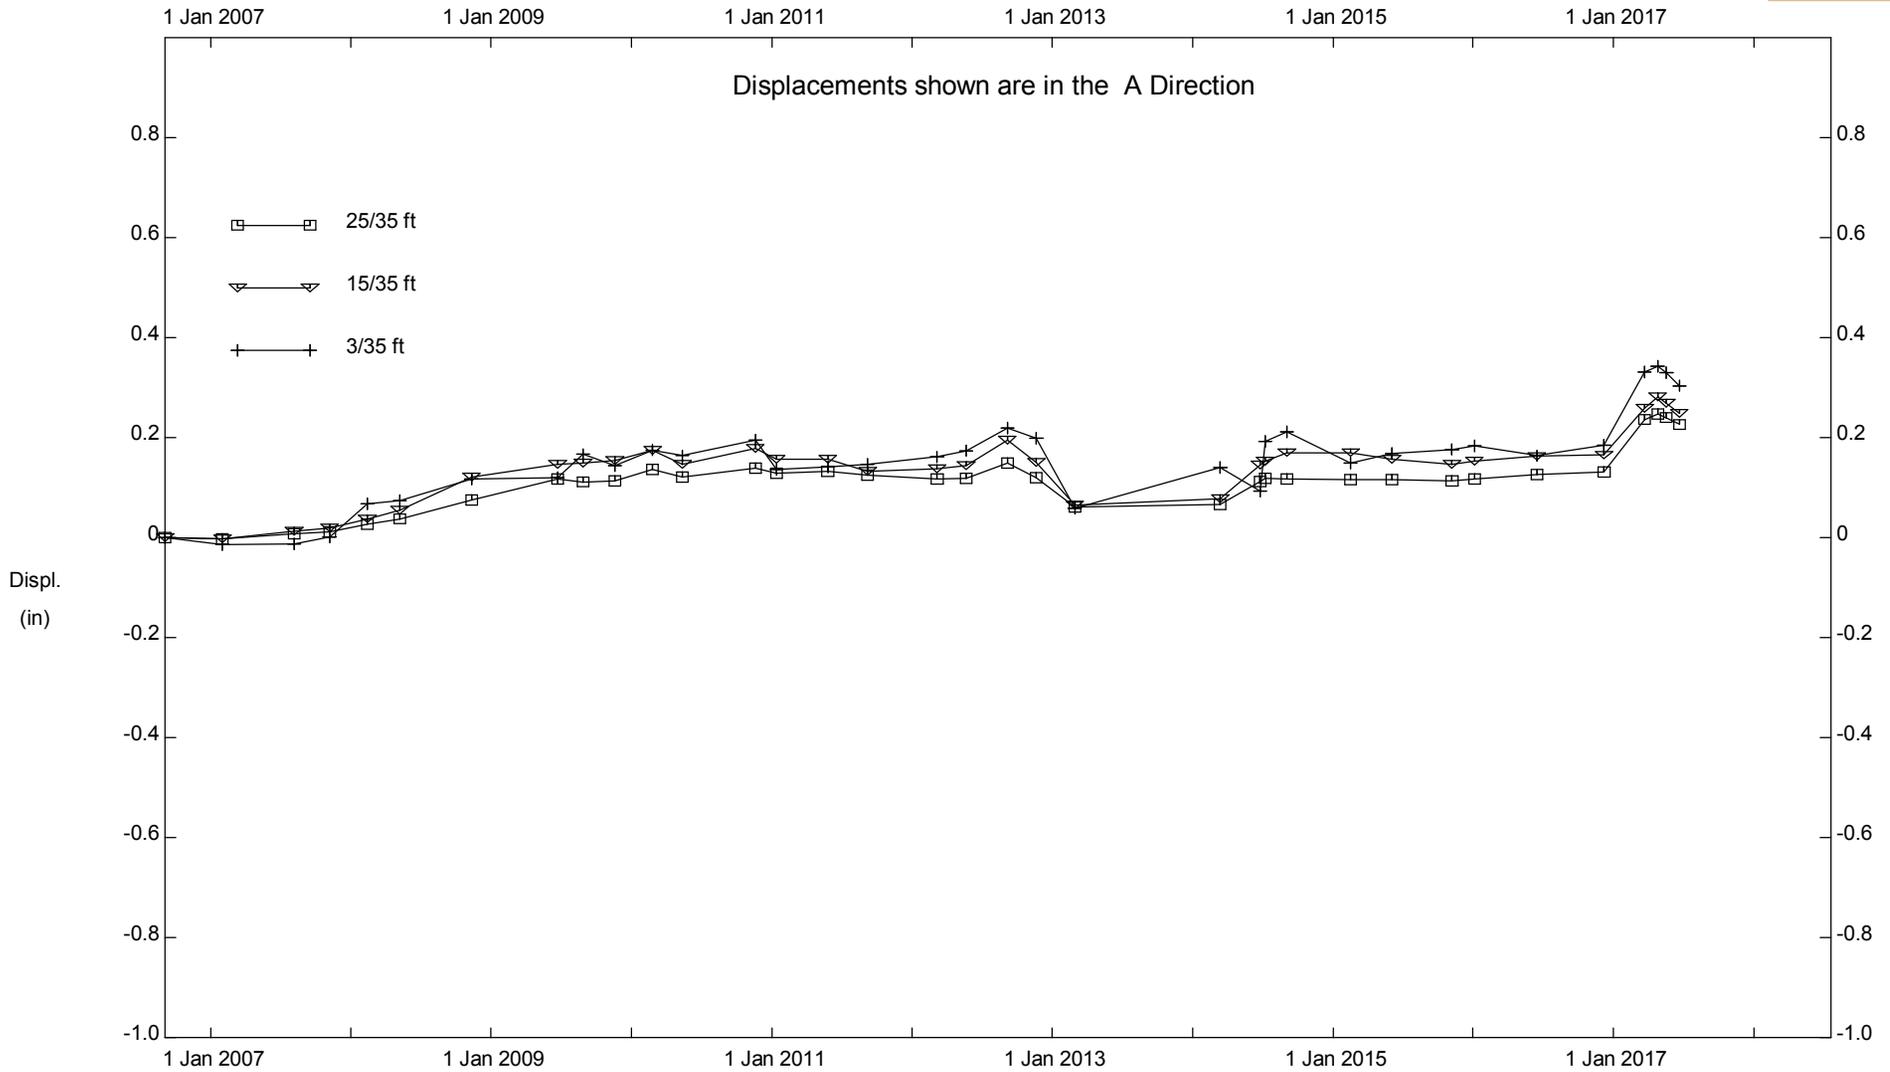
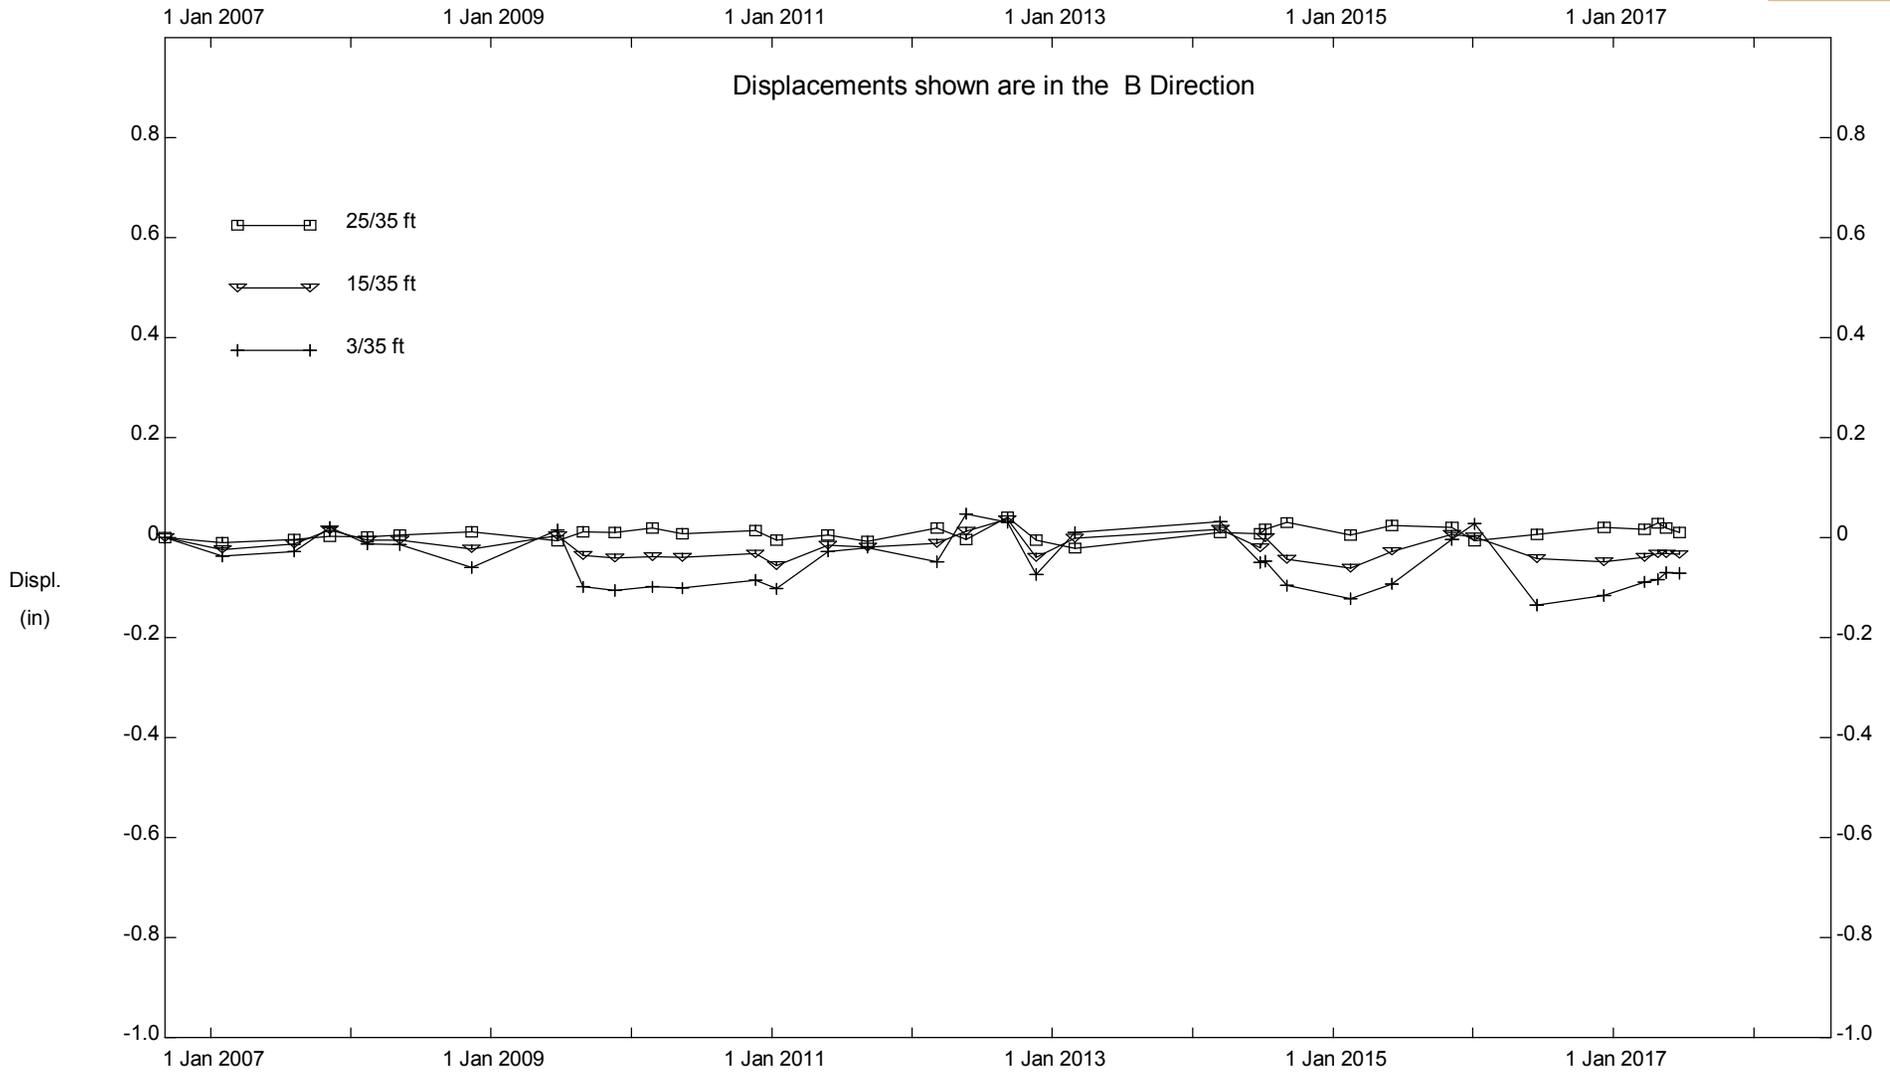
Assessment District 98-3, Inclinator SI-1A  
 City of Malibu

The March 2017 survey of the inclinometers along Malibu Road (SI-1A, SI-2A, SI-4A) showed distinct movement of approximately 0.1 to 0.15 inches. SI-1A showed movement of approximately 0.1 inches at a depth of 25 to 30 feet bgs. SI-2A showed movement of approximately 0.15 inches at 30 to 35 feet bgs. SI-4A showed movement of approximately 0.15 inches at 30 to 35 feet bgs. As a result of the interpreted movement, Fugro adjusted the survey frequency for those inclinometers from a quarterly to a monthly basis. After three successive months of no additional detectable movement, survey frequency was switched back to a quarterly basis.
