### Annual Report, July 2016 Through June 2017 Malibu Road Landslide Assessment District Malibu, California

January 2018  
Fugro Project No. 04.62160604  
Document No. 04.62160604-PR-001(Rev.00)

City of Malibu

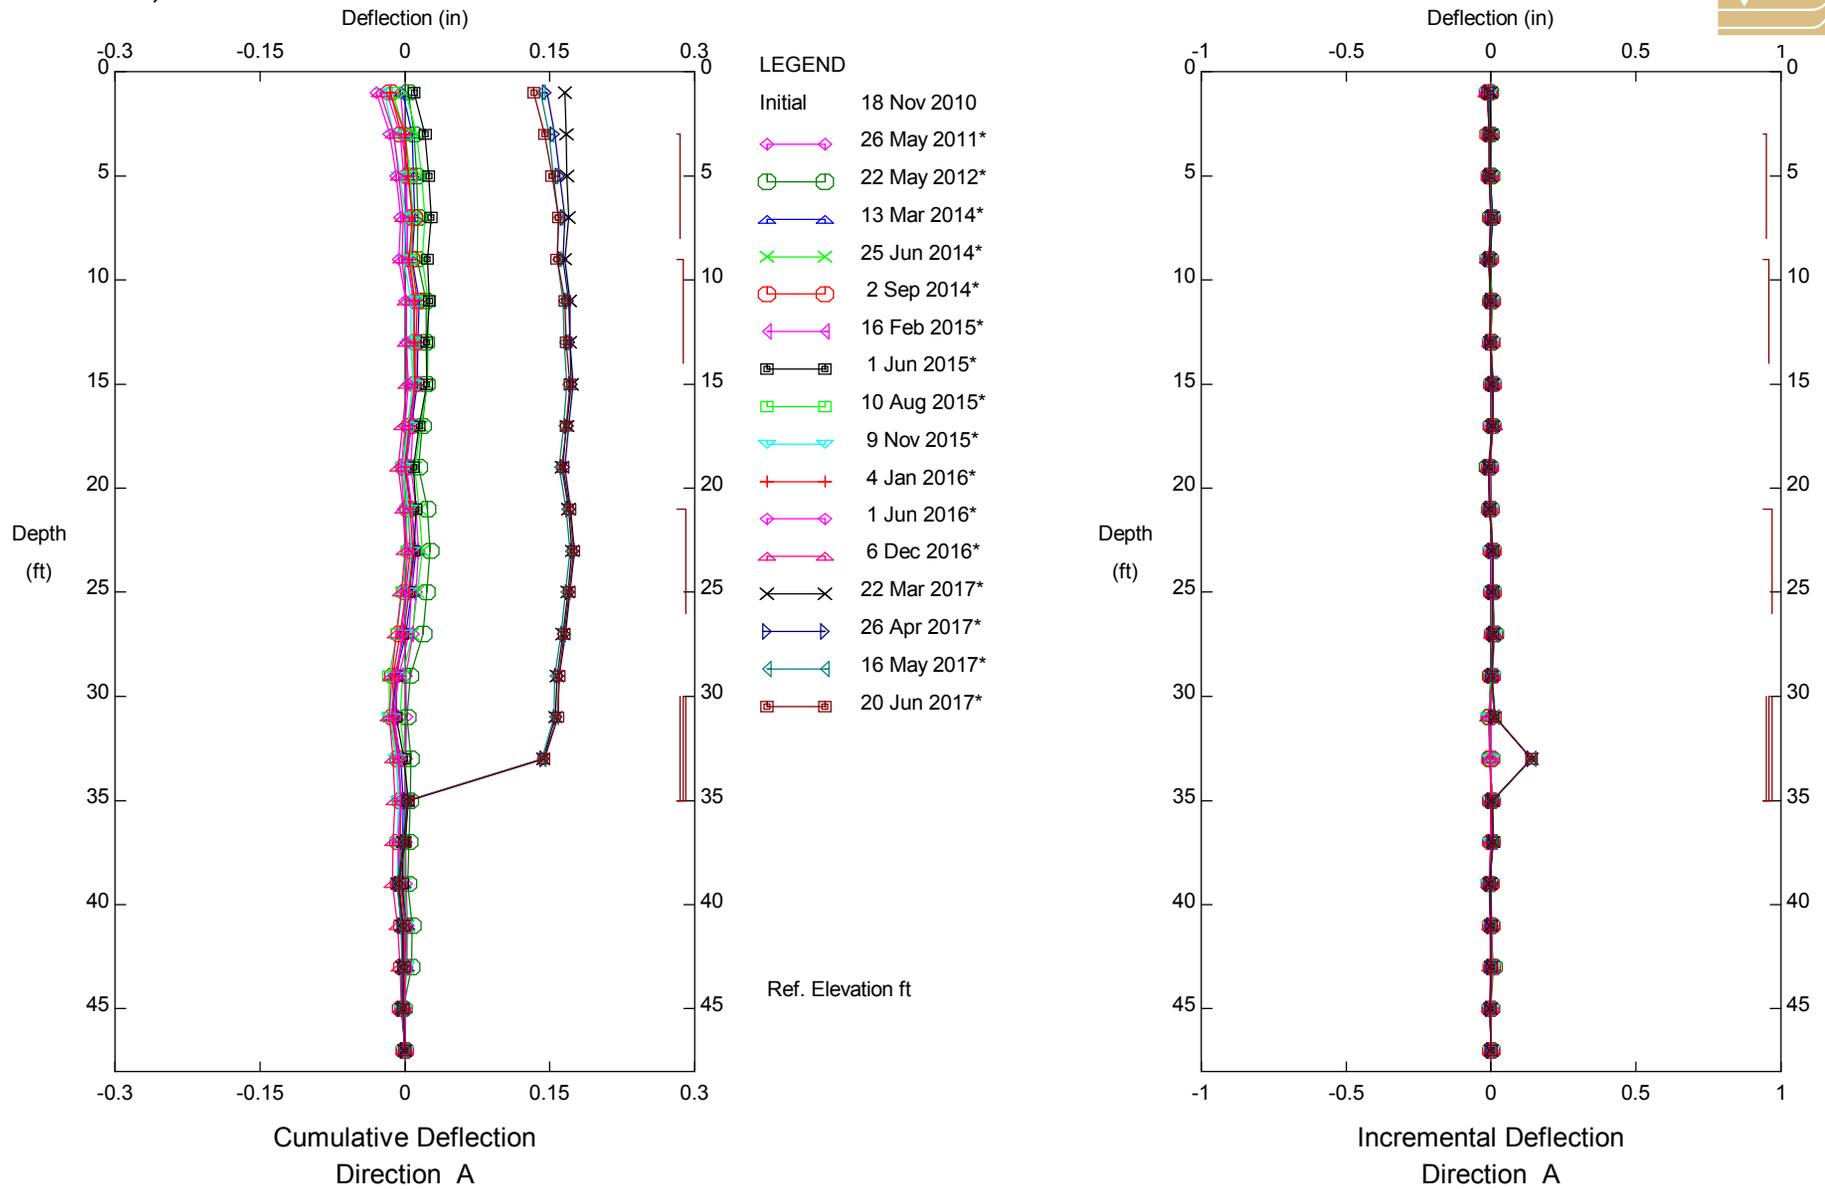
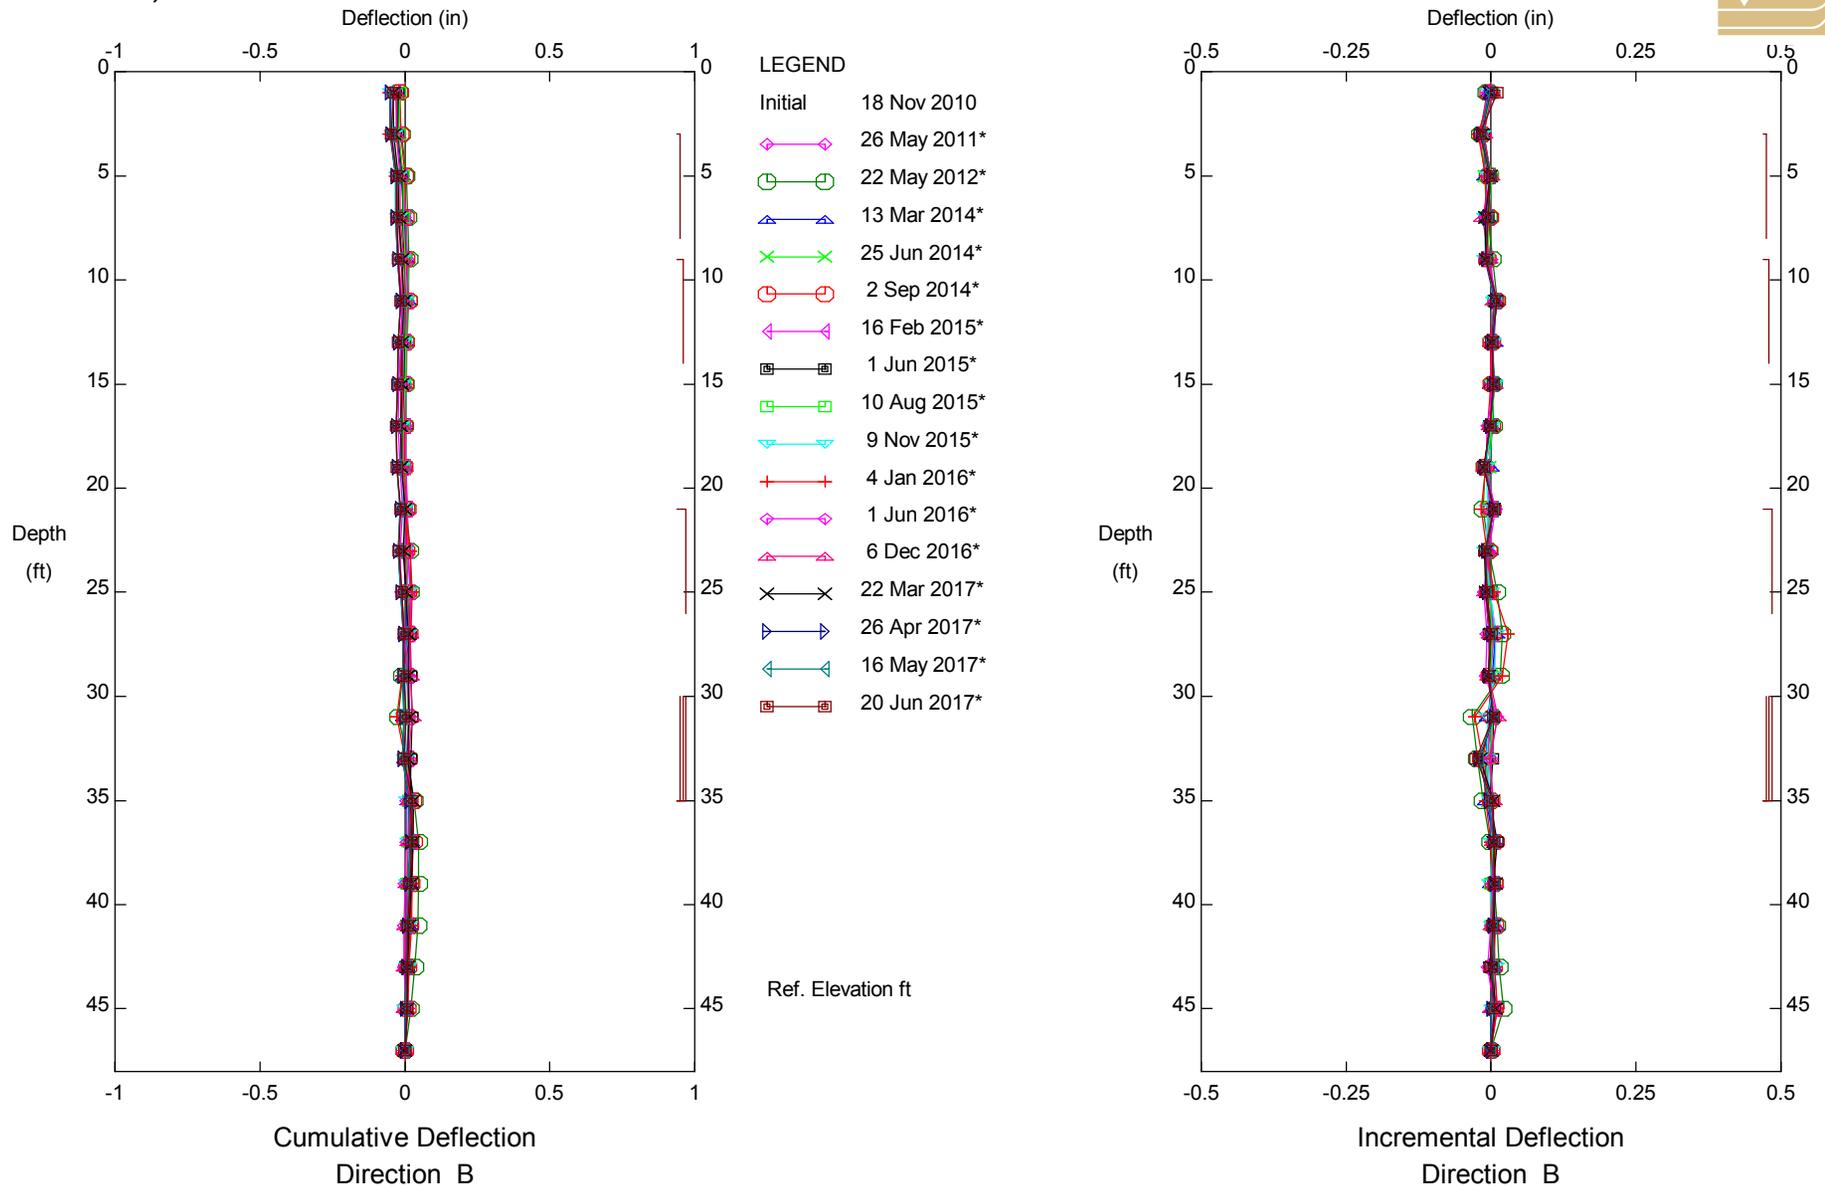
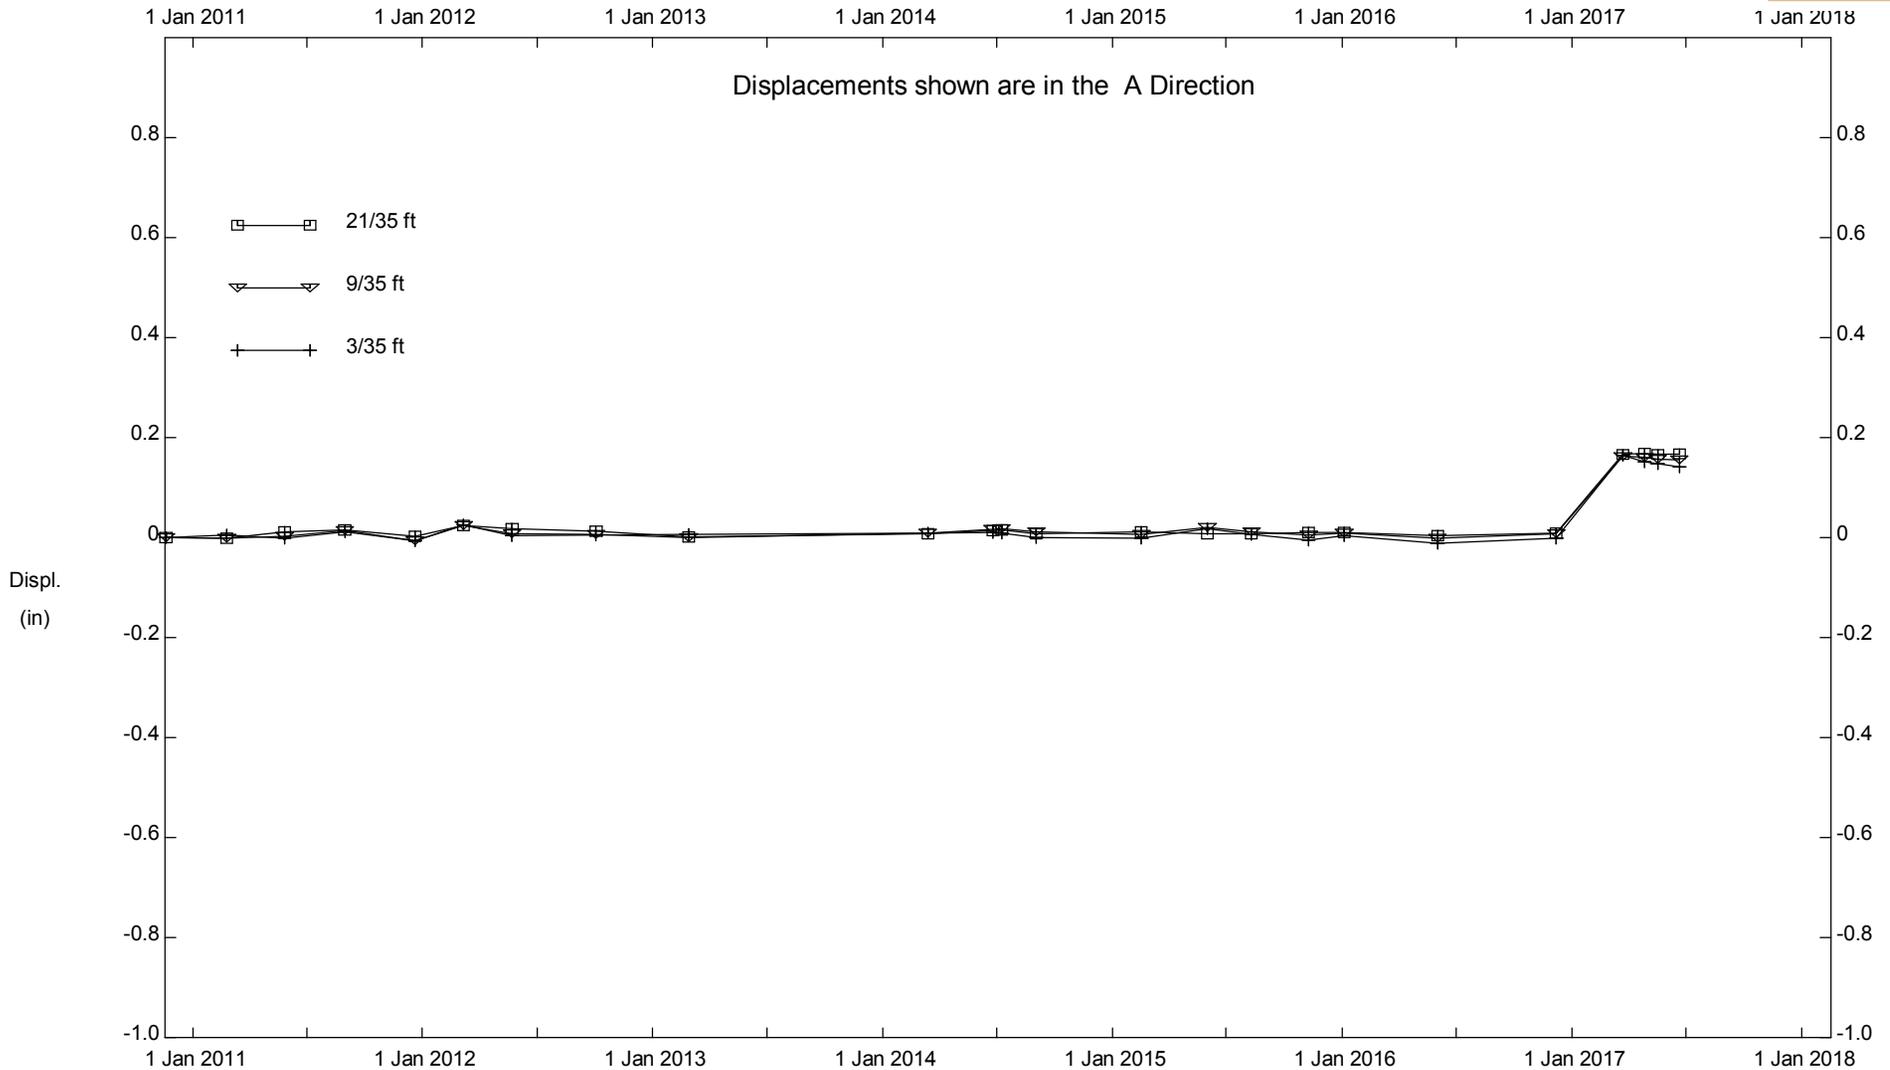
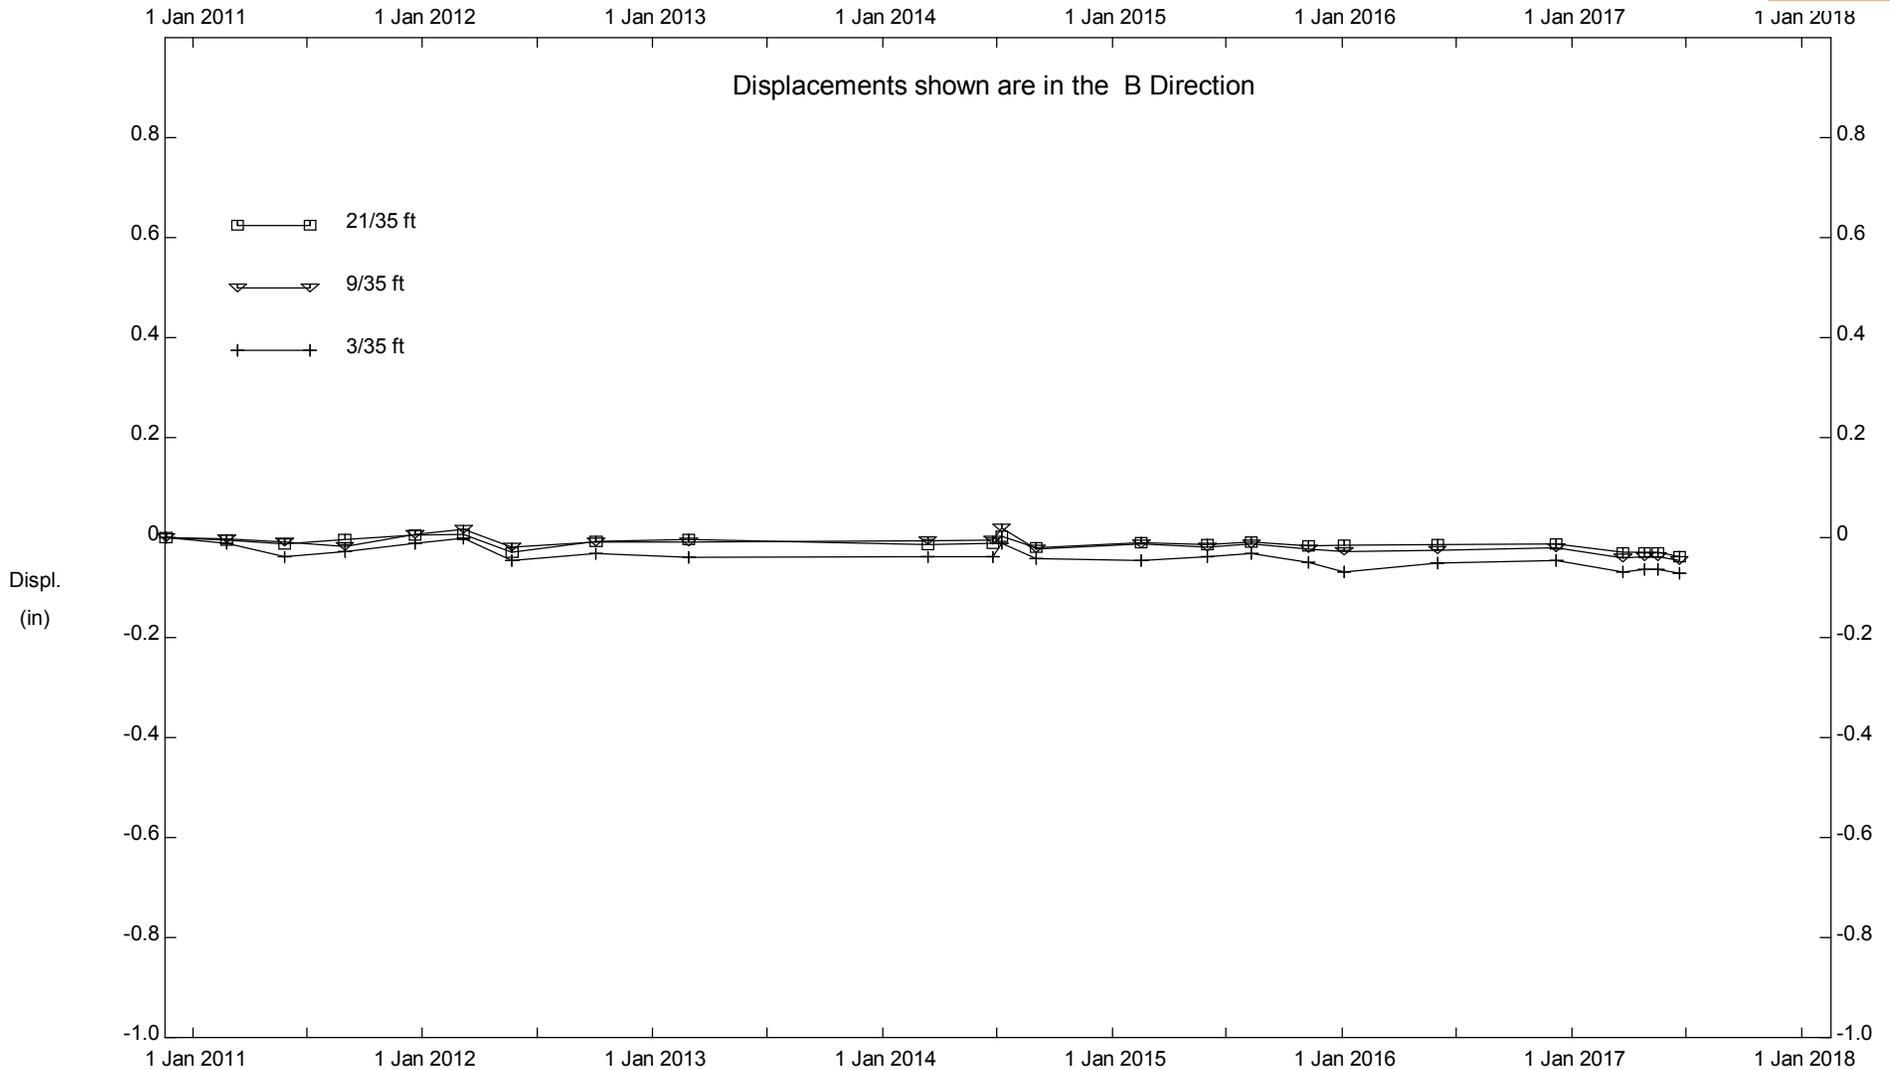
Assessment District 98-3, Inclinator SI-2A  
 City of Malibu

The March 2017 survey of the inclinometers along Malibu Road (SI-1A, SI-2A, SI-4A) showed distinct movement of approximately 0.1 to 0.15 inches. SI-1A showed movement of approximately 0.1 inches at a depth of 25 to 30 feet bgs. SI-2A showed movement of approximately 0.15 inches at 30 to 35 feet bgs. SI-4A showed movement of approximately 0.15 inches at 30 to 35 feet bgs. As a result of the interpreted movement, Fugro adjusted the survey frequency for those inclinometers from a quarterly to a monthly basis. After three successive months of no additional detectable movement, survey frequency was switched back to a quarterly basis.

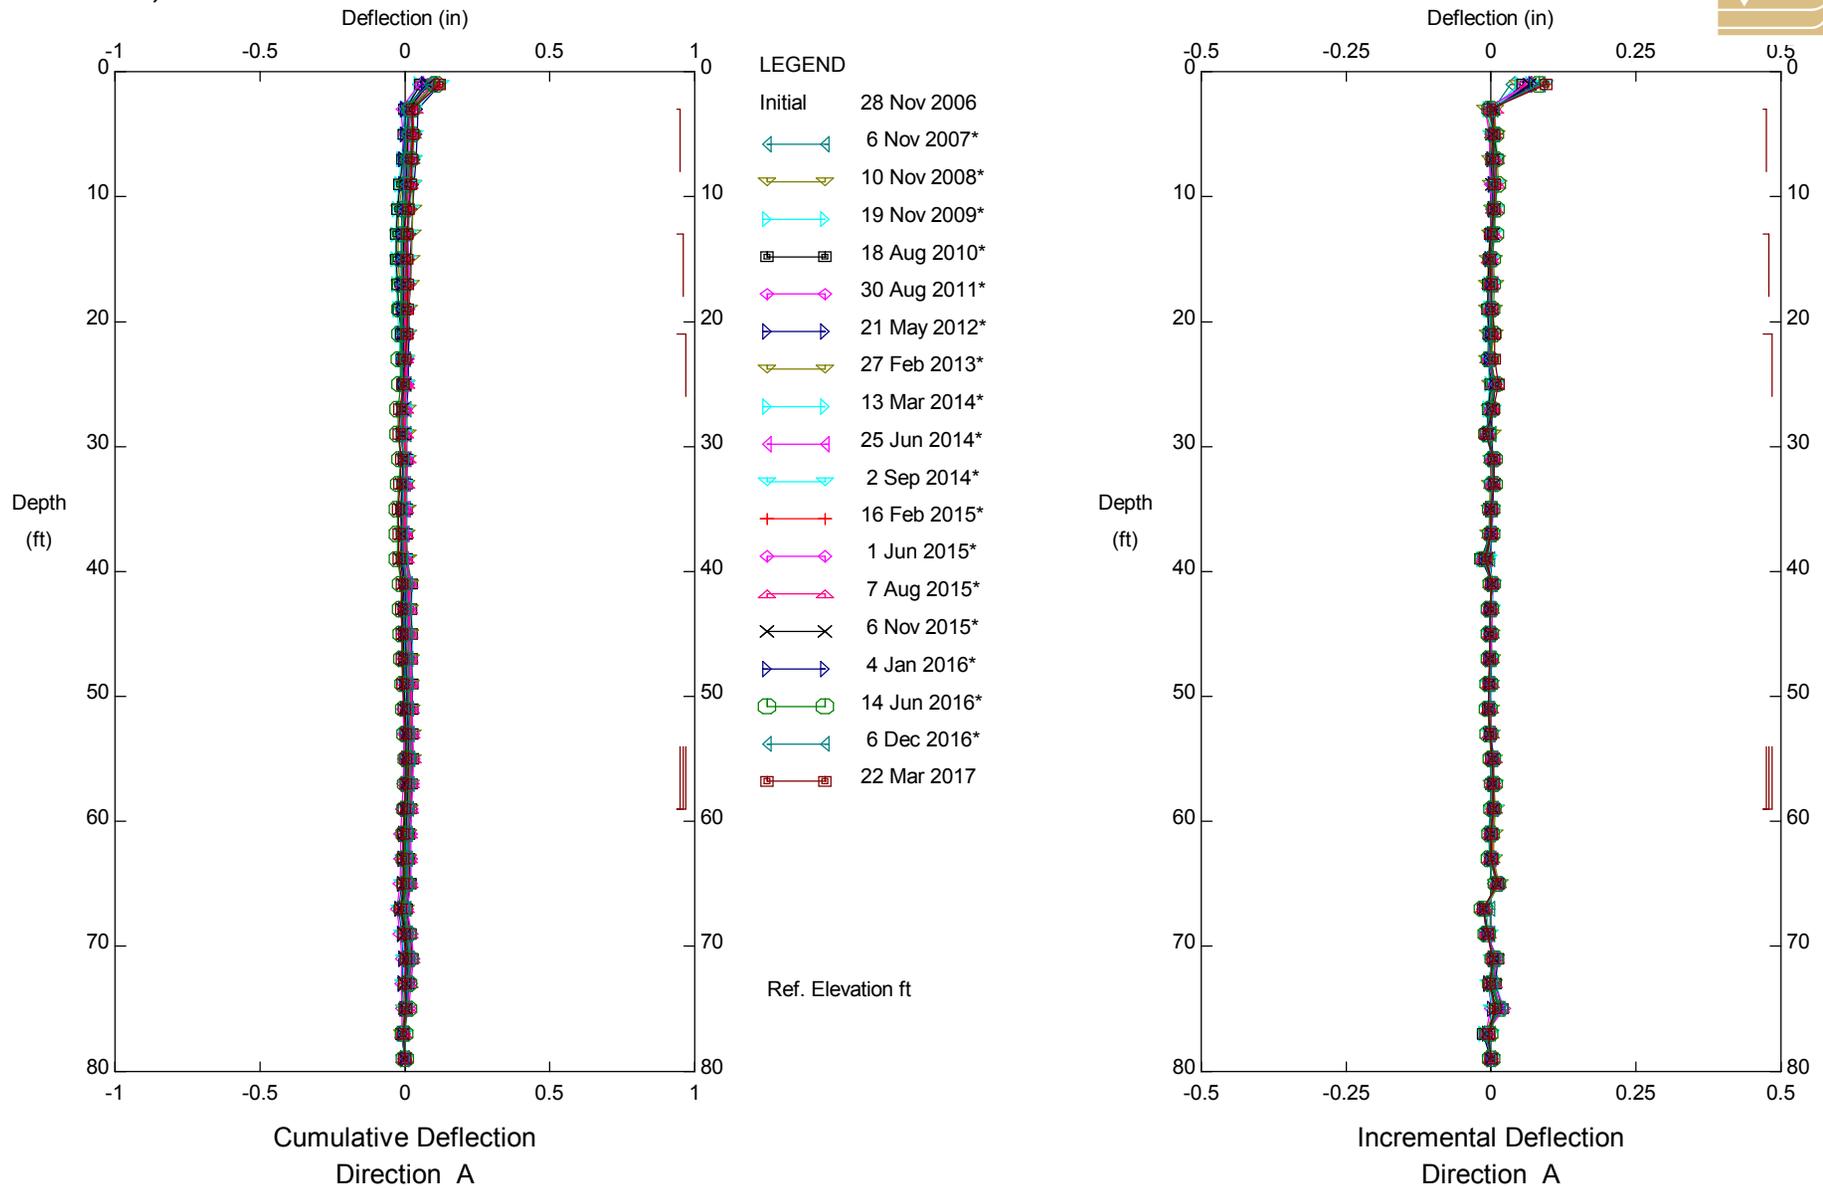
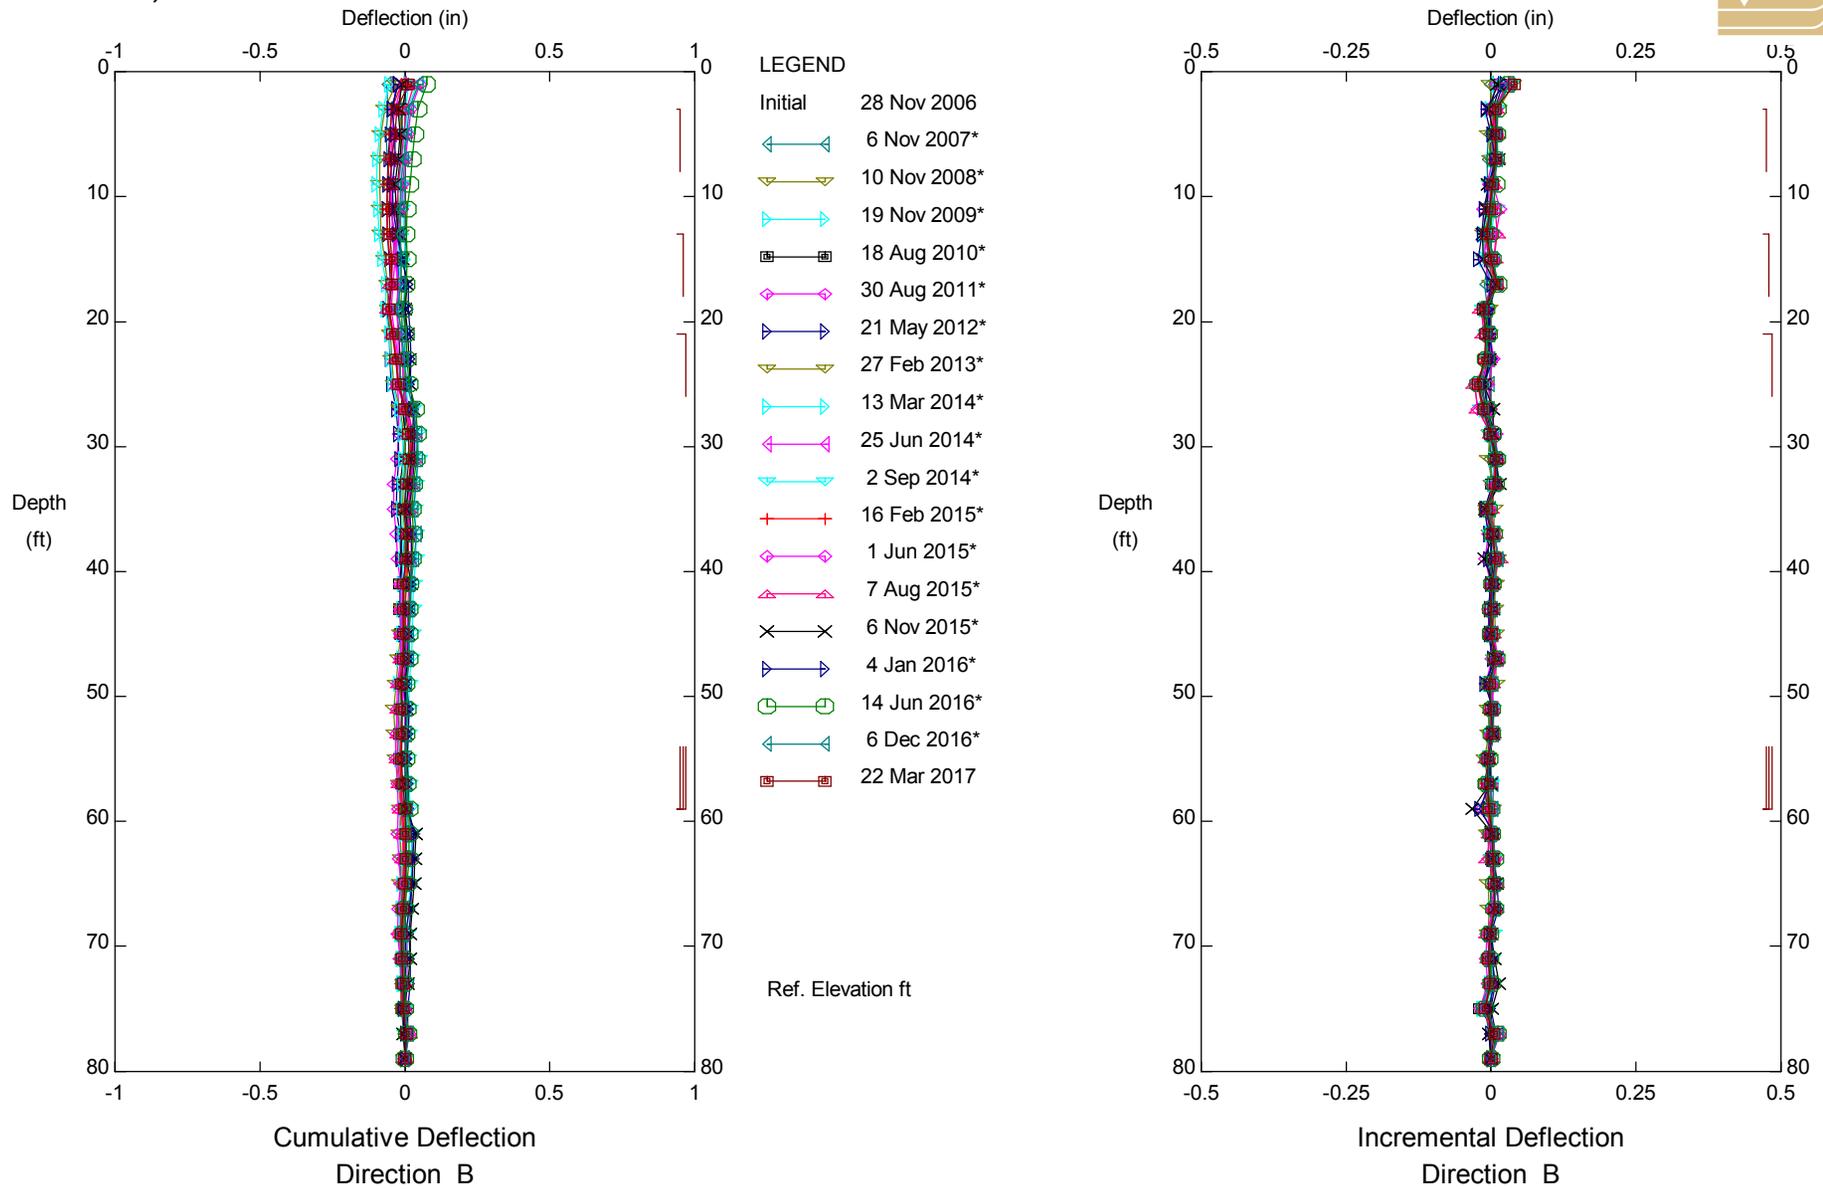
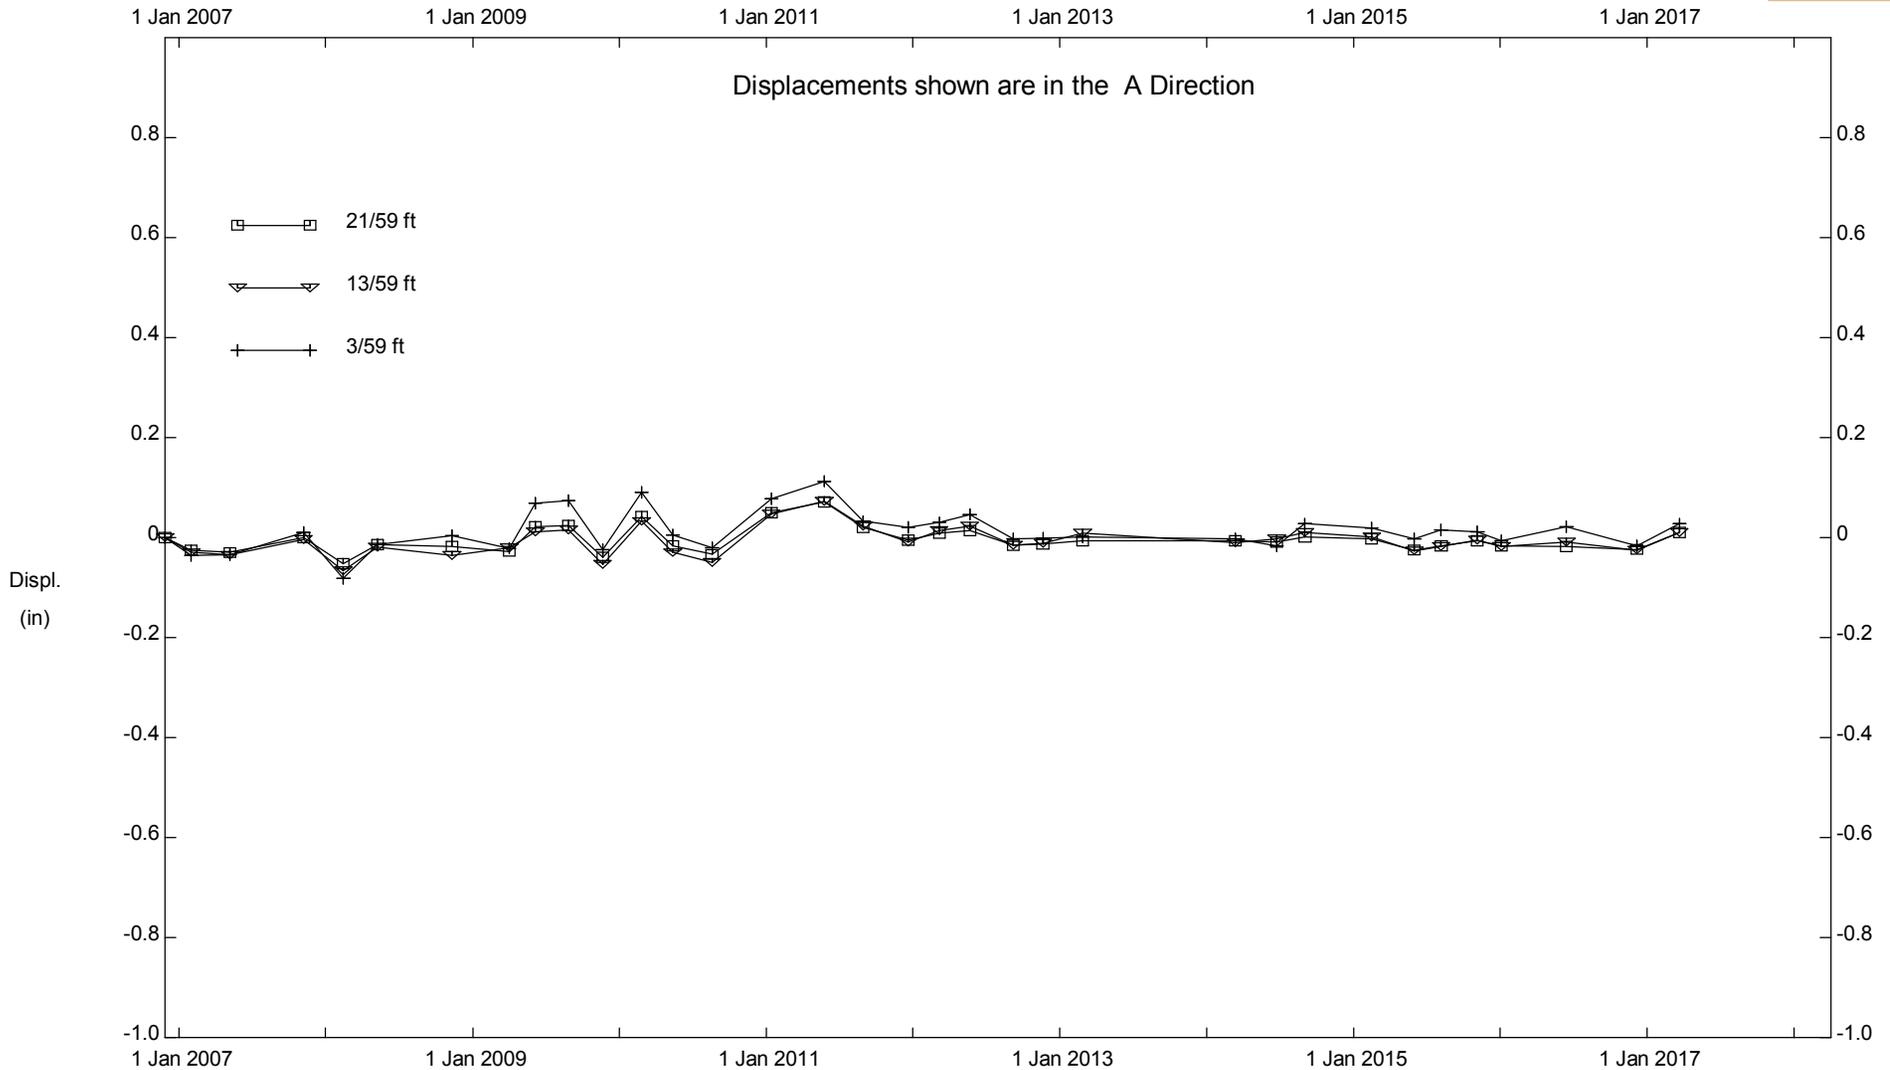
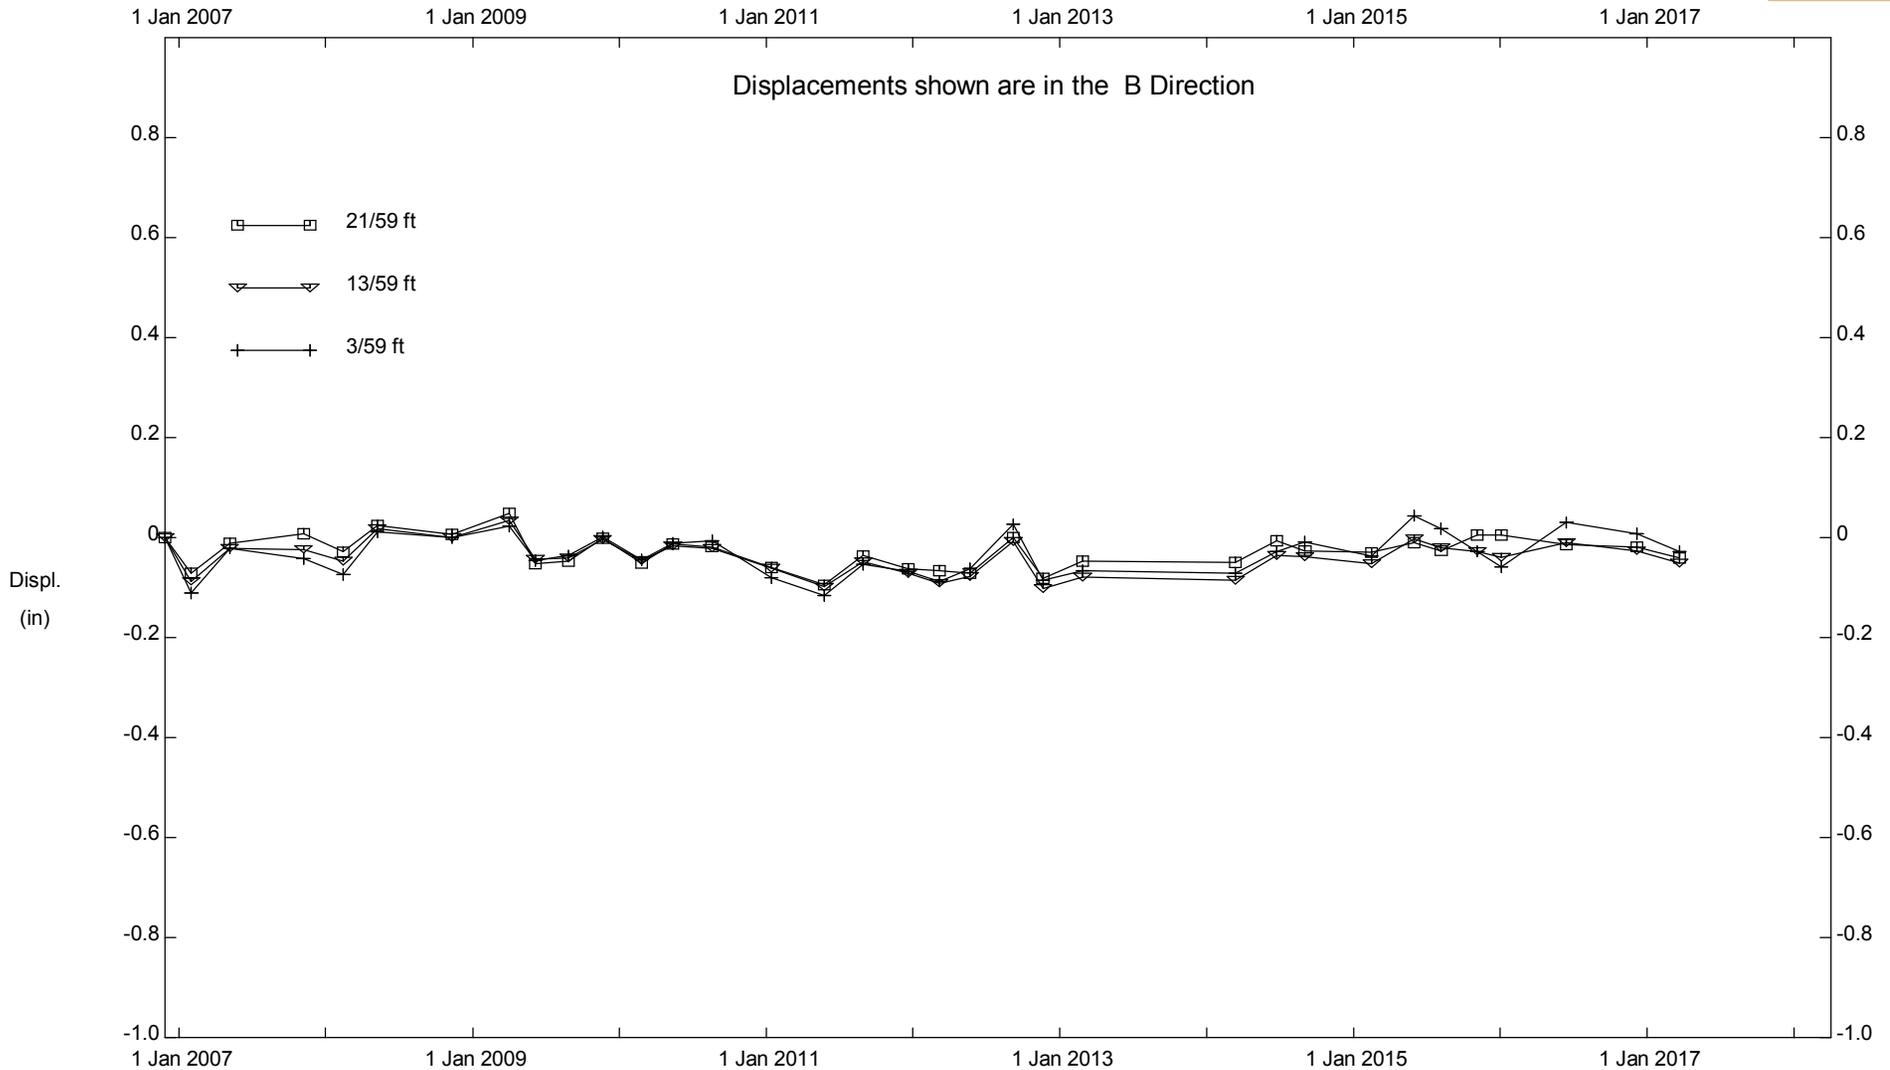
Assessment District 98-3, Inclinometer SI-5  
 City of Malibu

Inclinometers SI-5 and SI-6 are located on Bayshore Drive, upslope and outside the defined limit of the most recent 1998 movement. No detectable movement was observed during this monitoring year in SI-5 or SI-6. Profile changes to the top portion of inclinometer SI-6 are the result of ongoing damage to the casing from construction traffic currently working on Bayshore Drive. The vault and top of the casing have been crushed by heavy equipment.
