### Annual Report, July 2016 Through June 2017 Malibu Road Landslide Assessment District Malibu, California

January 2018  
Fugro Project No. 04.62160604  
Document No. 04.62160604-PR-001(Rev.00)

City of Malibu

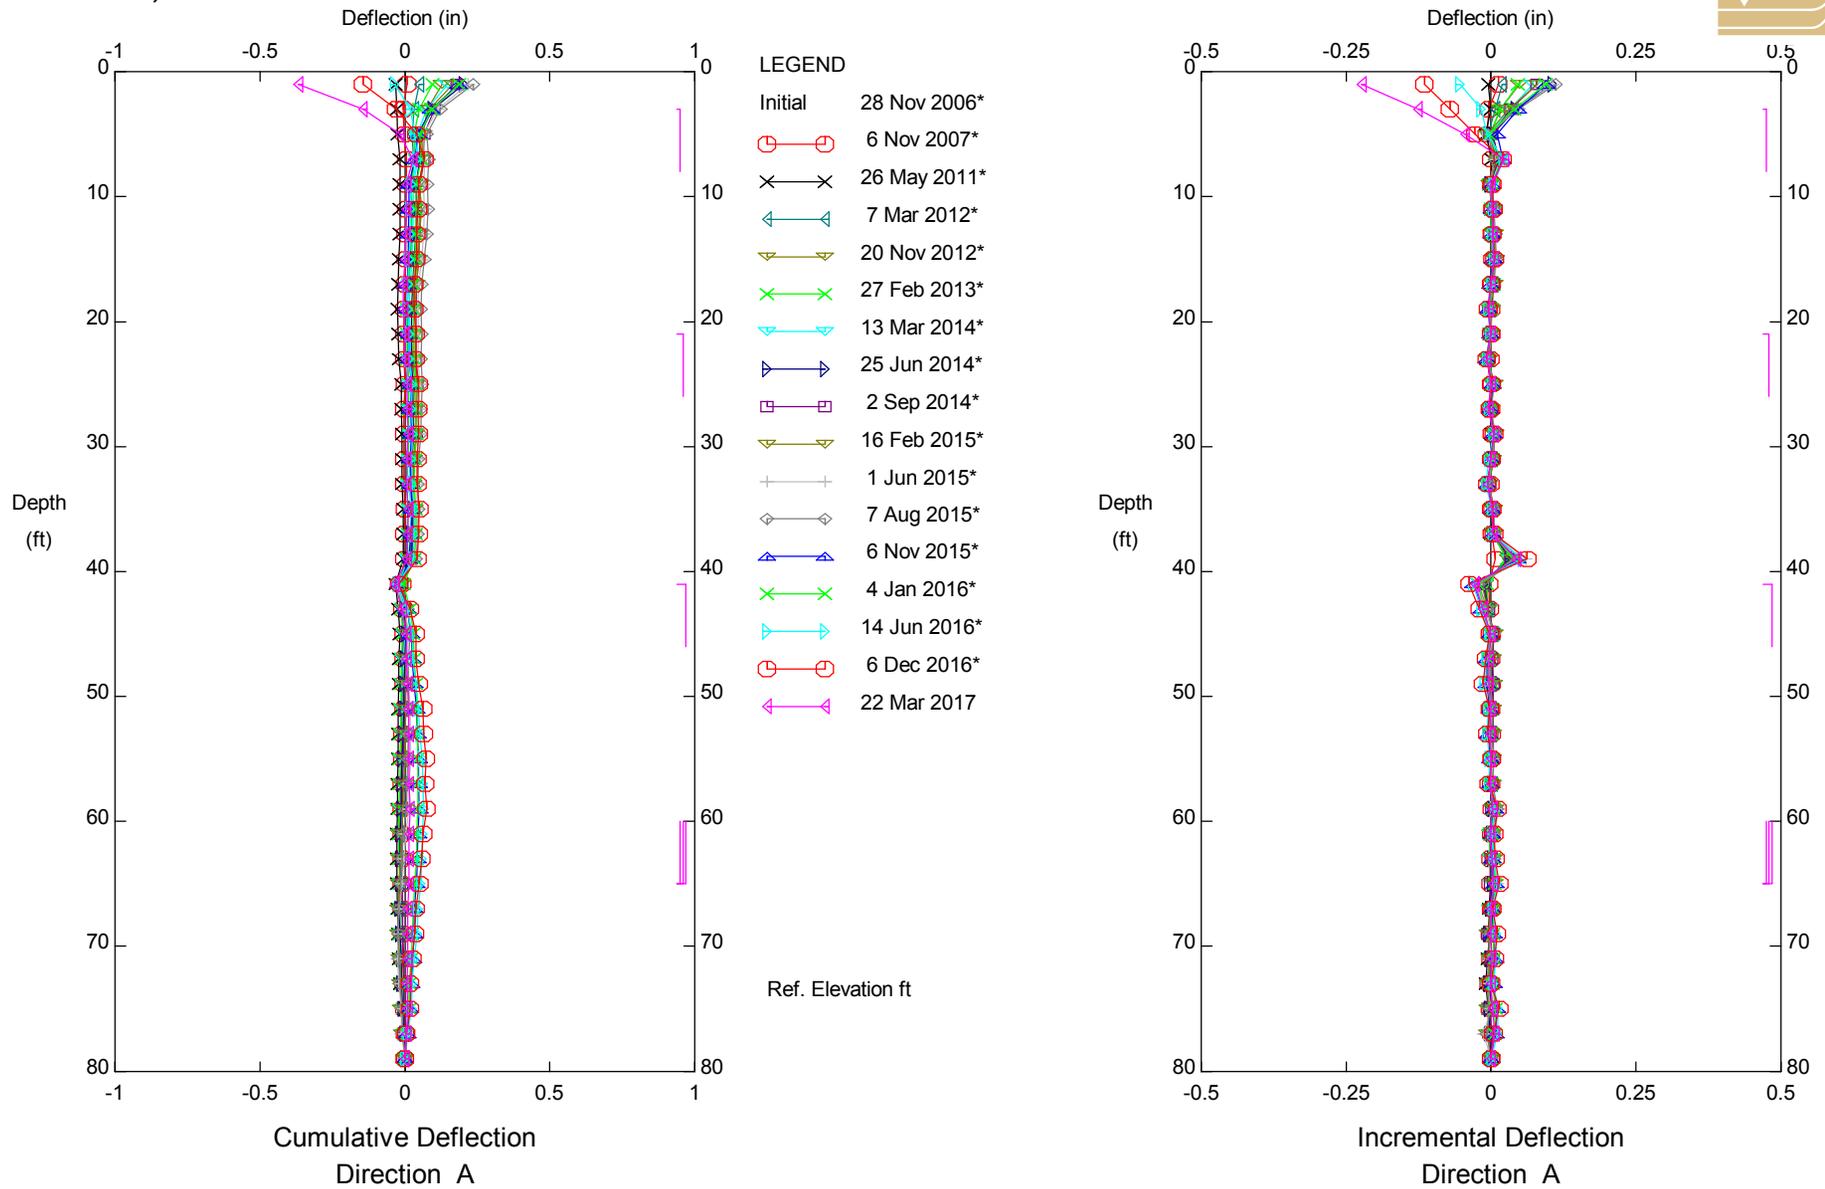
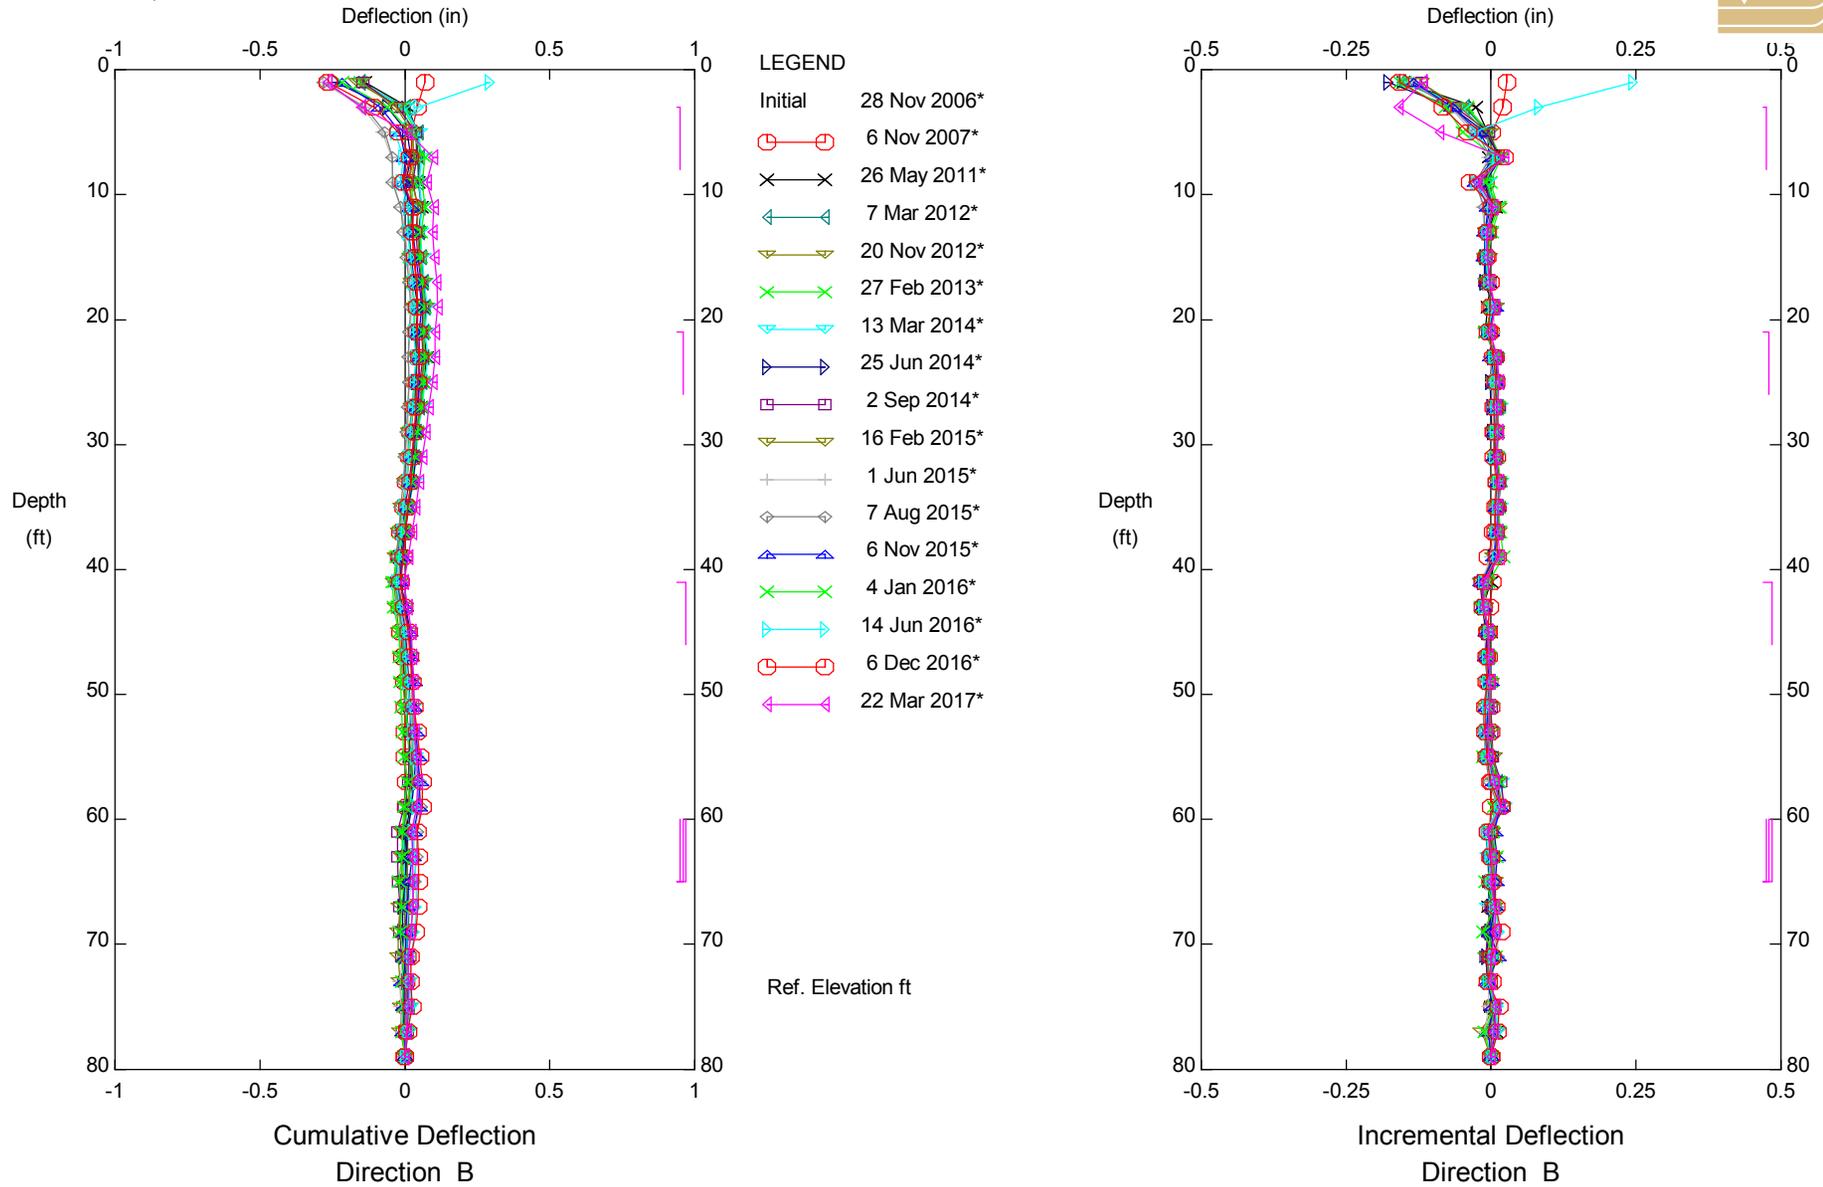
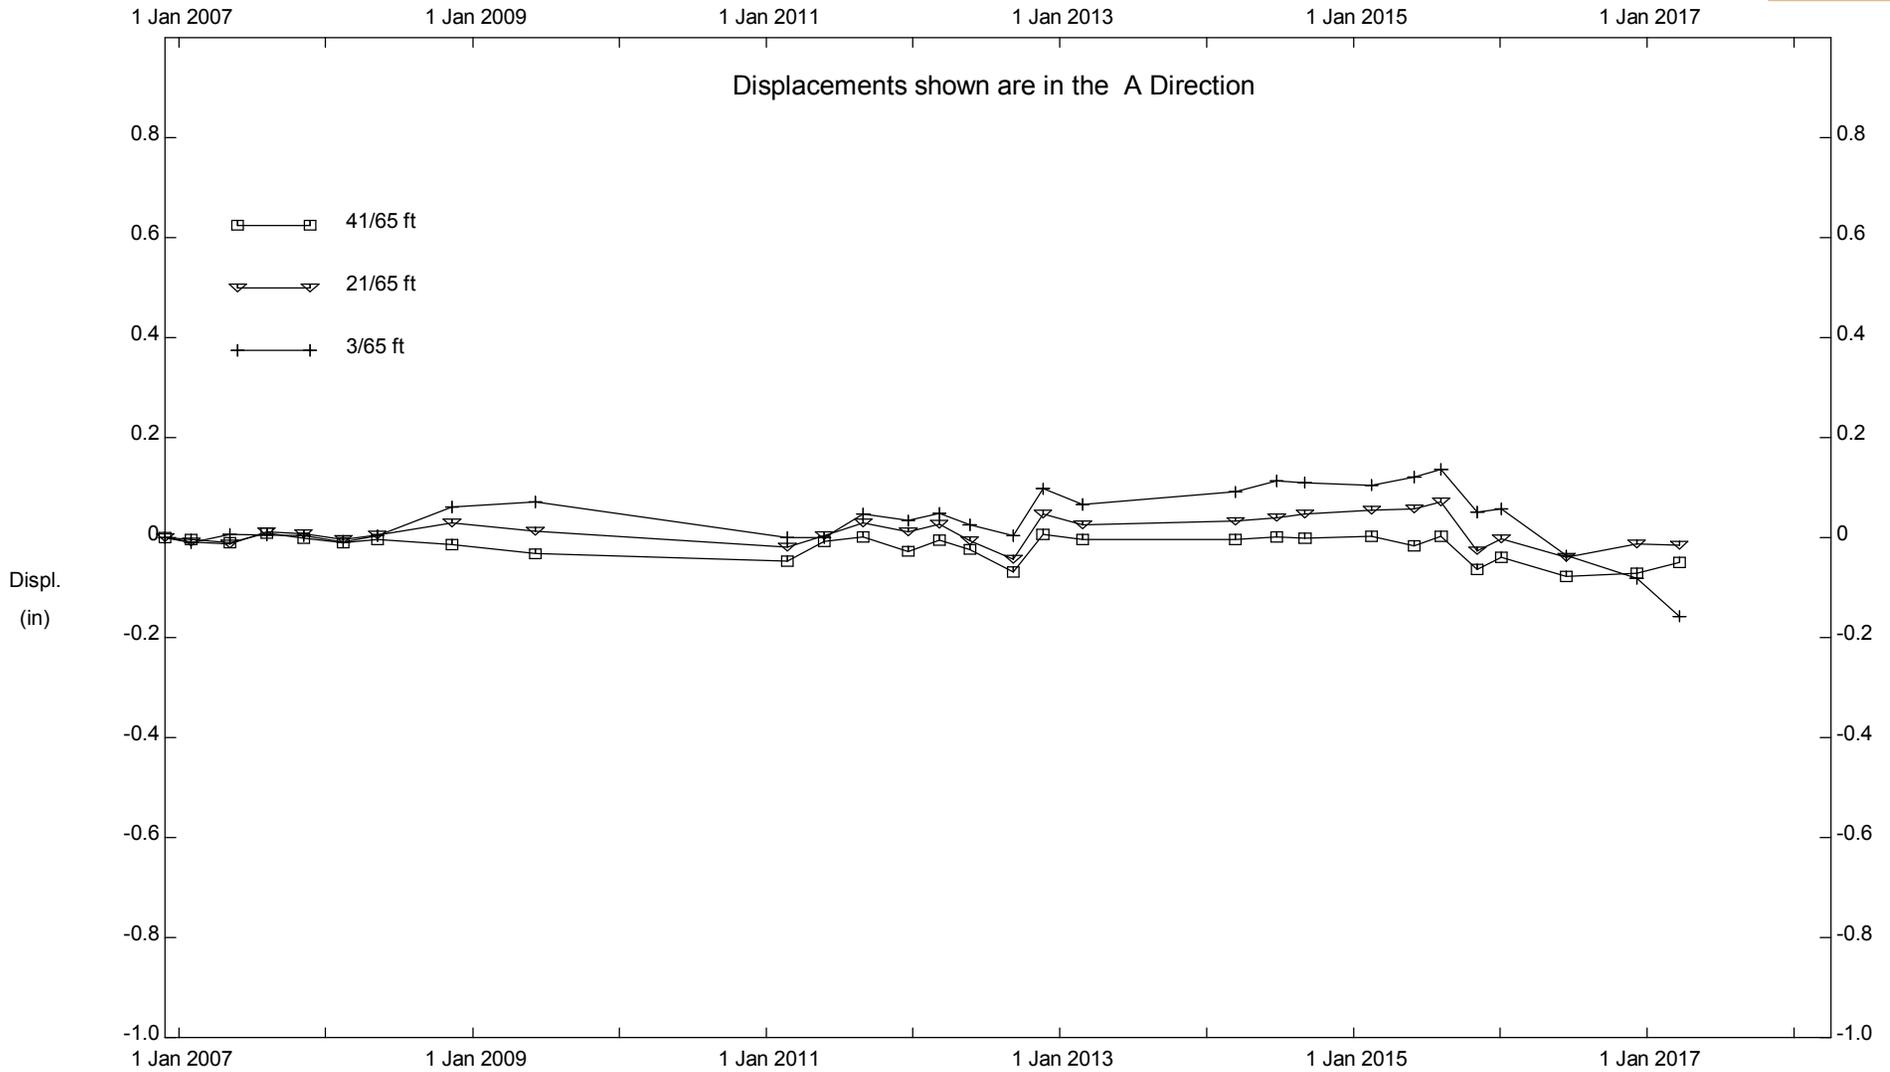
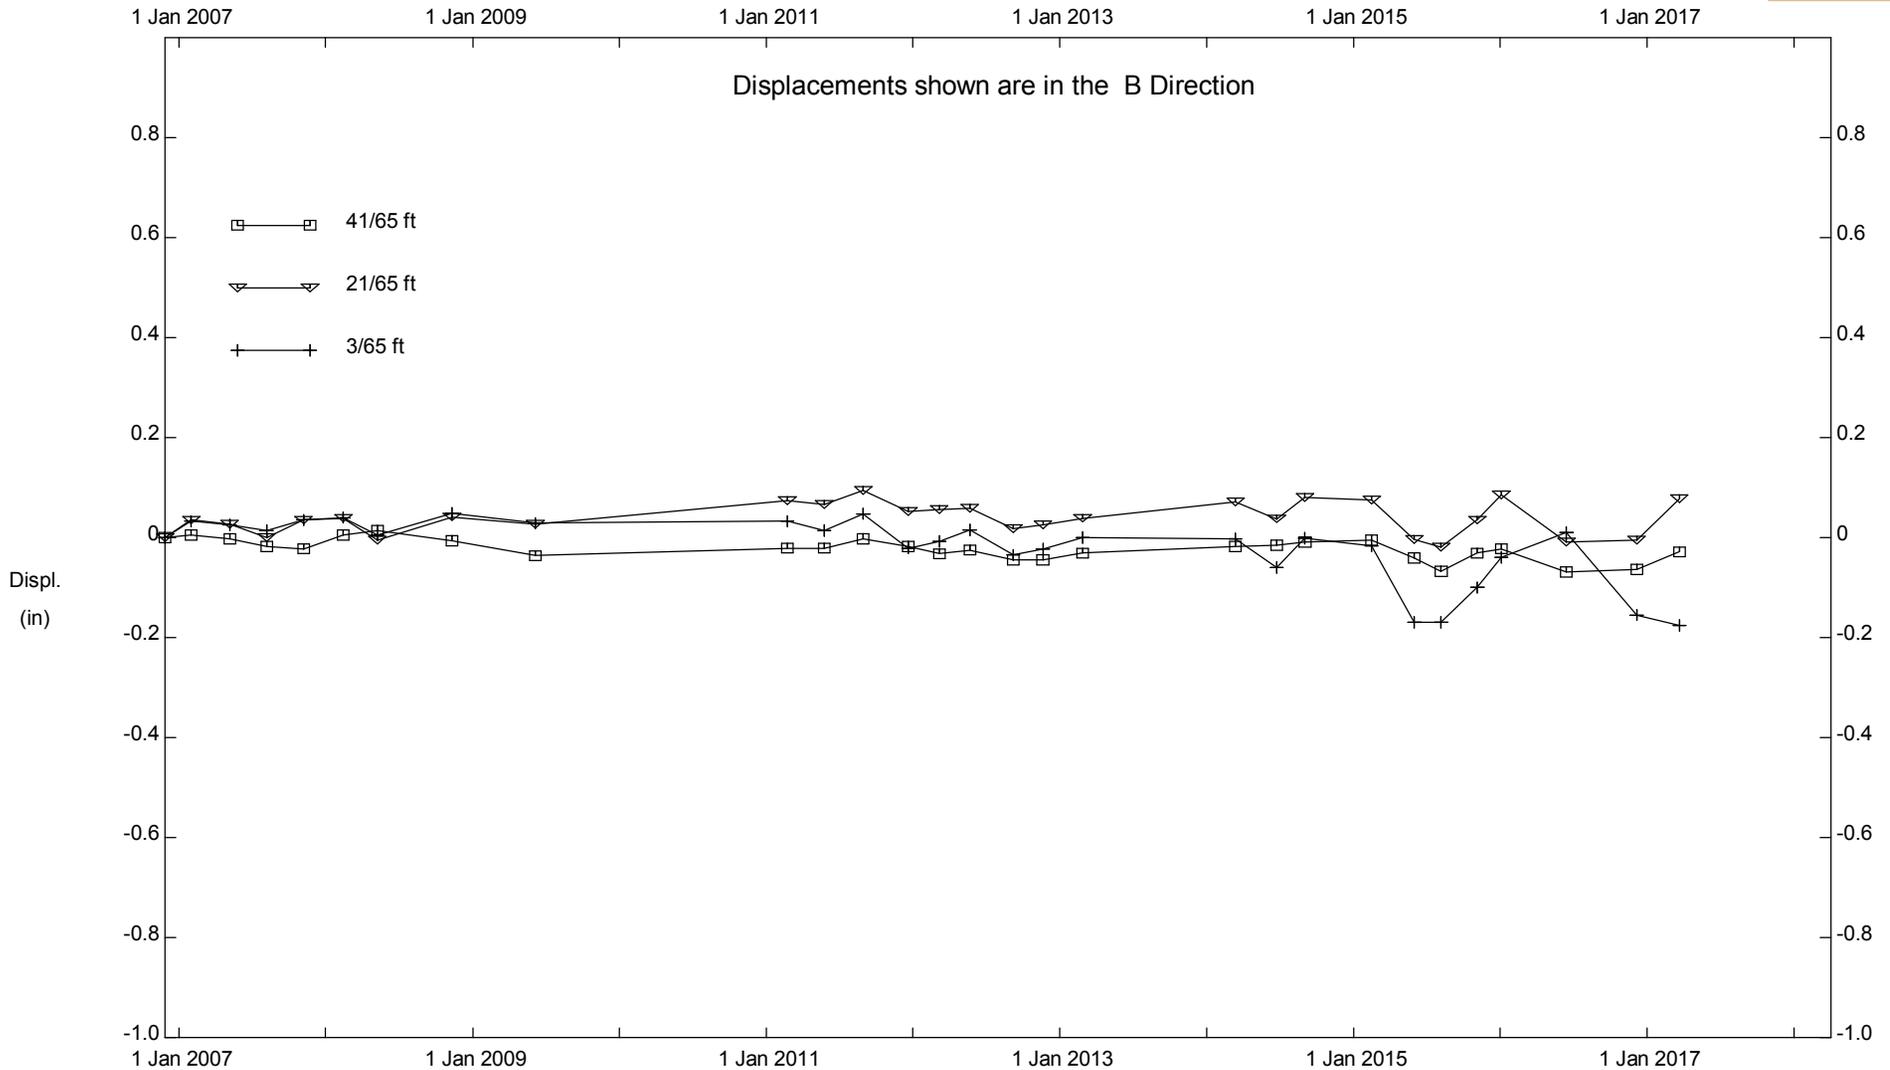
Assessment District 98-3, Inclinator SI-6  
 City of Malibu

Inclinometers SI-5 and SI-6 are located on Bayshore Drive, upslope and outside the defined limit of the most recent 1998 movement. No detectable movement was observed during this monitoring year in SI-5 or SI-6. Profile changes to the top portion of inclinometer SI-6 are the result of ongoing damage to the casing from construction traffic currently working on Bayshore Drive. The vault and top of the casing have been crushed by heavy equipment.
