Appendix C
Habitat Assessment

MEMORANDUM

Re: Habitat Assessment for the Proposed Malibu Civic Center Wastewater Treatment Facility Project, City of Malibu, Los Angeles County, California

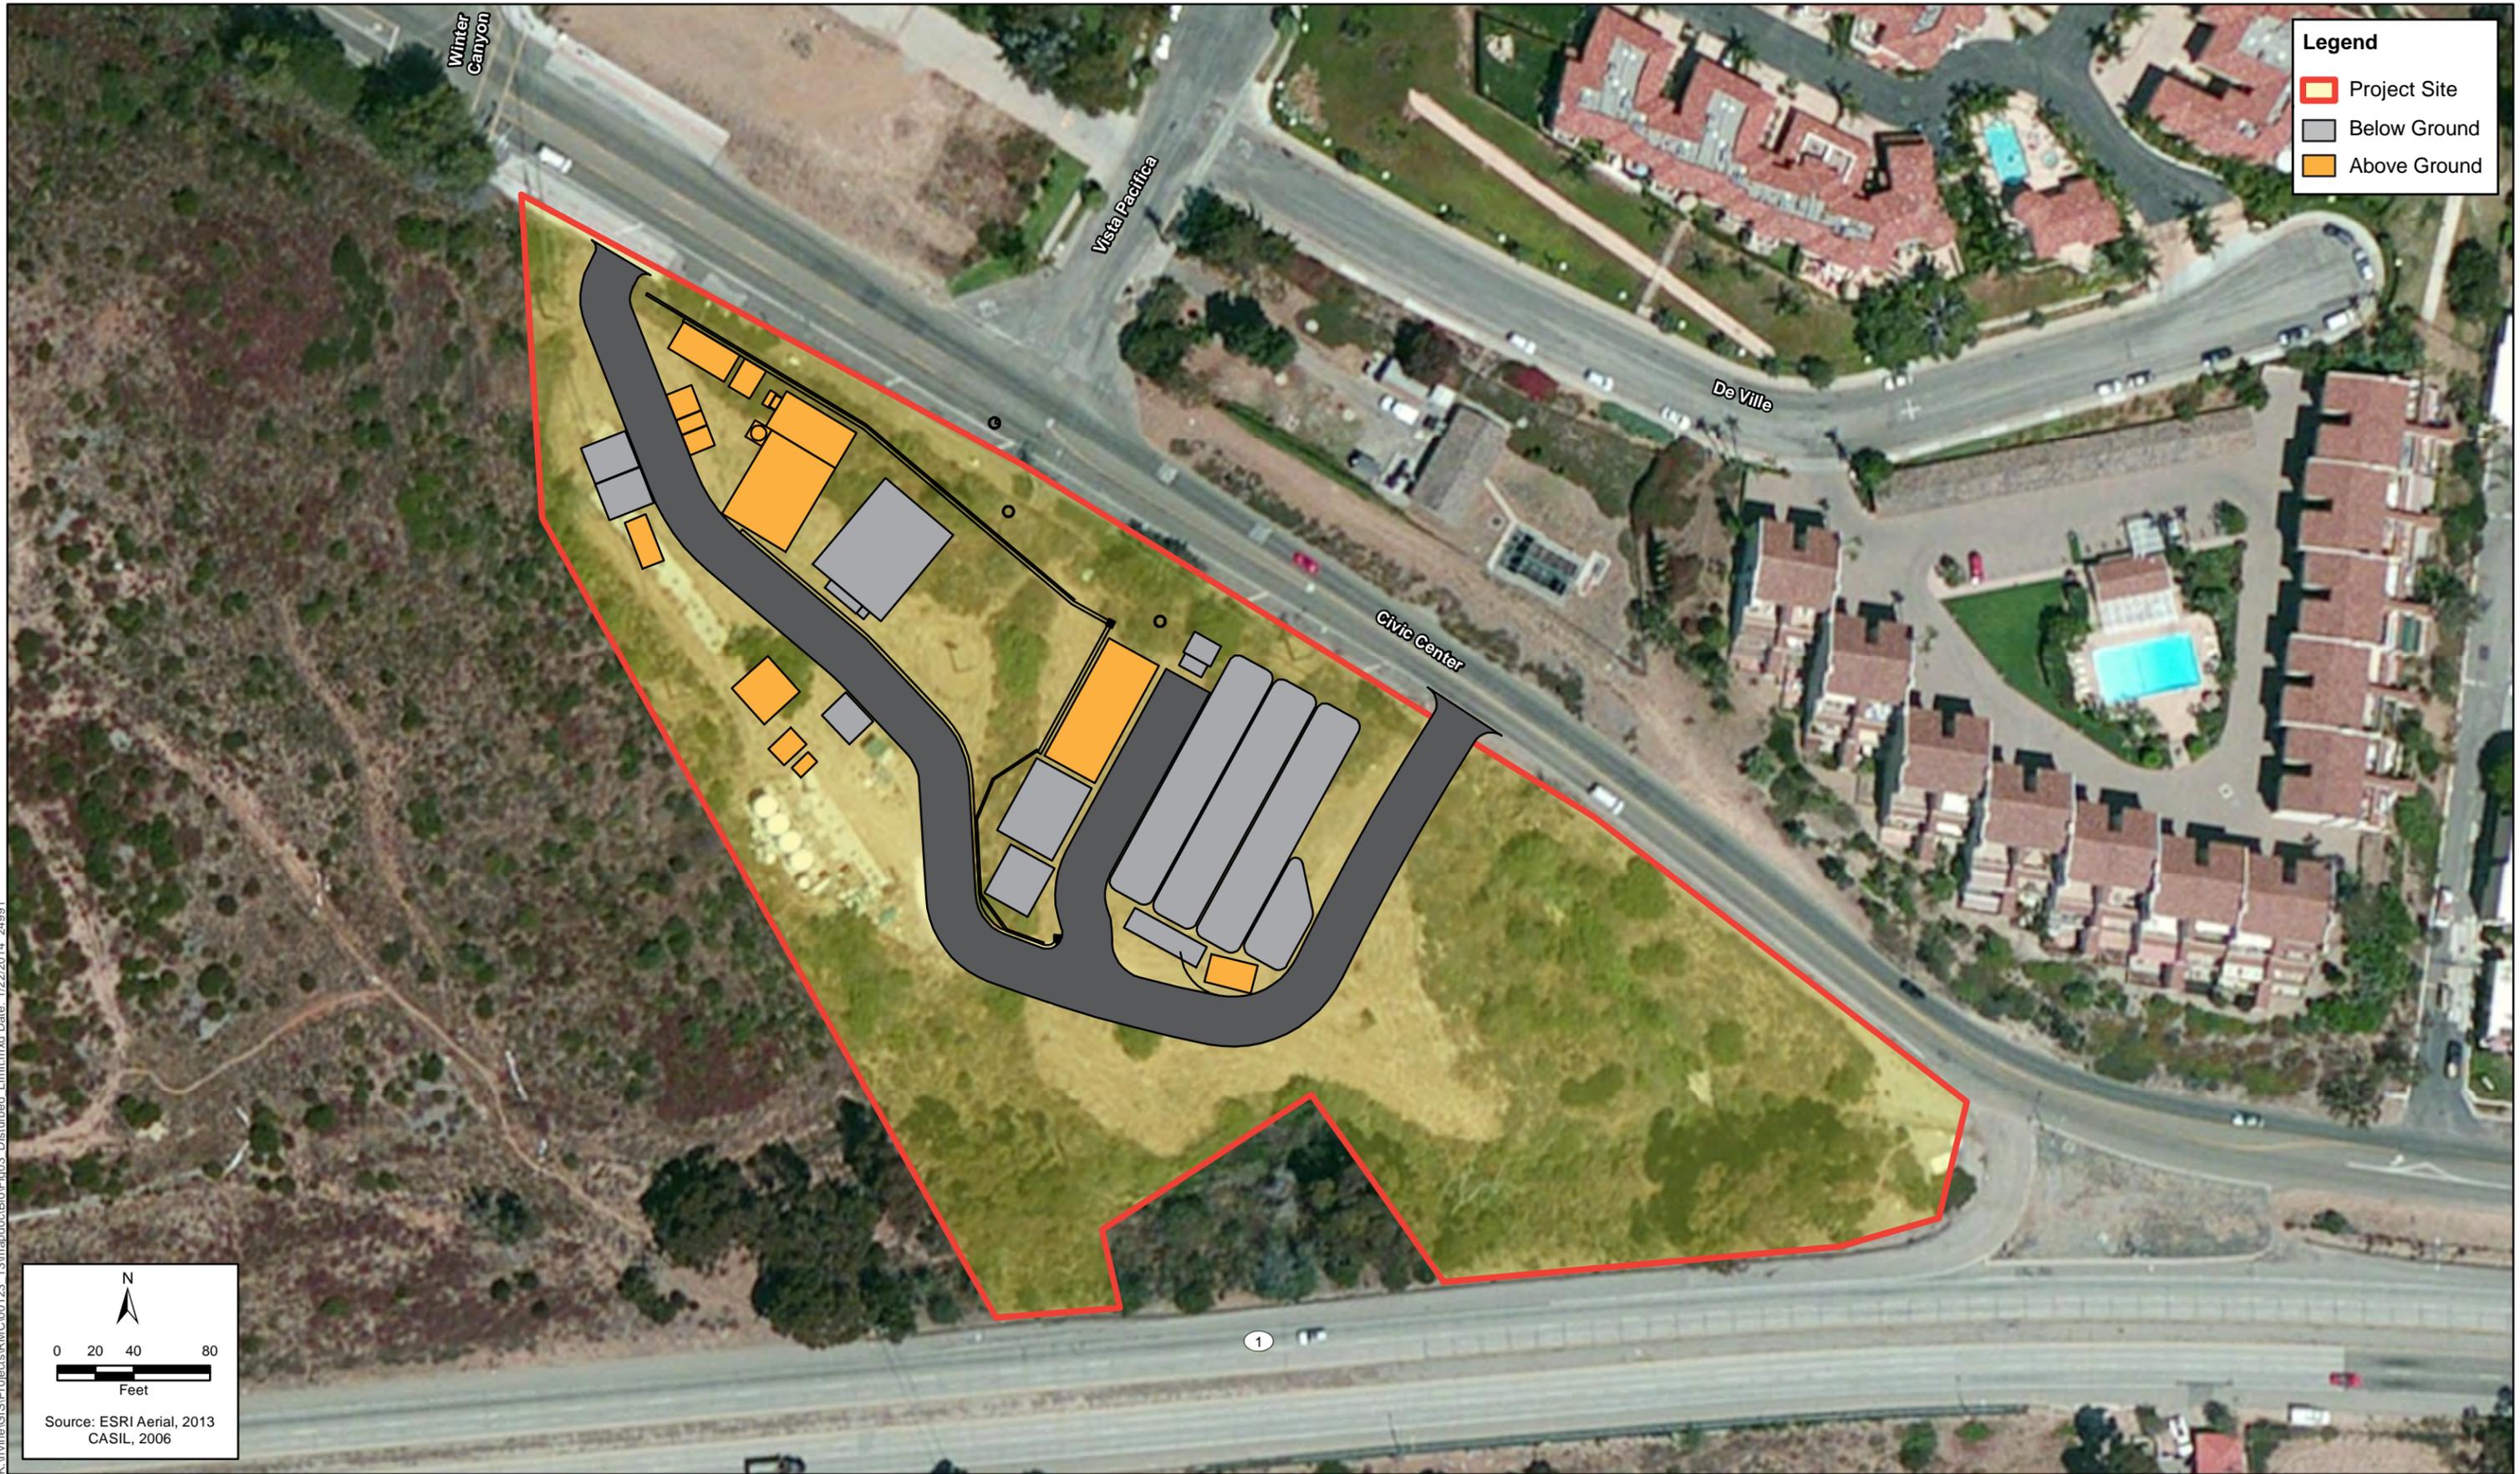
Figure 3
Disturbance Area
Malibu Civic Center Wastewater Treatment Facility Project

The City is proposing to build a wastewater treatment facility on an approximately 4.8-acre site (i.e., the limits of disturbance) (Figure 3). The proposed treatment plant would consist of various below-ground

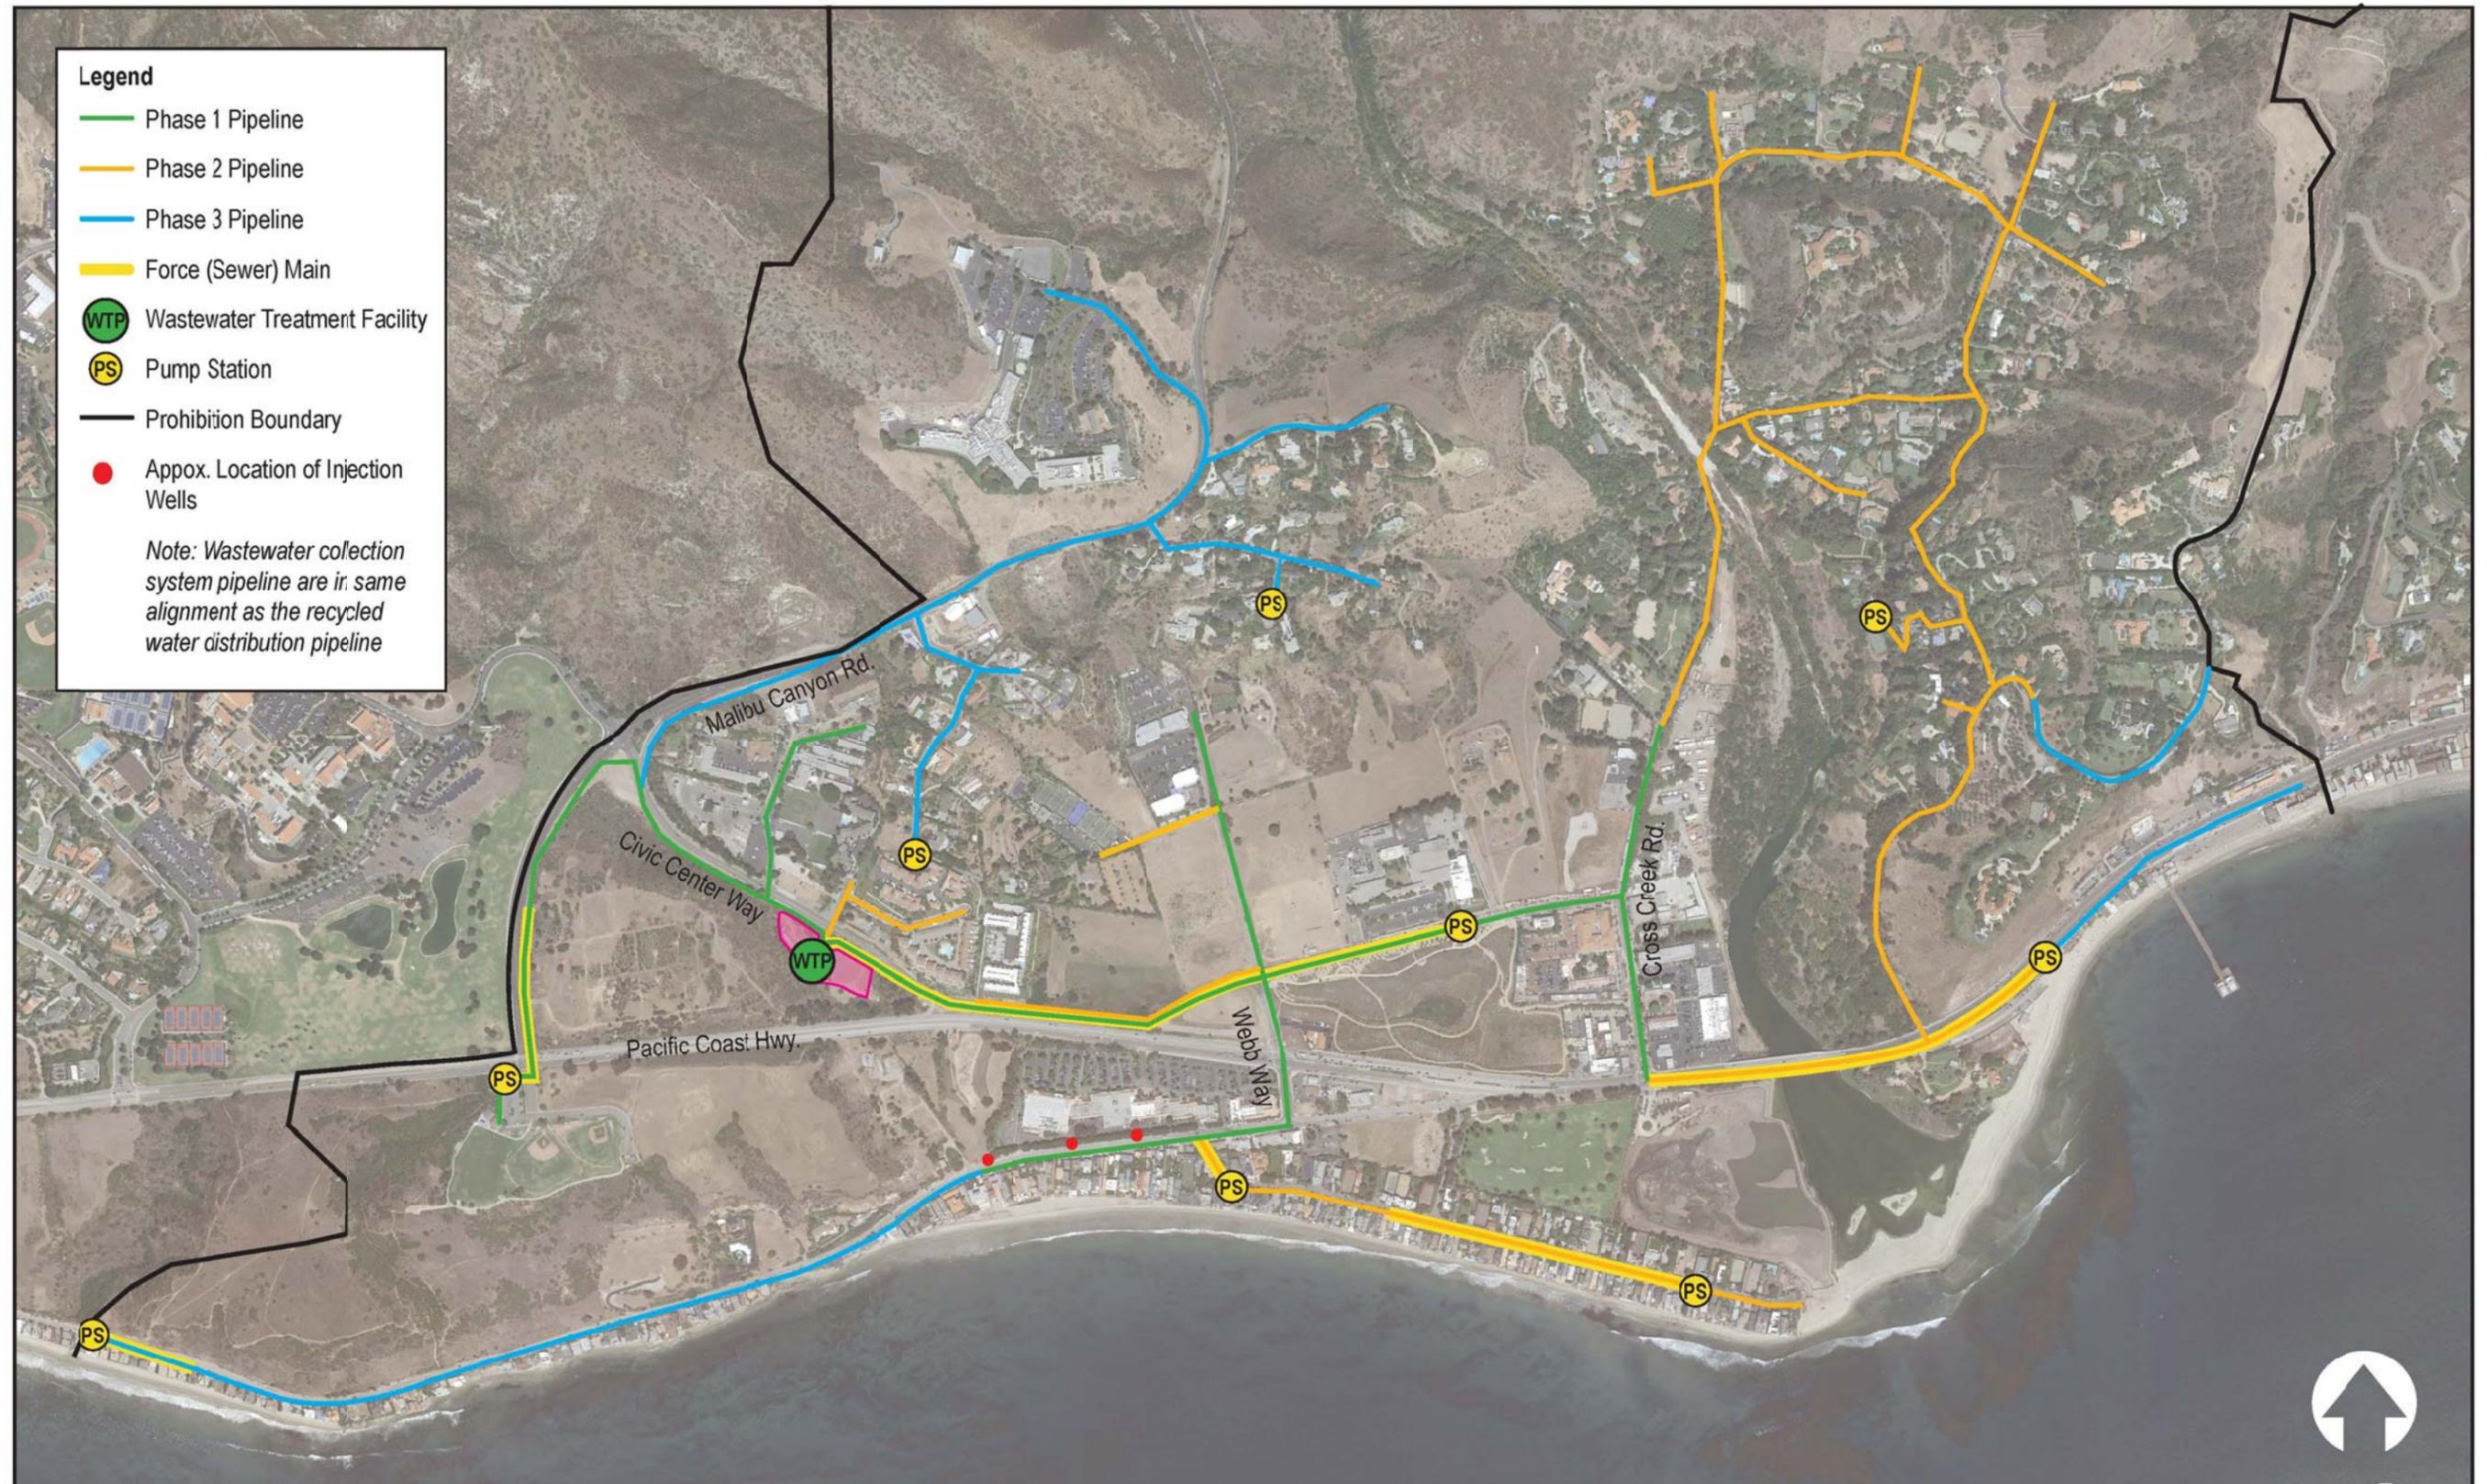
Figure 4
Prohibition Zone Off-site Collection System
Malibu Civic Center Wastewater Treatment Facility Project

elements, including aeration basins, concrete anoxic basins, post-anoxic basins, and recirculation facilities. The above-ground elements would include an operations building, a crane for removing membrane bioreactor filters for maintenance, ultraviolet (UV) disinfection facility, recycled water storage tank, pump station, landscape screening, and a driveway for vehicles. In addition, an off-site collection system would convey wastewater flows within the Prohibition Zone to the proposed wastewater treatment facility (Figure 4). An off-site recycled water distribution system would be constructed to distribute disinfected tertiary-treated effluent from the treatment facility to various land uses for reuse purposes. Additionally, a portion of the treated effluent would be percolated and/or injected in the deep aquifer of the Malibu Valley Groundwater Basin. The collection and distribution systems would consist of underground pipelines that would, generally, run beneath public rights-of-way or within easements. Phases 1 through 3 of the collection and recycled water distribution systems would follow existing street alignments, including Civic Center Way, Stuart Ranch Road, Cross Creek Road, Webb Way, Malibu Road, Winter Canyon Road, Malibu Canyon Road, and a small portion of PCH. Phases 2 and 3 of the collection and recycled water distribution systems would follow existing street alignments as shown in Figure 4.

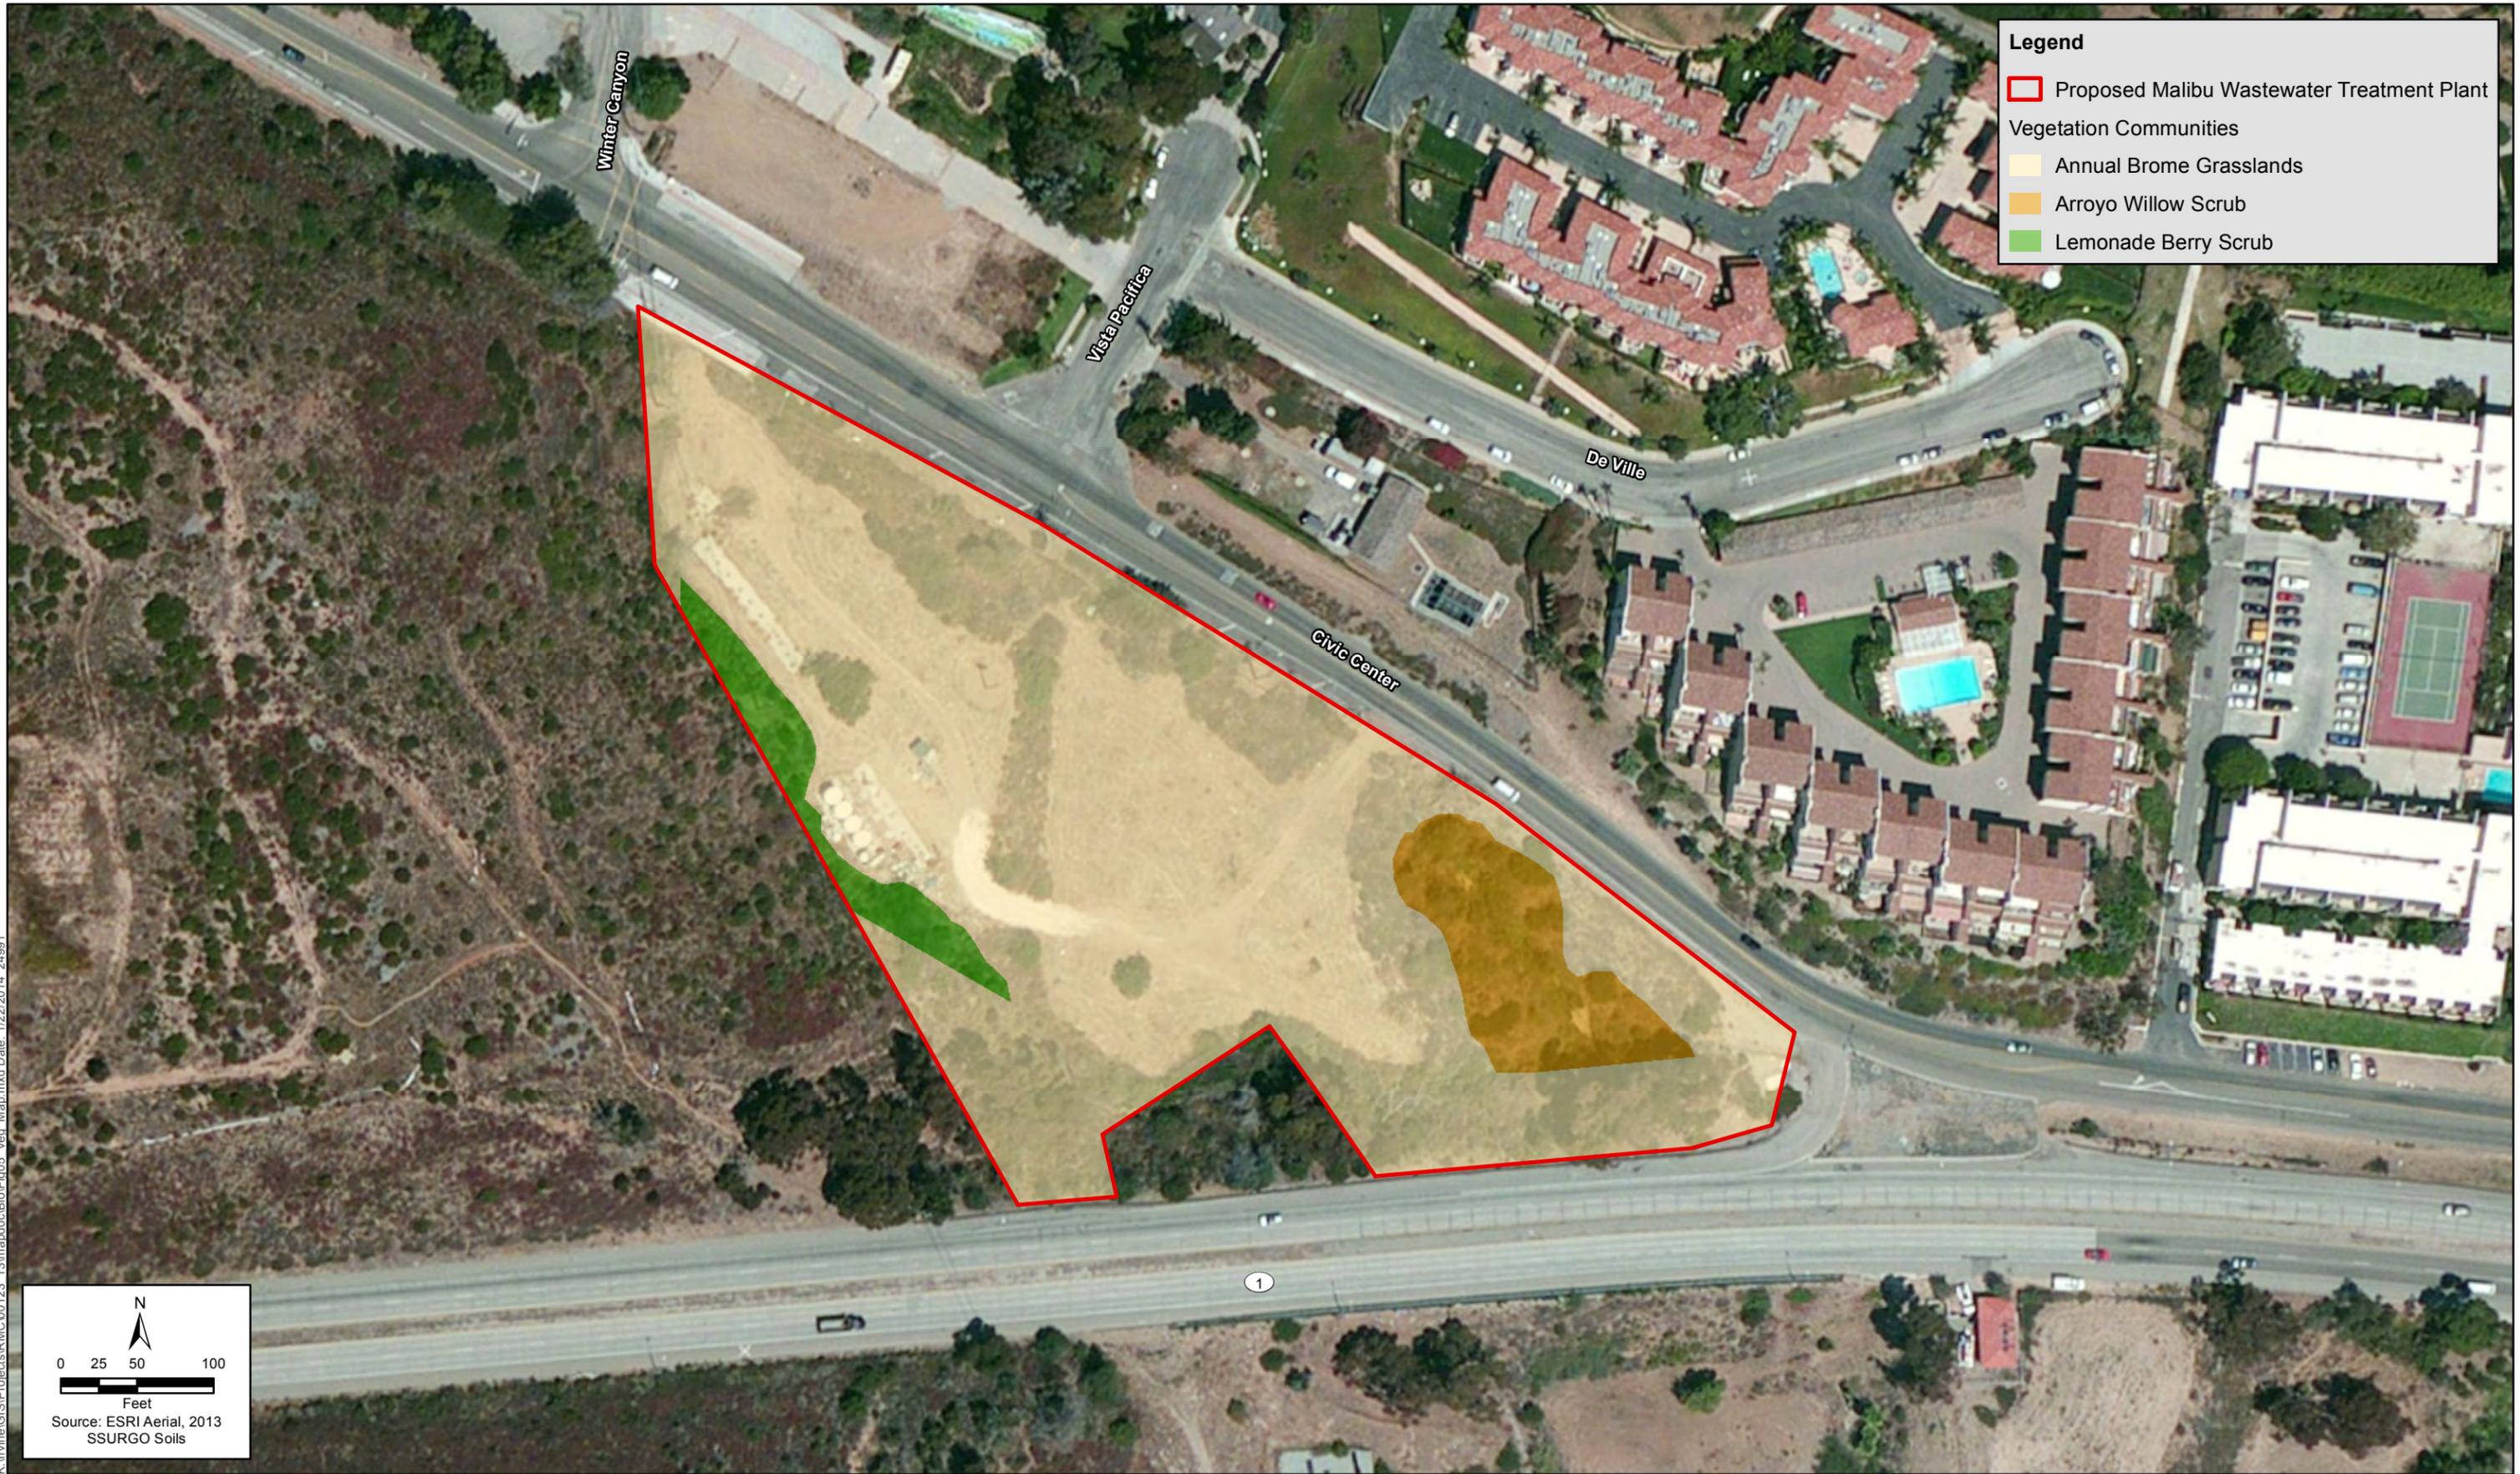
Figure 5
Vegetation Map
Malibu Civic Center Wastewater Treatment Facility Project

The proposed wastewater treatment facility site contains three vegetation communities: annual brome grasslands, lemonade berry scrub, and arroyo willow thicket (Figure 5). The wastewater collection and recycled water pipelines and pump stations would be generally located along roadway rights-of-way or easements in close proximity to existing residential and commercial developments. Vegetated

Approximately 4.3 acres of annual brome grasslands were mapped on the proposed wastewater treatment facility site. The majority of the central portion of the site is disturbed and dominated by bare ground and nonnative brome (*Bromus* sp.) grasses. This area is regularly mowed as part of operations at the existing wastewater treatment facility. Along the fence line, near Civic Center Way, this community is not maintained and includes dense patches of tree tobacco (*Nicotiana glauca*) and castor bean (*Ricinus communis*) between large black elderberry (*Sambucus nigra*) and eucalyptus trees (*Eucalyptus* sp.). Along the southern boundary, where the wastewater treatment facility site parallels PCH, this community includes brome grasses, sporadic coyote brush (*Baccharis pilularis*), carnation spurge (*Euphorbia terracina*), and a row of eucalyptus trees. Additional plants observed in this portion of the community include black mustard (*Brassica nigra*), canyon sunflower (*Venegasia carpesioides*), and a variety nonnative grasses. Walking paths, dirt roads, and other disturbances were found within this community.

Approximately 0.18 acre of lemonade berry scrub was mapped on the proposed wastewater treatment facility site. This scrub community, which is limited to the sloped portion of the site along the western edge of the property, is composed of shrubs, including lemonade berry (*Rhus integrifolia*), laurel sumac (*Malosma laurina*), and canyon sunflower, as well as various nonnative grasses. A few scattered Southern California black walnut (*Juglans californica*) trees, a designated CNPS California Rare Plant Rank (CRPR) 4.2 species, were observed in this community. The density and height of the shrubs in the community vary but are generally more than 60 percent of the cover and 6 feet in height.

Approximately 0.36 acre of arroyo willow thicket was mapped on the proposed wastewater treatment facility site. The arroyo willow thicket (commonly referred to as southern willow scrub) community is found only in the southeastern corner of the site in association with Winter Canyon Creek. This community is dominated by arroyo willow (*Salix lasiolepis*) and contains a few sporadic Southern California black walnuts and some nonnative grasses, including fountain grass (*Pennisetum setaceum*) and pampas grass (*Cortaderia jubata*). Winter Canyon Creek flows through this community; the arroyo willow is densest around the drainage feature, becoming more sparse toward the outer portions of this community. Away from the creek, the understory is composed of various upland species, including Carnation spurge, black mustard, and canyon sunflower. This riparian community is considered a sensitive natural community by CDFW when it is in association with drainage features and meets the definition of ESHA, according to the LCP/LIP ESHA overlay.

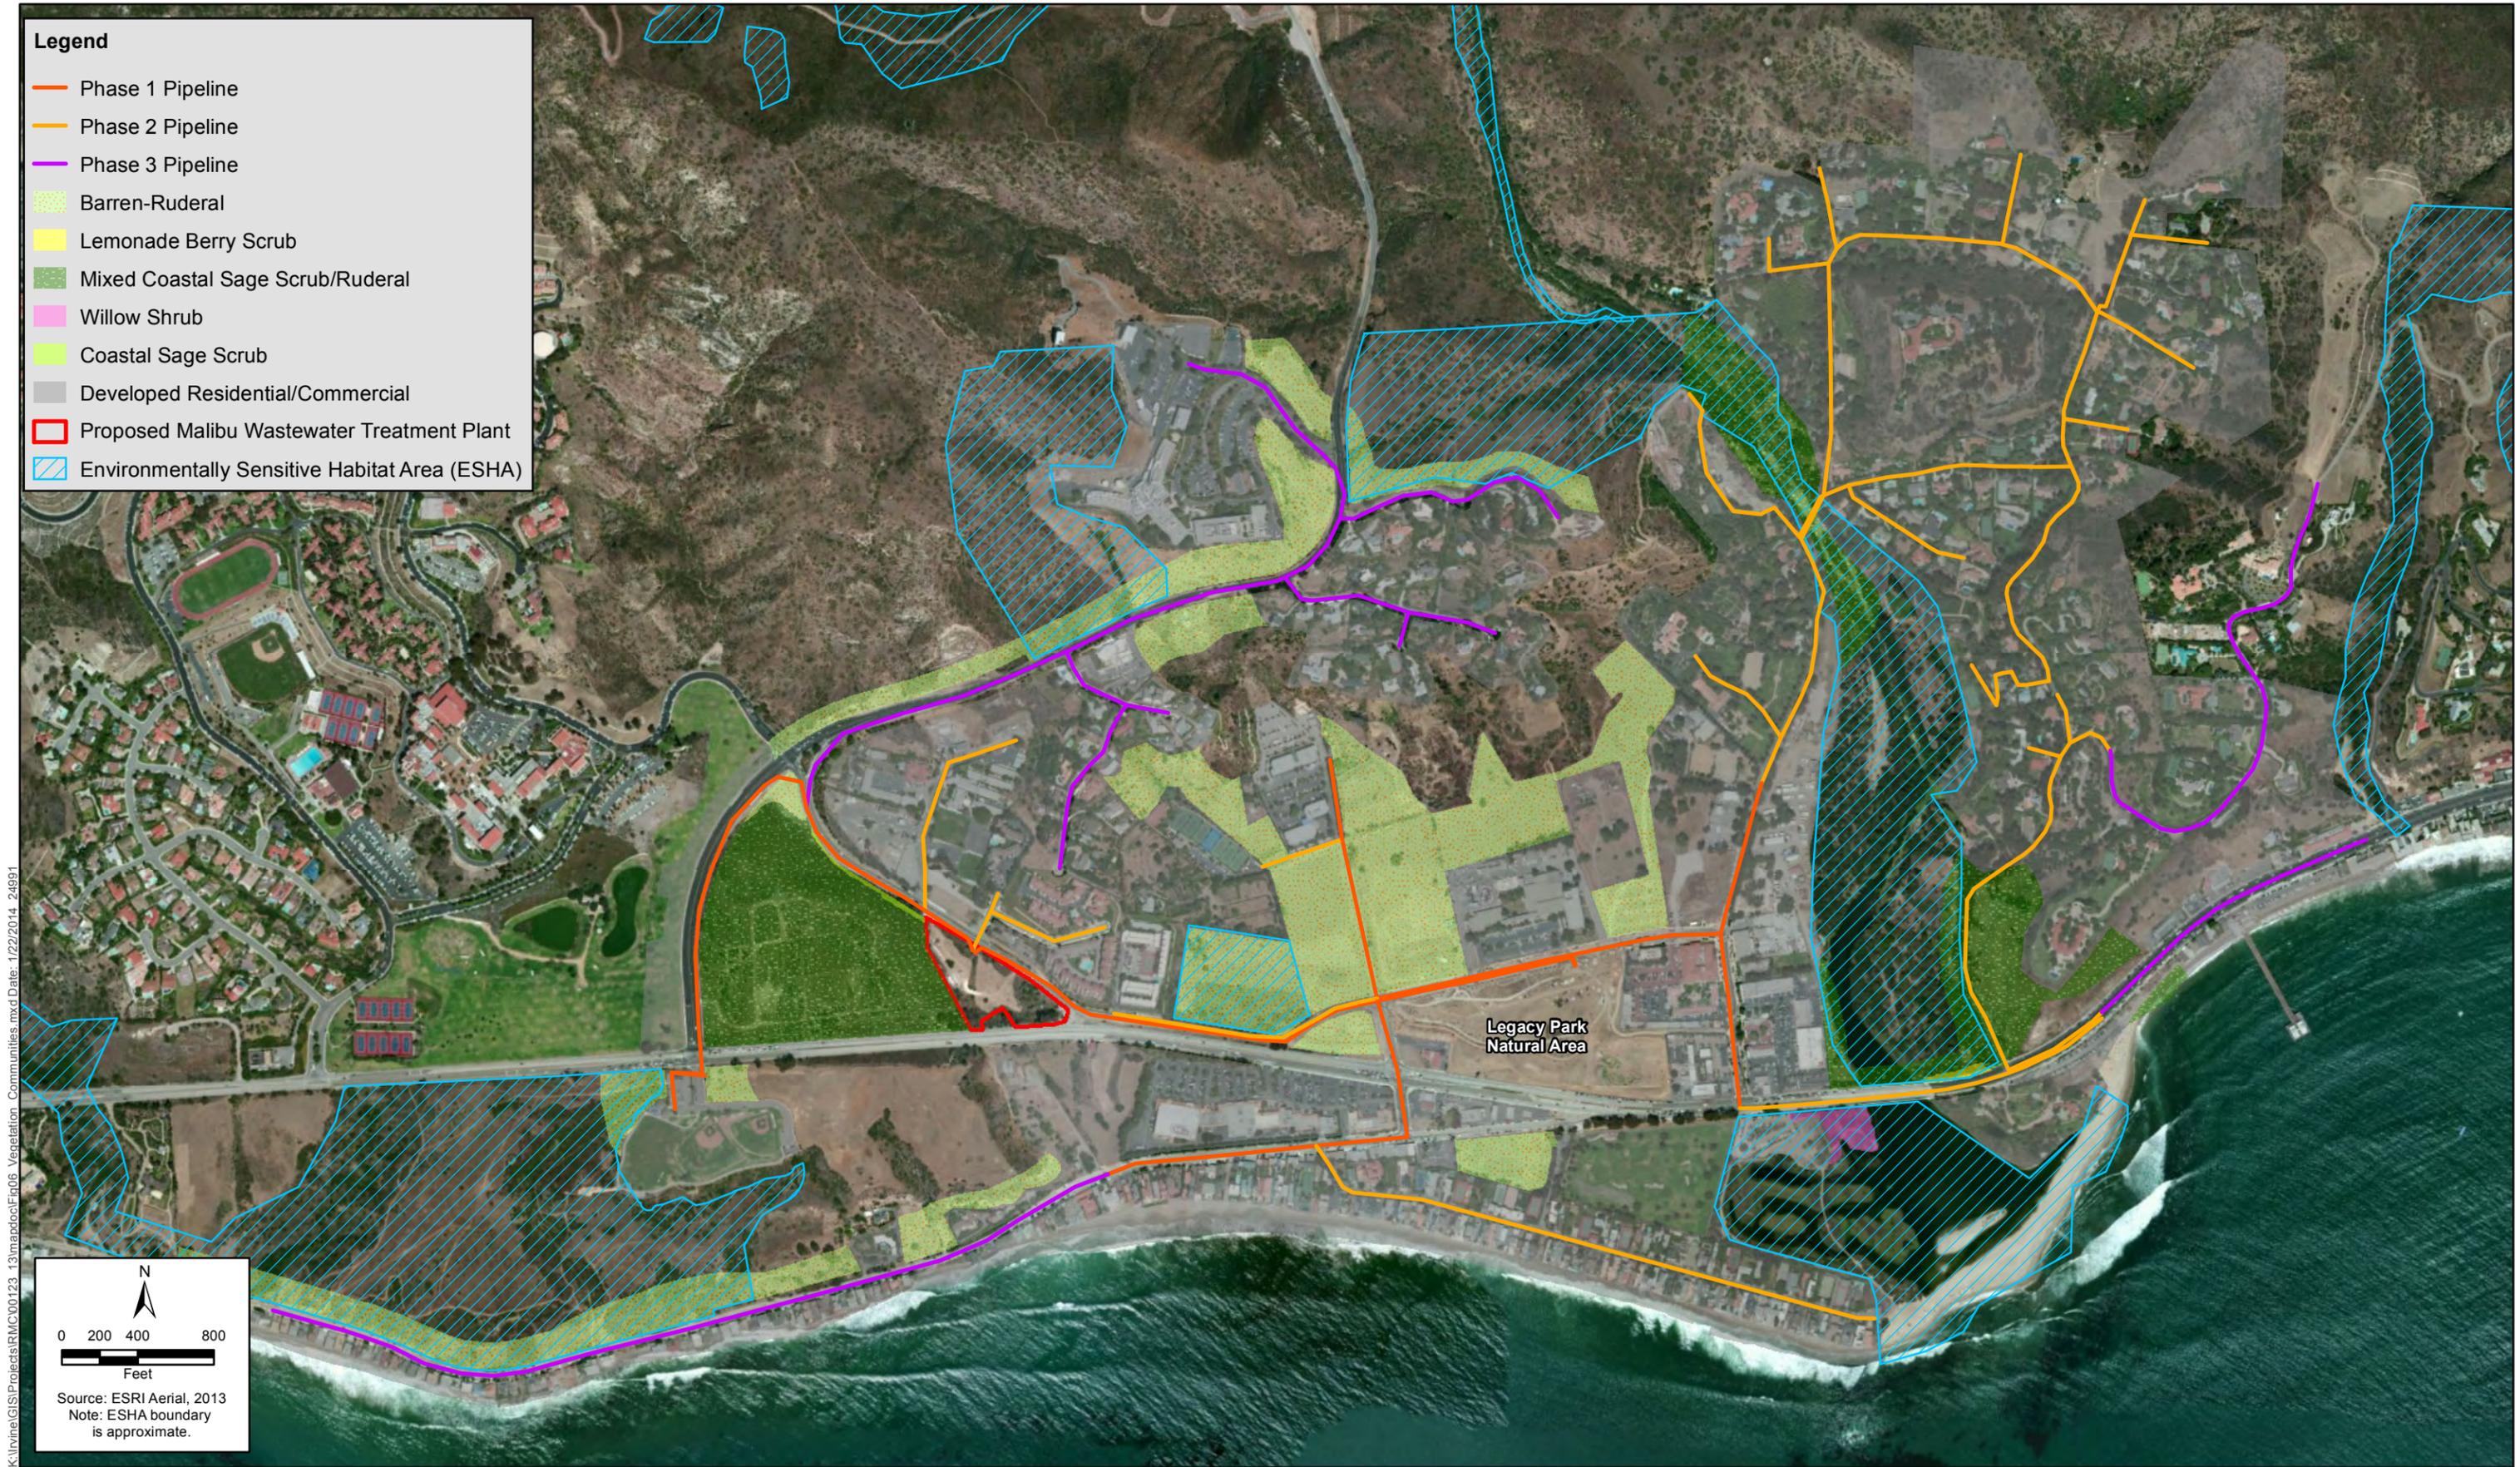
Figure 6
Vegetation Communities
Malibu Centralized Wastewater Project

communities located adjacent to the proposed pipeline alignments are coastal sage scrub, mixed coastal sage-ruderal scrub, and paved, developed barren-ruderal (Figure 6). Each vegetation community is described below. Areas that are not designated on the ESHA overlay map but meet the definition of an ESHA in the LCP/LIP will have the same requirements as an ESHA. Appendix C contains a list of the plants that were observed during the field visit.

Approximately 850 linear-feet of coastal sage scrub is located from the northwest boundary of the wastewater treatment facility to Malibu Canyon Road, south of Civic Center Way. This vegetated community is also located west of the proposed facility location. This scrub community is dominated by laurel sumac, California sagebrush (*Artemisia californica*), coyote brush (*Baccharis pilularis*), black walnut, goldenbush (*Hazardia squarrosa*), white and purple sage (*Salvia apiana* and *Salvia leucophylla*).

Areas of mixed coastal sage-ruderal scrub is located east of Malibu Canyon Road, from PCH north to the intersection of Civic Center Way and on the northwest side of Malibu Canyon Road north from Civic Center way to Malibu Knolls Road. These areas are characterized by California sagebrush, coyote brush, white sage, black mustard (*Hirschfeldia* sp.) and brome species.

The majority of the pipeline Project areas are paved, developed, with smaller locations of barren land (cleared of vegetation but the land is still undeveloped). Developed, commercial areas occur in all three phases and possess little value to wildlife species. Developed, commercial areas are characterized by residential homes, commercial businesses and landscaped areas such as along Malibu Canyon Road at Pepperdine University and along the west side of Serra Road into the gated residential community. Other portions of the pipeline locations were disked barren-ruderal areas at the time of the survey. These areas were observed along Phase 1 in the open spaces between residences and businesses; Phase 2 just east of Malibu Lagoon north of Pacific Coast Highway and Phase 3 from Malibu Knolls Road to Potter Road and from Malibu Canyon Road to the end of Malibu Crest Drive (see Figure 6). Essentially no standing vegetation remained most likely due to fire prevention practices by Los Angeles County. Because of the intense management practice of disking for fire control, this habitat possessed little use for wildlife at the time of the field survey. Current plans show six potential locations for pump stations. These six stations are located in residential and commercial occupied locations. Because these sites are currently within developed areas, they possess little value to wildlife species.

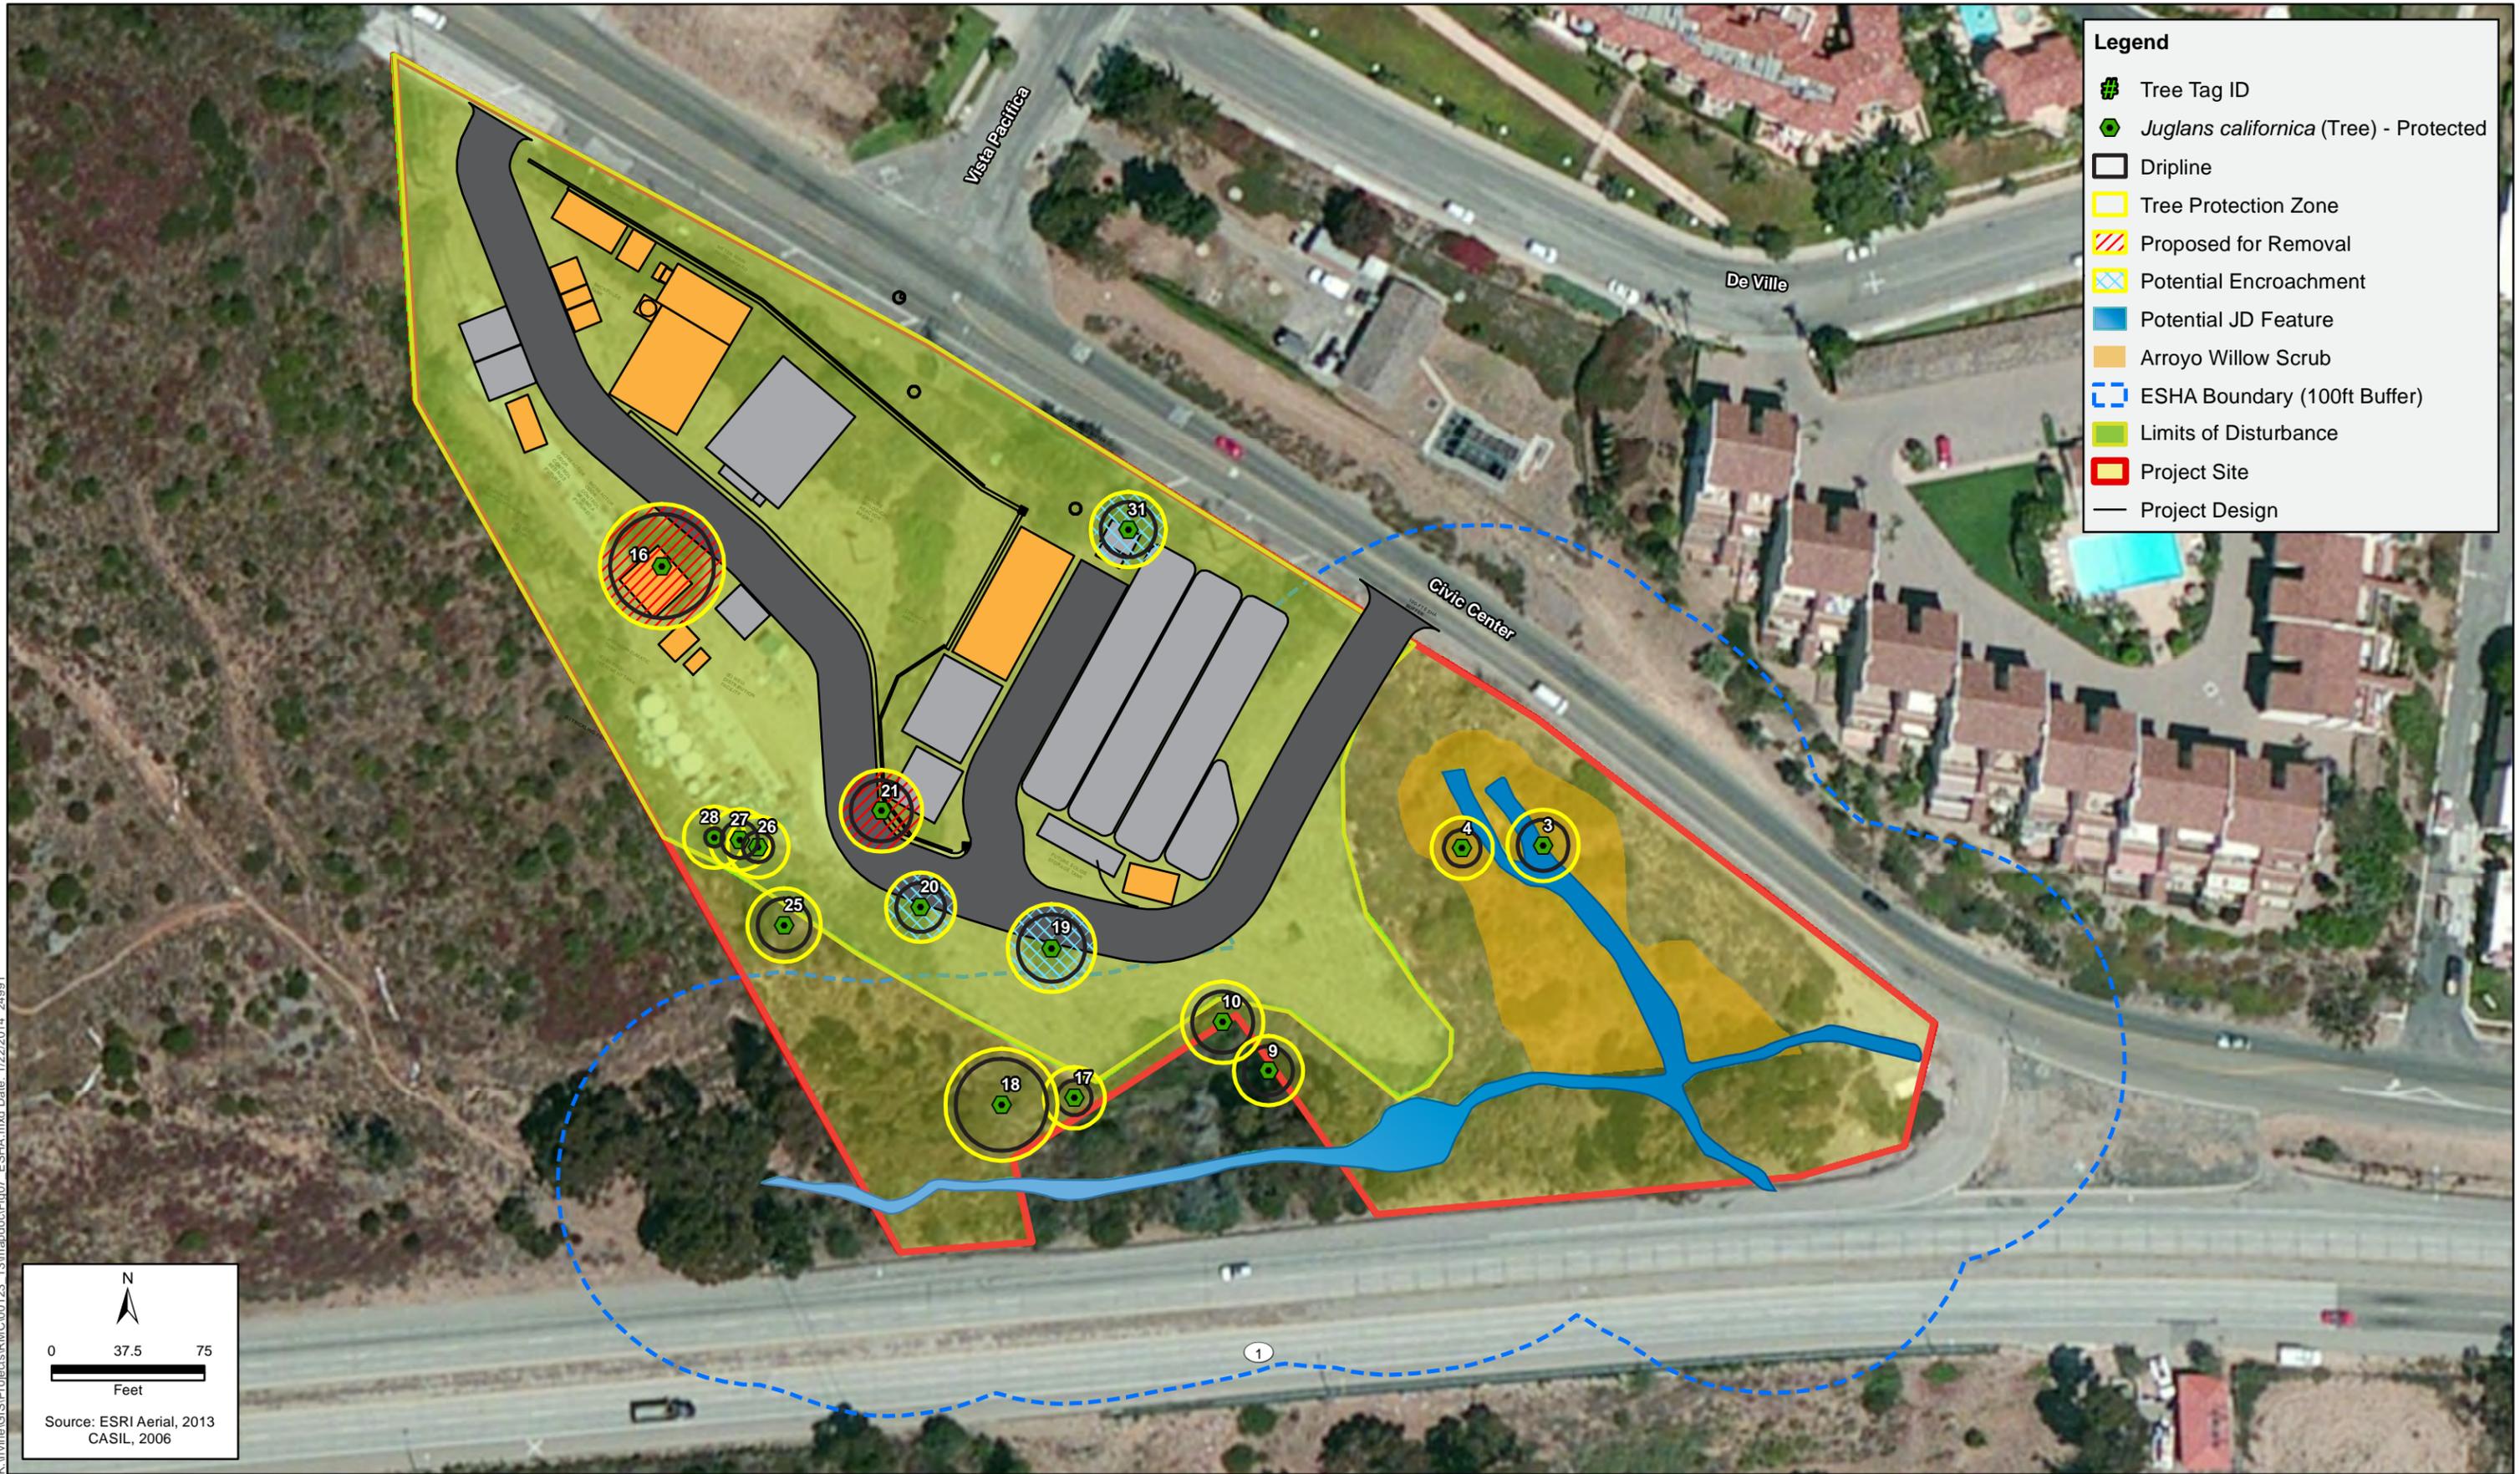
Figure 7
ESHA Boundaries and Protected Walnut Tree Locations
Malibu Civic Center Wastewater Treatment Facility Project

One jurisdictional blue-line drainage feature, Winter Canyon Creek, was observed in the southeastern portion of the proposed wastewater treatment facility site adjacent to the intersection of Civic Center Way and PCH. This area is not currently mapped on the existing LCP ESHA maps; however, this drainage is considered to be an ESHA, as outlined in the LCP/LIP. See Figure 7 for a map of the drainage, ESHA area, and 100-foot buffer.

Figure 7 depicts the ESHA buffers for the jurisdictional drainage, the willow scrub, and the protected walnut tree locations. This figure has been produced to illustrate development restrictions that could affect the wastewater treatment plant facility.

One jurisdictional drainage feature occurs on the proposed wastewater treatment facility site. However, as outlined in Figure 7, above, this feature will not be affected during construction of the wastewater treatment facility. As discussed with City of Malibu biologist, Dave Crawford, a jurisdictional delineation would not be required if the drainage will not be affected by construction. Additionally, Project construction will be conducted outside the 100-foot ESHA buffer, ~~also as~~ shown in Figure 7, with the exception of a biofilter to be installed along the edge of the improved driveway into the facility.

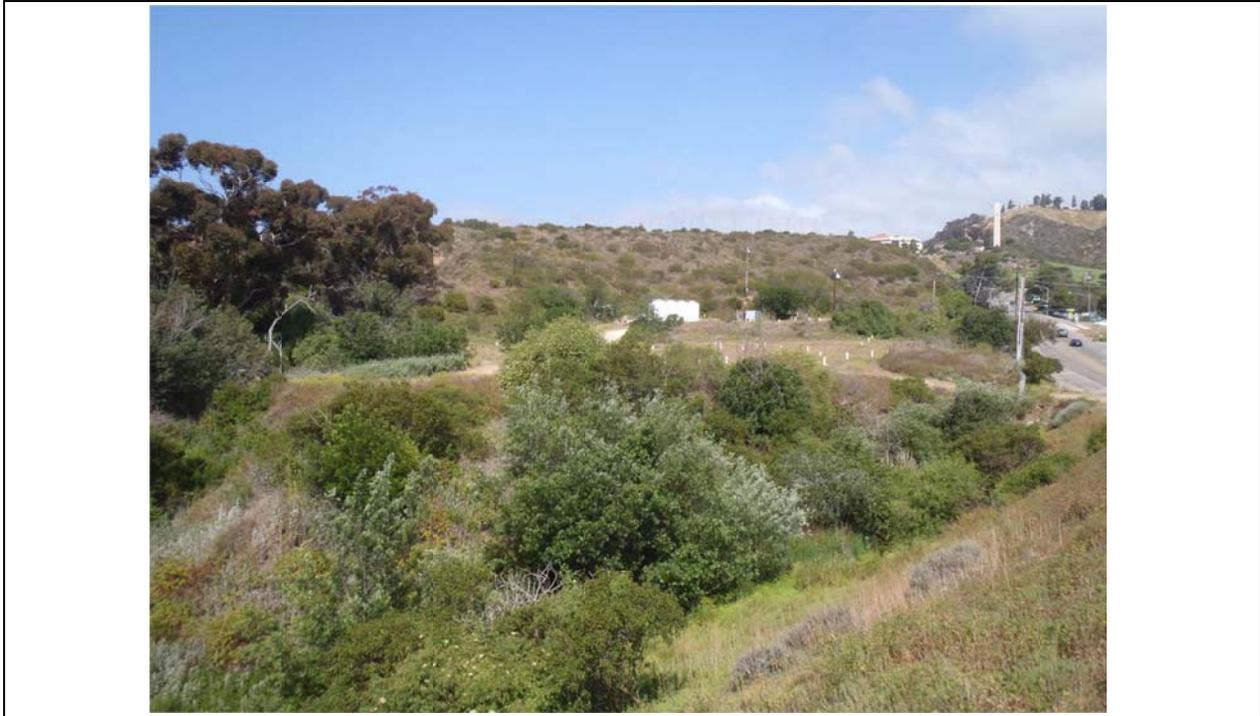
Photograph 1: Northwesterly view from near the southeastern corner of the proposed wastewater treatment facility site.
