Appendix C
Habitat Assessment

MEMORANDUM

Re: Habitat Assessment for the Proposed Malibu Civic Center Wastewater Treatment Facility Project, City of Malibu, Los Angeles County, California

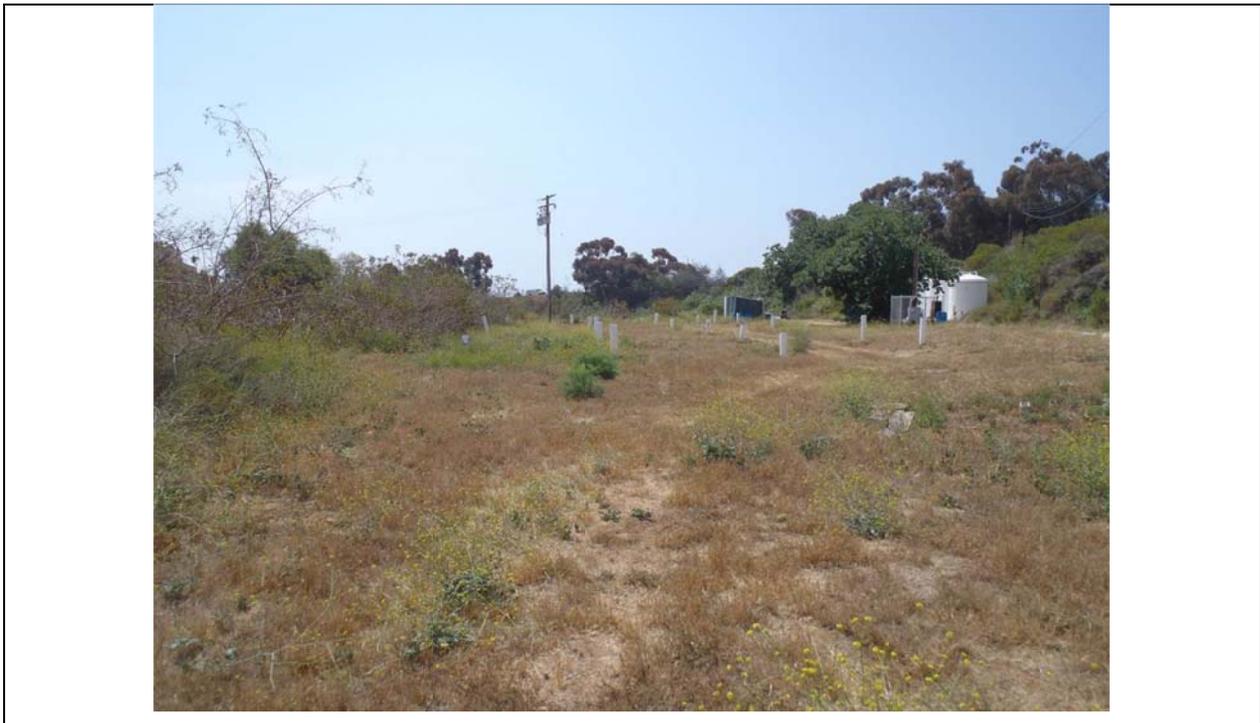
Photograph 2: Southerly view from within the northern portion of the proposed wastewater treatment facility site.

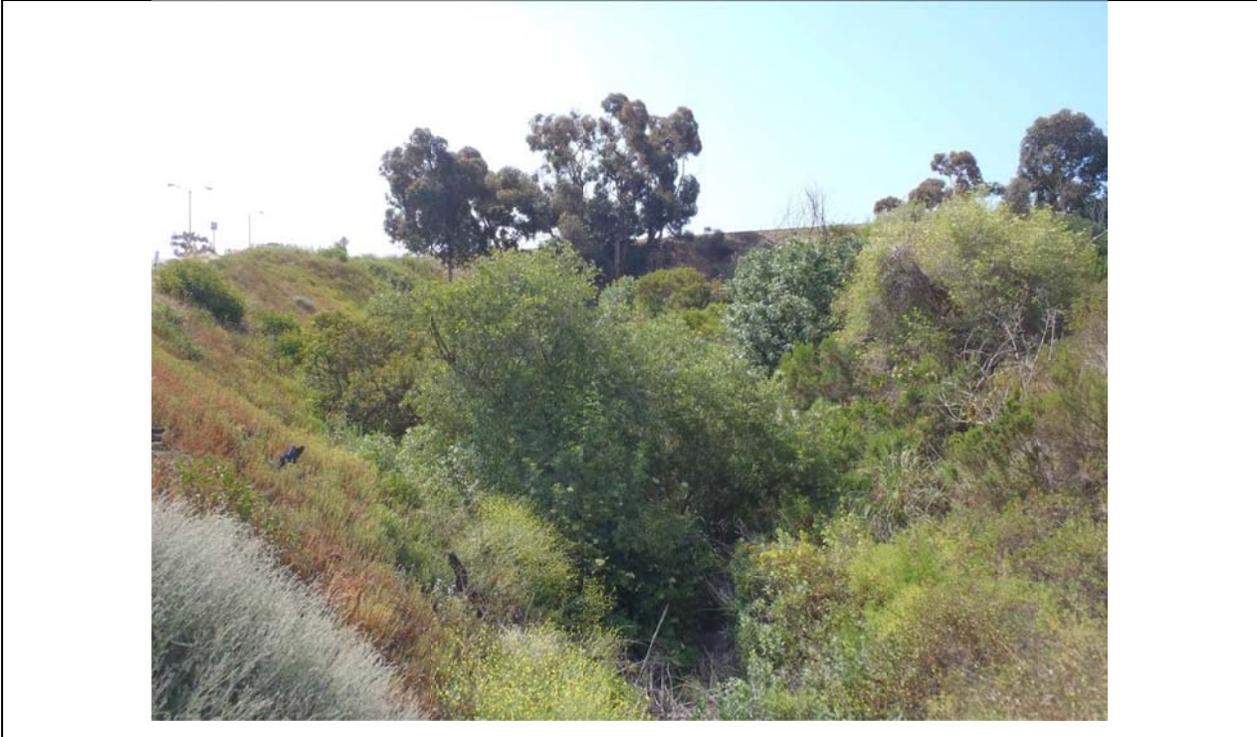
Photograph 3: Southerly view near the proposed wastewater treatment facility driveway of the drainage and riparian habitat.

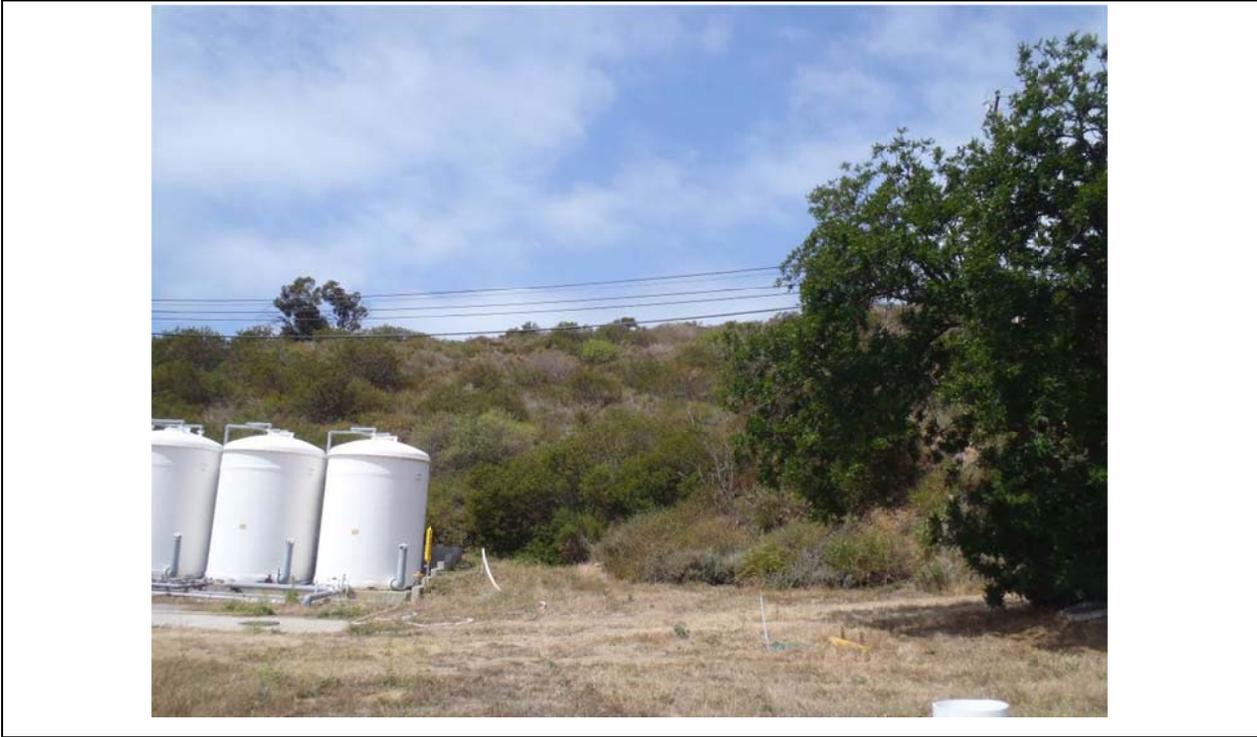
Photograph 4: Westerly view of the hill slope on the western boundary of the proposed wastewater treatment facility site.
