Appendix D
Native Tree Protection Plan

**MALIBU CIVIC CENTER WASTEWATER
TREATMENT FACILITY PROJECT
NATIVE TREE PROTECTION PLAN**

December 2013

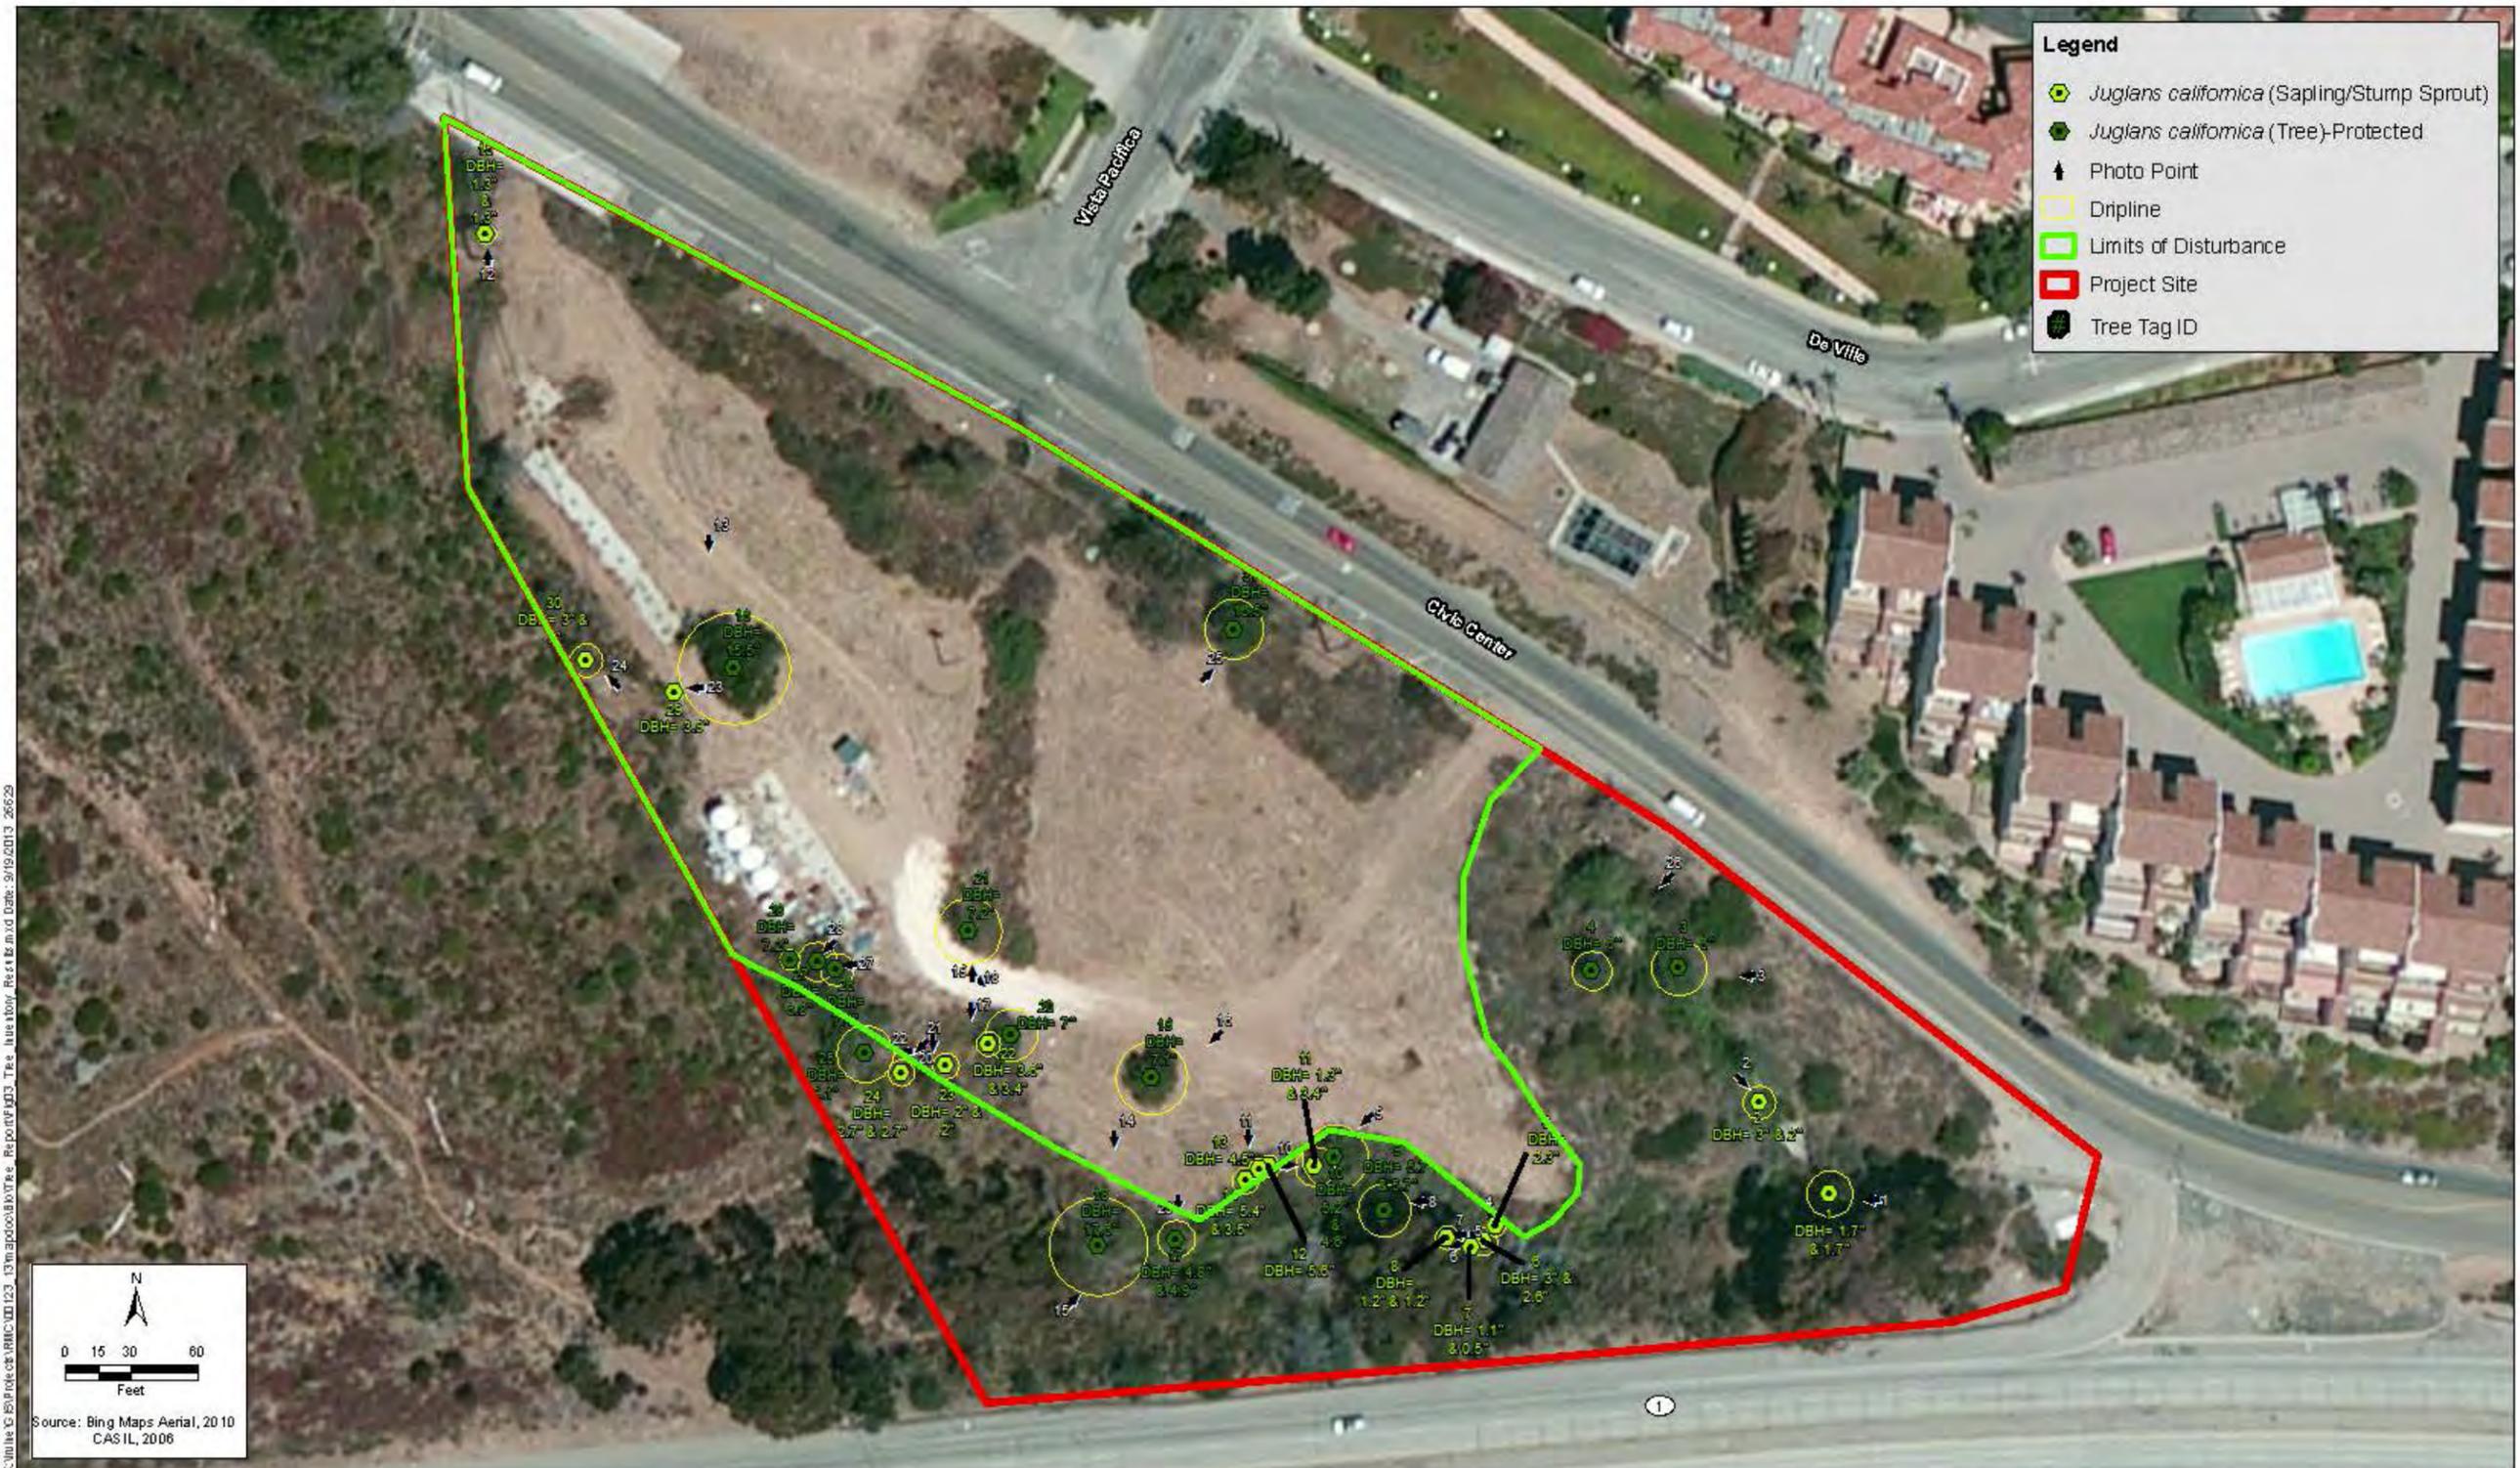
Figure 3
Tree Inventory Results
Malibu Civic Center Wastewater Treatment Facility Project

The Project site supports three vegetation communities: Disturbed, Chaparral, and Southern Willow Scrub (Figure 3). The chaparral community is limited to the sloped portion of the site along the western edge of limits of disturbance. This area consists of young shrubs, including lemonade berry (*Rhus integrifolia*), laurel sumac (*Malosma laurina*), canyon sunflower (*Venegasia carpesioides*), and various non-native grasses. A few sporadic California walnuts (*Juglans californica*) and black elderberry (*Sambucus nigra*) are also found in this area. The southern willow scrub community is found only in the southeastern corner of the Project site where the Winter Canyon Creek flows intermittently through the survey area. This community is dominated by arroyo willow (*Salix lasiolepis*) with a few sporadic California walnuts and some non-native species including fountain grass (*Pennisetum setaceum*) and pampas grass (*Cortaderia jubata*). The majority of the site is dominated by a disturbed community. This community consists of bare ground and non-native grasses that are frequently mowed. Along the fence line near Civic Center Way, the community contains a variety of native and non-native species, including various non-native grasses, canyon sunflower, eucalyptus trees, tree tobacco (*Nicotiana glauca*), castor bean (*Ricinus communis*), and black elderberry.

Thirty-one native trees occur within or directly adjacent to the limits of disturbance for the wastewater treatment facility site during this inventory. The location of each tree is shown in Figure 3. All of the native trees inventoried were California walnut (*Juglans californica*). No other native tree species protected under the Ordinance is present within 20 feet of the proposed wastewater treatment facility site limits. Of the 31 California walnuts inventoried, 15 (48 percent) meet the measurement requirements to be considered trees protected under the Ordinance. The remaining California walnuts were saplings or stump sprouts.

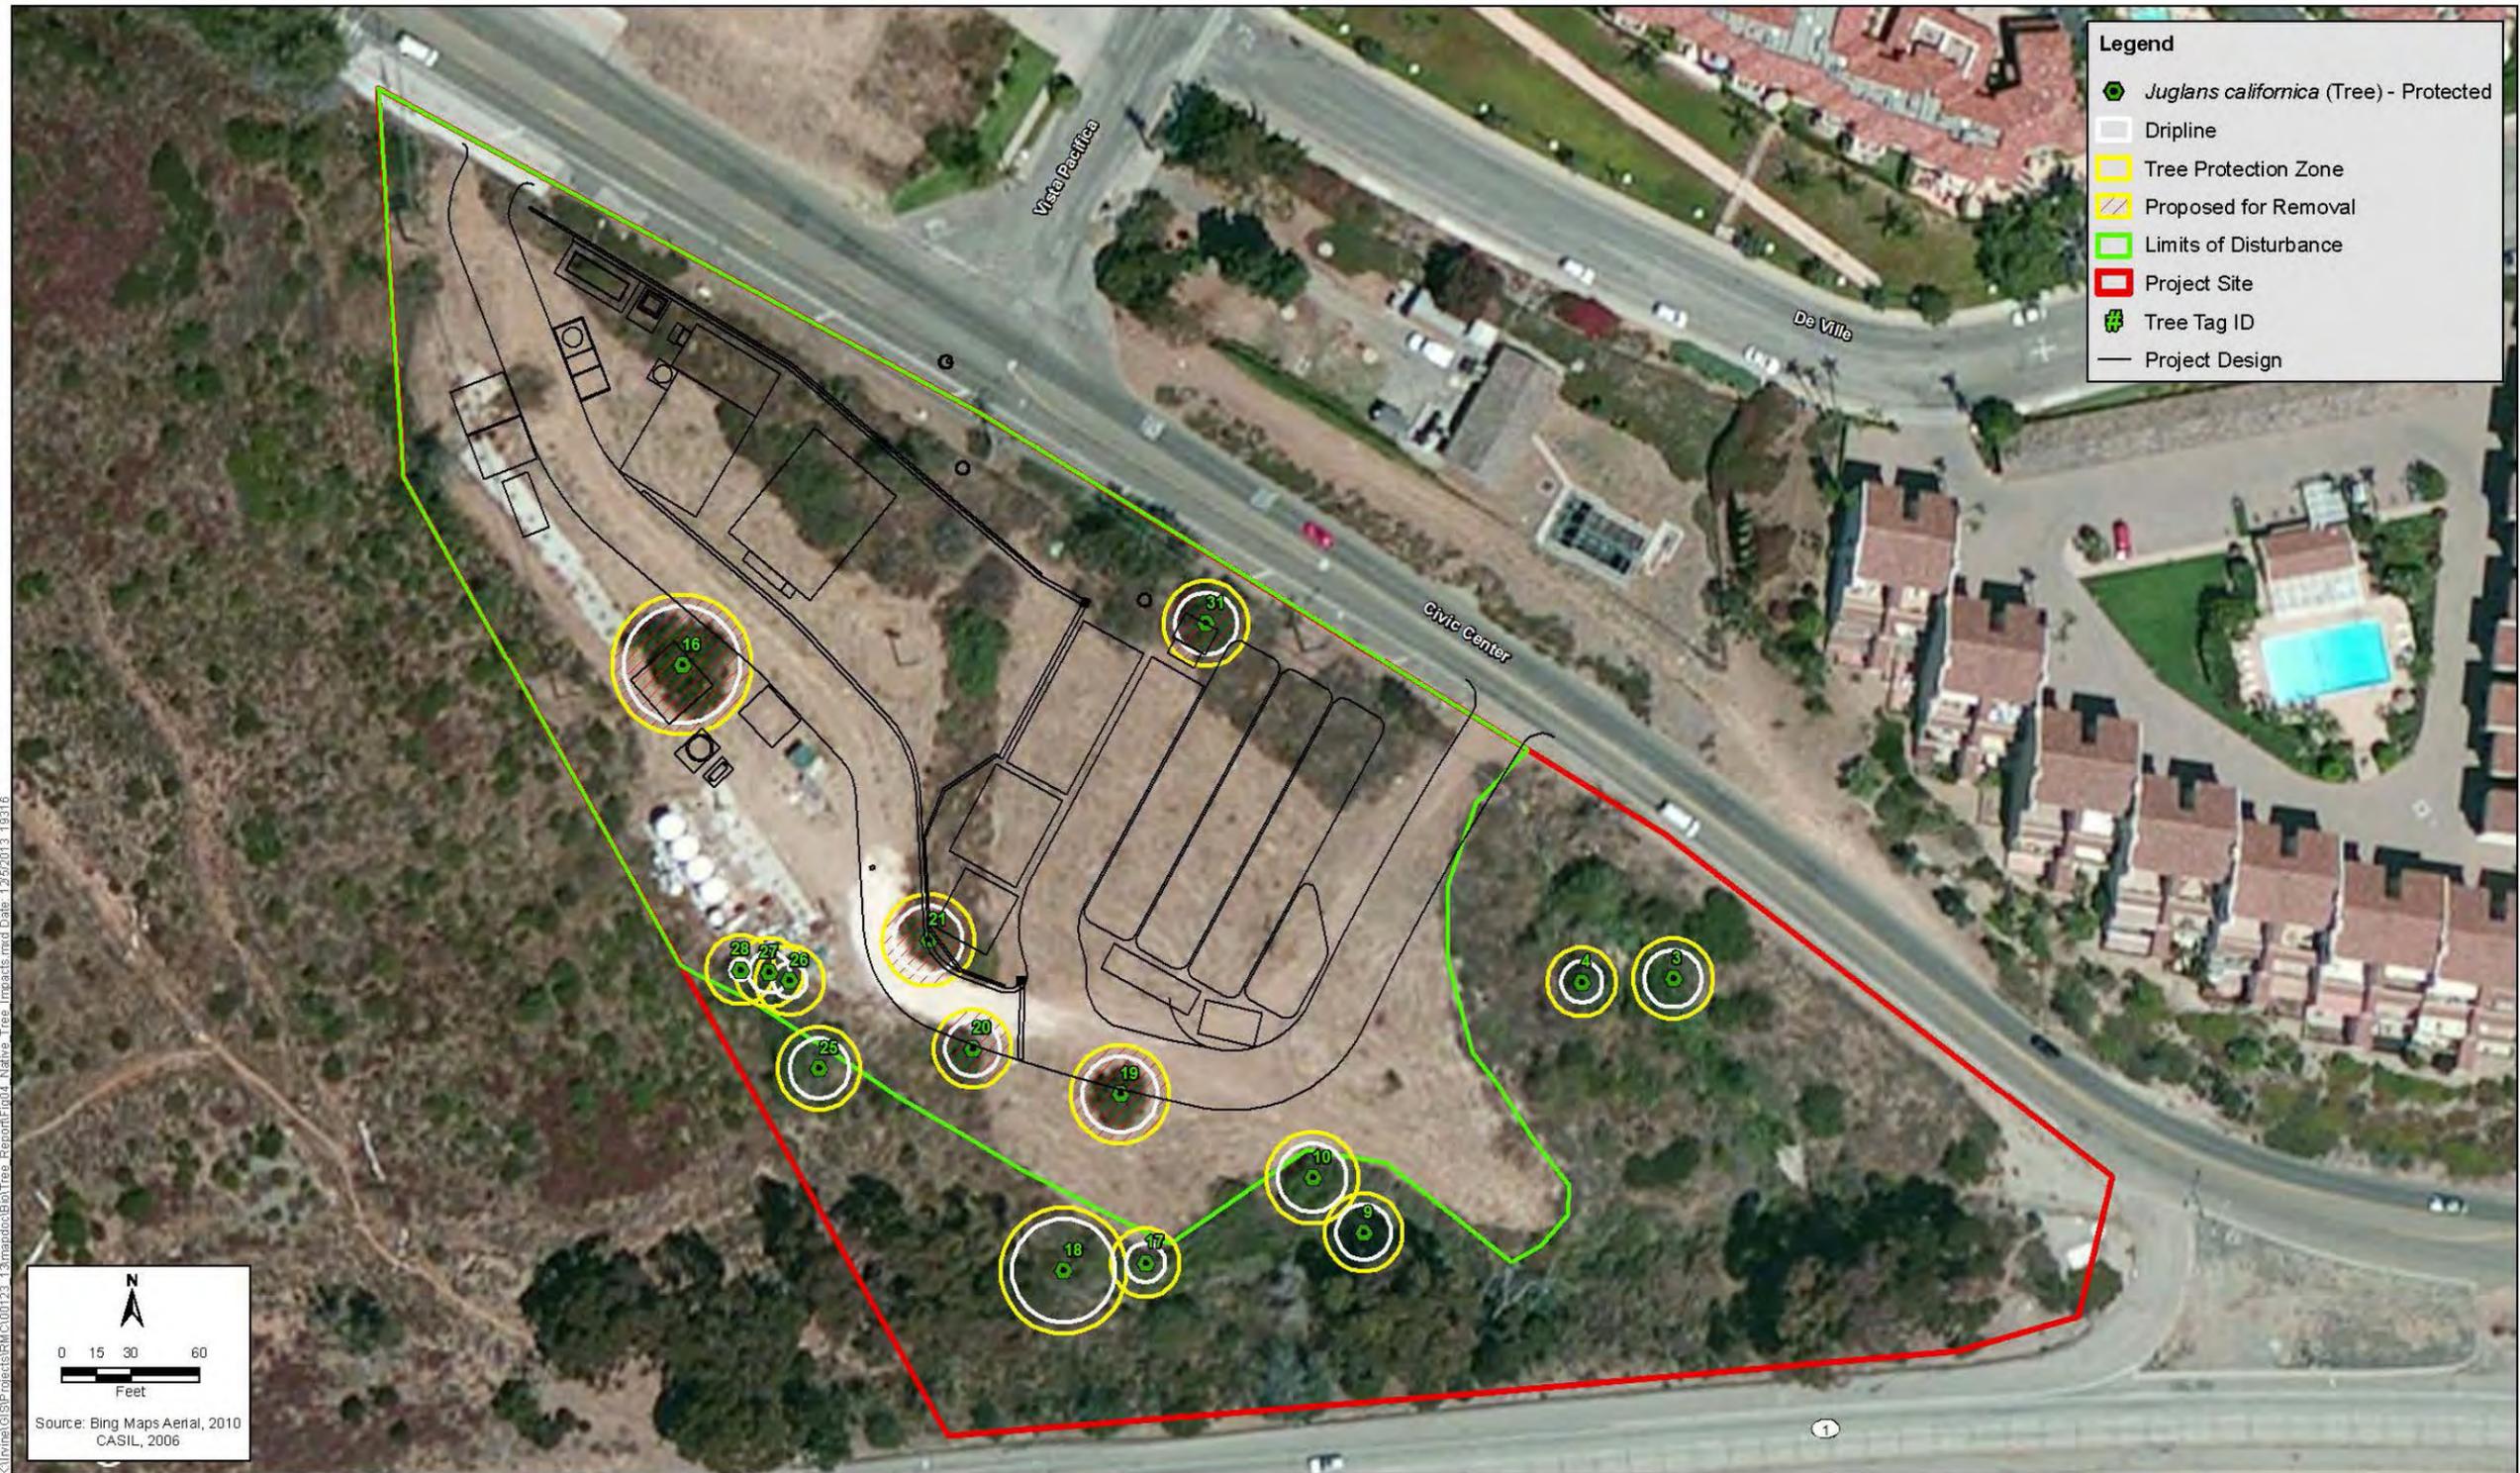
Figure 4
Native Tree Impacts
Malibu Civic Center Wastewater Treatment Facility Project

Based on the best available and current information on the wastewater treatment facility design, the proposed Project would remove five protected California walnut trees (tree tag ID #16, 19, 20, 21, and 30). Refer to Chapter 4 of this report for mitigation measures and best management practices.

The remaining nine trees and their protected zones within the limits of disturbance would be avoided during construction of the project and during operation of the proposed wastewater facility. Figure 4 identifies the trees that will be removed by the proposed project and the tree protection zones for all trees within the limits of disturbance.

- Any California walnut trees proposed for removal or where development encroaches into the protected zone of the native tree, resulting in the loss or worsened health of the tree, shall be replaced on-site (if suitable habitat is present) at a ratio of 10:1. Seedlings (less than one year old) shall be planted in an area of the proposed wastewater treatment facility site where suitable habitat is present.
