**Appendix E**  
**Jurisdictional Delineation Report**

April 8, 2014

**Subject: Jurisdictional Delineation Report for the Malibu Wastewater Treatment Facility Site in the City of Malibu, Los Angeles, California**

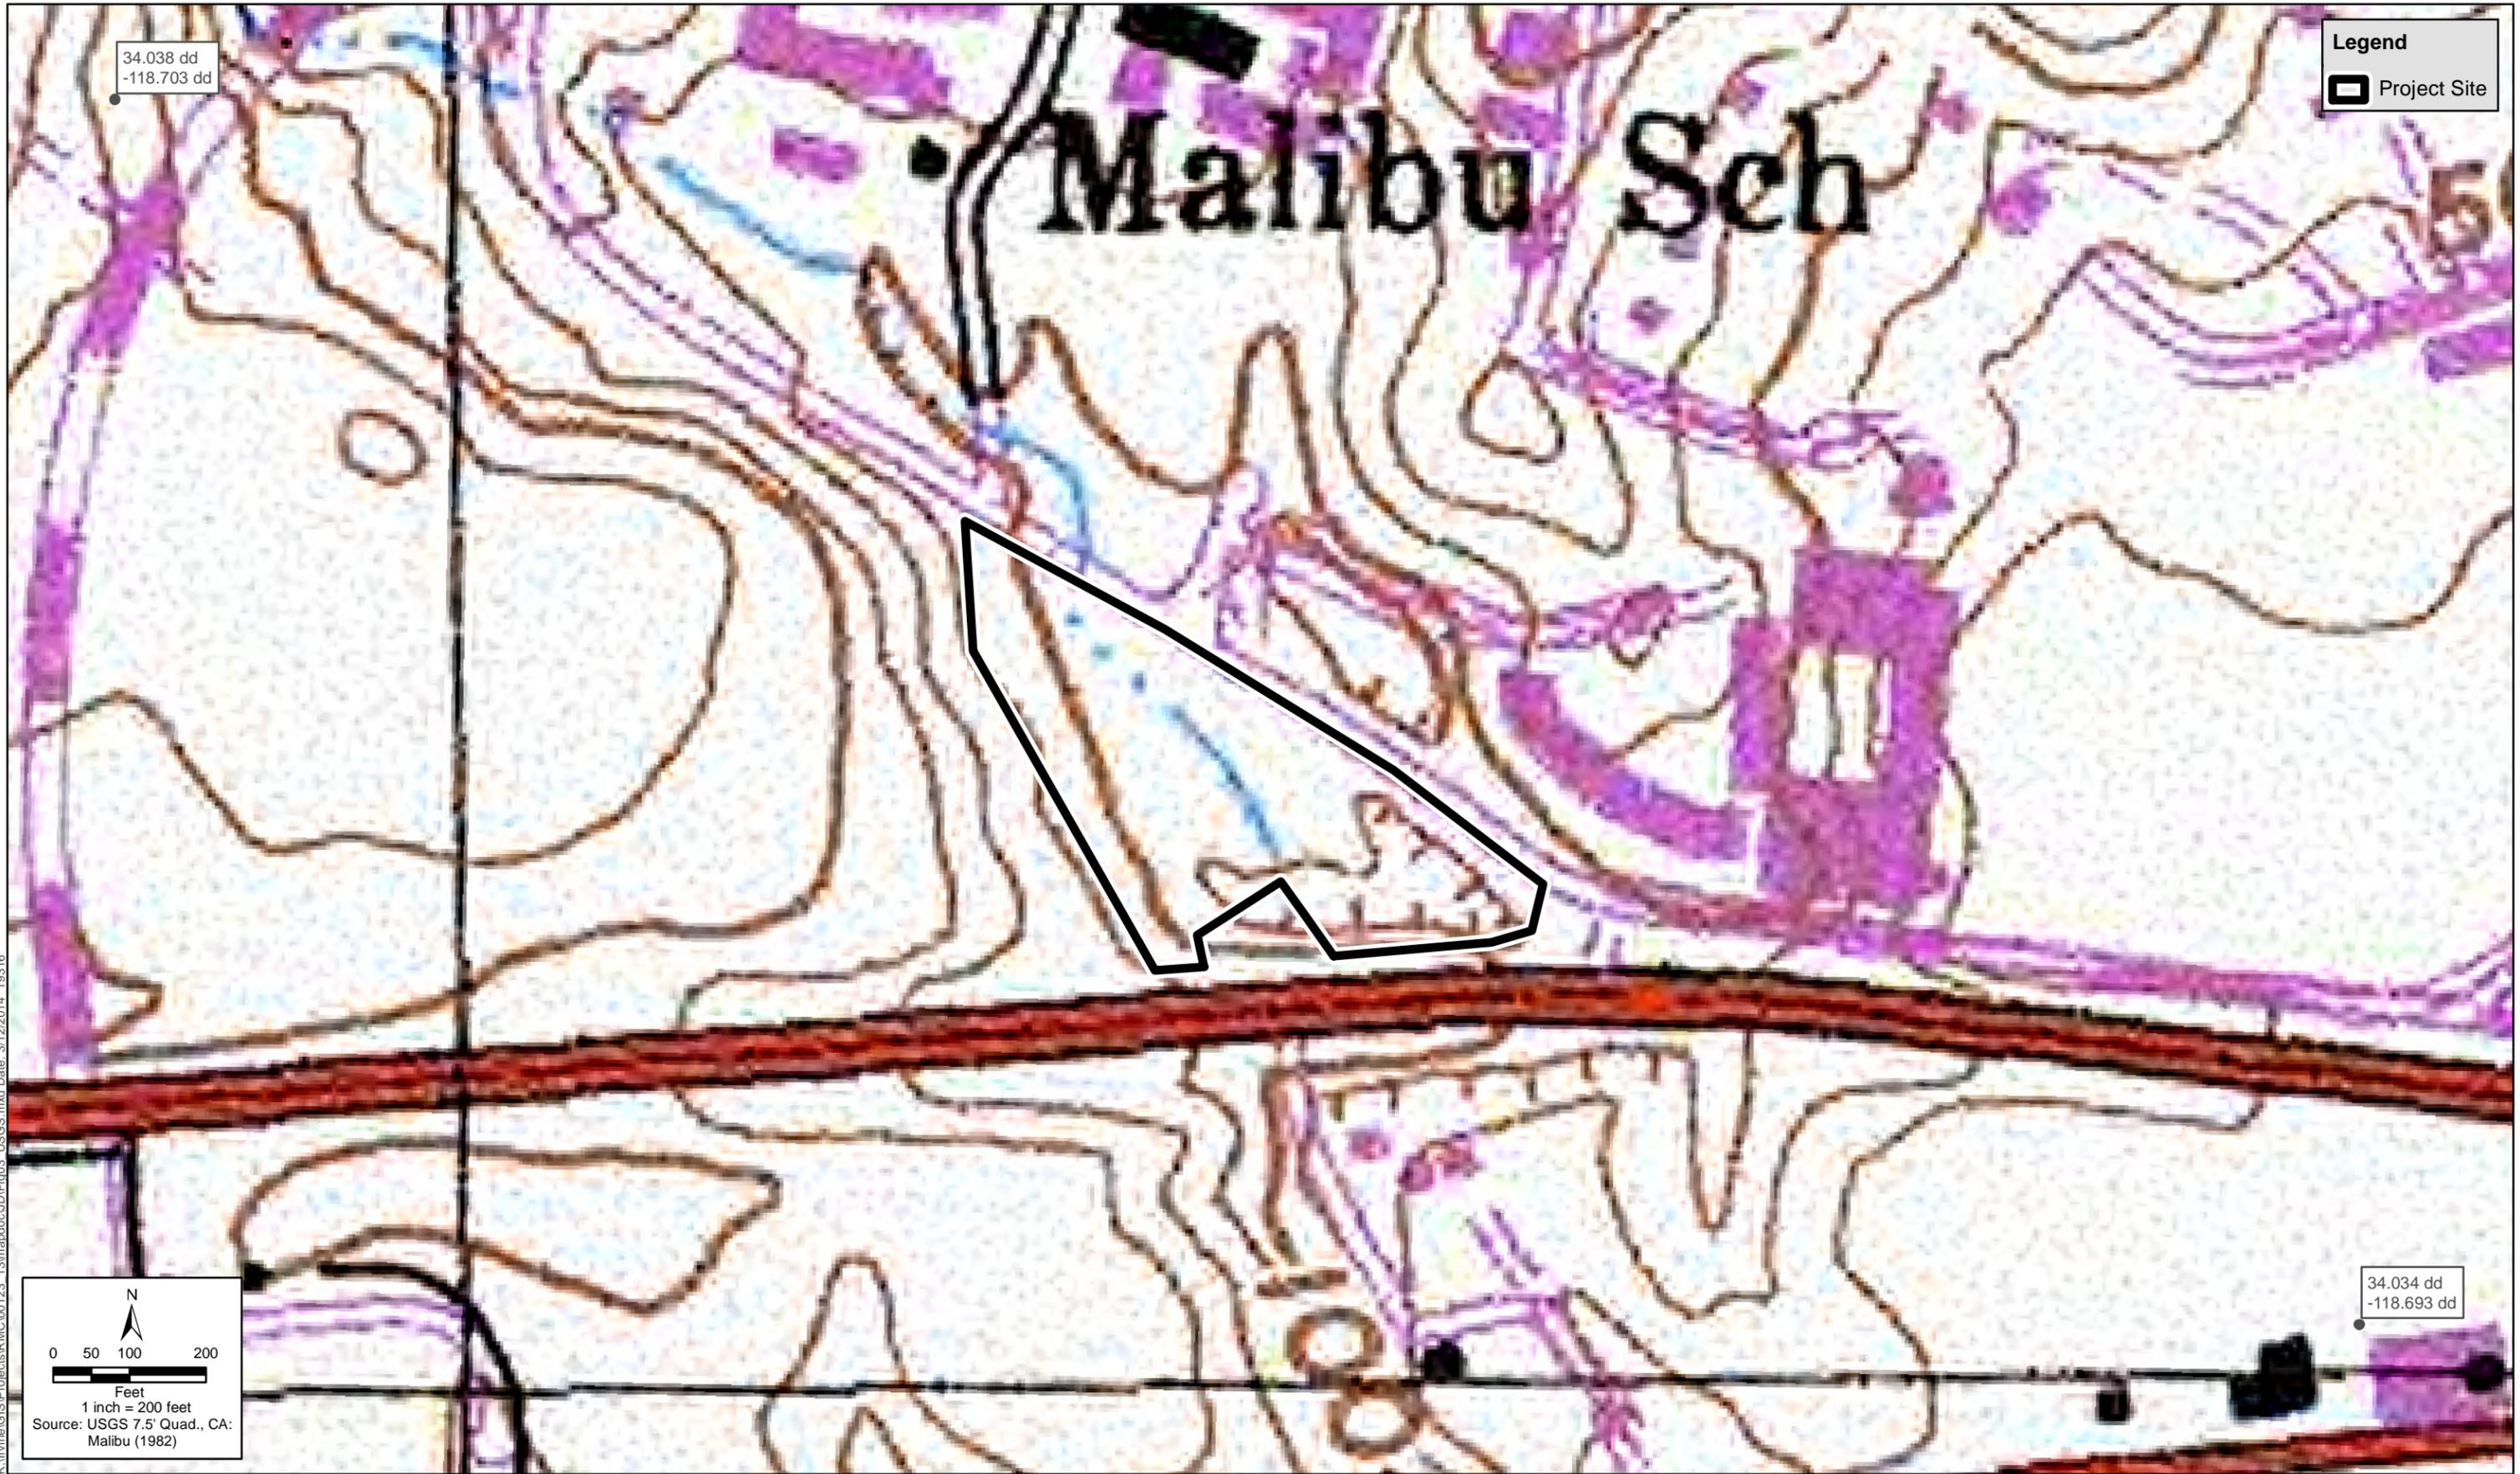
**Figure 3**  
**USGS Topographic Map**  
**Jurisdictional Delineation Report for the**  
**Malibu Wastewater Treatment Facility Project**

Average annual rainfall for the Project area (Santa Monica, California) totals 12.1 inches per year (WRCC 2013). Review of the USGS topographic map indicate a blue-lined stream through the site, however, no drainage was found to be associated with the location of the blue-line and the topography appears to have been altered some time back. Historic aerials appear consistent with the conditions observed on site.

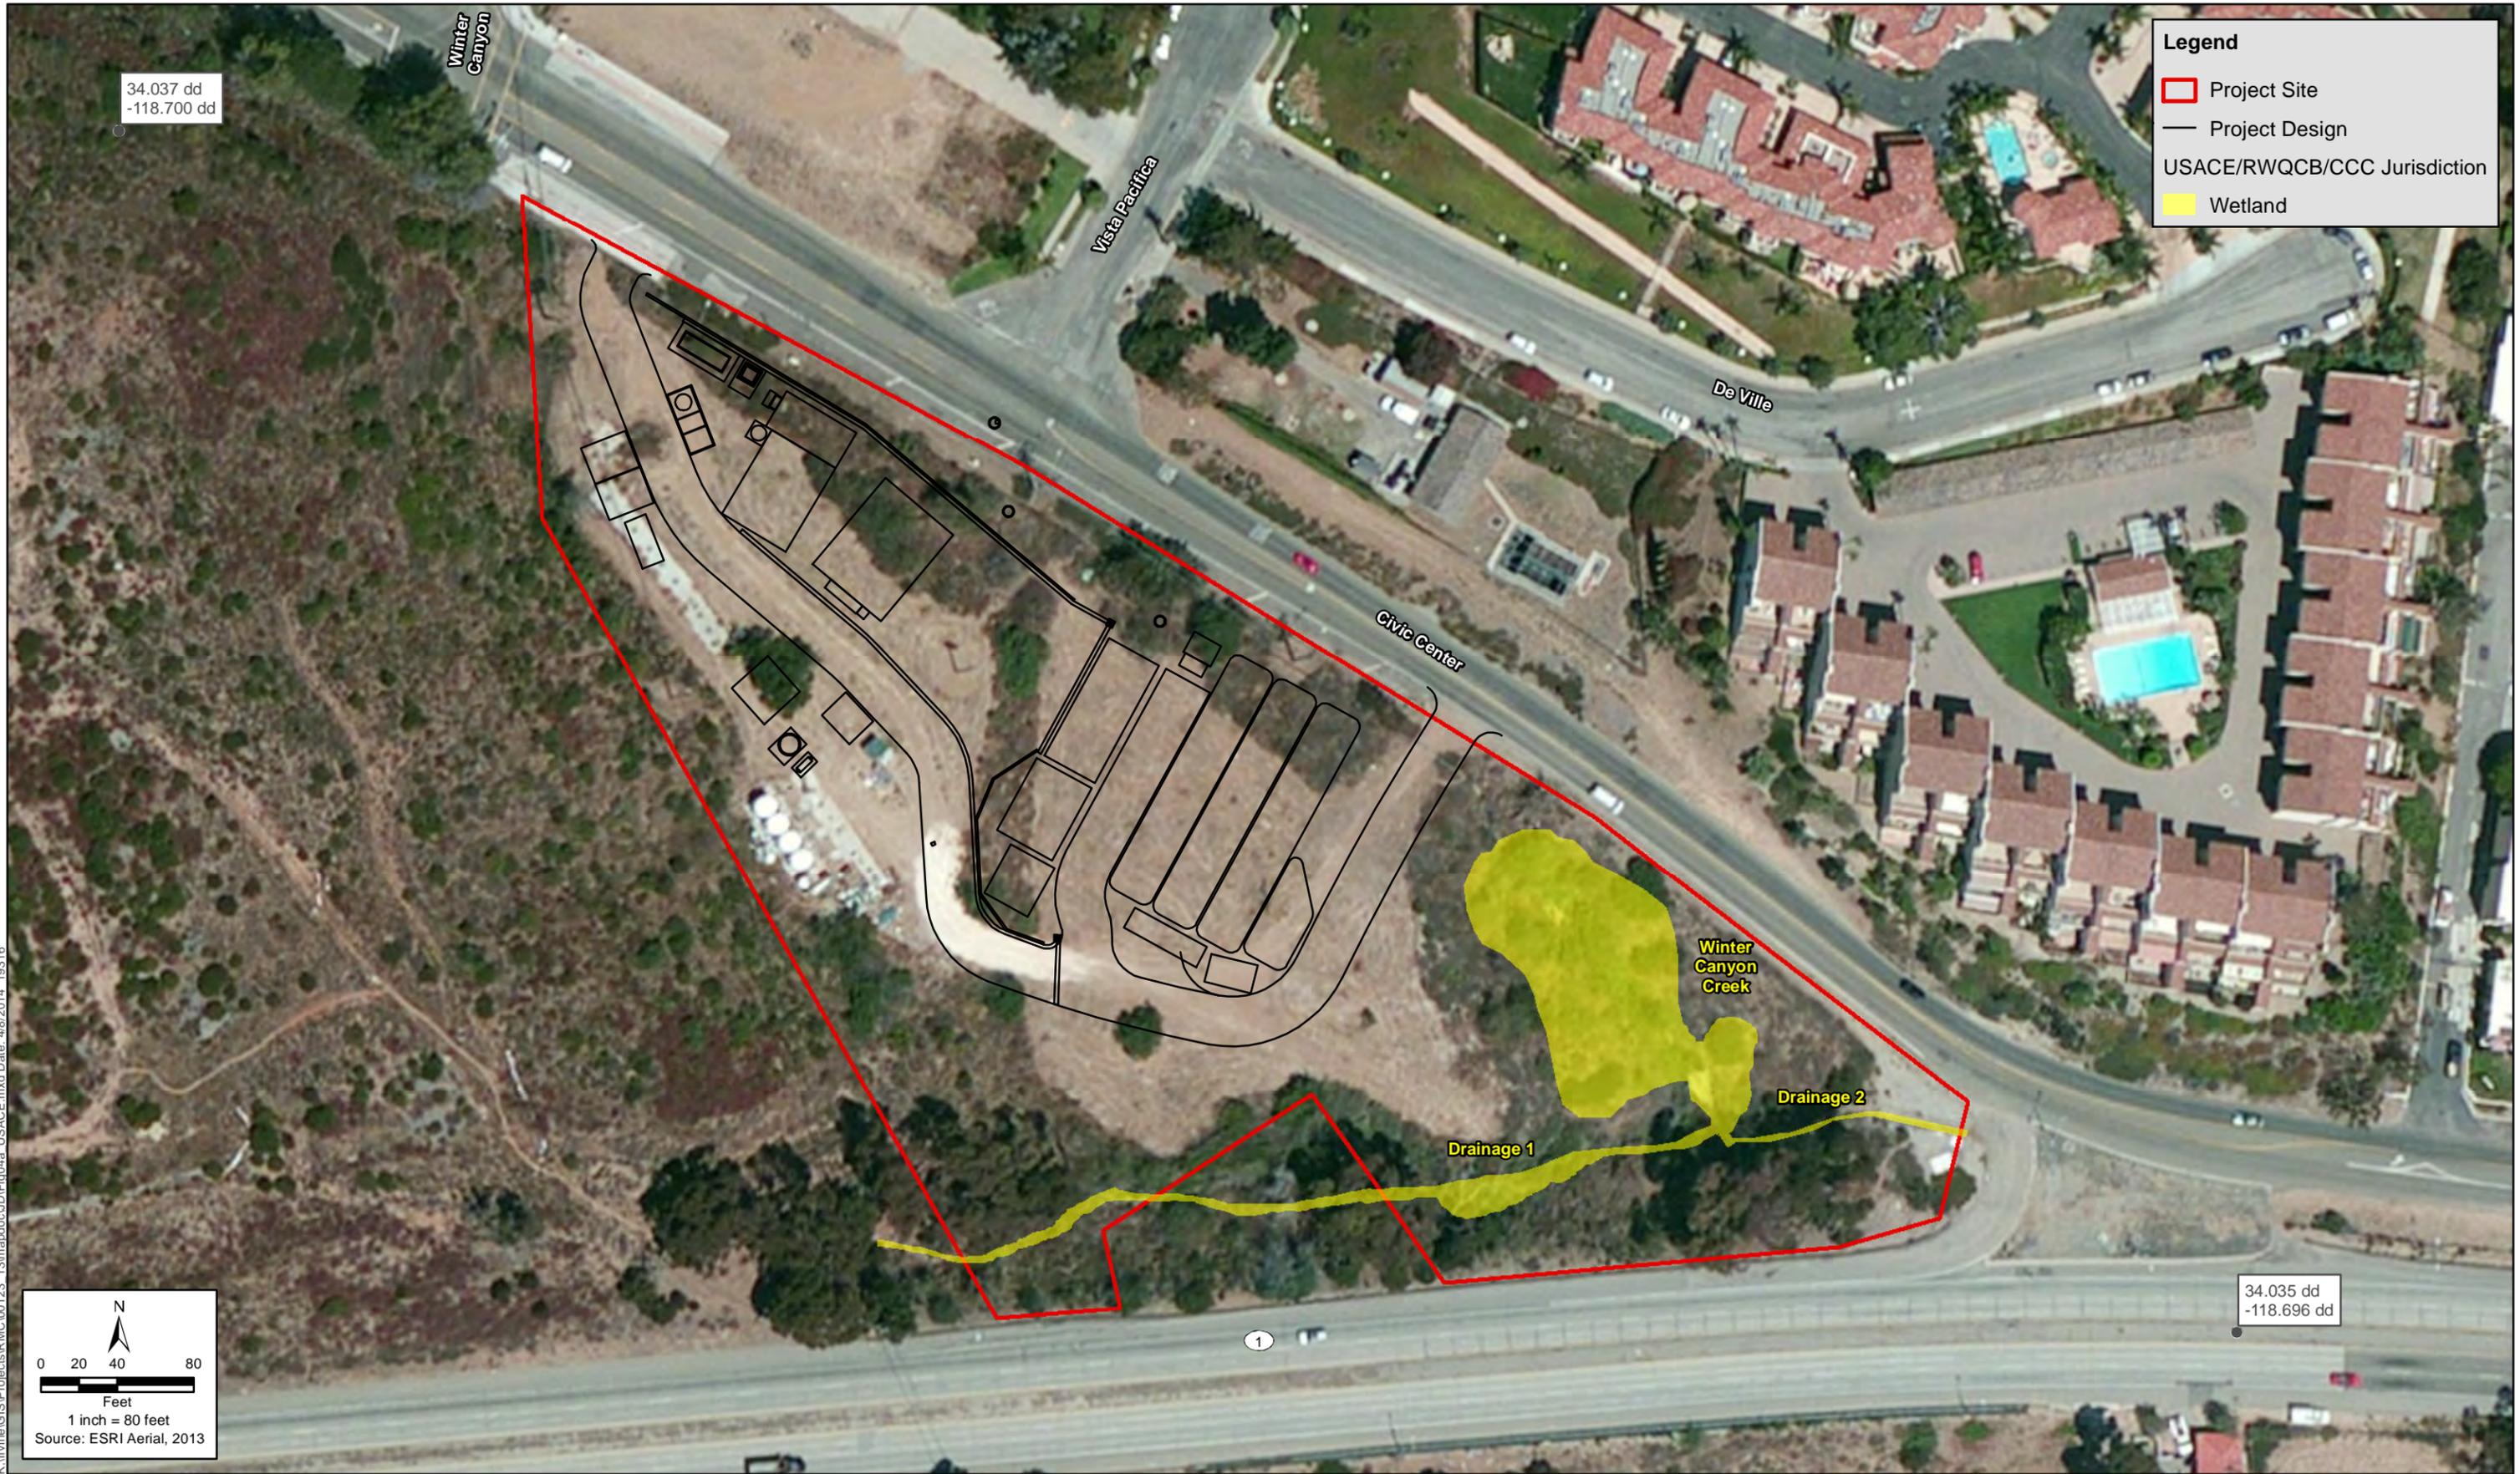
**Figure 4a**  
**Jurisdictional Features - USACE/RWQCB/California Coastal Commission**  
**Jurisdictional Delineation Report for the**  
**Malibu Wastewater Treatment Facility Project**

Within the wastewater treatment facility site, Winter Canyon Creek flows for approximately 207 linear feet. Winter Canyon Creek consists of 0.29 acre of wetland under the jurisdiction of USACE<sup>1</sup>, RWQCB, and CCC. CDFW jurisdiction associated with Winter Canyon Creek consists of 207 linear feet of streambed exhibiting a bed and bank, and comprises 0.29 acre of vegetated riparian habitat. Table 1 presents the total jurisdiction for each agency. Within the treatment facility site, Winter Canyon Creek exhibits a channel ranging from 2 to 9 feet in width (as measured by distance from OHWM on each bank), with visible indicators present such as the presence of bed and bank, break in bank slope, destruction of terrestrial vegetation, and wracking.

Within the treatment facility site, Drainage 1 flows for approximately 453 linear feet, and exhibits a channel ranging from 3 feet to 20 feet in width, with visible indicators such as a presence of bed and bank, break in bank slope, destruction of terrestrial vegetation, and wracking. Drainage 1 consists of 0.07 acre of wetland under the jurisdiction of USACE, RWQCB, and CCC. CDFW jurisdiction associated with Drainage 1 consists of 453 linear feet of streambed exhibiting bed and bank. CDFW jurisdiction associated with Drainage 1 comprises 0.10 acre of streambed. Table 1 presents the total jurisdiction for each agency.

Within the site, Drainage 2 flows for approximately 125 linear feet, and exhibits a channel between OHWMs ranging from 1 foot to 3 feet in width, with visible indicators such as a presence of bed and bank, break in bank slope, destruction of terrestrial vegetation, and wracking. Drainage 2 consists of 0.01 acre of wetland under the jurisdiction of USACE, RWQCB, and CCC. CDFW jurisdiction associated with Drainage 2 consists of 125 linear feet of streambed exhibiting bed and bank, and comprises 0.01 acre of streambed. Table 1 presents the total jurisdiction for each agency.

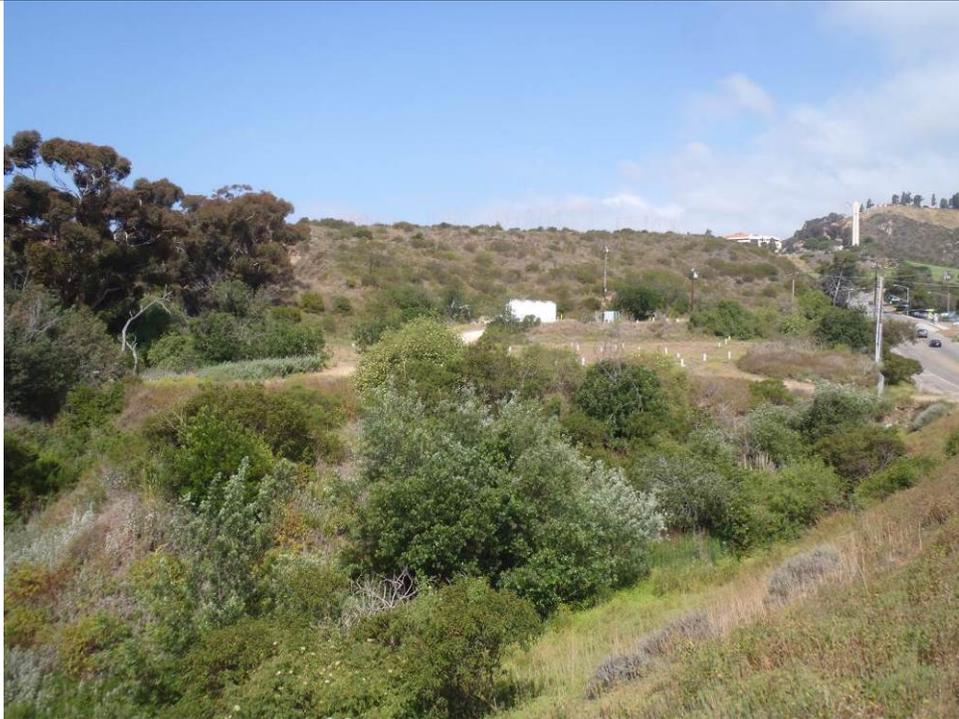
The majority of Winter Canyon Creek has an earthen bottom; however, a small segment (approximately 30 feet) downstream of the eastern inlet pipe, and approximately 15 feet on the upstream side of the outlet pipe is concrete. Several concrete/rock walls are associated to the upland area and retain small pools of water. The feature appears to receive regular flows, likely as a result of nuisance flows from the nearby developments.

Winter Canyon Creek is vegetated throughout, with an overstory consisting of arroyo willow (*Salix lasiolepis*) (FACW) and sporadic California black walnuts (*Juglans californica*) (FAC). The understory is generally sparse, but includes arroyo willow saplings, non-native grasses including fountain grass (*Pennisetum setaceum*) (UPL) and pampas grass (*Cortaderia jubata*) (FACU). One small patch containing fewer than ten cattail (*Typha* sp.) (OBL) plants was observed in this drainage.

**Photograph 1:** Northwesterly view of Winter Canyon Creek from the southeastern corner

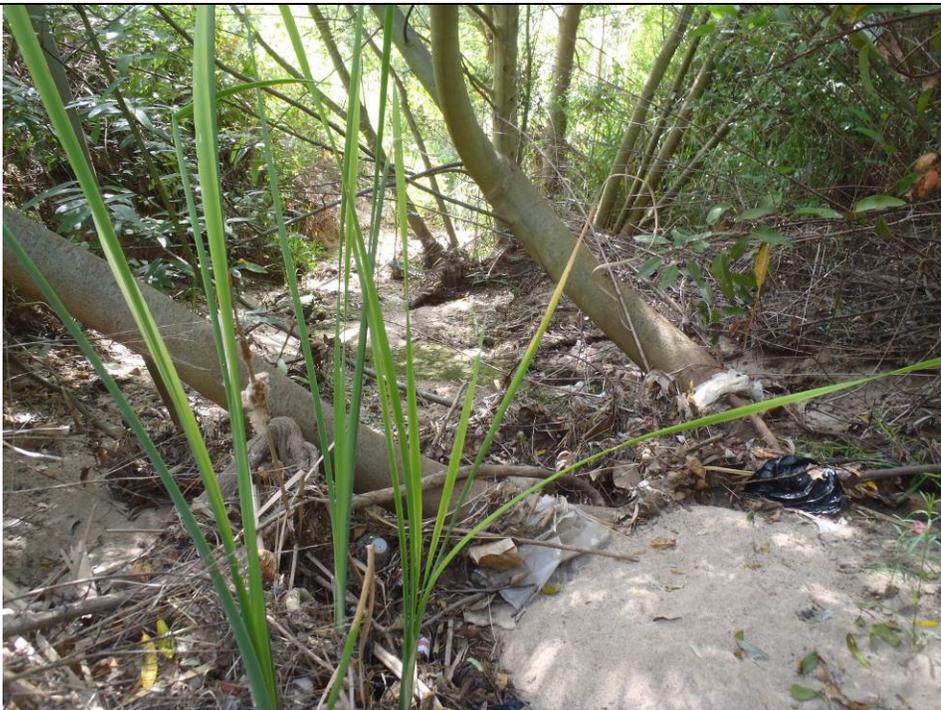
**Photograph 2:** Southerly view from within Winter Canyon Creek

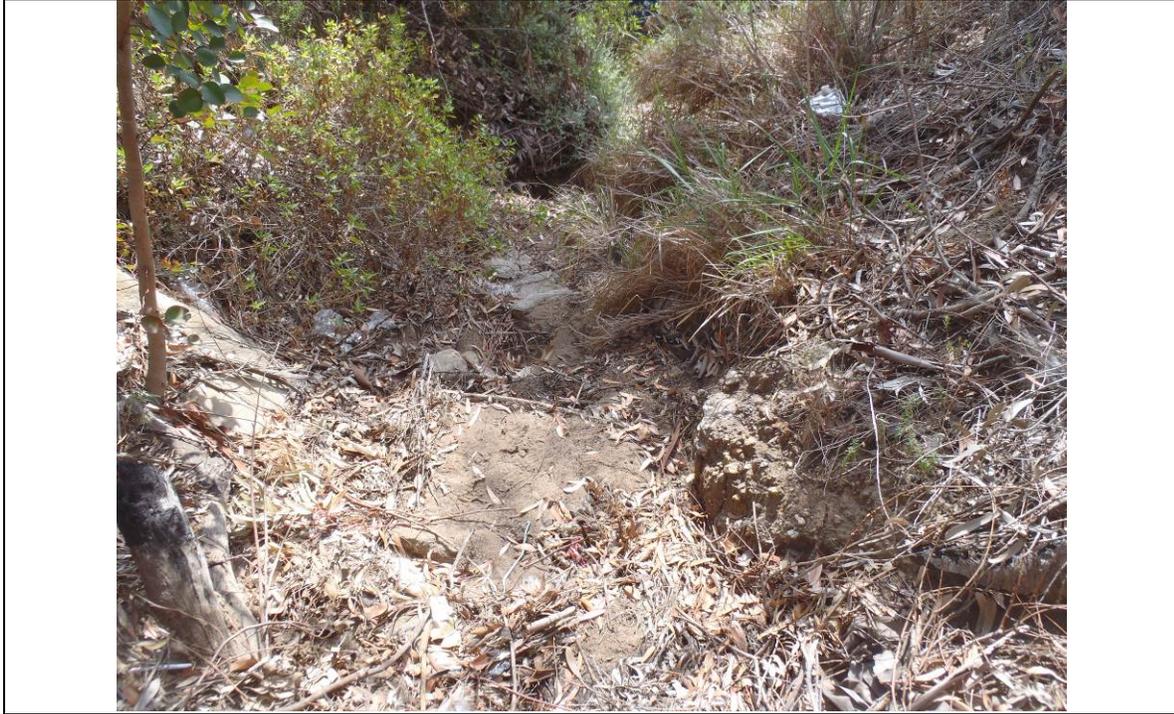
All of Drainage 1 has an earthen bottom. The feature conveys flows collected on PCH during rain events.

Drainage 1 is un-vegetated in the upstream portion of the channel; however, as the slope flattens and flows slow down, there is vegetation within the drainage. The vegetation within the drainage and on the banks is predominantly upland vegetation. Eucalyptus (*Eucalyptus* sp.) (UPL) trees and Mexican elderberry (FACU) are found along the length of the drainage along with nonnative grasses, giant wild rye (*Leymus condensatus*) (FACU), tree tobacco (*Nicotiana glauca*) (UPL), castor bean (*Ricinus communis*) (UPL), carnation spurge (UPL), and sporadic coyote brush (*Baccharis pilularis*) (UPL), California sagebrush (*Artemisia californica*) (UPL).

**Photograph 3:** Easterly view of Drainage 1 near the upstream portion of the feature

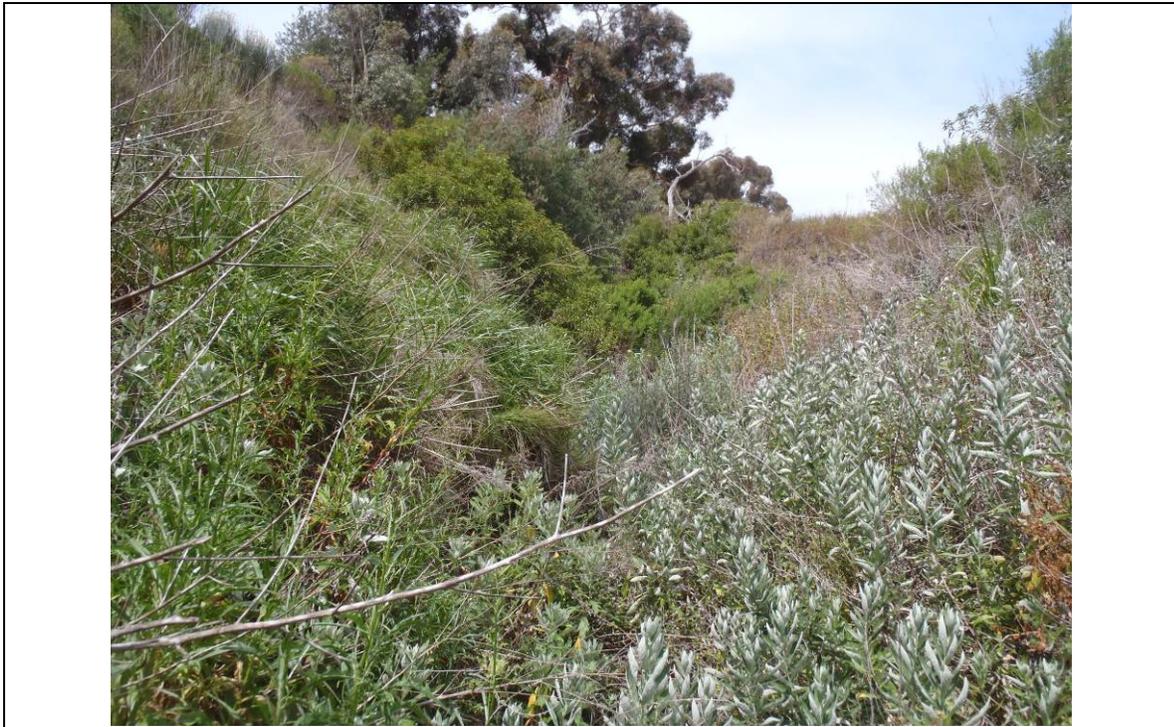
Drainage 1 is dominated by upland vegetation; however, the drainage is bordered by banks with an OHWM for 453 feet and therefore was determined to be a wetland using the one-parameter test. There is a small patch of mugwort (*Artemisia douglasiana*) (FAC) in the lower portion of the site, however the mugwort was growing with giant wild rye (FACU), coyote brush (UPL), and brome grass (UPL), so the area would not be qualified as having a preponderance of hydrophytic vegetation. Drainage 1 does exhibit hydrologic indicators in the form of drainage patterns and drift deposits (riverine). The presence of hydric soils was assumed in areas containing either hydrophytic vegetation or hydrology. As such, soil pits were not dug, so no data on hydric soil indicators was collected.

**Photograph 4:** Westerly view of Drainage 1 from the downstream extent.

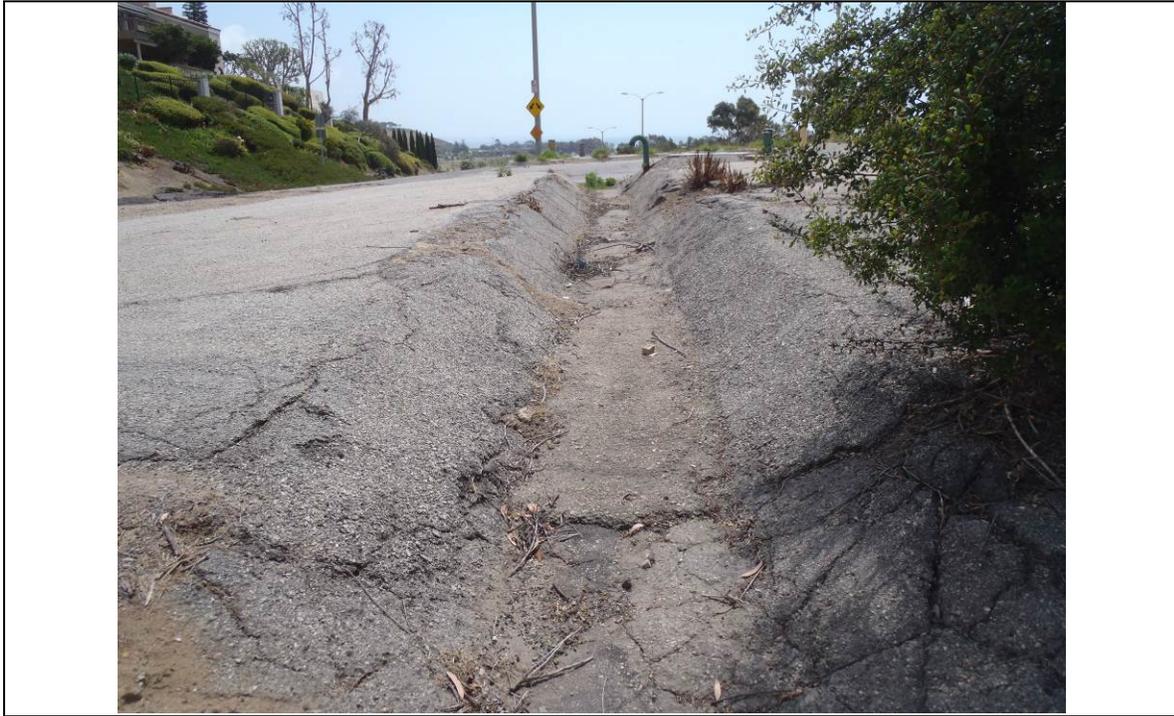
Drainage 2 is entirely paved on the upstream portion and is conveyed through a corrugated metal pipe in the downstream portion. The feature conveys flows collected from Civic Center Way during rain events.

Drainage 2 is largely un-vegetated. Where vegetation does occur within the drainage and on the banks it is predominantly upland vegetation including: carnation spurge, brome grass (UPL), cliff aster (*Malacothrix saxatilis*) (UPL), ice plant (*Carpobrotus chilensis*) (FACU), and canyon sunflower (*Venegasia carpesioides*) (UPL).

**Photograph 5:** Easterly view of Drainage 2 near the upstream extent

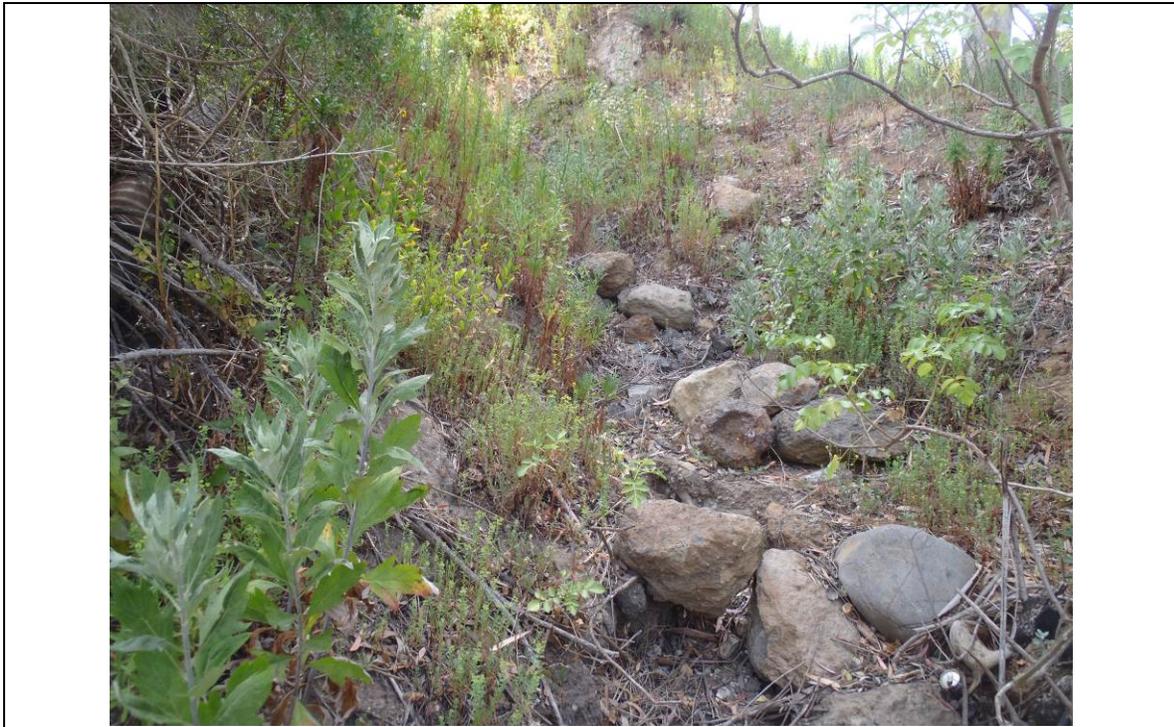
No areas supporting a preponderance of hydrophytic vegetation were observed within Drainage 2. Drainage 2 does, however, exhibit hydrologic indicators in the form of drainage patterns and drift deposits (riverine). The presence of hydric soils was assumed in areas containing either hydrophytic vegetation or hydrology. As such, soil pits were not dug, so no data on hydric soil indicators was collected.

**Photograph 6:** Easterly view of Drainage 2 from near the downstream extent.
