**Updated Hydrogeologic Assessment of the Proposed Malibu
Memorial Park Tract Map 69653, 4000 Malibu Canyon
Road, Malibu, California**

February 12, 2016

Earth Forensics Inc.
12532 Vista Panorama
North Tustin, CA 92705

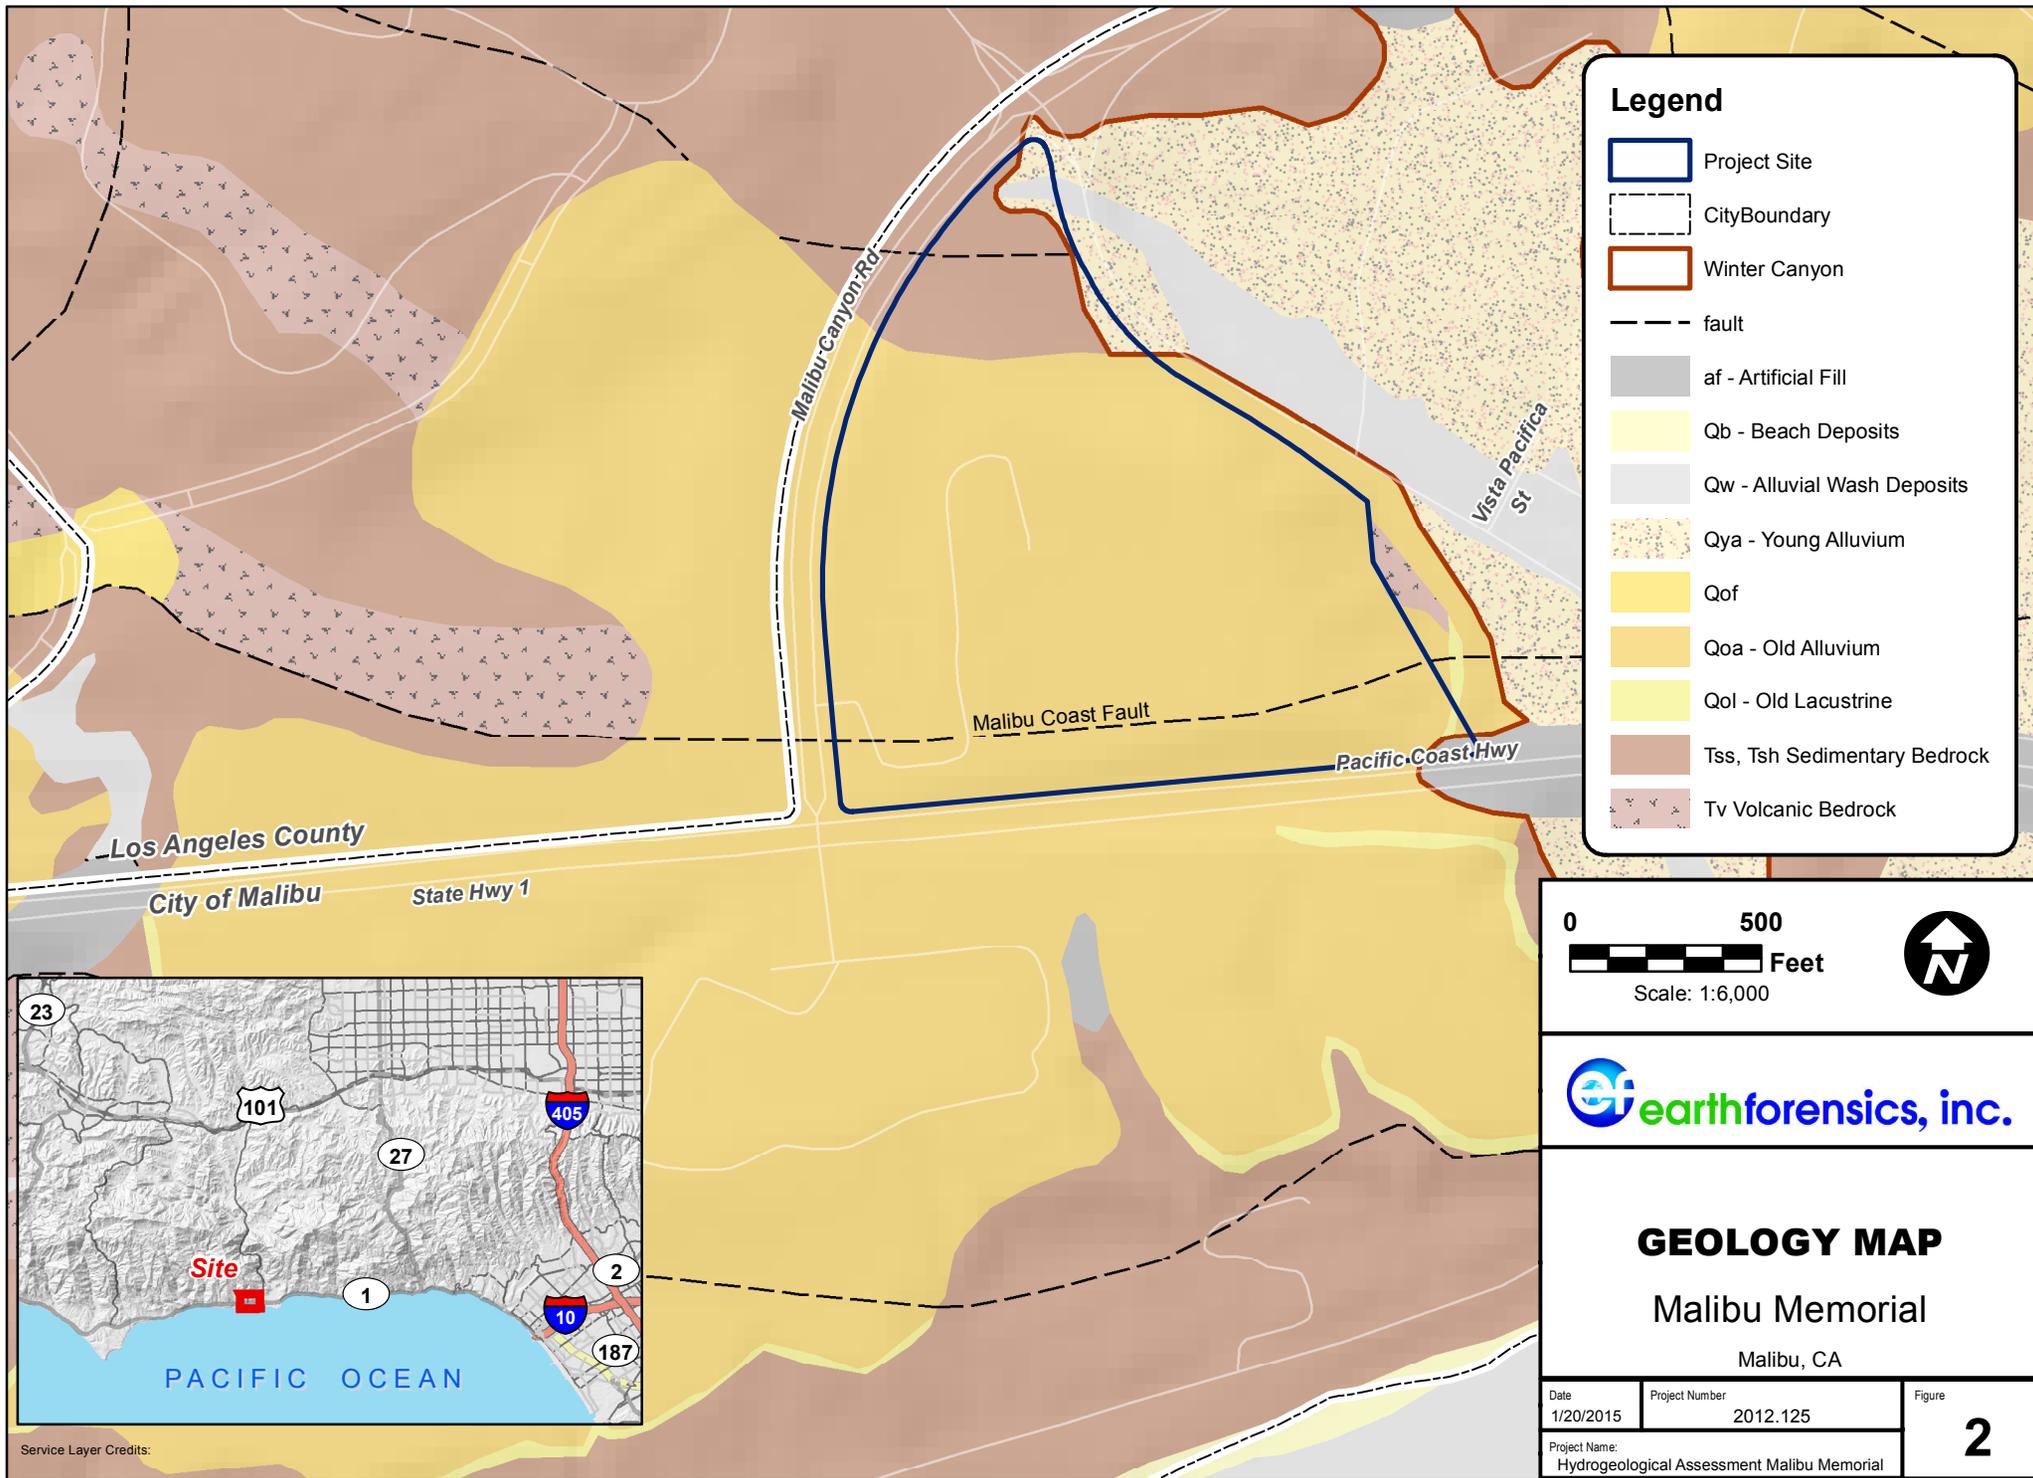
Date 1/20/2015	Project Number 2012.125	Figure 2
Project Name: Hydrogeological Assessment Malibu Memorial

The Project Site is underlain by different bedrock types. Figure 2 is a generalized geology map of the site. The Monterey Formation, Trancus, Sespe, Vaqueros, and Conejo Volcanics are present at depths to 84 feet, with all but the Monterey exposed at the surface.

GEOLOGY MAP

Unconsolidated marine and non-marine sediments, collectively referred to as terrace deposits, cap the bedrock. Marine deposits consist of gray to light brown well graded sand and gravelly sand, while non-marine deposits consist of reddish to yellowish brown, dense, silty sand and sand with varying amounts of gravel.

The Malibu Coast fault, a major structure in the region, trends east-west through the southern portion of the site. The fault has significantly offset the various bedrock units in the area, however it does not impact the upper part of the older terrace deposits (Leighton and Associates, 1989; Van Beveren & Butelo, 2007)

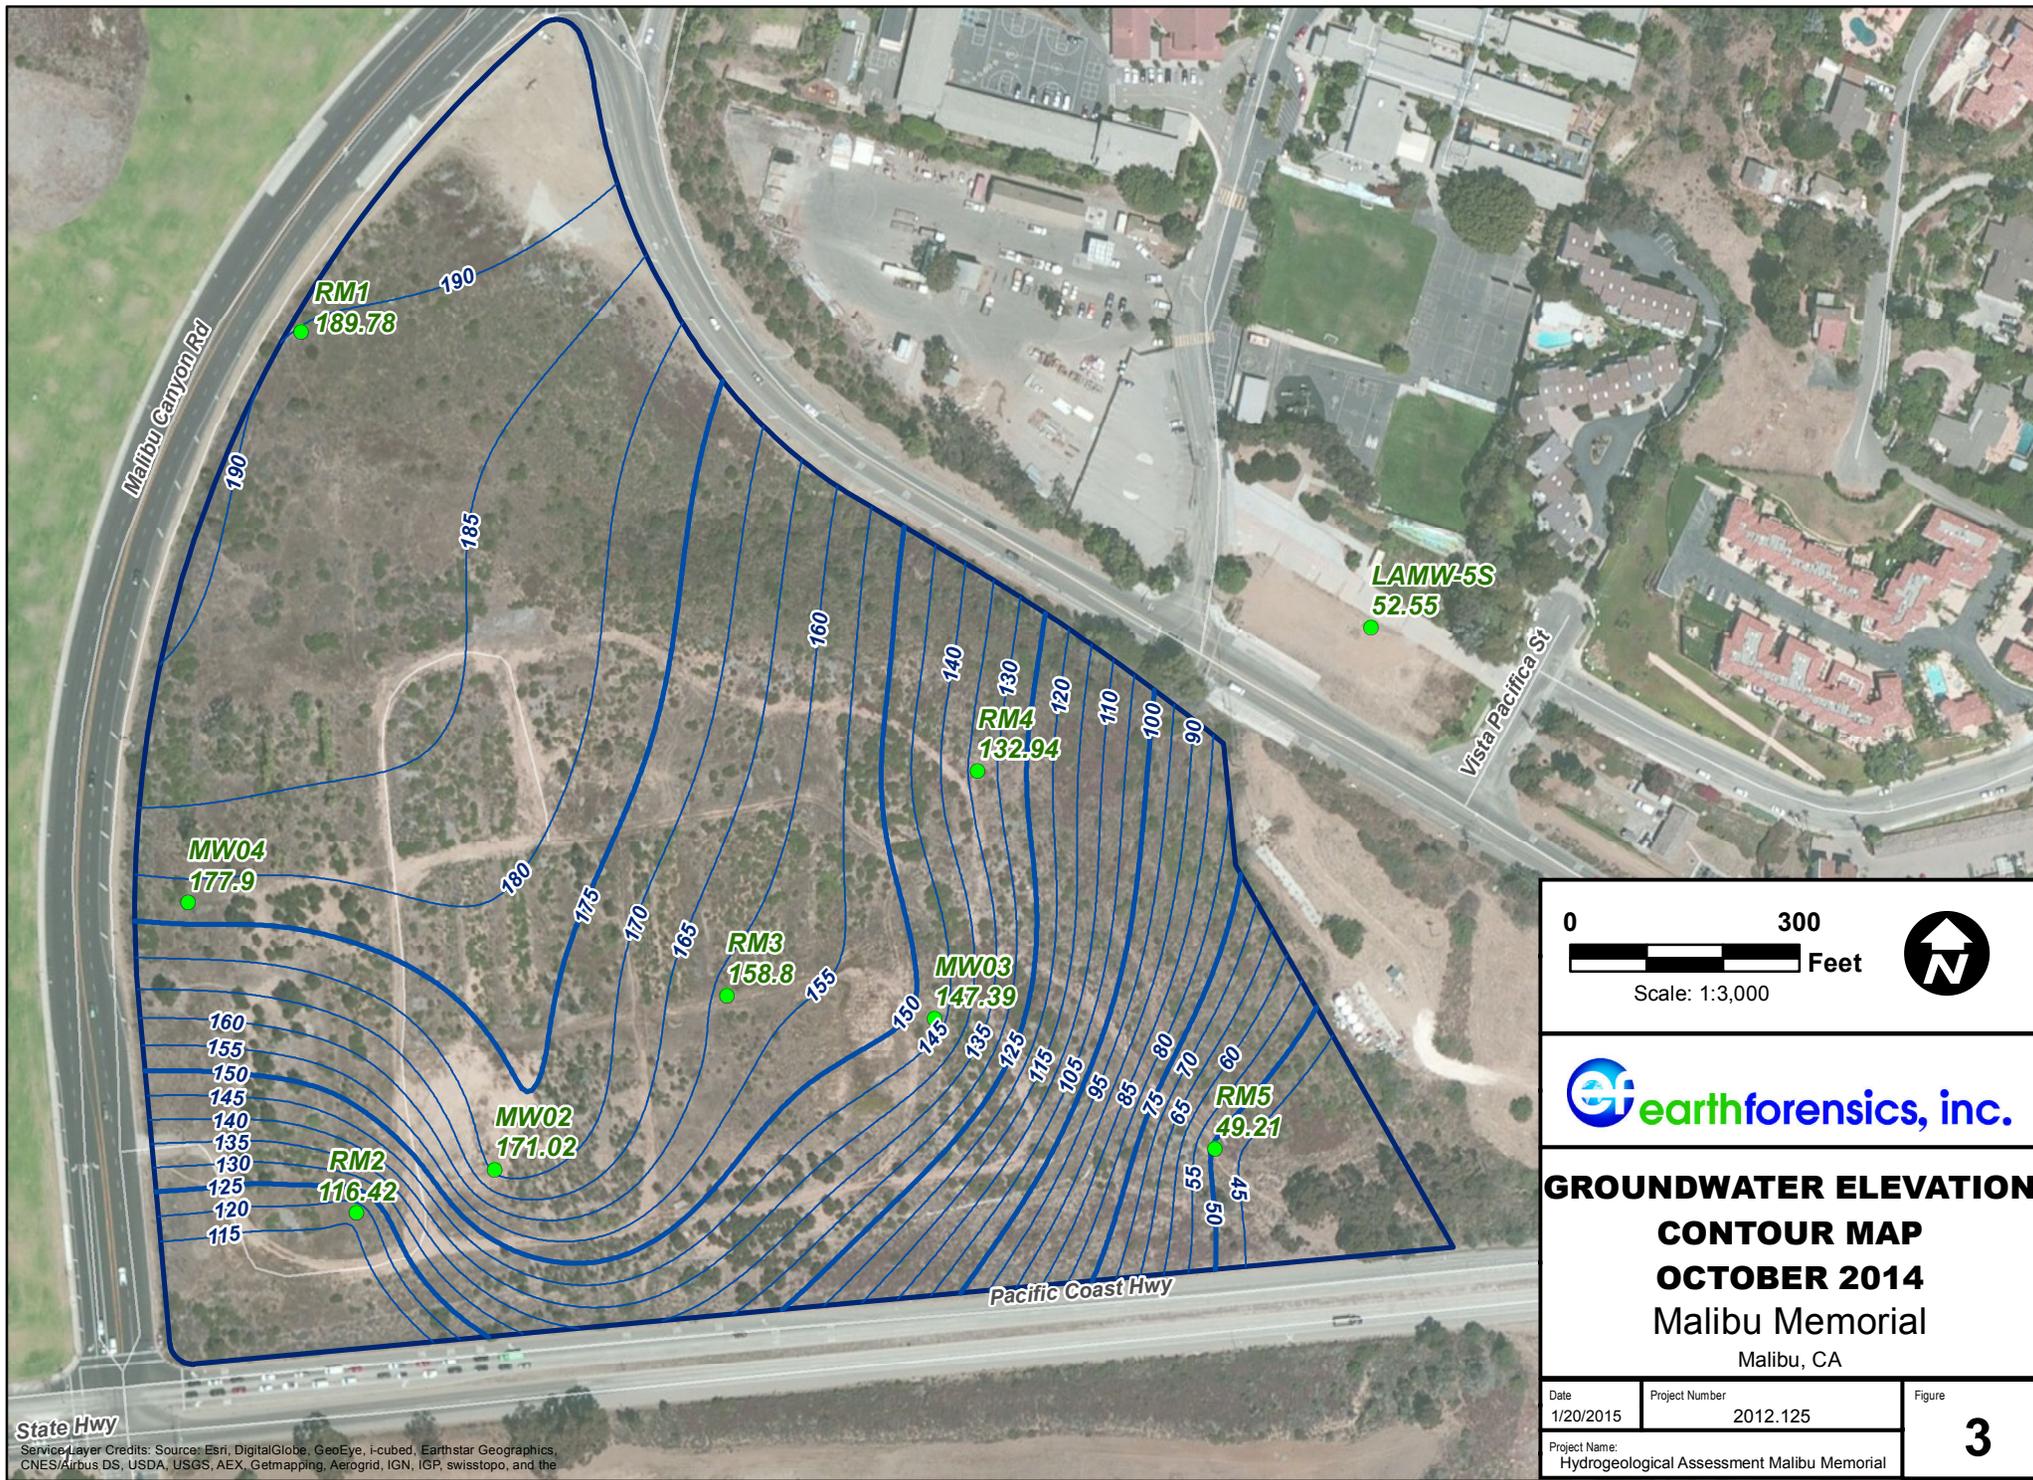
Scale: 1:3,000		
GROUNDWATER ELEVATION CONTOUR MAP OCTOBER 2014 Malibu Memorial Malibu, CA		
Date 1/20/2015	Project Number 2012.125	Figure 3
Project Name: Hydrogeological Assessment Malibu Memorial

There are 8 existing on-site groundwater monitoring wells. On October 17, 2014 a groundwater survey was conducted and the results are shown in Figure 4. To confirm that groundwater levels have remained near October 2014 levels, a groundwater level survey was conducted on October 6, 2015 and is shown in Table 1. Since the water levels have not drastically changed, the groundwater elevation contour map in Figure 4 was not updated.

Based on the monitoring wells on the Project Site and Pepperdine, groundwater flow direction is divided over the site. Along the eastern margin, the flow direction is easterly to southeasterly (Figure 4). Along the western margin, the flow direction is westerly to southwesterly. It is possible that the groundwater flow has been somewhat impeded by the Malibu Coast fault. If the fault were acting as a semi-permeable barrier to the subsurface flow, groundwater would potentially mound against the fault and flow parallel to it, ultimately draining through Winter Canyon to the east. Groundwater level data is plotted both as a groundwater contour map (see Figure 4) and as a hydrograph (see Figure 5).
