**Subject: Broad Beach Road Biofiltration Project, Preliminary Design Report
Addendum**

Geosyntec submitted a Preliminary Design Report (PDR) to the City of Malibu (City) on April 16, 2012 for the Broad Beach Road Biofiltration Project (the Project). The PDR described project objectives and presented two design alternatives. Around this same time, a Settlement Agreement between the City and the Santa Monica Baykeeper and the National Resources Defense Council (Case No.: CV 08-1465-AHM (PLAx)) imposed additional stormwater best management practices (BMPs) and water quality requirements on the City's Broad Beach Road drains. The purpose of this letter is to document the proposed revisions to the PDR, addressing these Settlement Agreement requirements. The letter lists the original project objectives, describes the additional requirements of the Settlement Agreement, proposes changes to the PDR required for compliance, and describes the implications to project cost.

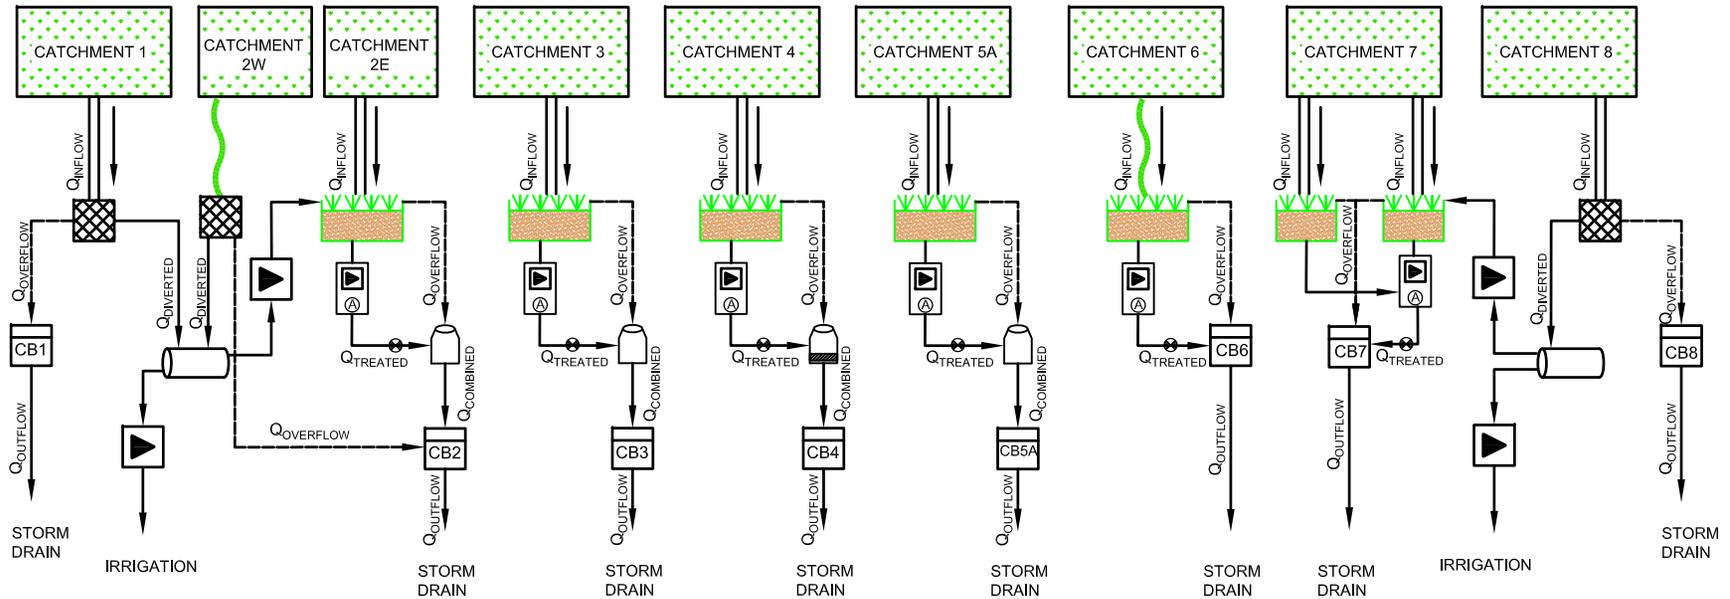
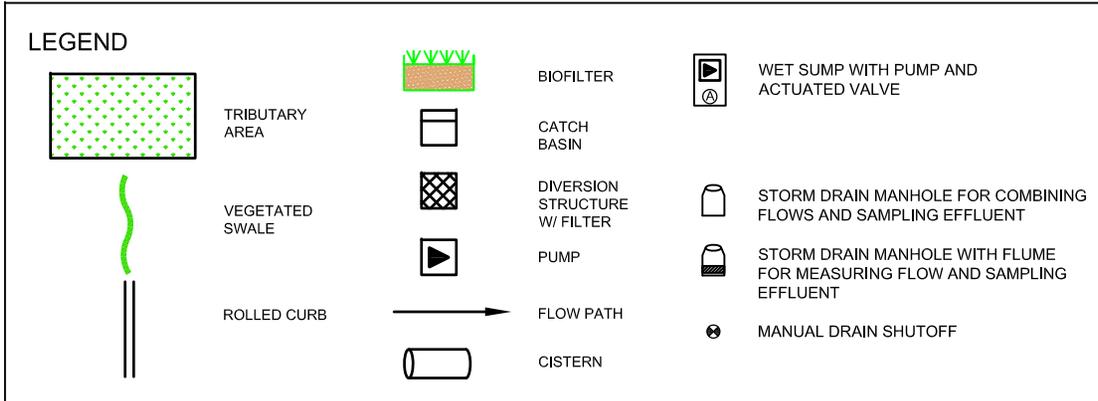
REVISED FLOW SCHEMATIC
 PRELIMINARY DESIGN REPORT ADDENDUM
 BROAD BEACH ROAD BIOFILTRATION PROJECT
 CITY OF MALIBU, CA

To function as bioretention devices and meet the goal of reducing the number of stormwater discharges, the filling and emptying of the biofilters must be regulated. This will be accomplished by installation of a wet sump within the biofilter, fitted with a sump pump and level controls. A typical profile and section of the biofilters is shown in Figure 1. At the high-water-level set point of the biofilter, the sump pump would be automatically cycled, emptying

the biofilter and readying it to receive additional stormwater. The biofilter would also be constructed with an overflow pipe to prevent flooding, should the biofilter be inundated or in the event of pump failure. Figure 2 illustrates the design flow schematic. Catchments 2, 3, 4, 5, and Drain 2 were selected for monitoring. Applying historical precipitation data to this design, we calculate that the biofilters would discharge approximately 15 times per year.

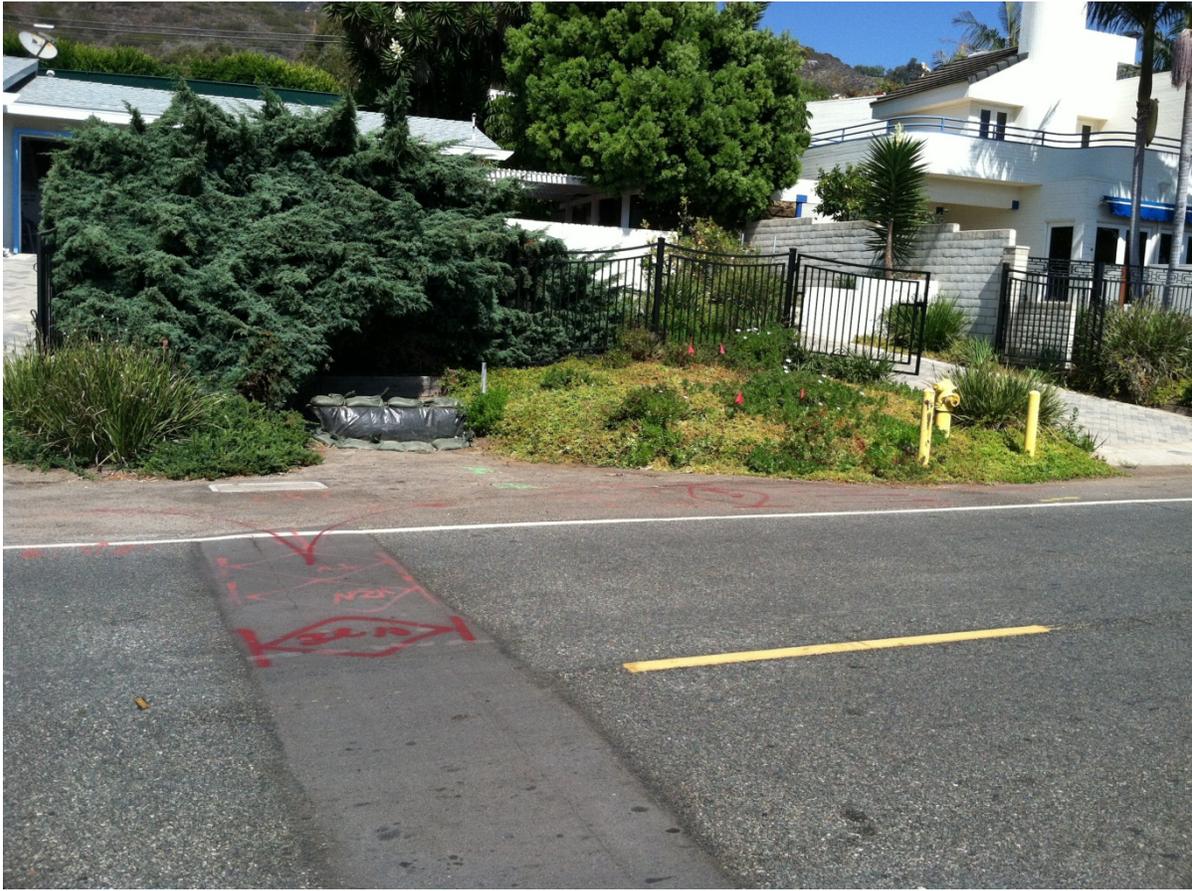
Drain 2 Catch Basin Looking North Across Broad Beach Road.

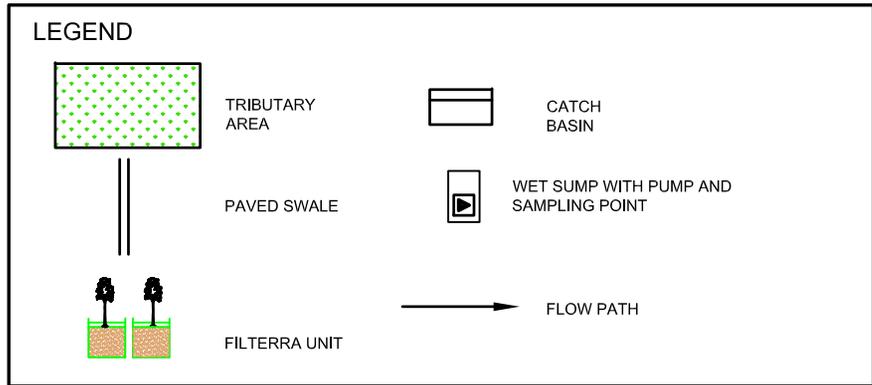
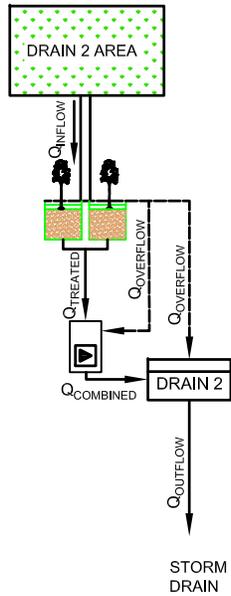
Figure 5
Los Angeles, CA	NOVEMBER 2012

DRAIN 2 FLOW SCHEMATIC
PRELIMINARY DESIGN REPORT ADDENDUM
BROAD BEACH ROAD BIOFILTRATION PROJECT
CITY OF MALIBU, CA

- *Requirement 4 - During dry weather, flow/no flow conditions to catch basins must be continuously monitored.* The wet well will be continuously monitored and logged using a bubbler-type water level indicator. All treated water drains to this wet well. If water accumulates in the wet well such that the wet well pump is actuated, indicating a discharge has occurred, the bubbler will log and document this discharge. This approach fulfills the continuous dry weather discharge monitoring requirement.

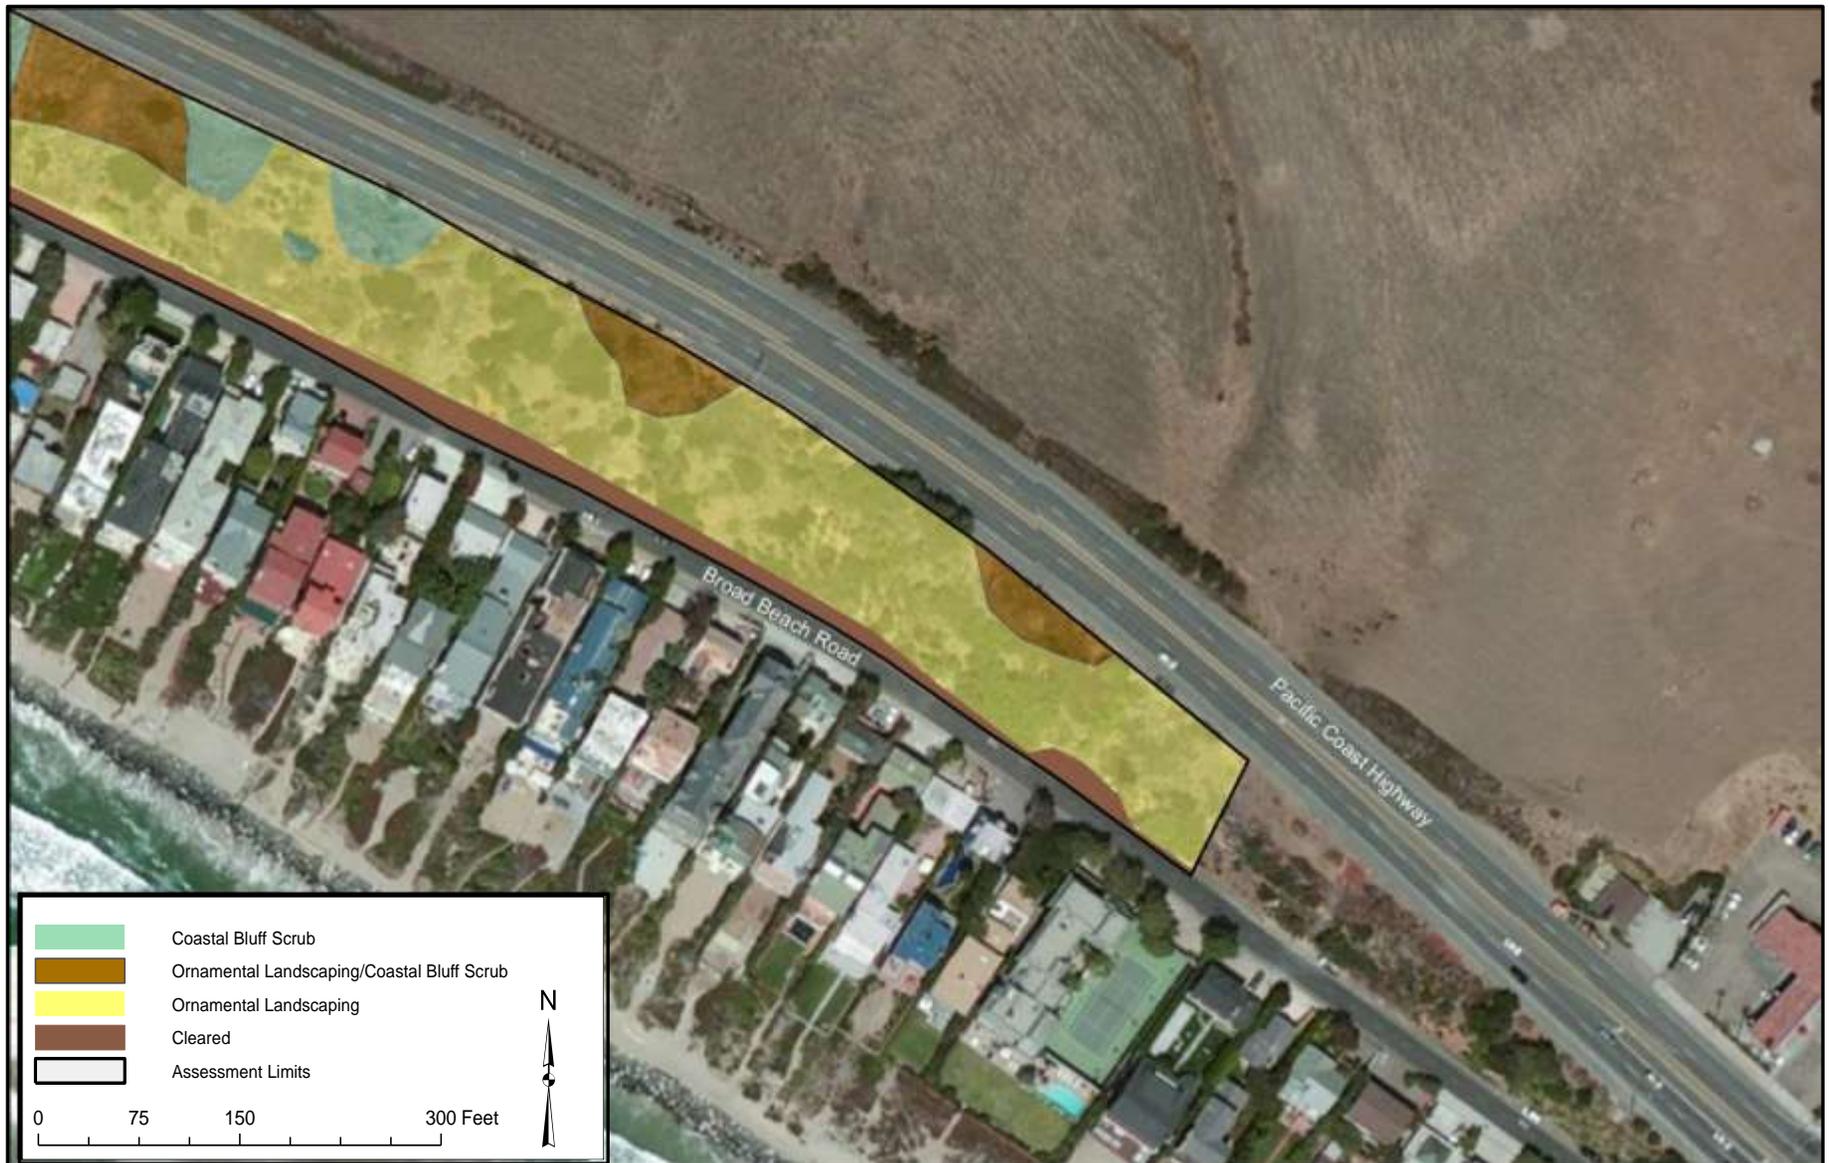
Figure 2A. Vegetation Types of Section 1 - East

Figures 2A, 2B, 2C, and 2D show vegetation types in the assessment area. Figures 3 and 4 provide photographs representing site conditions in sections 1 and 2, respectively. Table 1 provides a list of plant species observed.

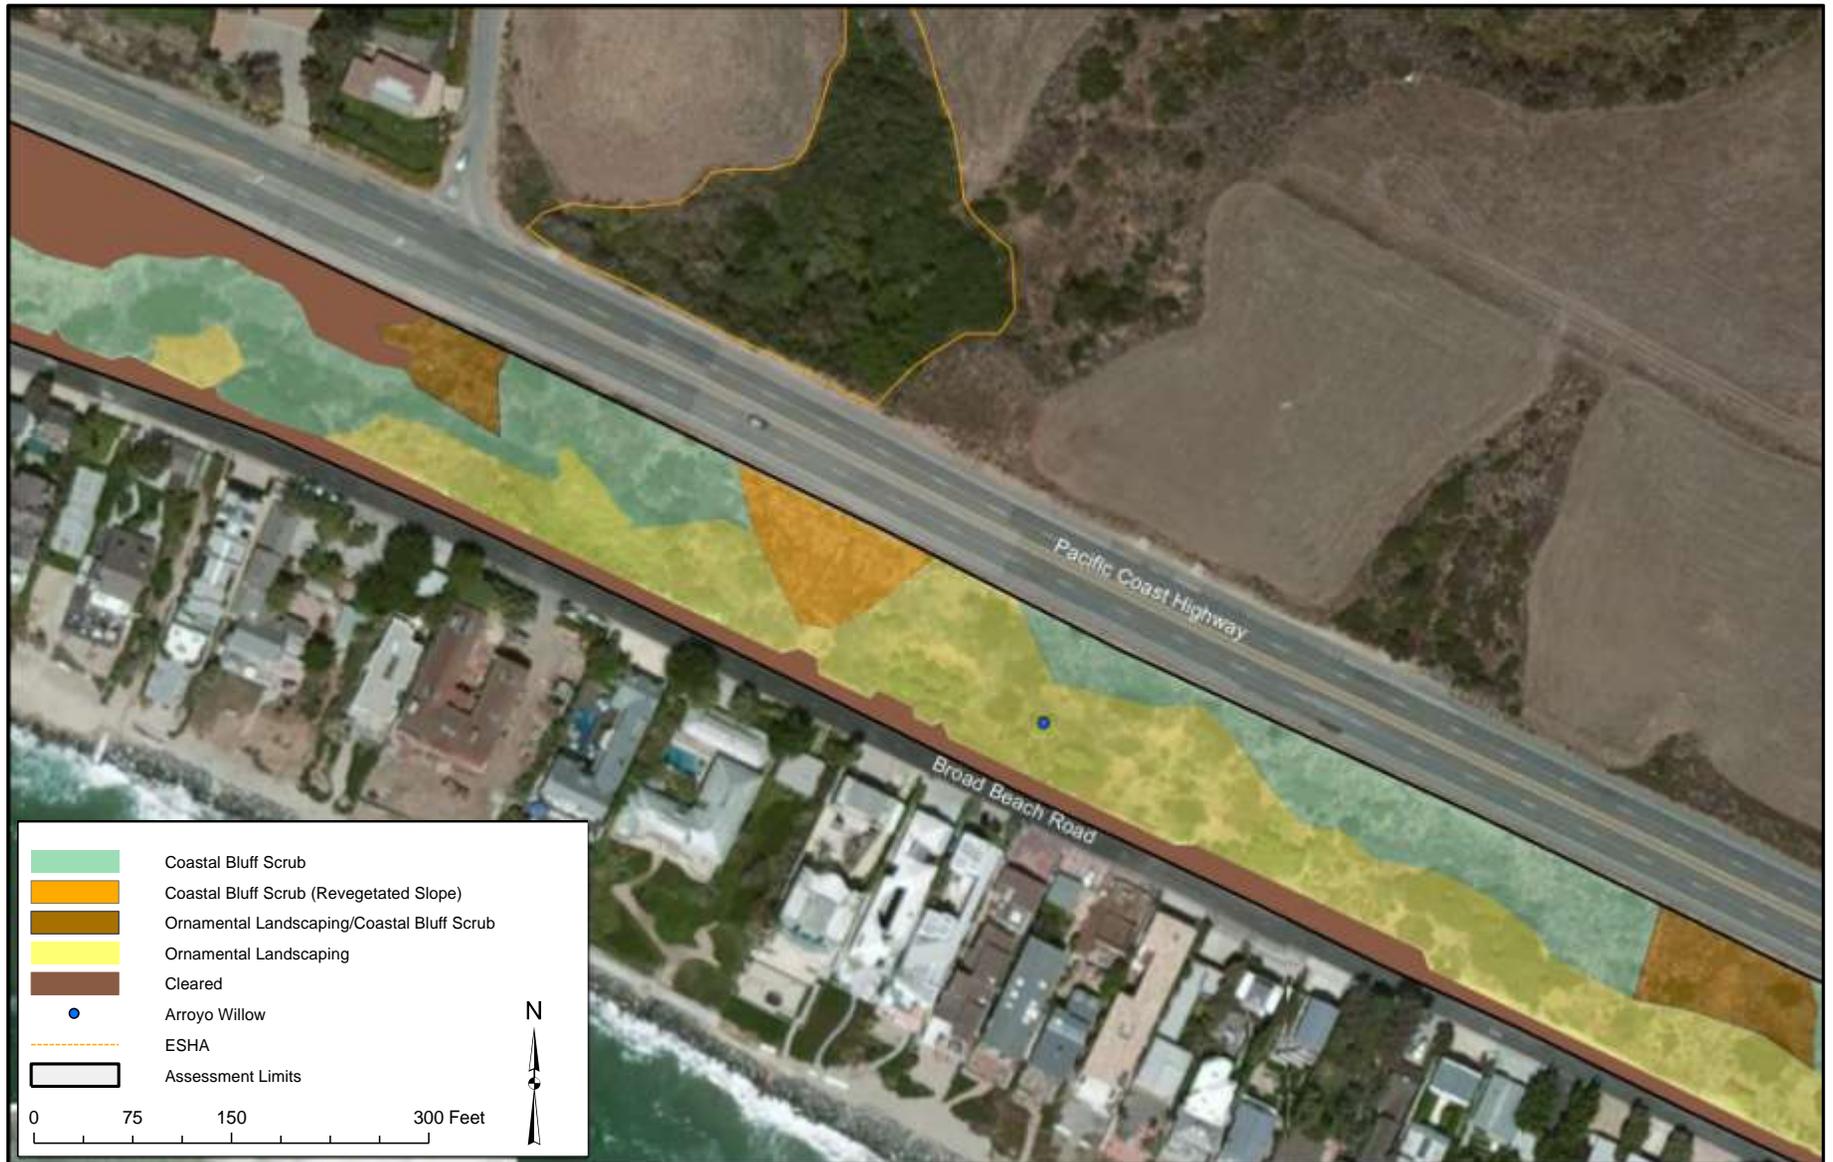
Figure 2B. Vegetation Types of Section 1 - Center

This vegetation type is confined to a small area of steep bluff below Pacific Coast Highway (Figure 2B), and is associated with a short section of the highway that appears to have been repaired. Density and uniformity of the shrub vegetation, along with erosion control material (straw rolls) are evidence of intentional revegetation. The dominant species is native (ashy-leaved buckwheat).

One willow was observed on a slope in the center section of the site (see mapped location, Figure 2B). The willow is associated with a localized zone of high moisture, most likely irrigation. No streambed or wetland indicators were observed at this location.

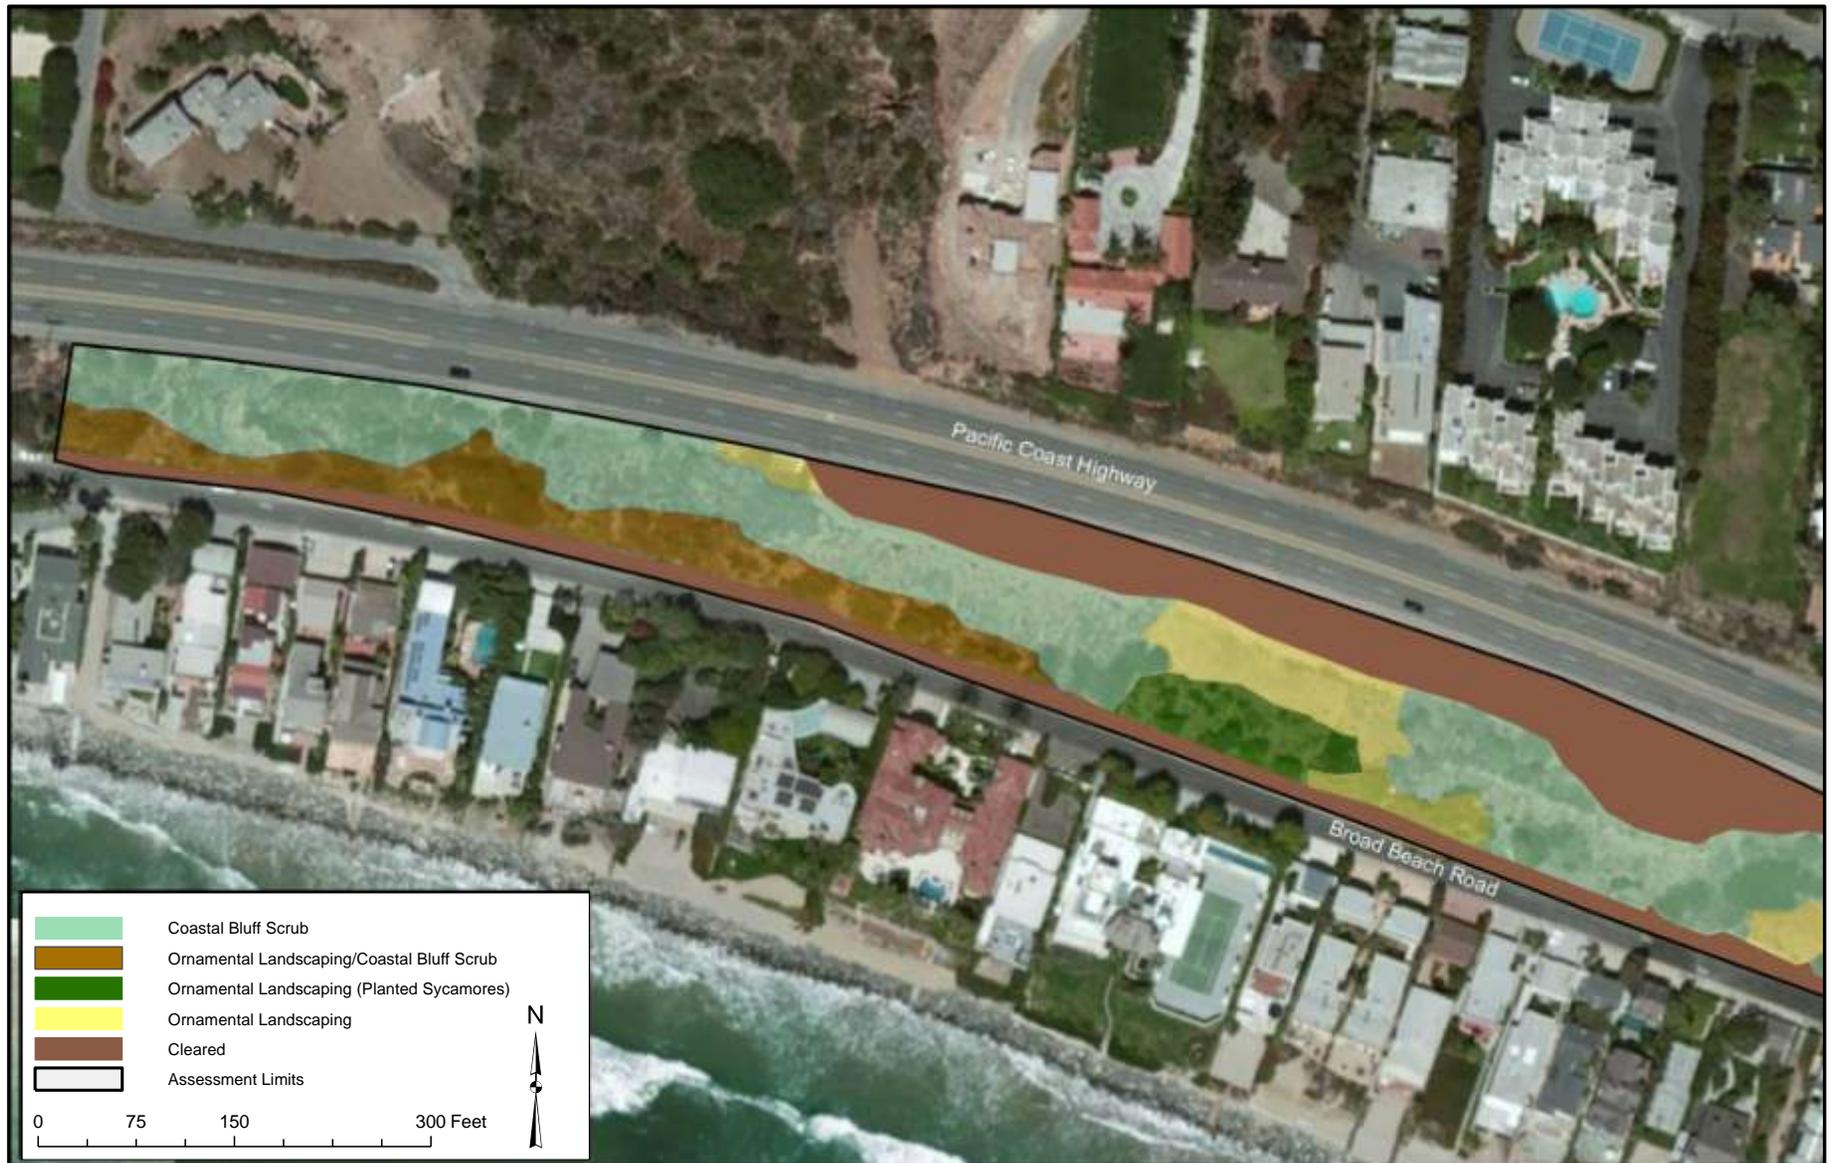
Figure 2C. Vegetation Types of Section 1 - West

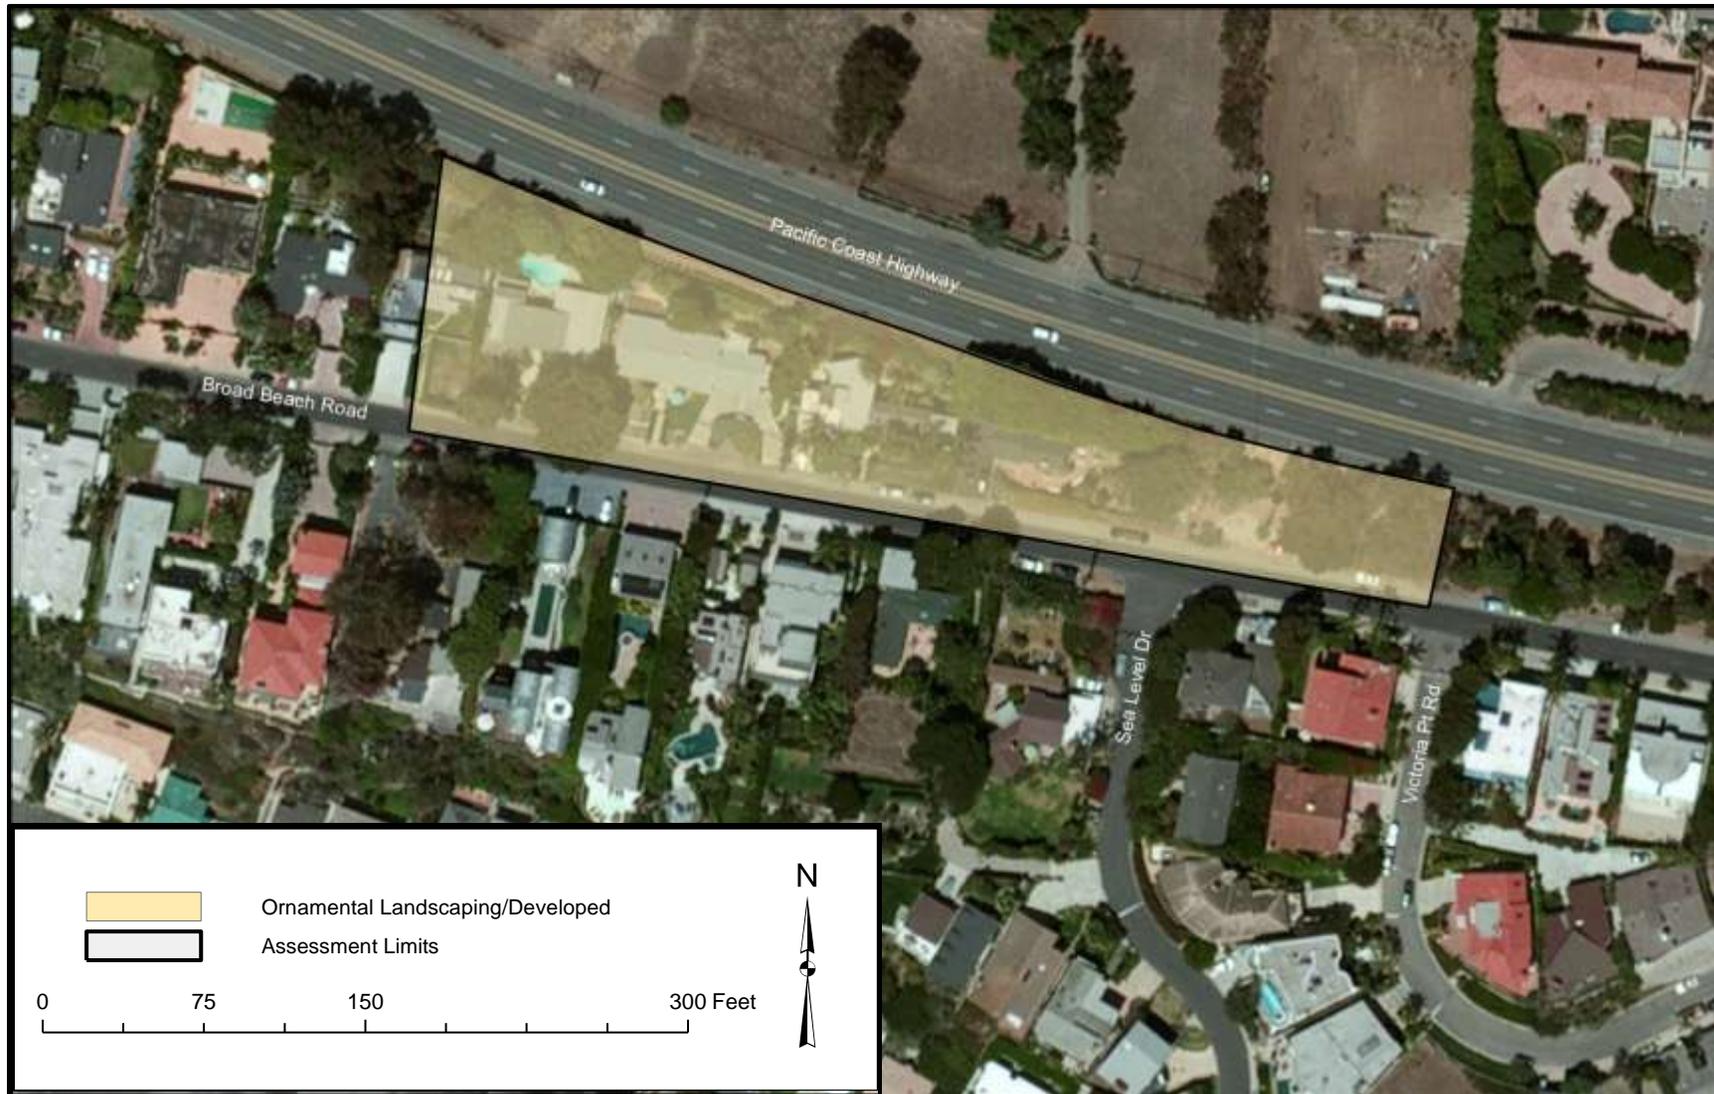
Figure 2D. Vegetation of Section 2

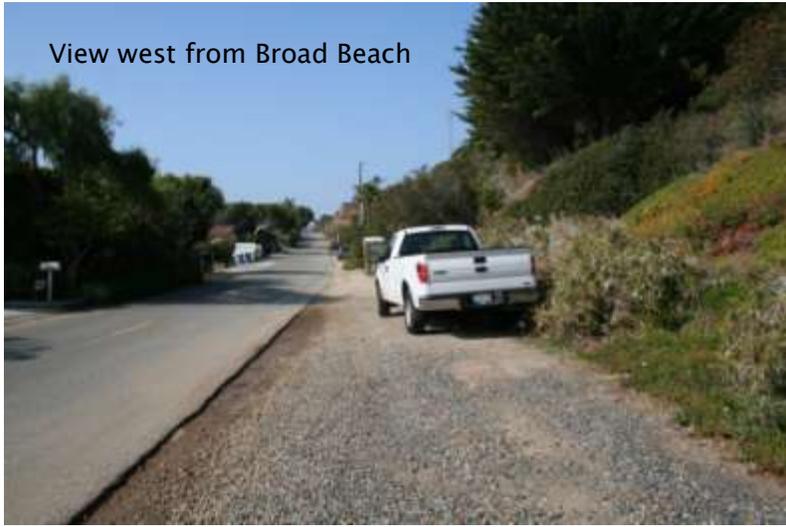
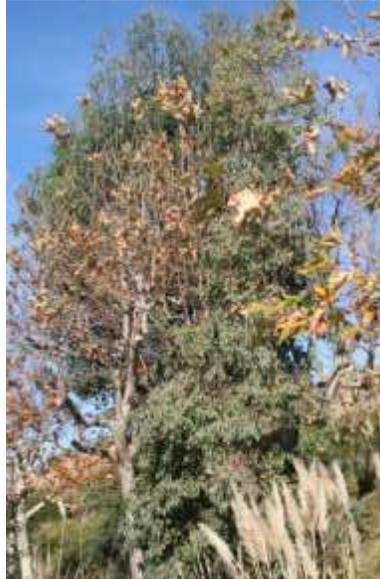
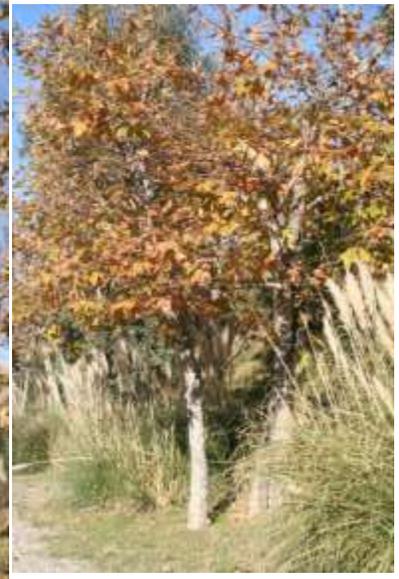
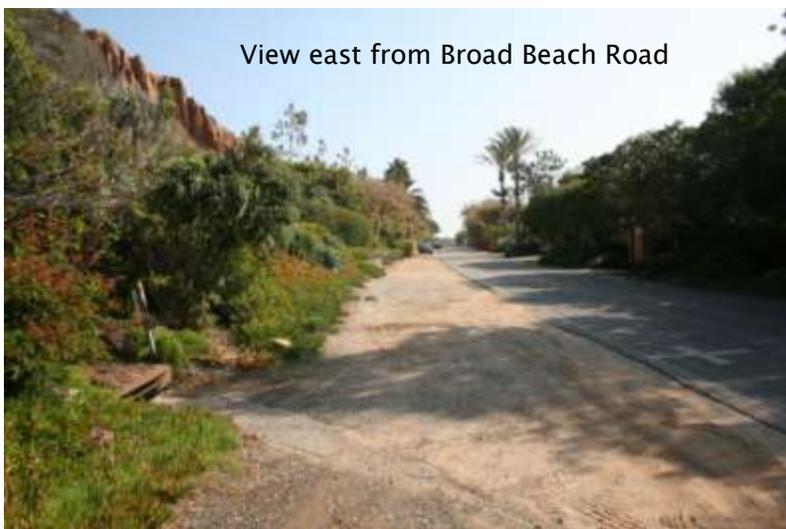
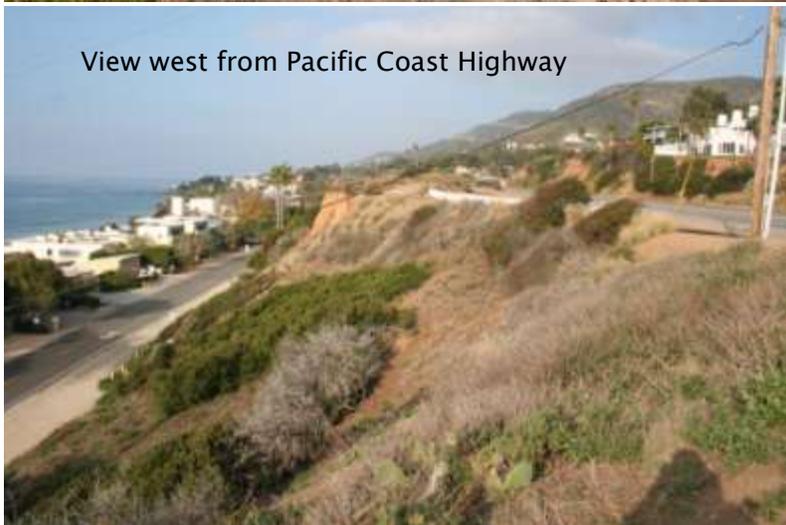
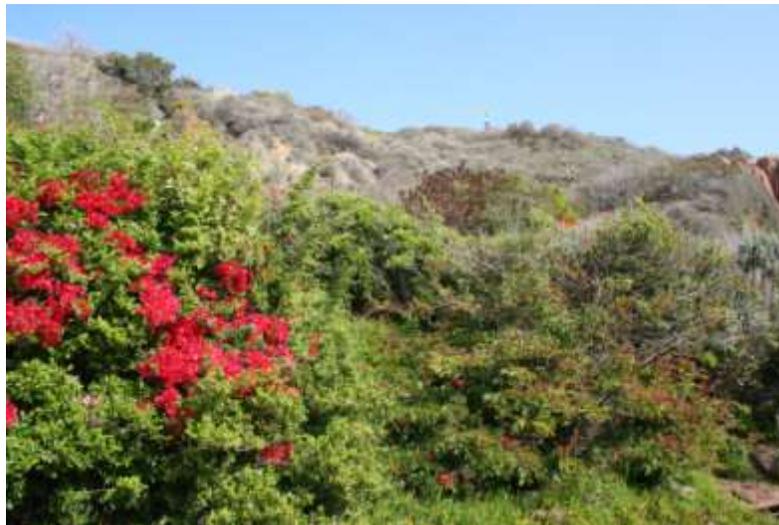
Figure 3. Site Photographs, Section 1

View west from Broad Beach

View east from Broad Beach Road

Above: planted sycamore grove mapped on Figure 2C, associated with non-native vegetation (eucalyptus, pampas grass).

Below: view northeast from Broad Beach Road, showing coastal bluff scrub on the upper slopes (outside expected project footprint) and ornamental vegetation on the lower slopes. Flowering shrub is bougainvillea, a planted ornamental that is not invasive but requires irrigation.

View west from Pacific Coast Highway

Ornamental landscaping consists primarily of exotic vegetation that has been planted and irrigated. As can be seen from the photographs in Figure 3, this vegetation dominates the lower slope of the assessment area along Broad Beach Road. This vegetation includes invasive species such as pampas grass (*Cortaderia selloana*). No attempt was made here to identify and list all of the planted ornamental species and nursery cultivars, but examples include pines, junipers, eucalyptus, bamboo, bougainvillea, plumbago, pepper trees, and myoporum.

Examples of these trees are shown in the photographs in Figure 3. Despite being planted, and arguably not native to the area since there is no historical evidence of trees at this site, these trees probably fall under the protection of the City's Native Tree Protection Ordinance because they are native to California. This Ordinance does not distinguish between indigenous and planted trees.

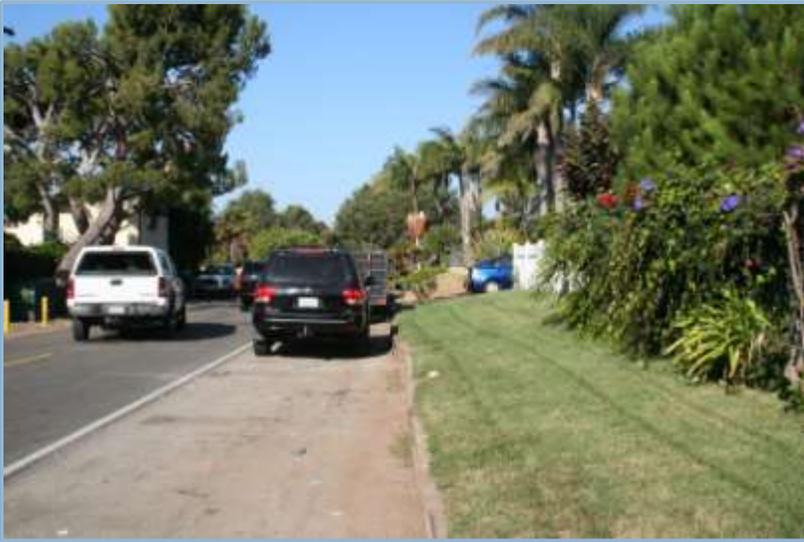
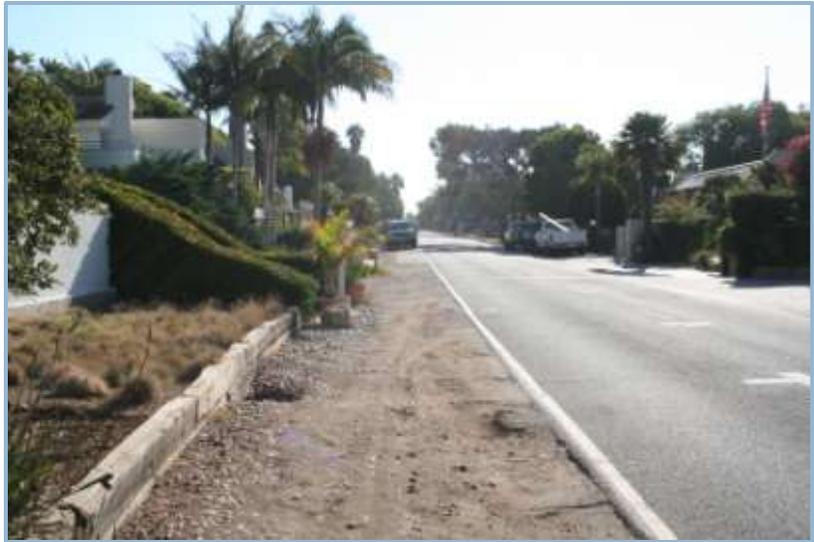
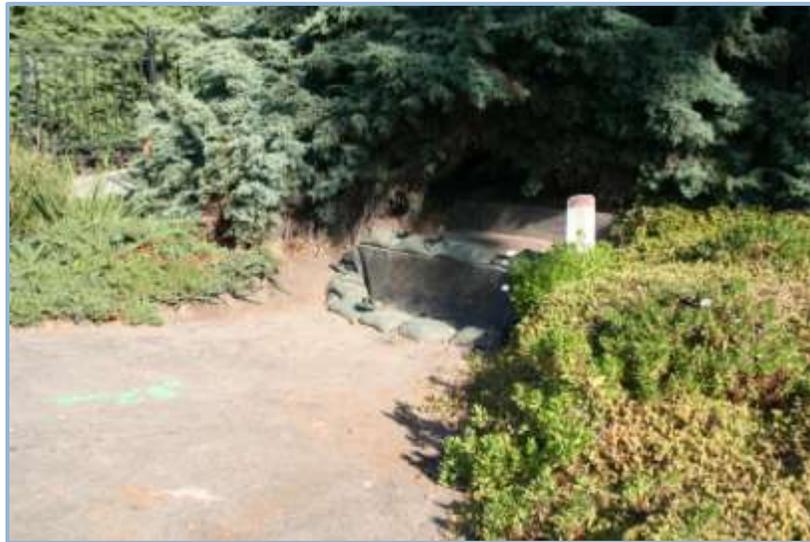
Figure 4. Site Photographs, Section 2

View west from east end
of Drain 2 catchment

View east from west end
of Drain 2 catchment

Drain location

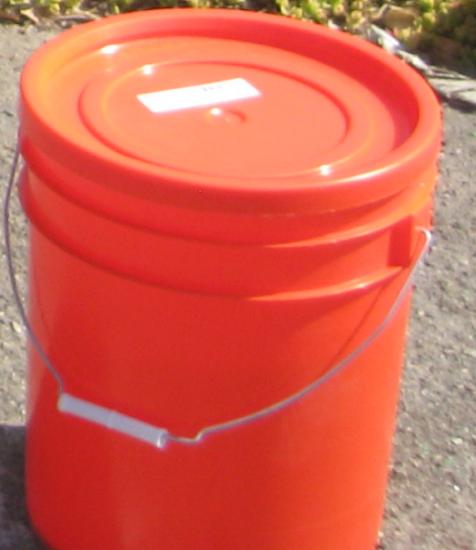
Borehole 1

1) Soil Name (USCS) 6) Plasticity 2) Color 7) Density/Consistency 3) Moisture 8) Other (Mineral Content, Discoloration, Odor, etc.) 4) Grain Size 5) Percentage								1) Rig Behavior 2) Air Monitoring 3) Pocket Pen 4) Tor Vane									
0'		Organic silt of low plasticity (OL). Brown black. Absorbs moisture, dry. (10, 10, 80). Roots.	OL							11:00									
1'		Inorganic silt of low plasticity (ML) low plasticity. Black brown Dry to moist. (15, 10, 75)	ML																
2'	10																		
3'	20																		
4'	20	Sand-silt mixtures (SM) Brown. Dry to moist. (10, 45, 45). Piece of sandstone.	SM																
5'	25	Inorganic clay of low plasticity (CL). Brown. Dry to moist. (10, 20, 70). Smearing	CL	2															
6'	30

In summary, the soils encountered on Broad Beach Boulevard in Malibu California appear to be adequate to support the construction of the Filterra Bioretention System. The upper 8 inches of the borehole consisted of an organic low plasticity silt, which was most likely placed in the area for landscaping purposes. Low plasticity silt was found directly below the vegetated area. A sand-silt seam of approximately 6 inches thick was found below the silt layer. Below the sand seam, low plasticity clay extended throughout the rest of the borehole. In general, the water content and the plasticity of the soil both increased with depth. Based on the visual classification of the soils in the vicinity, it does not appear that there are special geotechnical conditions which would restrict the installation of the Filterra unit.
