City of Malibu
23825 Stuart Ranch Road
Malibu, CA 90265-4861

Broad Beach Road Biofiltration Project

Preliminary Design Report

April 2011

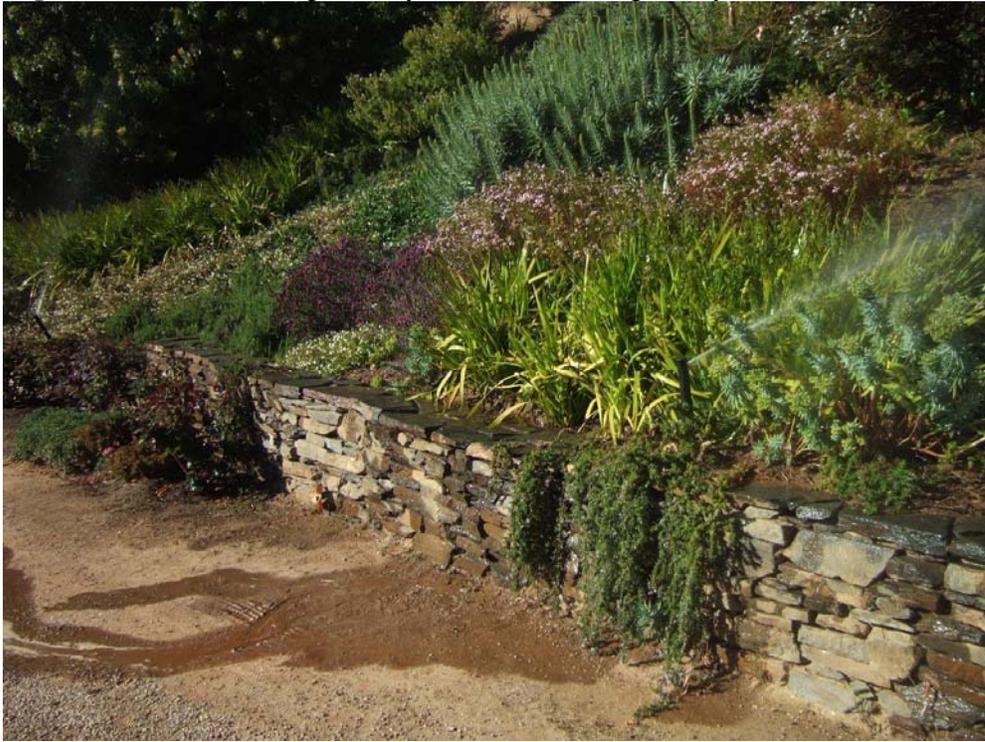
Figure 2-3. Private irrigation system contributing to dry-weather runoff

private drains owned by each residence. Many residents have installed separate private irrigation systems on the north side of the street, on city of Malibu property and within the Project area. To eliminate dry-weather flows, these irrigation systems will be removed and city-operated water-efficient irrigation will be installed in place of these private systems. High-water-use ornamental and exotic plants will be removed and replaced with drought-tolerant native species, reducing the need for frequent irrigation during the dry season.

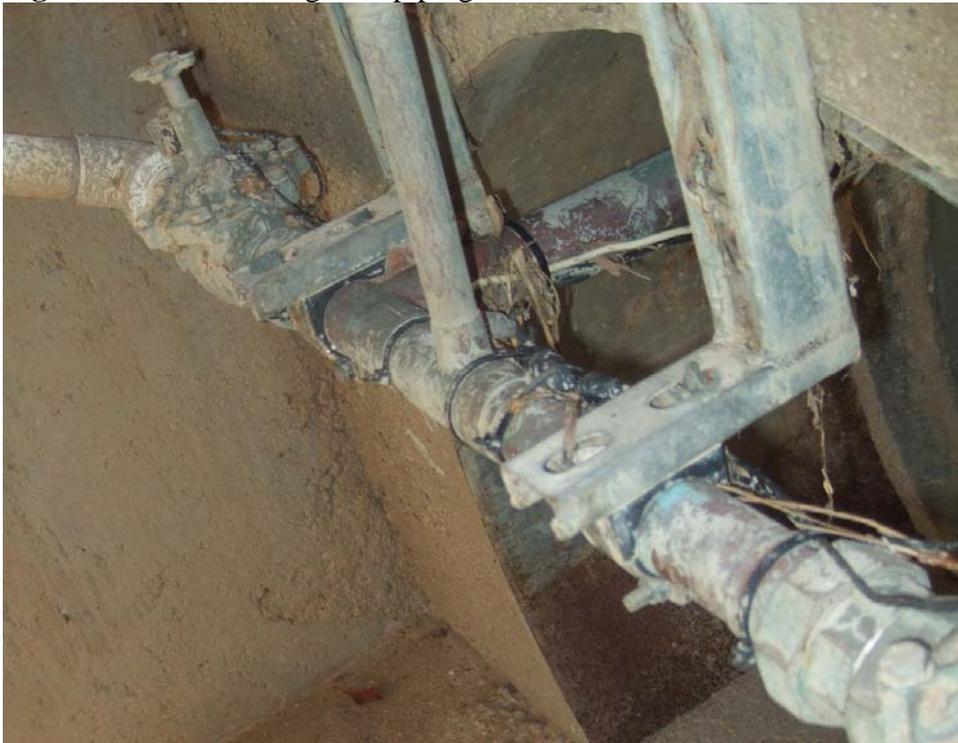
Figure 2-4. Private irrigation piping in storm drain

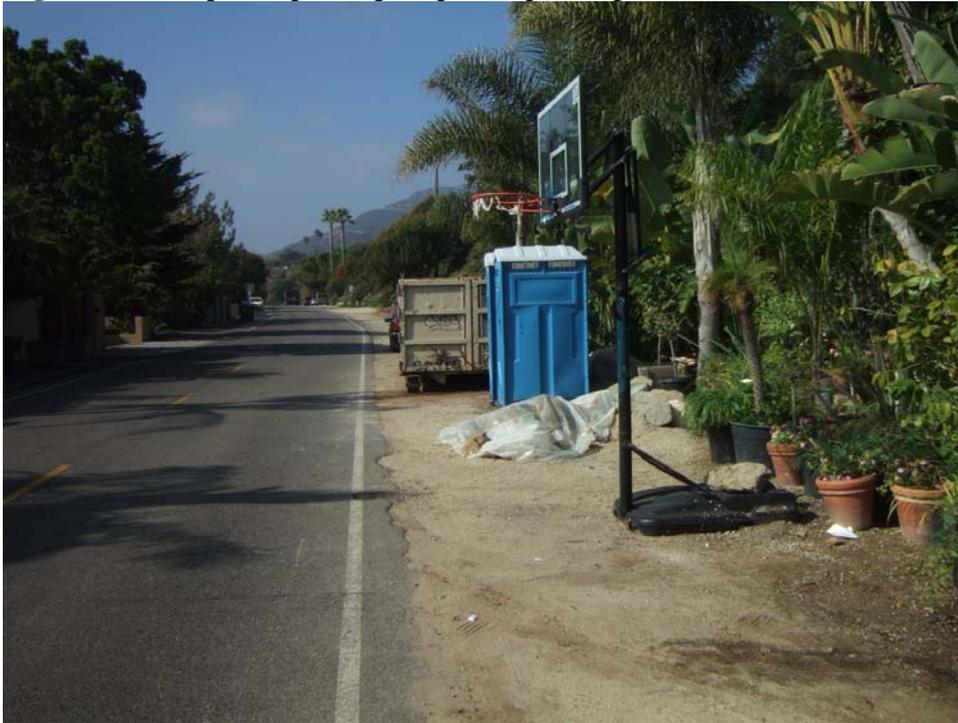
Figure 2-5. Unpaved parking strip with potted plants

Many Broad Beach Road residents have created gardens across from their residences on city property. These gardens include many non-native invasive or ornamental plants and shrubs. On several parcels, numerous potted plants are also stored along the roadway. Although this property is owned by the city, many homeowners have installed private irrigation systems plumbed back to their residential water services. Irrigation piping runs under the road and was also observed within existing storm drain pipe. The private irrigation of gardens creates uncontrolled and unmanageable dry-weather flows which have been observed during recent site visits.

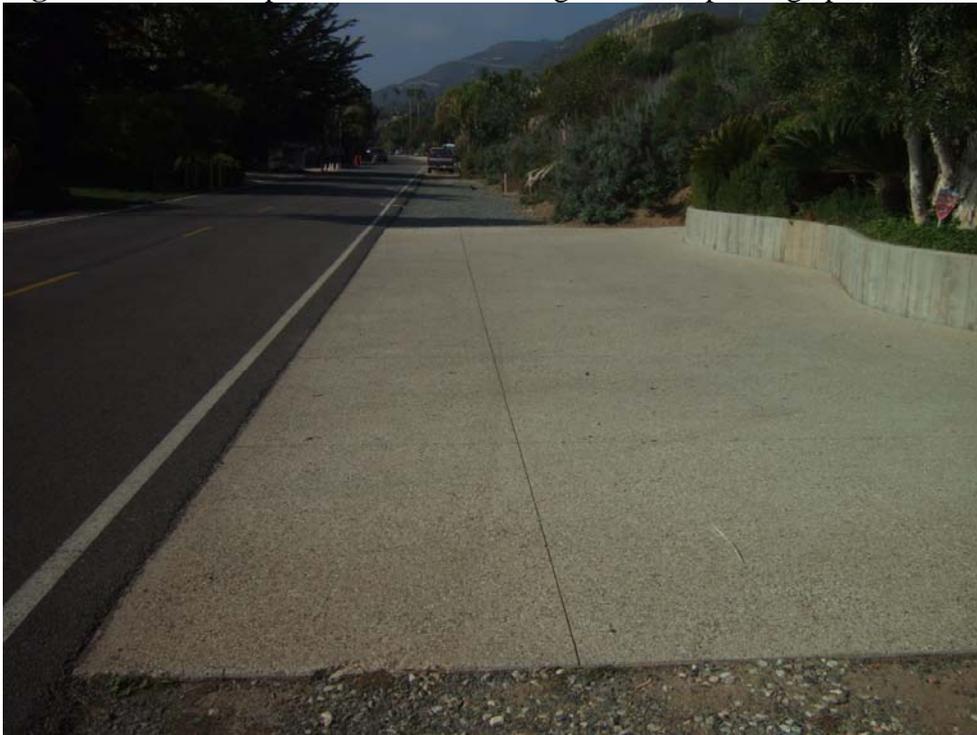
Figure 2-6. Cast in place concrete retaining wall with parking apron

Residents have also constructed several garden and retaining walls along the hillside. These walls are constructed of a myriad of materials including cobbles, broken concrete, masonry brick, and cast-in-place concrete. Some walls appear to have served as a means of disposal of waste broken concrete from driveway replacements. The parcel-specific variable hardscape and landscape elements have created an inconsistent environmental theme for the neighborhood.

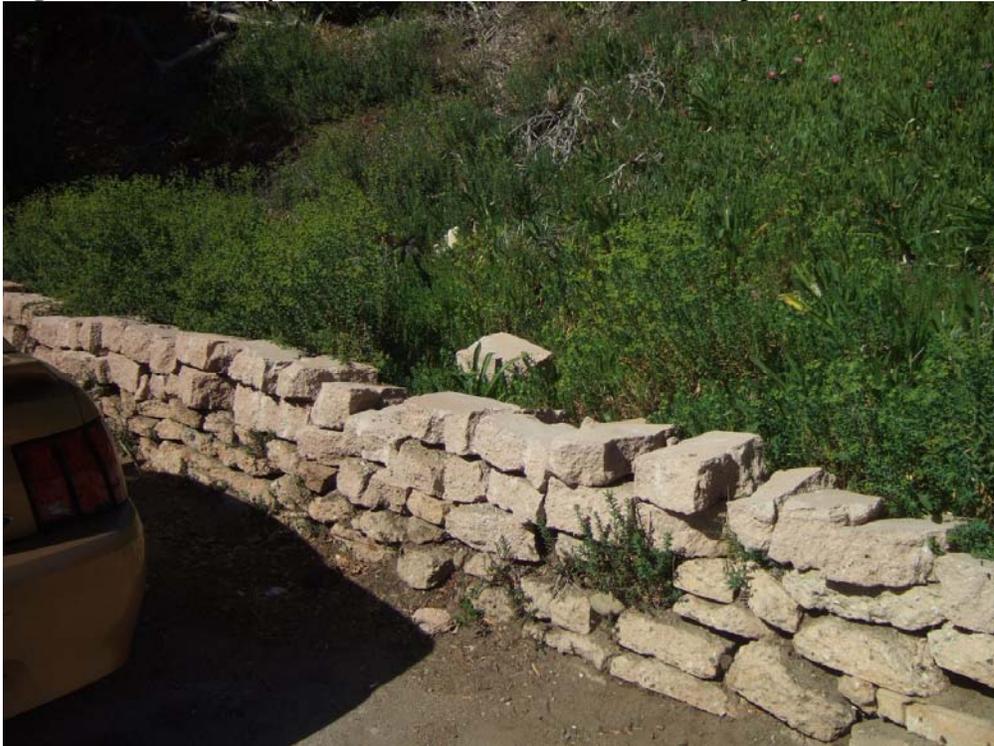
Figure 2-7. Privately constructed waste concrete hardscape

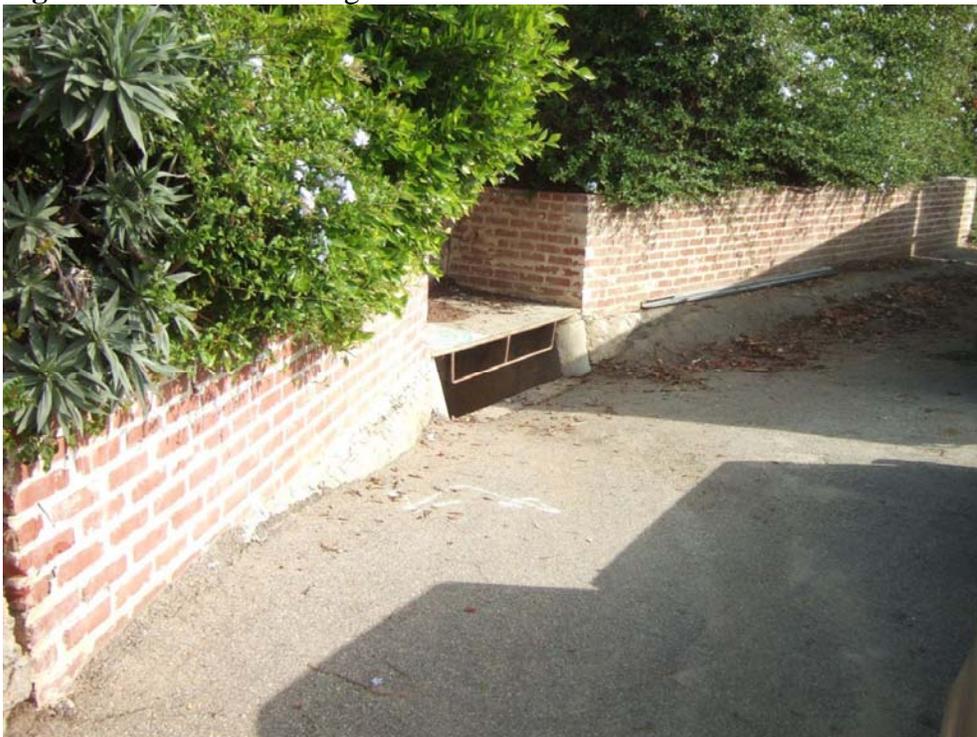
Figure 2-8. Brick retaining wall

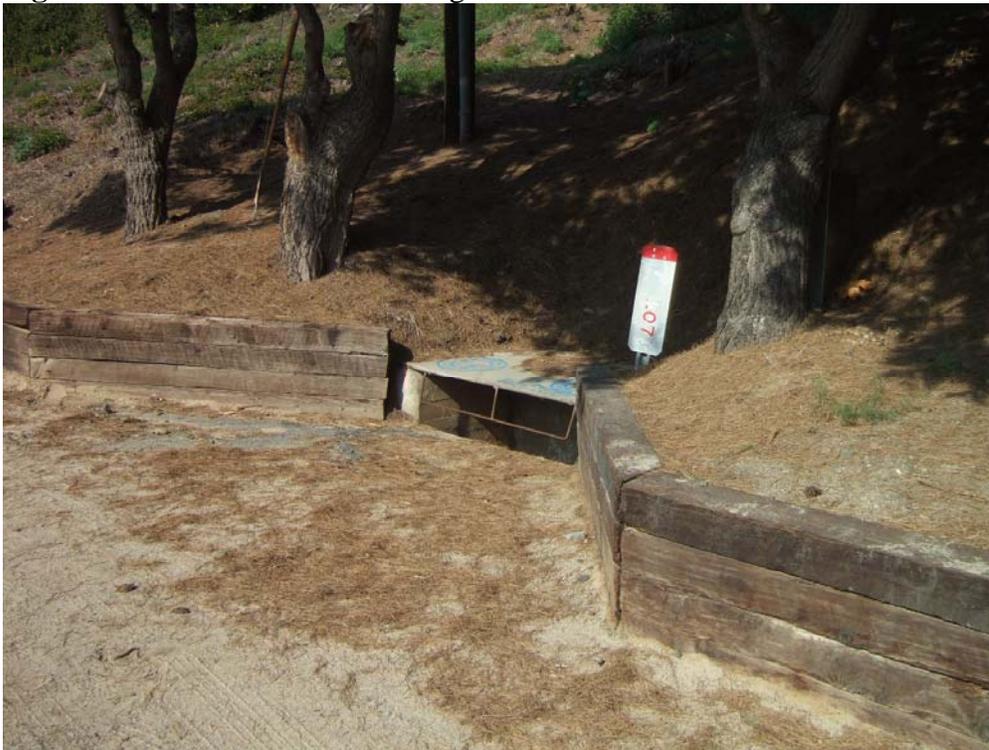
Figure 2-9. Treated wood retaining wall

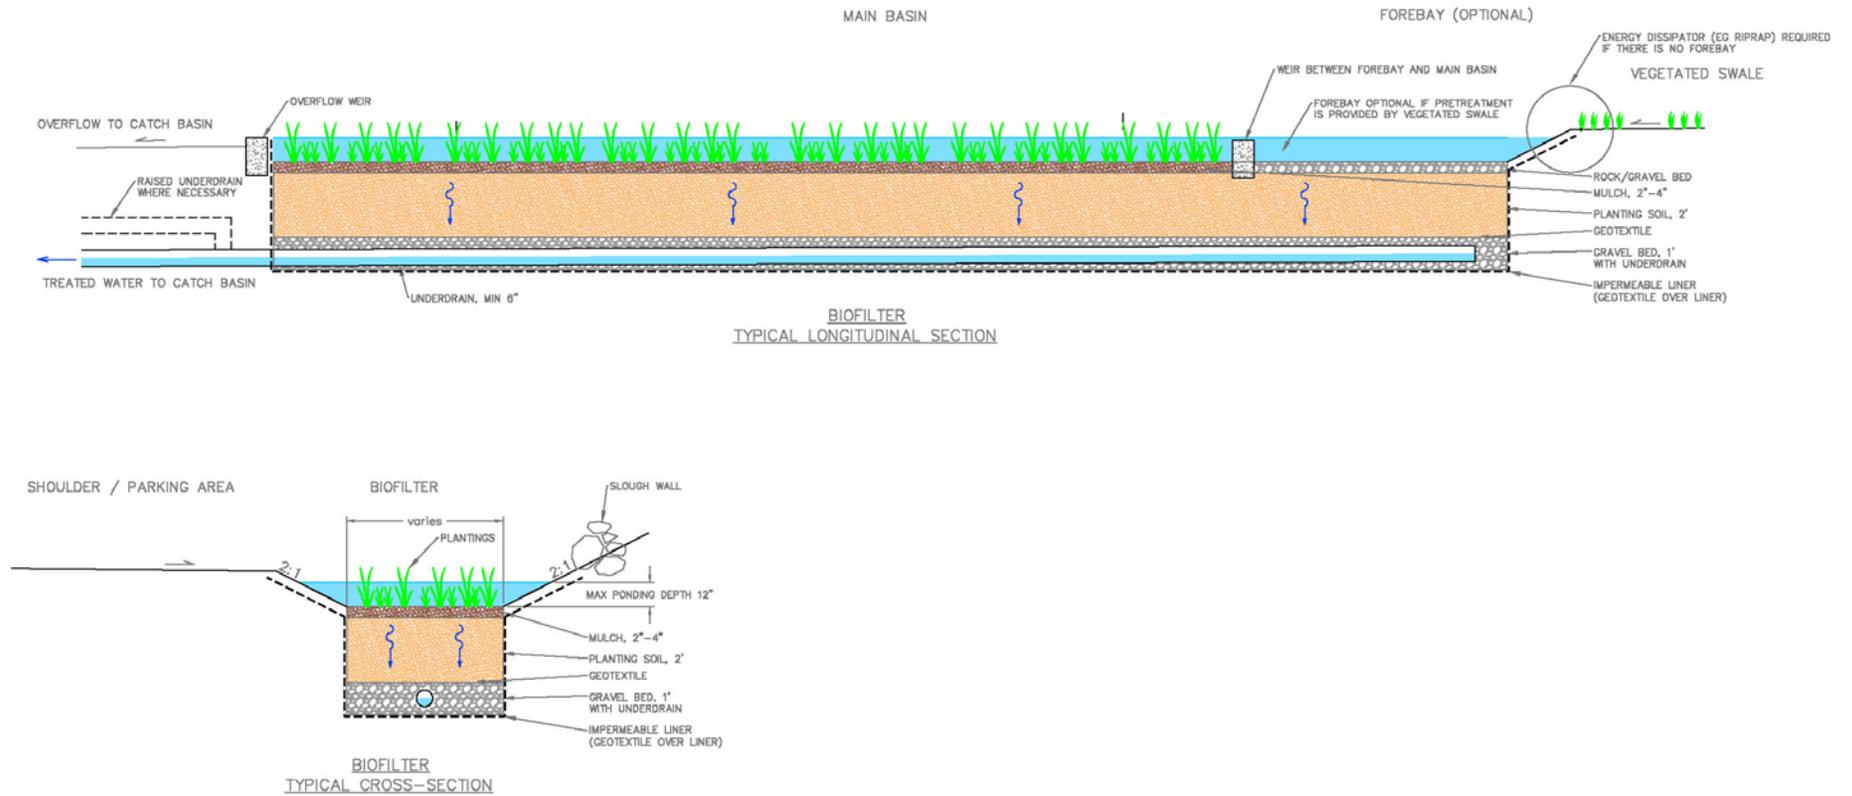
Figure 6-1. Typical biofilter cross-sections and details

- Biofiltration with underdrains and impermeable geo-membranes;
- Permeable pavements with no infiltration to subgrade; and
- Vegetated swales.

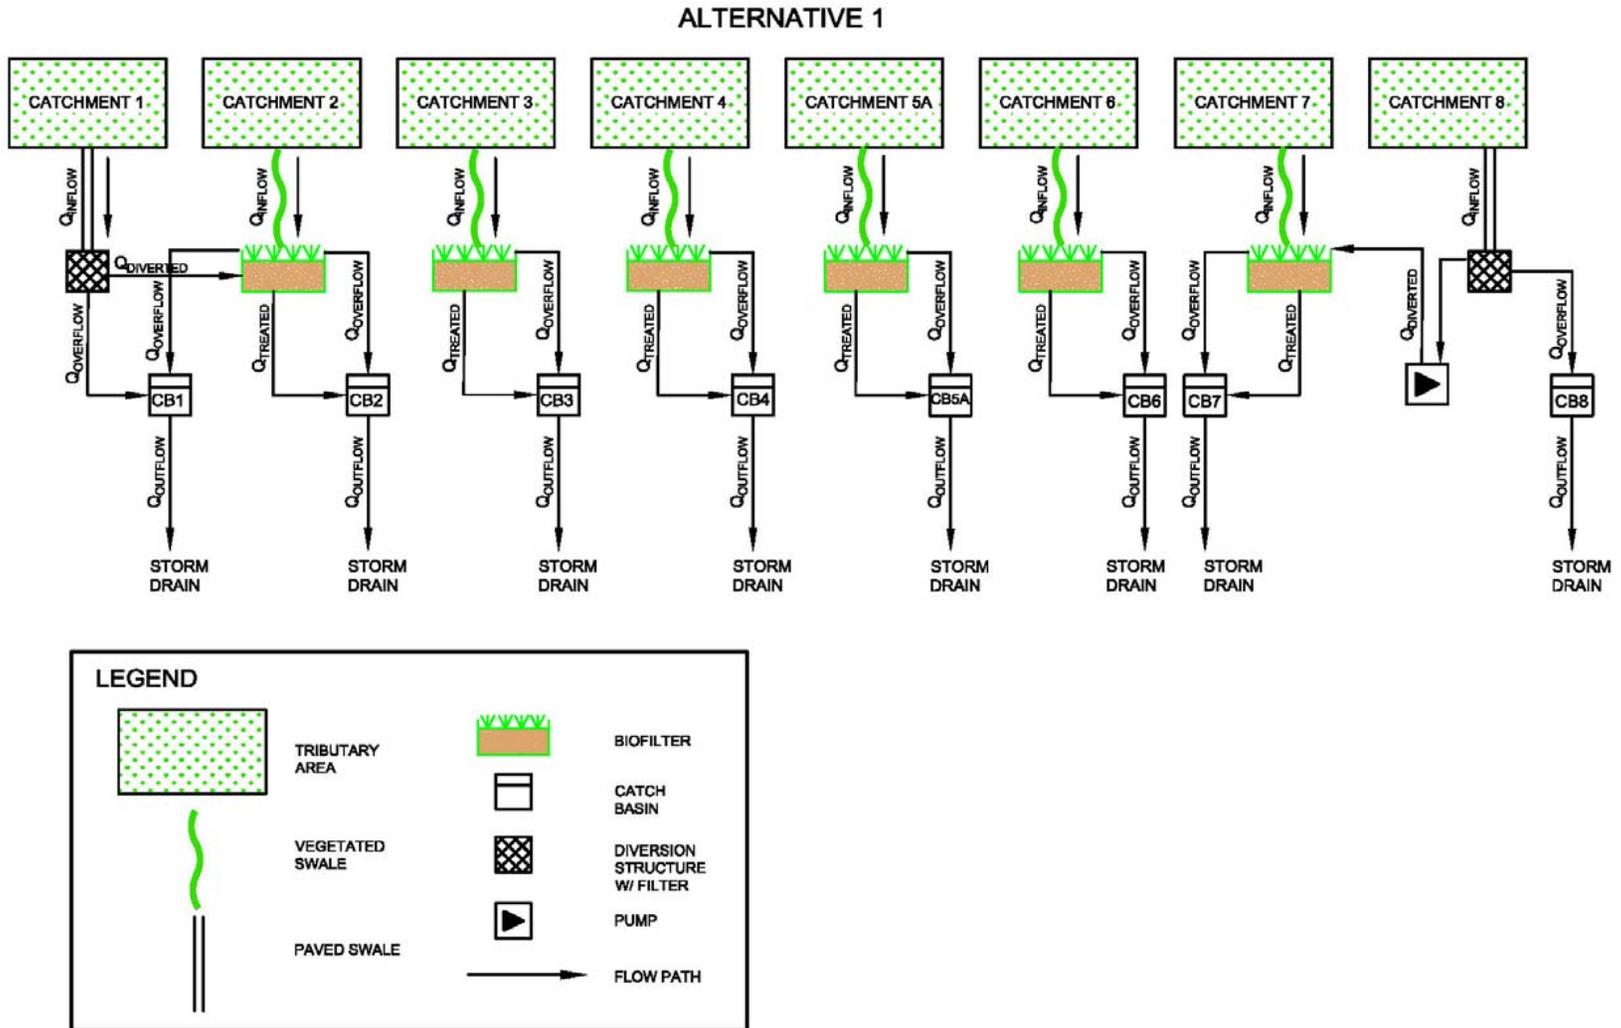
Figure 6-2. Flow diagram for Alternative 1

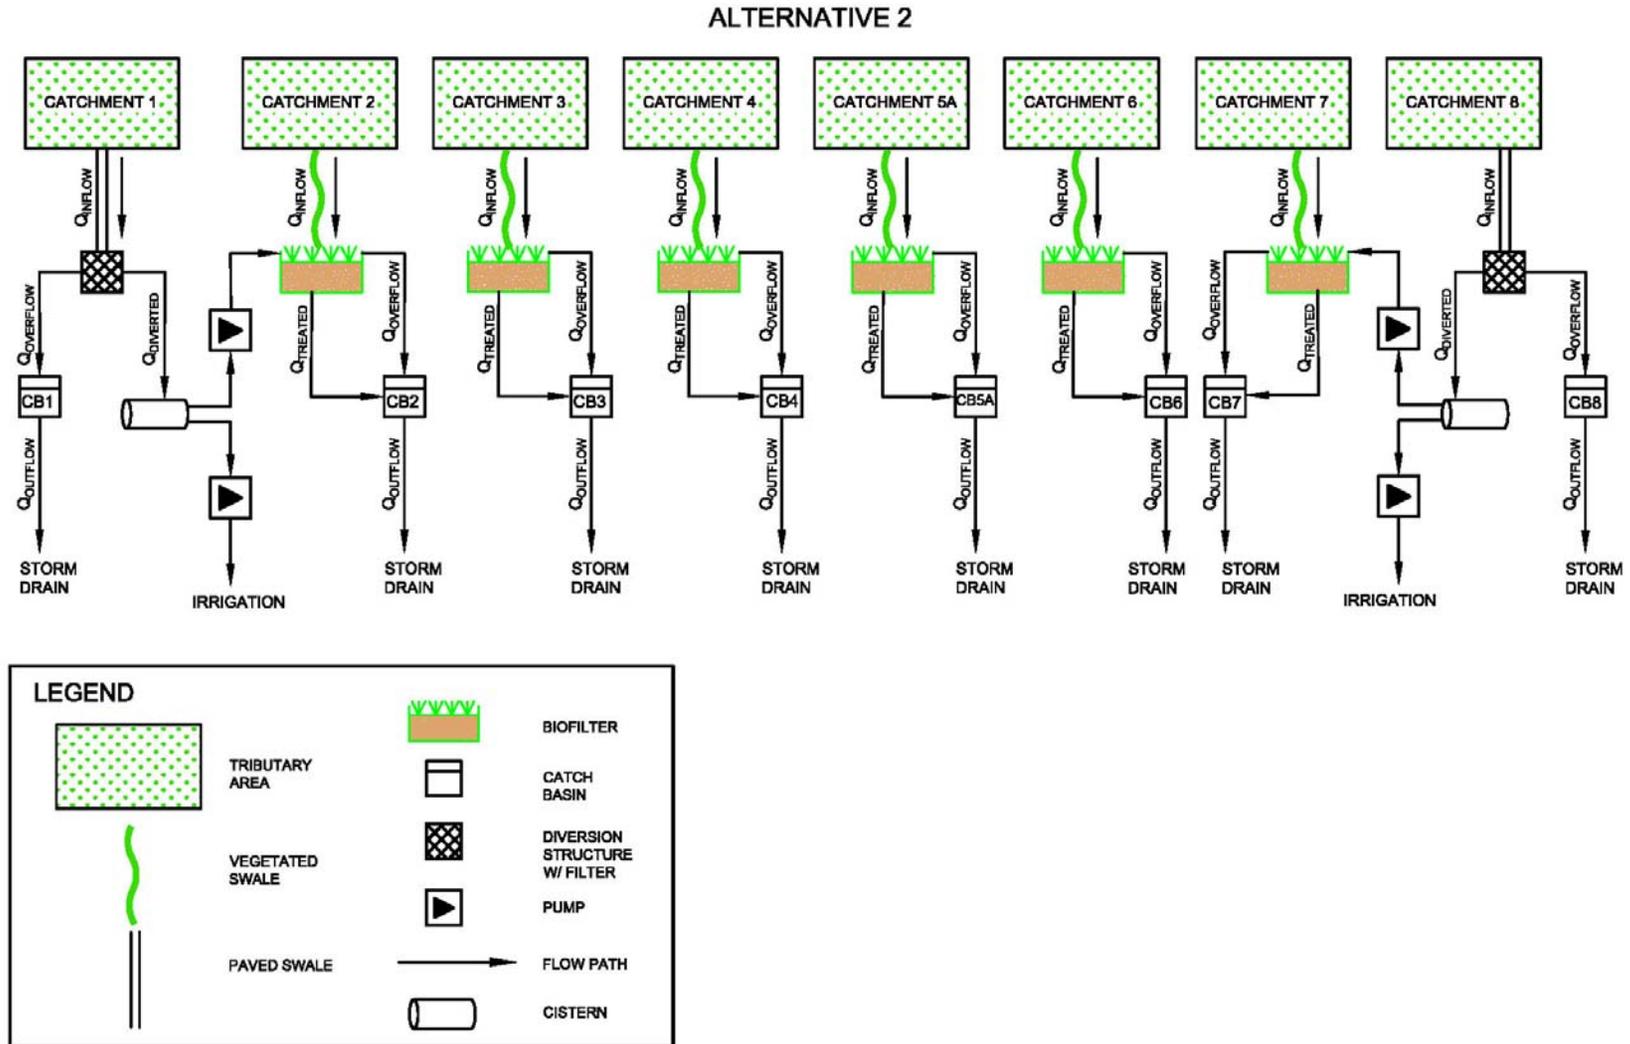
Figure 6-3. Flow diagram for Alternative 2

Objective 2: Reduce wet-weather flows to storm drain (as feasible). This objective is focused on water storage, use, and/or infiltration as a means of reducing discharge to the storm drains. Alternative 2 includes a water use option to reduce wet-weather flow. The soil and groundwater investigation specifically recommended no infiltration for this project, primarily due to the proximity to OWTS, low depth to groundwater, and concern for water intrusion in basements; therefore, infiltration is not considered an option for wet-weather flow reduction.

stormwater is proposed to be used to replace potable water, for a portion of the Project area irrigation needs.

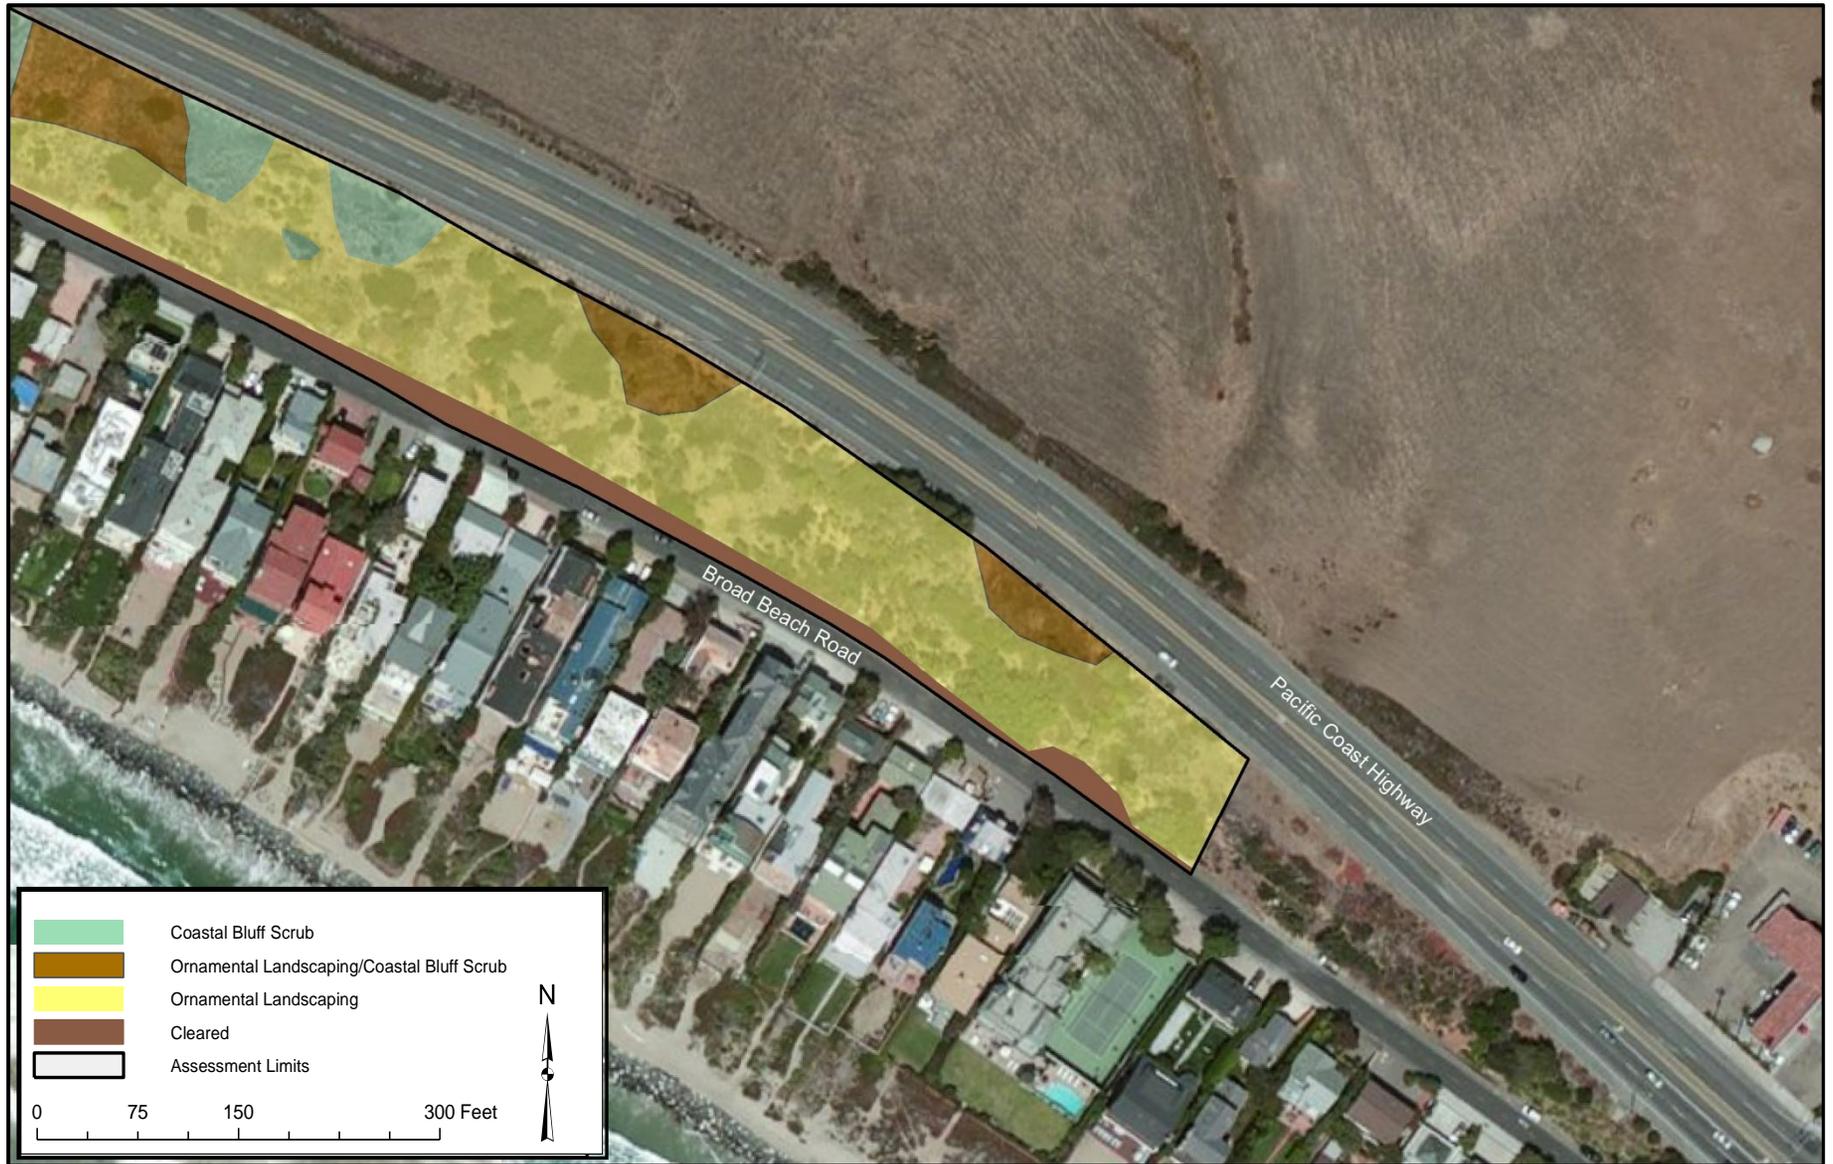
Figure 2A. Vegetation Types - East Section

Figures 2A, 2B, and 2C show vegetation types in the assessment area. Figure 3 provides photographs representing site conditions. Table 1 provides a list of plant species observed.

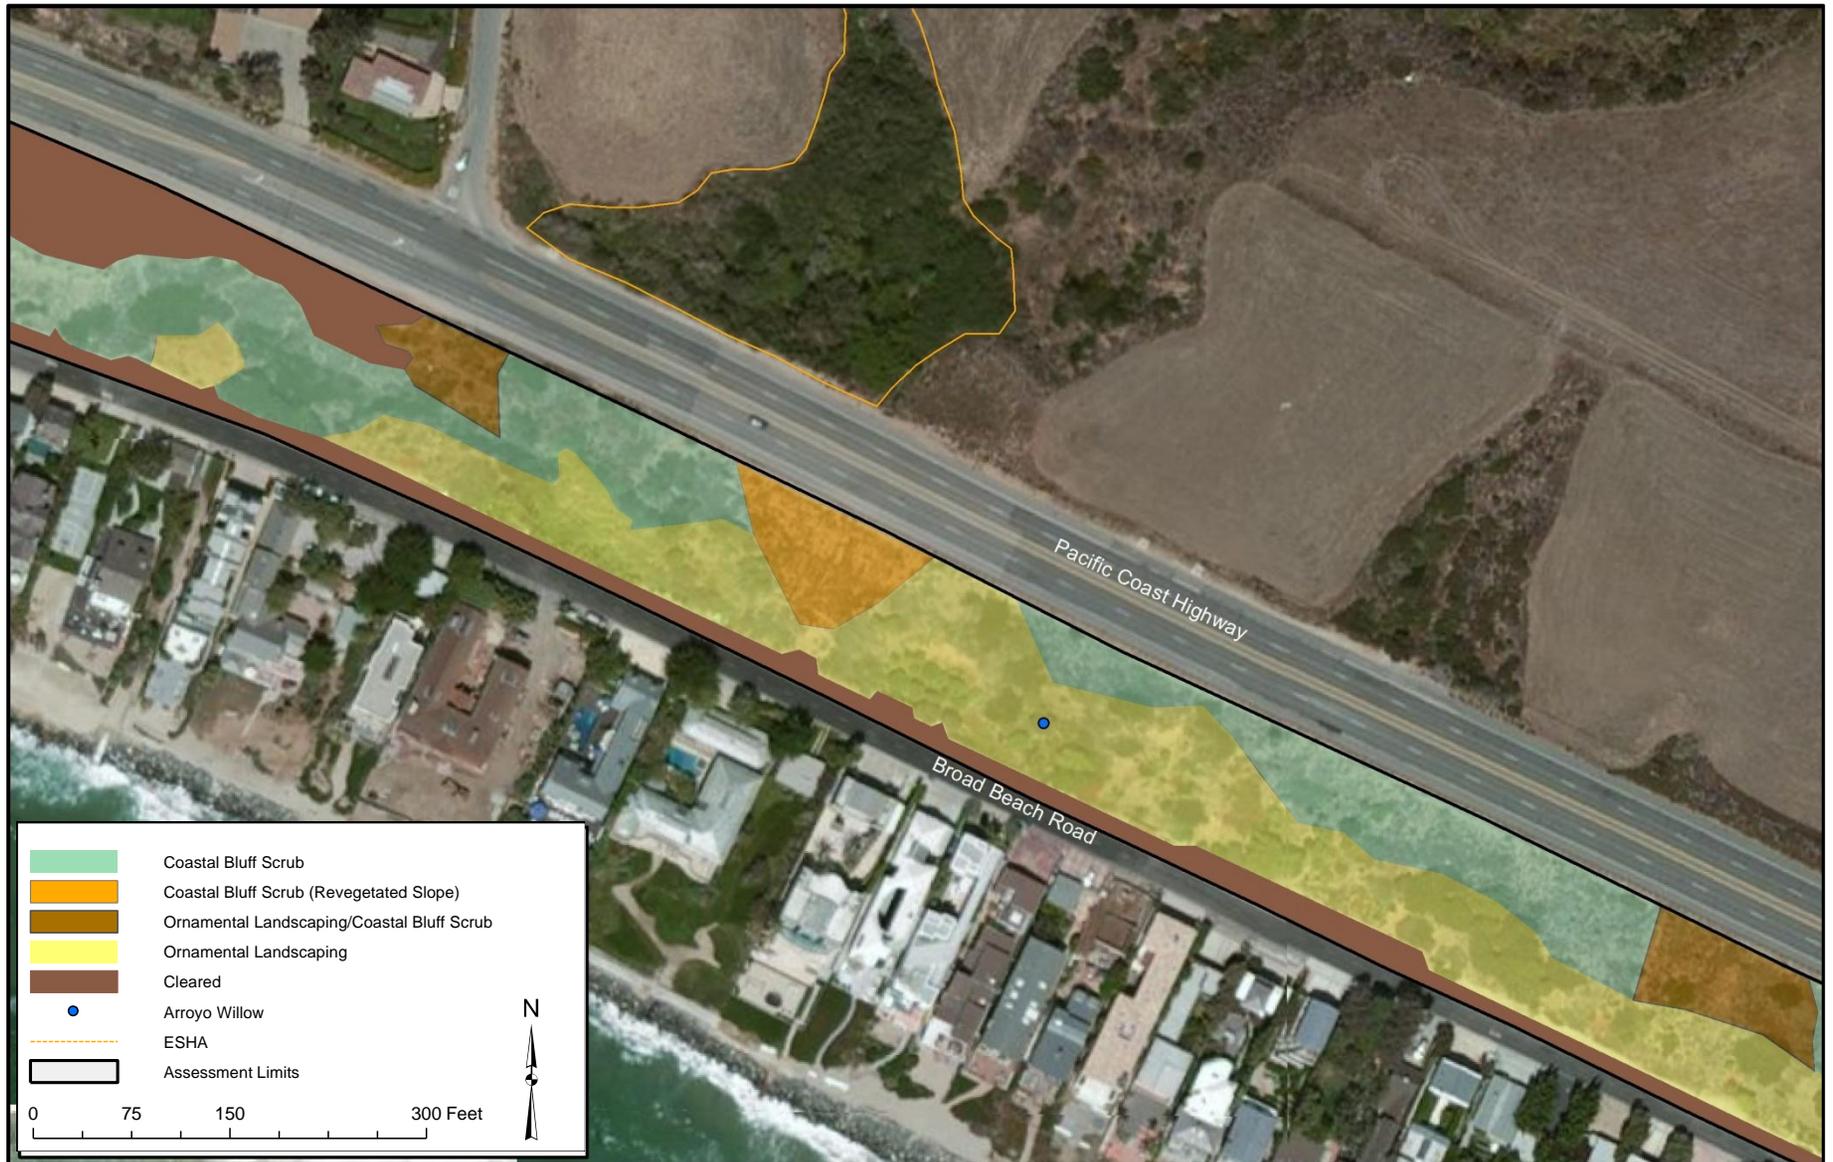
Figure 2B. Vegetation Types – Center Section

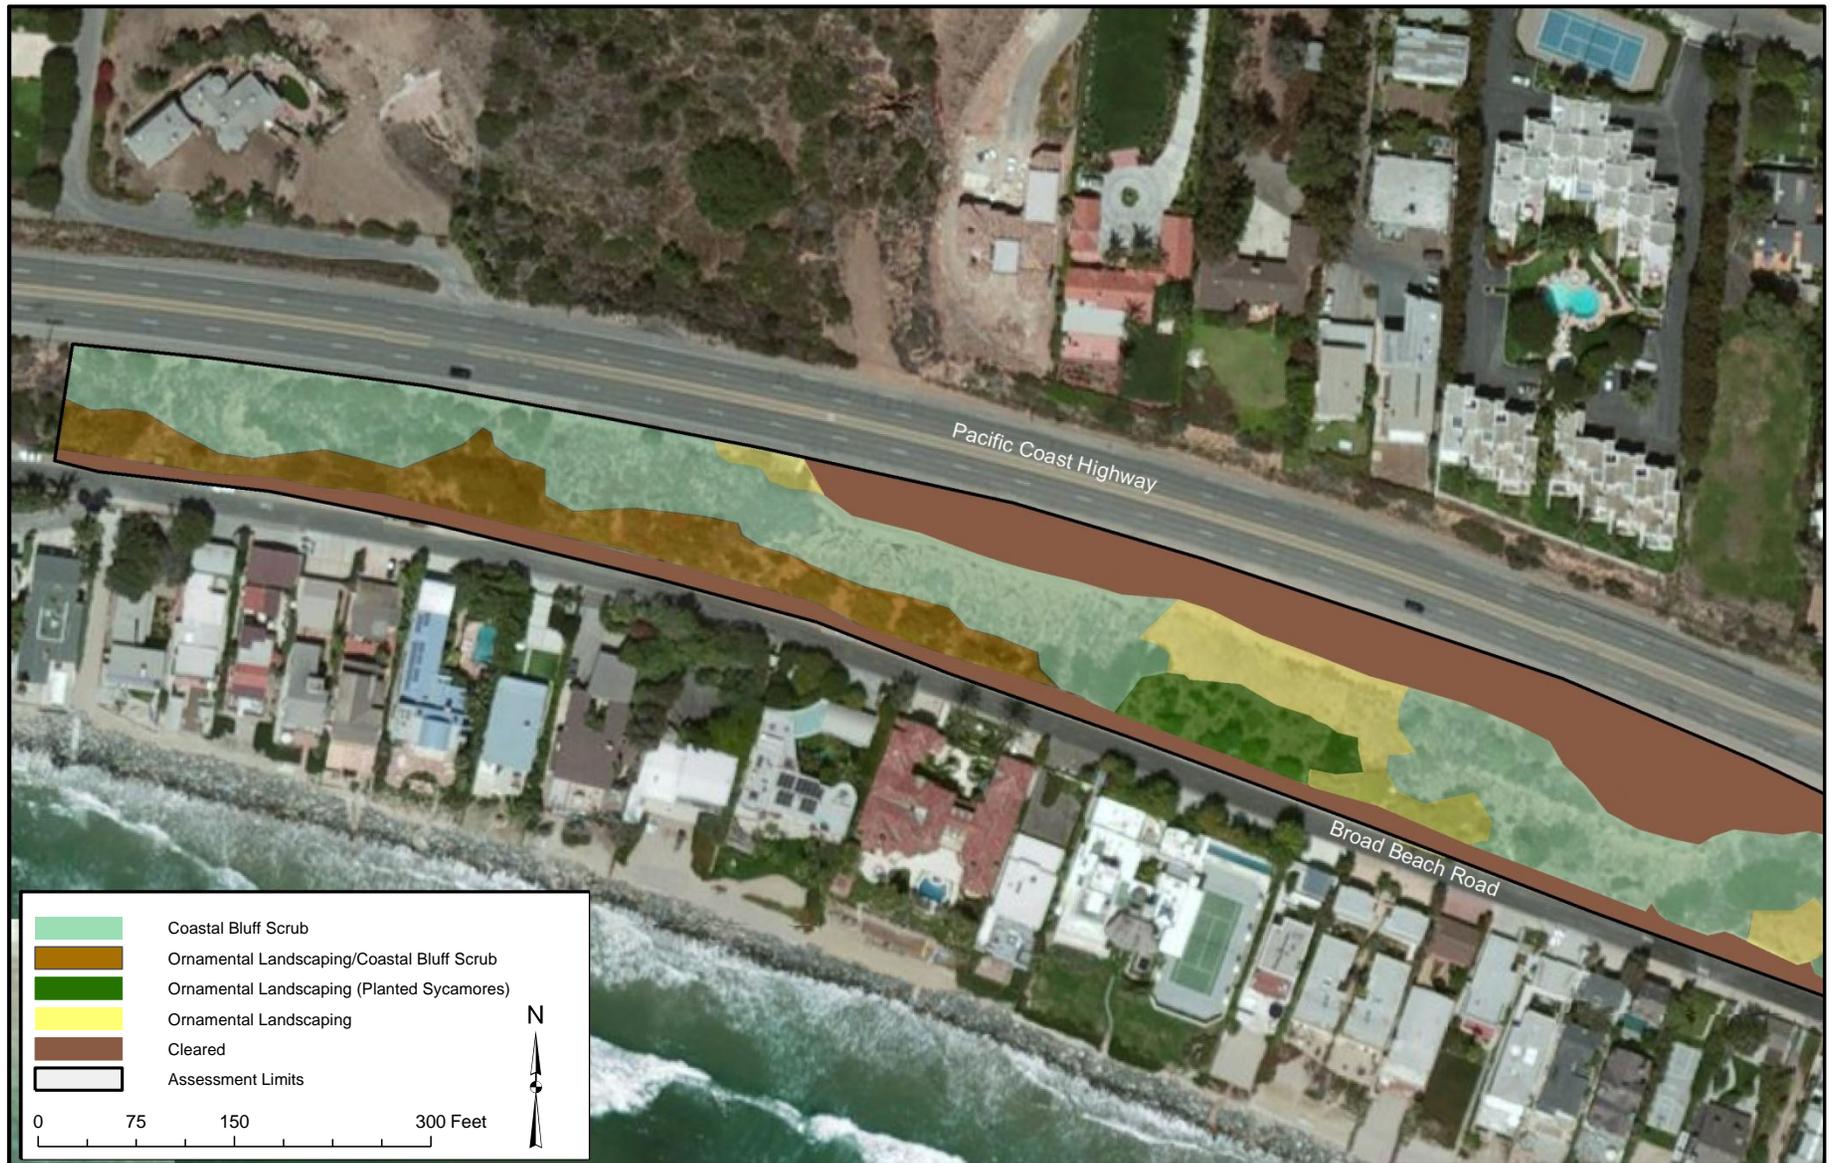
Figure 2C. Vegetation Types – West Section

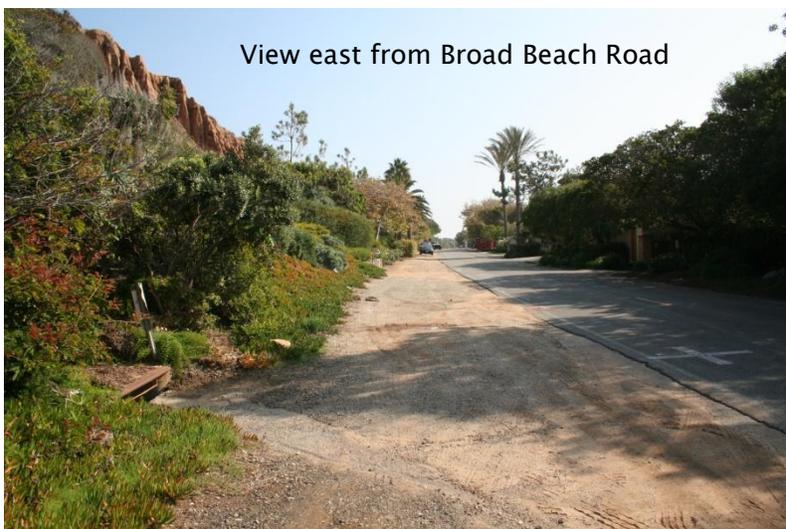
Above: planted sycamore grove mapped on Figure 2C. Associated with non-native vegetation (eucalyptus, pampas grass).

Below: view northeast from Broad Beach Road, showing coastal bluff scrub on the upper slopes and ornamental vegetation on the lower slopes. Flowering shrub is bougainvillea, a planted ornamental that is not invasive but requires irrigation.

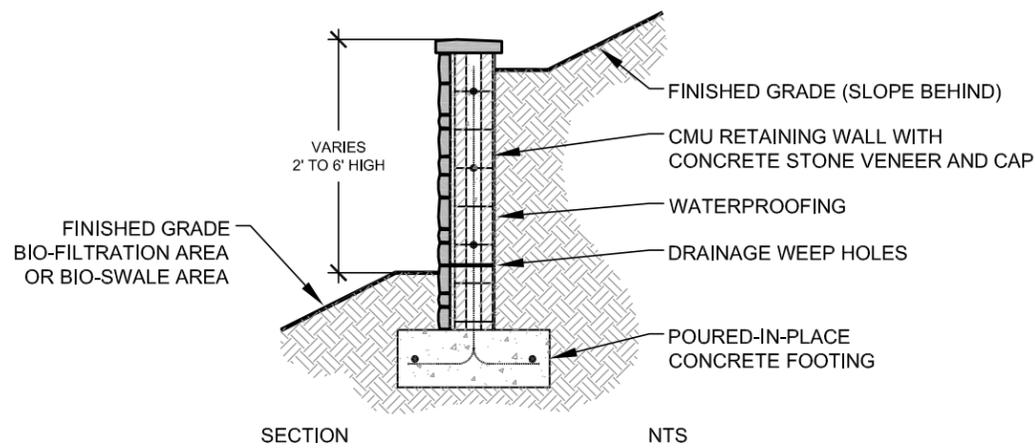
SECTION NTS
Concrete Stone Veneer Garden / Slough & Retaining Wall

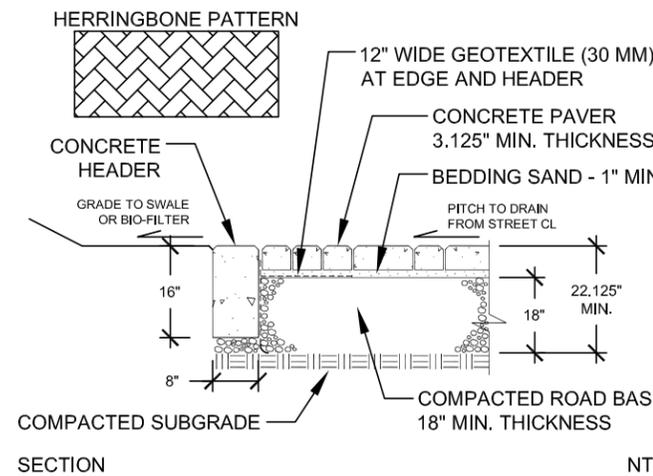
SECTION NTS
Concrete Paver on Aggregate Base
