TREE REPORT

Whole Foods In The Park City of Malibu

January 2009

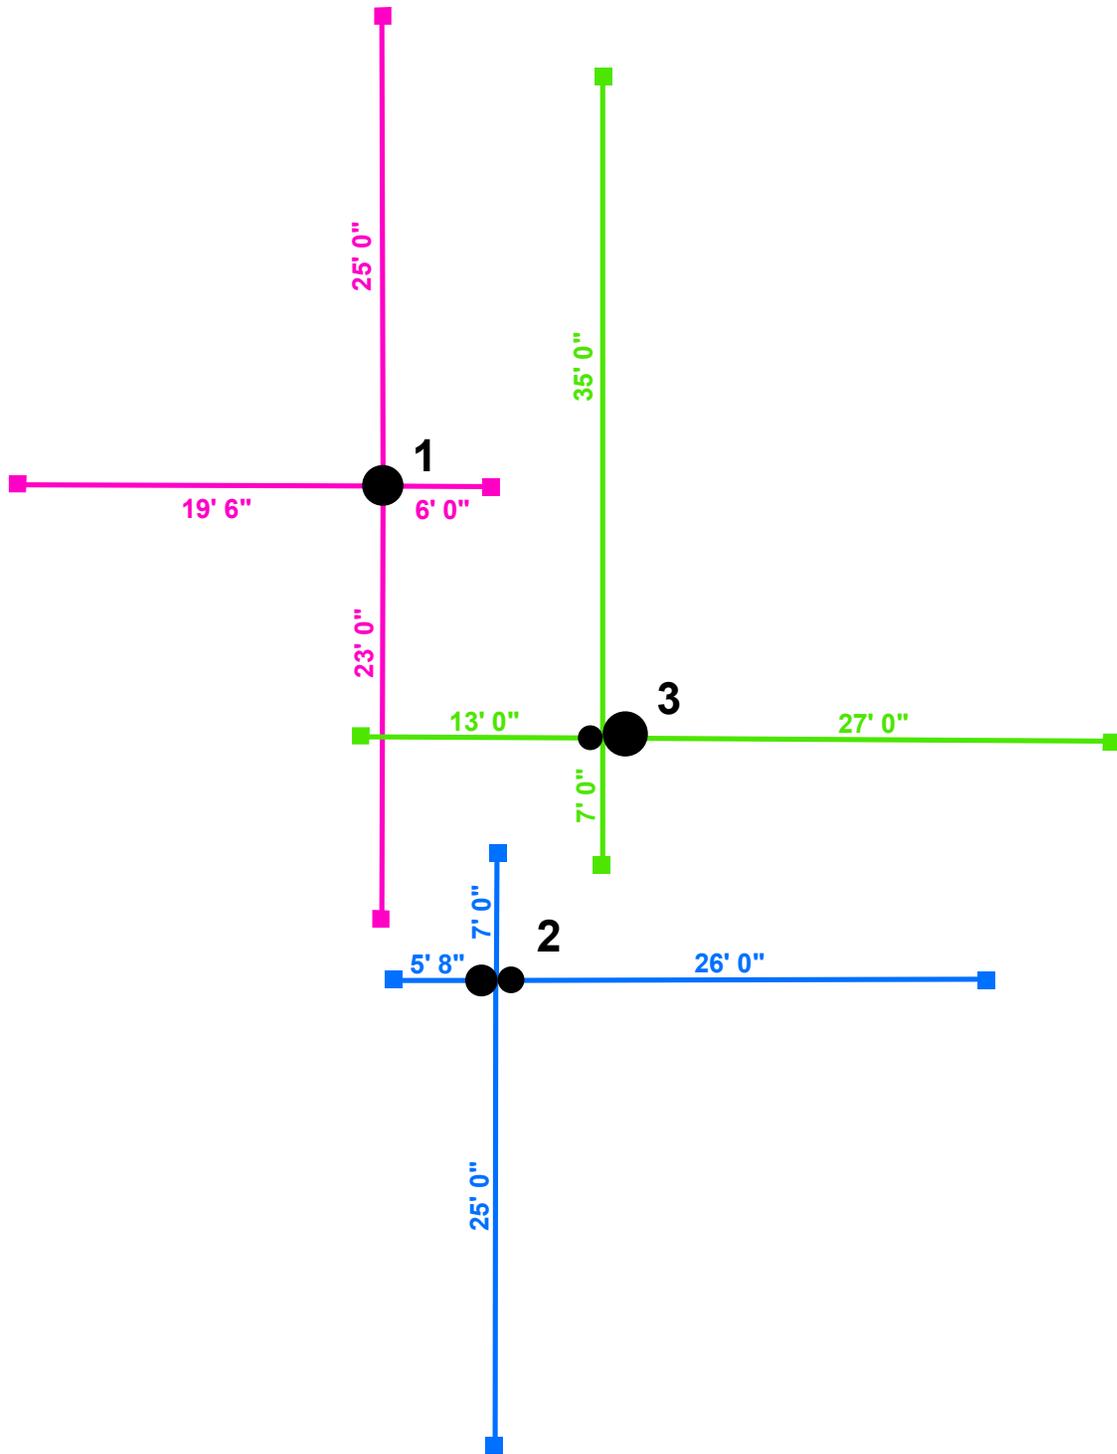
Figure 4: Scale Drawing of Protected Tree Trunks and Canopies

aesthetic rating, and the other half exhibited an average (C) health and a below average/poor (D) aesthetic rating (Table 1). The majority of the trees exhibiting the lower health and aesthetic ratings are located in the northwest corner of the site and appear to have been damaged by fire in the past and/or are suffering from termite damage. Nearly all of the trees exhibited signs of Anthracnose, a fungal infection common to sycamores, which rarely causes permanent damage but can cause cankers or defoliation.¹ The canopy extent for the protected trees on-site ranged from a radius of zero (where two trees were adjacent to each other) to 43.5 feet; Figures 3 through 5 depict the trunk diameter and canopy extent measurements for each protected tree.
