**ANNUAL REPORT
JULY 2013 THROUGH JUNE 2014
CALLE DEL BARCO
LANDSLIDE ASSESSMENT DISTRICT
MALIBU, CALIFORNIA**

Prepared for:
CITY OF MALIBU

April 2015
Fugro Project No. 04.62140605

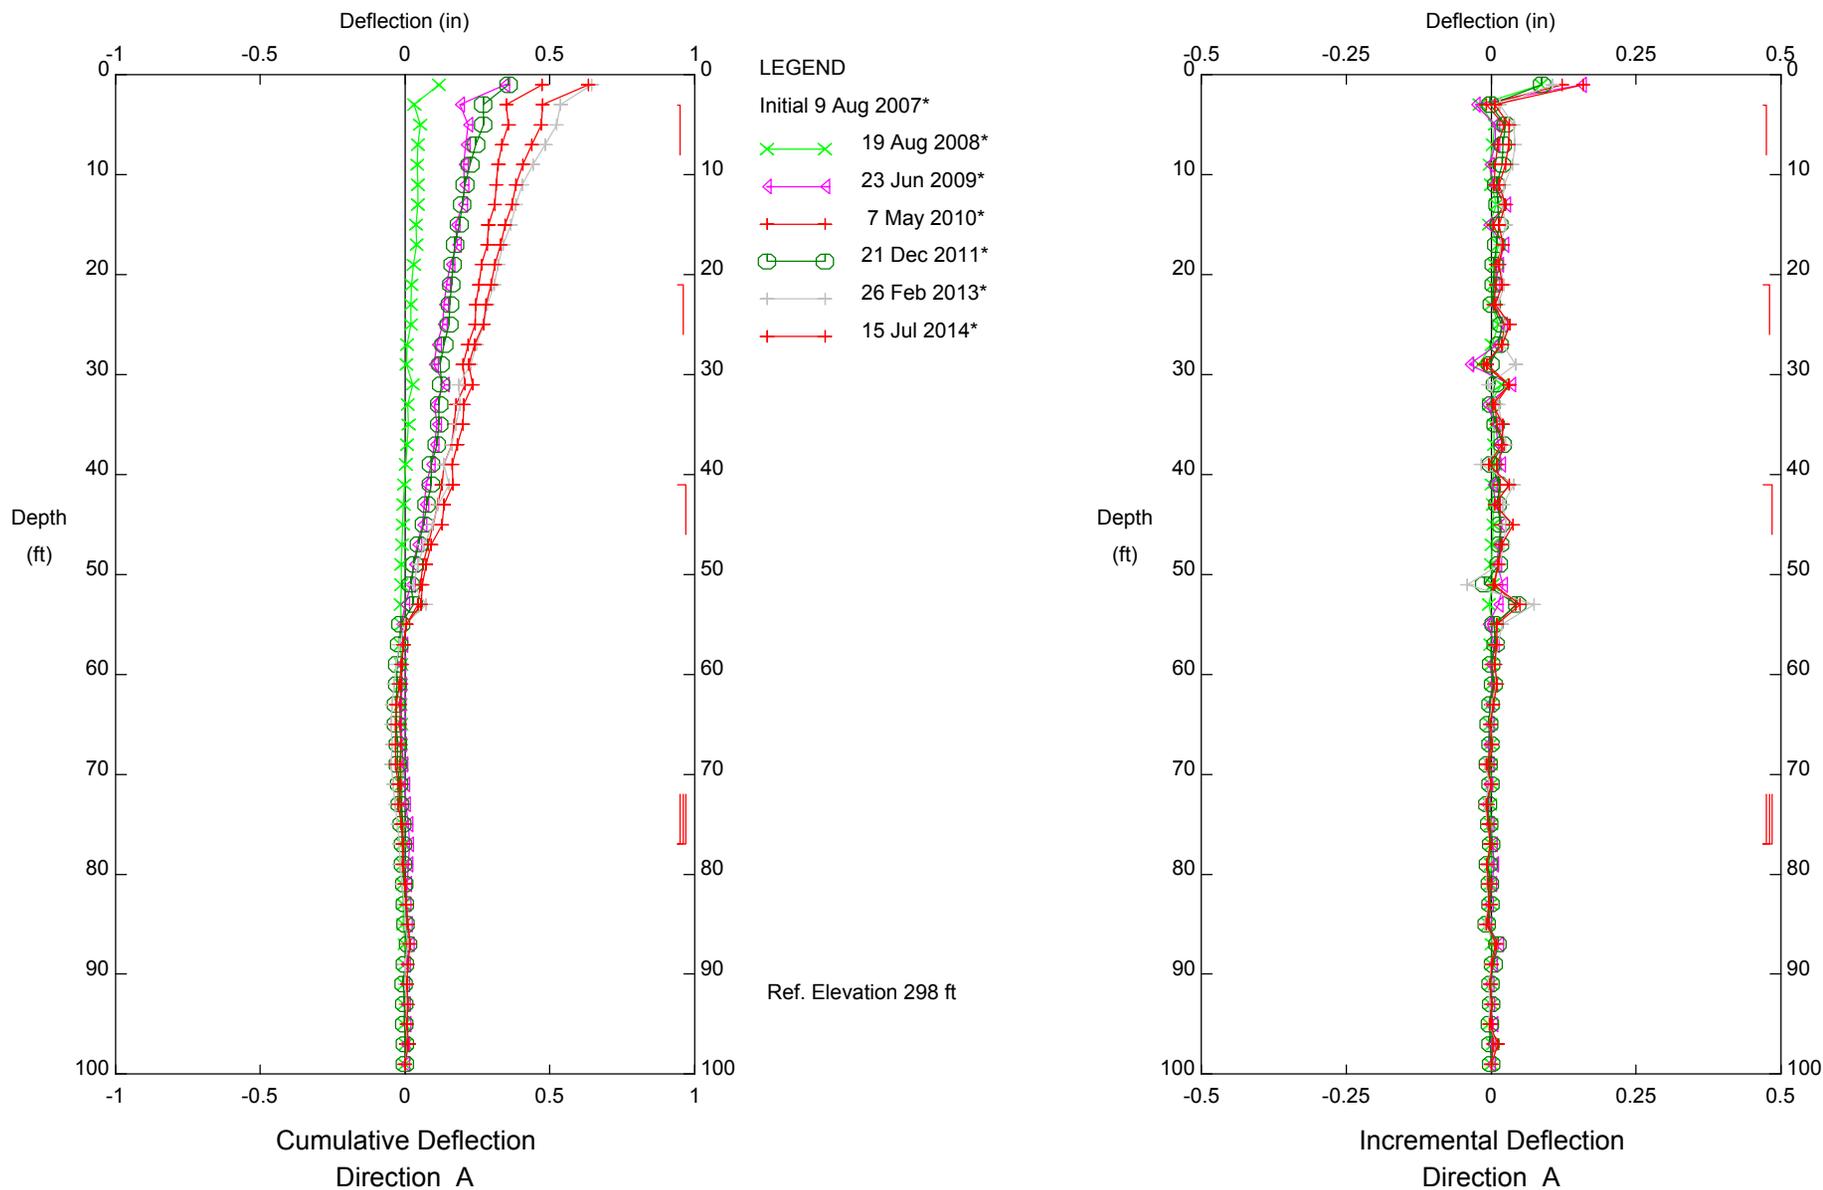
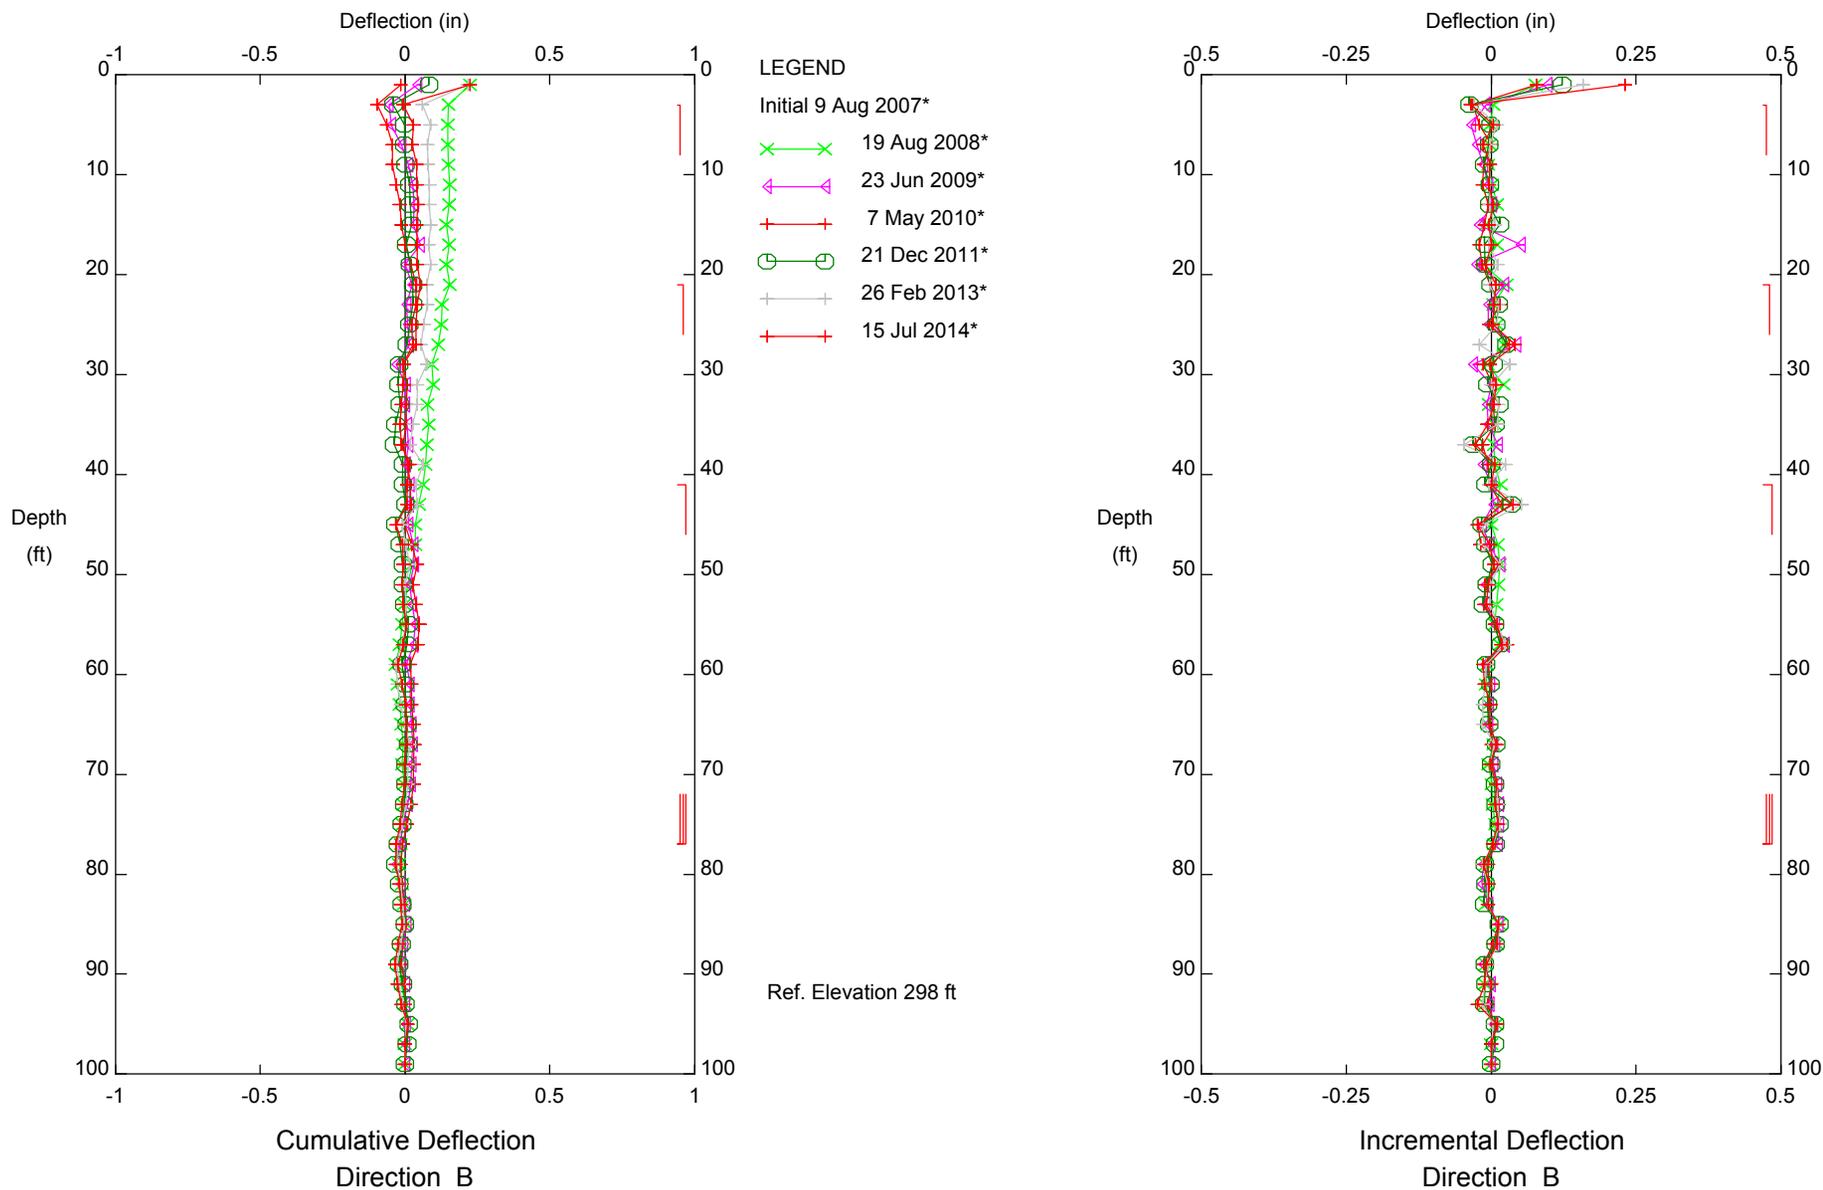
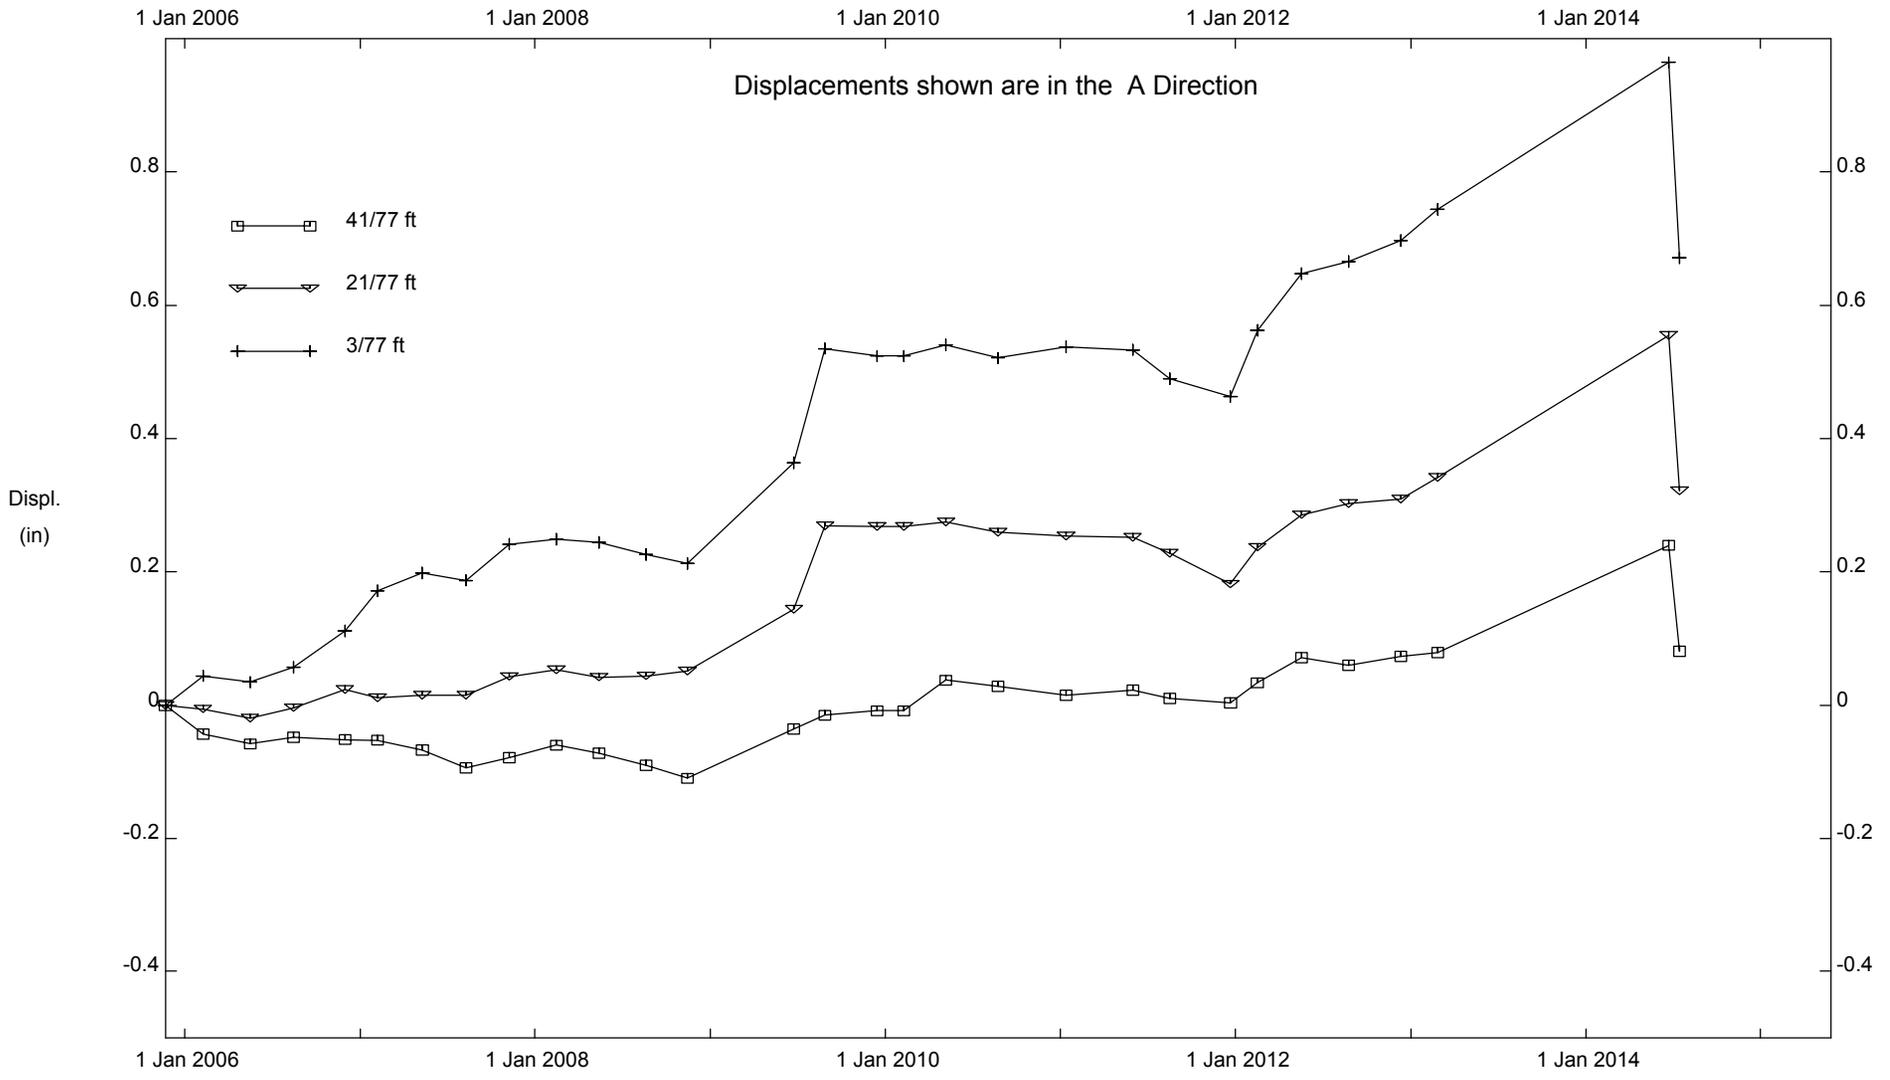
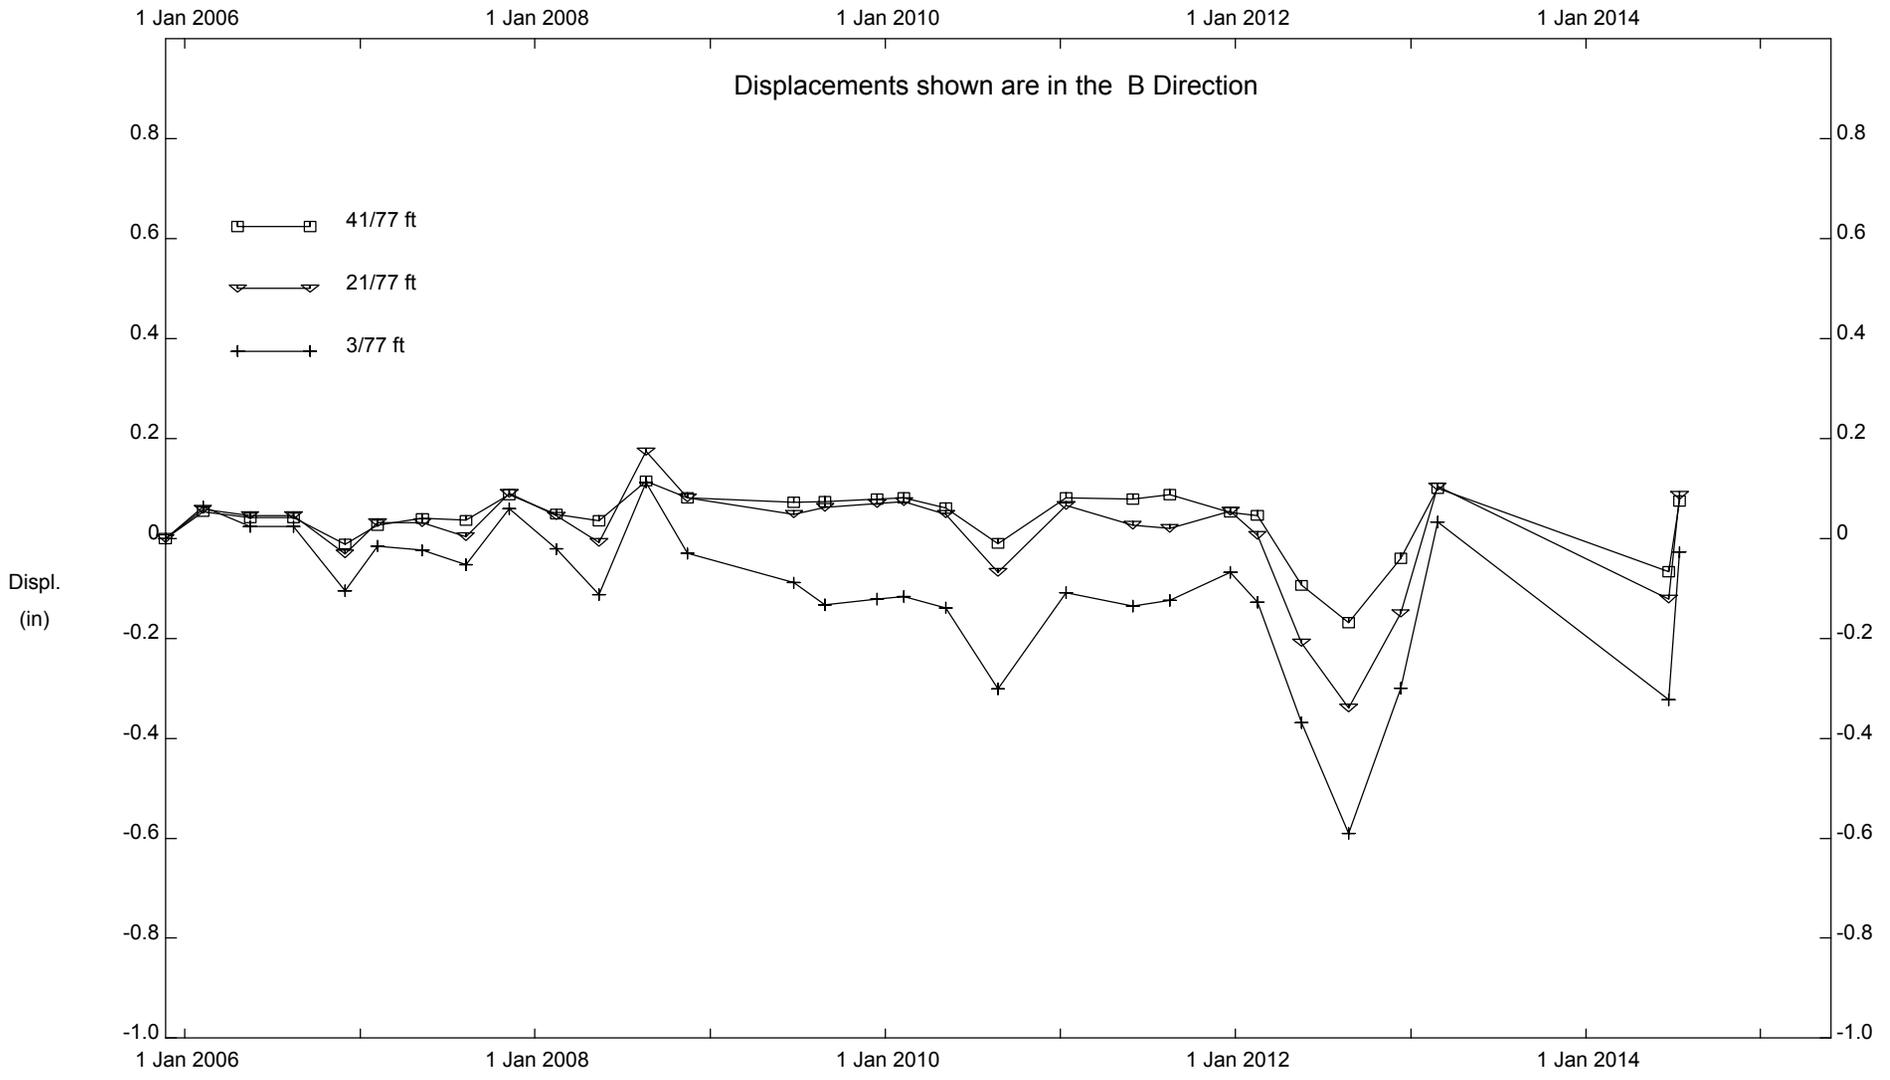
Calle del Barco, Inclinometer SI-9
 City of Malibu

Inclinometer SI-16 exhibits a pattern of movement measured at the ground surface at an average rate of up about 0.08 inches/year since 2005, resulting in approximately 0.5 inches of cumulative displacement at the ground surface since the 2004-05 monitoring period. Movement of the inclinometer appears to be both translational at specific depths between 0 to 10 feet and between 40 and 85 feet and rotational about a hinge point at about 50 feet below the ground surface. This is similar to the movement observed in inclinometer SI-9 located in close proximity to SI-16.

Although the movement observed in inclinometers SI-9 and SI-16 has not produced observed distress in pavements or other development of which Fugro is aware, the movement is nevertheless quantifiable and can be defined by a clear trend.
