**ANNUAL REPORT
JULY 2013 THROUGH JUNE 2014
MALIBU ROAD LANDSLIDE ASSESSMENT DISTRICT
MALIBU, CALIFORNIA**

Prepared for:
CITY OF MALIBU

April 2015
Fugro Project No. 04.62140604

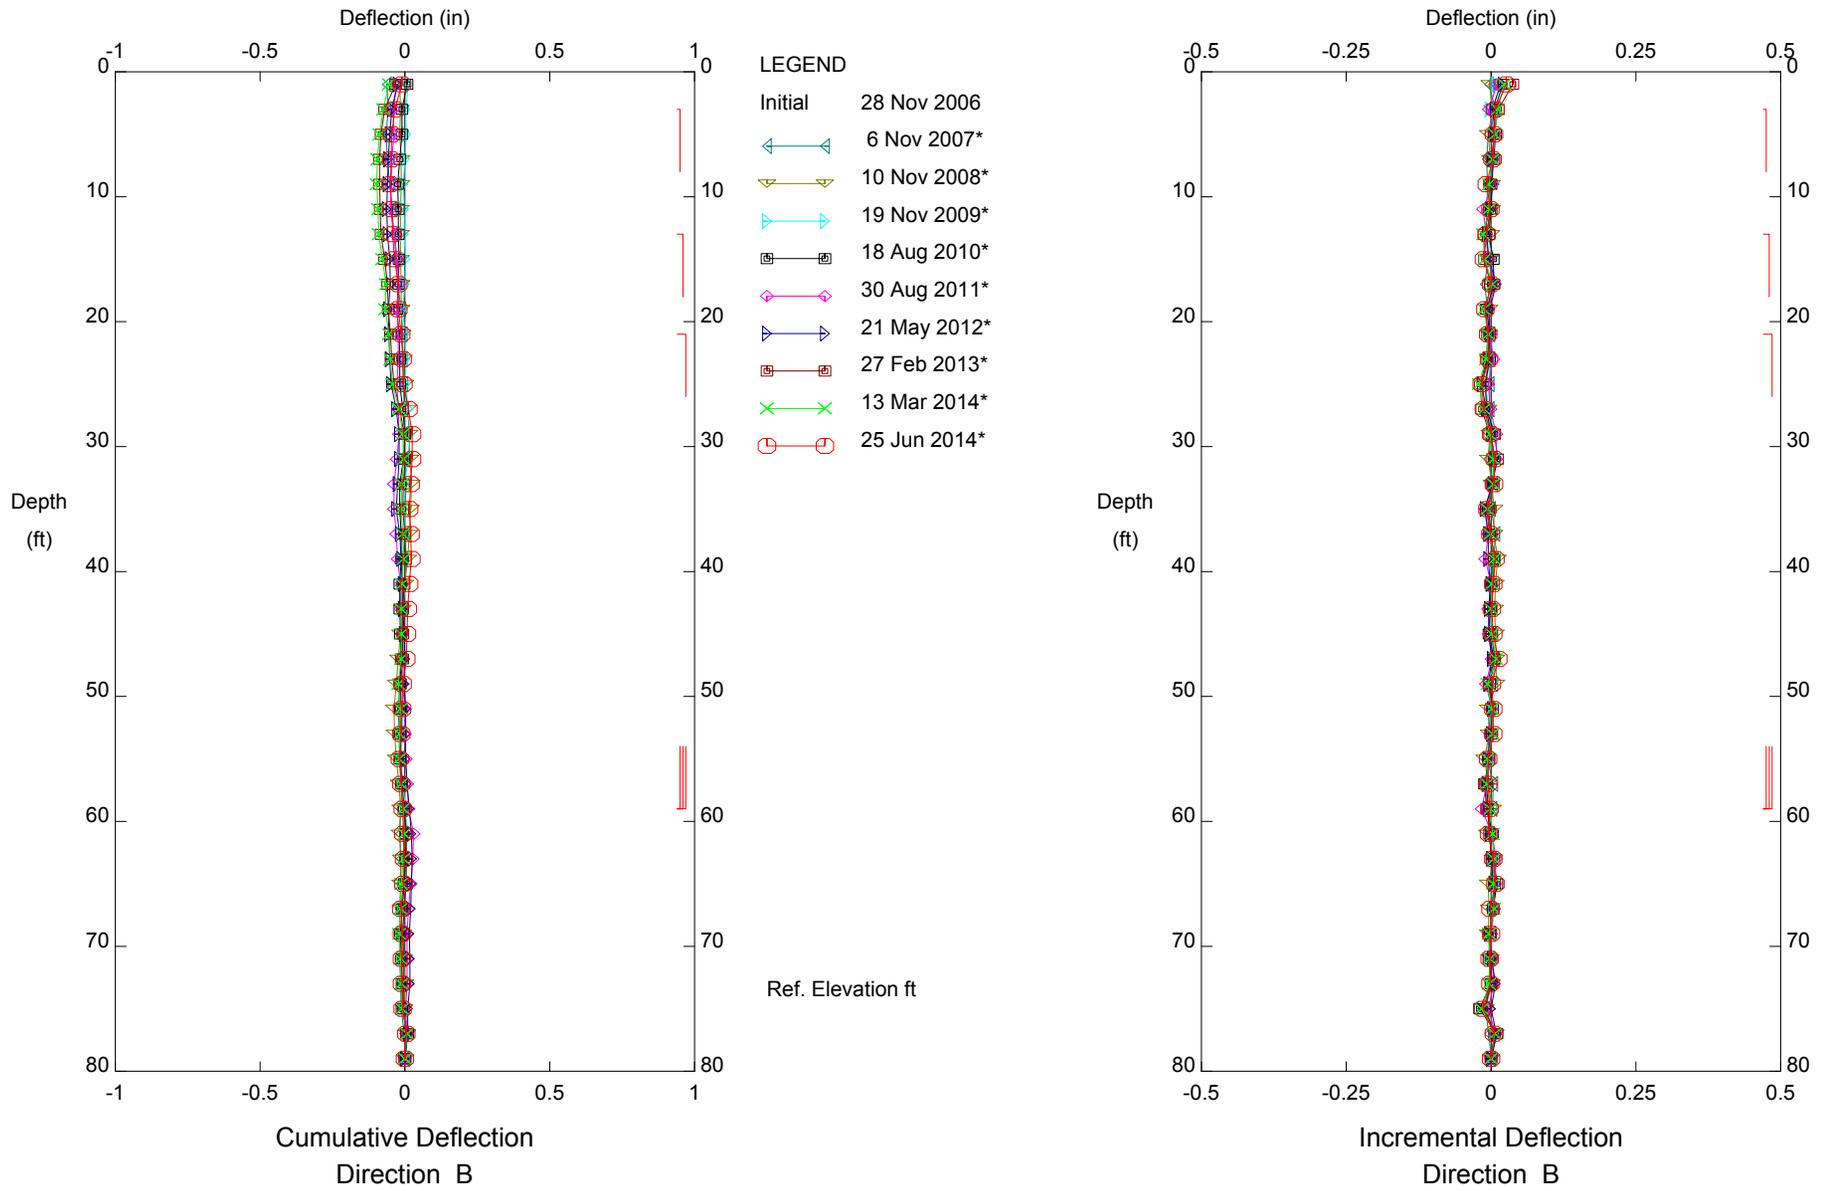
Assessment District 98-3, Inclinometer SI-5
 City of Malibu

Inclinometers SI-5 and SI-6 are located on Bayshore Drive, upslope and outside the defined limit of the most recent 1998 movement. No clearly defined interpreted movement was observed during this monitoring year in SI-5 or SI-6.
