### Annual Report July 2017 Through June 2018 Malibu Road Landslide Assessment District Malibu, California

March 2019  
Fugro Project No. 04.62160604  
Document No. 04.62160604-PR-002(Rev.00)

City of Malibu

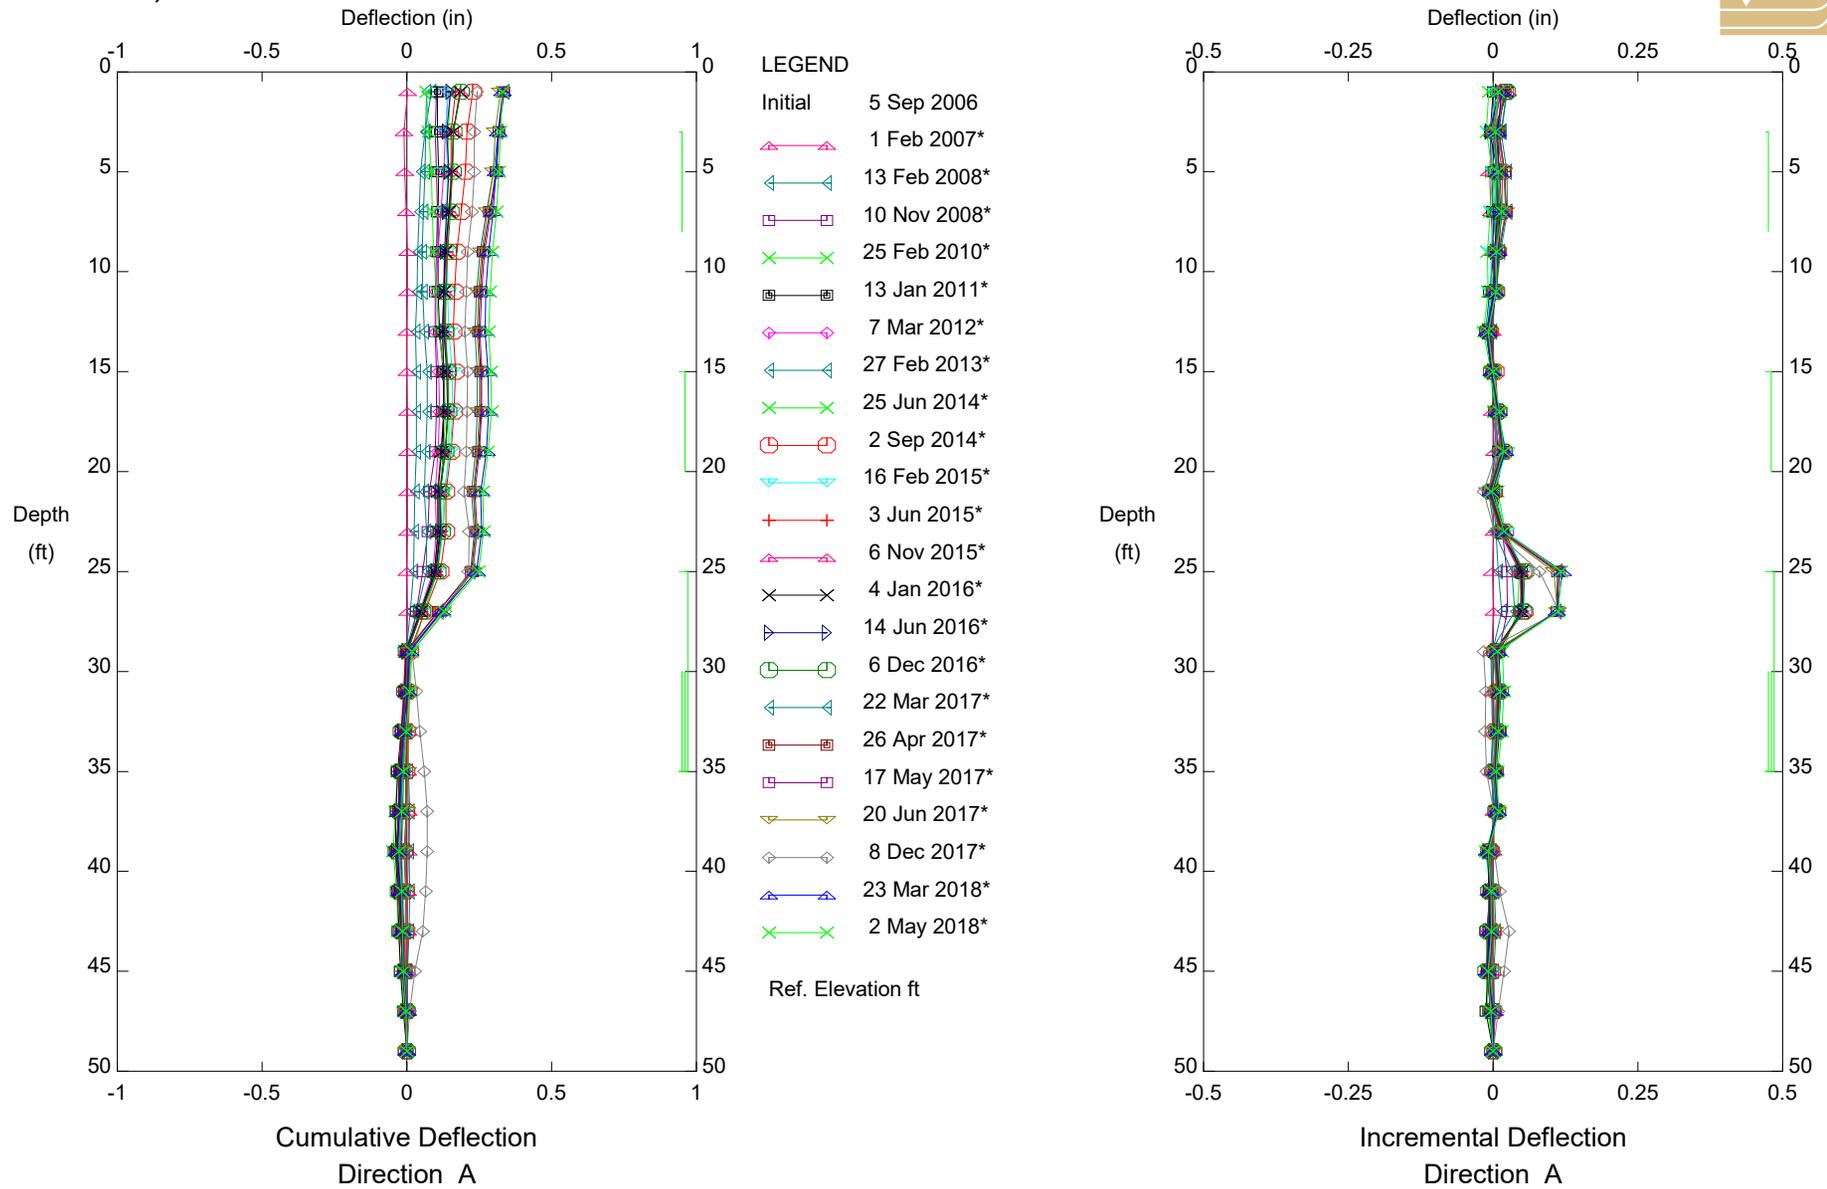
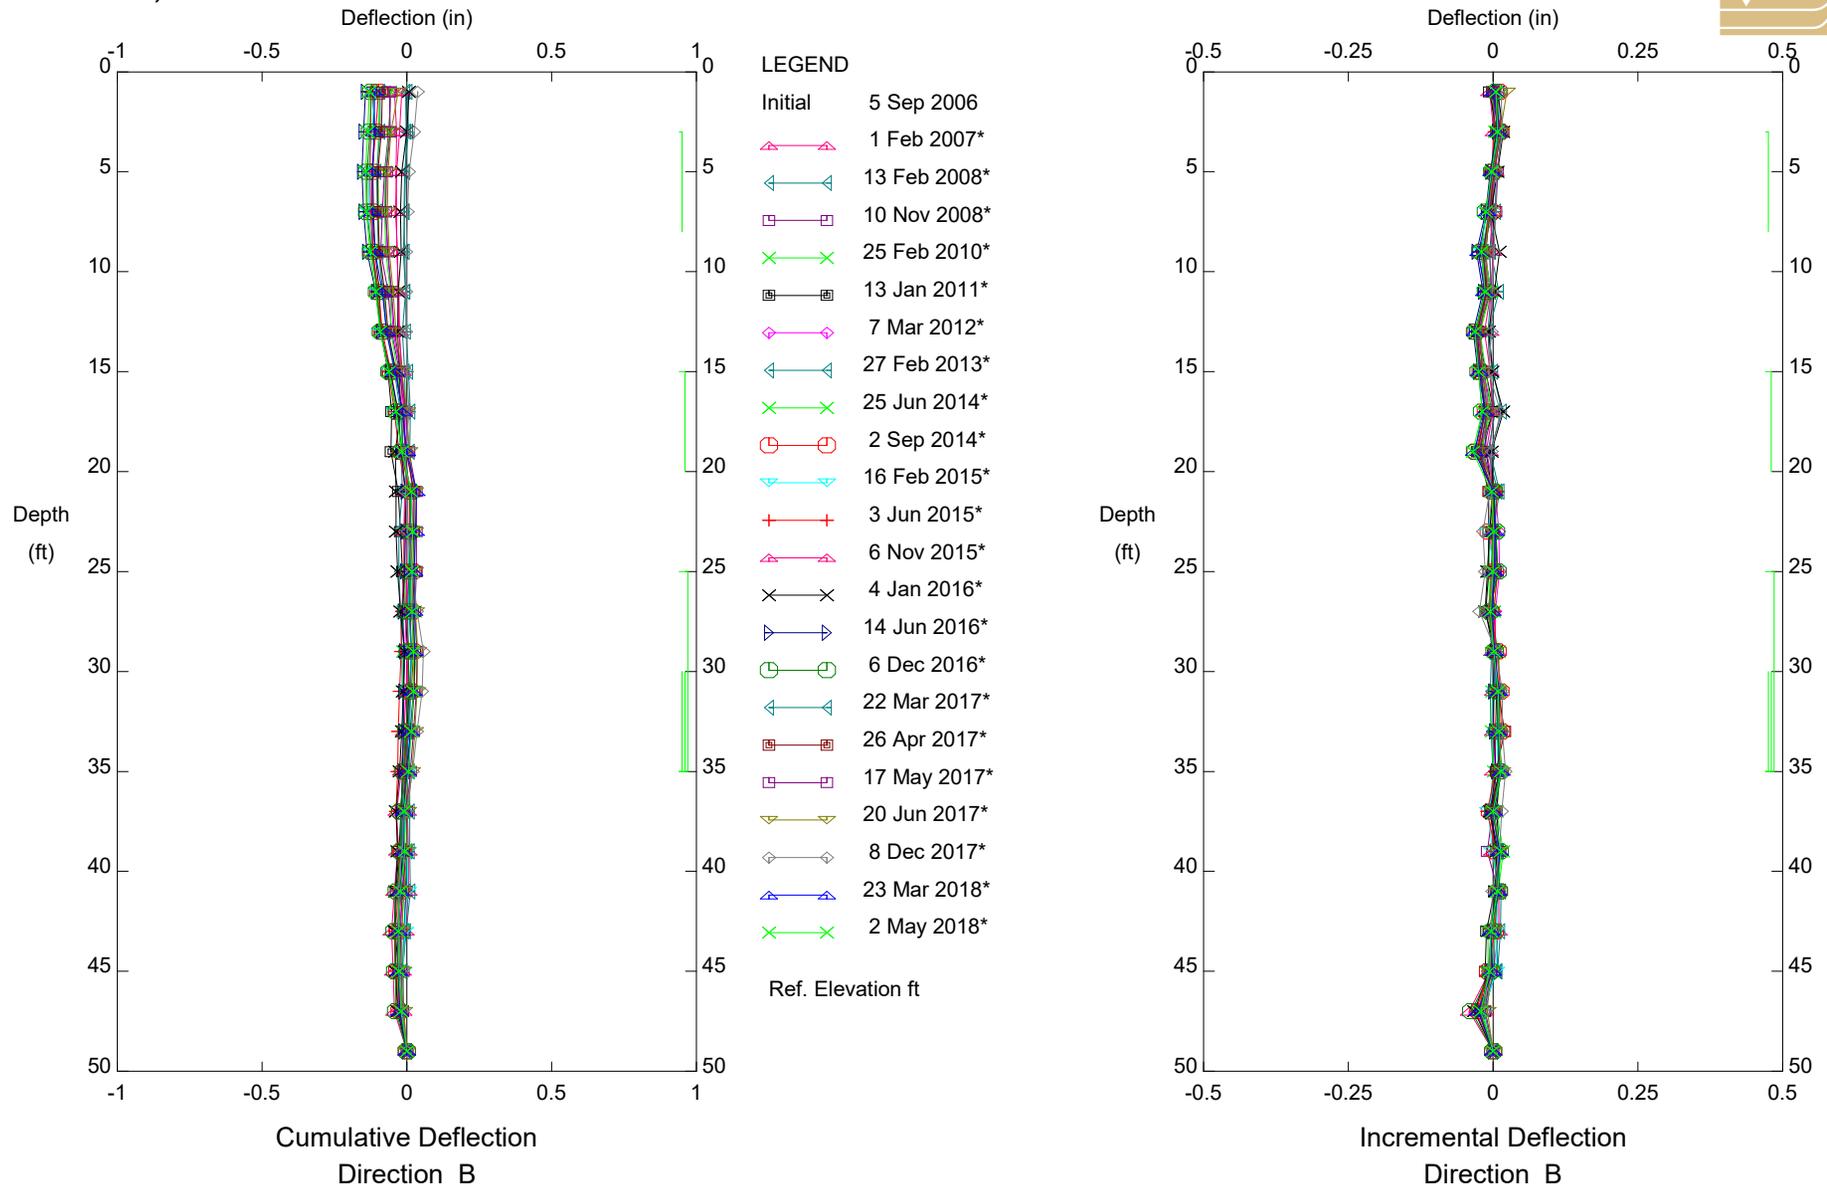
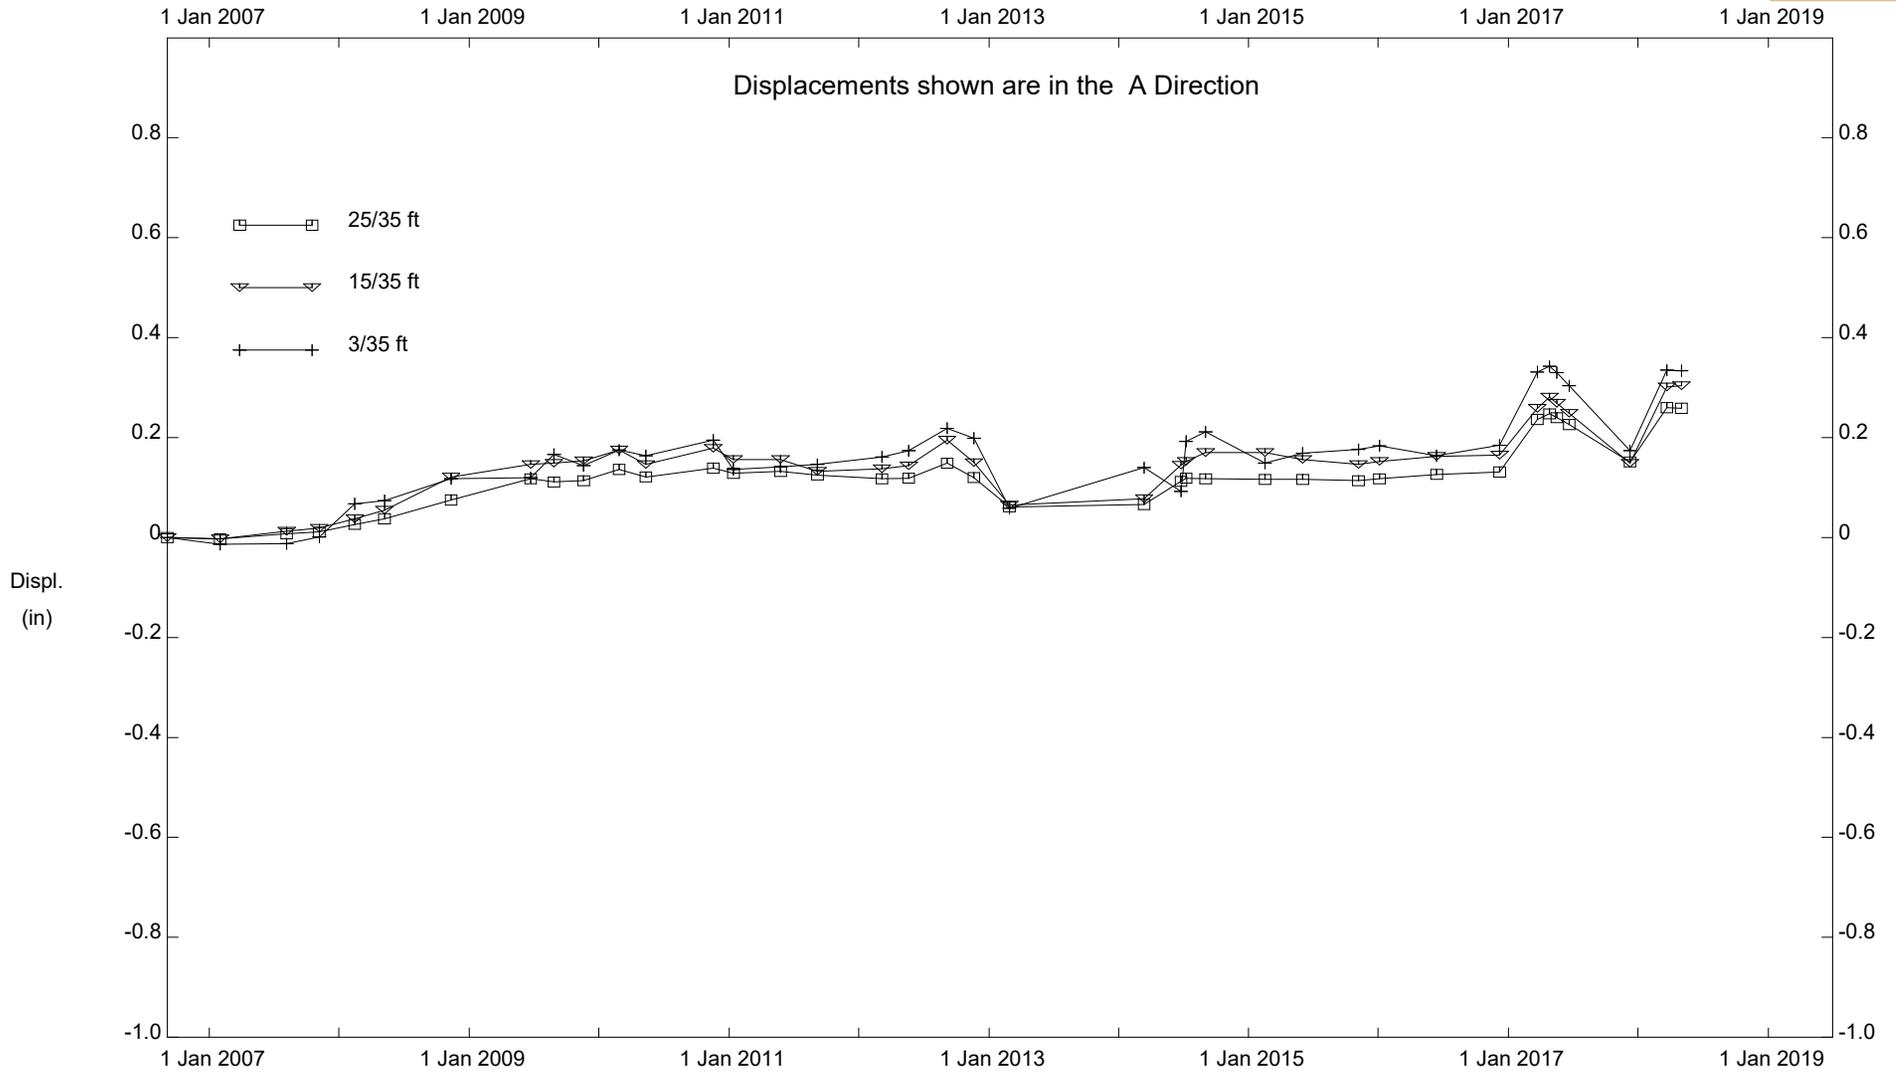
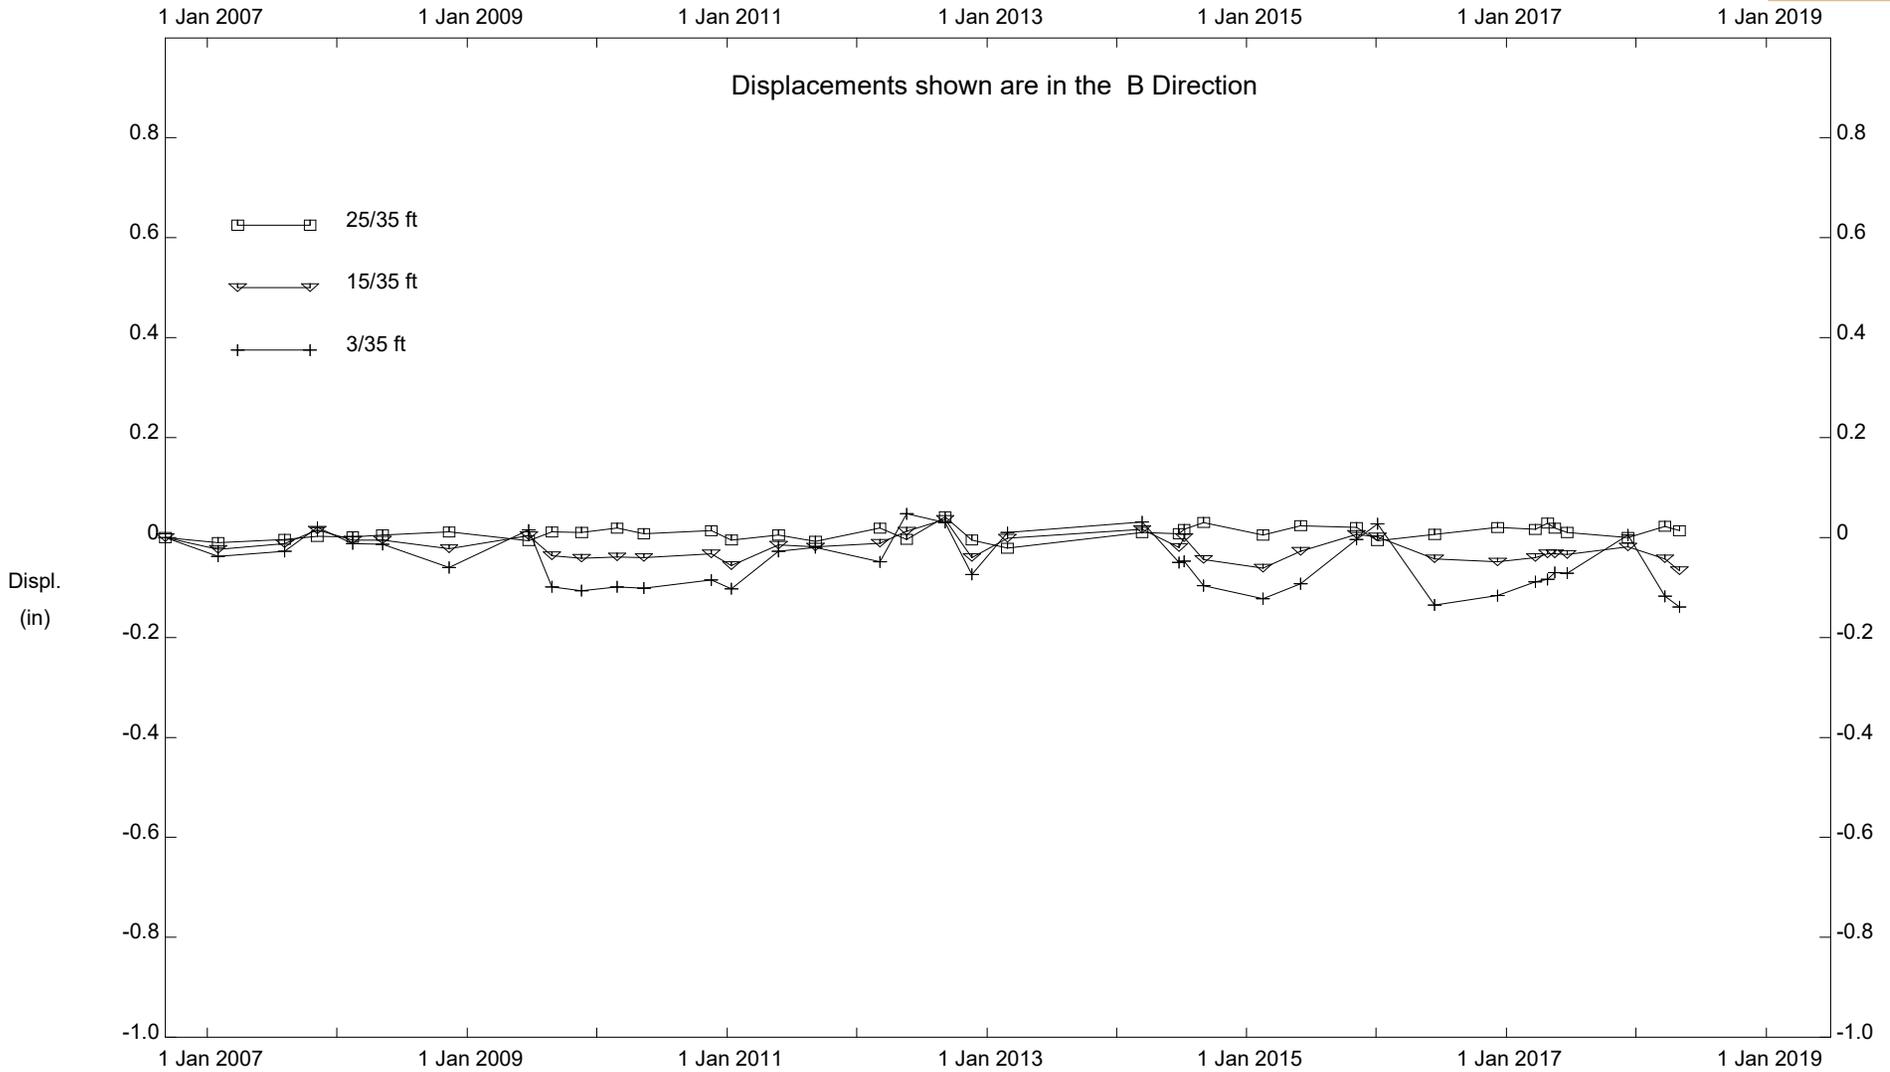
Assessment District 98-3, Inclinometer SI-1A  
 City of Malibu

No significant detectable movement was observed during this monitoring year in any inclinometers within the Malibu Road Assessment District.
