FY20/21 Maintenance and Monitoring

AD98-3, Malibu Road

Yeh Project No.: 220-278

Subject: Annual Monitoring and Maintenance Report FY20/21, City of Malibu Assessment District 98-3, Malibu Road, Malibu, CA

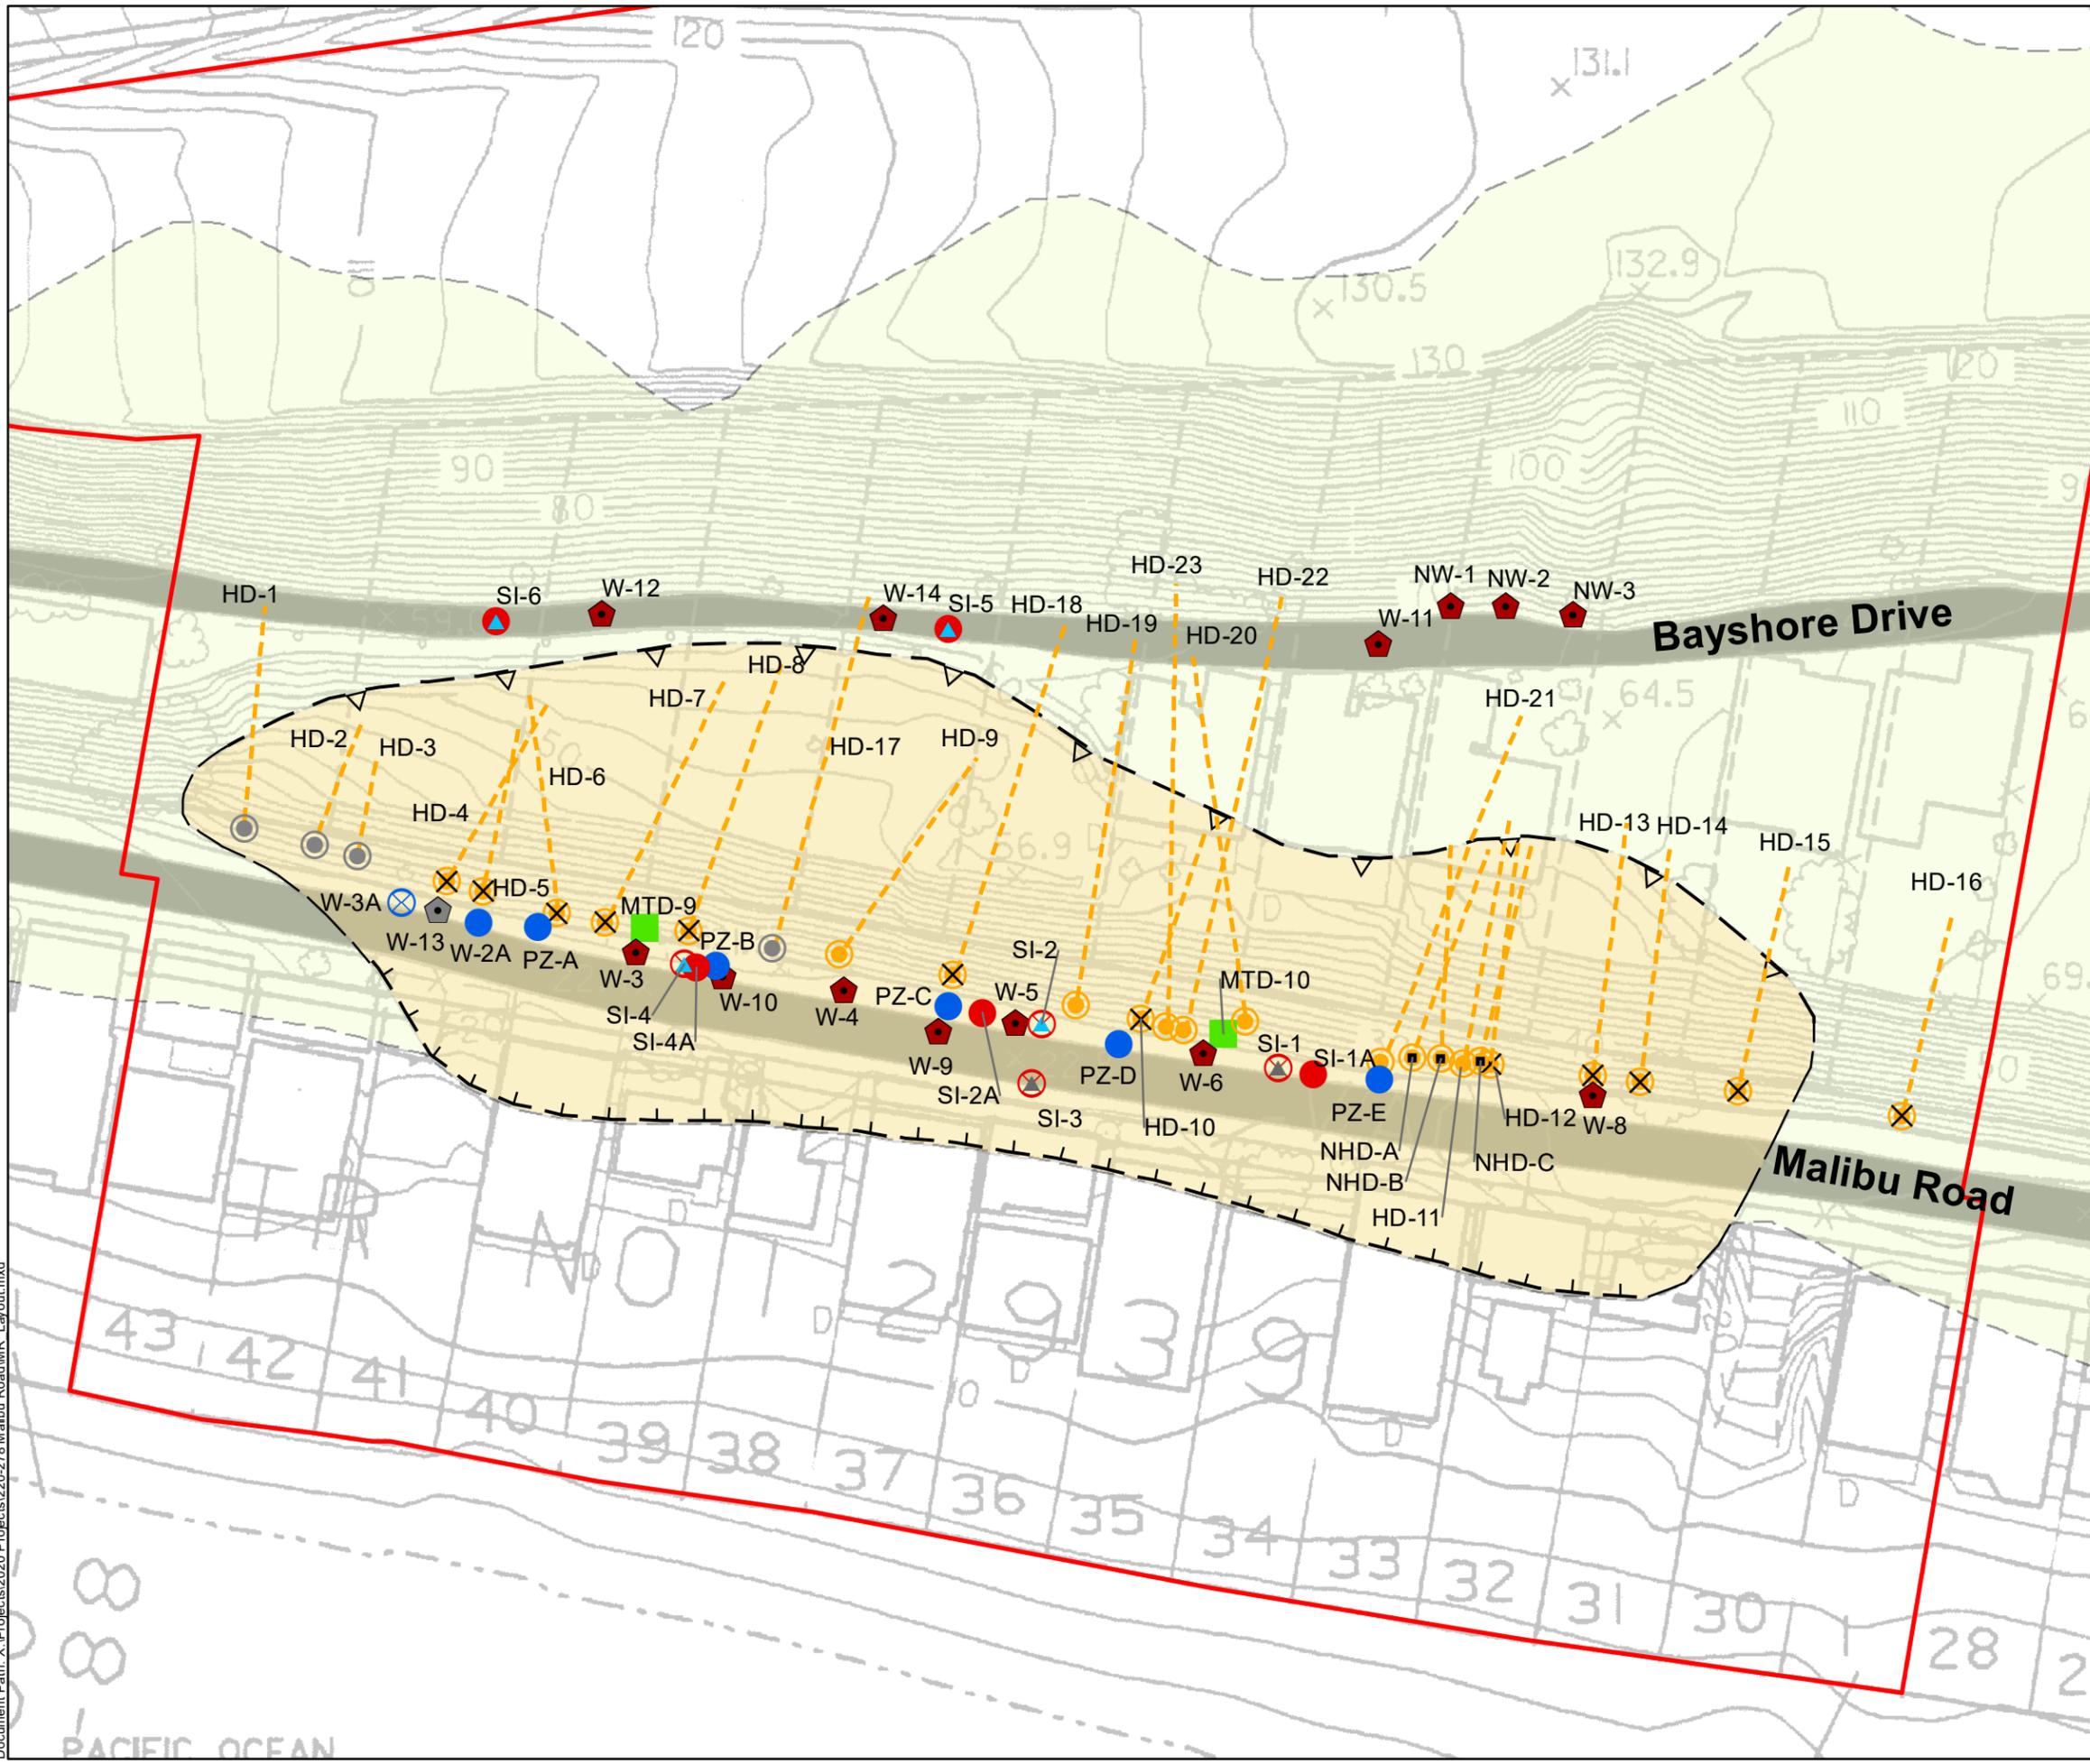
DATE: 1/26/22	PROJECT NUMBER: 220-278	PLATE: 1
DRAWN BY: MB	APPROVED BY: NS/LB

Groundwater levels were measured approximately monthly in 7 standpipe piezometers shown on Plate 1. Groundwater level data and hydrographs for individual standpipes are presented in Appendix A for the FY20/21 monitoring year. Water levels are acquired by lowering an electric probe into the standpipe to contact the groundwater surface and manually record the depth to water.

MONITORING INSTRUMENTATION AND DEWATERING FACILITIES MAP

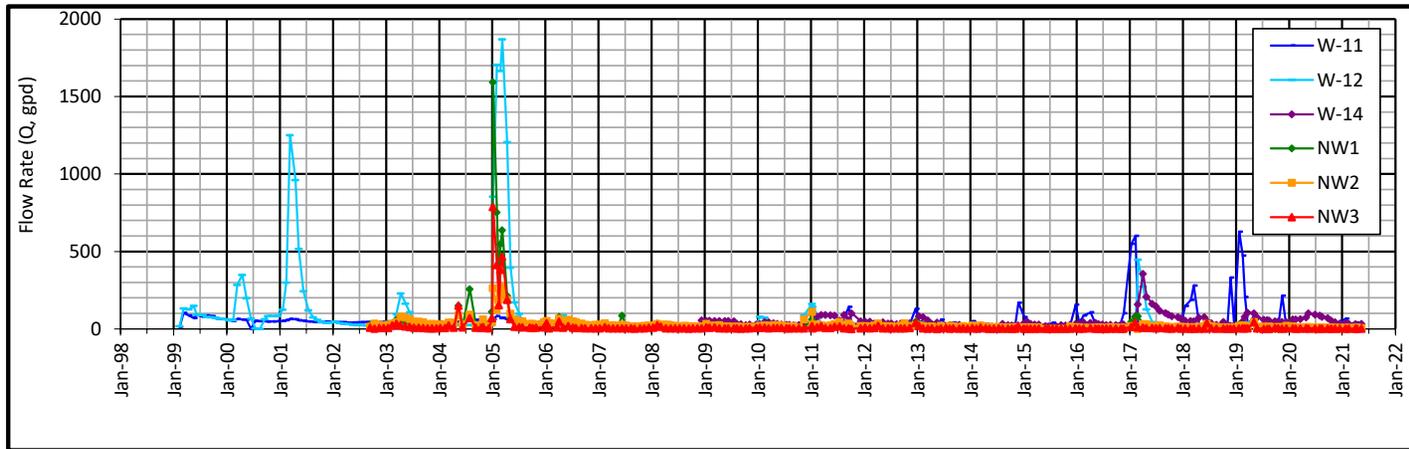
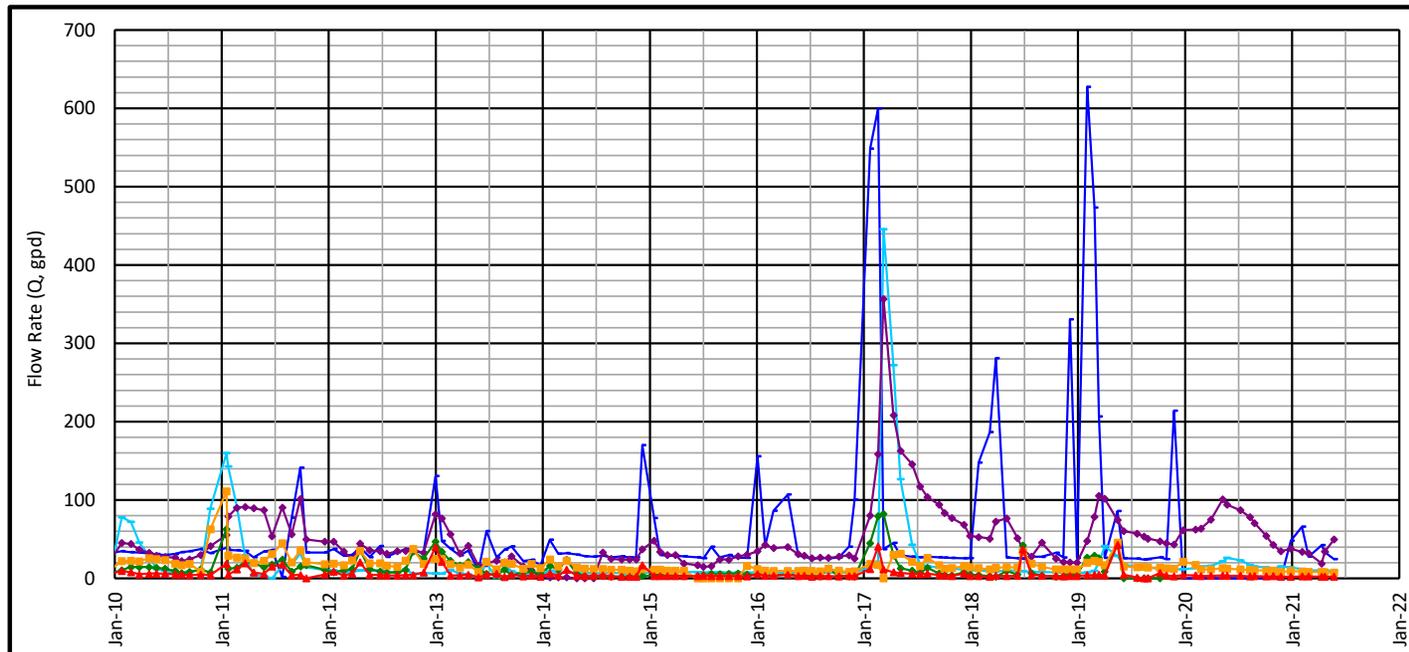
DEWATERING WELL DISCHARGE RATE GRAPH

Well production typically varies in response to rainfall totals. The dewatering well production decrease over this monitoring year is consistent with the historically low rainfall totals and extended drought conditions at the project. Electrical and power connectivity issues were identified and repaired during October through December 2021 and the effect of those repairs on dewatering production will be presented in subsequent reports.
