FY21/22 Maintenance and Monitoring

AD98-2, Calle del Barco

City of Malibu, California

Subject: Annual Monitoring and Maintenance Report FY21/22, City of Malibu Assessment District 98-2, Calle del Barco, Malibu, CA

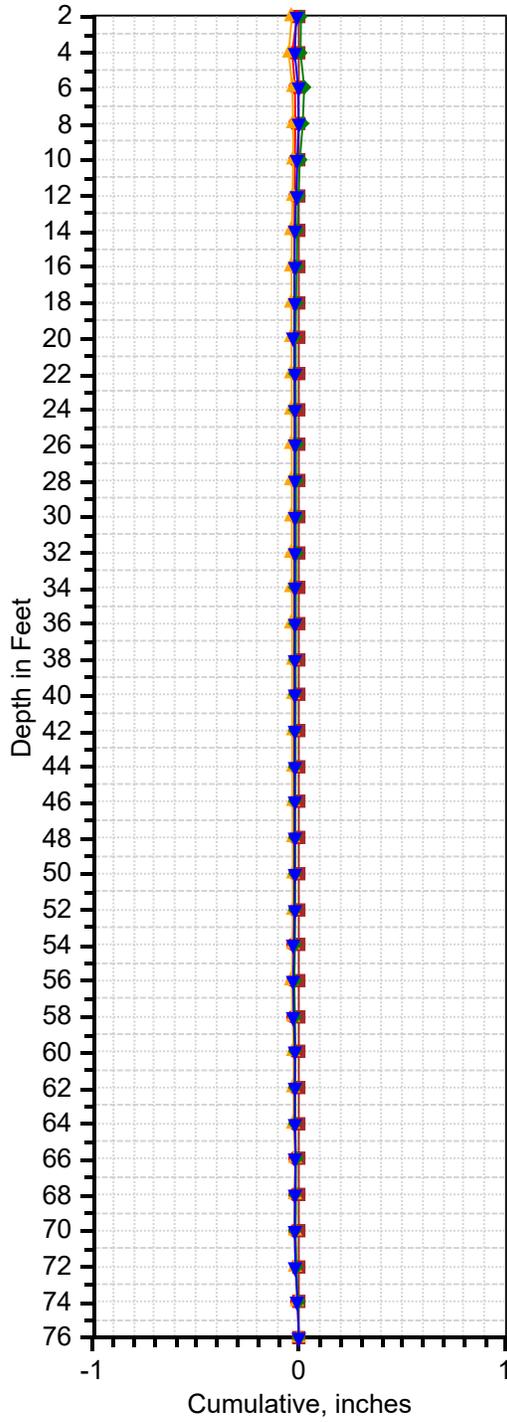
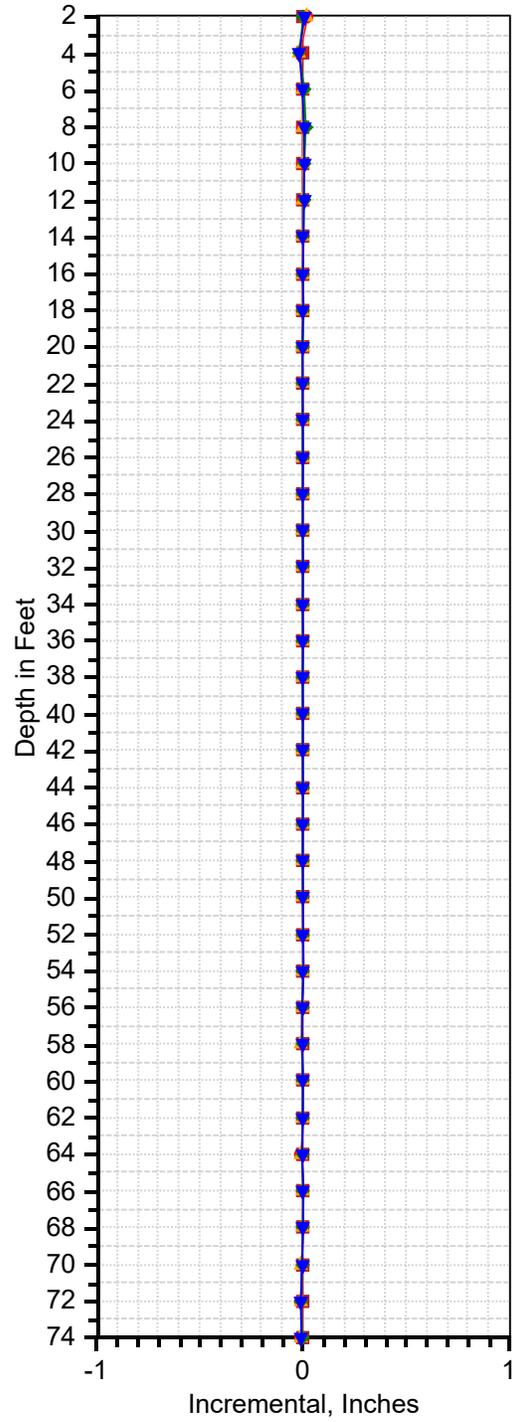
SI-14 A Direction

There are two inclinometers currently surveyed in the Rambla Pacifico Region; SI-13 and SI-14. Neither of the inclinometers displayed discernable shear-type displacement. SI-13 displayed up to about 0.08 inches of apparent deformation above a depth of 20 feet. This is consistent with previously noted “bowing” in the upper portion of the casing, which could be caused by backfill settlement. This type of casing deformation had been detected on SI-13 since installation in 1998. Additional survey methods would be required to exclude or identify a specific cause of the apparent deformation.
