FY20/21 Maintenance and Monitoring

AD98-2, Calle del Barco

Yeh Project No.: 220-277

Subject: Annual Monitoring and Maintenance Report FY20/21, City of Malibu Assessment District 98-2, Calle del Barco, Malibu, CA

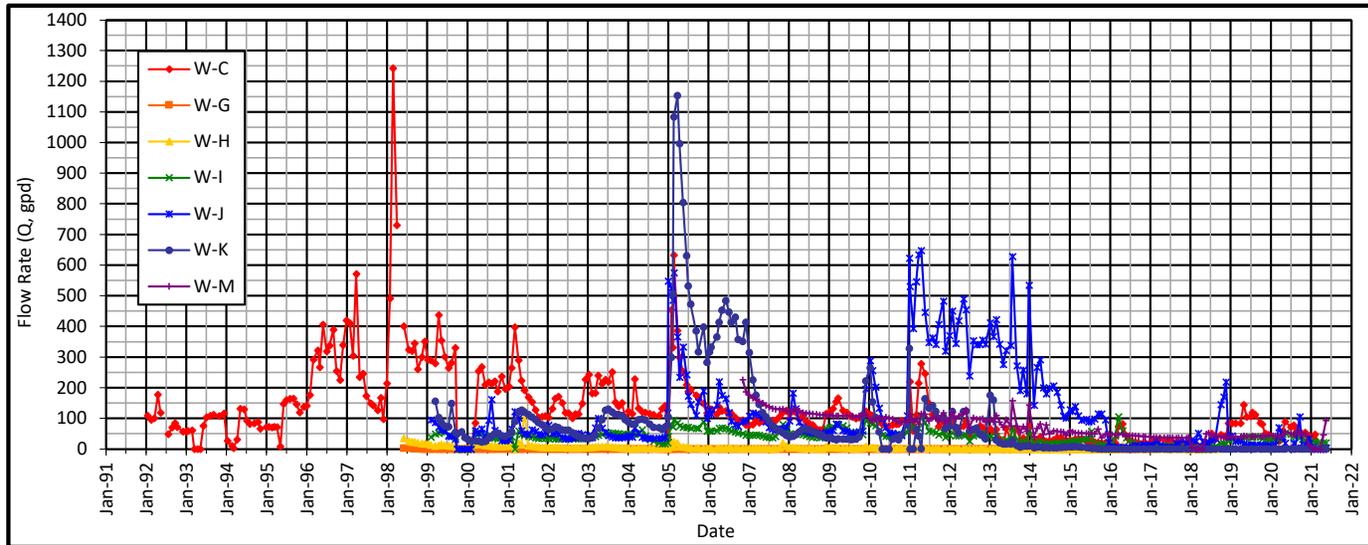
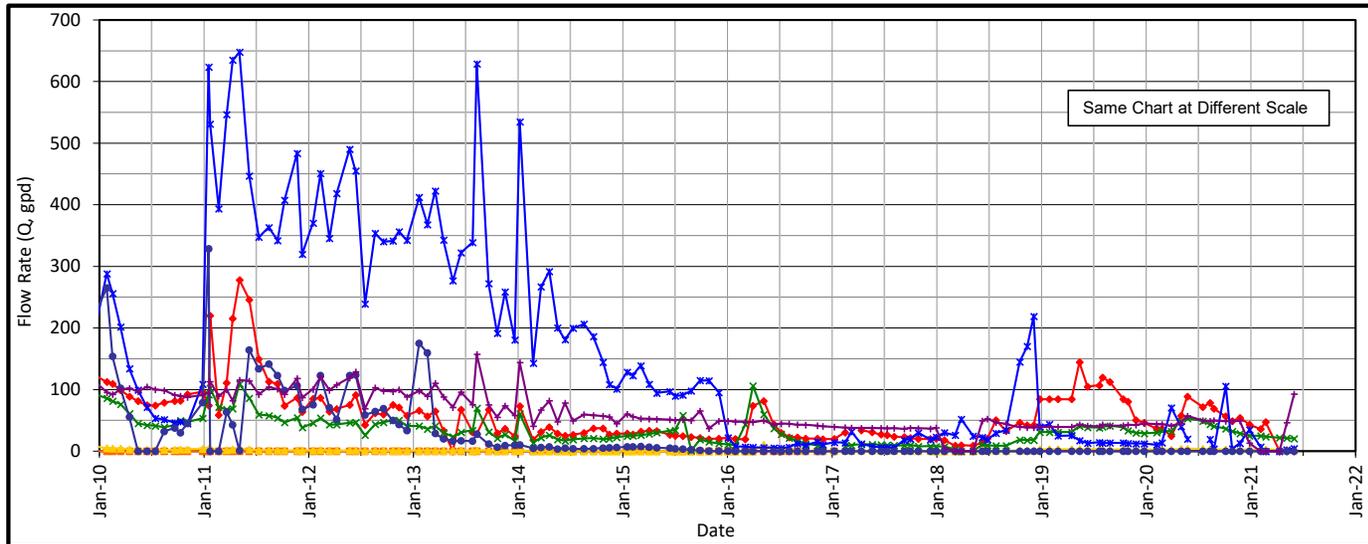
DEWATERING WELL DISCHARGE RATE GRAPH
Rambla Orienta and Slope
Calle del Barco Landslide Assessment District
Malibu, California

Well production typically varies in response to rainfall totals. The dewatering well production decrease over this monitoring year is consistent with the historically low rainfall totals and extended drought conditions at the project.

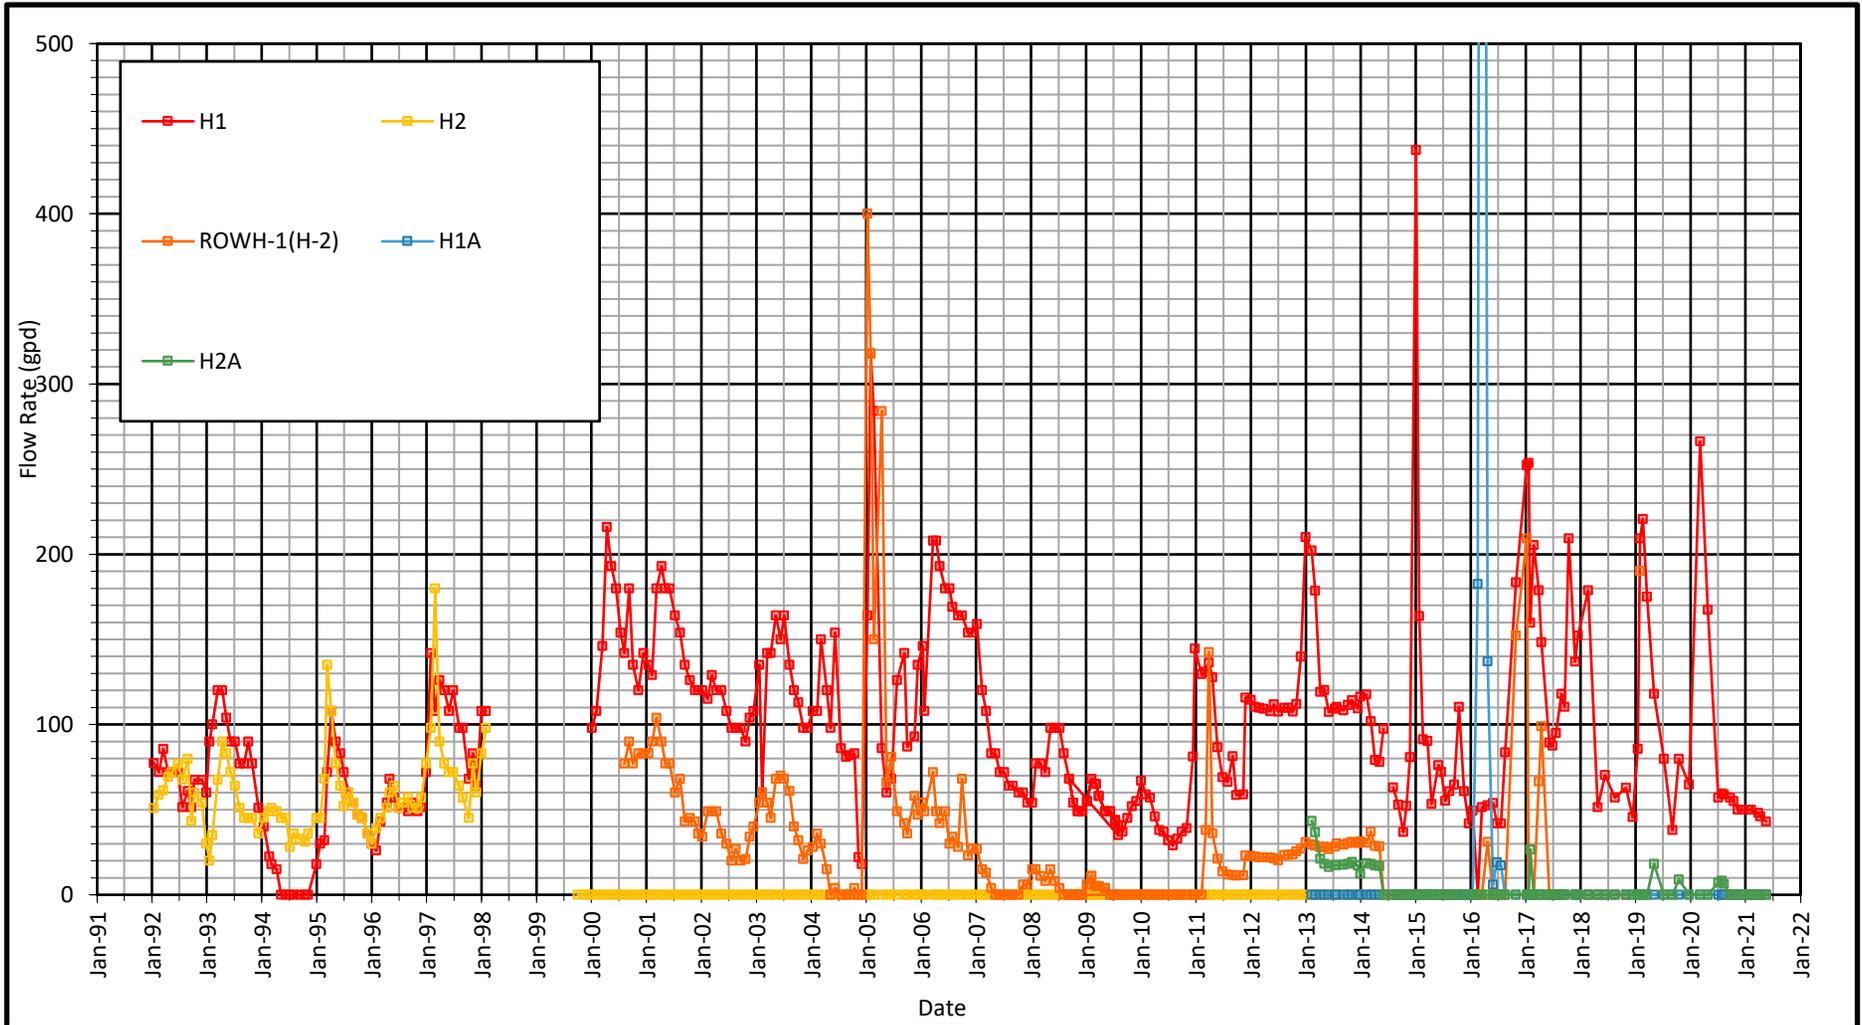
HYDRAUGER DISCHARGE RATE GRAPH
Rambla Orienta
Calle del Barco Landslide Assessment District
Malibu, California

Hydrauger production typically varies in response to rainfall totals. The decrease in hydrauger production over this monitoring year is consistent with the historically low rainfall totals and extended drought conditions at the project.
